PUMPOUT REPORT 2016

**California Clean Vessel Act
Pumpout Performance Report**

**San Francisco Estuary Partnership
The Bay Foundation**

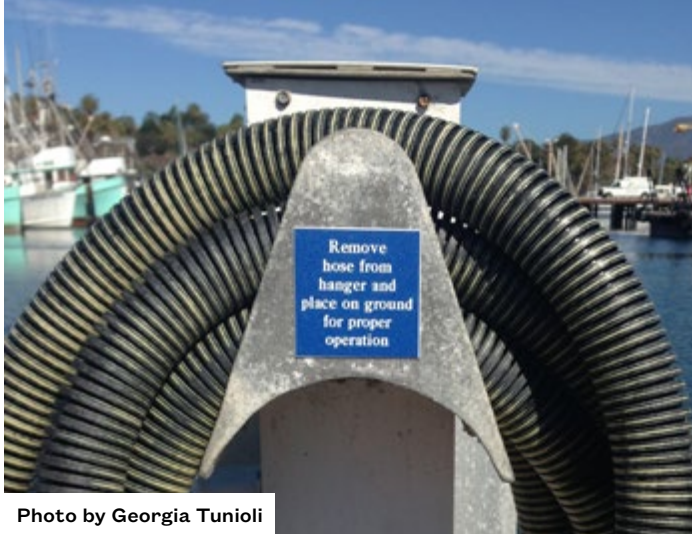
This sign works as a helpful reminder for boaters to remove the hose from the hanger for optimum performance of the pumpout system.

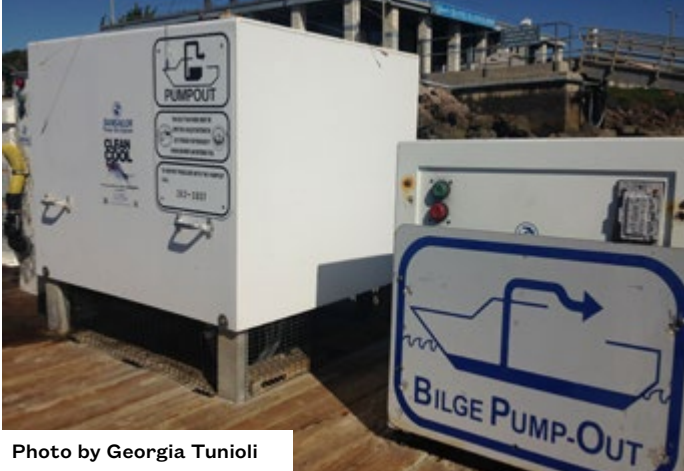
Located on the Harbor Patrol dock, alongside the sewage pumpout, is a bilge pumpout. Sewage pumpouts are unable to properly process oily bilge water and should only be used for sewage. If management notices a sewage pumpout being used for oily bilge water they can post appropriate signage and consider installing a bilge pumpout. In order to ensure this bilge pumpout is not used improperly, a boater must ask Harbor Patrol staff to turn it on. Before staff turns on the bilge pumpout, they use a handheld sensor to detect if there are any flammable liquids in the bilge. If flammable liquids are present or Harbor Patrol determines the use of the bilge pumpout is not appropriate, the boater is directed to a boat yard to ensure the material is properly disposed.

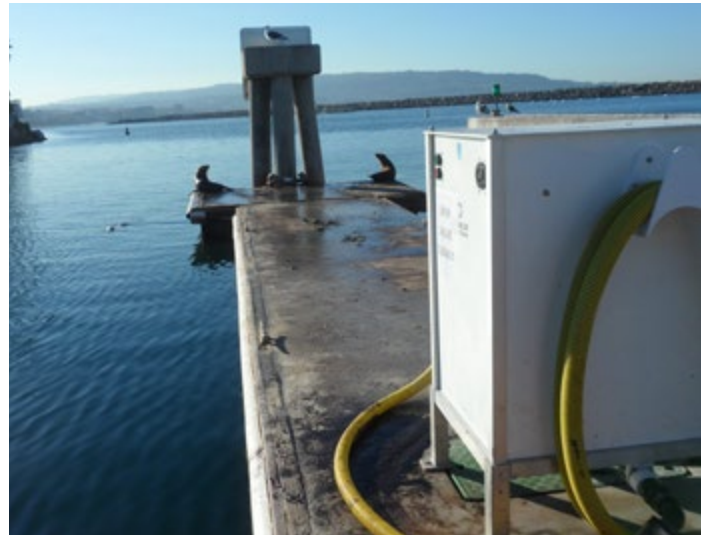
Sea lions can be fun to watch but are also a nuisance. They can damage docks and accumulated waste is unsightly. To combat this problem, King Harbor installed a rolling railing system that acts as a physical deterrent to sea lions. This solution works very well.
