Malibu Lagoon Restoration and Enhancement Project Comprehensive Monitoring Report (Year 3)

May 2016

Prepared by: The Bay Foundation

Prepared for: State of California, Department of Parks and Recreation

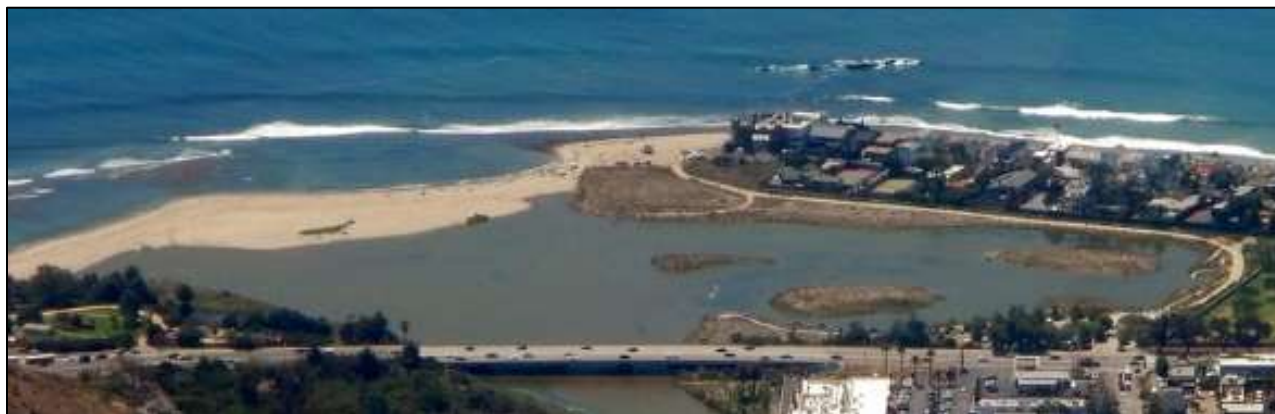
Figure 1. Aerial view of Malibu Lagoon from Lighthawk flight on 23 June 2015 (closed berm).

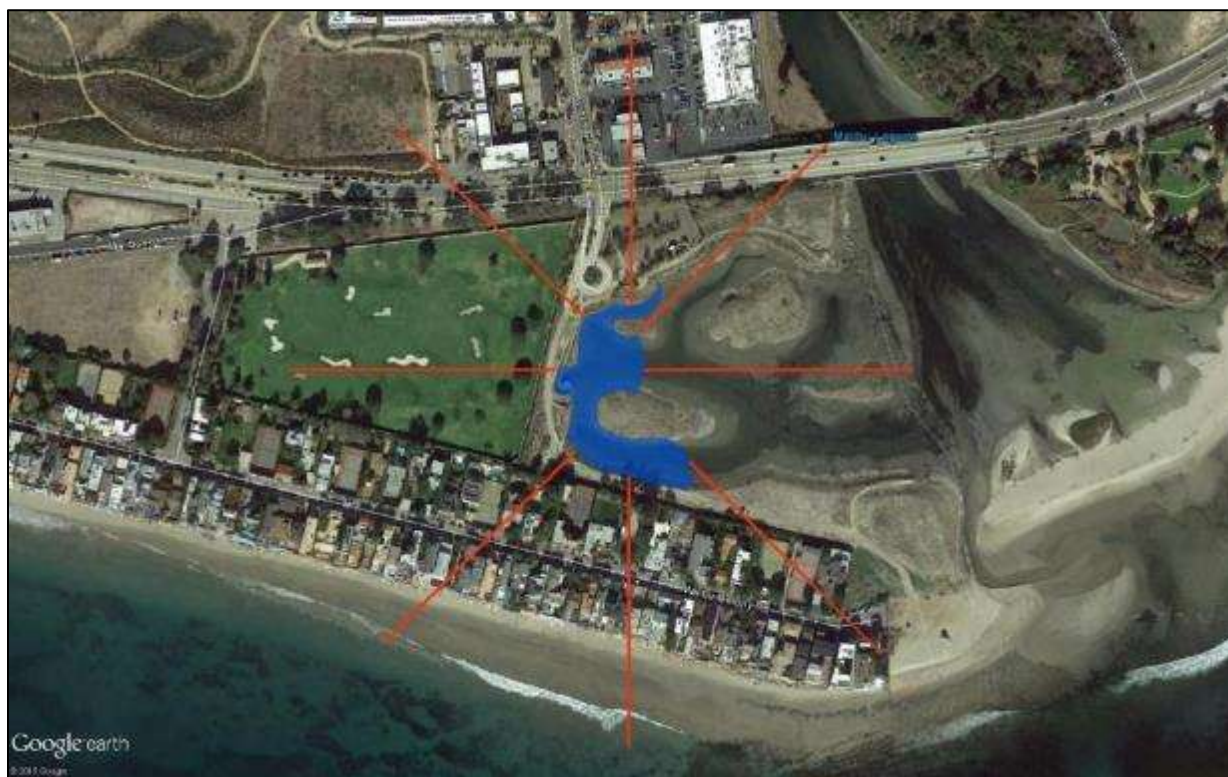
Figure 4 displays the Assessment Area (AA) and buffer lines for the post-restoration CRAM survey. The AA is approximately one hectare, or two and a half acres of wetland habitats, following guidelines described in the User Manual. The AA location is approximately the same as the pre-restoration survey.

Figure 4. Post-restoration CRAM Assessment Area (blue polygon) at Malibu Lagoon. Red lines indicate radiating (potential) buffer lines.

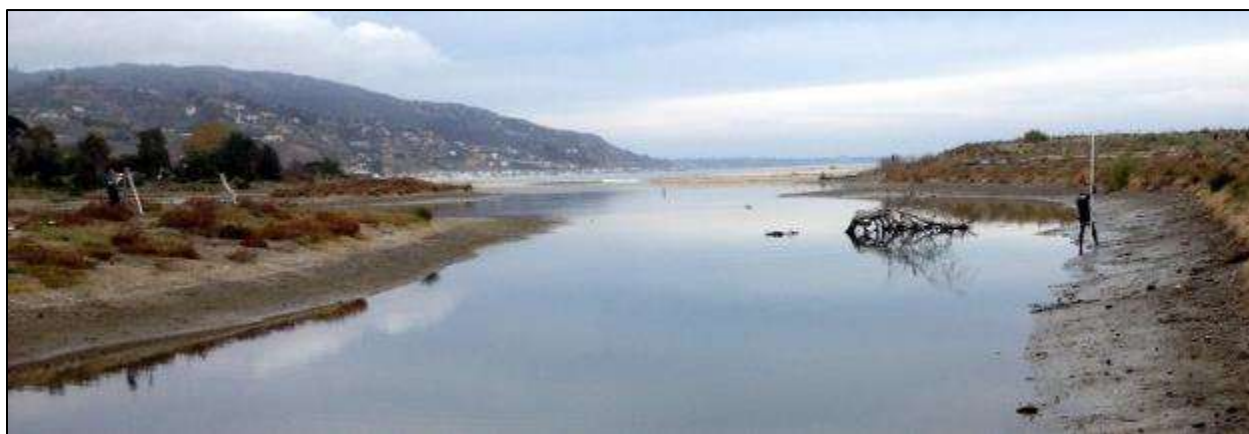
Figure 5. Cross-channel elevation surveys at Malibu Lagoon, 19 January 2016.

Five permanent and repeatable cross-section locations were monitored for three consecutive post-restoration years on 14 February 2013, 18 December 2014, 19 January 2016 (Figures 5 and 6). Horizontal and vertical locations of cross-section end-points were fixed by monuments. Sediment scour or deposition depths were calculated from the data.

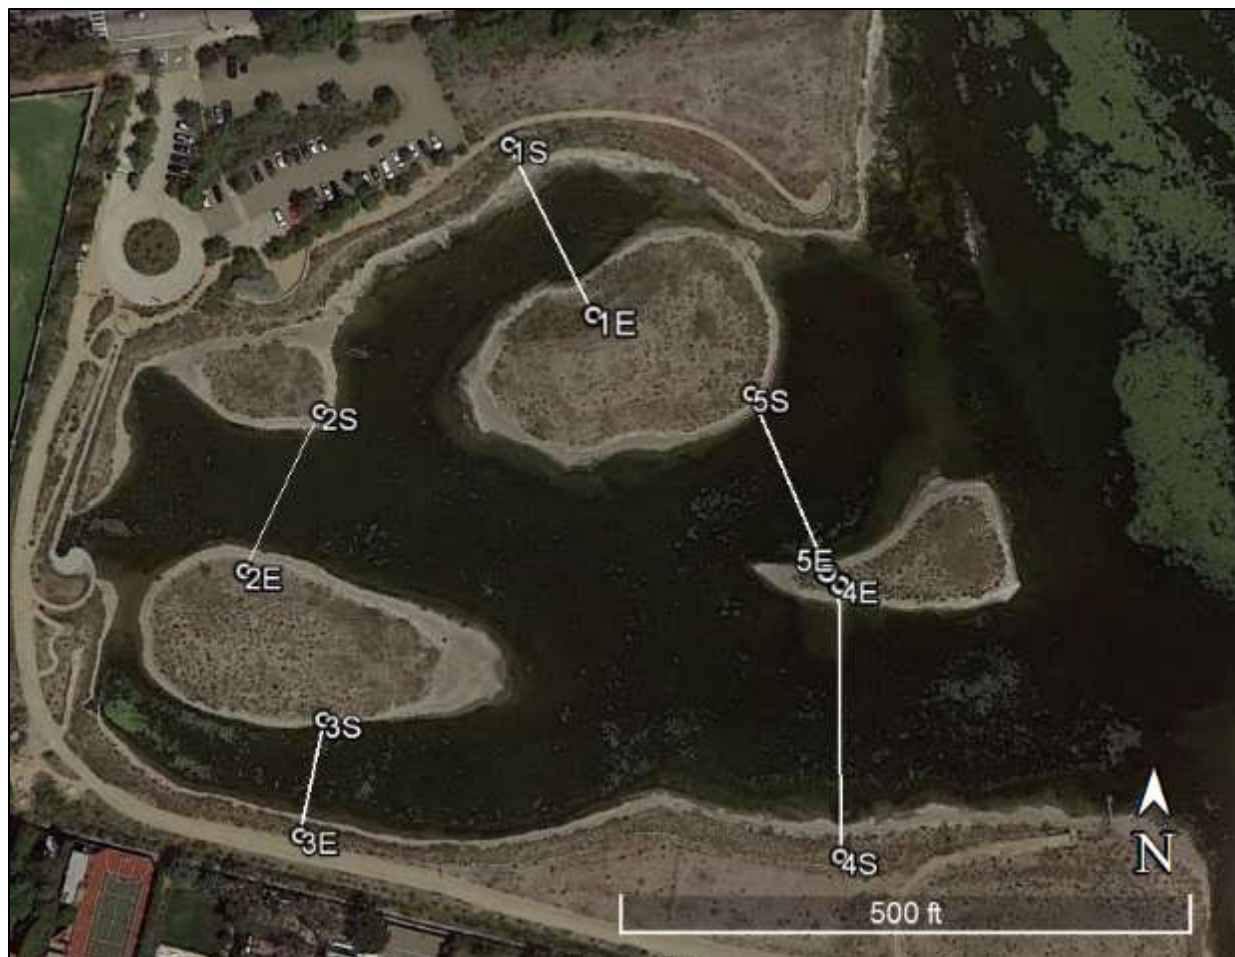
Figure 6. Map of cross-channel elevation transect locations.

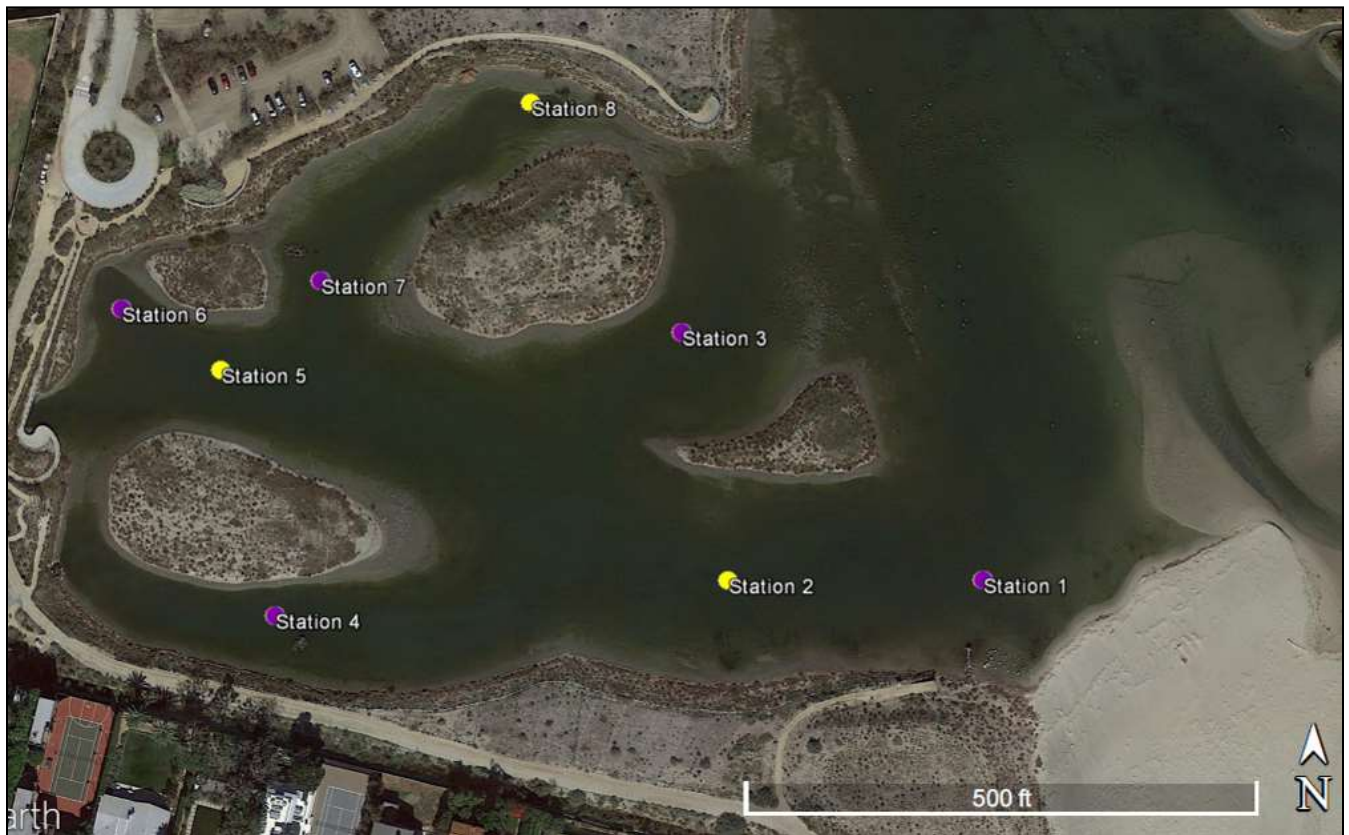
Figure 15. Map of post-restoration vertical profile, SAV/algae, surface and bottom water nutrient, and sediment survey stations. Stations 2, 5, and 8 are the locations of the three permanently-deployed YSI data sondes (in yellow).

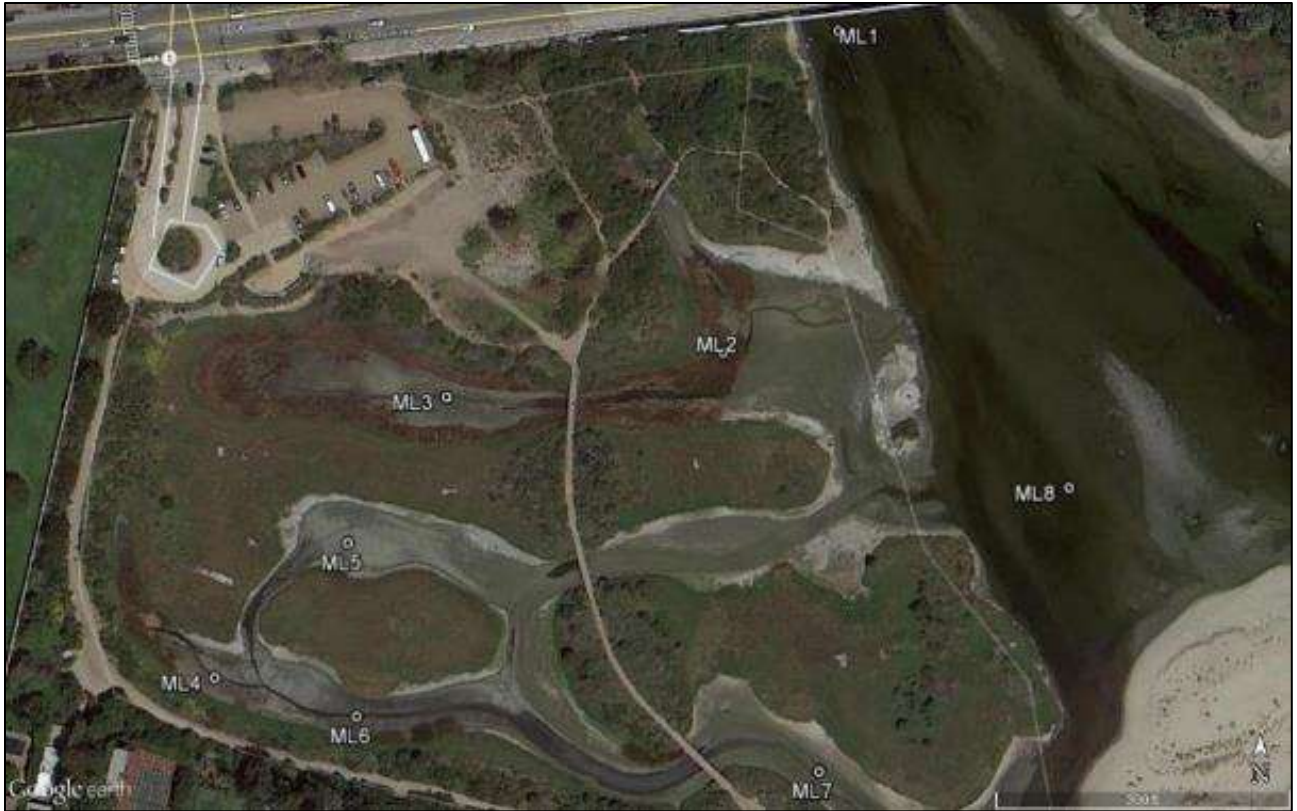
Figure 16. Map of pre-restoration water quality monitoring stations. ML2 and ML6 are the locations of the pre-restoration permanently-deployed YSI data sondes.

Data were collected between May 2013 and December 2015 at three permanent post-restoration stations. Dates of deployment varied by station due to probe malfunctions, servicing, or calibration glitches (Table 4). Post-restoration monitoring stations were located within the western Lagoon's main channel (Station 2) and within the western Lagoon's back channels (Stations 5 and 8) (Figure 15). When possible, data were compared to pre-restoration data collected from hydrologically similar back channels (ML2 and ML6) (Figure 16). Pre-restoration data were collected between October 2006 and June 2012.

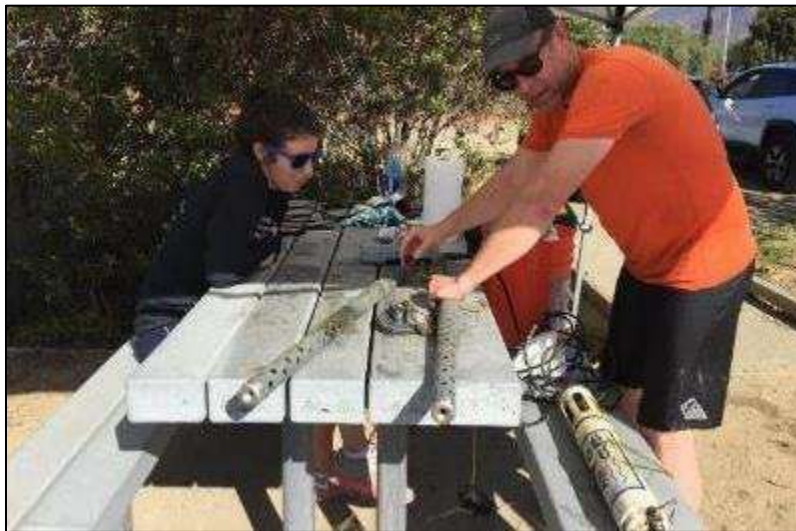
Figure 17. In-field sonde calibration; 29 September 2015.

Data were downloaded, and the sondes were calibrated, cleaned, and redeployed approximately once monthly (Figure 17). YSI calibration instructions (www.ysi.com) and Hydrolab calibration instructions (www.otl.com) were followed for each calibration and each probe. Data output from the sondes were exported into a spreadsheet and QAQC procedures were performed by removing inaccurate data from the analyses, including: data from probes not meeting full calibration or operating standards, data that were acquired when the sonde was not submerged, data that were outside of user manual range specifications, and data that were collected when the battery readings were insufficient. Malfunctioning probes and sondes were sent back to the manufacturer for maintenance. Additionally, YSI data loggers at Station 2 and Station 6 were replaced with new Hydrolab data loggers because of probe failure.

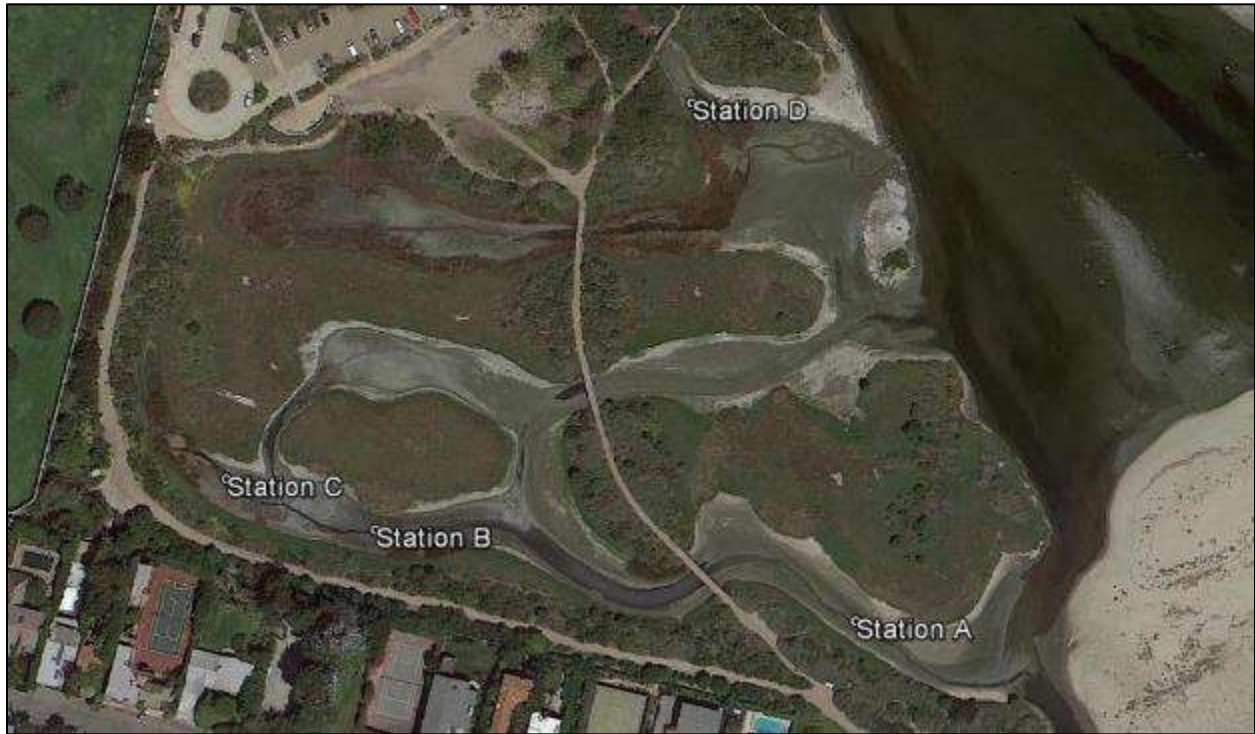
Figure 27. Map showing the location of pre-restoration sediment monitoring stations.

Sediment data were collected during pre-restoration conditions at four sampling locations (Figure 27) during four sampling events in September 2006, April 2007, September 2007, and April 2008. Pre-restoration sediment samples were processed for nitrates, total phosphorus, Total Kjeldahl nitrogen, and total nitrogen. Whenever possible, site-wide data trends are compared for pre- and post-restoration sediment nutrient data.

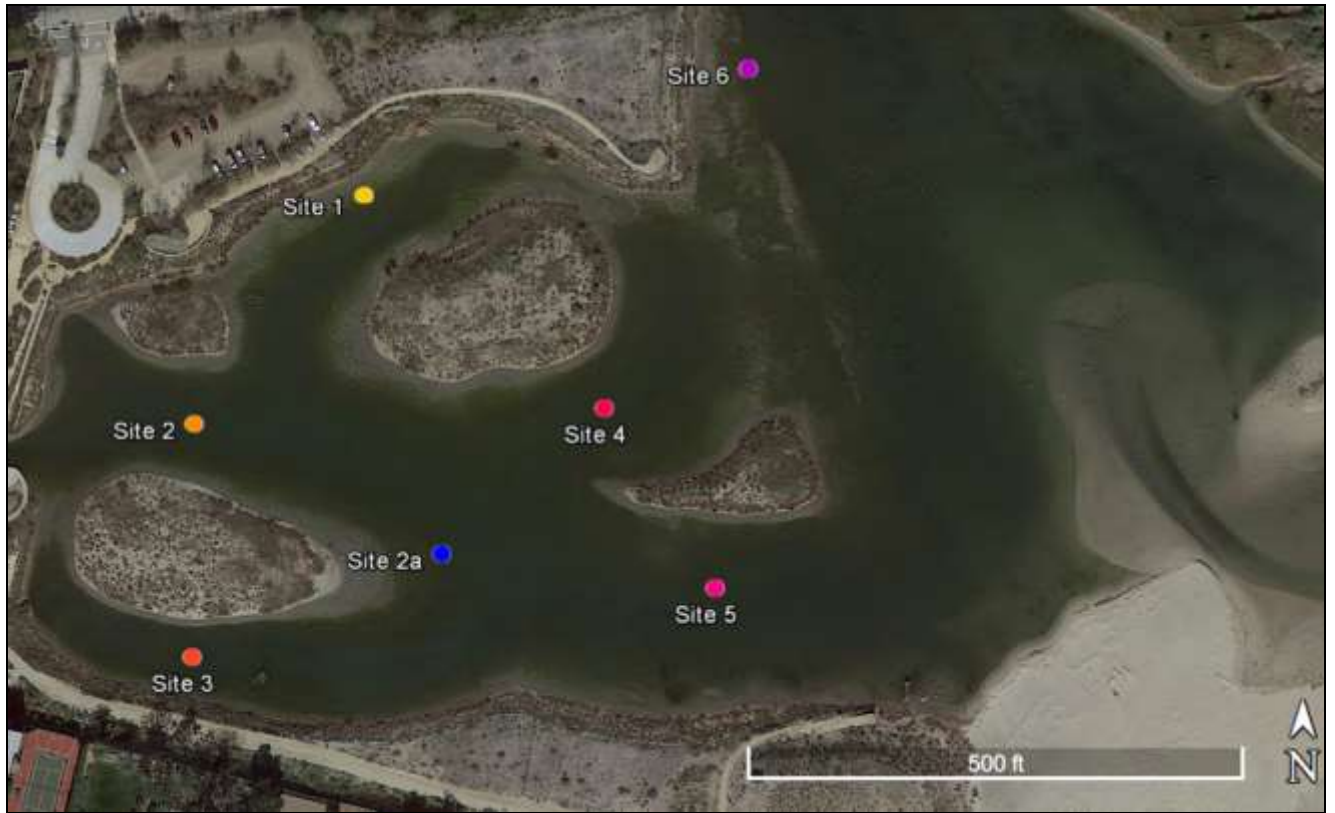
Figure 30. Map of the six permanent fish monitoring Sites.

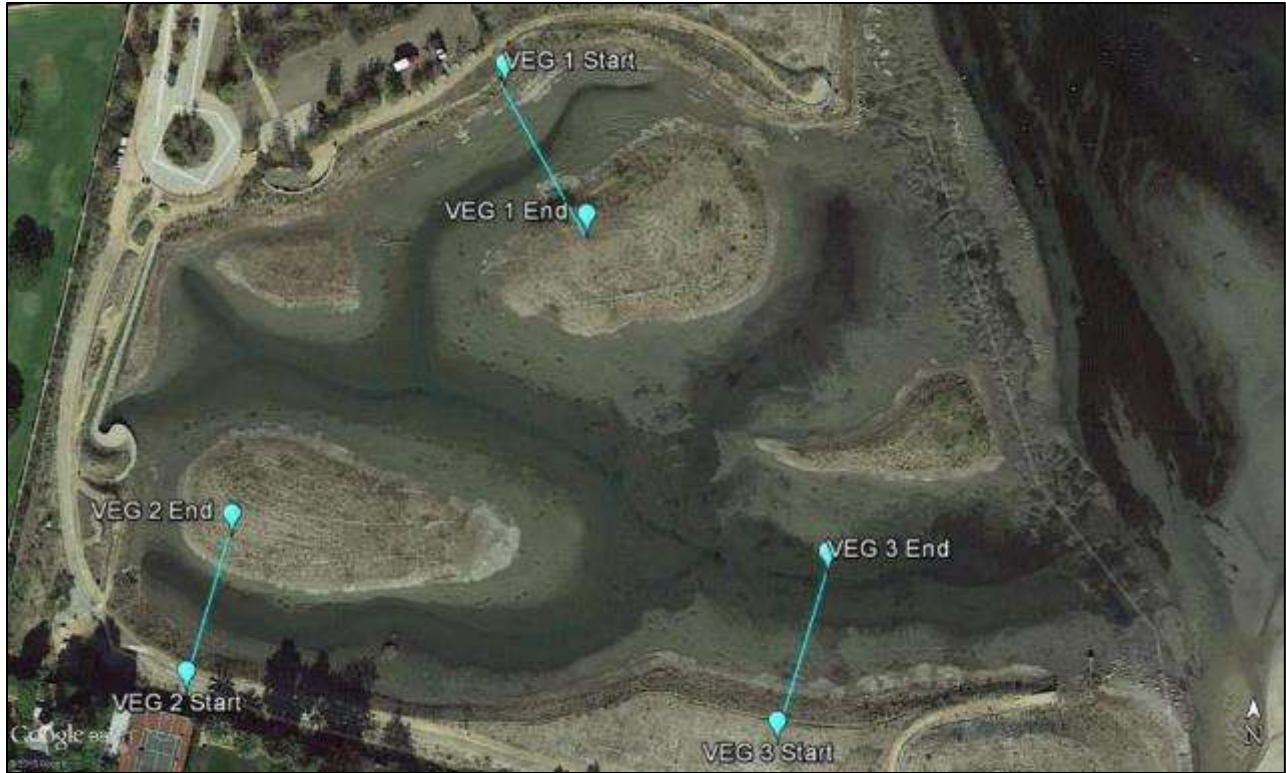
Figure 32. Map of vegetation transect locations and start/end points.

Data for absolute percent cover of native/nonnative vegetation species were collected along three, 50-meter transects (Figure 32) using the line-intercept method on 15 March 2013, 7 May 2014, 18 December 2014, 5 May 2015, and 22 December 2015. These data were combined to provide a comprehensive set of post-restoration vegetation surveys to evaluate native and non-native relative vegetation cover over time.

Each transect location was recorded with a submeter global positioning system (GPS) unit and photographed at each end. Absolute cover data were calculated based on the total distance for each species within each transect. Species data were collected to an accuracy of 0.01 m along each 50-meter transect. Species were categorized into native or non-native and added together. Cover data were relative, as non-vegetated mudflat and channel habitats were removed from the total transect length. Data were displayed as a bar graph for each transect.

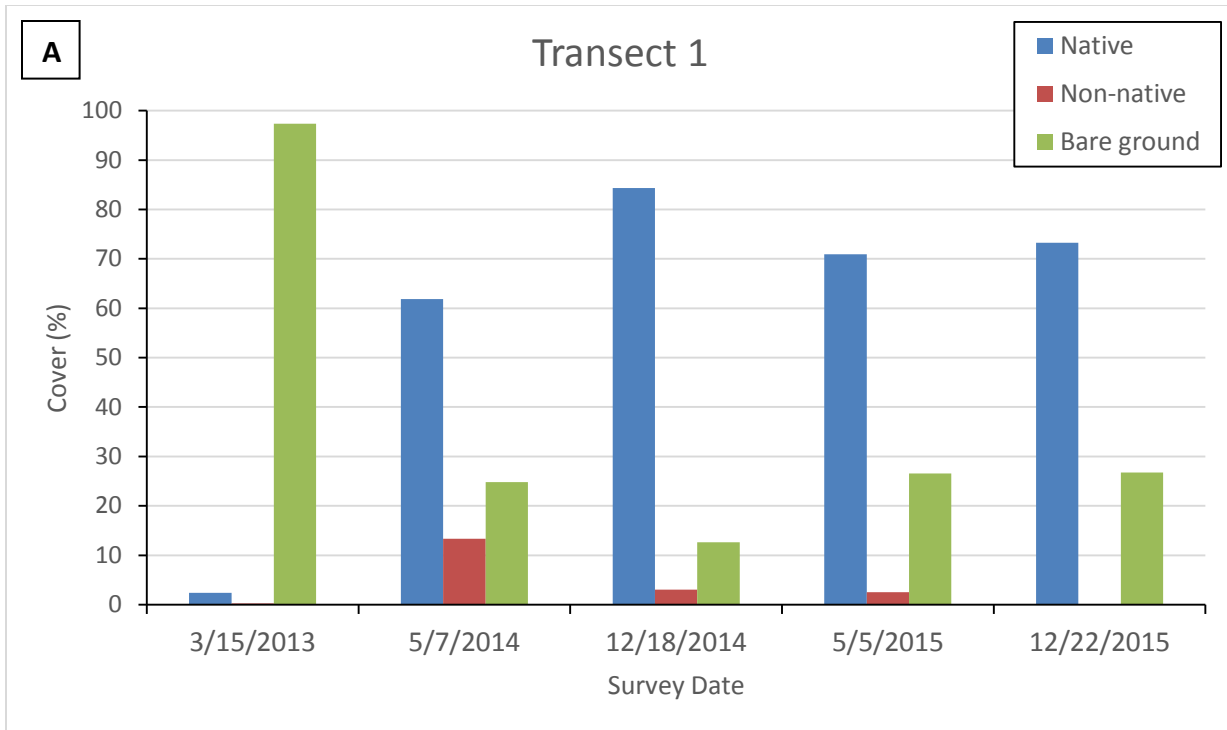
Figure 33. Graphs displaying absolute cover of vegetation across each Transect: (A) 1, (B) 2, and (C) 3.

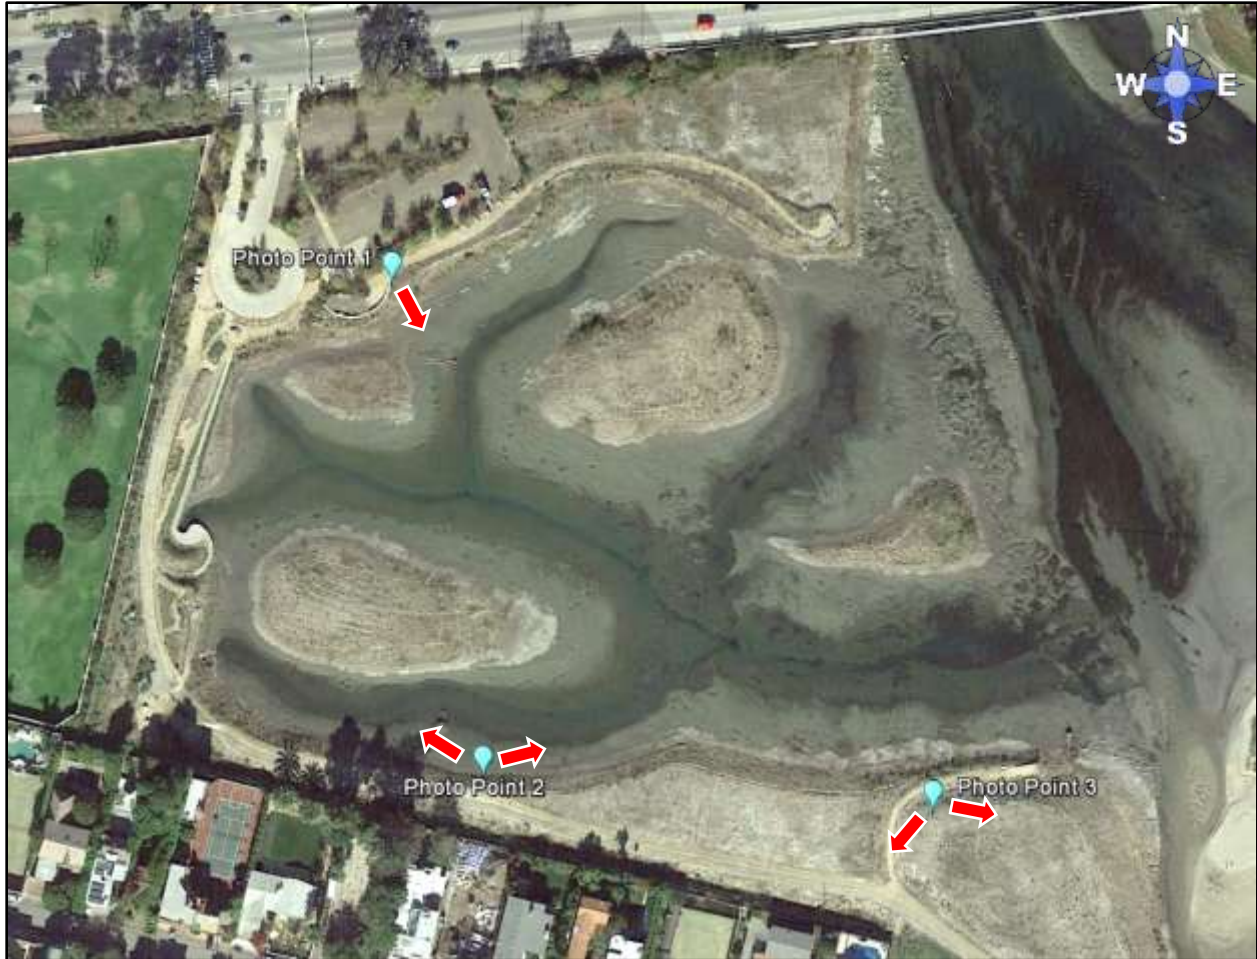
Figure 34. Map of photo-point locations and bearings for the surveys.

Three permanent, photo-monitoring locations (Table 20 and Figure 34) were established to visually document the establishment of vegetation and large-scale landscape changes following restoration. Stations were located using GPS and baseline photographs. The baseline photo-point survey was conducted immediately post-restoration on 15 March 2013 during a low tide; post-restoration surveys were conducted again on 7 May 2014, 18 December 2014, 5 May 2015, and 22 December 2015 (Table 20). Approximate bearing is relative to the center of the photograph; detailed bearing ranges are included on the datasheets.

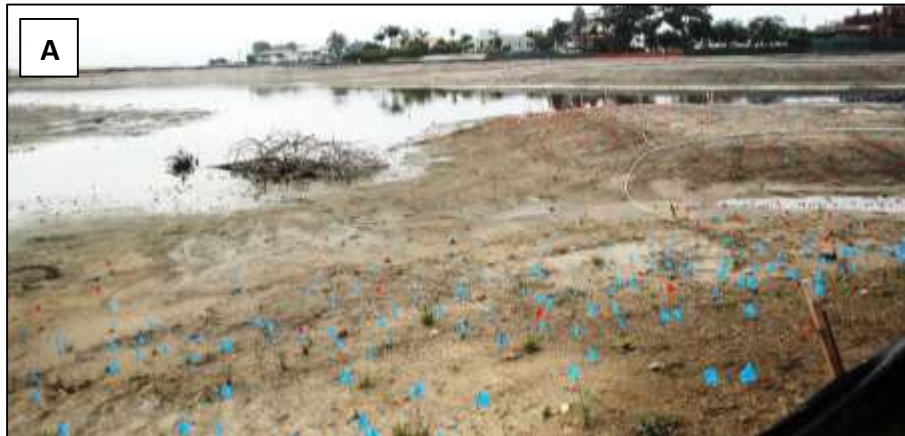
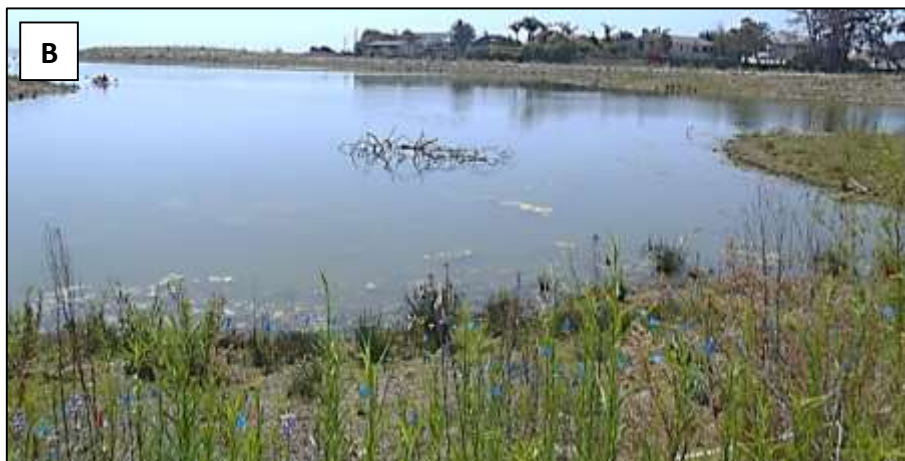
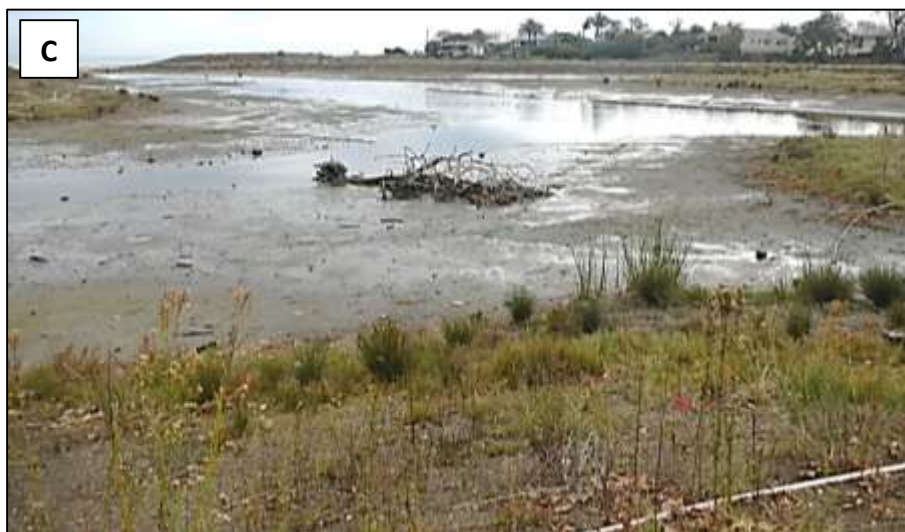
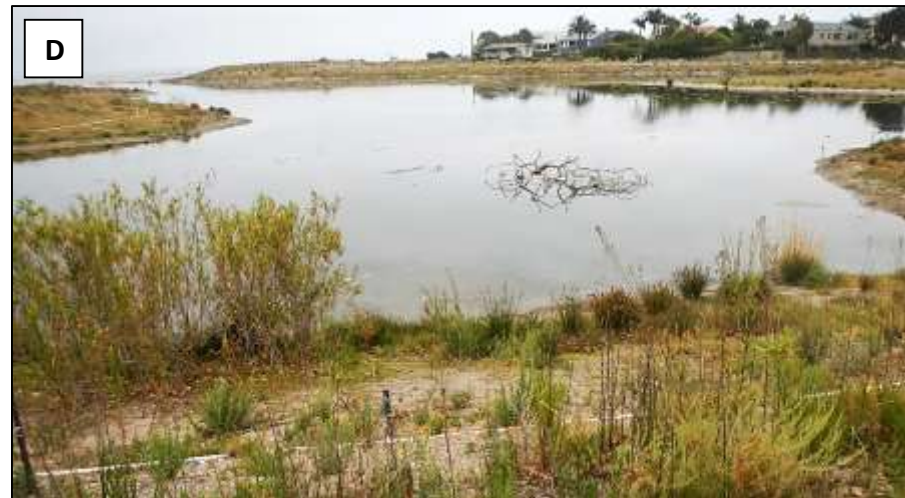
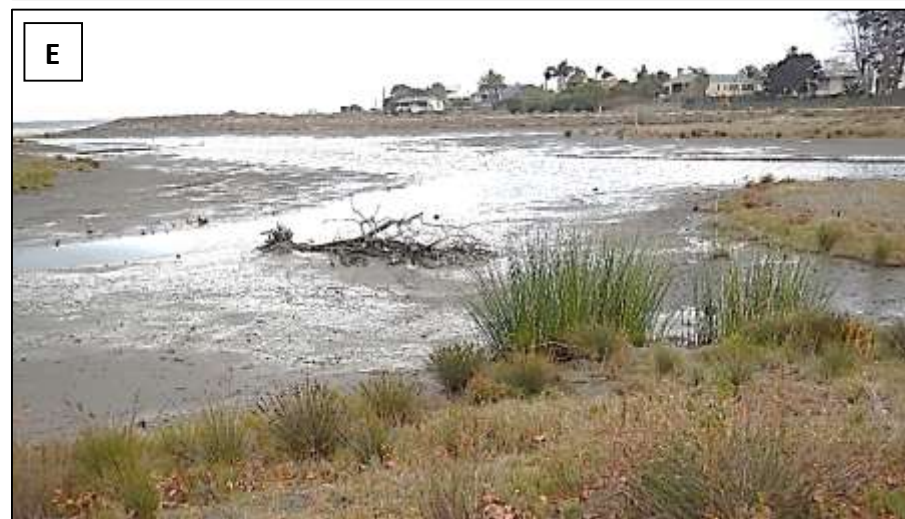
Figure 35. Photograph of Photo Point 1, bearing 155° on (A) 15 March 2013; (B) 7 May 2014; (C) 18 December 2014; (D) 5 May 2015; (E) 22 December 2015.

A total of five photos were taken at three locations to assess a range of habitat types across the restoration area. Figures 35 through 39 (A - E) display the photos from the five locations post-restoration on the three survey dates, respectively.

Consistent with the evaluation for plant cover transect monitoring and CRAM scores, the post-restoration georeferenced photos show a consistent increase in vegetation over time, with a large increase after the initial post-restoration Photo Point survey. Unlike the prolific growth seen in the second and third photo point surveys (March 2014 and December 2014), the third year surveys (May 2015 and December 2015) showed more subtle variations. Gaps in vegetation seen in the December 2015 photos but not in the May 2015 shots were either from seasonal vegetation variation, post-restoration weed management, or slight shifts in the photographer's perspective.

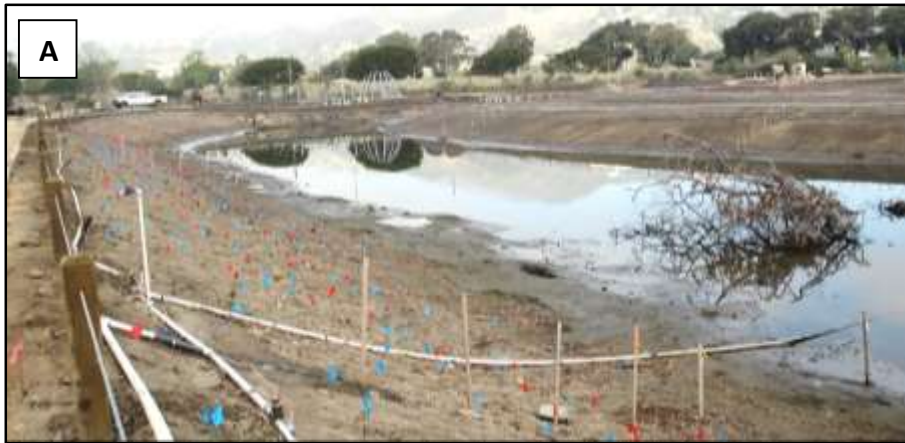
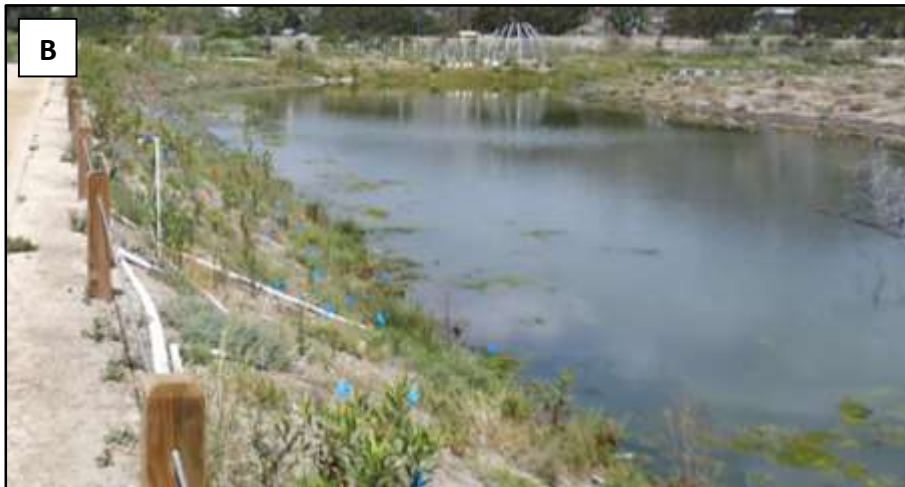
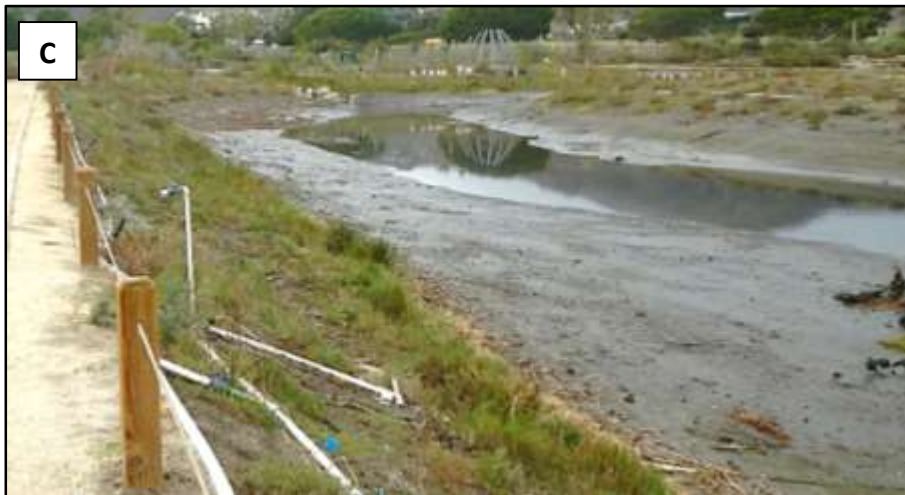
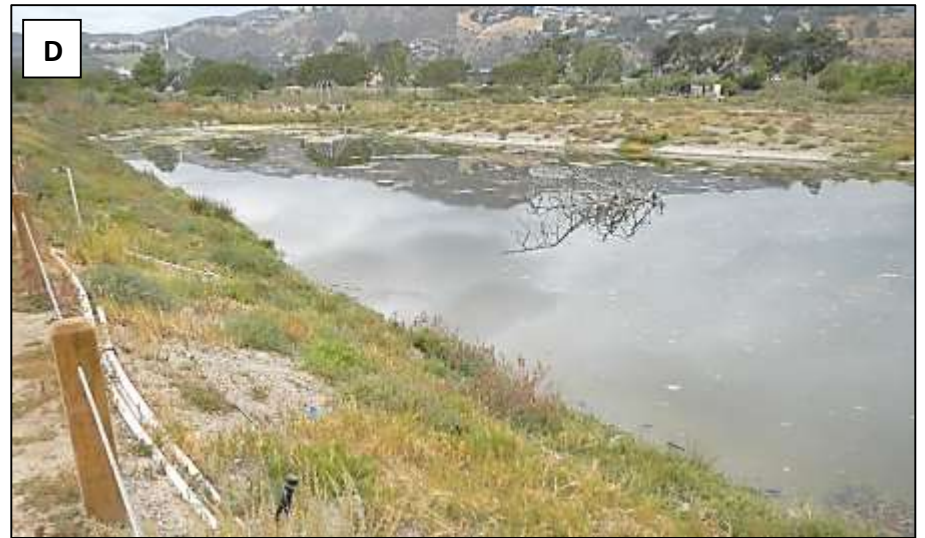
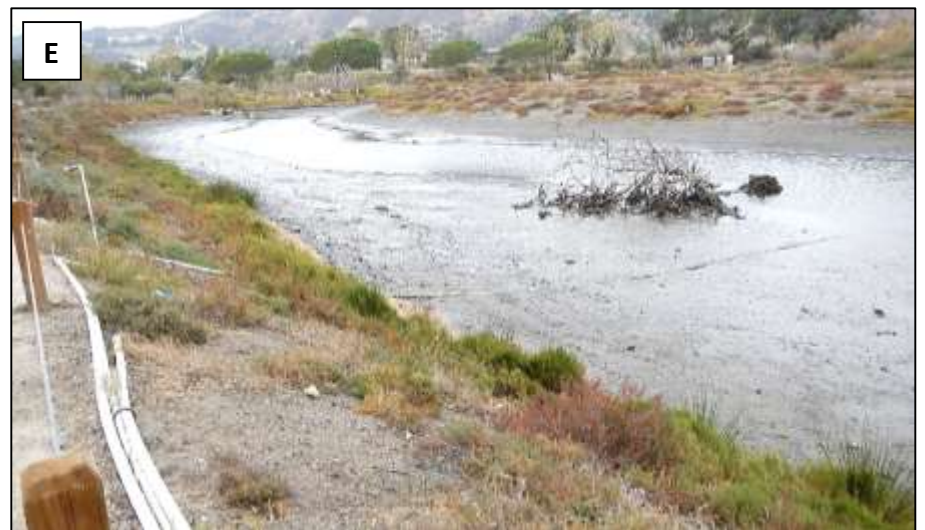
Figure 36. Photograph of Photo Point 2, bearing 300° on (A) 15 March 2013; (B) 7 May 2014; (C) 18 December 2014; (D) 5 May 2015; (E) 22 December 2015.

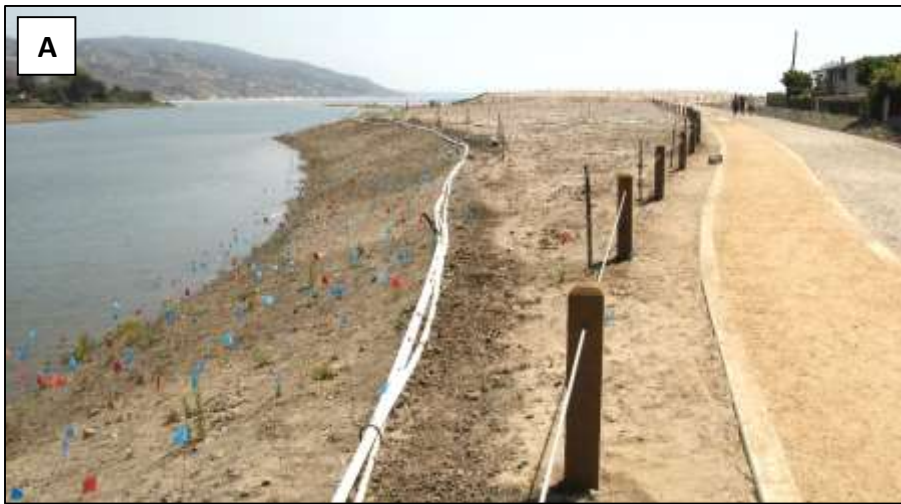
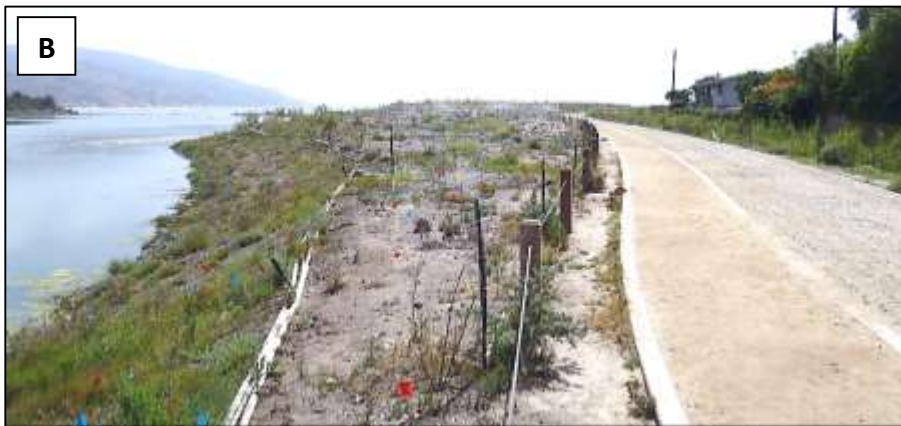
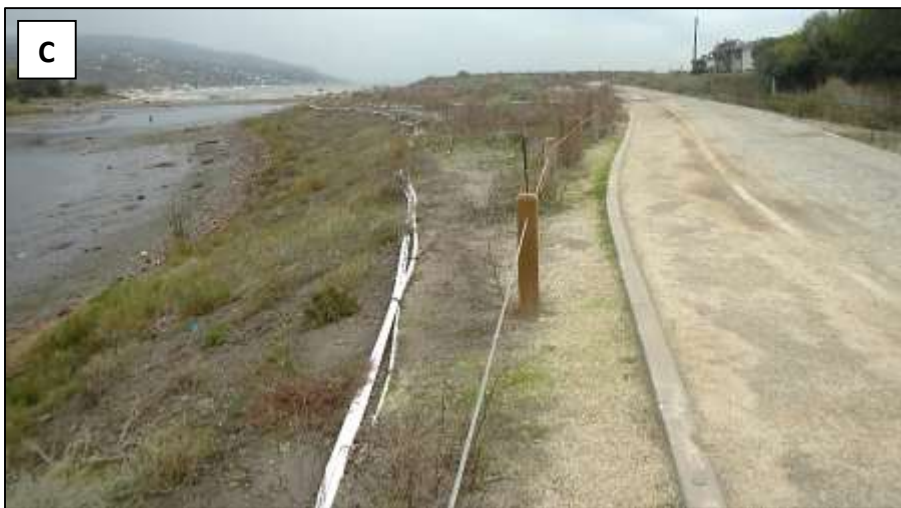
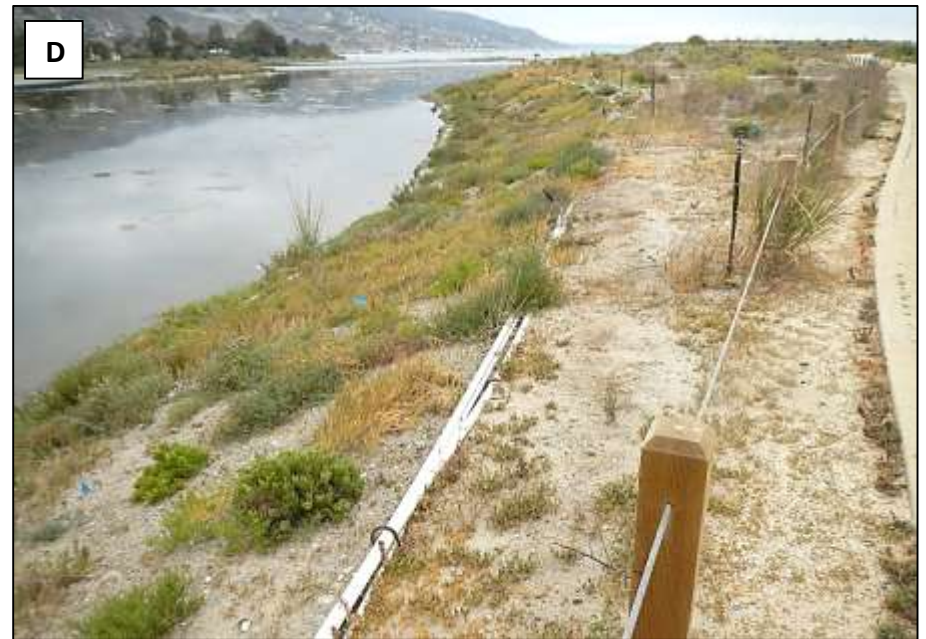
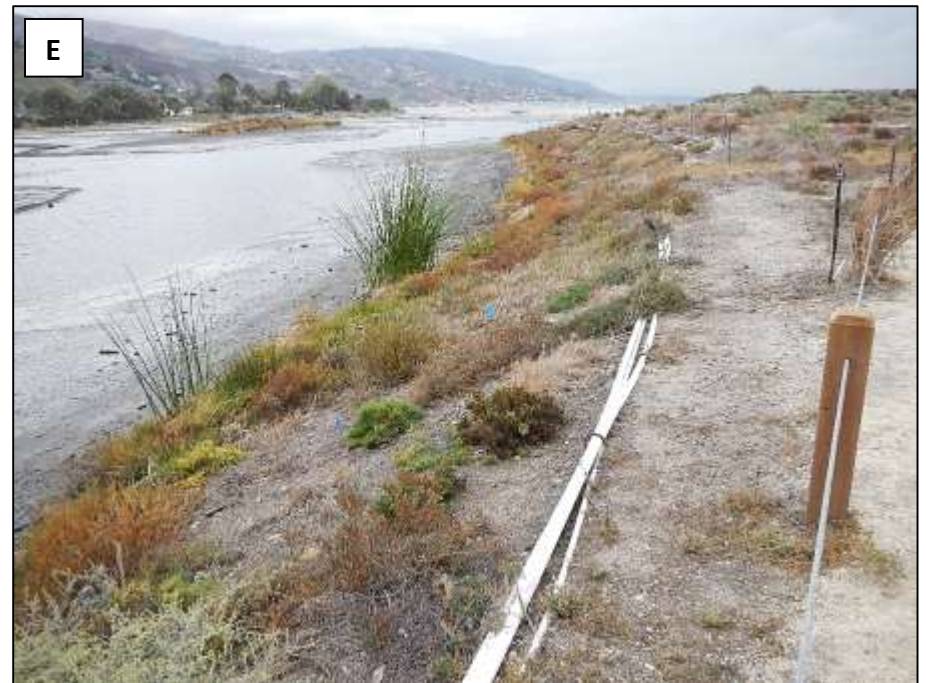
Figure 37. Photograph of Photo Point 2, bearing 75° on (A) 15 March 2013; (B) 7 May 2014; (C) 18 December 2014; (D) 5 May 2015; (E) 22 December 2015.

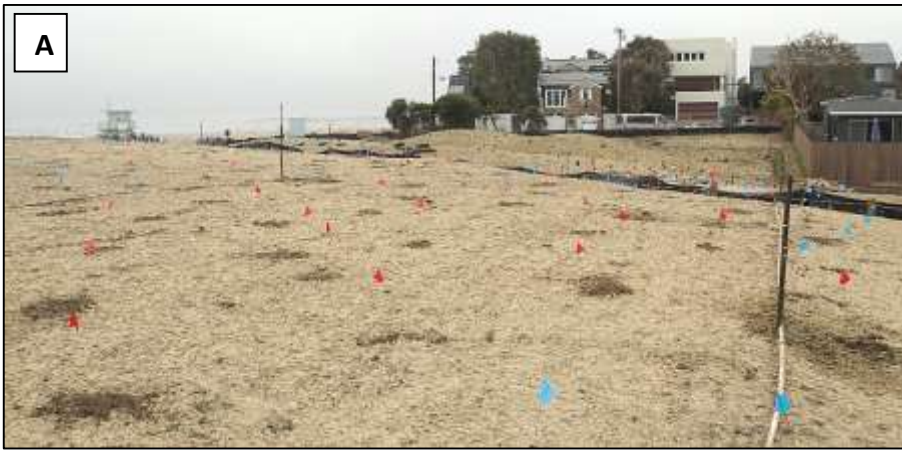
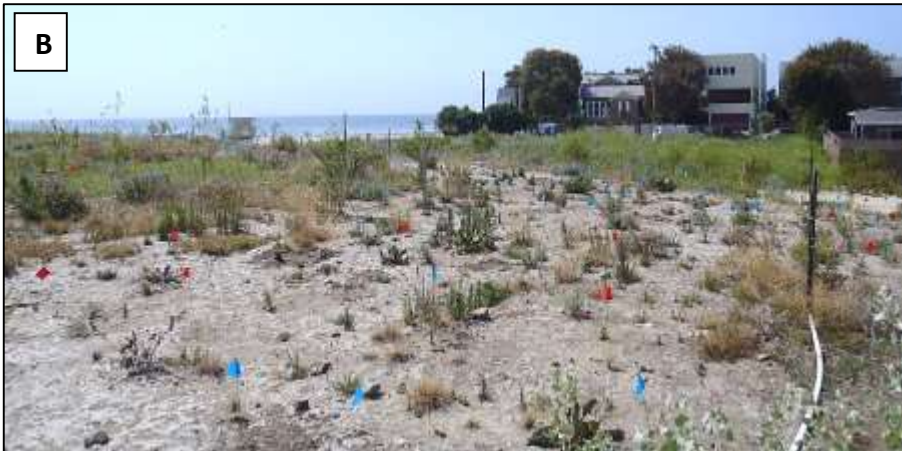
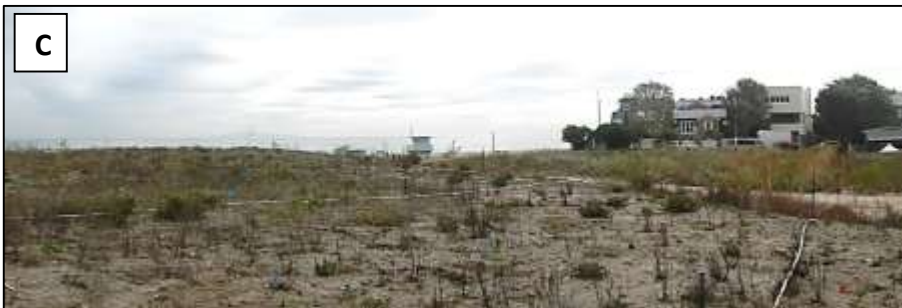
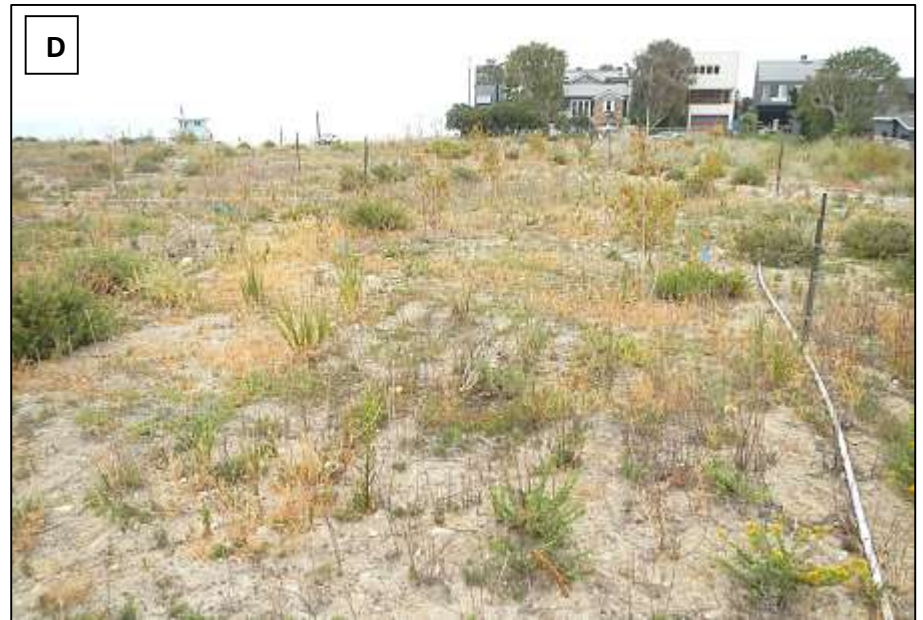
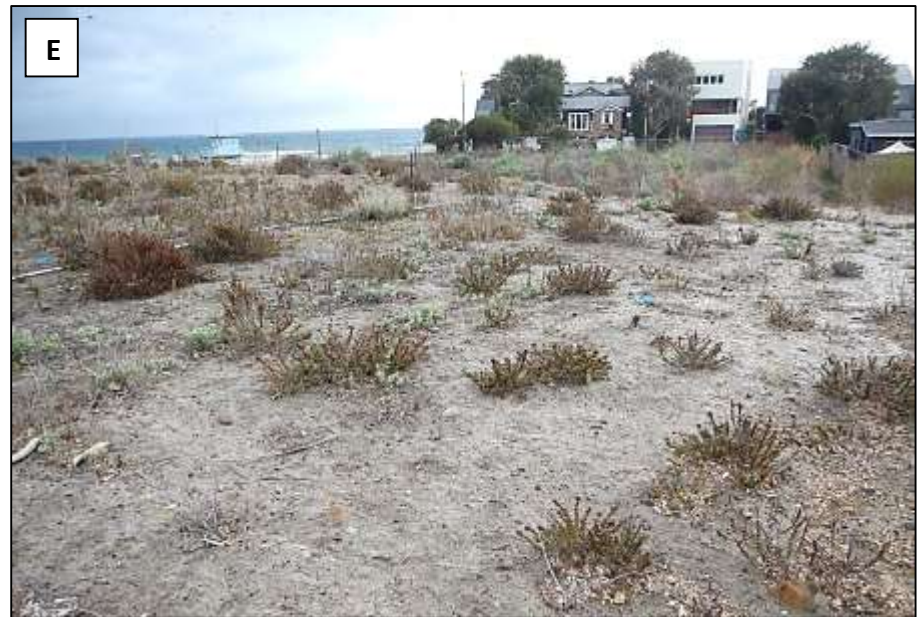
Figure 38. Photograph of Photo Point 3, bearing 220° on (A) 15 March 2013; (B) 7 May 2014; (C) 18 December 2014; (D) 5 May 2015; (E) 22 December 2015.
