Malibu Lagoon Restoration and Enhancement Project Comprehensive Monitoring Report (Year 3)

May 2016

Prepared by: The Bay Foundation

Prepared for: State of California, Department of Parks and Recreation

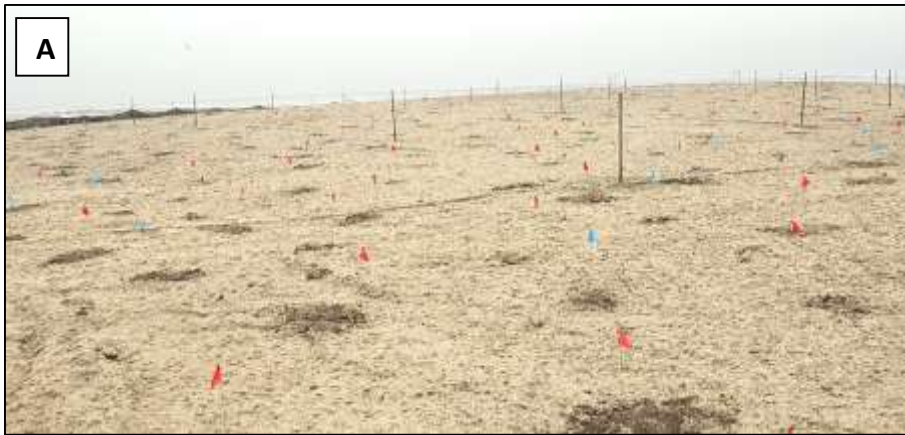
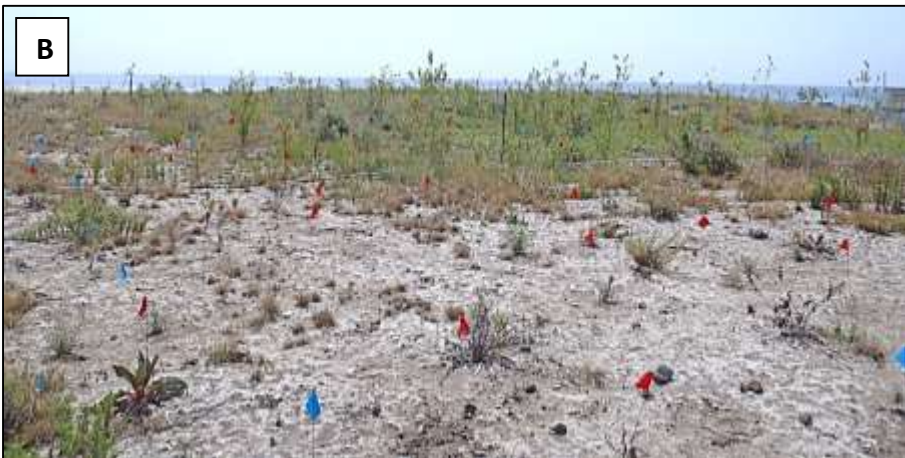
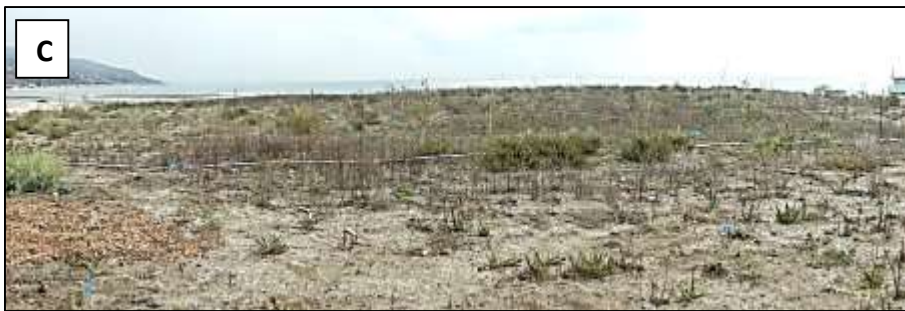
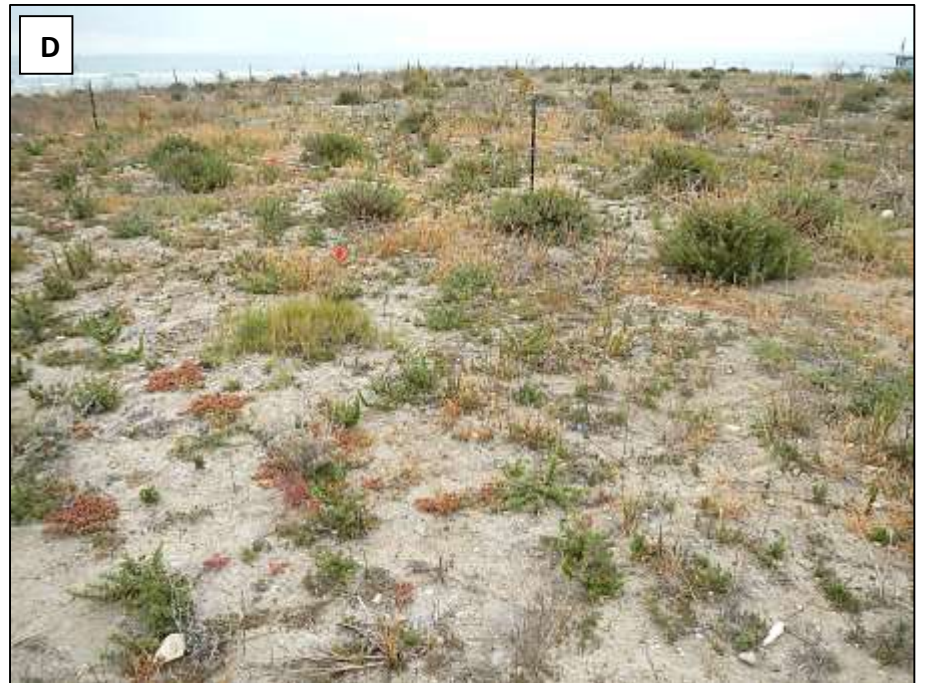
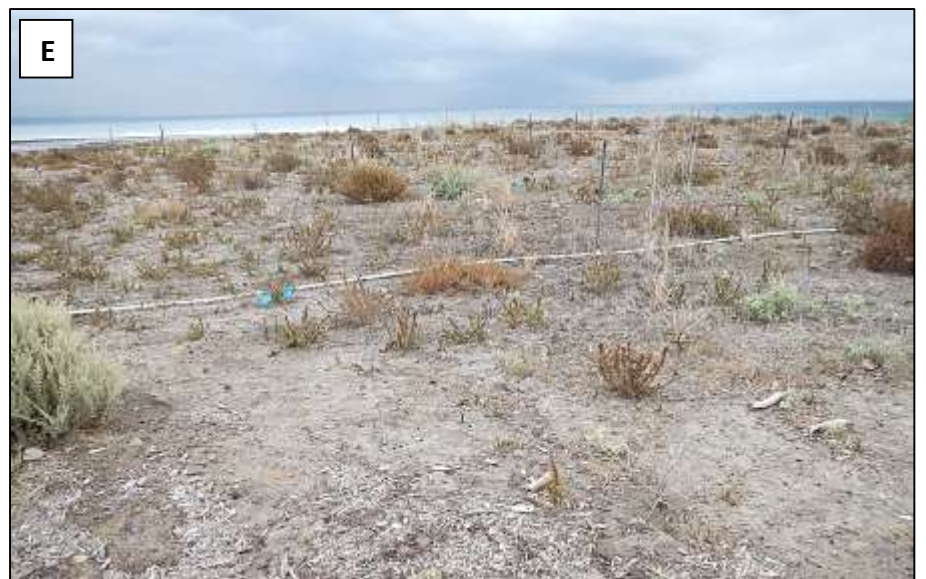
Figure 39. Photograph of Photo Point 3, bearing 100° on (A) 15 March 2013; (B) 7 May 2014; (C) 18 December 2014; (D) 5 May 2015; (E) 22 December 2015.

A total of five photos were taken at three locations to assess a range of habitat types across the restoration area. Figures 35 through 39 (A - E) display the photos from the five locations post-restoration on the three survey dates, respectively.

Consistent with the evaluation for plant cover transect monitoring and CRAM scores, the post-restoration georeferenced photos show a consistent increase in vegetation over time, with a large increase after the initial post-restoration Photo Point survey. Unlike the prolific growth seen in the second and third photo point surveys (March 2014 and December 2014), the third year surveys (May 2015 and December 2015) showed more subtle variations. Gaps in vegetation seen in the December 2015 photos but not in the May 2015 shots were either from seasonal vegetation variation, post-restoration weed management, or slight shifts in the photographer's perspective.

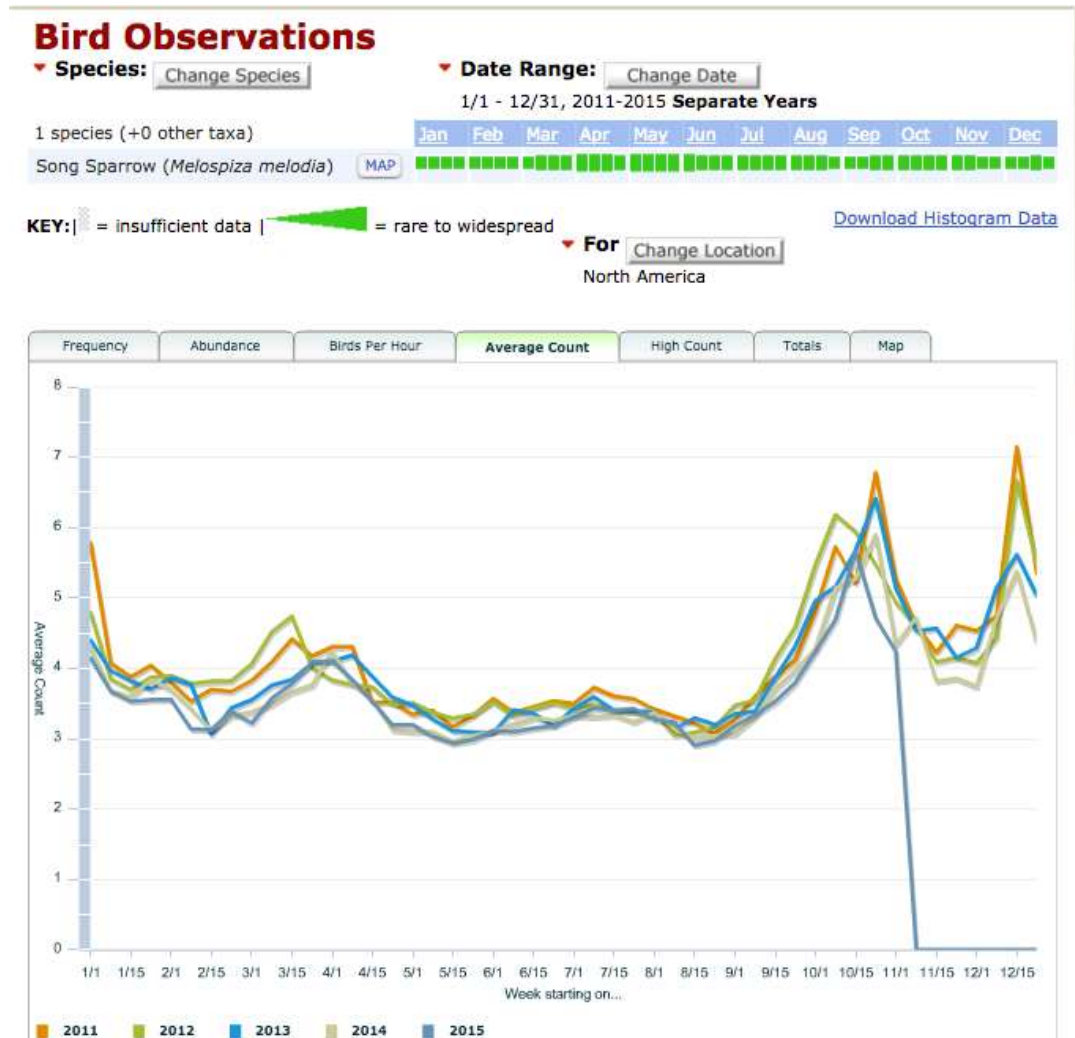
which shows a basically consistent pattern across all five years (2011-15)⁸, with slightly higher average counts pre-restoration (2011 and 2012). This suggests that the species has been able to adapt well to the scrub plantings on the site year after year.

Figure 1. Counts of Song Sparrow at Malibu Lagoon, Jan. 2011 - Oct. 2015 (from eBird data).

These observations may be compared to a much larger database of birders' reports to the eBird database (www.ebird.org); Figure 1 presents a graph of counts of one representative scrub-dwelling species, the Song Sparrow, at the site from multiple observers since 2011,

⁸ Reasons for the consistent peaks in October and mid-December are hard to interpret, but be linked to an influx of fall migrants in October, and facultative movement of birds out of the Pacific Northwest following mid-winter rains and colder temperatures during December.
