# Malibu Lagoon Restoration and Enhancement Project

## Comprehensive Monitoring Report (Year 2)

9 June 2015

*Prepared by:* The Bay Foundation

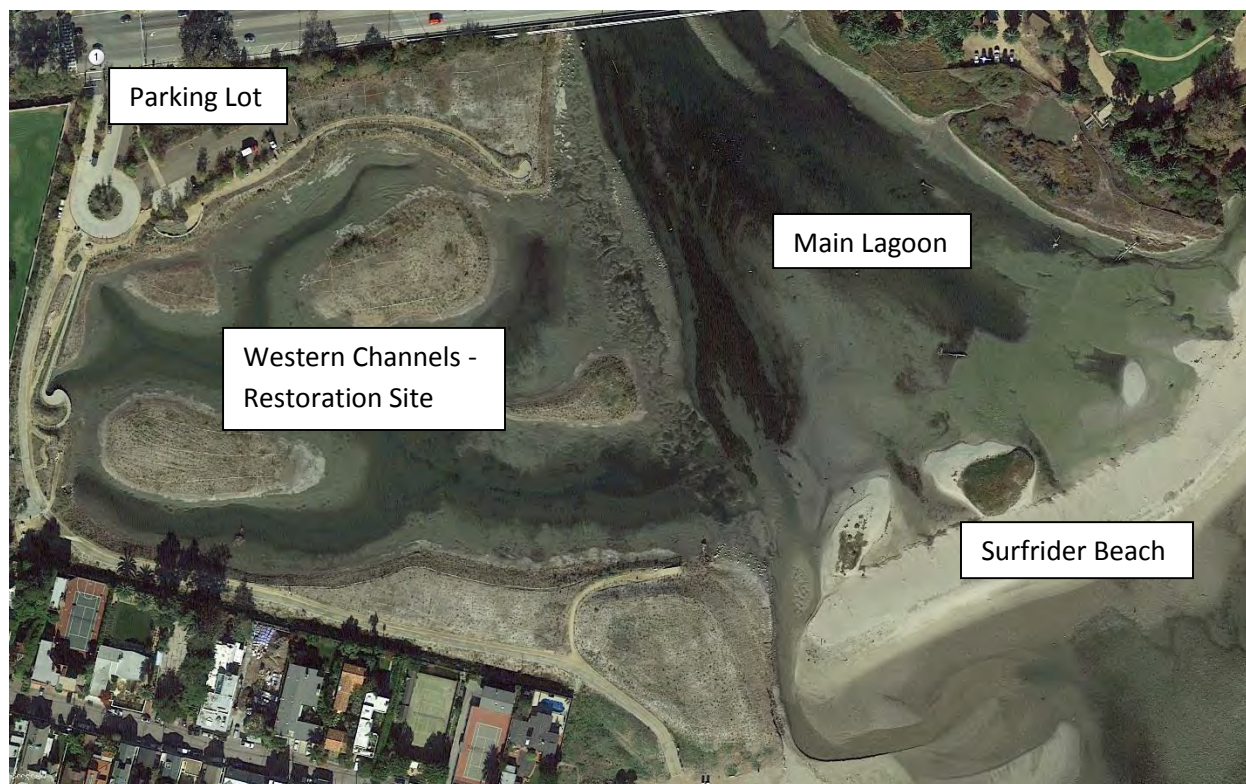
Figure 1. Map of project location site (Western Channels) and the surrounding Malibu Lagoon.

Post-construction monitoring was conducted as described in the “Malibu Lagoon Restoration and Enhancement Plan, Hydrologic and Biological Monitoring Plan” and the “Malibu Lagoon Plant Communities Restoration, Monitoring, and Reporting Plan” which each specify hydrologic and biological monitoring protocols and procedures for conducting monitoring before, during, and after the Project. The post-restoration monitoring and data collection time period covered by this report is from 14 February 2013 to 30 December 2014. An aerial overview of Malibu Lagoon highlighting the restoration and monitoring areas in relation to the main lagoon and Surfrider Beach are displayed in Figure 1.

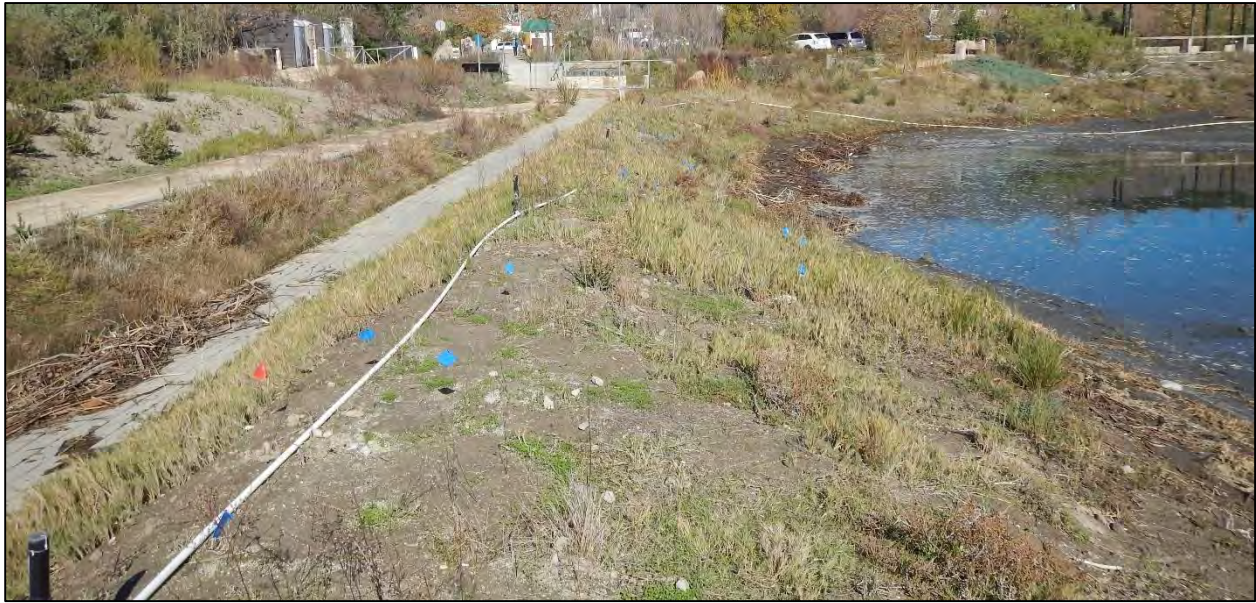
Figure 2. Landscape photo of a portion of the CRAM AA for Malibu Lagoon on the most recent survey, 23 December 2014.

Four post-restoration surveys were completed within the wetland habitats on 14 February 2013, 4 October 2013, 7 May 2014, and 23 December 2014 (Figure 2); the May 2014 sampling event was an extra survey implemented during a closed-berm condition. According to module requirements, bar-built CRAM assessments should be conducted during an open berm condition and low tide; therefore, the May data may be skewed towards slightly lower condition scores. The pre-restoration survey was conducted on 1 June 2012 and is evaluated alongside the post-restoration data. CRAM attributes and final score data are evaluated on a 30-100 scale, with 30 being the poorest possible condition score, and 100 being the highest possible “reference” score for the state of California.

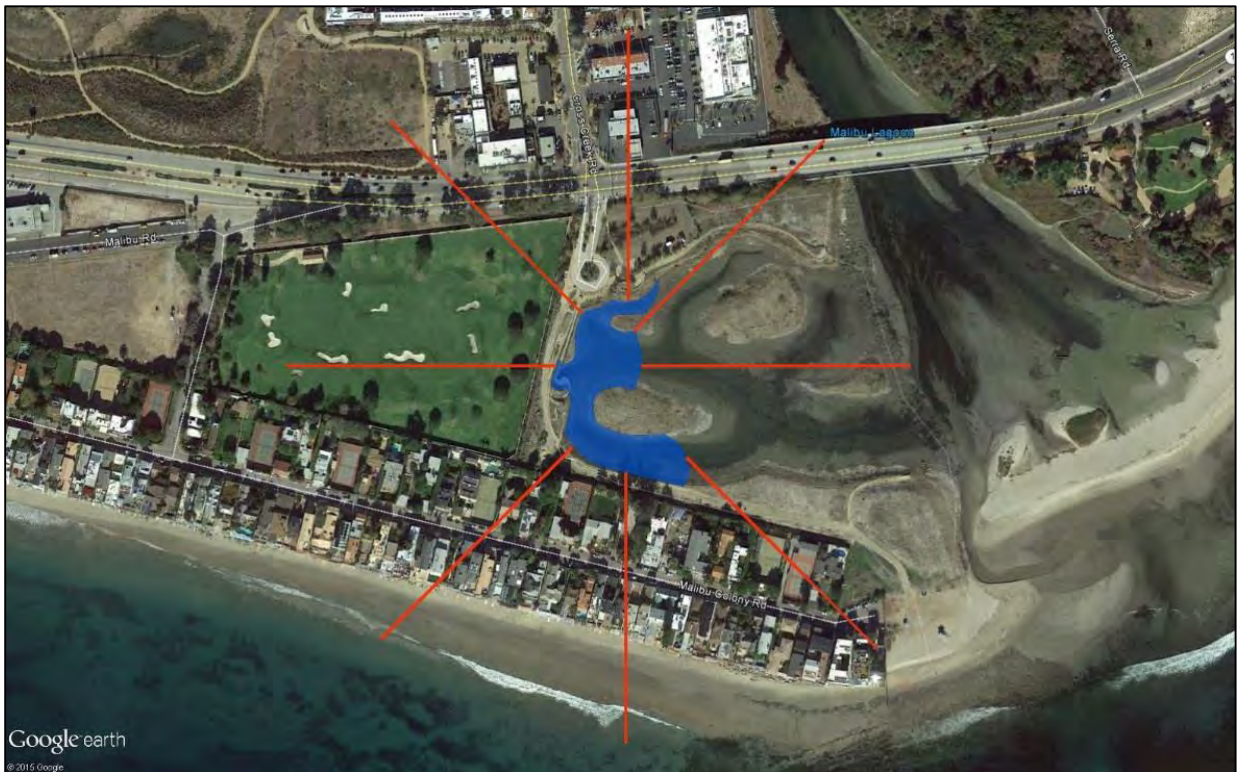
Figure 3. Post-restoration CRAM Assessment Area (blue polygon) at Malibu Lagoon. Red lines indicate radiating (potential) buffer lines.

Figure 3 displays the Assessment Area (AA) and buffer lines for the post-restoration CRAM survey. The AA is approximately one hectare, or two and a half acres of wetland habitats, following guidelines described in the User Manual. The AA location is approximately the same as the pre-restoration survey.

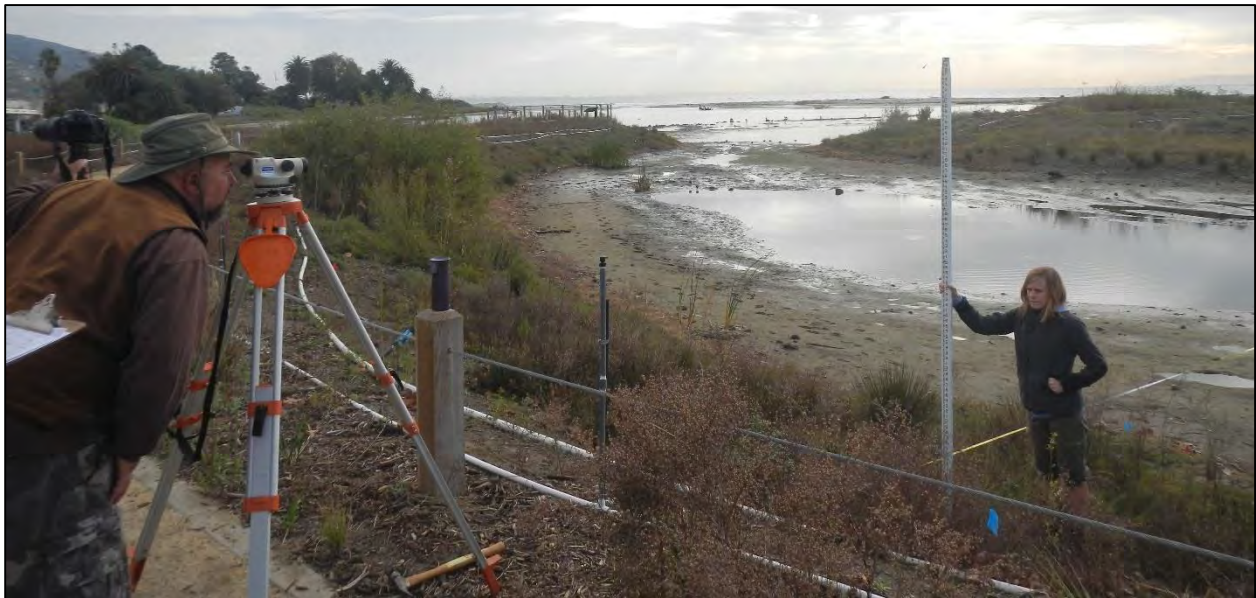
Figure 4. Cross channel elevation surveys at Malibu Lagoon, 18 December 2014.

Five permanent and repeatable cross-section locations were monitored twice post-restoration on 14 February 2013 and 18 December 2014 (Figures 4 and 5). Horizontal and vertical locations of cross-section end-points were fixed by monuments. Sediment scour or deposition depths were calculated from the data.

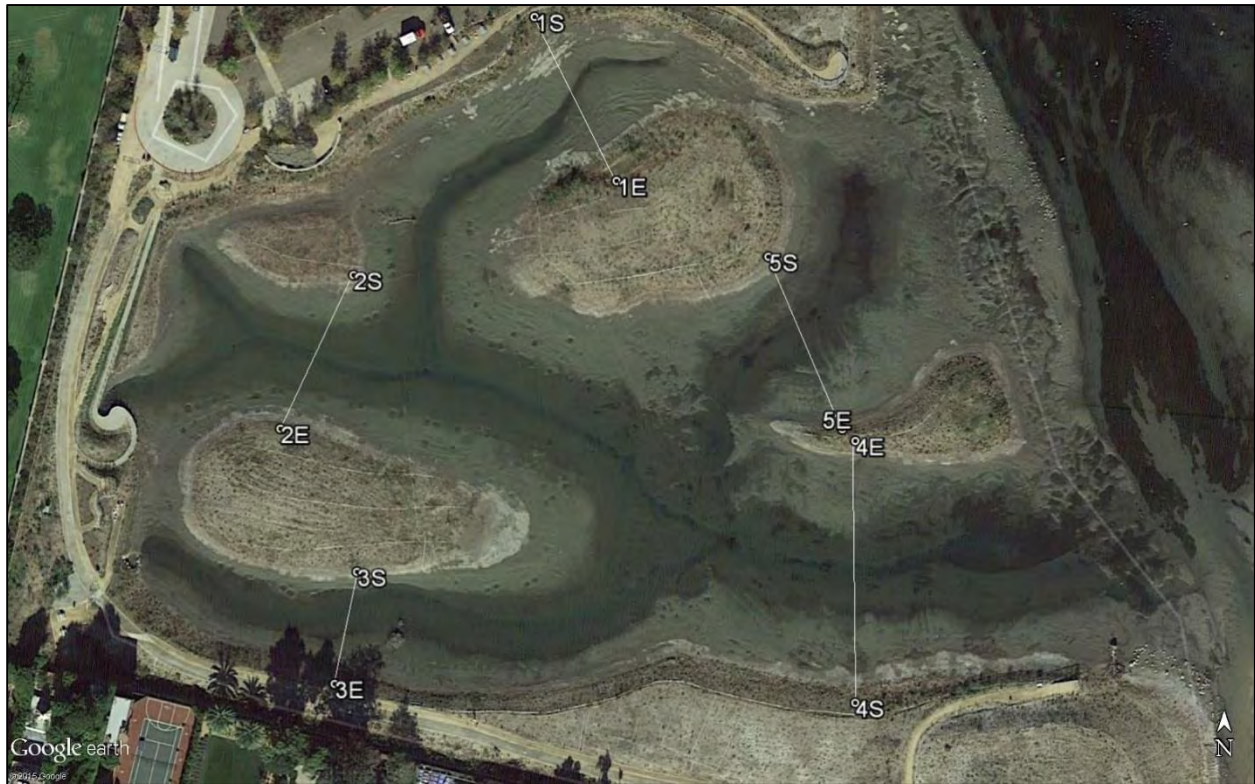
Figure 5. Map of cross-channel elevation transect locations.

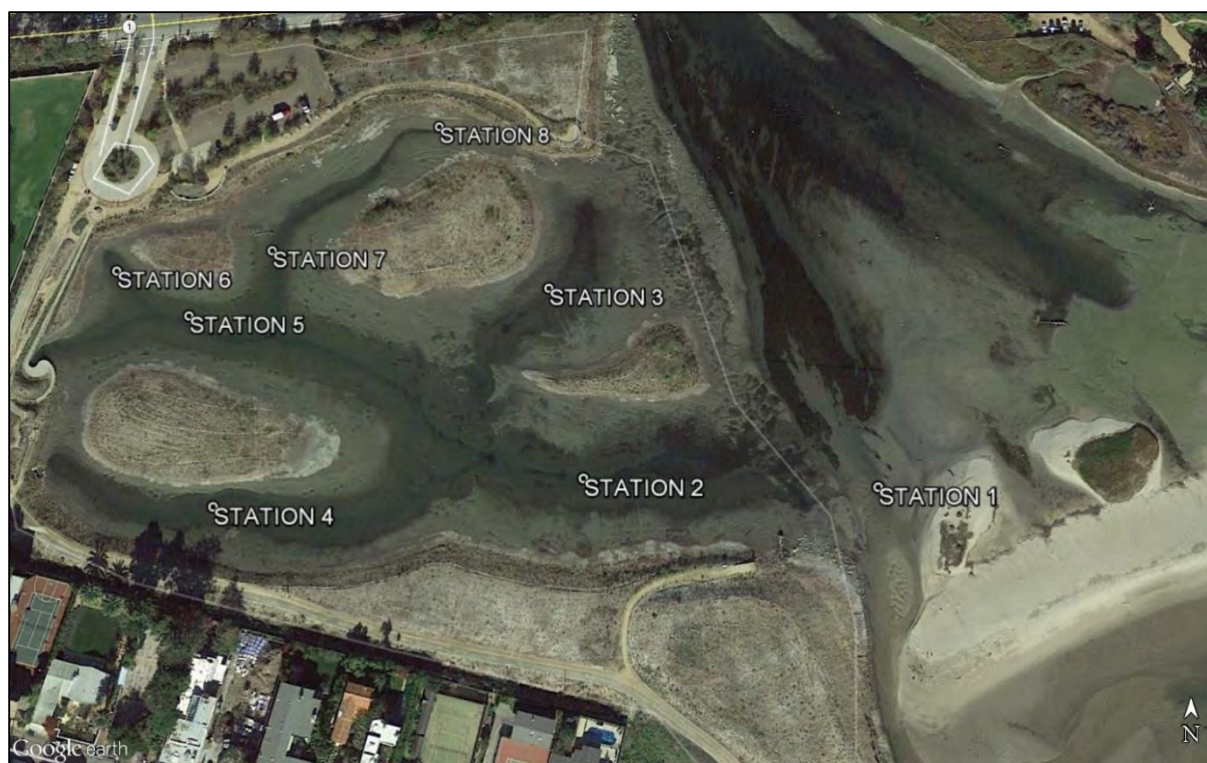
Figure 11. Map of post-restoration vertical profile, SAV/algae, surface and bottom water nutrient, and sediment survey stations. Stations 2, 5, and 8 are the locations of the three permanently-deployed YSI data sondes.

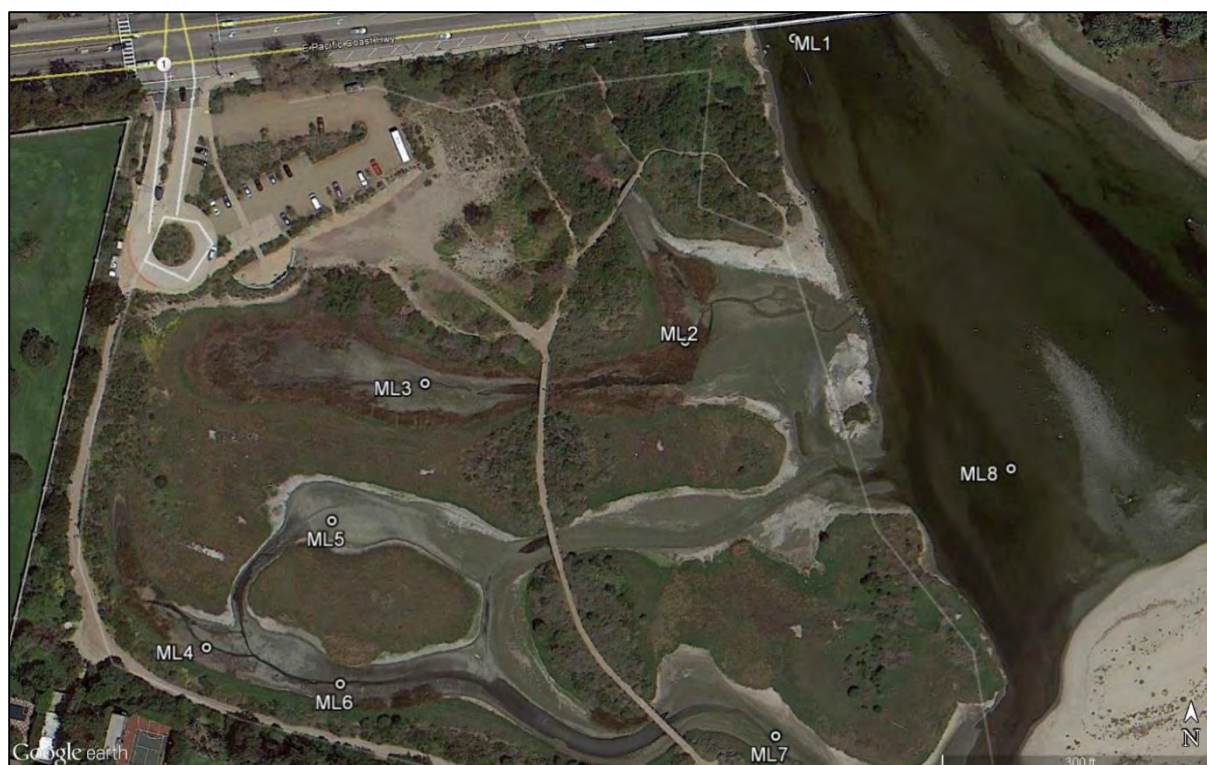
Figure 12. Map of pre-restoration water quality monitoring stations. ML2 and ML6 are the locations of the pre-restoration permanently-deployed YSI data sondes.

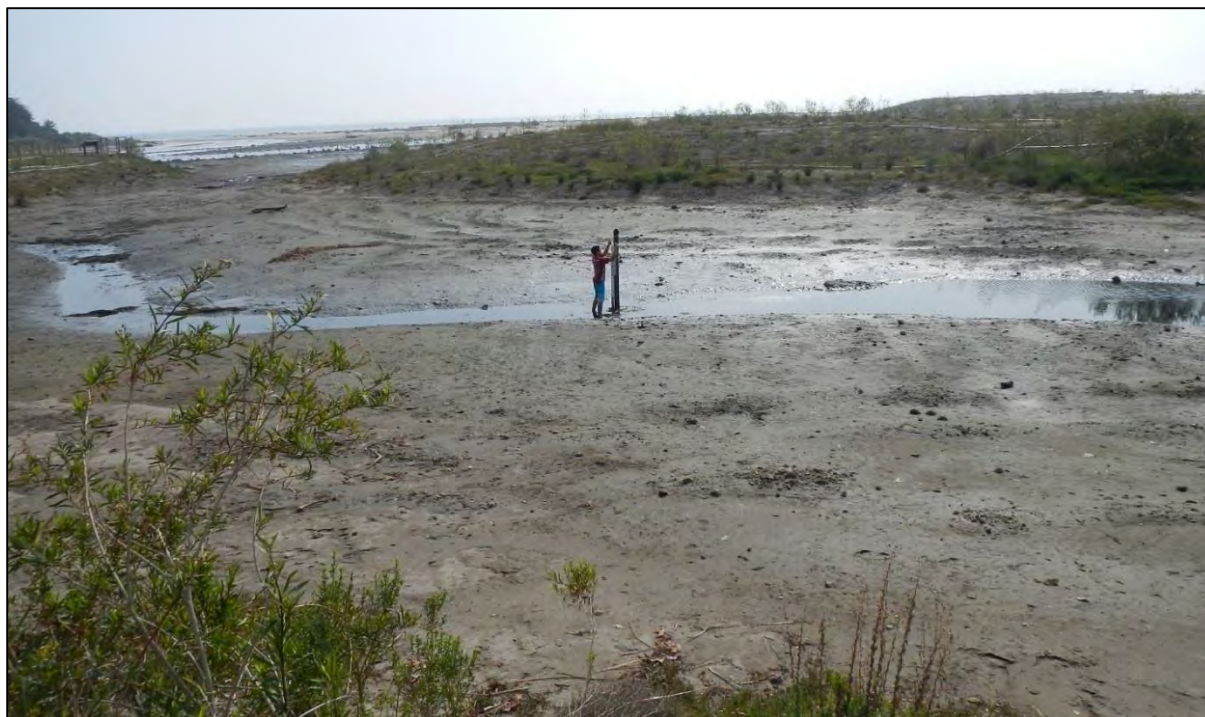
Figure 13. Deploying a YSI sonde post-restoration at Station 8; 5 March 2014.

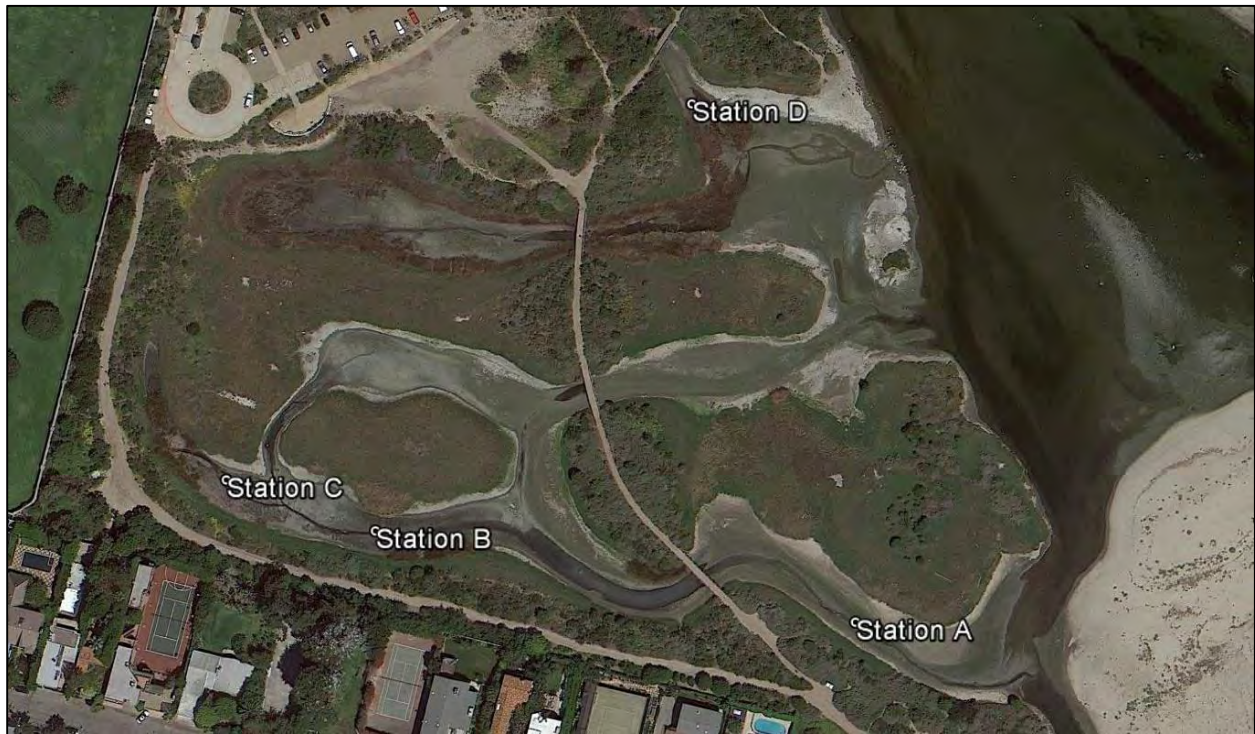
Figure 23. Map showing the location of pre-restoration sediment monitoring stations.

Sediment data were collected during pre-restoration conditions at four sampling locations (Figure 23) during four sampling events in September 2006, April 2007, September 2007, and April 2008. Pre-restoration sediment samples were processed for nitrates, total phosphorus, total kjeldahl nitrogen, and

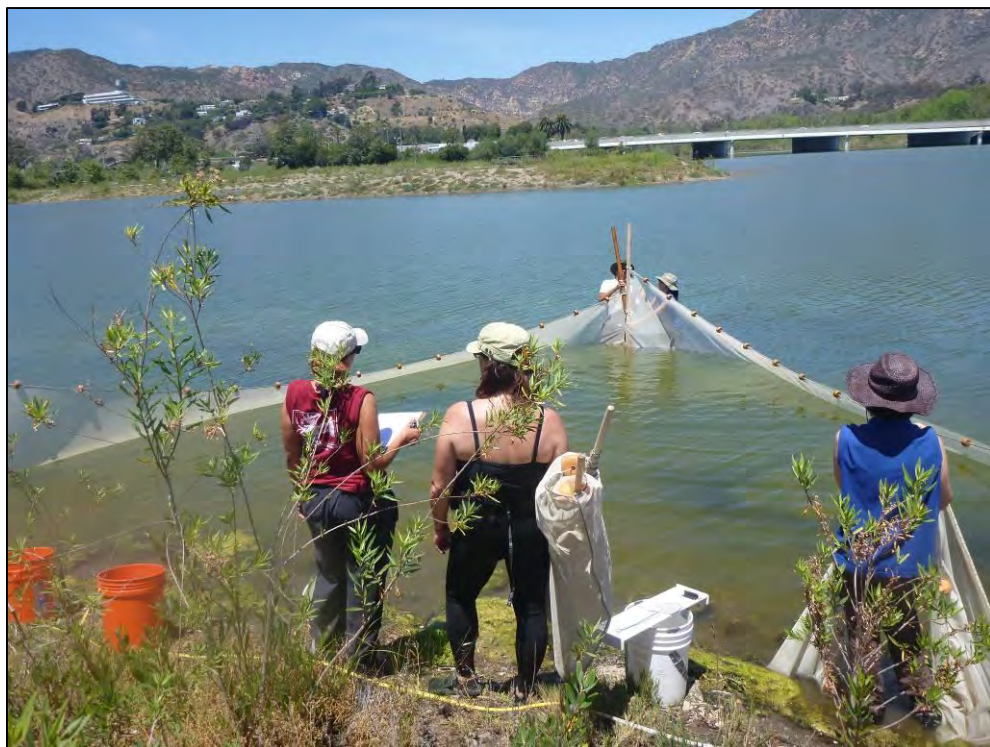
Figure 27. Representative photograph of fish surveys being conducted at Site 5 on 15 May 2014 (photo: RCDSMM).

Six permanent sites (Figures 26 and 27) were seined to depletion and spot surveying was conducted at three places along the banks of the Main Lagoon. Site 2, which was established for monitoring in 2013, was inaccessible due to depth resulting from the closed condition of the lagoon. Therefore, Site 2a was added to comply with monitoring plan requirements.

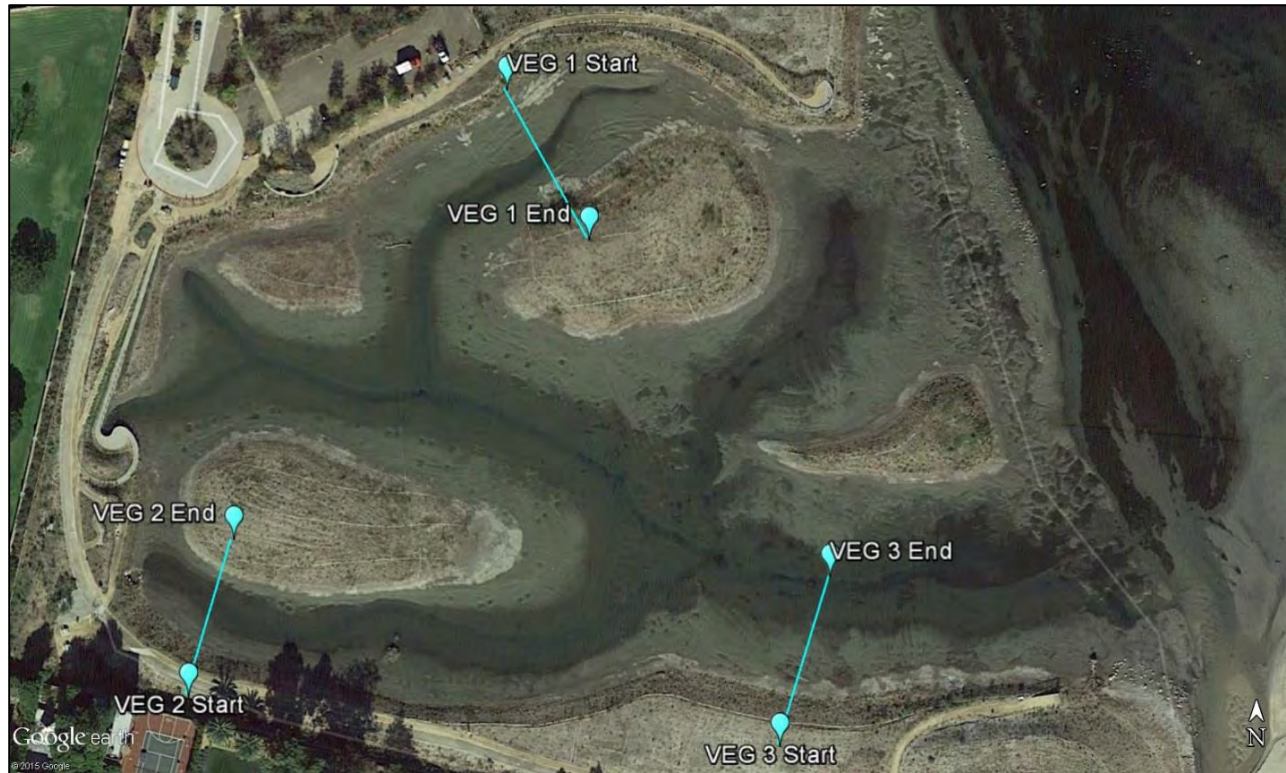
Figure 29. Map of vegetation transect locations and start/end points.

Each transect location was recorded with a submeter global positioning system (GPS) unit and photographed at each end. Absolute cover data were calculated based on the total distance for each species within each transect. Species data were collected to an accuracy of 0.01 m along each 50-meter transect. Species were categorized into native or non-native and added together. Cover data were relative, as non-vegetated mudflat and channel habitats were removed from the total transect length. Data were displayed as a bar graph for each transect.

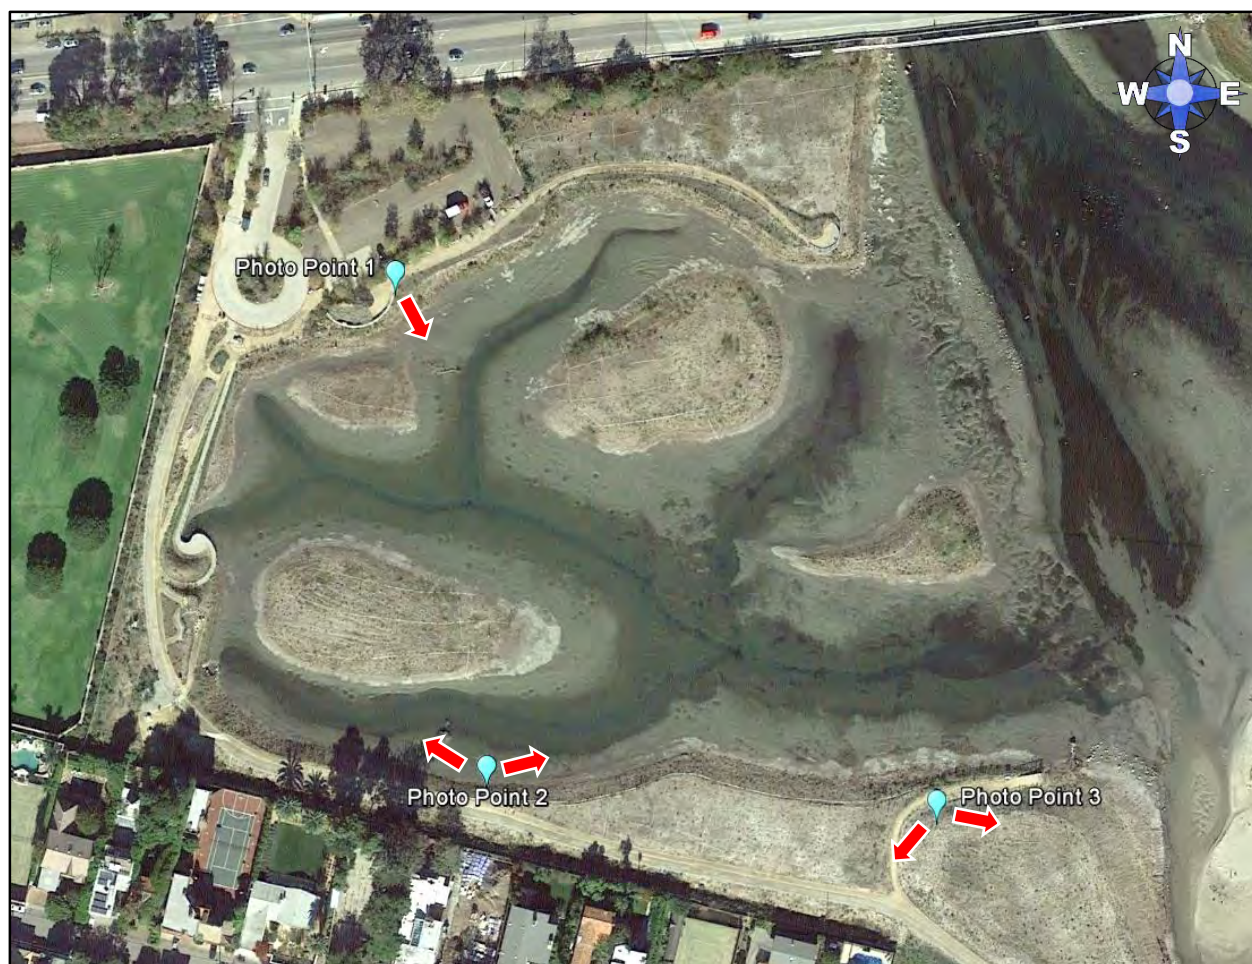
Figure 31. Map of photo-point locations and bearings.

Three permanent, photo-monitoring locations (Table 16 and Figure 31) were established to visually document the establishment of vegetation and large-scale landscape changes following restoration. Stations were located using GPS and baseline photographs. The baseline photo-point survey was conducted immediately post-restoration on 15 March 2013 during a low tide; post-restoration surveys were conducted again on 7 May 2014 and 18 December 2014 (Table 16). Approximate bearing is relative to the center of the photograph; detailed bearing ranges are included on the datasheets.

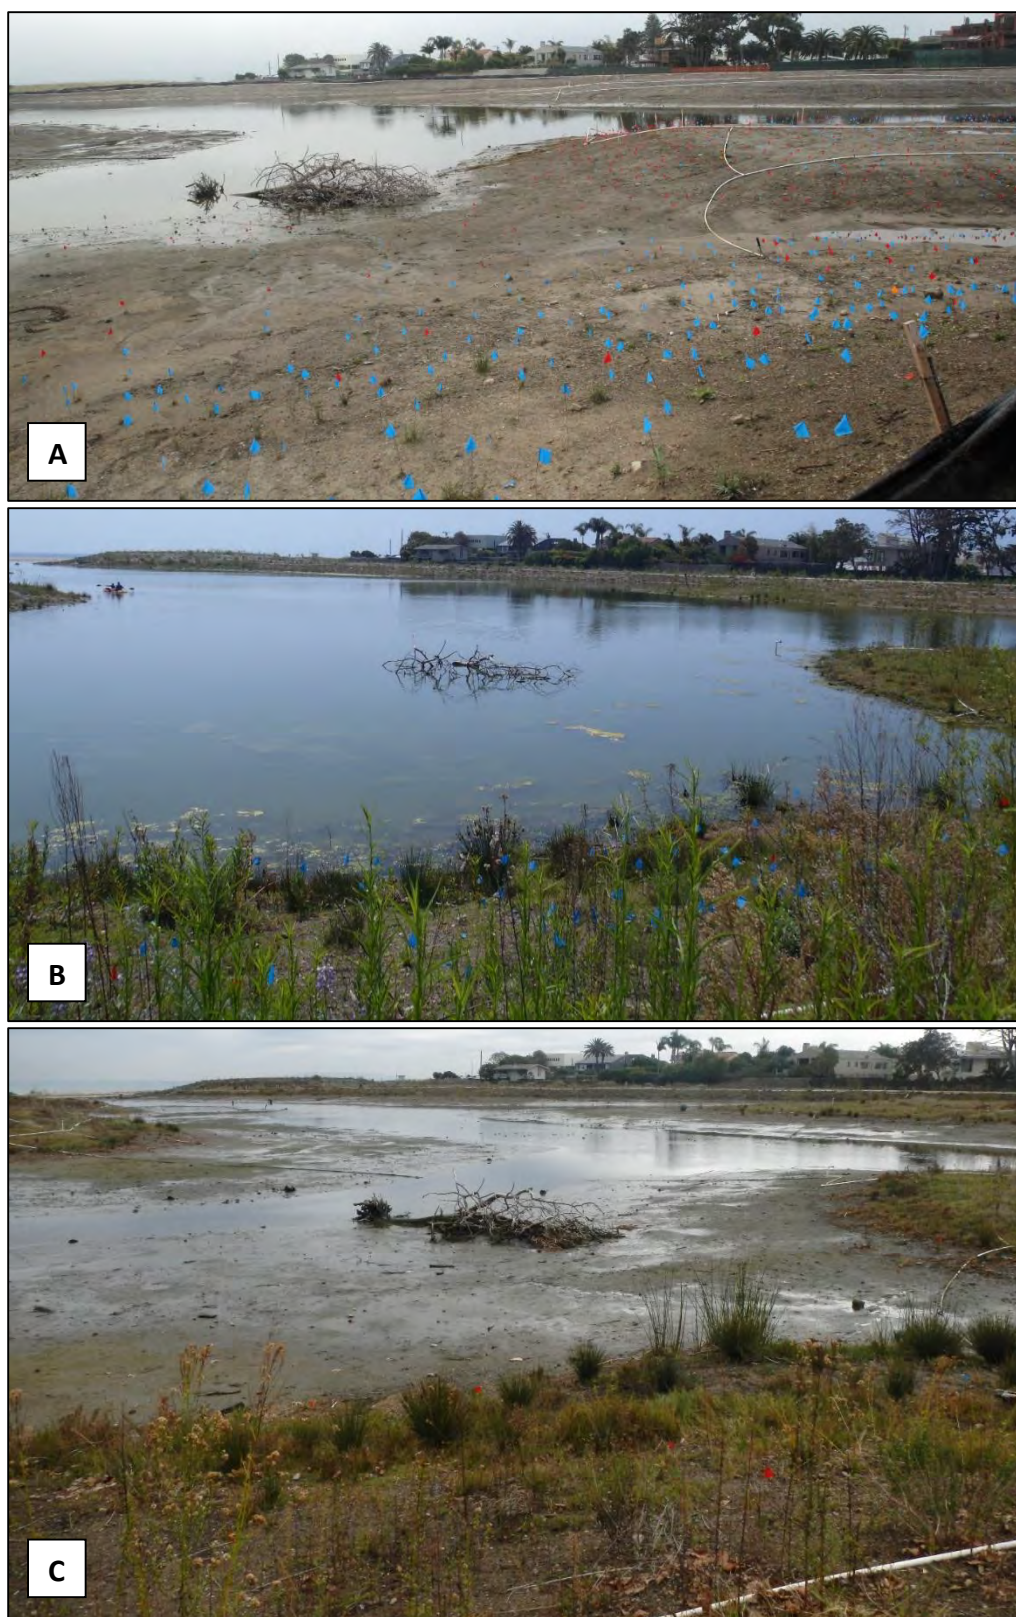
Figure 32. Photograph of Photo Point 1, bearing 155° on (A) 15 March 2013; (B) 7 May 2014; (C) 18 December 2014.

A total of five photos were taken at three locations to assess a range of habitat types across the restoration area. Figures 32 - 36 (A - C) display the photos from the five locations post-restoration on the three survey dates, respectively.

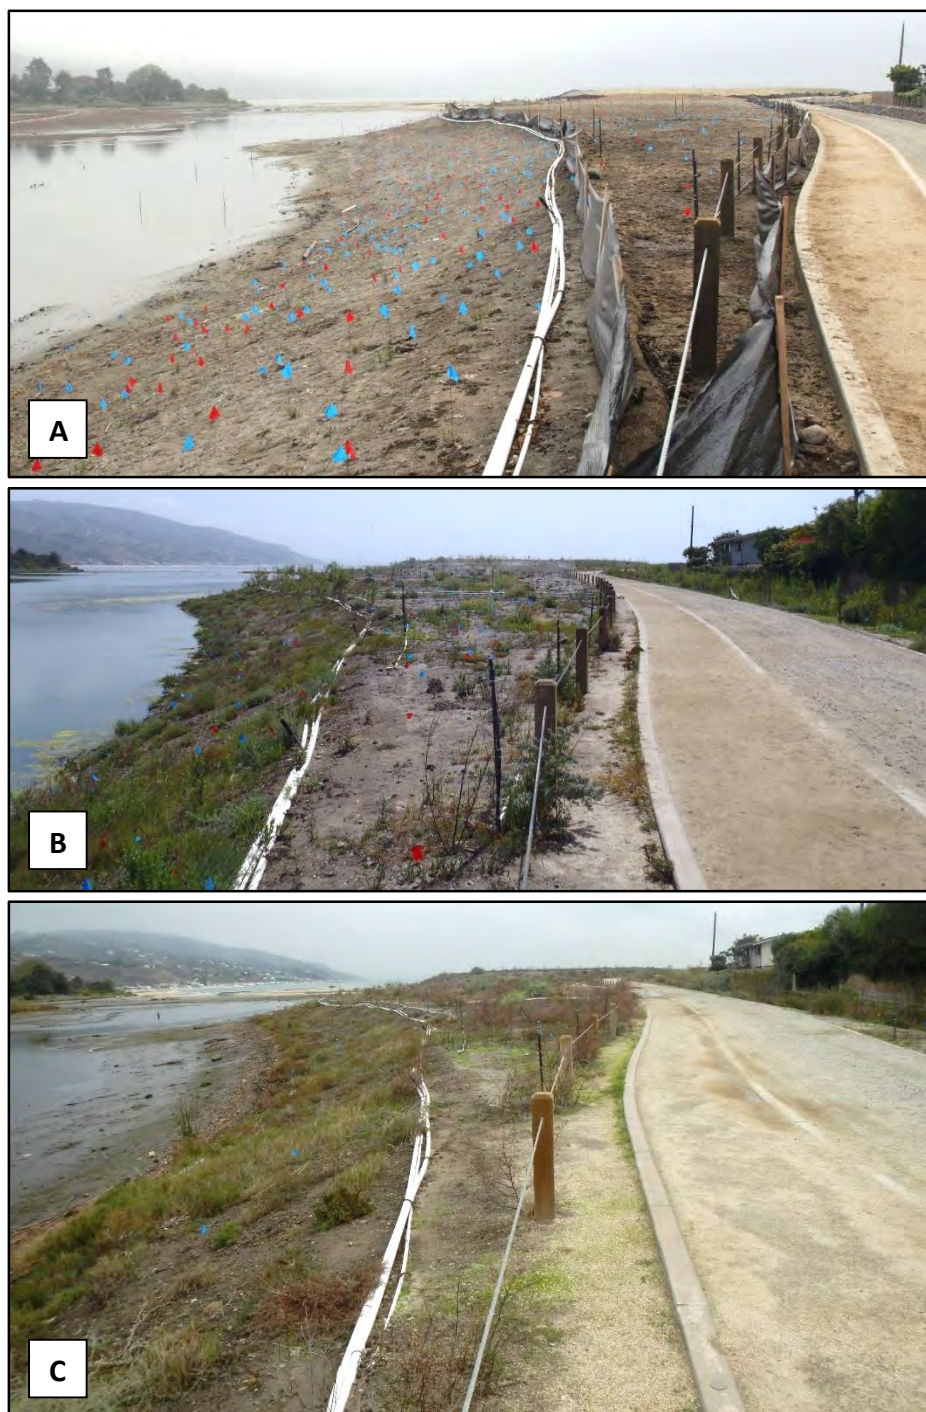
Figure 34. Photograph of Photo Point 2, bearing 75° on (A) 15 March 2013; (B) 7 May 2014; (C) 18 December 2014.

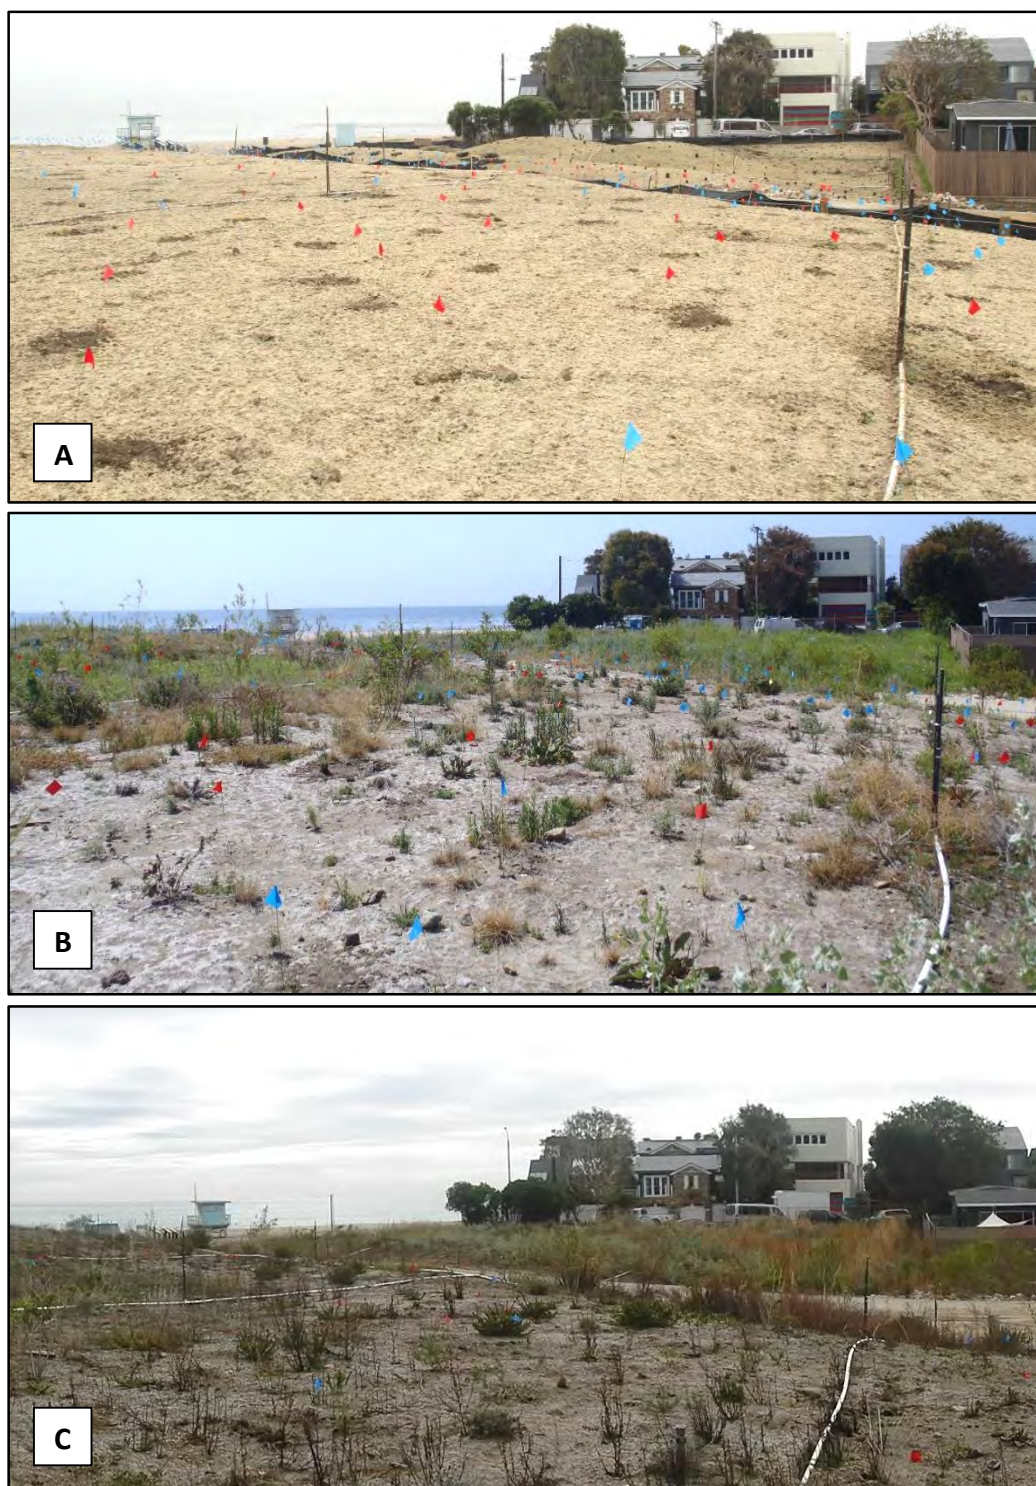
Figure 35. Photograph of Photo Point 3, bearing 220° on (A) 15 March 2013; (B) 7 May 2014; (C) 18 December 2014.

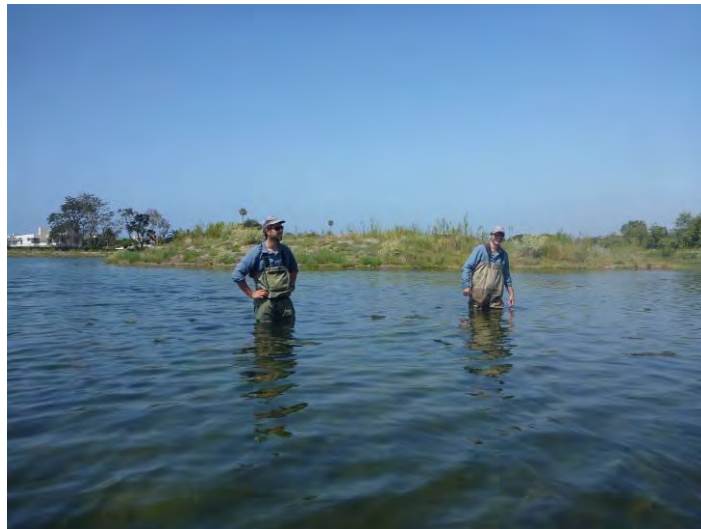
Figure 3. DIDSON camera at Site 1. Kayak used to herd fish towards the camera.

On Thursday, 5 June 2014, a team from the Santa Barbara office of CDFW brought a DIDSON camera to deploy in Malibu lagoon in hopes of capturing the *O. mykiss* in action. Using a generator carried to the watershed overlook near Site 6 for power, we deployed the camera at Site 4, outside the clumps of algae. The camera was deployed for 45 minutes at Site 4, 45 minutes at Site 1, 20 minutes at Site 3 (visibility was really poor), and 30 minutes near the bird blind in the far west channel. A GoPro camera was attached to the DIDSON camera frame to capture video images to compare to the ultra-sound images allowing more direct comparison and fish identification. Processing the images and correlating them is in progress.
