Malibu Lagoon Restoration and Enhancement Project Comprehensive Monitoring Report (Year 2)

27 May 2015

Prepared by: The Bay Foundation

Prepared for: State of California, Department of Parks and Recreation

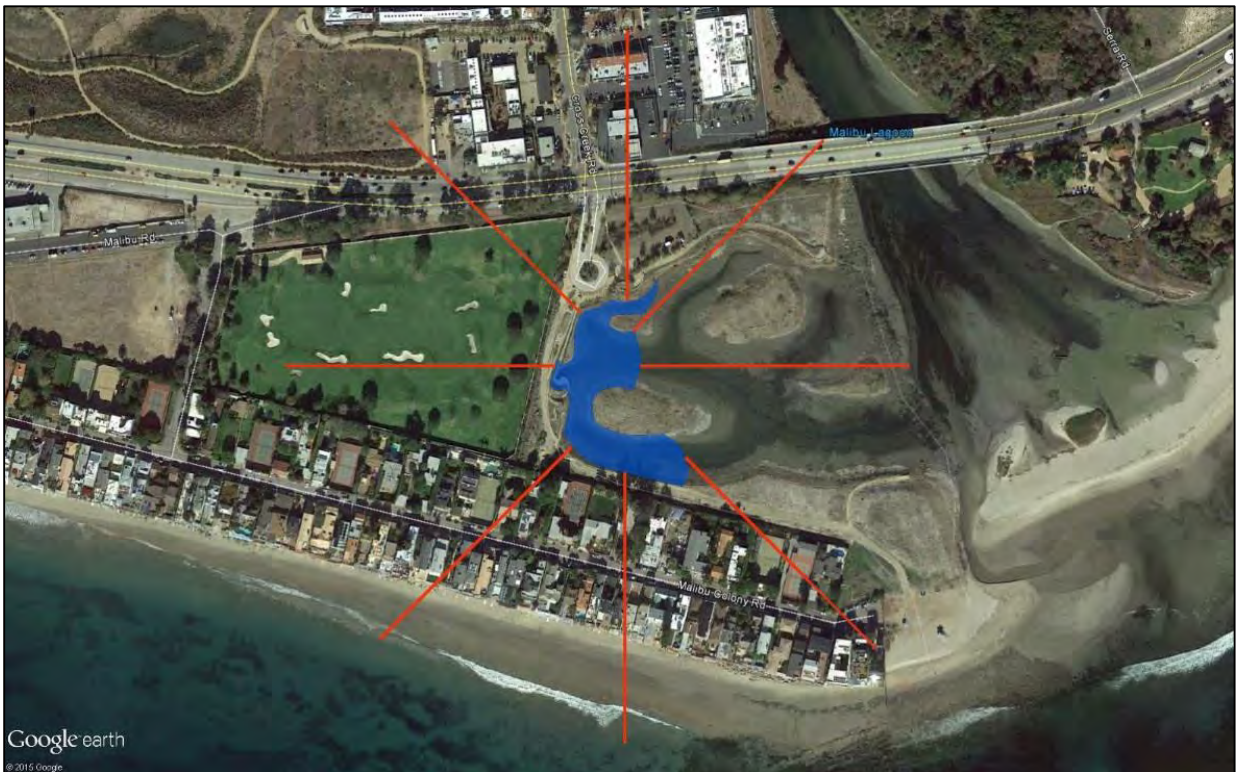
Figure 3 displays the Assessment Area (AA) and buffer lines for the post-restoration CRAM survey. The AA is approximately one hectare, or two and a half acres of wetland habitats, following guidelines described in the User Manual. The AA location is approximately the same as the pre-restoration survey.

Figure 3. Post-restoration CRAM Assessment Area (blue polygon) at Malibu Lagoon. Red lines indicate radiating (potential) buffer lines.

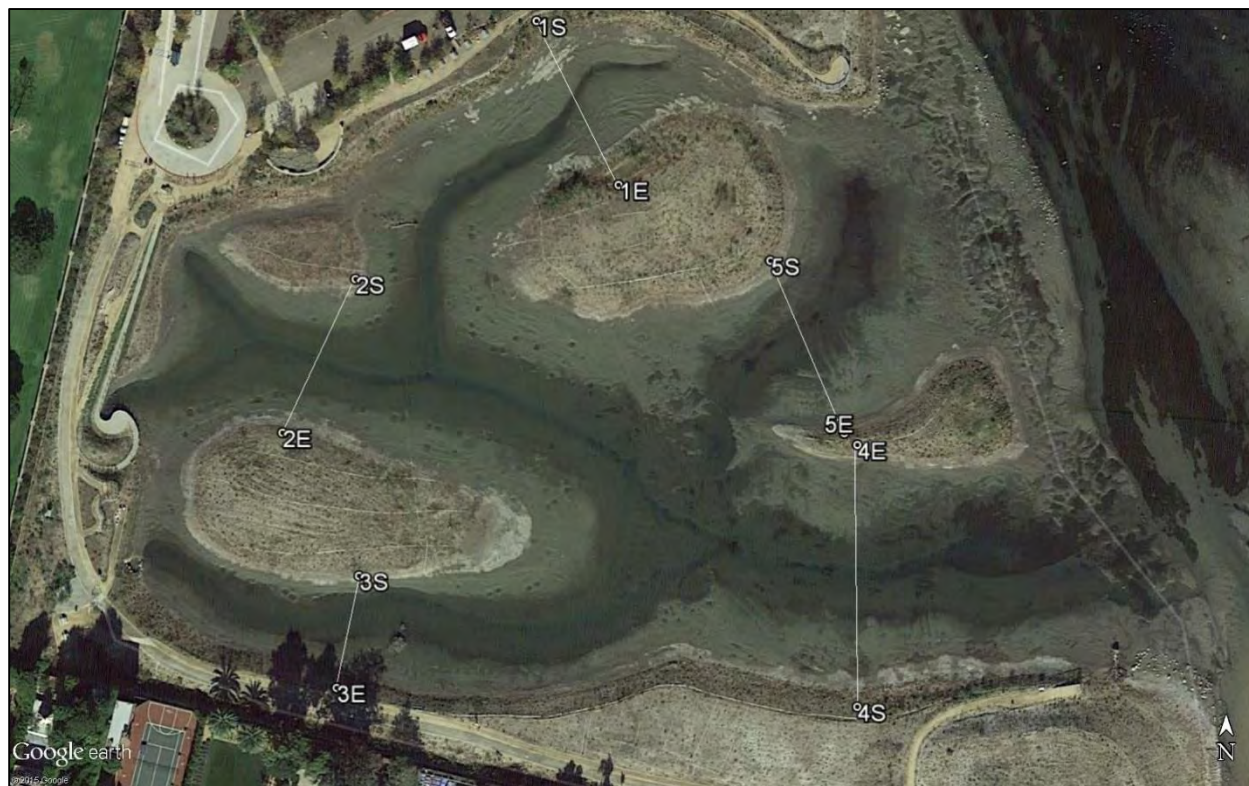
Five permanent and repeatable cross-section locations were monitored twice post-restoration on 14 February 2013 and 18 December 2014 (Figures 4 and 5). Horizontal and vertical locations of cross-section end-points were fixed by monuments. Sediment scour or deposition depths were calculated from the data.

Figure 5. Map of cross-channel elevation transect locations.

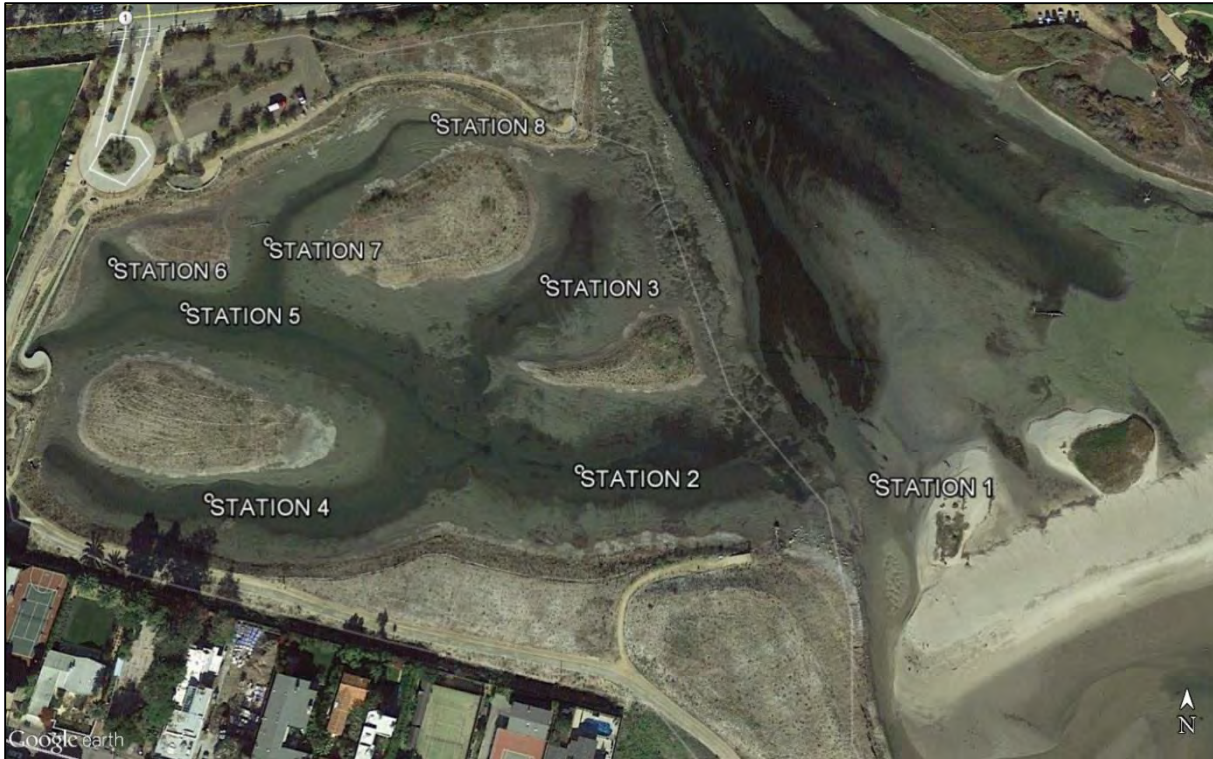
Figure 11. Map of post-restoration vertical profile, SAV/algae, surface and bottom water nutrient, and sediment survey stations. Stations 2, 5, and 8 are the locations of the three permanently-deployed YSI data sondes.

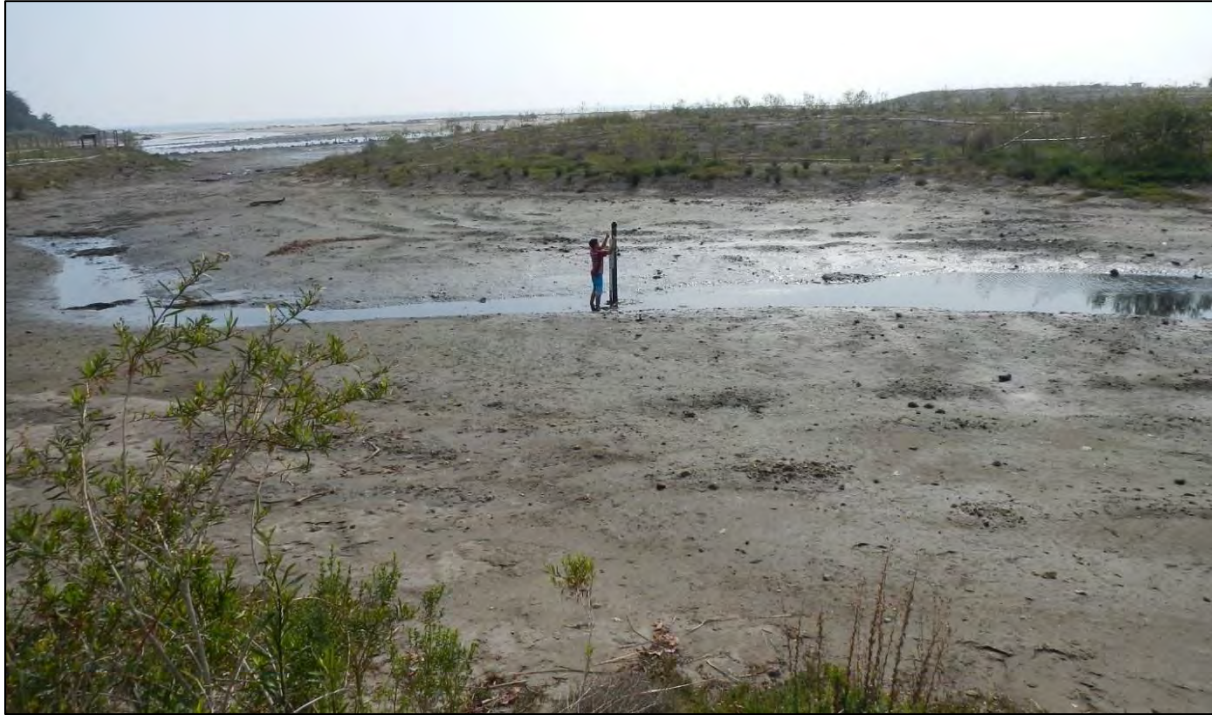
Three Yellow Springs Instruments (YSI) 600XLM or equivalent multi-parameter data loggers were deployed in the Lagoon approximately 0.5 ft above the bottom sediments to measure water depth, dissolved oxygen (mg/L), temperature, salinity, conductivity, pH, and oxygen reduction potential (ORP) at 30-minute intervals. Detailed user manuals were used for calibration and maintenance; in-depth descriptions of the specifications and operations of these instruments can be found at www.ysi.com.

Figure 13. Deploying a YSI sonde post-restoration at Station 8; 5 March 2014.

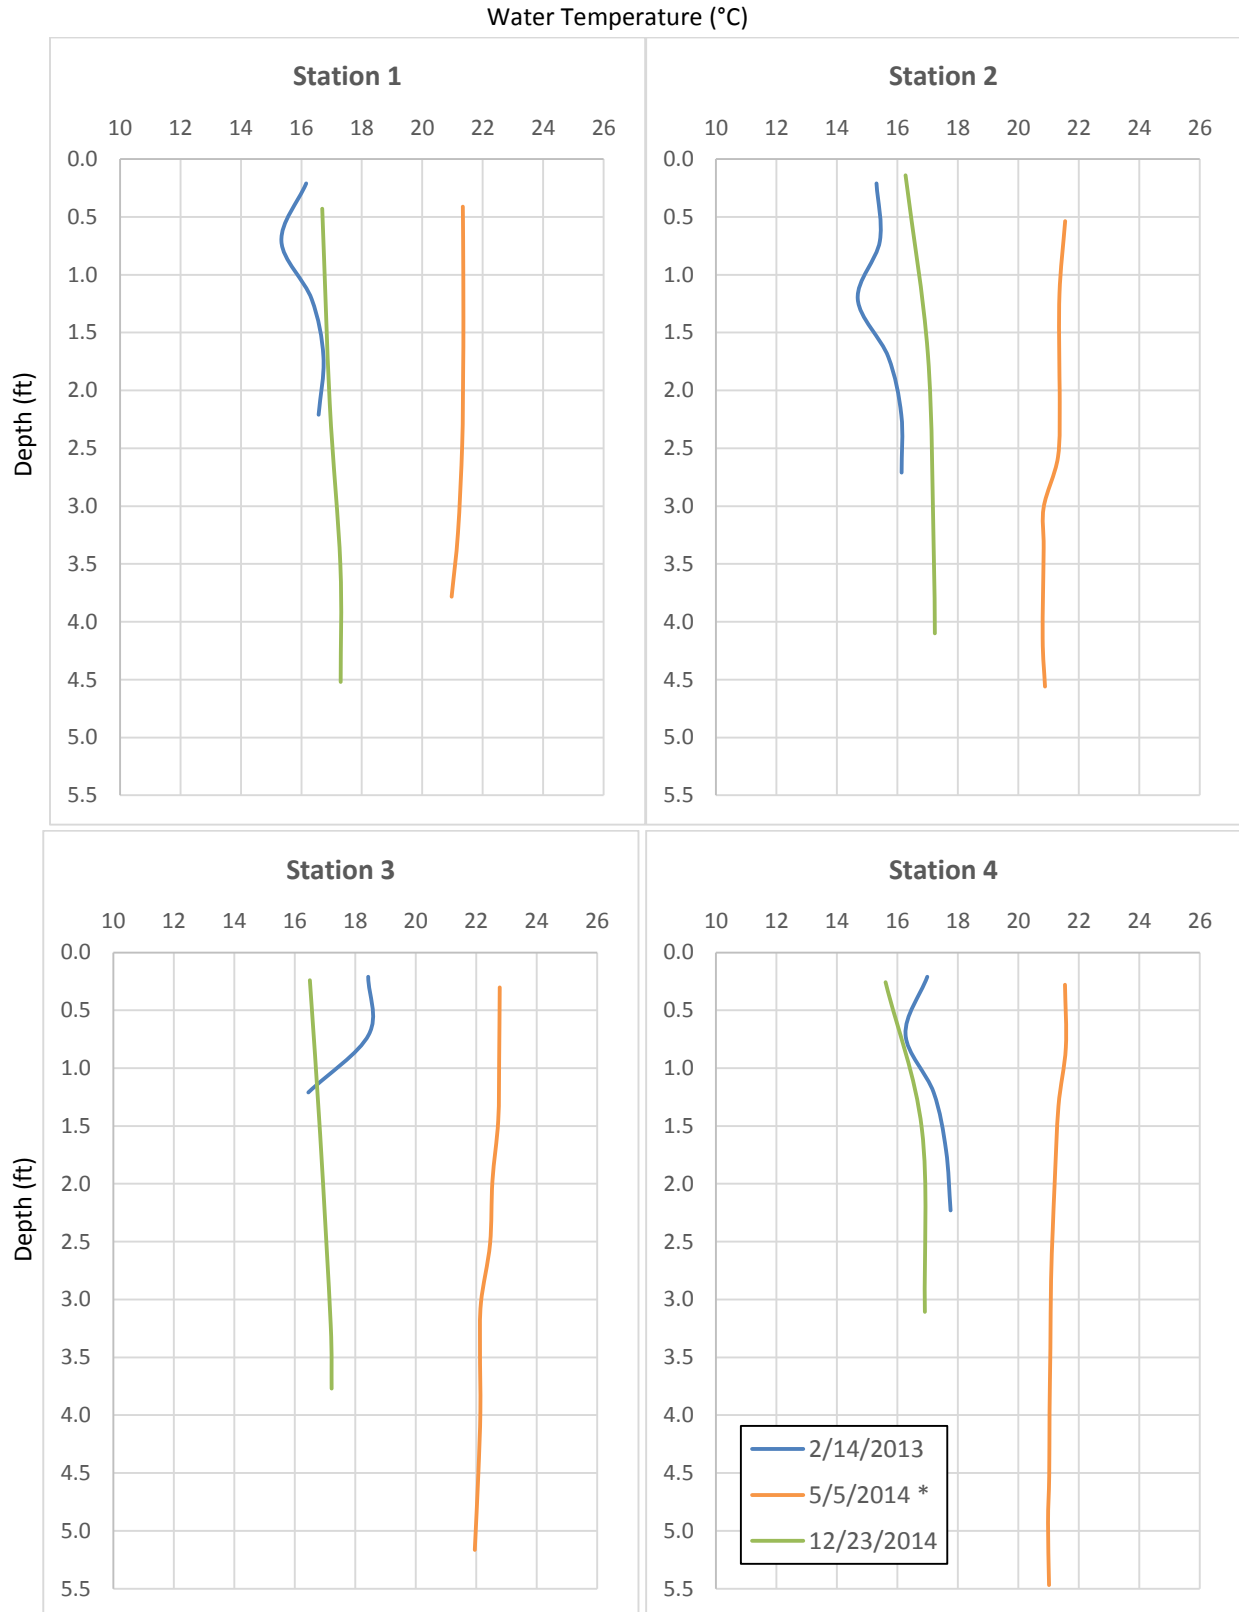
Figure 17a. Post-restoration temperature vertical water quality profiles at Stations 1-4. Asterisk indicates a closed berm condition.

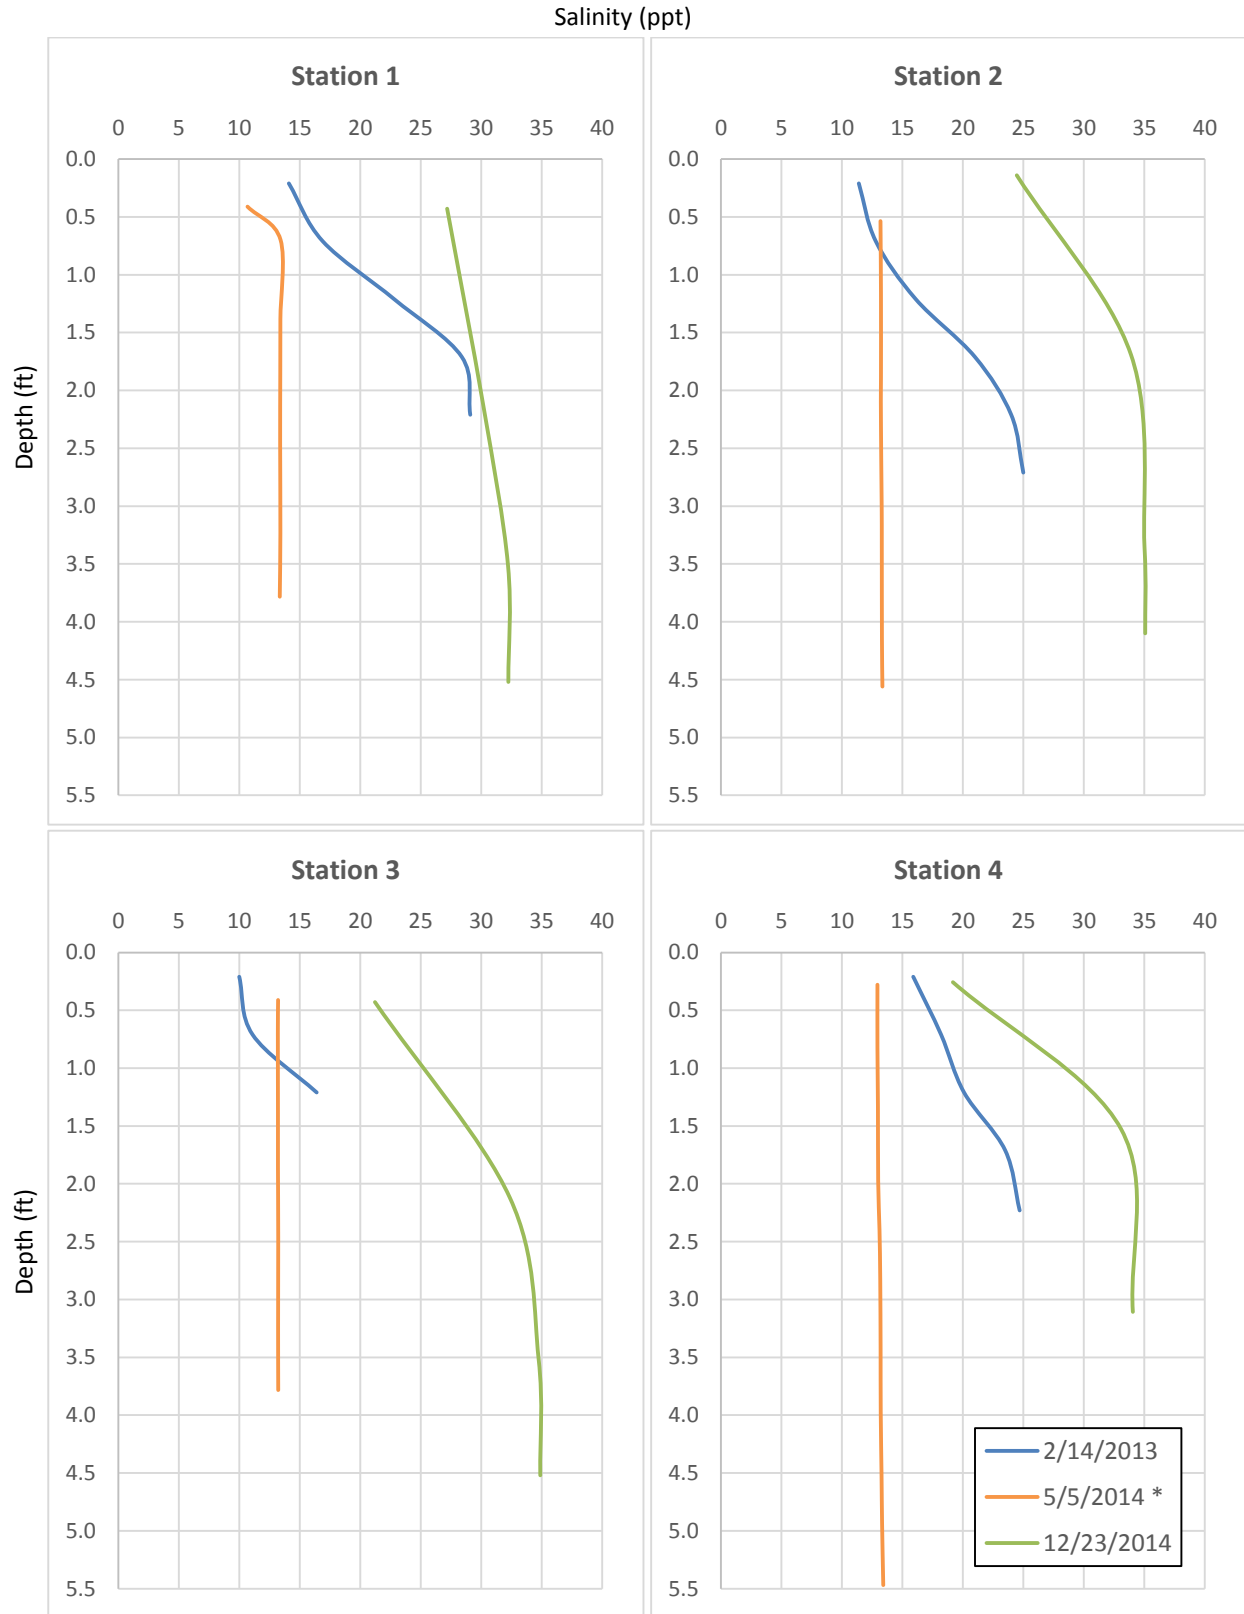
Figure 18a. Post-restoration salinity vertical water quality profiles at Stations 1-4. Asterisk indicates a closed berm condition.

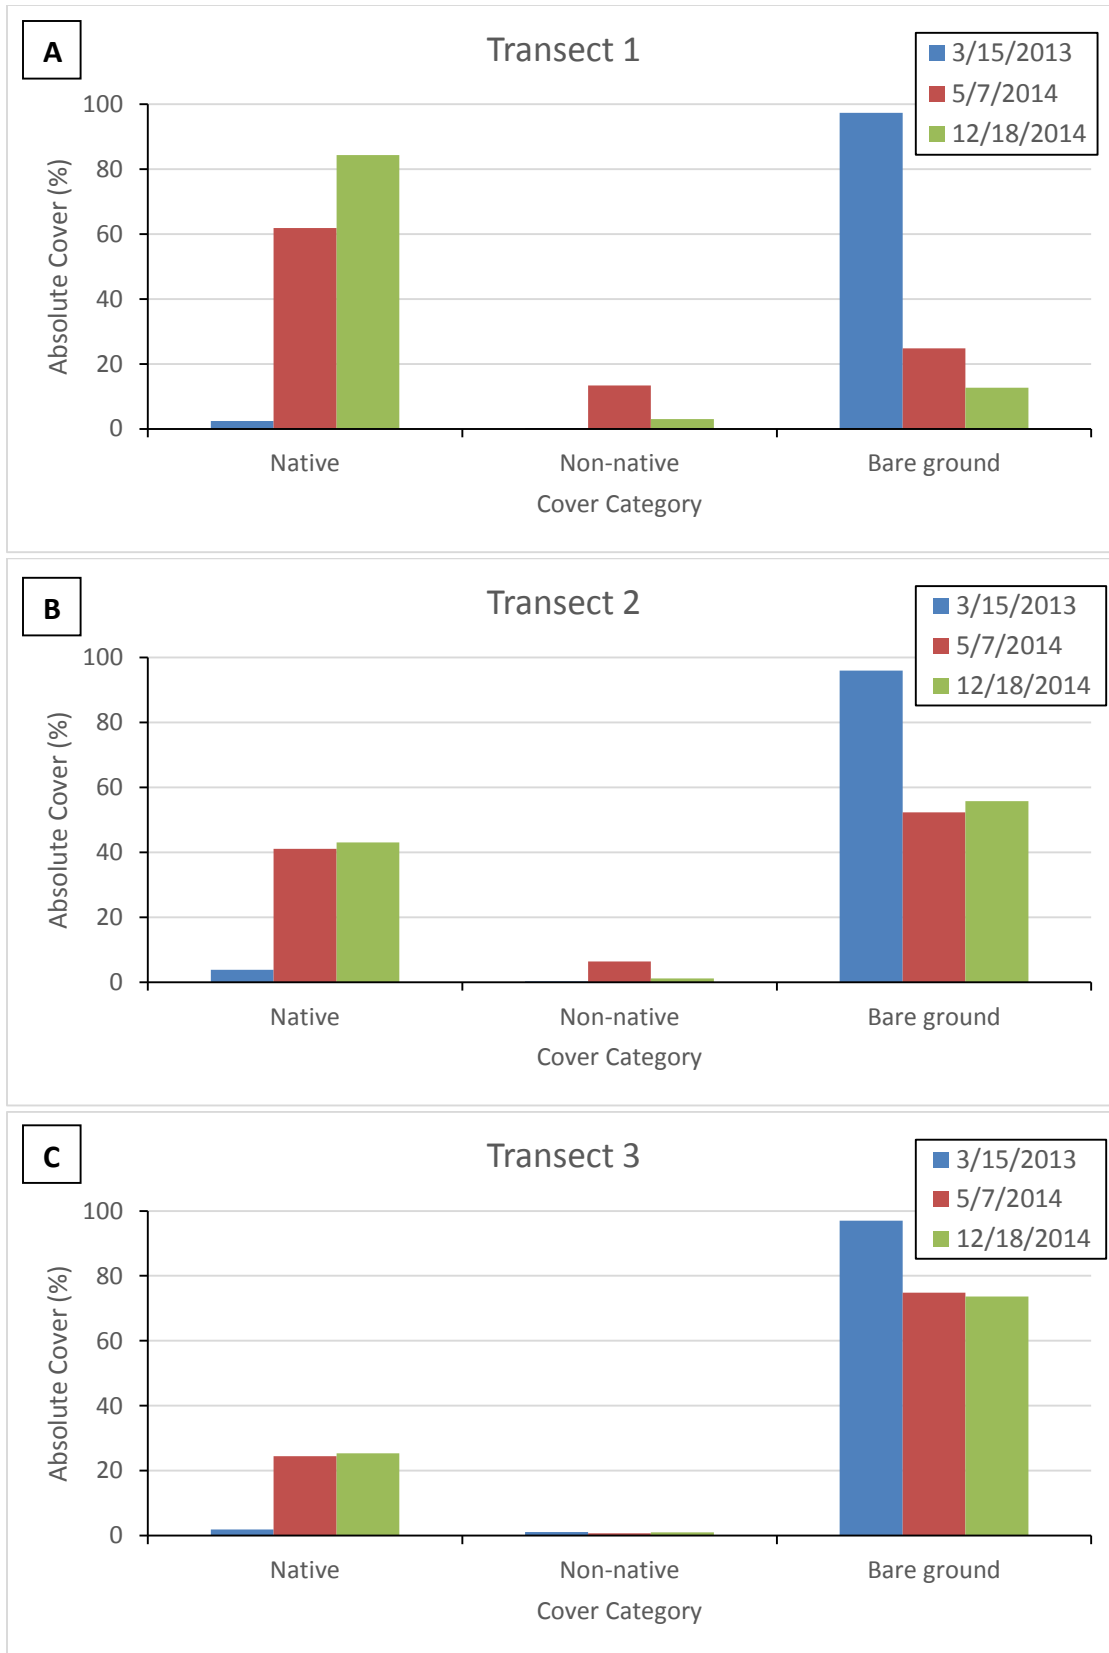
Figure 30. Graph displaying absolute cover of vegetation across each Transect: (A) 1, (B) 2, and (C) 3.

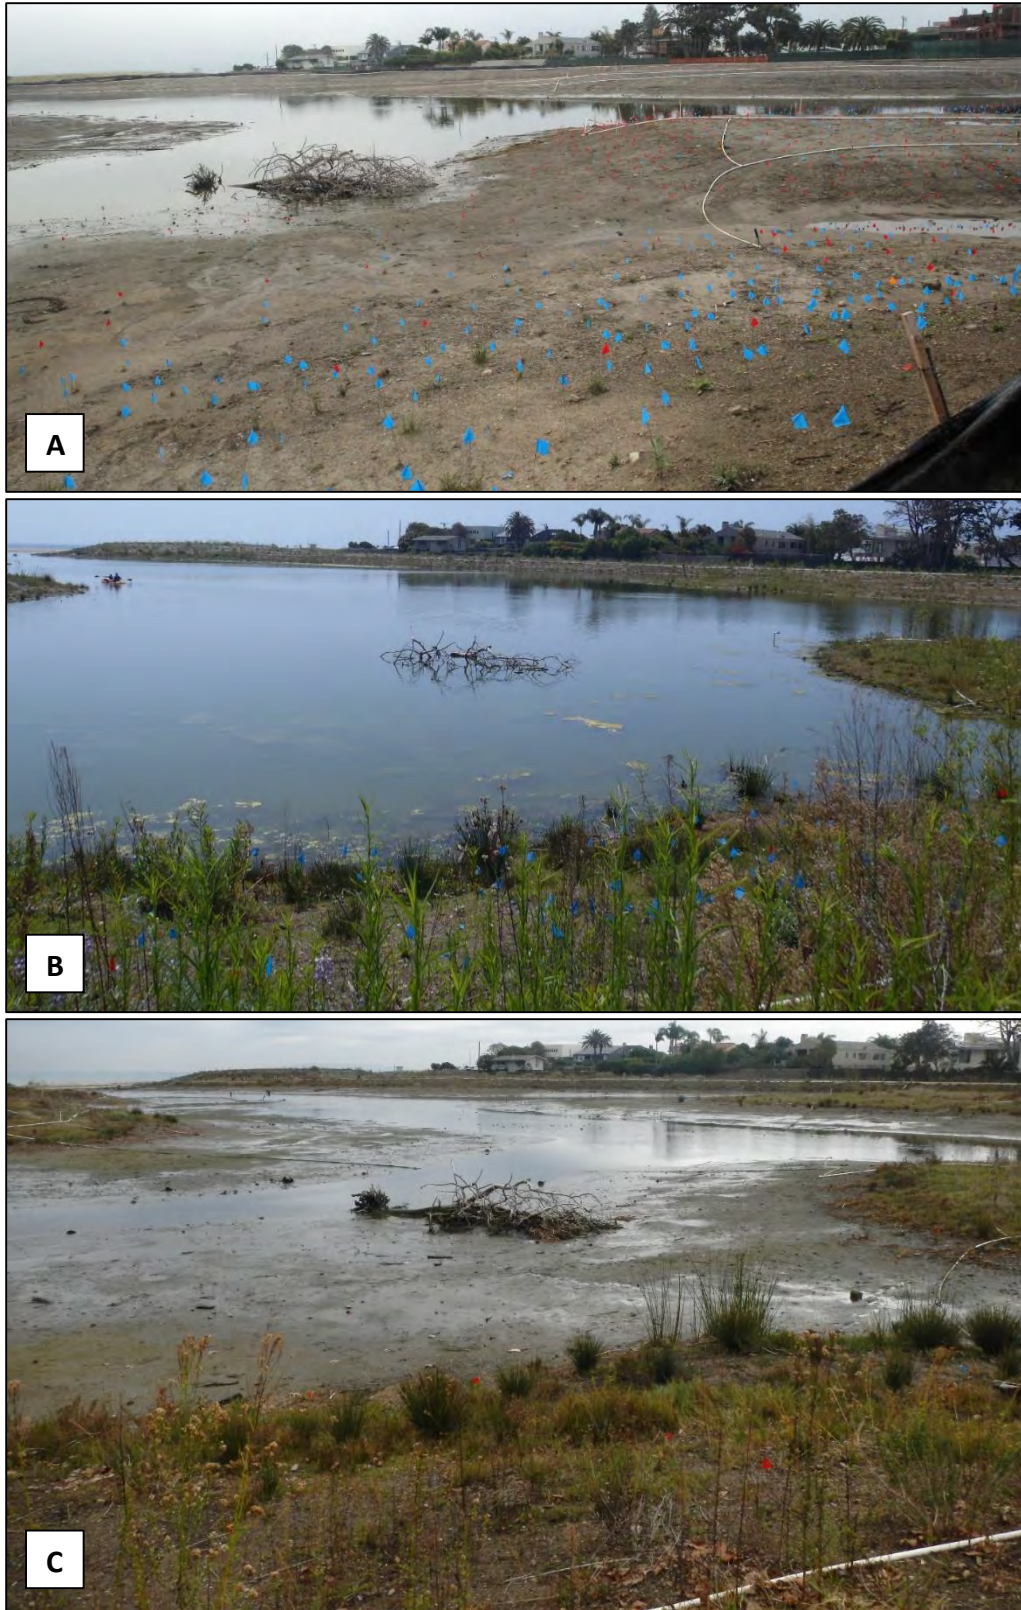
Figure 32. Photograph of Photo Point 1, bearing 155° on (A) 15 March 2013; (B) 7 May 2014; (C) 18 December 2014.

A total of five photos were taken at three locations to assess a range of habitat types across the restoration area. Figures 32 - 36 (A - C) display the photos from the five locations post-restoration on the three survey dates, respectively.

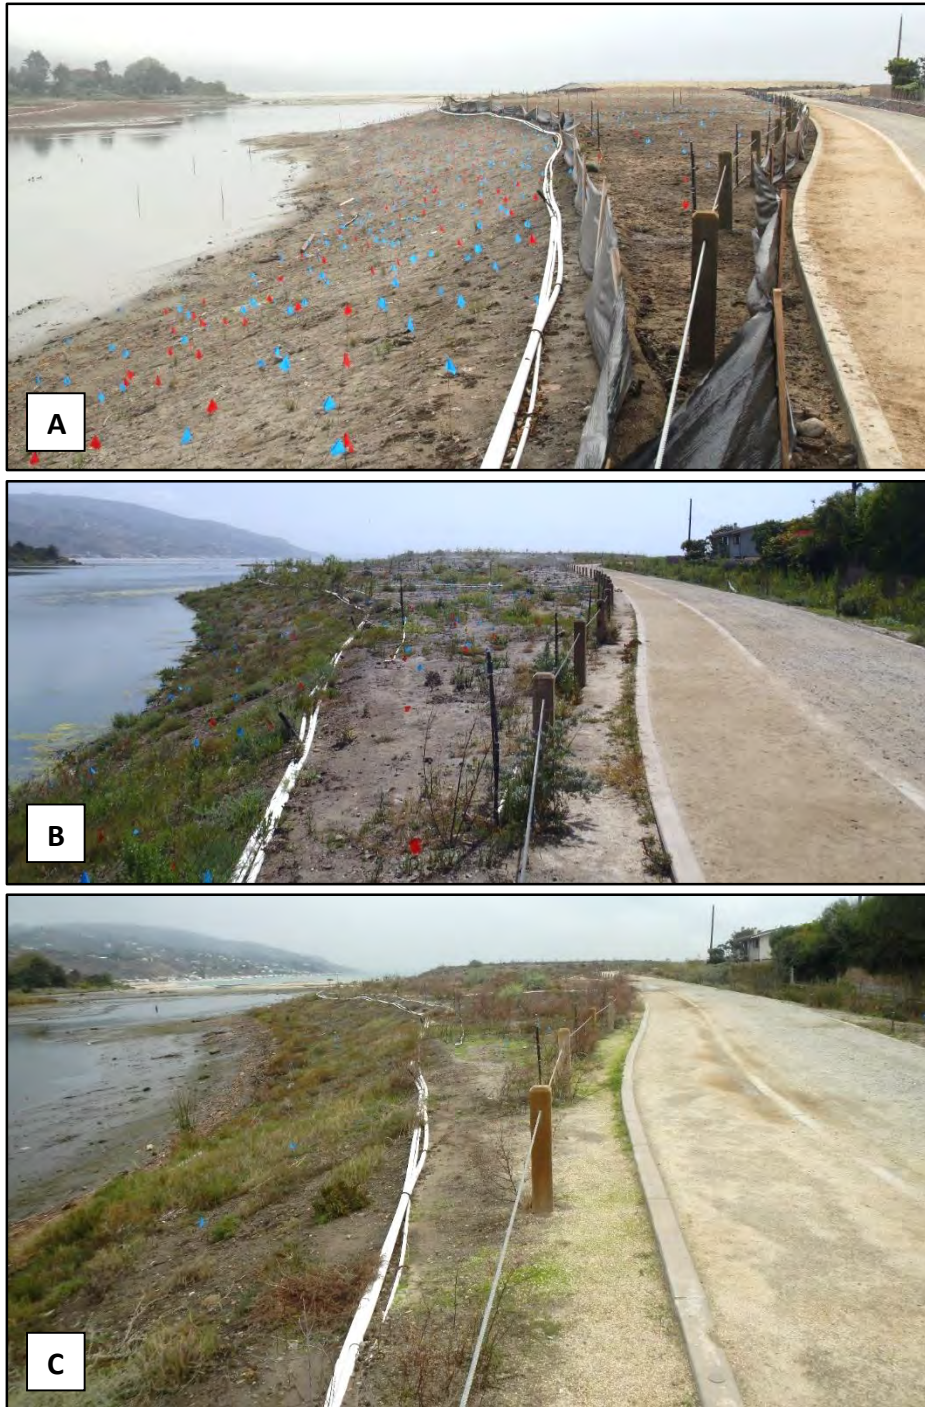
Figure 34. Photograph of Photo Point 2, bearing 75° on (A) 15 March 2013; (B) 7 May 2014; (C) 18 December 2014.

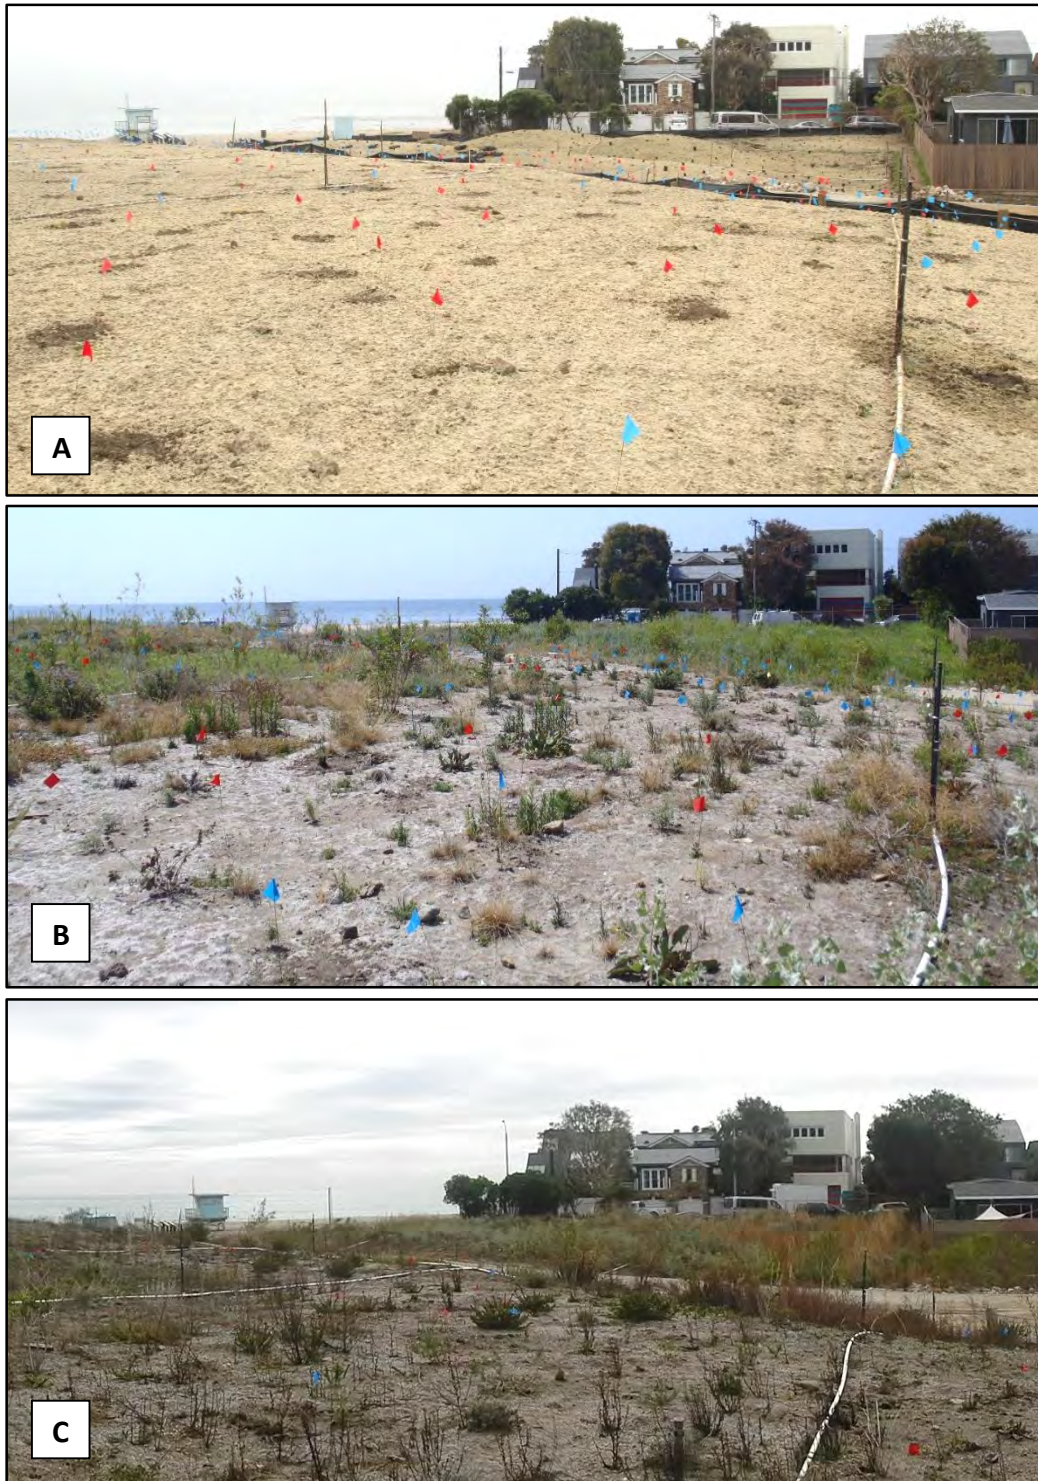
Figure 35. Photograph of Photo Point 3, bearing 220° on (A) 15 March 2013; (B) 7 May 2014; (C) 18 December 2014.
