Los Angeles International Airport Coastal Dunes Improvement Project Ecological Monitoring Report

20 June 2018

Prepared for Los Angeles World Airports and
the California Coastal Commission

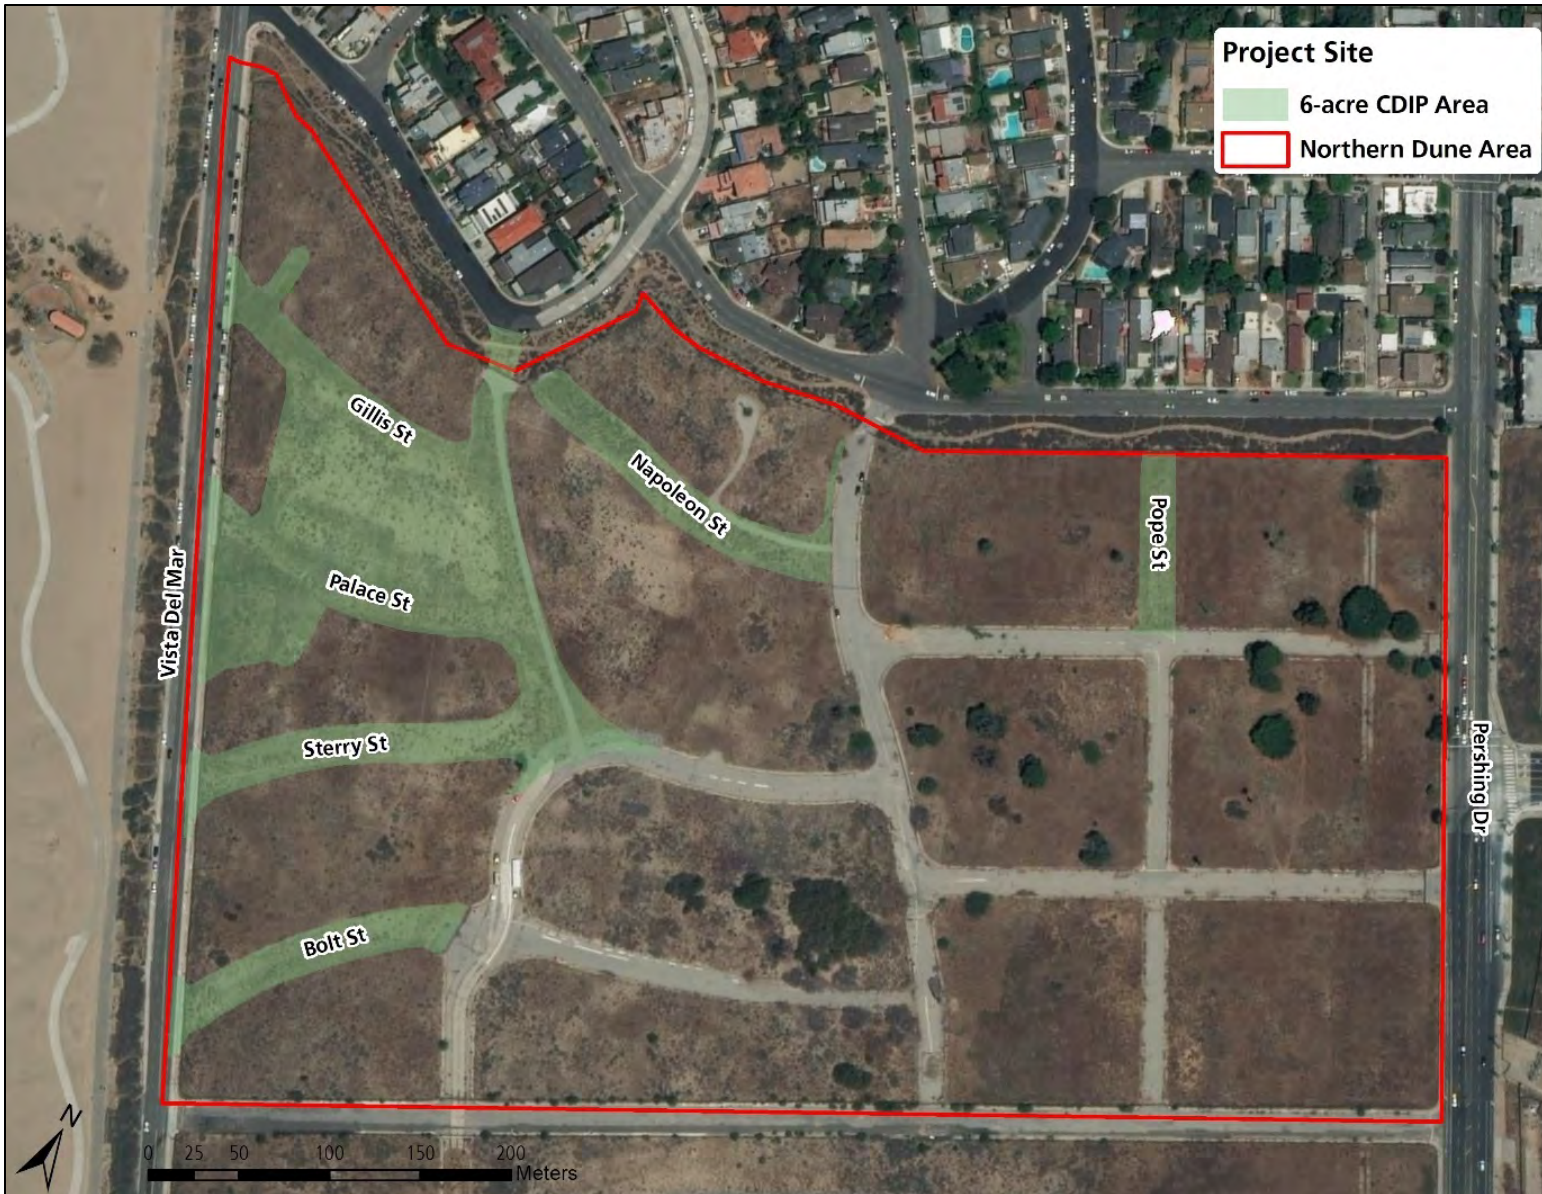
Figure 2. Site map of 6-acre LAX Coastal Dunes Improvement Project (green mapped areas).

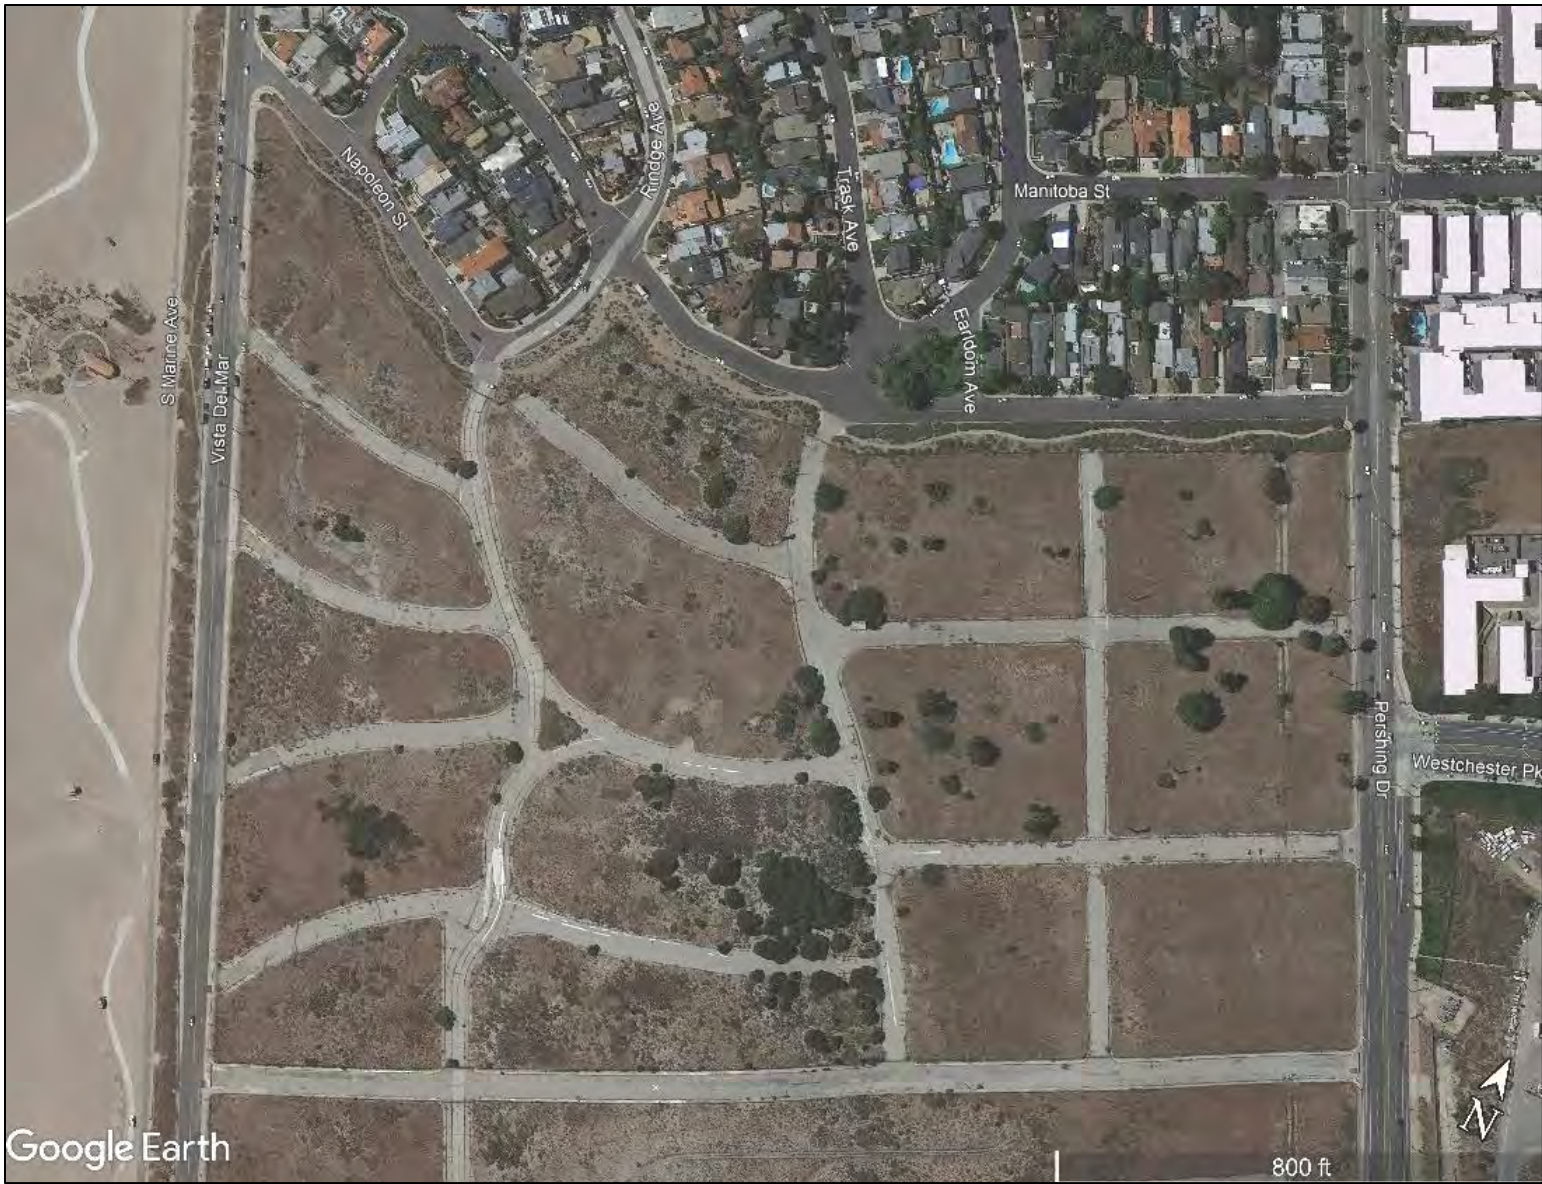
Figure 5. Aerial imagery of site prior to initial restoration efforts (April 2013) (Source: Google Earth).

Initial restoration efforts included the removal of six paved streets, including gutters, sidewalks, retaining walls, foundations, and above-ground utilities, followed by revegetation through seeding and planting. LAWA began restoration efforts in June 2013 following the issuance of the CDP along with the approved Ecological Landscape Plan (KMA 2013). Detailed engineering plans to remove hardscape were prepared by AECOM and approved prior to implementation (AECOM 2013).

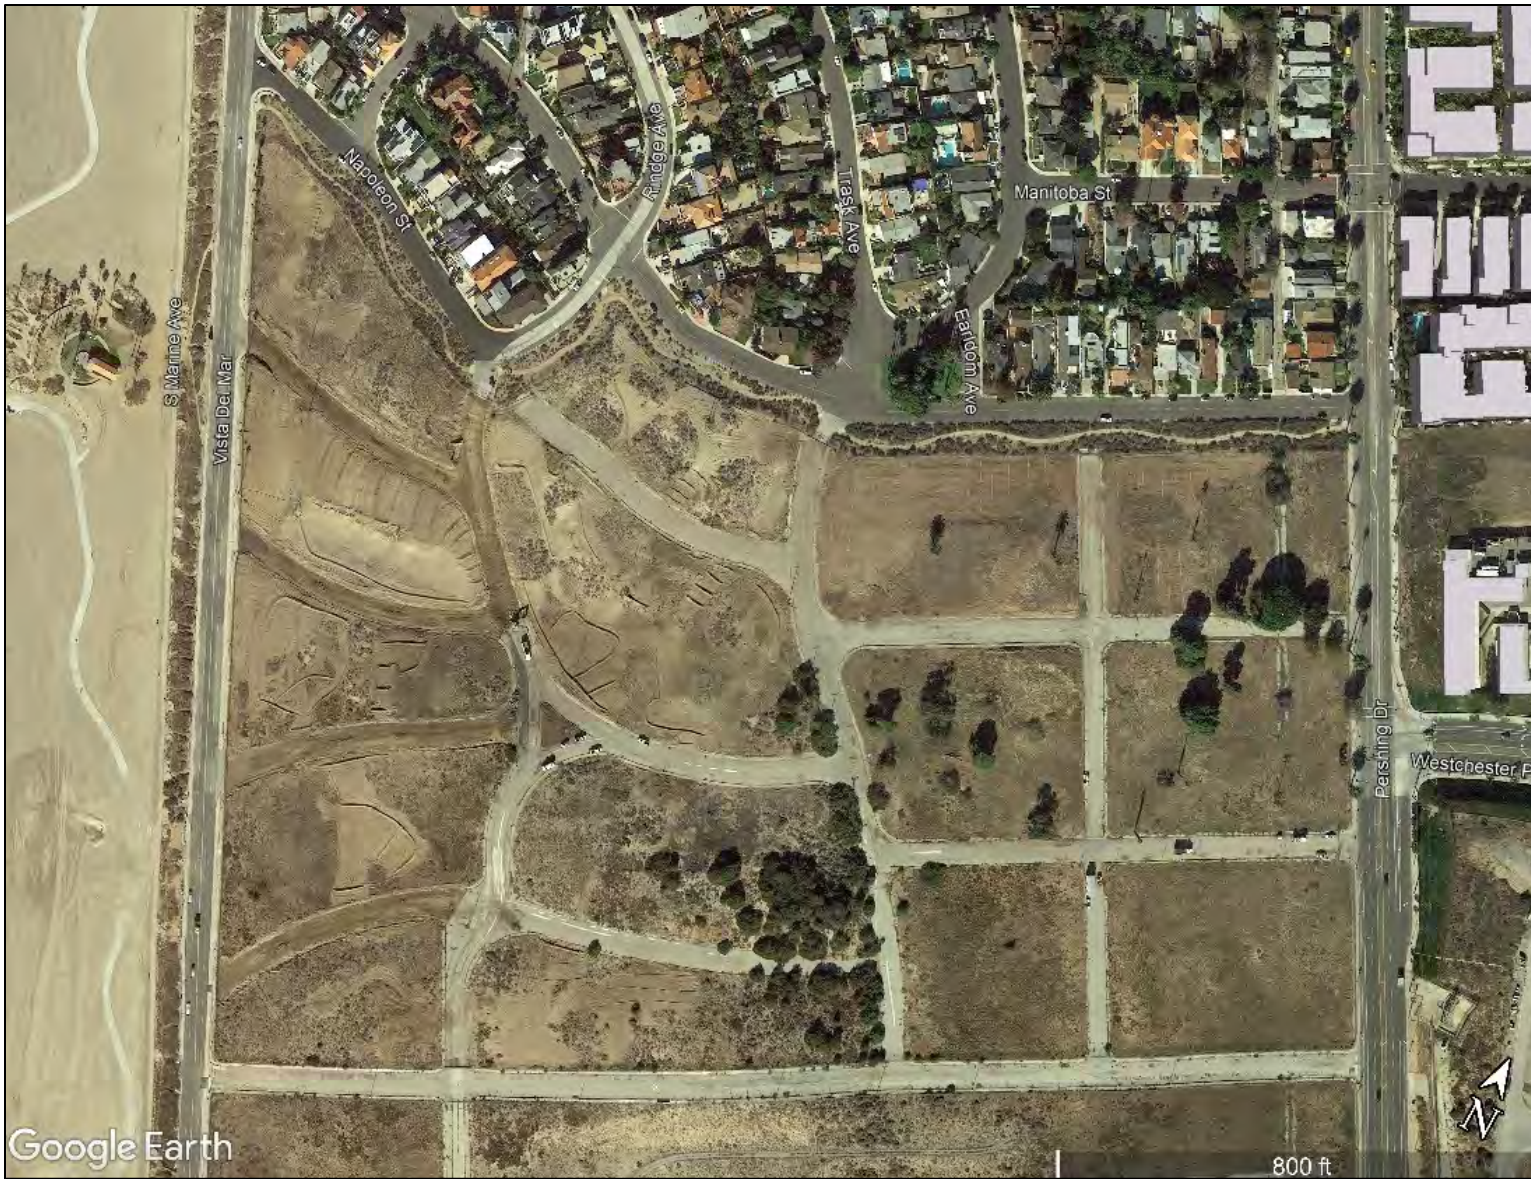
Figure 6. Aerial imagery of site following initial restoration efforts (December 2013) (Source: Google Earth).

Following the removal of hardscape, the restoration area was stabilized with fiber rolls and revegetated using both native seed and container stock (Figure 3). Habitat maintenance has included non-native vegetation removal and management through LAWA MSD staff (Figure 4), and monthly volunteer restoration events led by TBF and FOLD. Figures 5, 6, and 7 show the aerial view progression of the site from pre-restoration, to immediately following restoration, to current day, respectively.

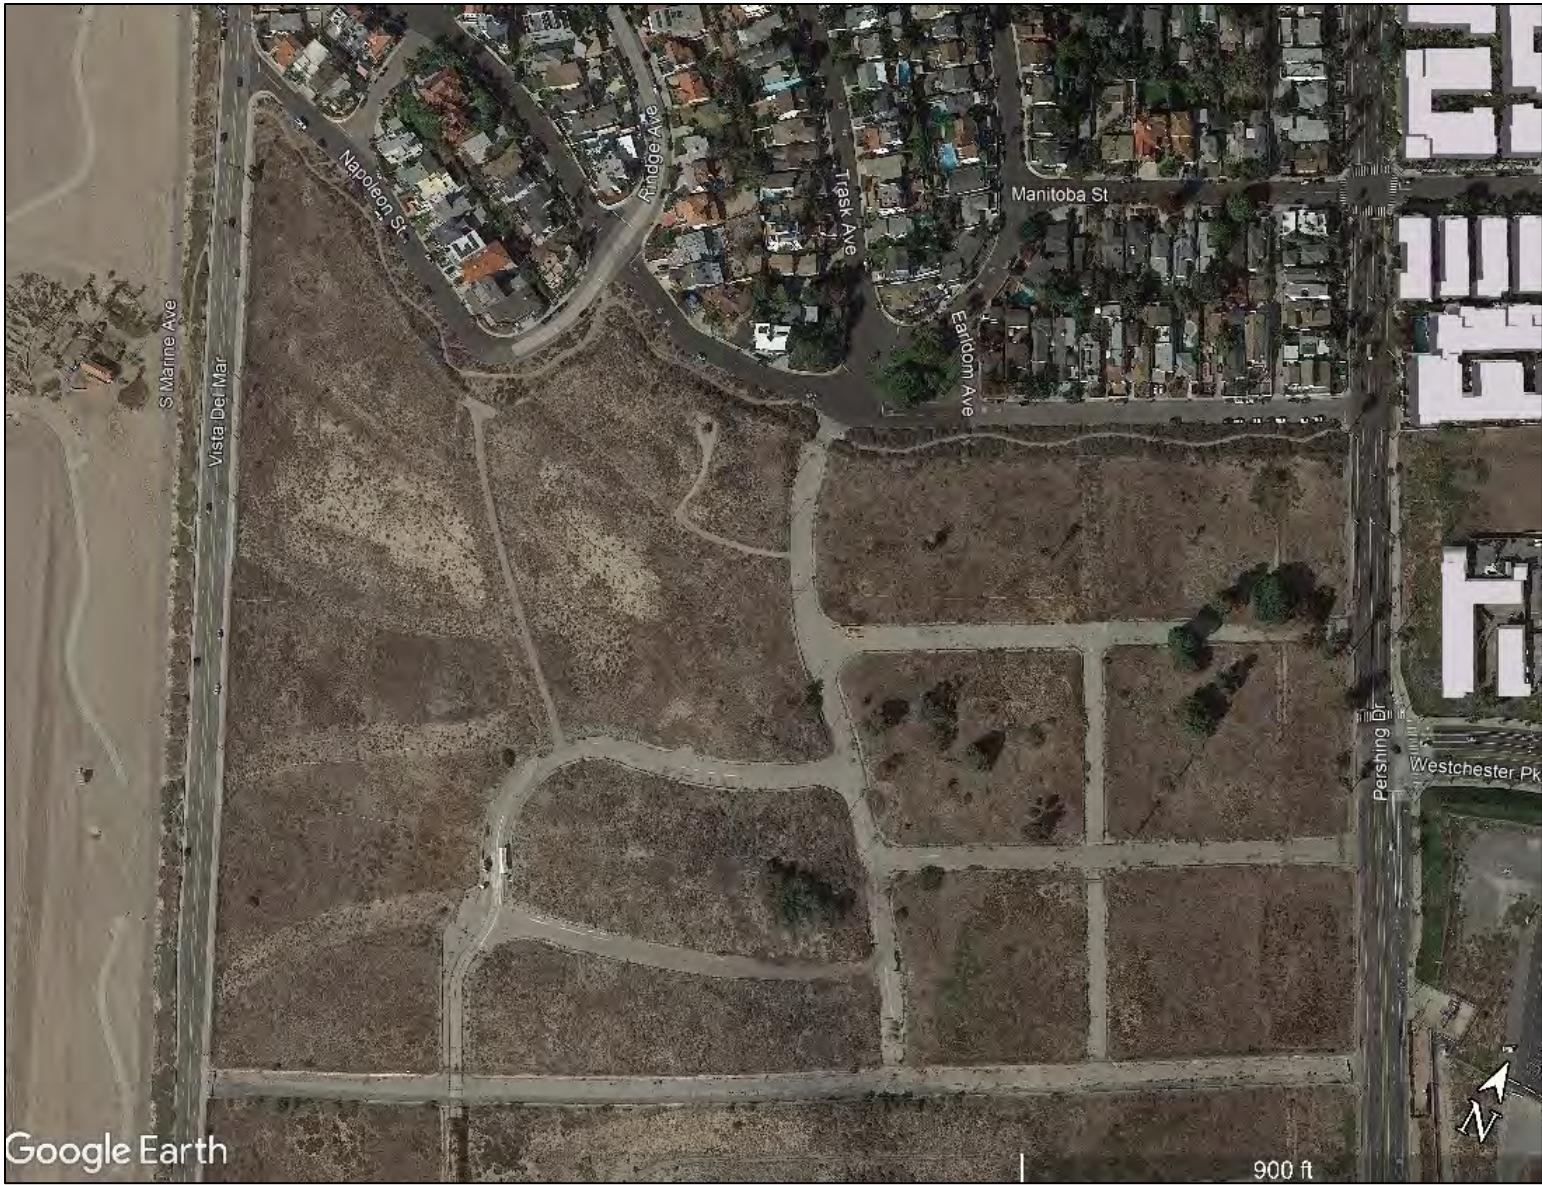
Figure 7. Aerial imagery of present day (December 2017) (Source: Google Earth).

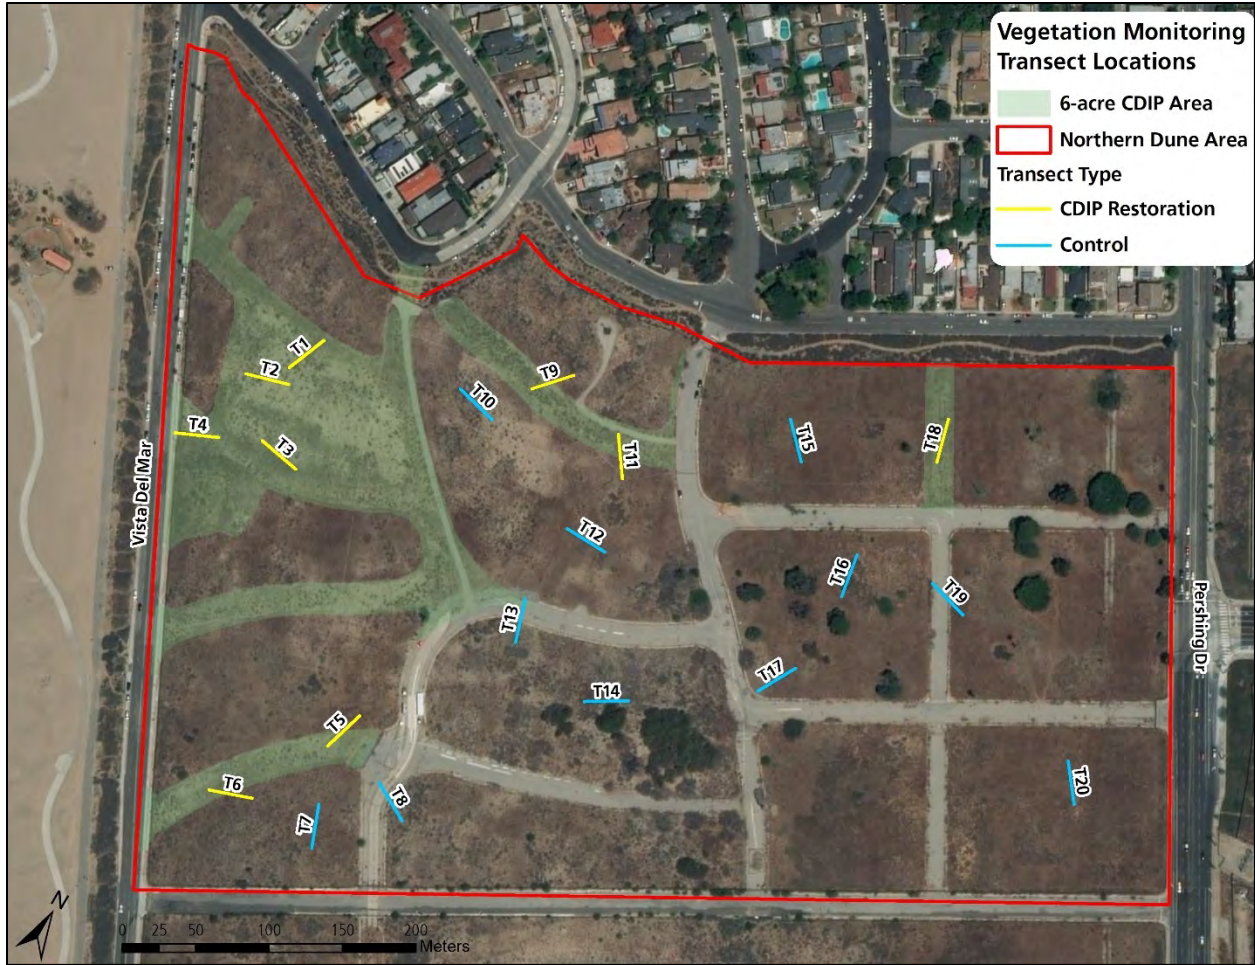
Figure 12. Map of vegetation monitoring transect locations.

The transect survey methods are described, along with field data sheets, in [SOP 3.2 Vegetation Cover Surveys](#) (TBF 2015b). Line-intercept transects document every species observed directly below the transect tape where vegetation crosses a minimum of 0.01 m (or 1 cm). This transect survey method is useful when collecting vegetation cover data in patchy habitats such as dunes or those with a significant amount of unvegetated ground (e.g., sand). Cover class quadrat surveys were conducted to supplement the line-intercept data and provide another level of cover assessment using 1 m² PVC quadrats subdivided into 16 sub-quadrats. Nine transects were surveyed in the CDIP restoration area, with an additional 11 “control” transects. Five fixed-location quadrats were surveyed along each transect. Vegetation surveys were conducted on 12, 18, and 26 January; and 9, 12, 16, and 23 February 2018. The nine vegetation transects were resurveyed on 12 June 2018 to assess the effectiveness of restoration efforts within the CDIP area over the four-month period as well as to provide an estimate of seasonal changes (Figure 13). Cover estimate results are provided for both sets of surveys for comparison.

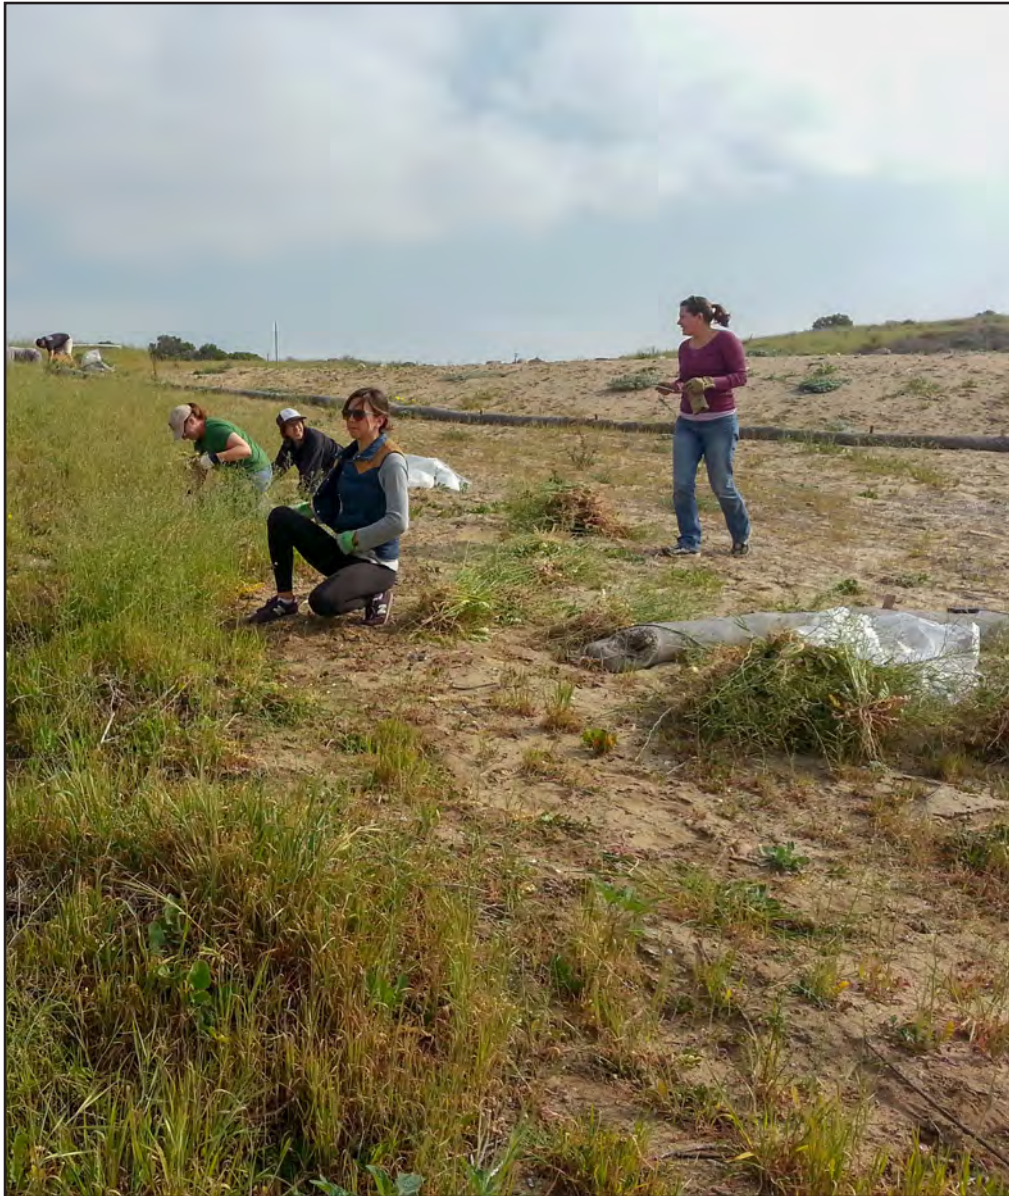
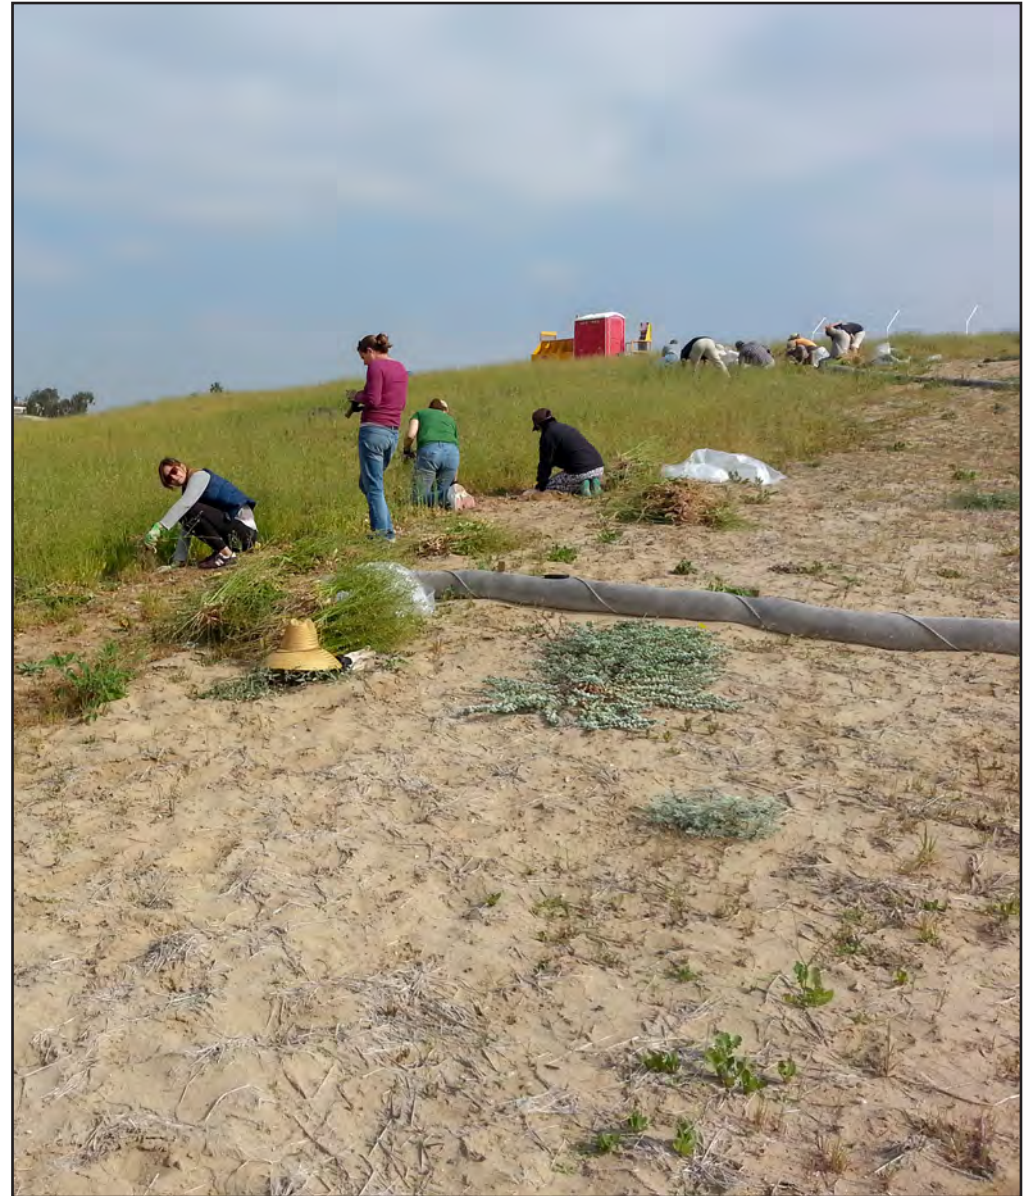
Figure 14. TBF staff cleared non-native mustards on and near areas of restoration on 17 February 2015 (credit: Rod Abbott, TBF).

Photo Point data are qualitative representations of restoration activities and the dune habitats in general. Figures 14 through 17 display "before" and "after" representative photographs from four restoration areas. Figure 16 is a particularly good example of resilience in the dune system; the last photograph in the series was taken more than a year after a restoration event took place (6 May 2017) and shows only minor non-native invasion (12 June 2018). Figure 17 shows another example of a TBF led restoration event removing Saharan mustard and filaree, which if left unchecked could grow, seed, and threaten native plants such as deerweed, beach evening primrose, and beach bur. Figure 18 displays a representative series of photographs from an established vegetation monitoring transect.

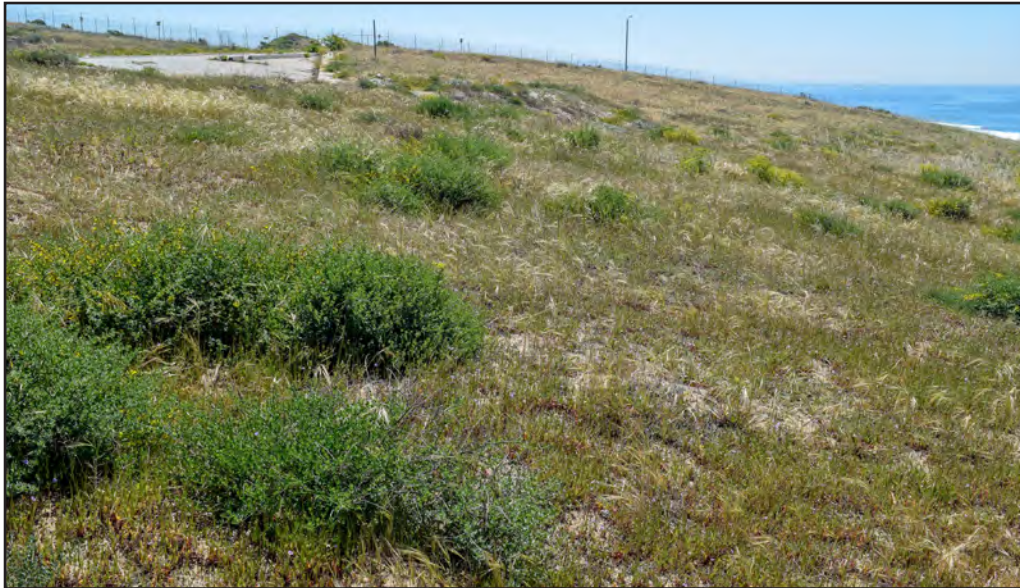
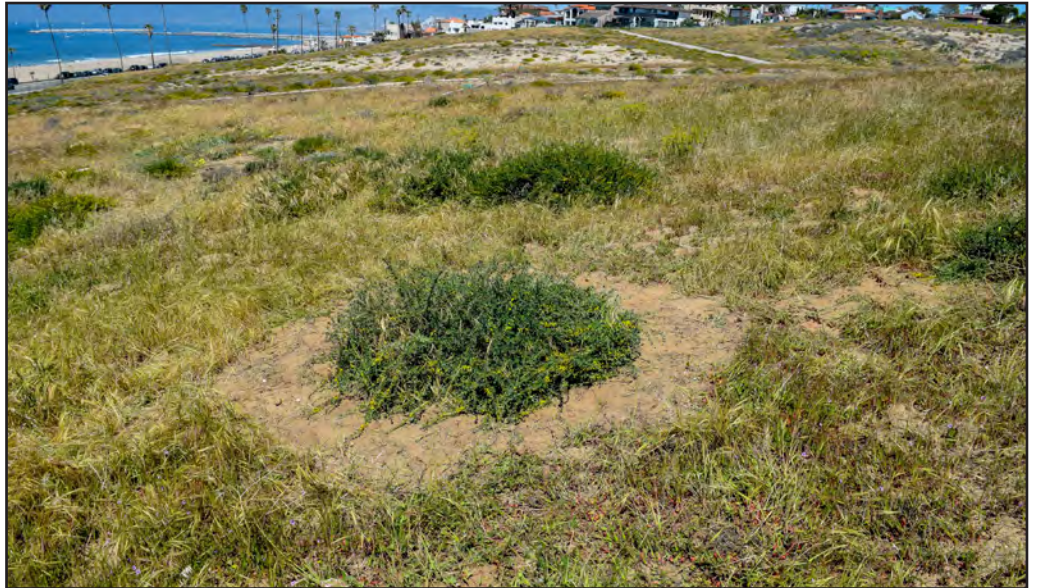
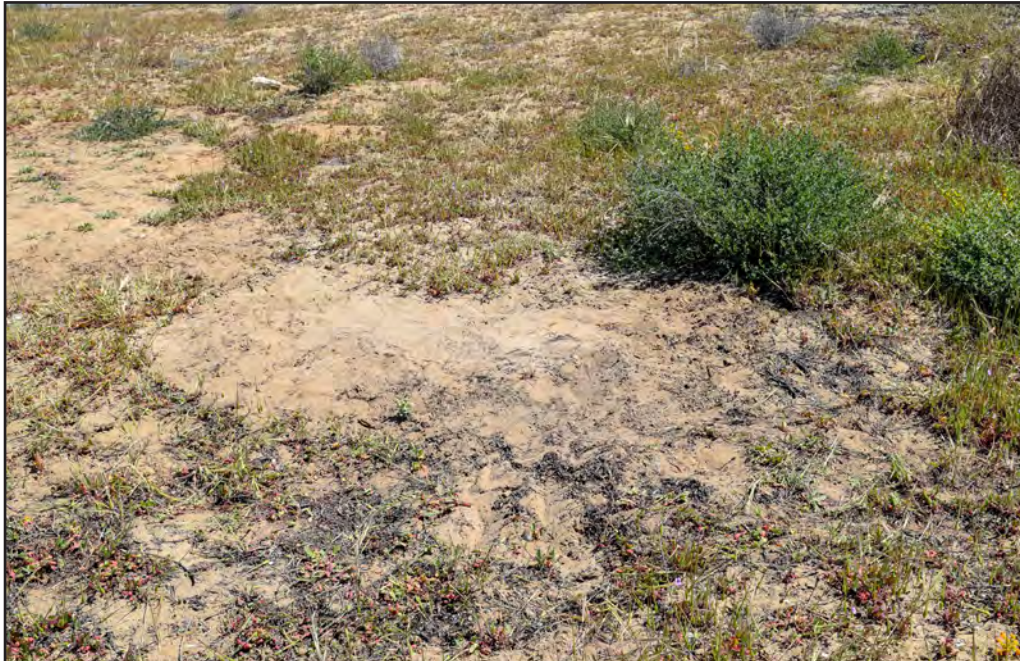
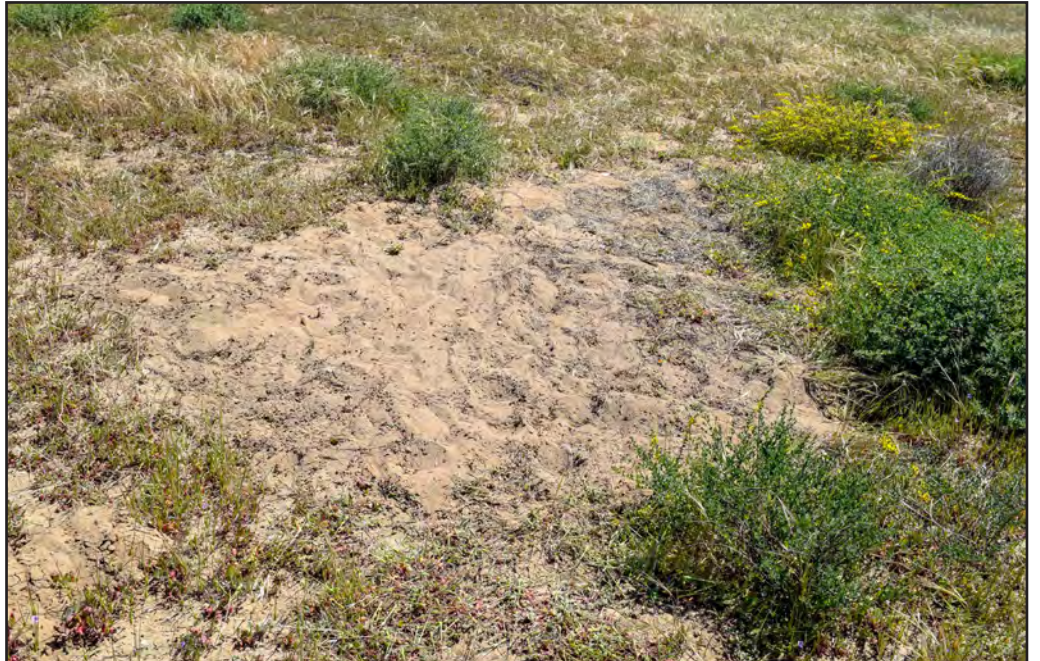
Figure 15. Volunteers remove non-native vegetation in and around plants such as the deerweed on 1 April 2017 (credit: Rod Abbott, TBF).

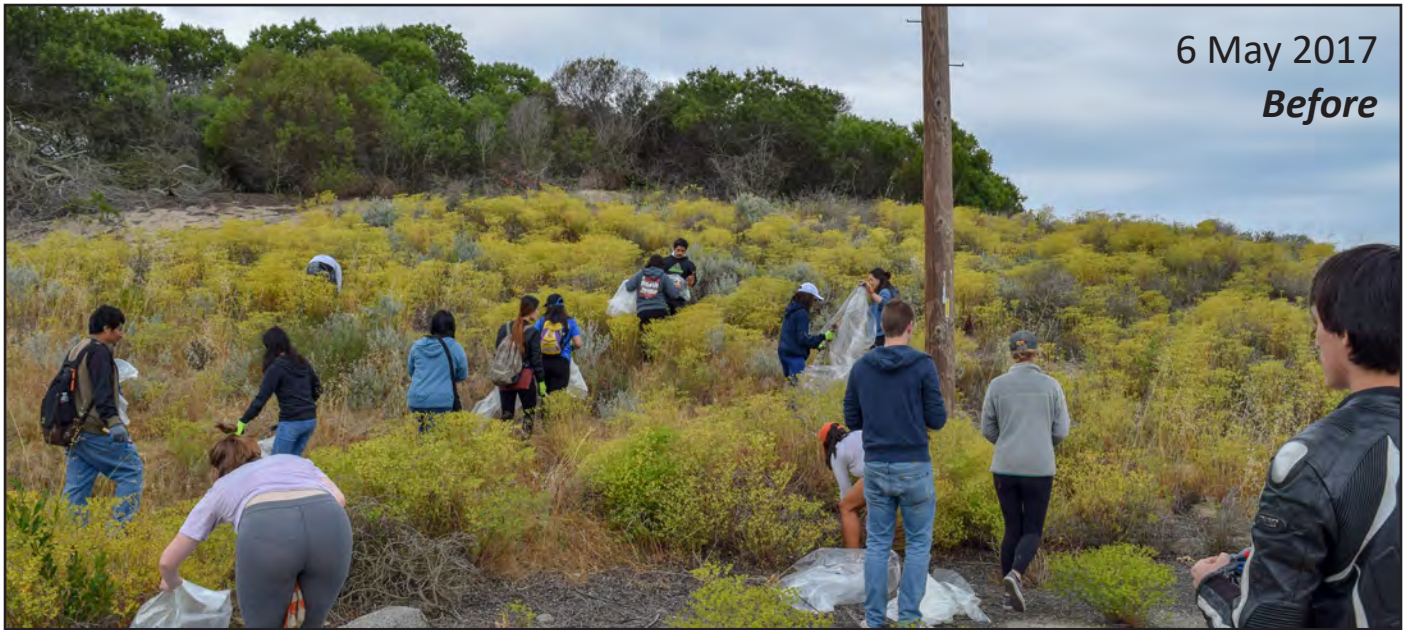
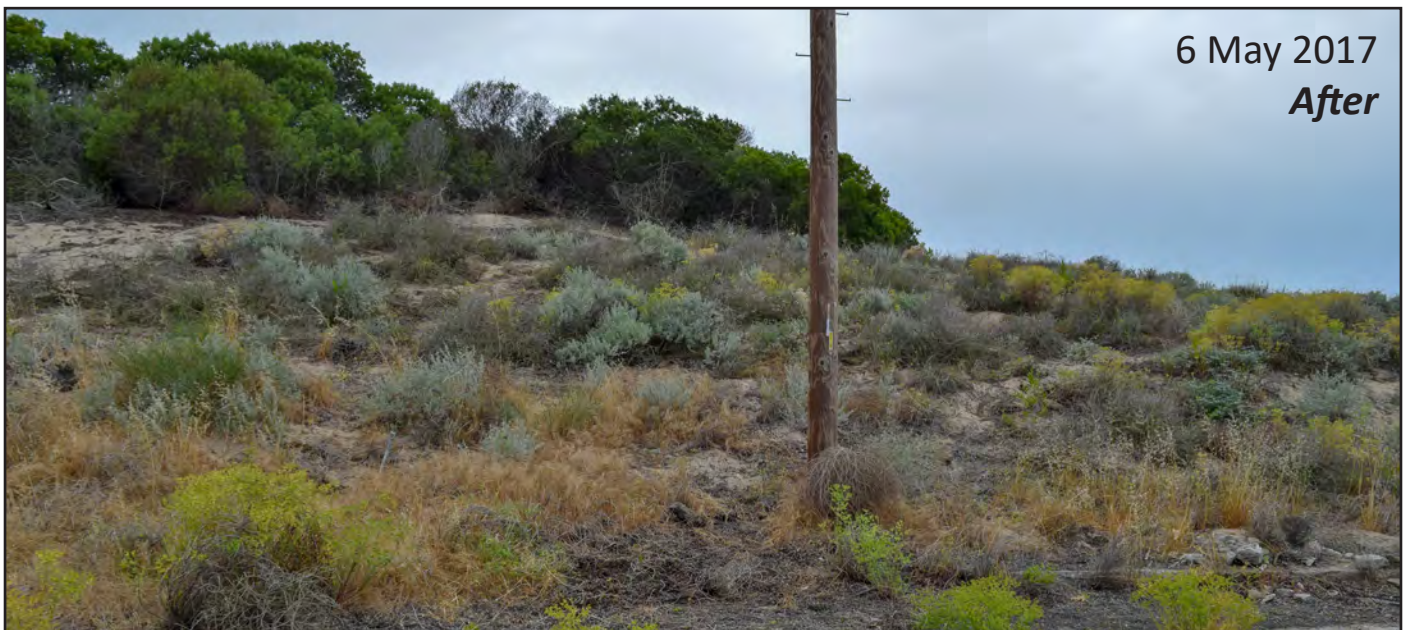
Figure 16. UCLA students removed 80 bags of invasive *Terracina* spurge encroaching on beach blue lupine on 6 May 2017 (credit: Rod Abbott, TBF).

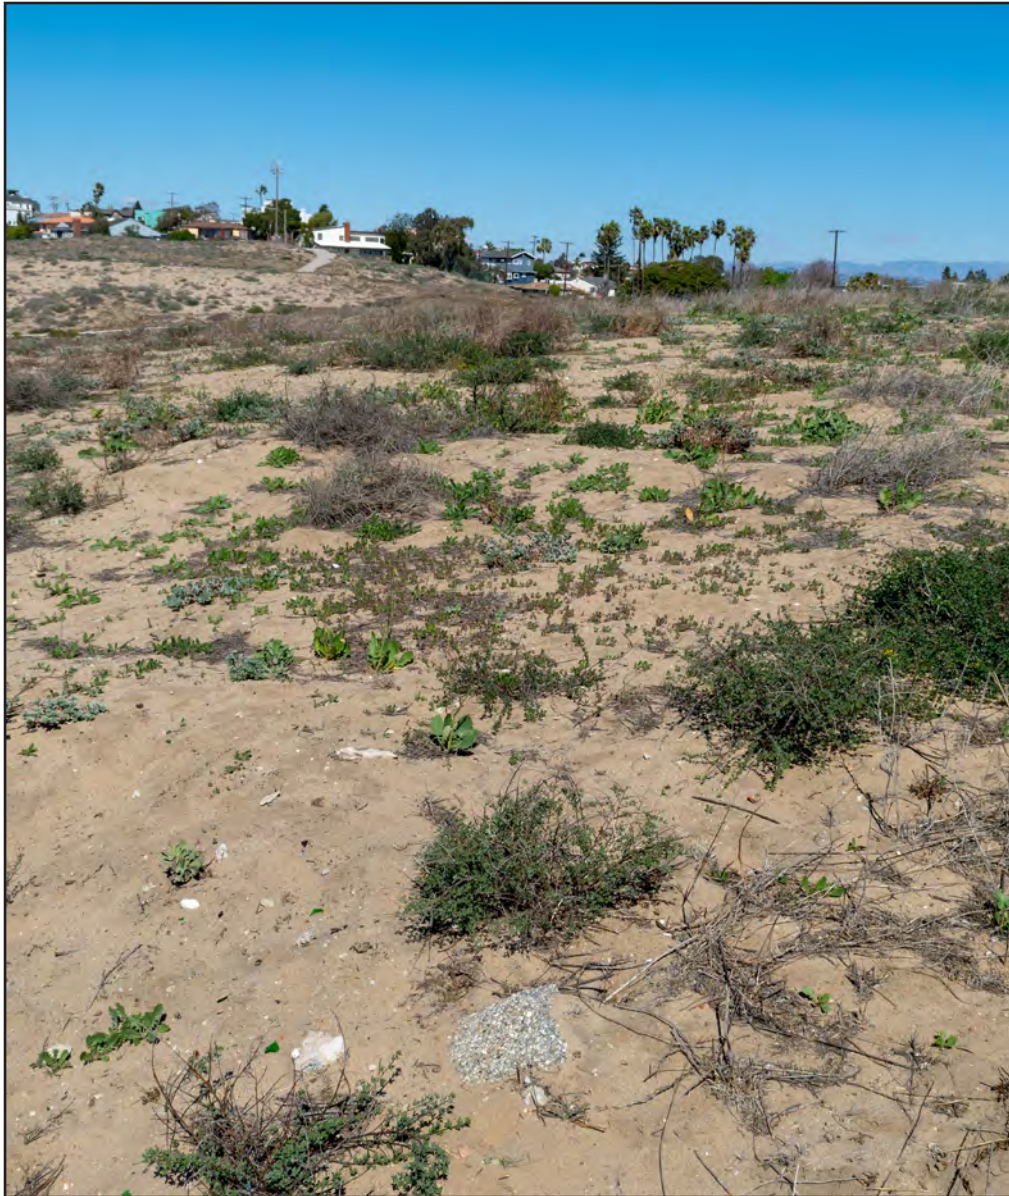
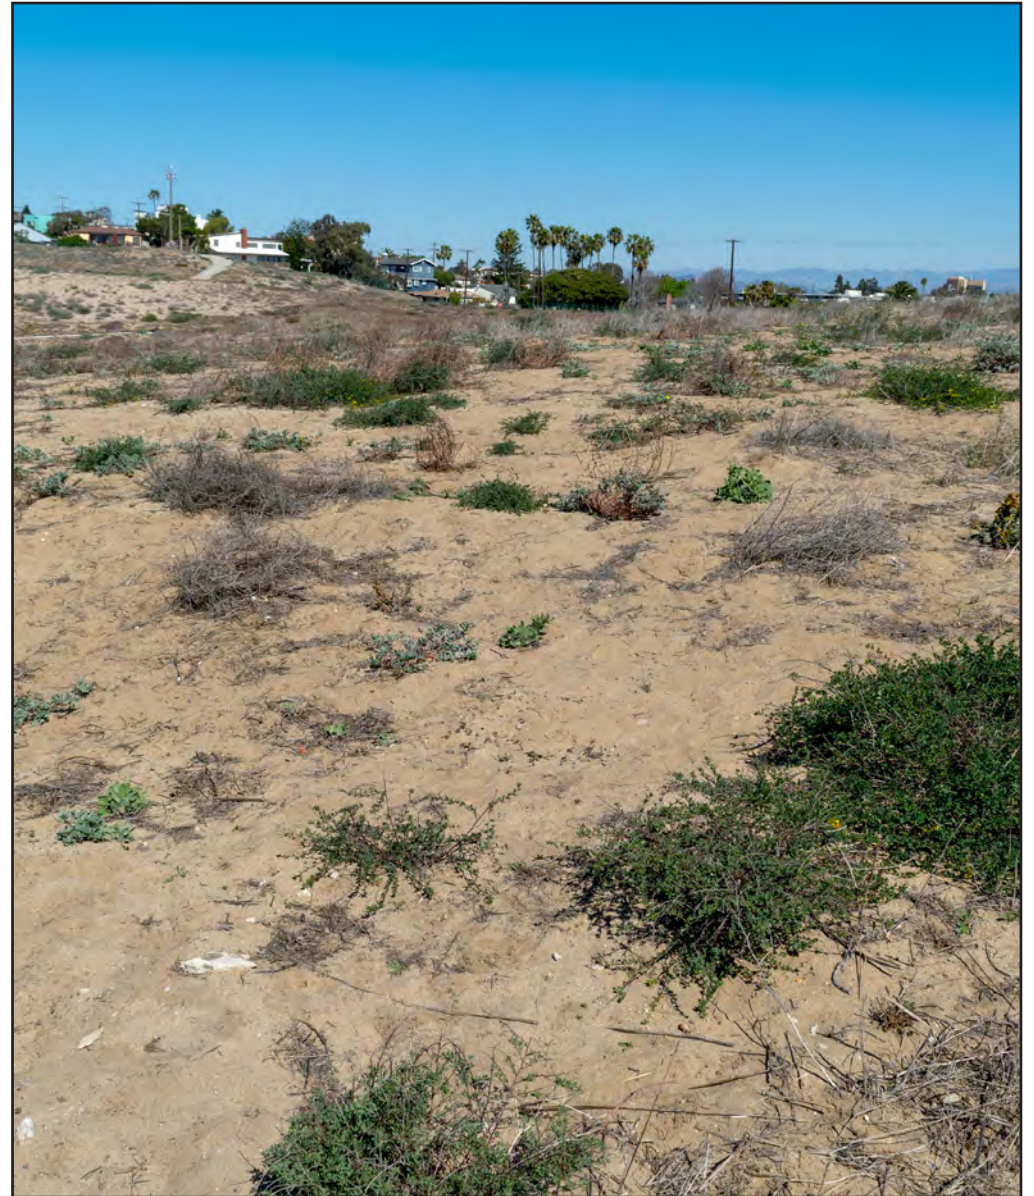
Figure 17. Volunteers removed juvenile Saharan mustard and filaree around deerweed, beach evening primrose, and beach bur on 24 February 2018 (credit: Rod Abbott, TBF).

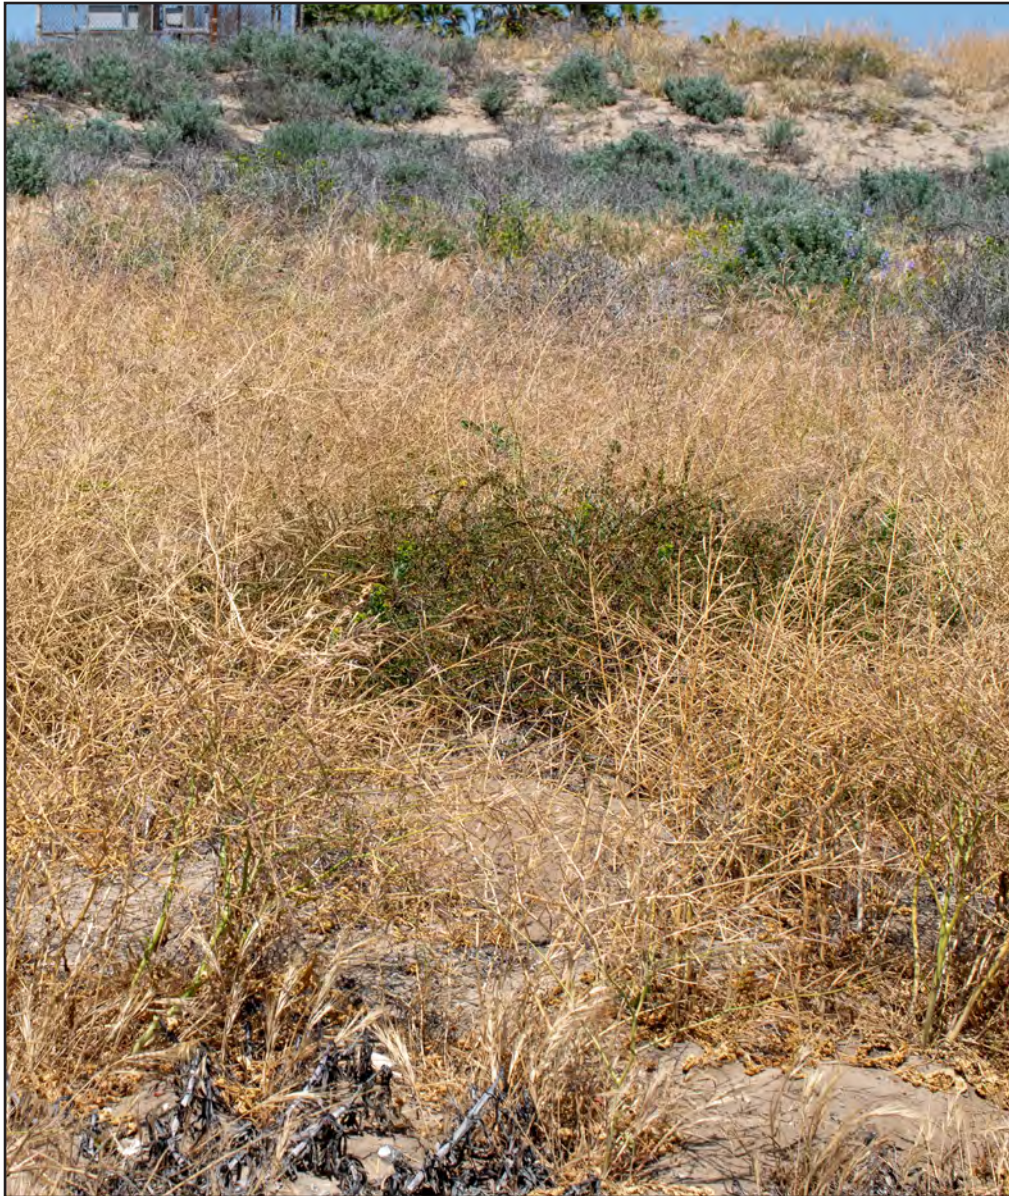
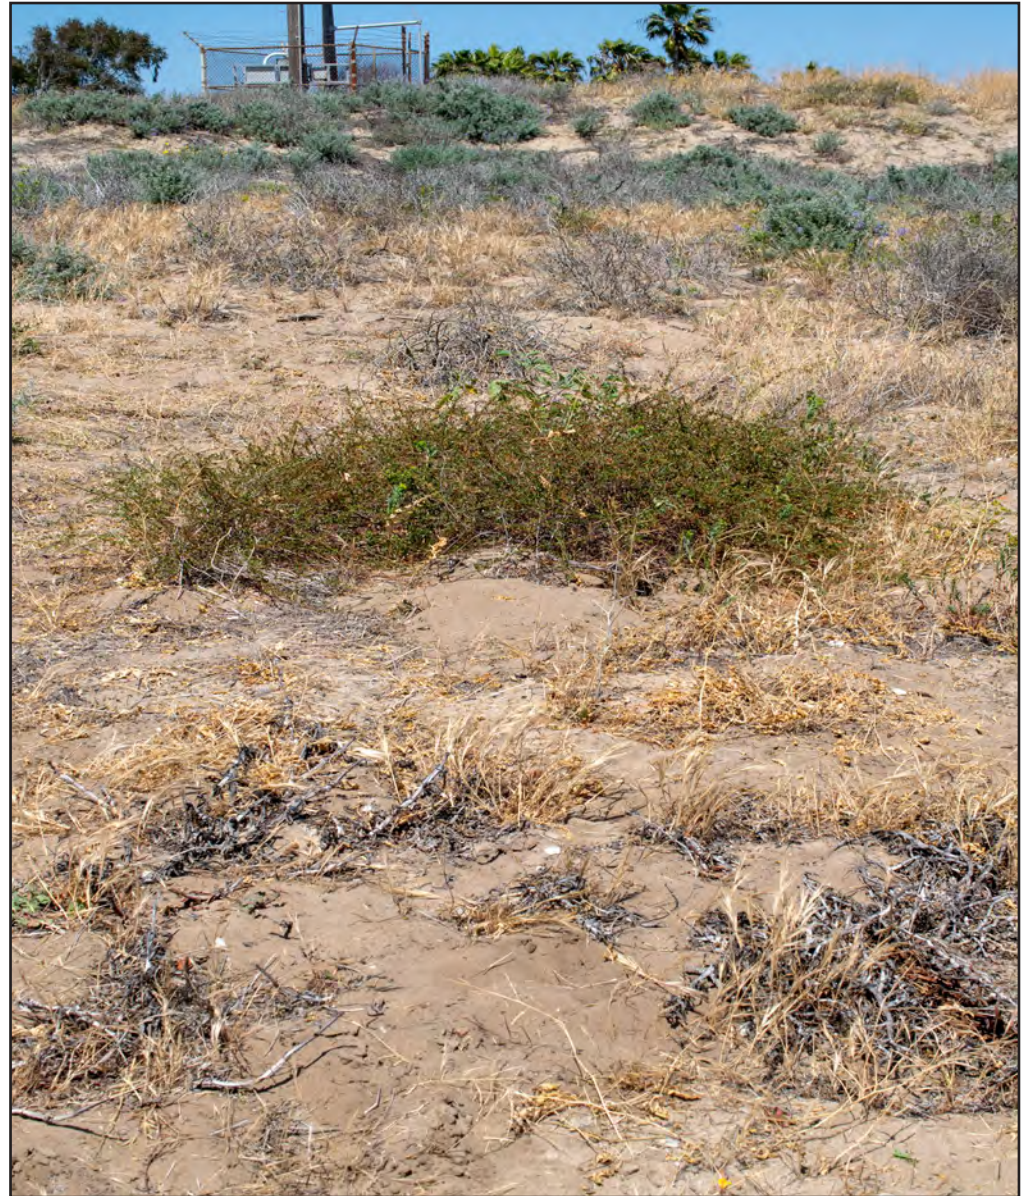
Figure 18. TBF interns cleared mustards, Terracina spurge, and grasses on 15 May 2018 (credit: Rod Abbott, TBF).

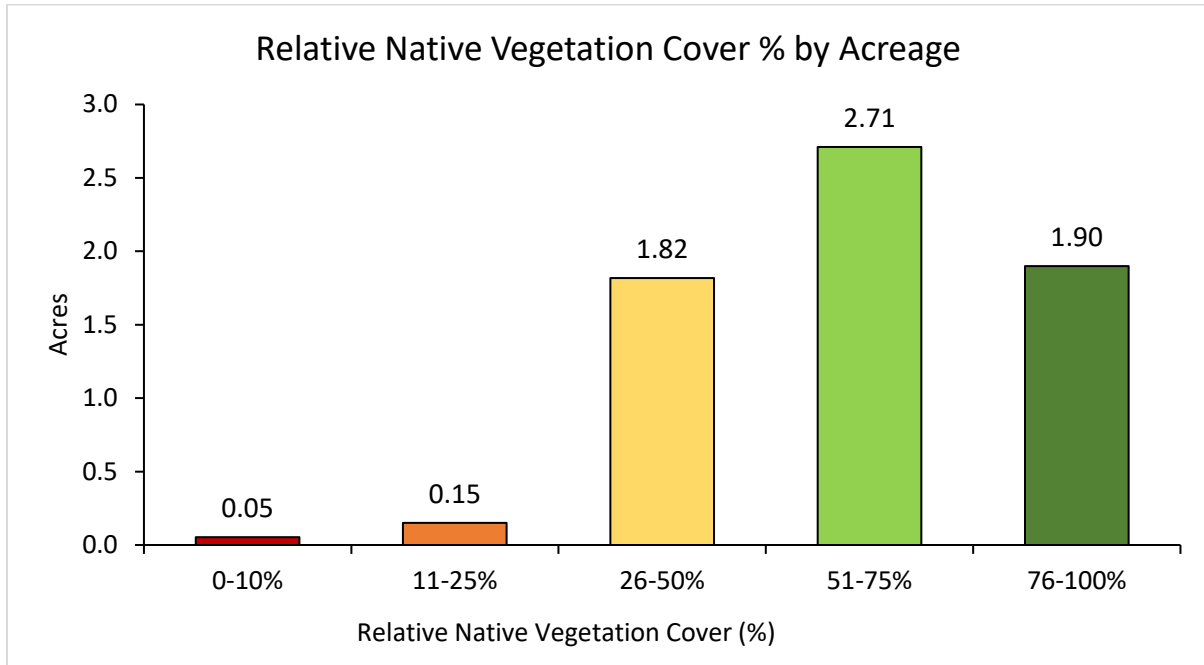
Figure 25. Relative native vegetation cover percentage by acreage. Note: bar graph labels refer to exact acreage of each percentage category.

Vegetation mapping results established similar trends as the cover assessment surveys. High relative native vegetation cover dominated the majority of the CDIP restoration area, with small areas of non-native cover, particularly along the fence line separating the dunes from Vista del Mar.
