Los Angeles International Airport Coastal Dunes Improvement Project Ecological Monitoring Report

20 June 2018

Prepared for Los Angeles World Airports and
the California Coastal Commission

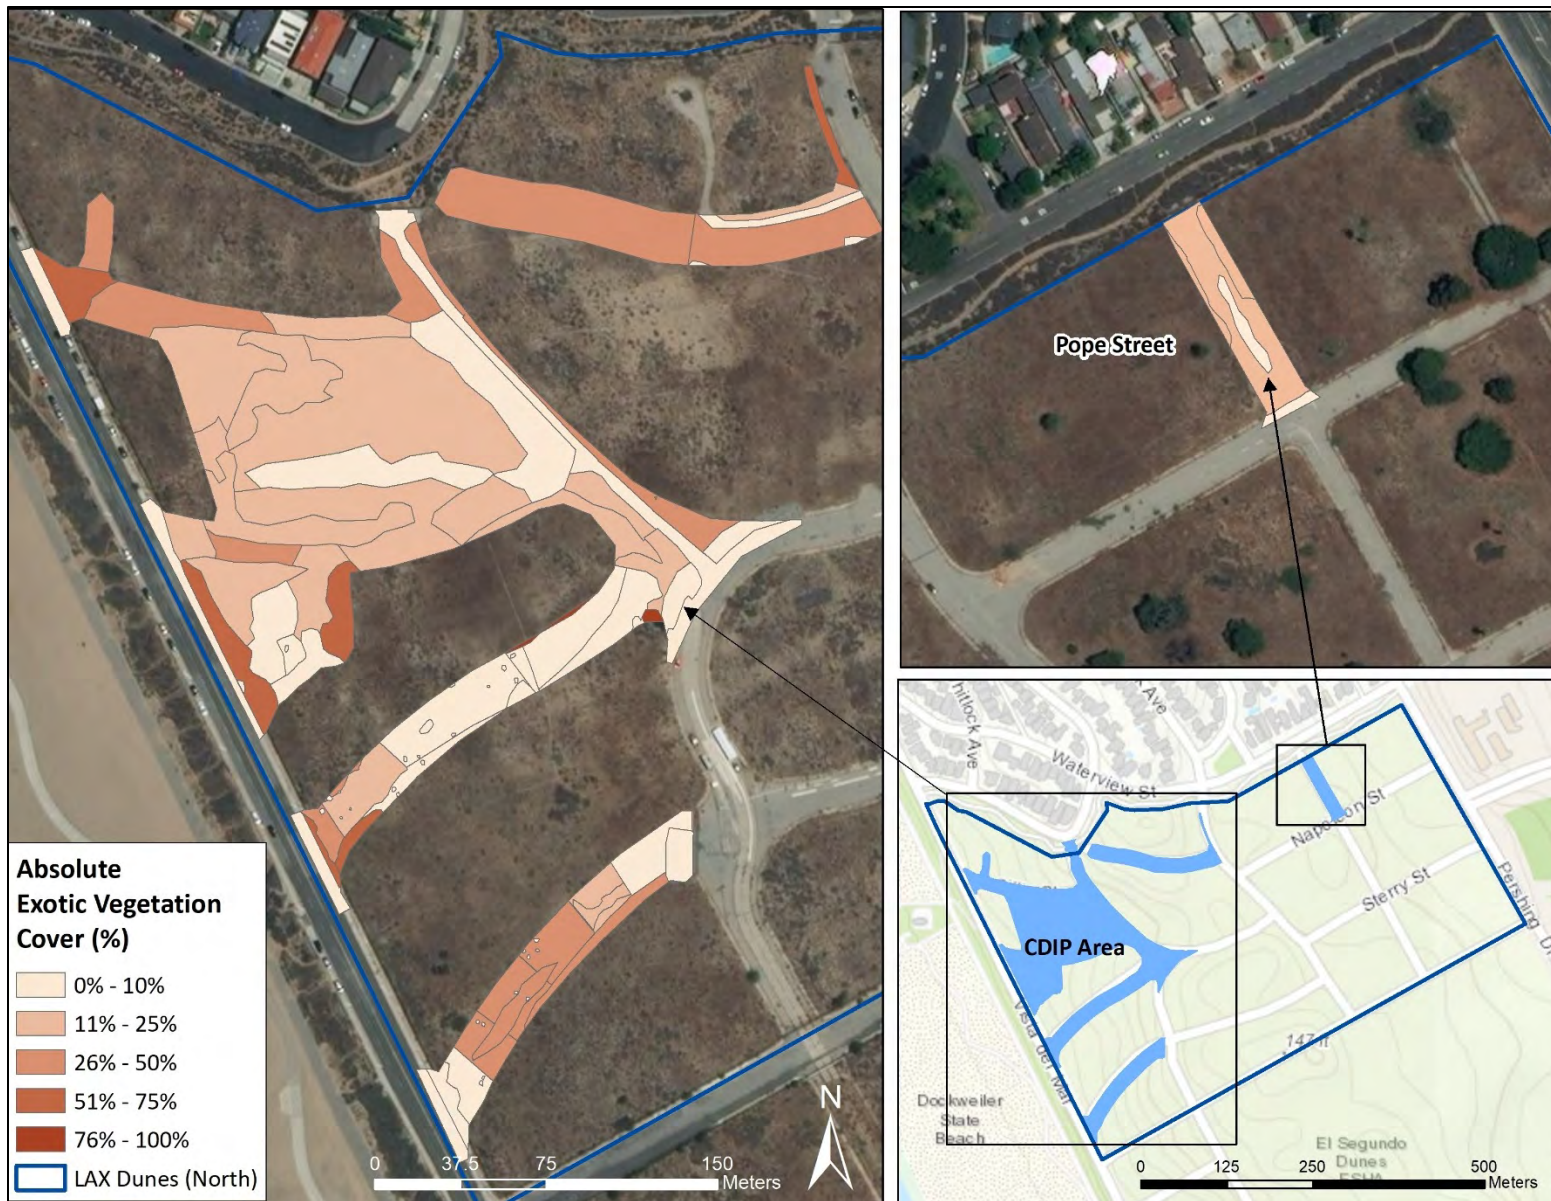
Figure 27. Absolute non-native vegetation cover map of CDIP restoration area.

Vegetation mapping results established similar trends as the cover assessment surveys. High relative native vegetation cover dominated the majority of the CDIP restoration area, with small areas of non-native cover, particularly along the fence line separating the dunes from Vista del Mar.

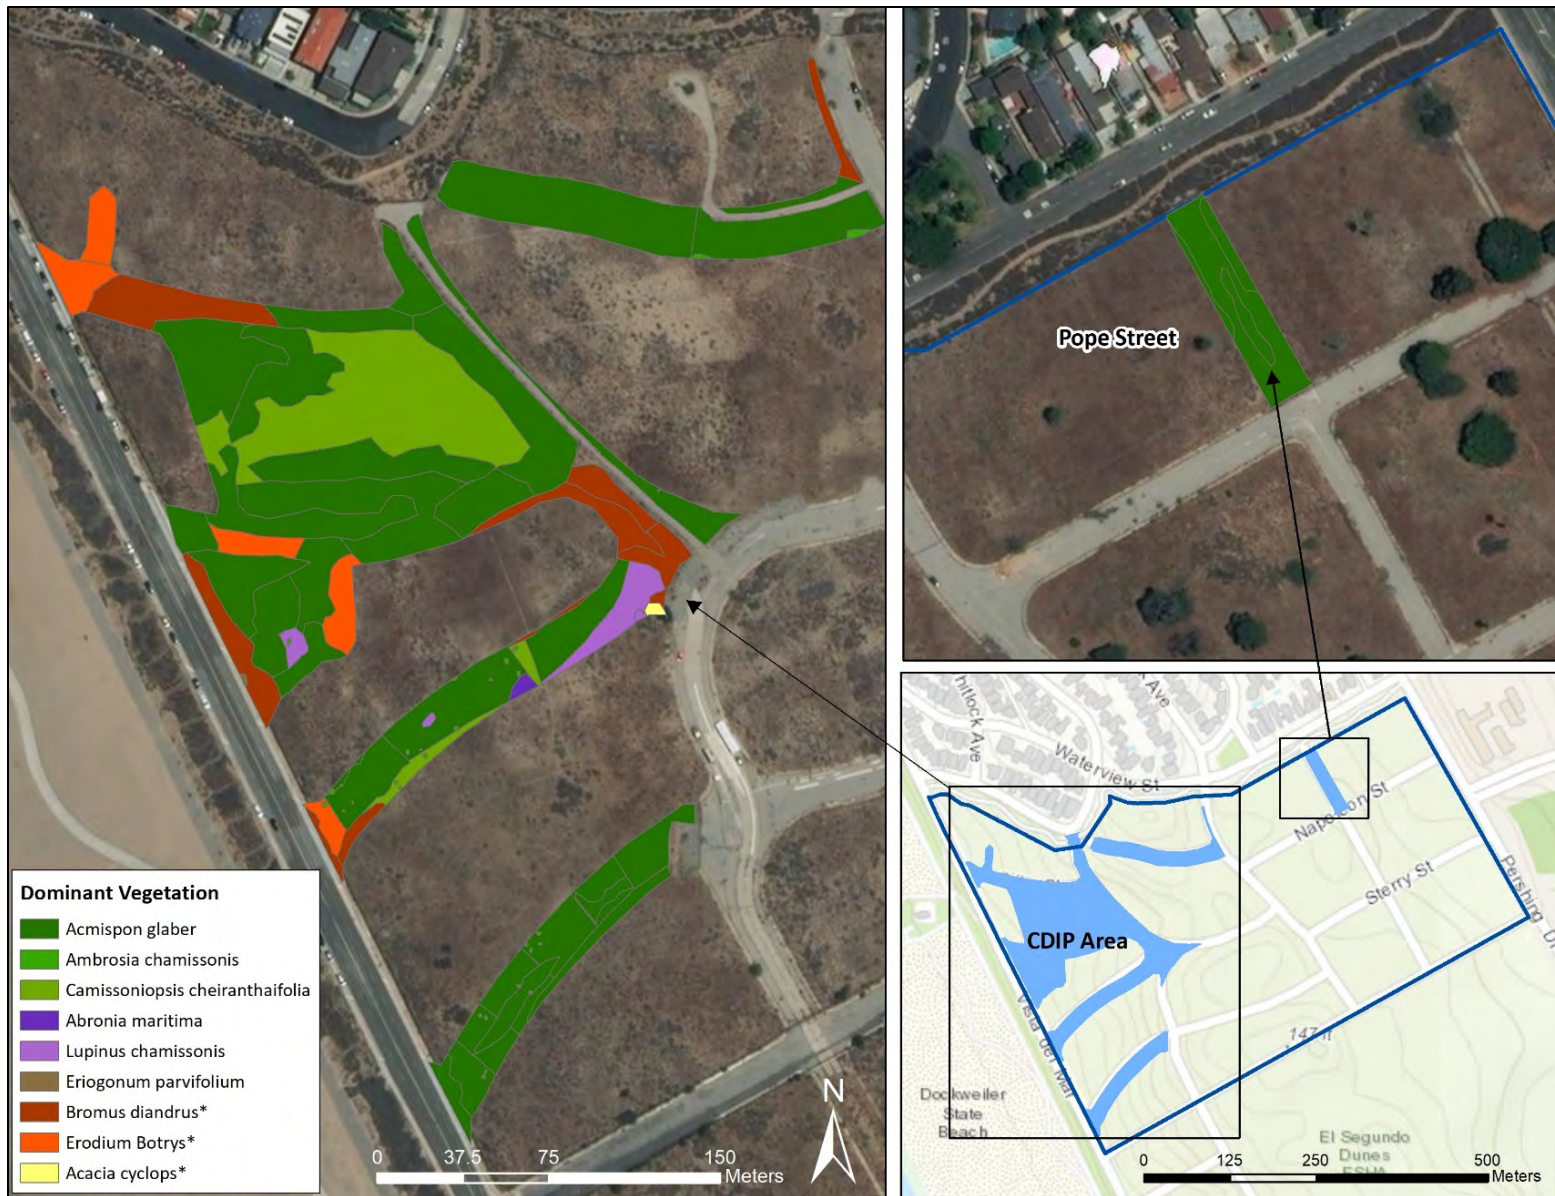
Dominant species within each GIS polygon are displayed in Figure 28. Native species dominated approximately 85.5% of the total project area, and polygons dominated by non-native species accounted for approximately 14.6% of the total project area. Deerweed and beach evening-primrose dominated approximately 82% of the total CDIP area. Except for a small stand of non-native red-eyed wattle (*Acacia cyclops*), only 14.5% of the total CDIP area was dominated by non-native vegetation consisting of riggut brome (*Bromus diandrus*) and filaree.

Figure 28. Dominant vegetation within CDIP area (* indicates non-native species).

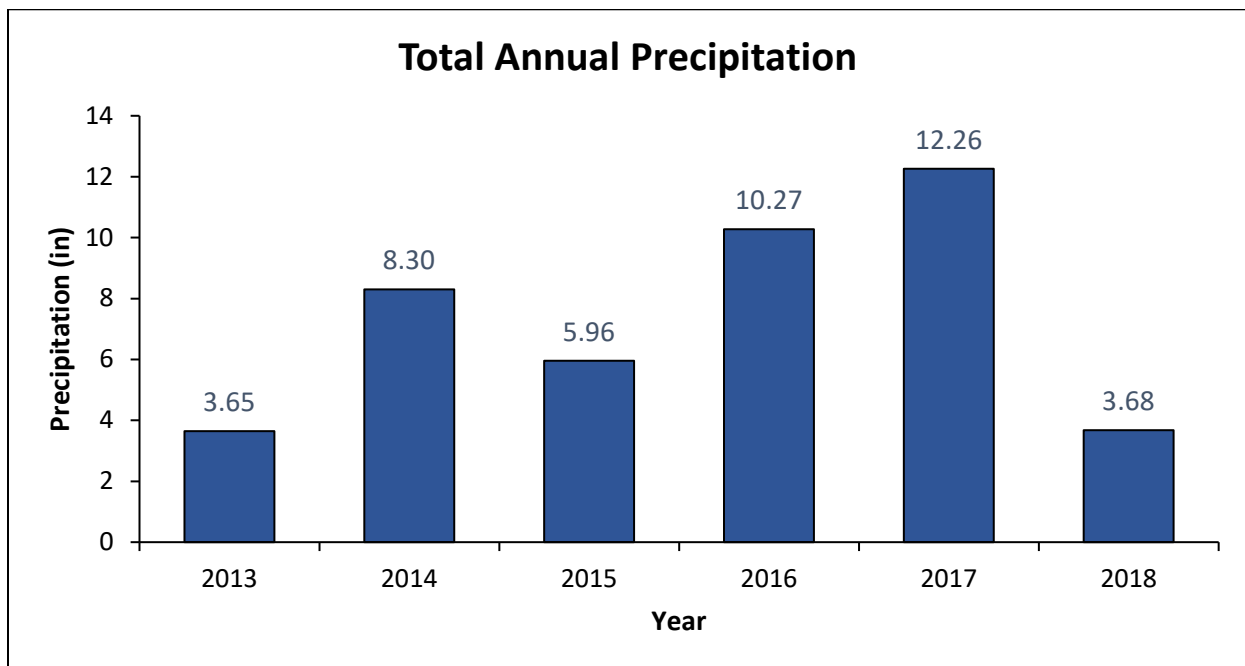
Between 2013 to 2015, drought conditions were prevalent across most of Los Angeles County and southern California. El Niño conditions during the winter of 2016-2017 recorded the highest precipitation amounts following initial restoration activities in 2013, though still below 15 inches, which is the approximate “average” annual rainfall for the Los Angeles region (NOAA 2018). In January 2017, over seven inches of rain was recorded at the LAX station. Figure 29 summarizes total annual precipitation recorded at LAX, and Table 10 details monthly total precipitation (inches), average wind speed (miles per hour, mph), and air temperature (°C) parameters (i.e., average, minimum, and maximum) from January 2013 to May 2018. Note that the precipitation and wind speed units are intentionally English standard instead of metric for ease in interpretation. Inches and mph, respectively, are most commonly used by the US public.

Figure 29. Total annual precipitation from January 2013 through May 2018. Note that an annual total breaks up the winter season at 31 December each year.
