Ballona Wetlands Restoration: Community Iceplant Removal Project

Year 2 Annual Report

July 2018

Prepared for the California Coastal Commission, California
Department of Fish and Wildlife, and National Fish and
Wildlife Foundation

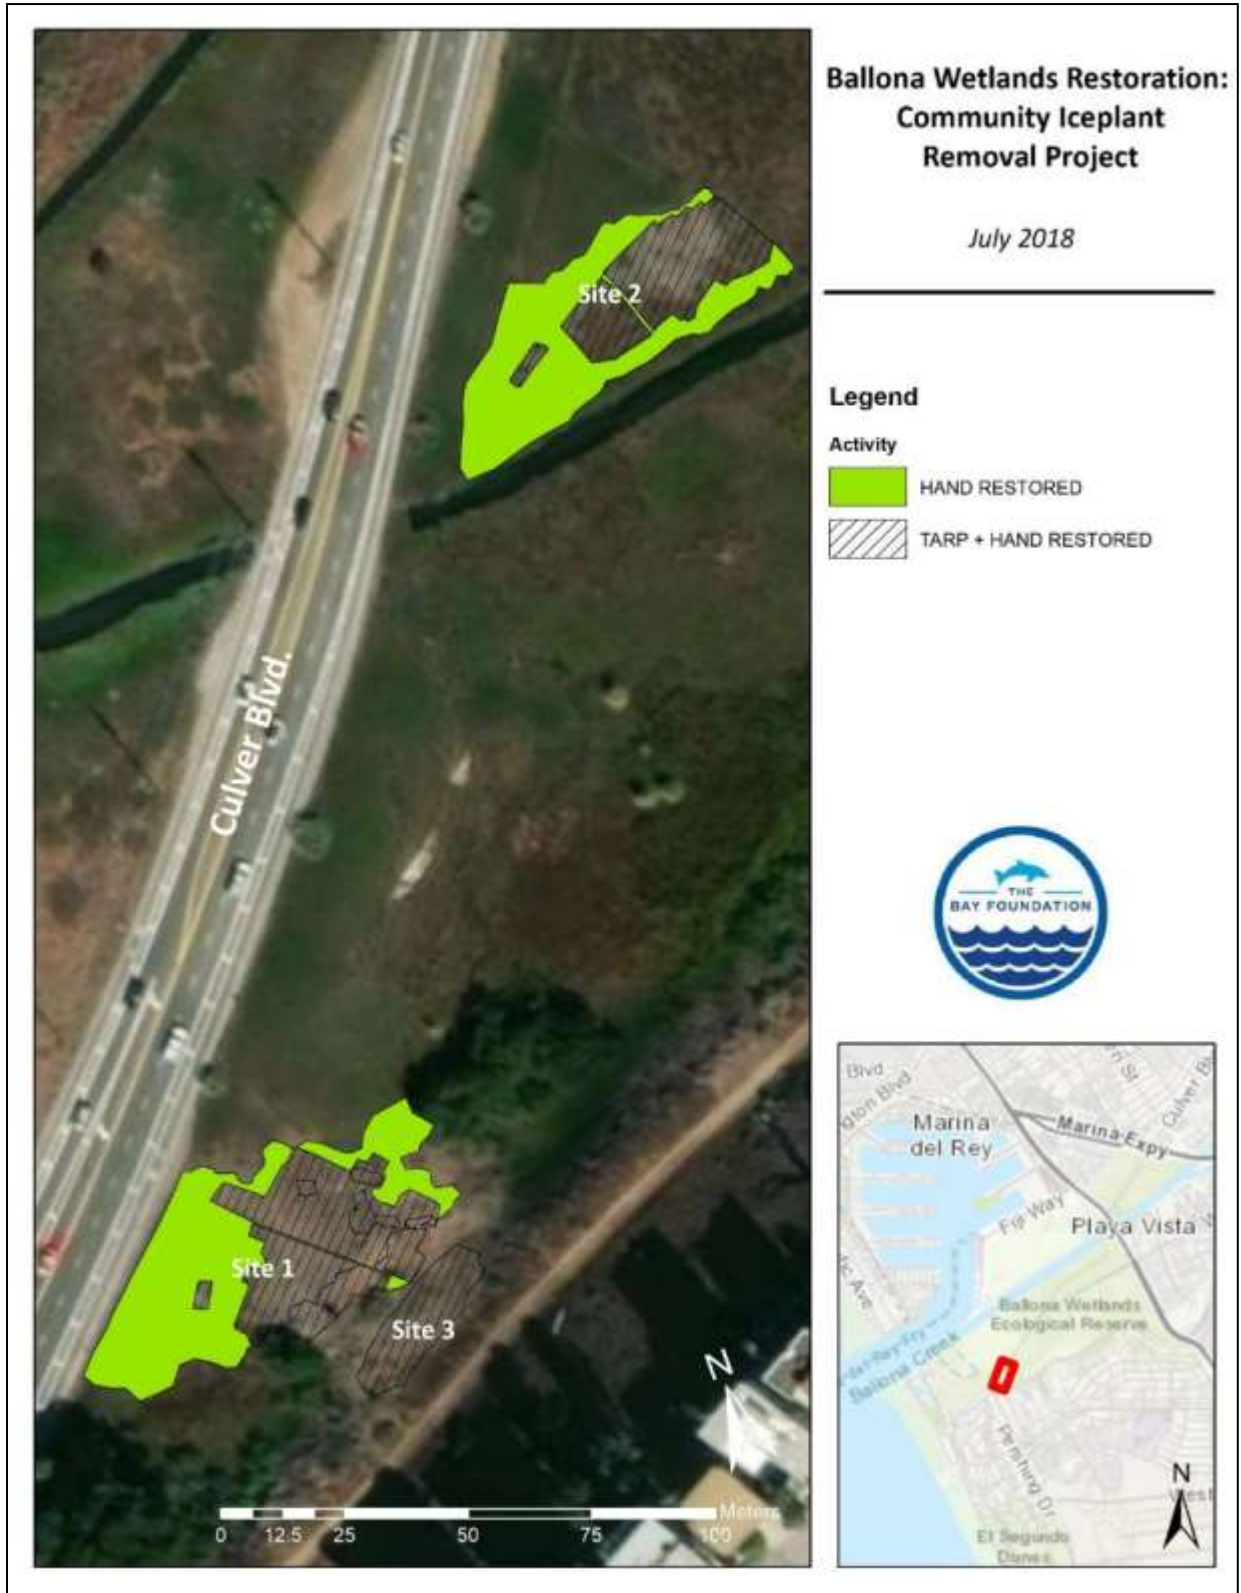
Figure 3. Map of hand-restored and tarped restoration activity locations at the Ballona Reserve.

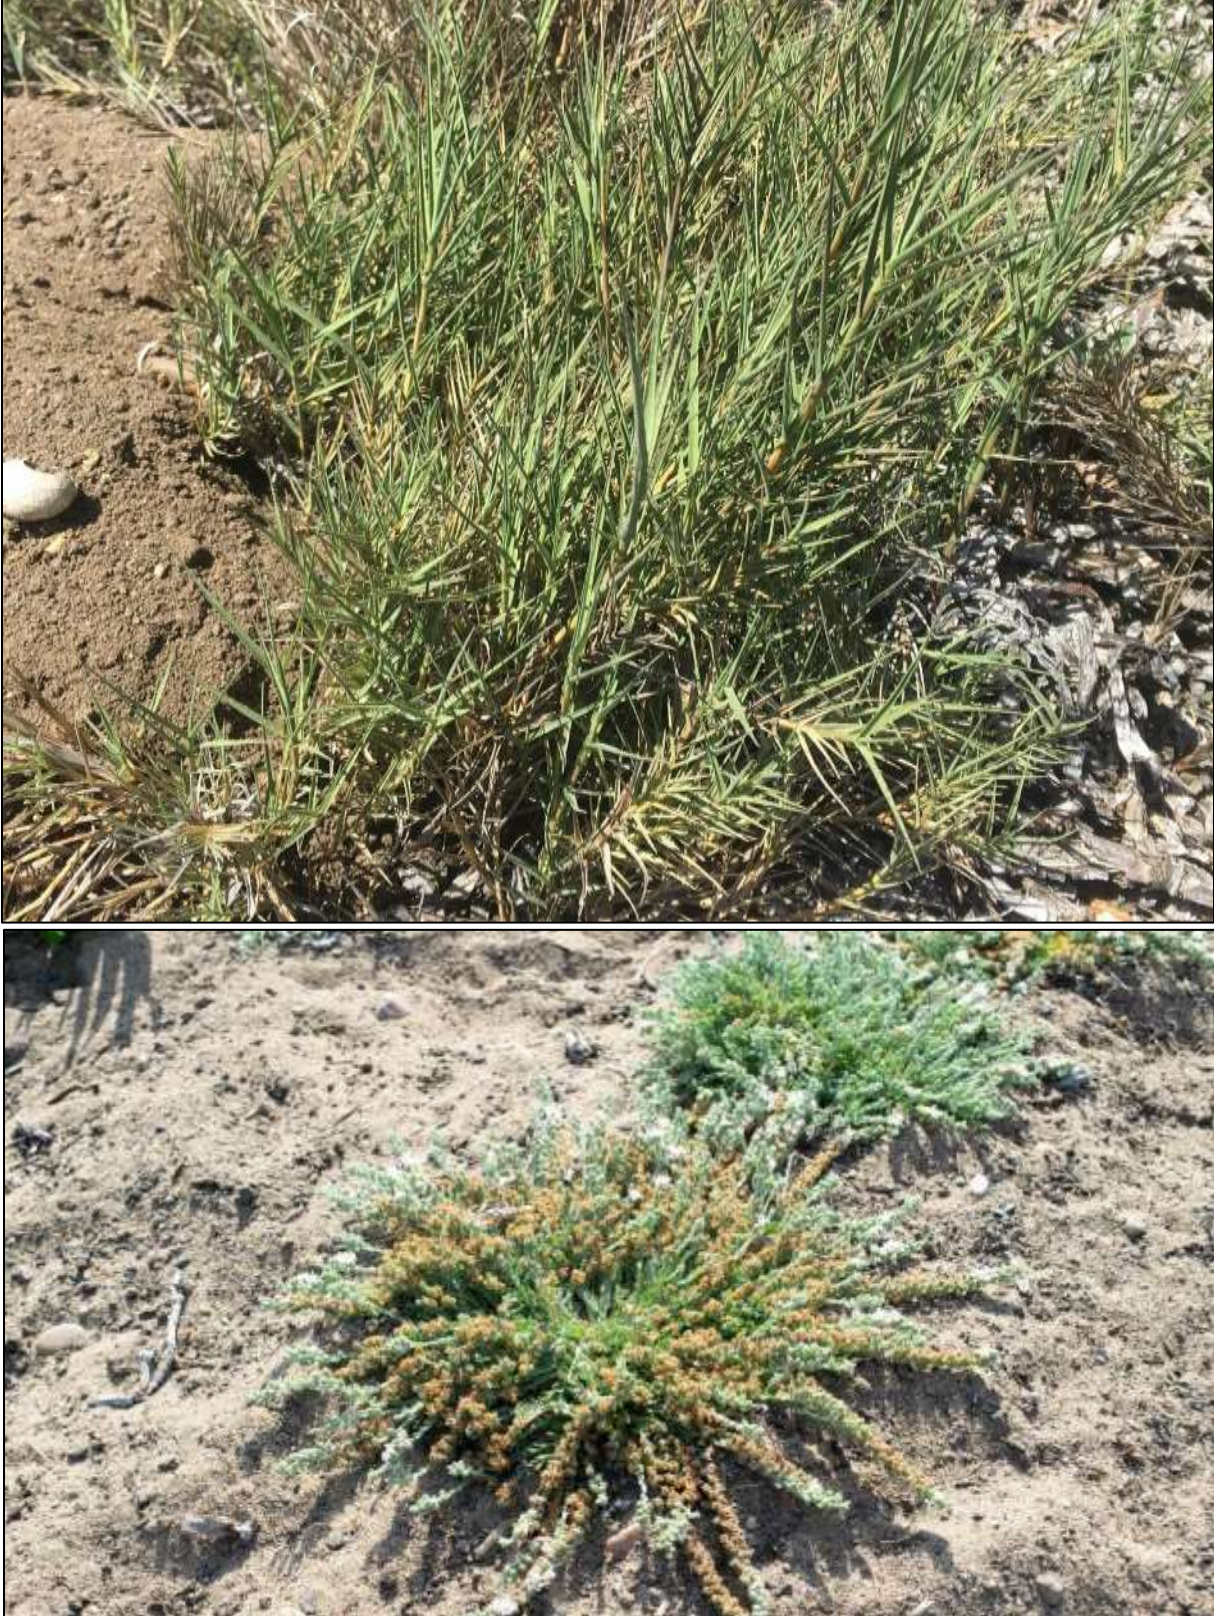
Figure 4. New native saltgrass (18 April 2018; top) intermixed with desiccated iceplant, and seeding native alkali weed (11 July 2018; bottom) in disturbed soils, both within the restoration area.

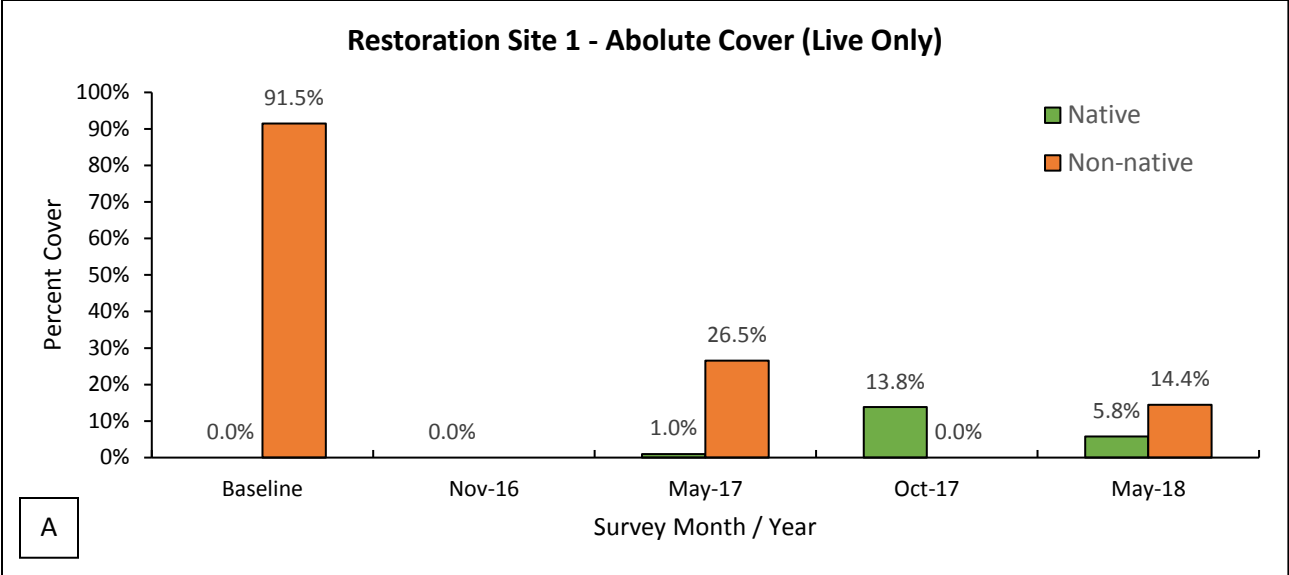
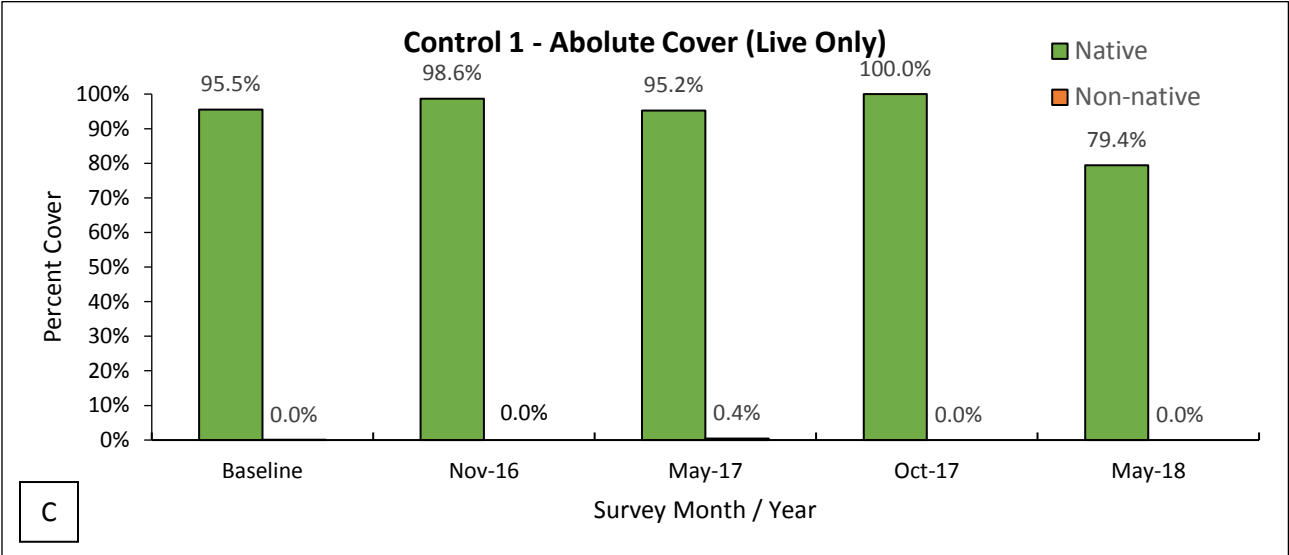
Figure 9. Vegetation data cover results from Site 1 (A), Site 2 (B), and the control area (outside the restoration footprint; C, D).

fluctuation between 0% and a high of 7.2% in the October 2017 survey, with a total of 1.4% in the most recent survey (May 2018) (Figure 9, B). This fluctuation was primarily due to expansion and then restriction of the area of saltgrass within the restoration area and some small patches of alkali weed (*Cressa truxillensis*). However, there were patches of native vegetation (again, primarily saltgrass) of over 25% cover in some of the Site 2 restoration areas, especially in October 2017 (Figure 11, quadrat photograph). The non-native vegetation cover at Site 2 varied but included non-native brome grasses and Bermuda buttercup.

Control results (transects surveyed outside of the restoration area and not altered during restorations) indicated some stability in the predominantly native areas, with live native cover ranging from a high of 98.6% dropping to a low of 79.4% native cover in May 2018, but still exhibiting resistance to invasion, with less than 1% non-native cover across all surveys (Figure 9, C). Conversely, control results in the predominantly non-native areas were highly fluctuating, indicated by a dramatic rise in non-native cover in May 2017, and a subsequent decline in October 2017, and again in May 2018. In May 2018, the non-native control area displayed approximately even non-native (44.0%) and native (41.8%) cover (Figure 9, D). These control transects are indicative of the variability of both native and non-native cover outside of the restoration project footprint area, but within the Reserve during the time period surveyed. Many of the areas adjacent to the project area had high non-native cover (e.g. Figure 12 taken immediately across Culver Boulevard from the project site).

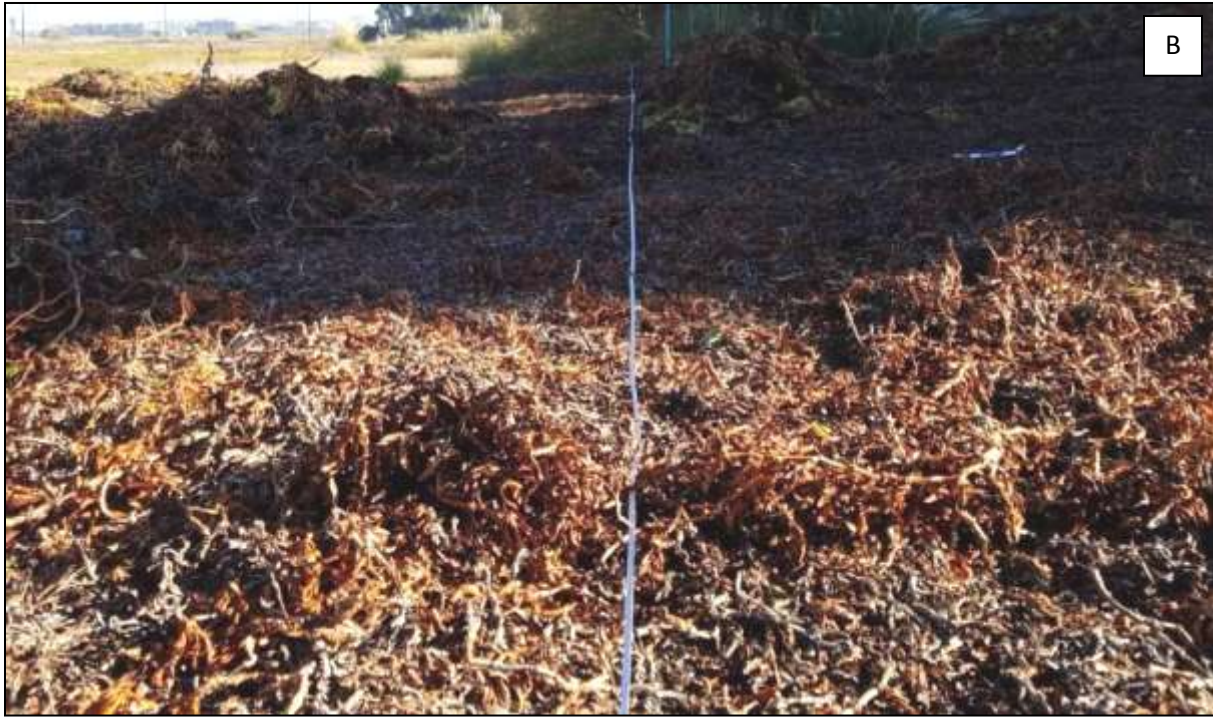
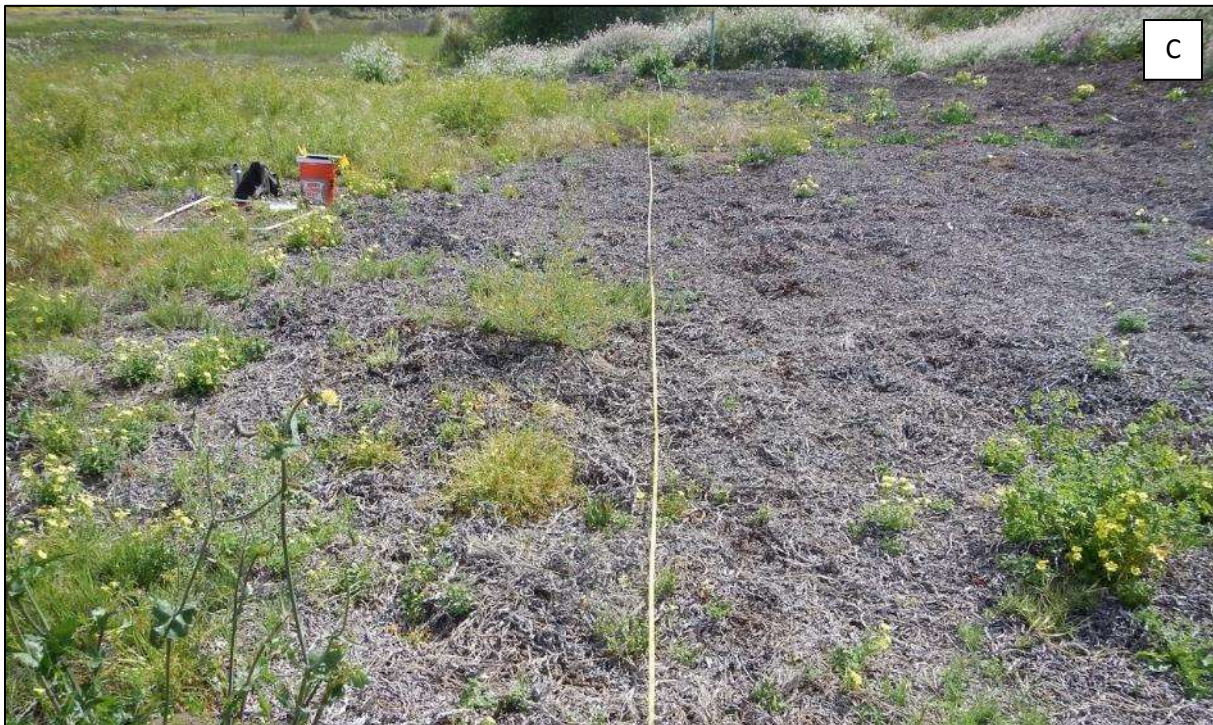
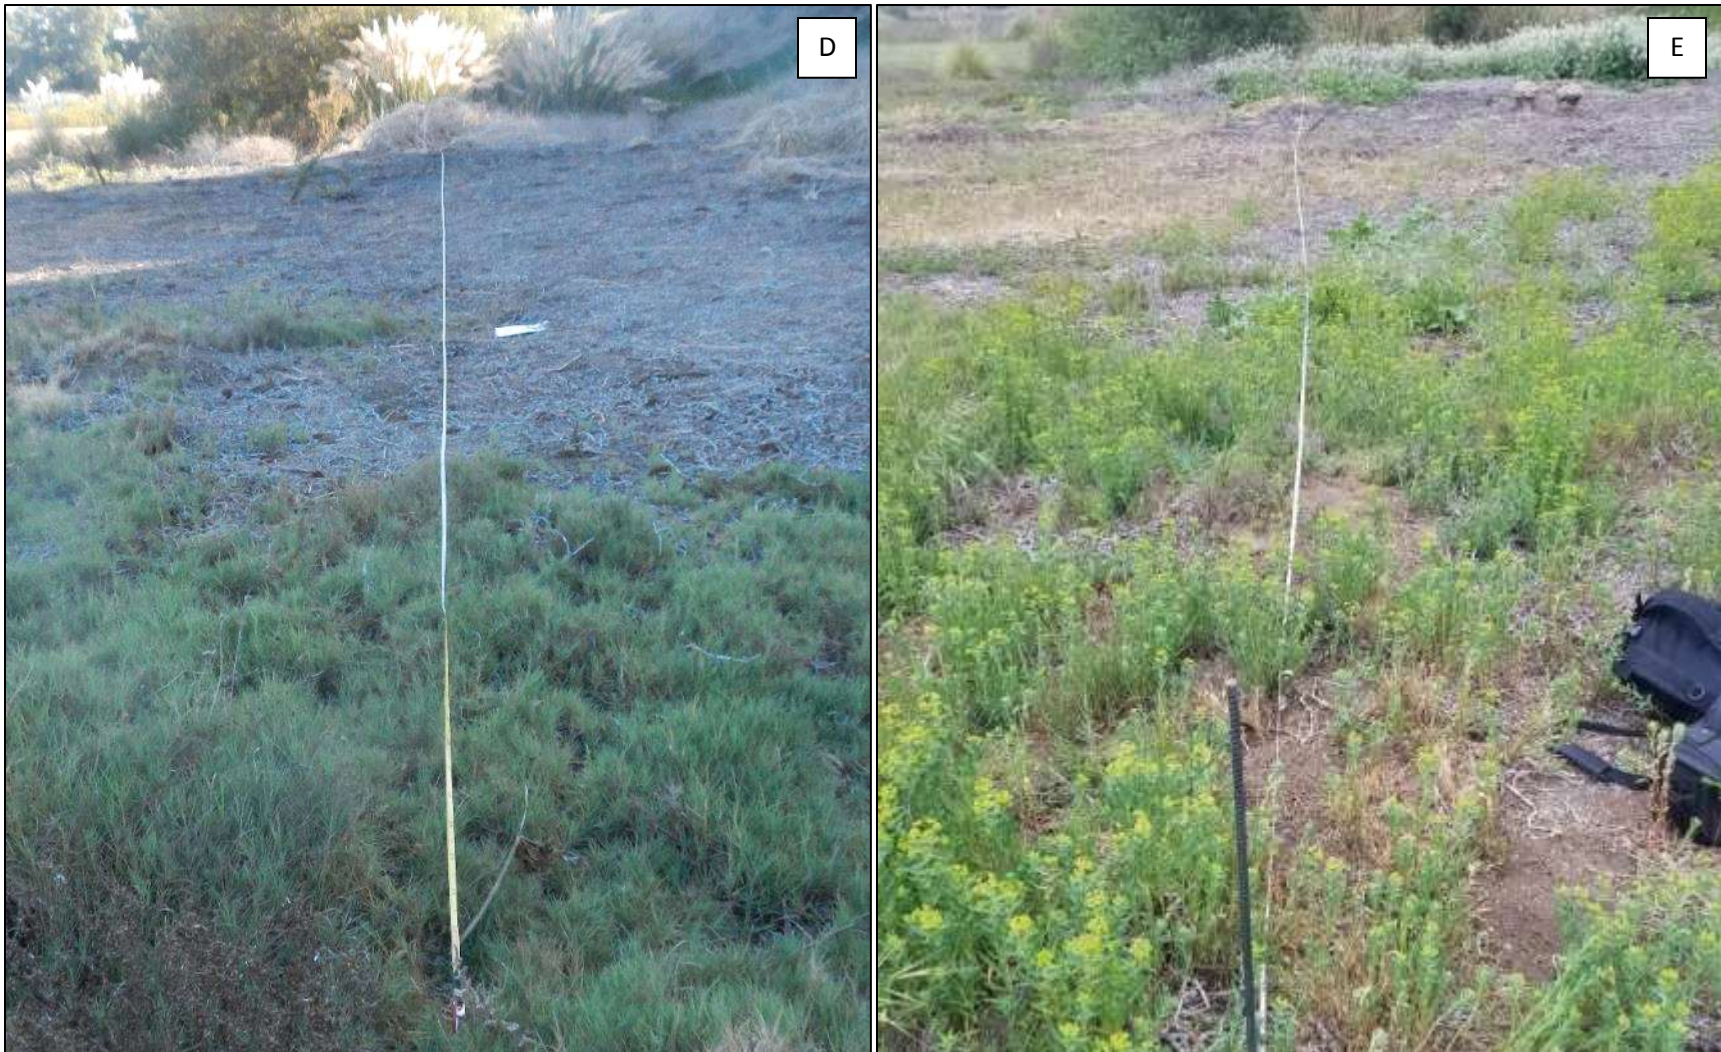
Figure 10. Photographs of Transect 5 pre-restoration on 23 August 2016 (A), immediately post-restoration on 29 November 2016 (B), and post-restoration on 1 May 2017 (C), 27 October 2017 (D; Year 2), and 1 May 2018 (E; Year 2).

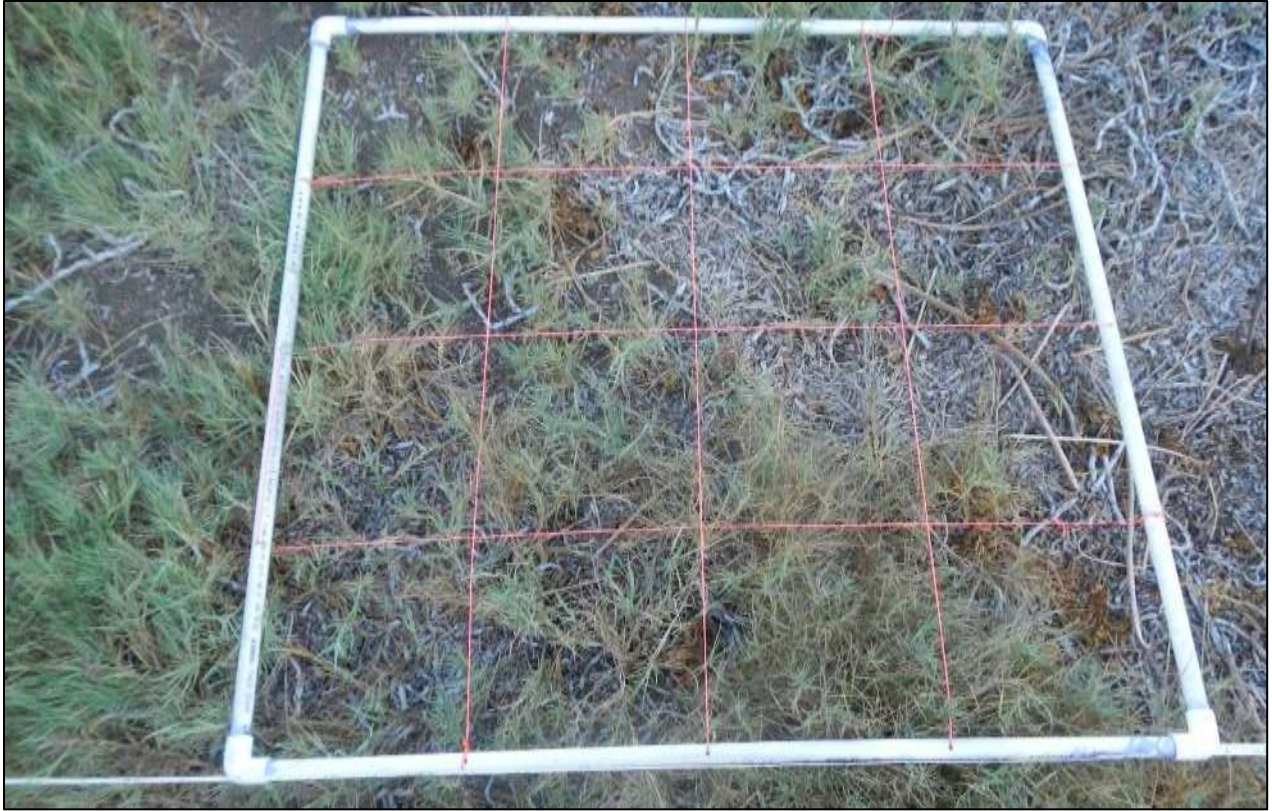
Figure 11. Photograph of saltgrass vegetation in a cover class quadrat at Site 2 (27 October 2017).
