Malibu Lagoon Restoration and Enhancement Project

Final Comprehensive Monitoring Report (Year 6)

August 2019

Prepared by: The Bay Foundation (TBF)

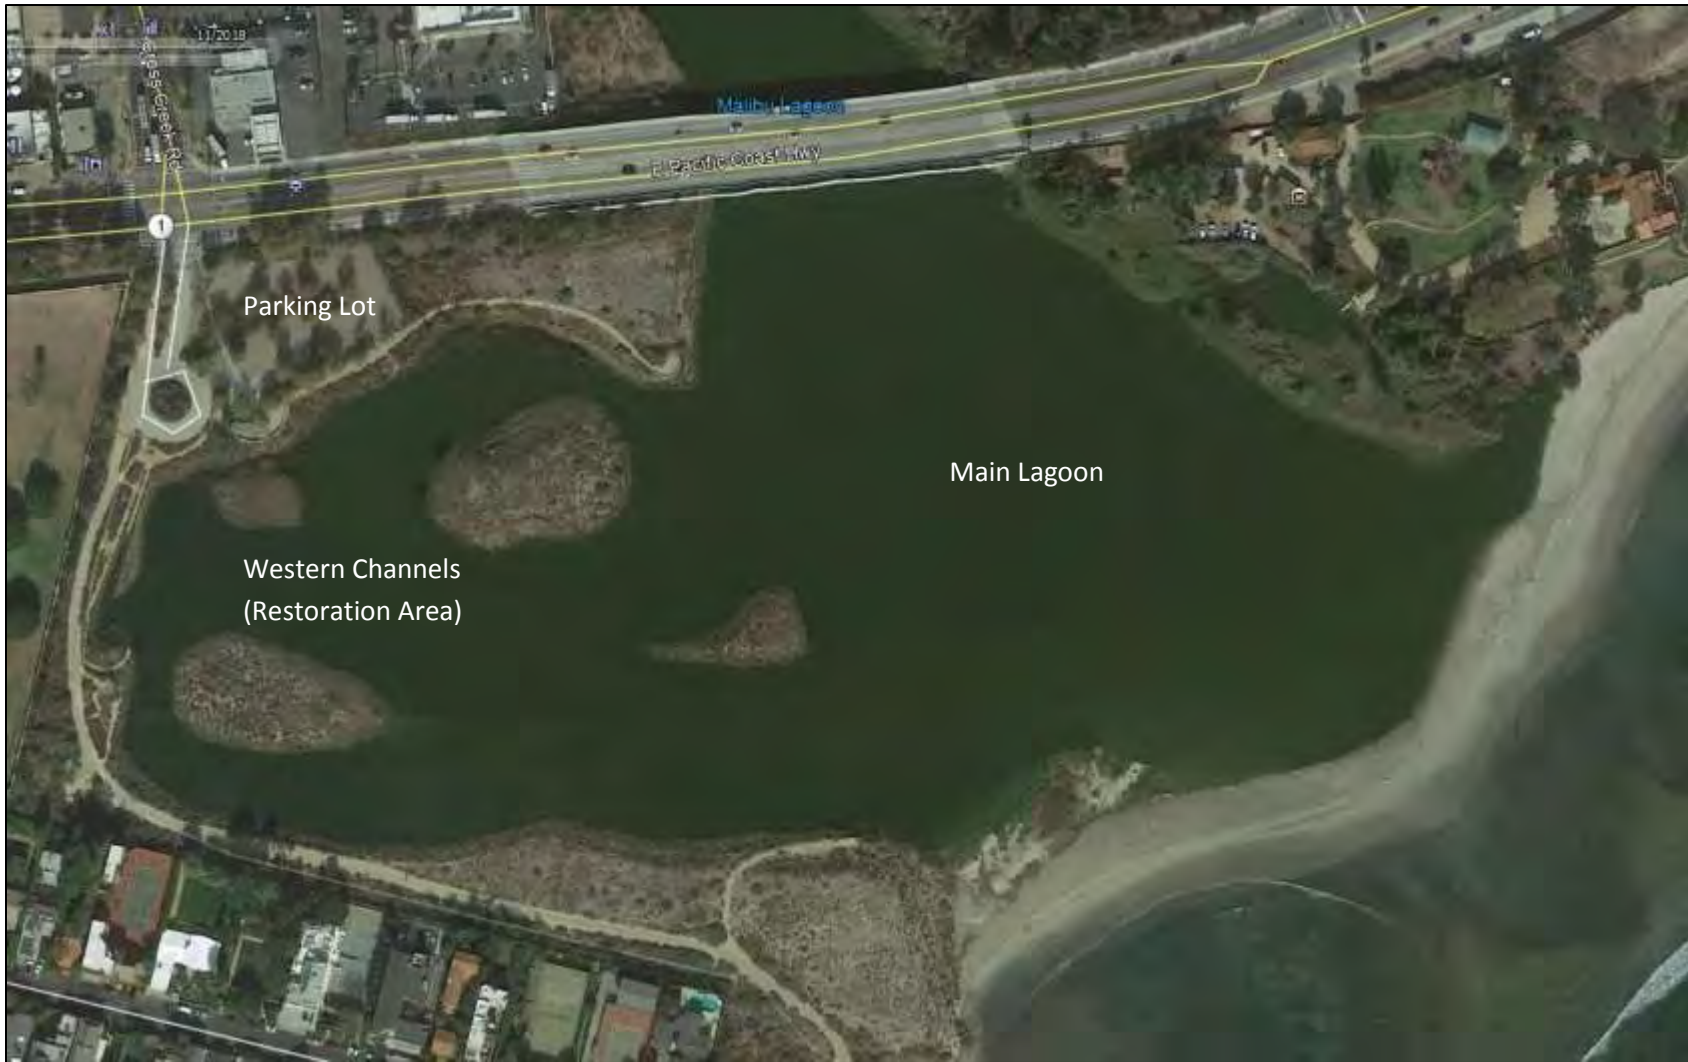
Figure 1. Map of project location site (Western Channels) and environs several years after the restoration (credit: Google Earth, 19 Nov 2018).

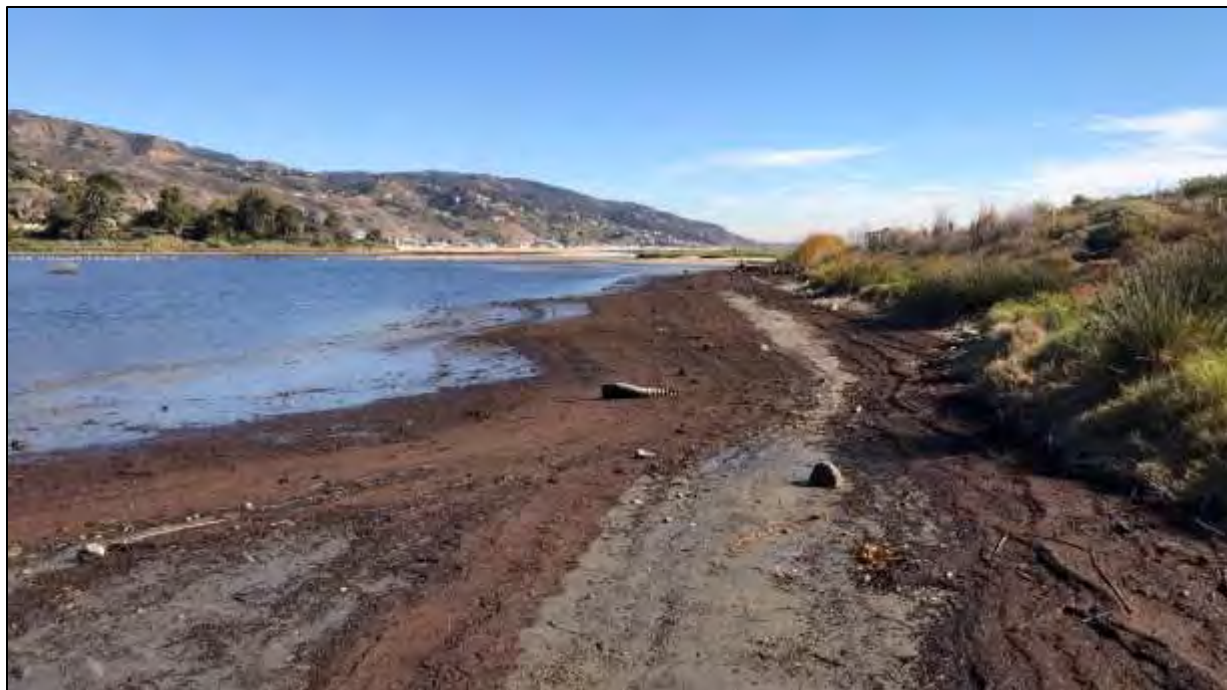
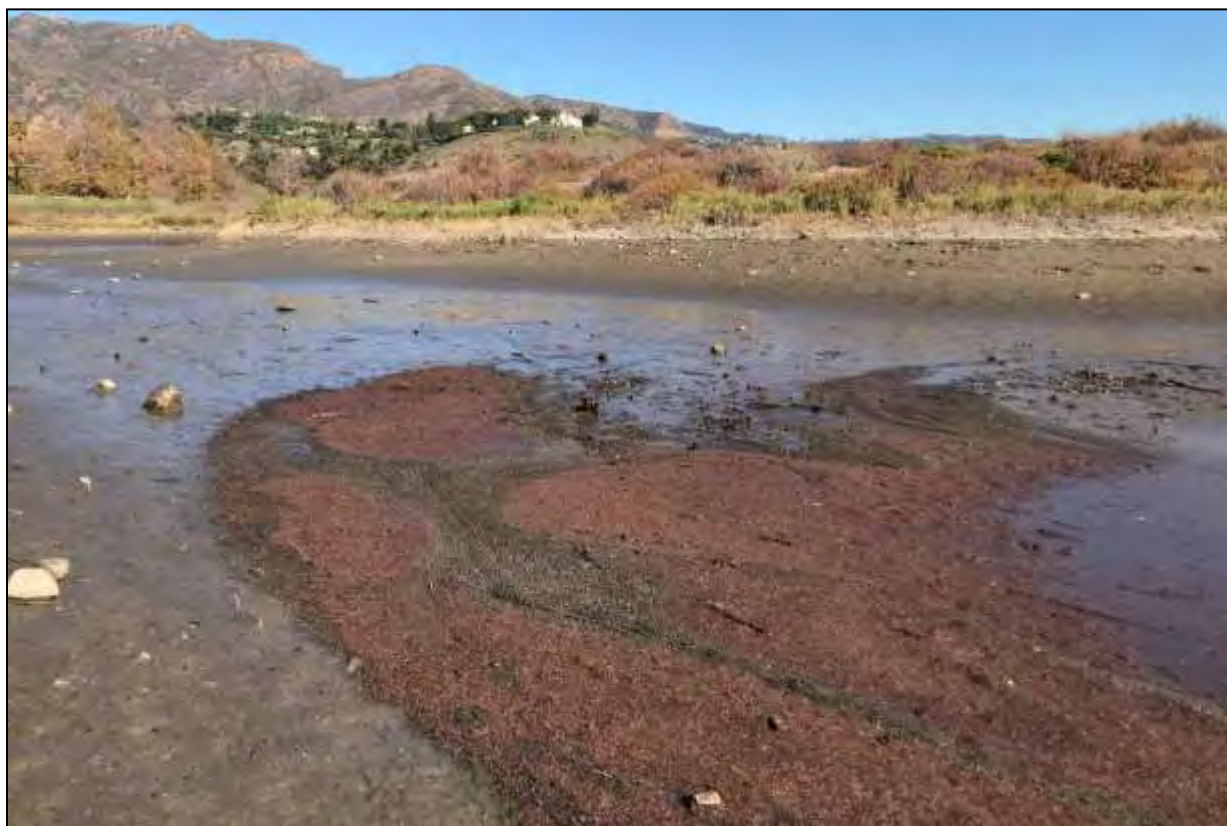
Figure 11. Photographs of organic detritus from the Woolsey Fire in the Malibu Lagoon (4 December 2018).

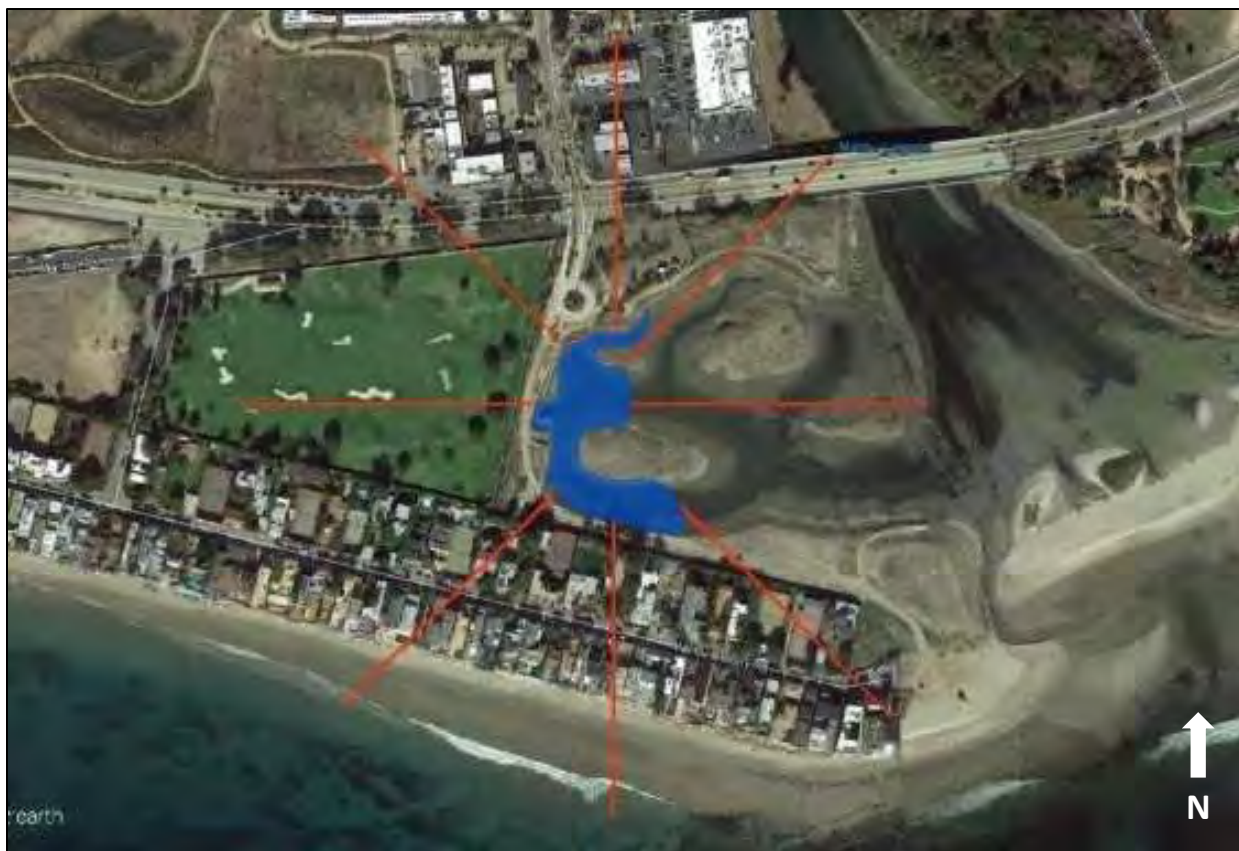
Figure 13. Post-restoration CRAM Assessment Area (blue polygon) at Malibu Lagoon. Red lines indicate radiating (potential) buffer lines.

Figure 12 displays a landscape photo of a portion of the CRAM AA taken on the 4 December 2018 survey. Figure 13 displays the Assessment Area (AA) and buffer lines for the post-restoration CRAM survey. The AA is approximately one hectare, or two and a half acres of wetland habitats, following guidelines described in the User Manual. The AA location is approximately the same as the pre-restoration survey, fitted specifically to wetland habitats as defined by the Manual.

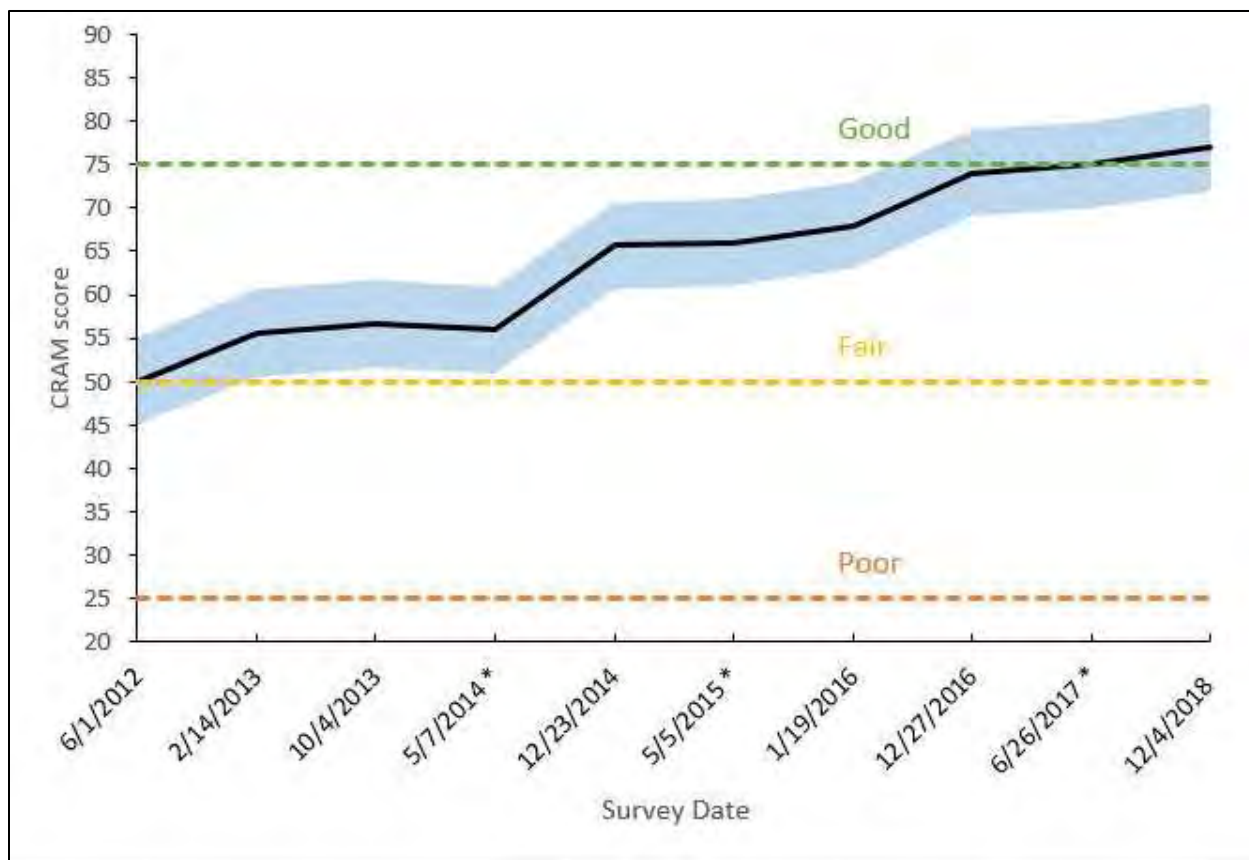
Figure 15. Graph of CRAM attribute and overall scores over time. “Poor, Fair, and Good” represent the generic wetland condition tertiles to define the condition classes per the CRAM Technical Bulletin (2018).

Post-restoration surveys showed a consistent increase in final CRAM scores over time, culminating with the highest scores in the most recent surveys (Figures 14 and 15). Scores indicate that the wetlands are in good condition overall. As predicted, the biotic structure attribute continued to increase slightly as the vegetation community increased in overall cover and complexity over time. The overall CRAM final score is also likely to remain consistently above the pre-restoration assessment final score. Although there were no quantitative success metrics identified for the CRAM scores, the final trend is above pre-restoration scores, with a consistent increase over time, suggesting support for a healthy and robust wetland community. The photographs serve to further illustrate the wetland vegetation community.

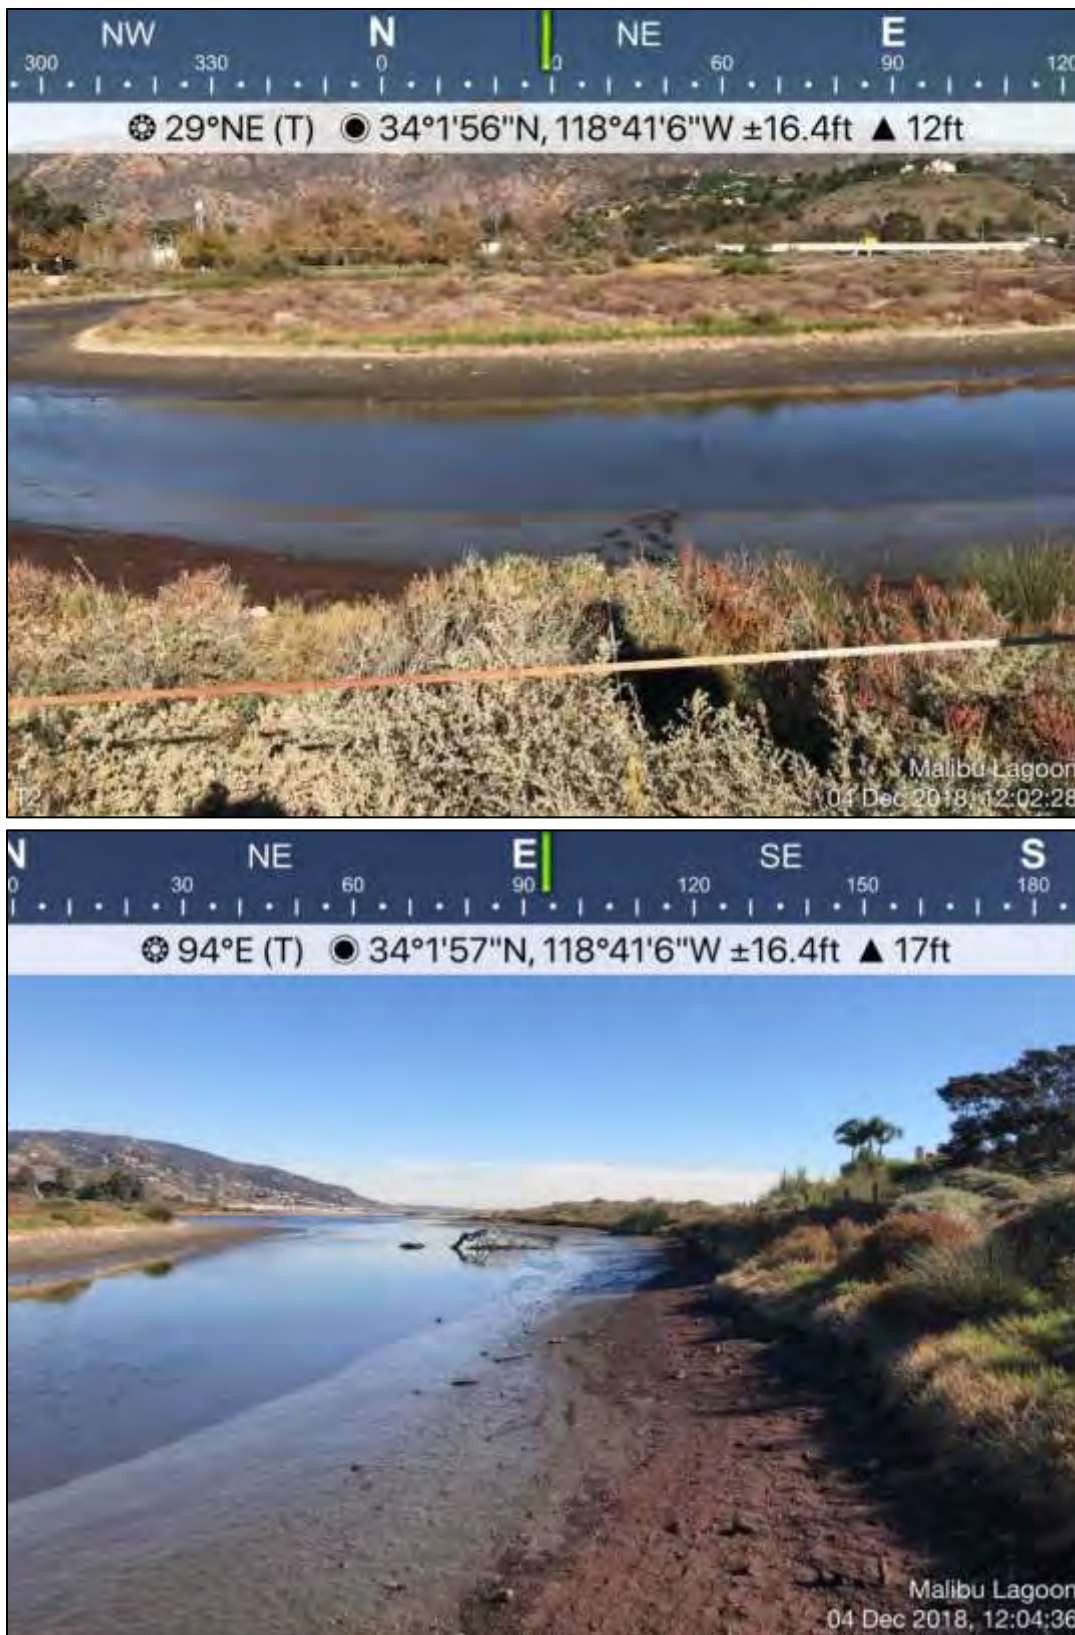
Figure 16. Geotagged photographs taken within the AA (southern portion) on 4 December 2018.

Figures 16, 17, and 18 contain representative geotagged photographs including bearing from the most recent CRAM survey within the AA on 4 December 2018 during a low outgoing spring tide. Figure 16 contains photographs from the southern portion of the AA facing towards wetland habitats at 29° NE (top) and 94° E (bottom). Figure 17 contains photographs from the central portion of the AA facing towards wetland habitats at 137° SE (top) and 90° E (bottom). Figure 18 contains photographs from the northern portion of the AA facing towards wetland habitats at 66° NE (top) and 135° SE (bottom). Detailed global positioning system (GPS) and bearing data are included as a watermark stamp on each photograph for ease of reference.

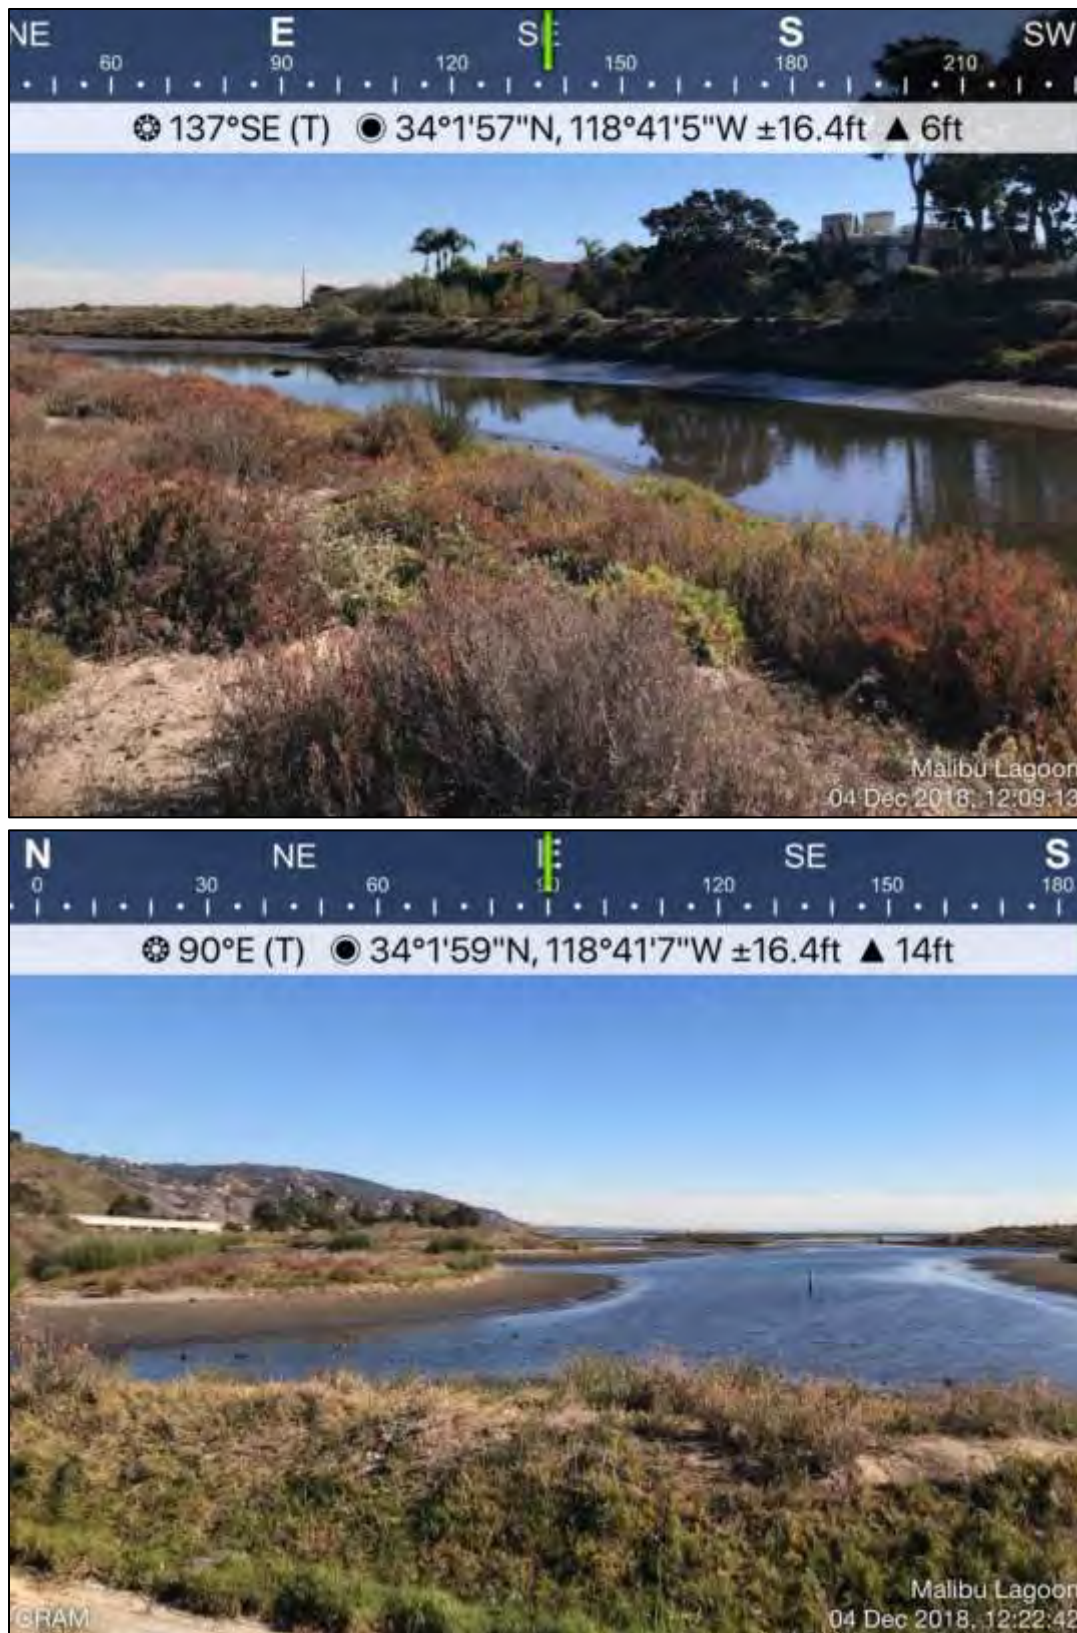
Figure 17. Geotagged photographs taken within the AA (central portion) on 4 December 2018.

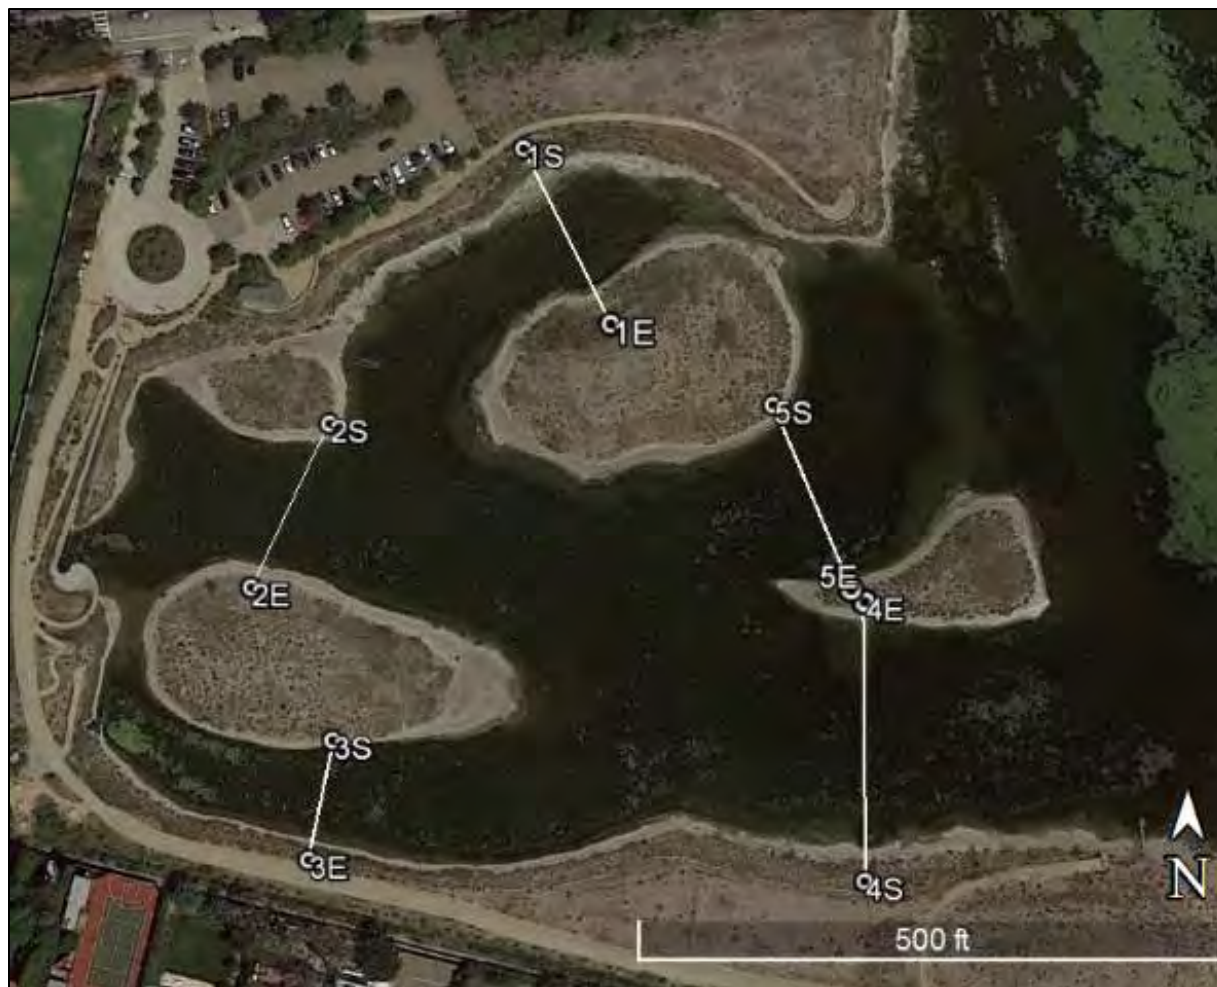
Figure 21. Map of cross-channel elevation transect locations.

Five permanent and repeatable cross-section locations were monitored for six consecutive post-restoration years. Surveys were conducted on 14 February 2013, 18 December 2014, 19 January 2016, 21 and 27 December 2016, 20 February 2018, 9 May 2018, and 26 February 2019 (Figures 6 and 7). Horizontal and vertical locations of cross-section end-points were fixed by permanent monuments; however, in Year 5 and 6, field leaders were unable to locate several monuments which may have been inadvertently removed along with irrigation pipes. Missing monuments were referenced in the field using recorded GPS locations and the monuments were replaced; however, slight variances in Year 5 and 6 surveys may be due to small-scale variability in the transect location. Sediment scour or deposition depths were calculated from the data based on area approximated using a Riemann sums method and compared across survey dates.

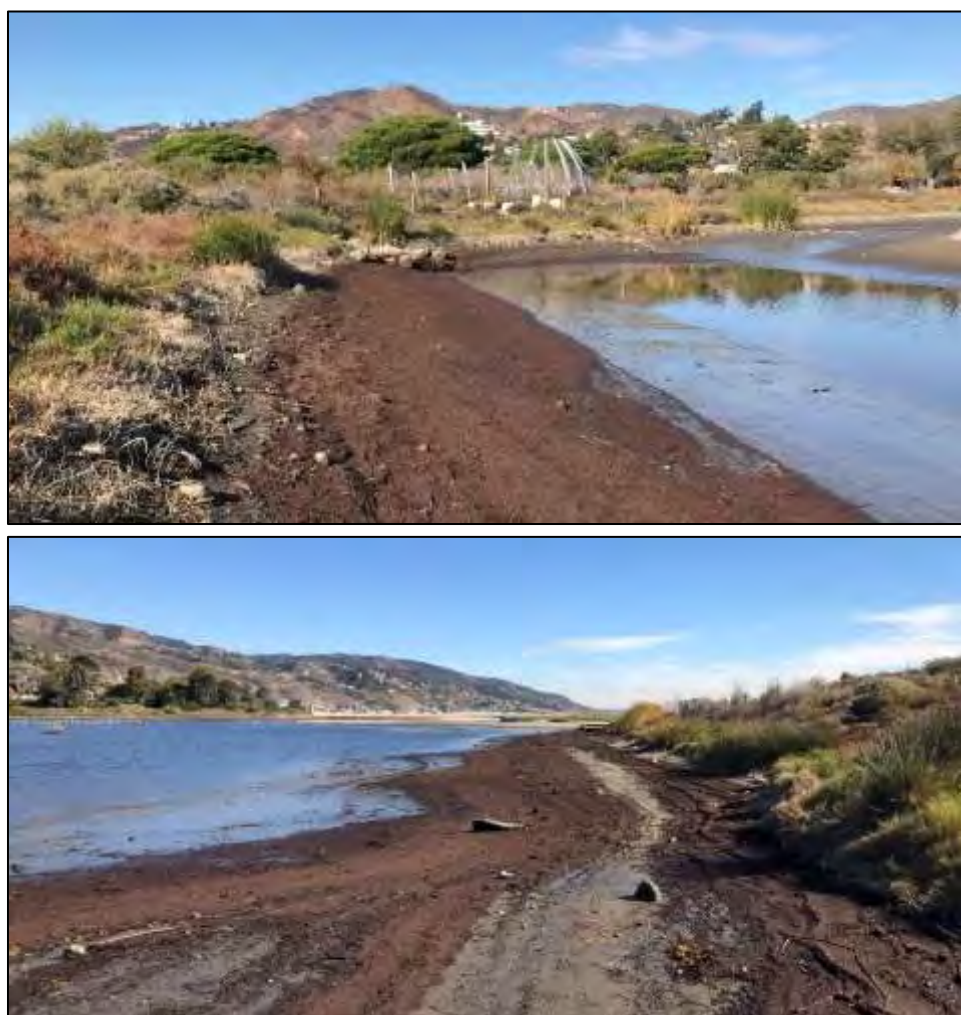
Figure 22. Photos of burn material from the Woolsey fire on the lagoon's west banks following a storm event (8 December 2019).

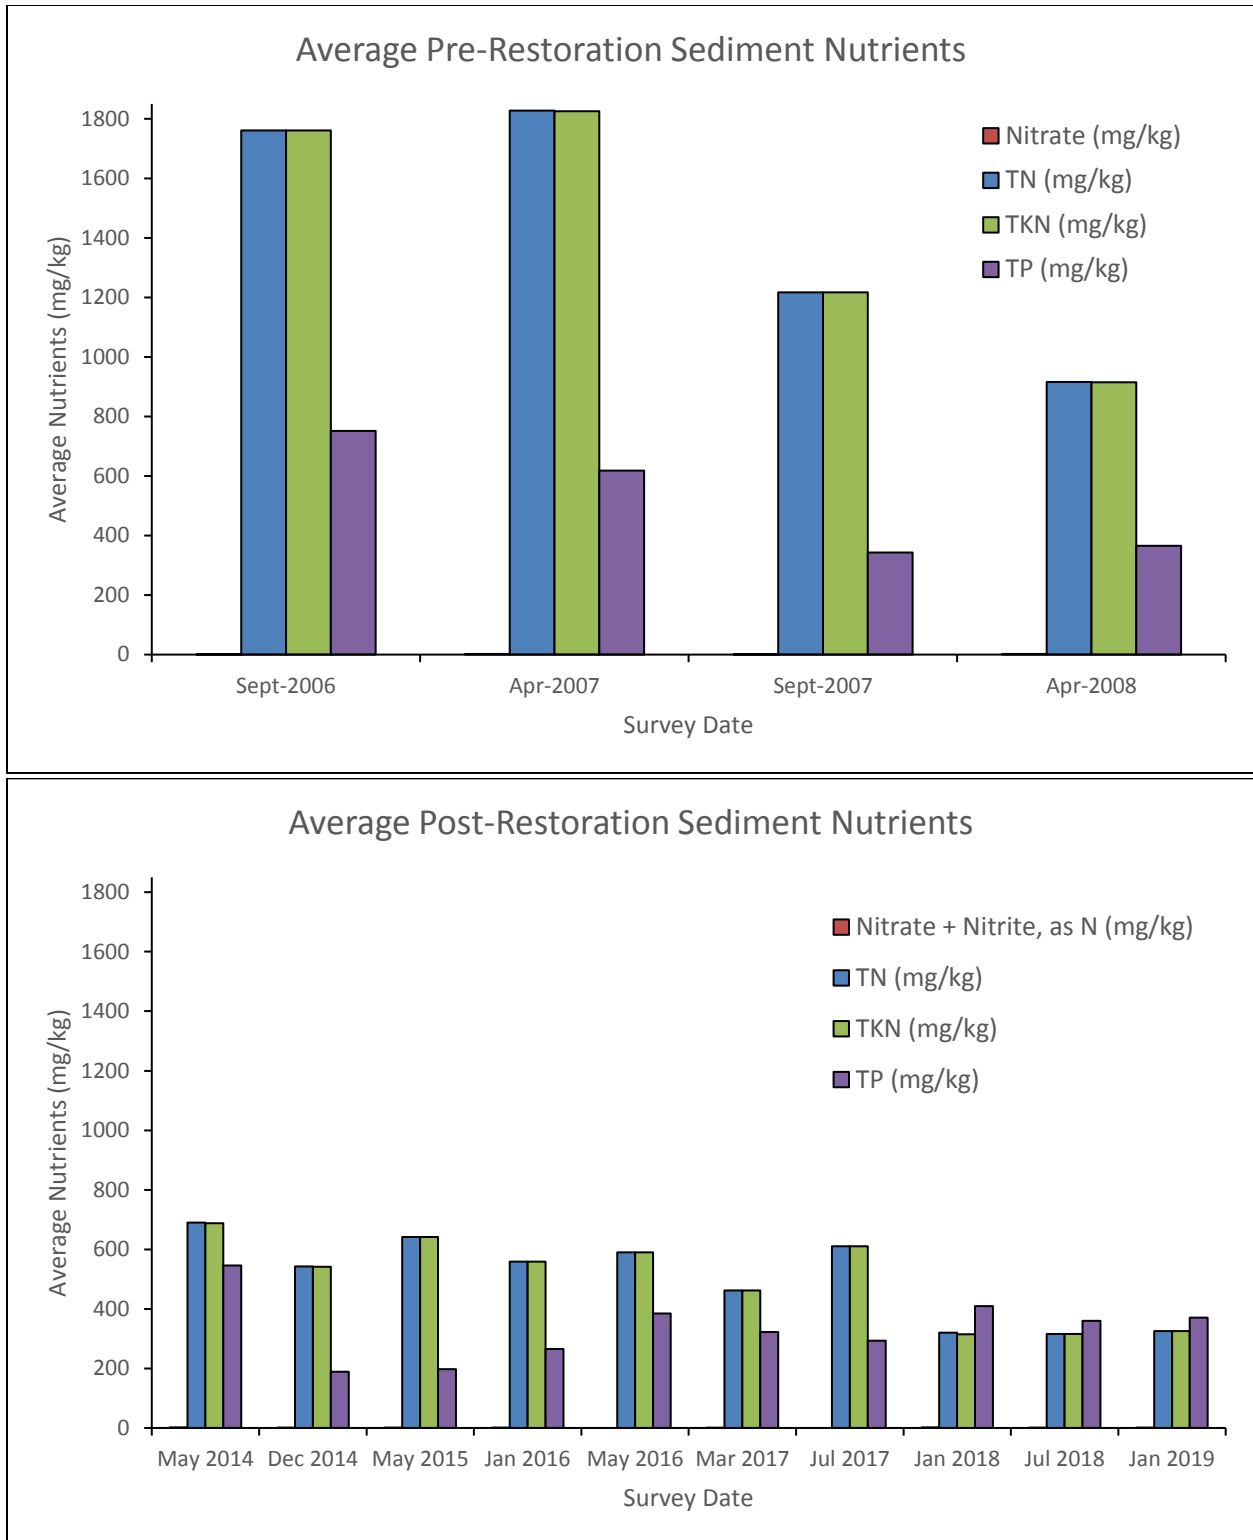
Figure 54. Sediment nutrient averages for all Stations combined for each pre- (top) and post-restoration (bottom) surveys. Note the same y-axis scale for ease of comparison.

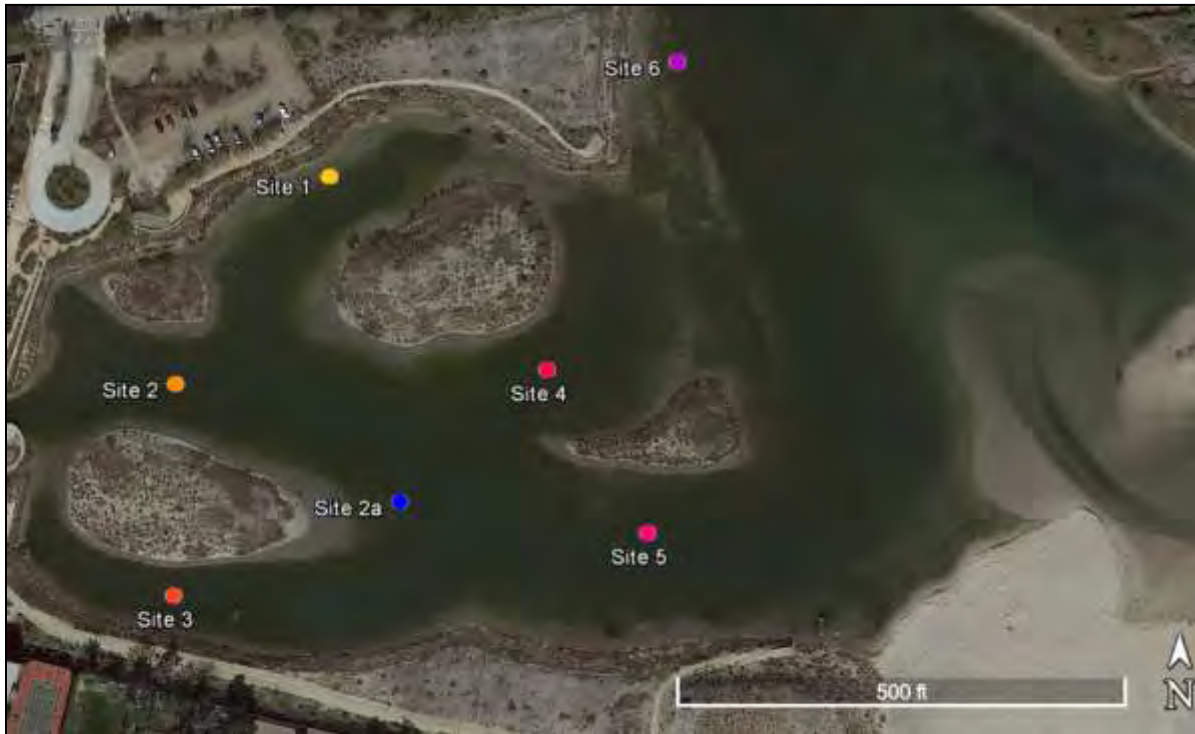
Figure 59. Map of the six permanent fish monitoring Sites.

Six permanent sites were seined to depletion and spot surveying was conducted at three places along the banks of the Main Lagoon (Figures 59 and 60). For seine sites, two 10 x 2 m blocking nets were deployed perpendicular from the shore. The two nets were pulled together to form a triangle, trapping fish inside. Two teams with 3 m x 1 m seines walked to the apex of the triangle and pulled from the apex towards the shore. Seines were beached at the water edge and all contents examined. For spot surveys, three teams pulled 2 m x 1 m seines parallel to shoreline in three spots along the Main Lagoon beach bank from west to east. On 3 March 2017, due to the shallow nature of the lagoon at the time, blocking nets spanned the entire channel, instead of the triangle form. Additionally, on 3 March 2017, an additional spot seine was surveyed adjacent to the tree snag at Site 3, but the beach spot seines were not conducted due to time constraints. Subsequent to that survey event, spot surveys returned to the usual protocol, focused on the eastern end of the beach.

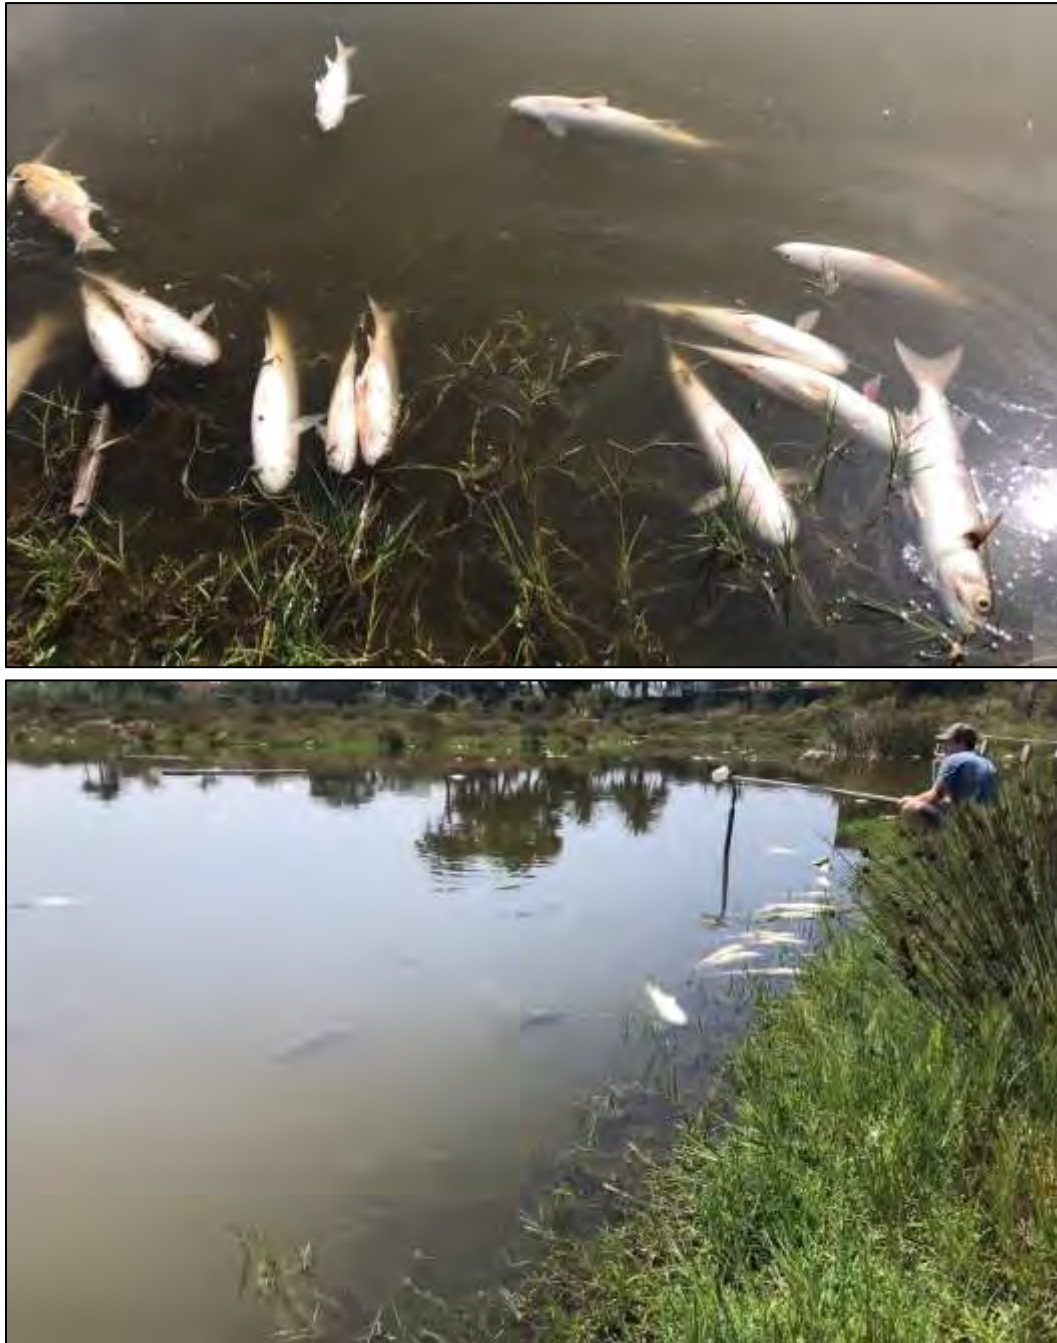
In August 2018, warming waters and an extended closed berm condition led to a low dissolved oxygen event that caused a die off of mullet (Figure 61). Additional vertical profile surveys and water quality analyses were conducted (see other chapters in this report). As part of an impact assessment, supplemental spot fishing surveys were conducted on 3 October 2018 and 6 November 2018.

Figure 61. Photographs of mullet and water quality spot sampling on 23 August 2018.

In August 2018, an estimated 4,000 striped mullet and more than 100 topsmelt perished over the course of several days. Mullet die offs have occurred at the Malibu Lagoon prior to restoration and various species die offs occur periodically throughout the bar-built estuaries of southern California. No lesions were common on the carcasses. The significant biomass of mullet associated with the die off was noteworthy. Many of the individuals were over 50 cm in fork length. Expert scientists (when presented with the limited data that were available) agreed that it was likely a single event tied to extremely warm nights (27-28 °C), resulting lower dissolved oxygen levels, and potentially overcrowding in the system (Dr. Dave Jacobs, pers. comm. 2018 and Dr. Sean Anderson, pers. comm. 2018). Targeted spot surveys at several stations in October and November 2018 found longjawed mudsuckers and mosquitofish present but no other fish species (R. Dagit, pers. comm. 2018). A co-occurring die off happened at Ormond Lagoon approximately three weeks prior, with impacts also likely caused in part by higher temperatures (S. Anderson, pers. comm. August 2018).

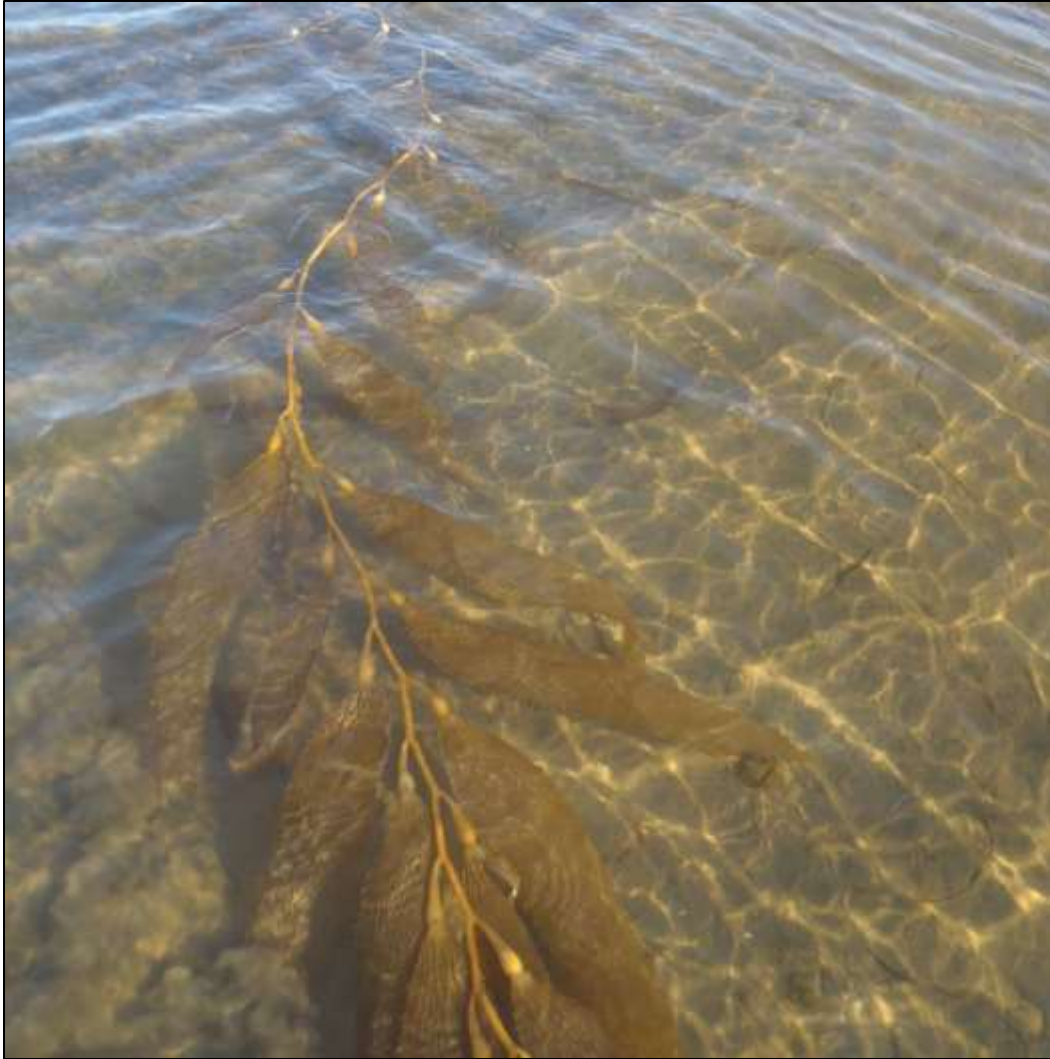
The average cover results of algae and SAV can be broken down into several categories, including: wrack, *Cladophora*, and *Ruppia*. The category 'wrack' is an amalgamation of several types of unattached or floating kelp species, including those in the genera *Macrocystis* (Figure 73), *Phyllospadix*, *Dictyota*, *Egregia*, *Eisenia*, *Cystoseira*, and woody debris. '*Cladophora*' is the genus for small, turf-like green alga. Since January 2016, surveys have also identified *Ruppia* sp., or ditchgrass, which is an attached submerged aquatic vegetation (SAV) species. Algae, wrack, and SAV all function very differently with regards to nutrient uptake and sequestration as well as dissolved oxygen cycling, so are thus evaluated separately. In the two Year 6 surveys (12 July 2018 and 11 April 2019), the average *Ruppia* cover was $13.69\% \pm 4.11$ and $0.22\% \pm 0.16$, average algae cover was $7.00\% \pm 3.42$ and $1.65\% \pm 0.85$, and average wrack cover was $0.00\% \pm 0.00$ and $0.99\% \pm 0.44$ (Figures 74 and 75). Visual qualitative estimate data from the July 2018 and June 2019 surveys indicated presence of submerged live *Ruppia* across most stations, with minimal floating turf-like algae (less than 5% of the total station area, Figure 76) and very little wrack present.

Figure 73. Photograph of floating *Macrocyctis* at Station 2 (14 February 2013).

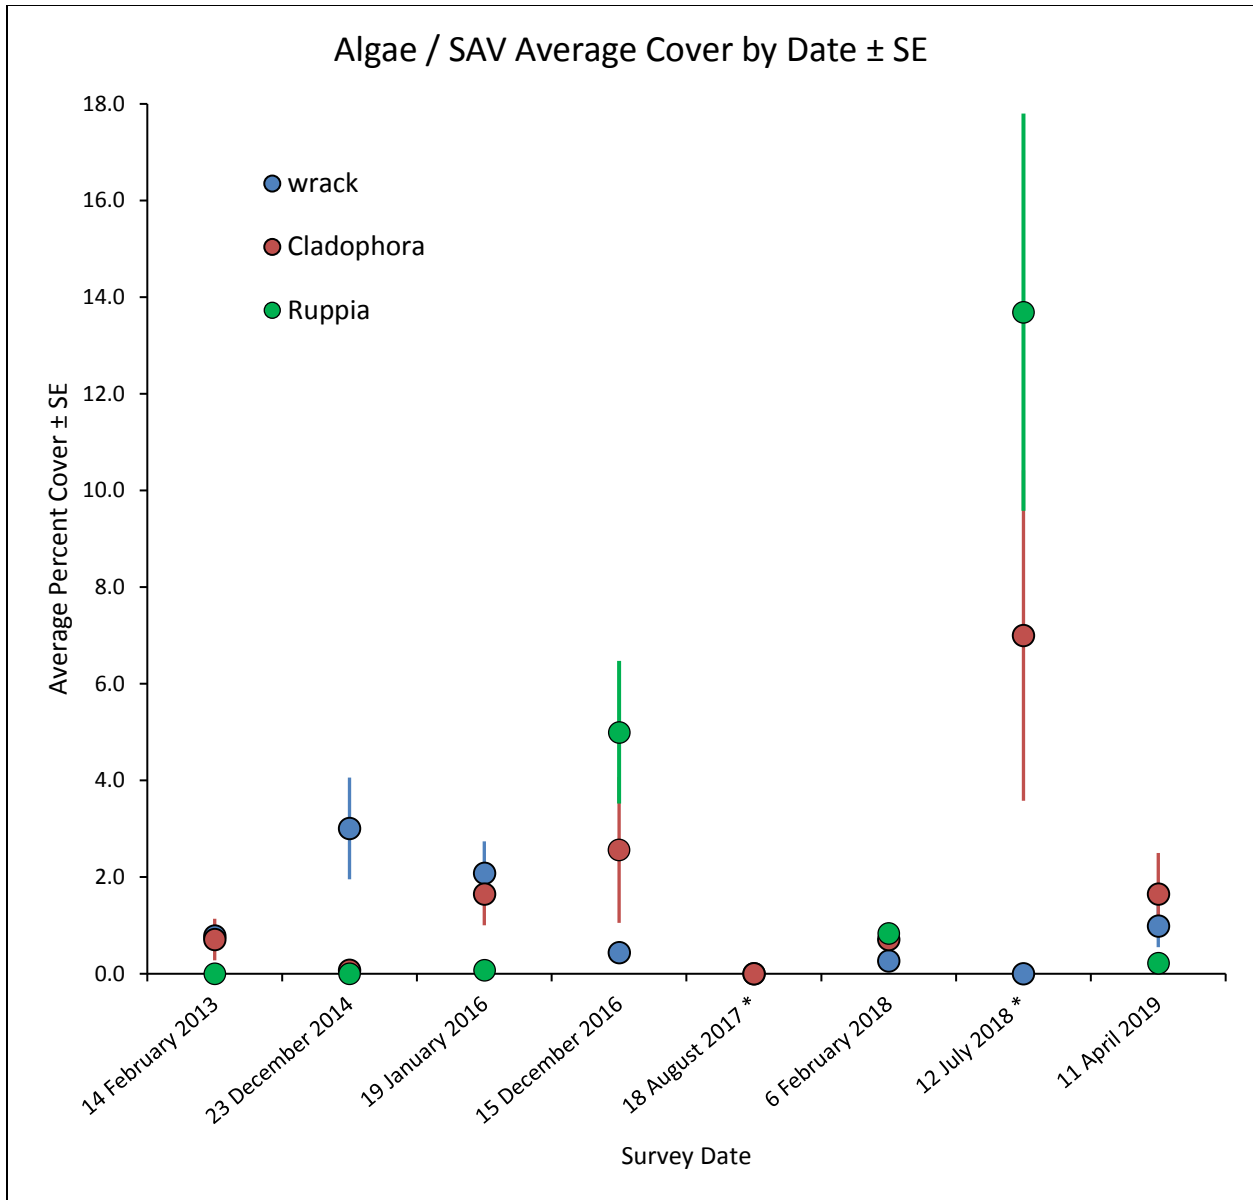
Figure 74. Graph indicating average algae and SAV cover (\pm SE) by survey date and category of algae/SAV. Asterisk indicates closed condition survey. Note: *Ruppia* data were excluded from the 18 August 2017 survey as an outlier from the graph; see *Ruppia* totals in Table 19.

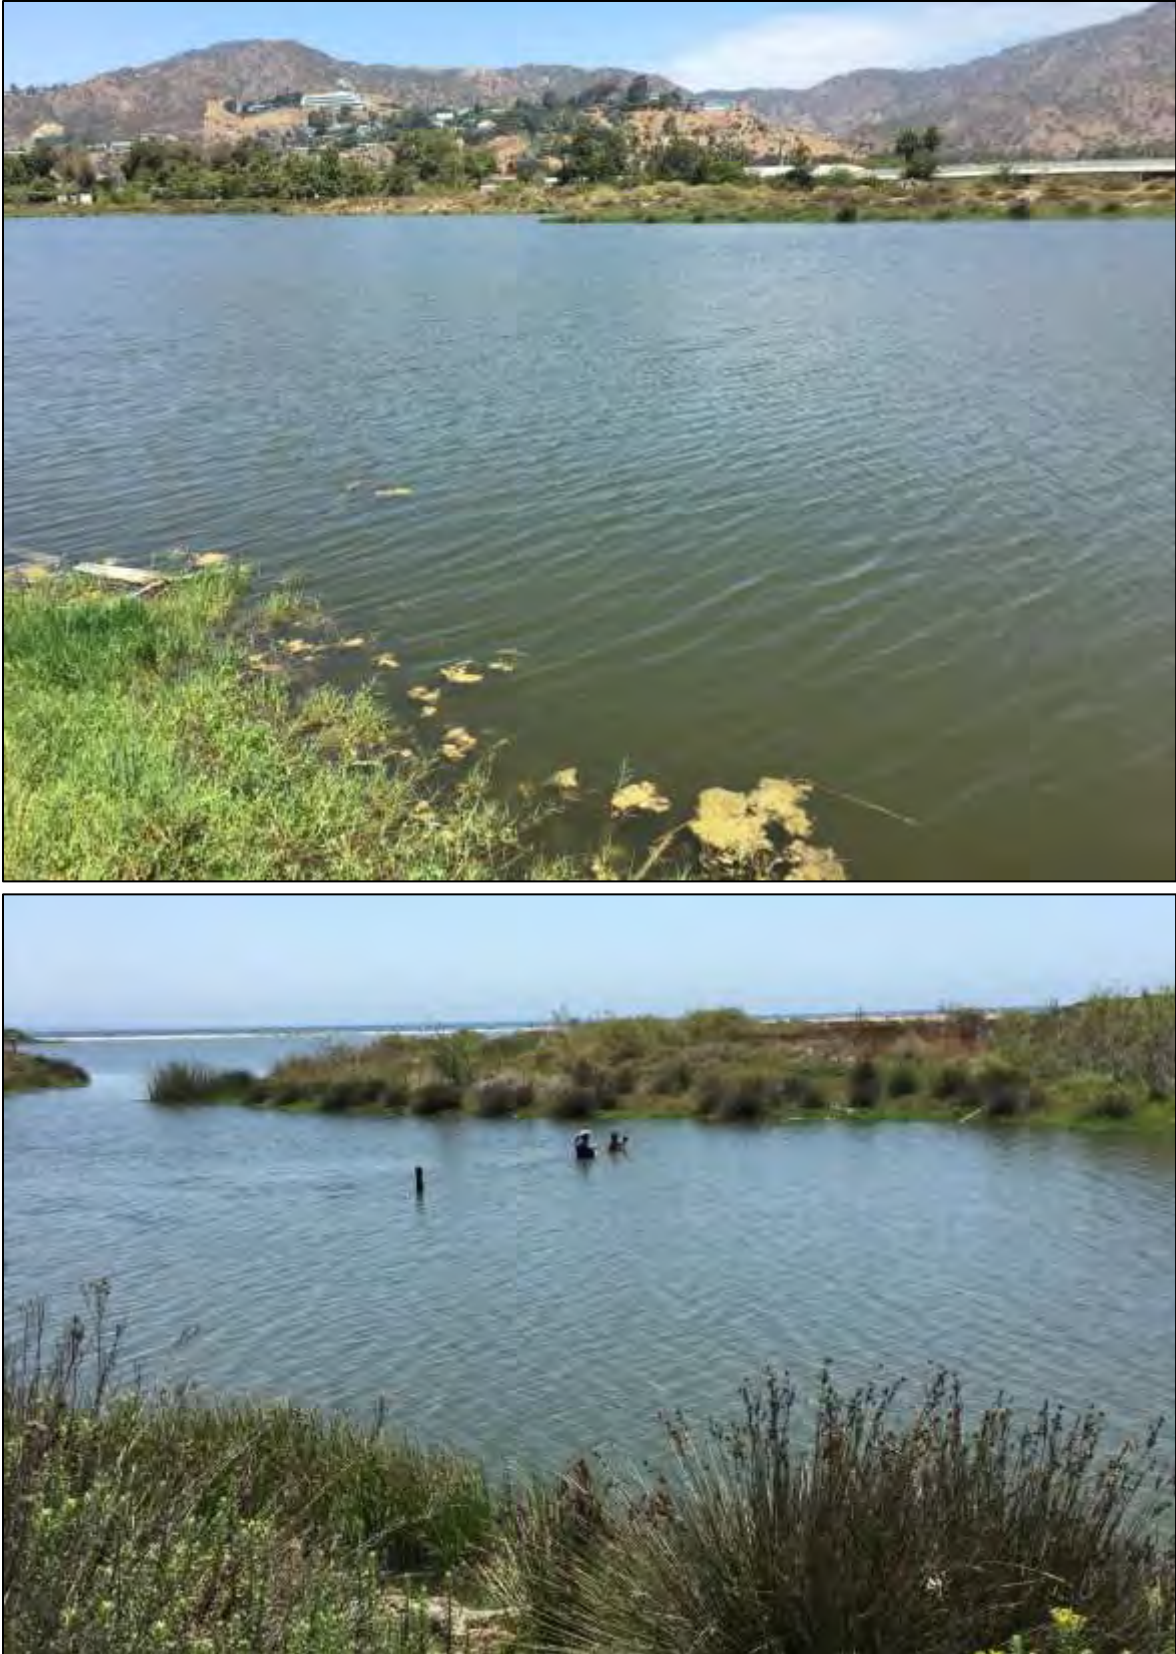
Figure 75. Representative photograph of (top) Station 2 and (bottom) Station 5 on 12 July 2018 (closed berm).
