Malibu Lagoon Restoration and Enhancement Project

Final Comprehensive Monitoring Report (Year 6)

August 2019

Prepared by: The Bay Foundation (TBF)

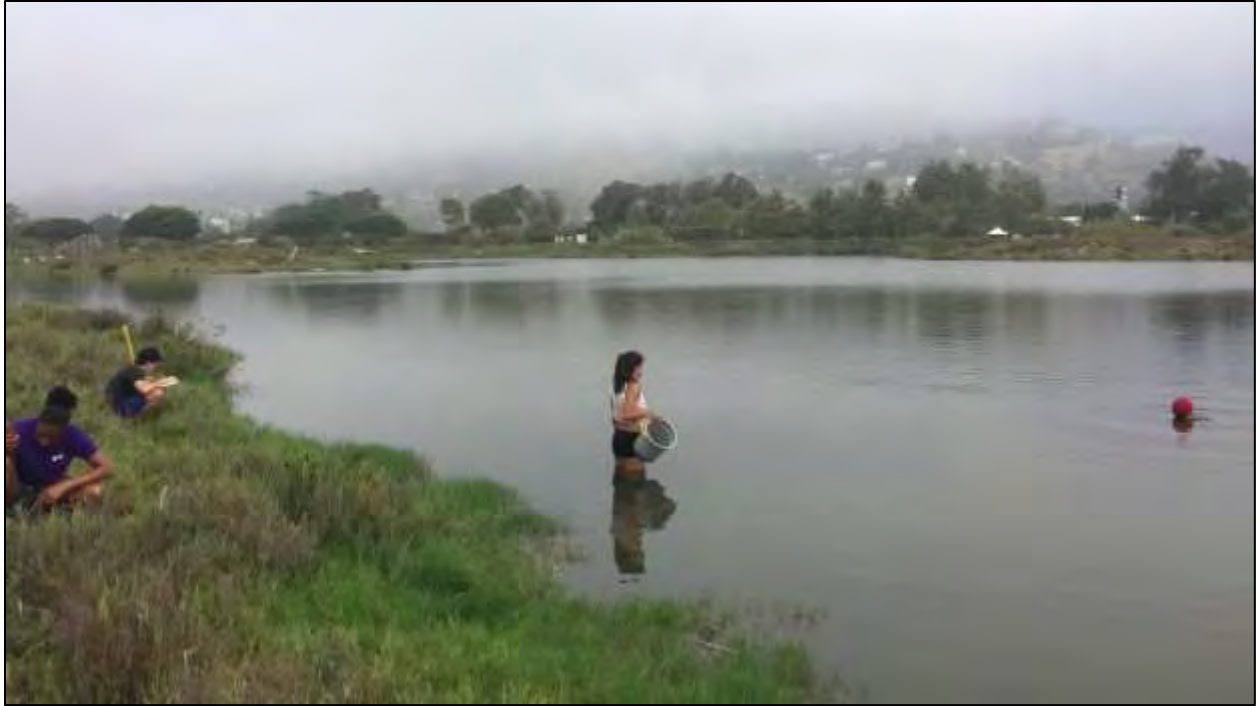
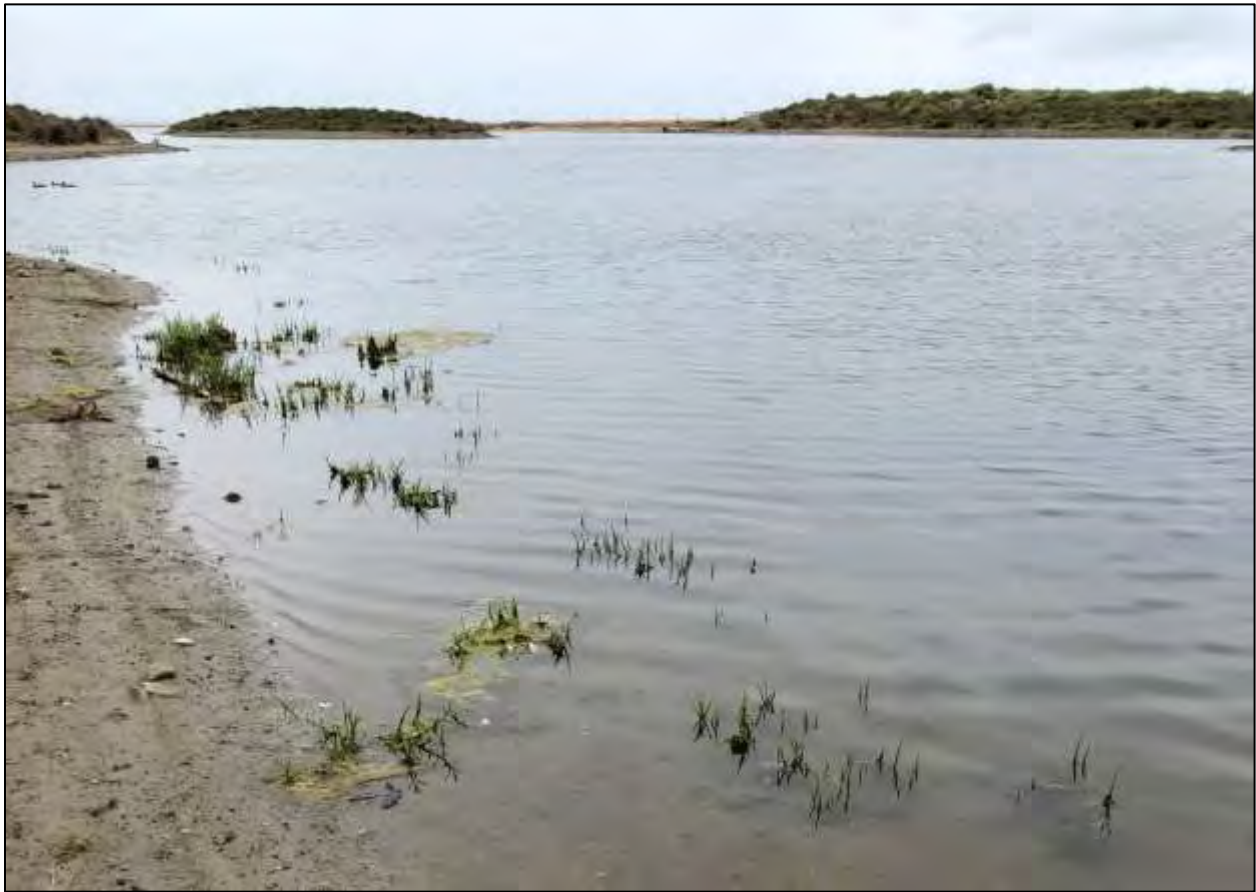
The average cover results of algae and SAV can be broken down into several categories, including: wrack, *Cladophora*, and *Ruppia*. The category 'wrack' is an amalgamation of several types of unattached or floating kelp species, including those in the genera *Macrocystis* (Figure 73), *Phyllospadix*, *Dictyota*, *Egregia*, *Eisenia*, *Cystoseira*, and woody debris. '*Cladophora*' is the genus for small, turf-like green alga. Since January 2016, surveys have also identified *Ruppia* sp., or ditchgrass, which is an attached submerged aquatic vegetation (SAV) species. Algae, wrack, and SAV all function very differently with regards to nutrient uptake and sequestration as well as dissolved oxygen cycling, so are thus evaluated separately. In the two Year 6 surveys (12 July 2018 and 11 April 2019), the average *Ruppia* cover was $13.69\% \pm 4.11$ and $0.22\% \pm 0.16$, average algae cover was $7.00\% \pm 3.42$ and $1.65\% \pm 0.85$, and average wrack cover was $0.00\% \pm 0.00$ and $0.99\% \pm 0.44$ (Figures 74 and 75). Visual qualitative estimate data from the July 2018 and June 2019 surveys indicated presence of submerged live *Ruppia* across most stations, with minimal floating turf-like algae (less than 5% of the total station area, Figure 76) and very little wrack present.

Figure 76. Representative photograph of (top) Station 2 on 25 July 2018 and (bottom) Station 5 on 25 June 2019.

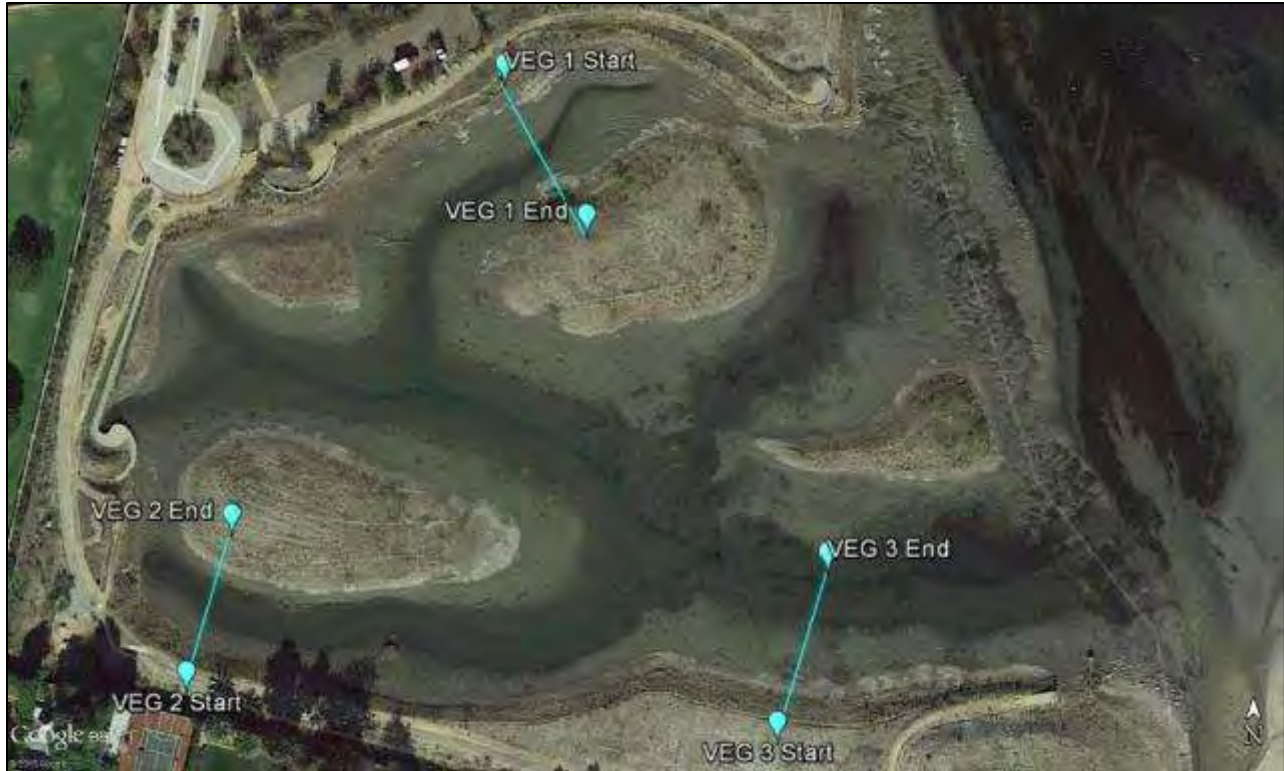
Figure 79. Map of vegetation transect locations and start/end points.

Data for absolute percent cover of native/nonnative vegetation species were collected along three, 50-meter transects (Figures 78 and 79) using the line-intercept method on 15 March 2013, 7 May 2014, 18 December 2014, 5 May 2015, 22 December 2015, 20 May 2016, 21 December 2016, 27 June 2017, 17 April 2018, 12 July 2018 (Year 6), and 4 December 2018 (Year 6). Eleven full surveys were completed, with an extra subset of surveys to capture growth over the final growing season conducted on 25 June 2019 (Year 6). These data were combined to provide a comprehensive set of post-restoration vegetation surveys to evaluate native and non-native relative vegetation cover over time.

Each transect location was recorded with a submeter global positioning system (GPS) unit and photographed at each end. Absolute cover data were calculated based on the total distance for each species within each transect. Species data were collected to an accuracy of 0.01 m along each 50-meter transect. Species were categorized into native or non-native and added together. Cover data were relative, as non-vegetated mudflat and channel habitats were removed from the total transect length. Data were displayed as a bar graph showing percent cover for each transect.

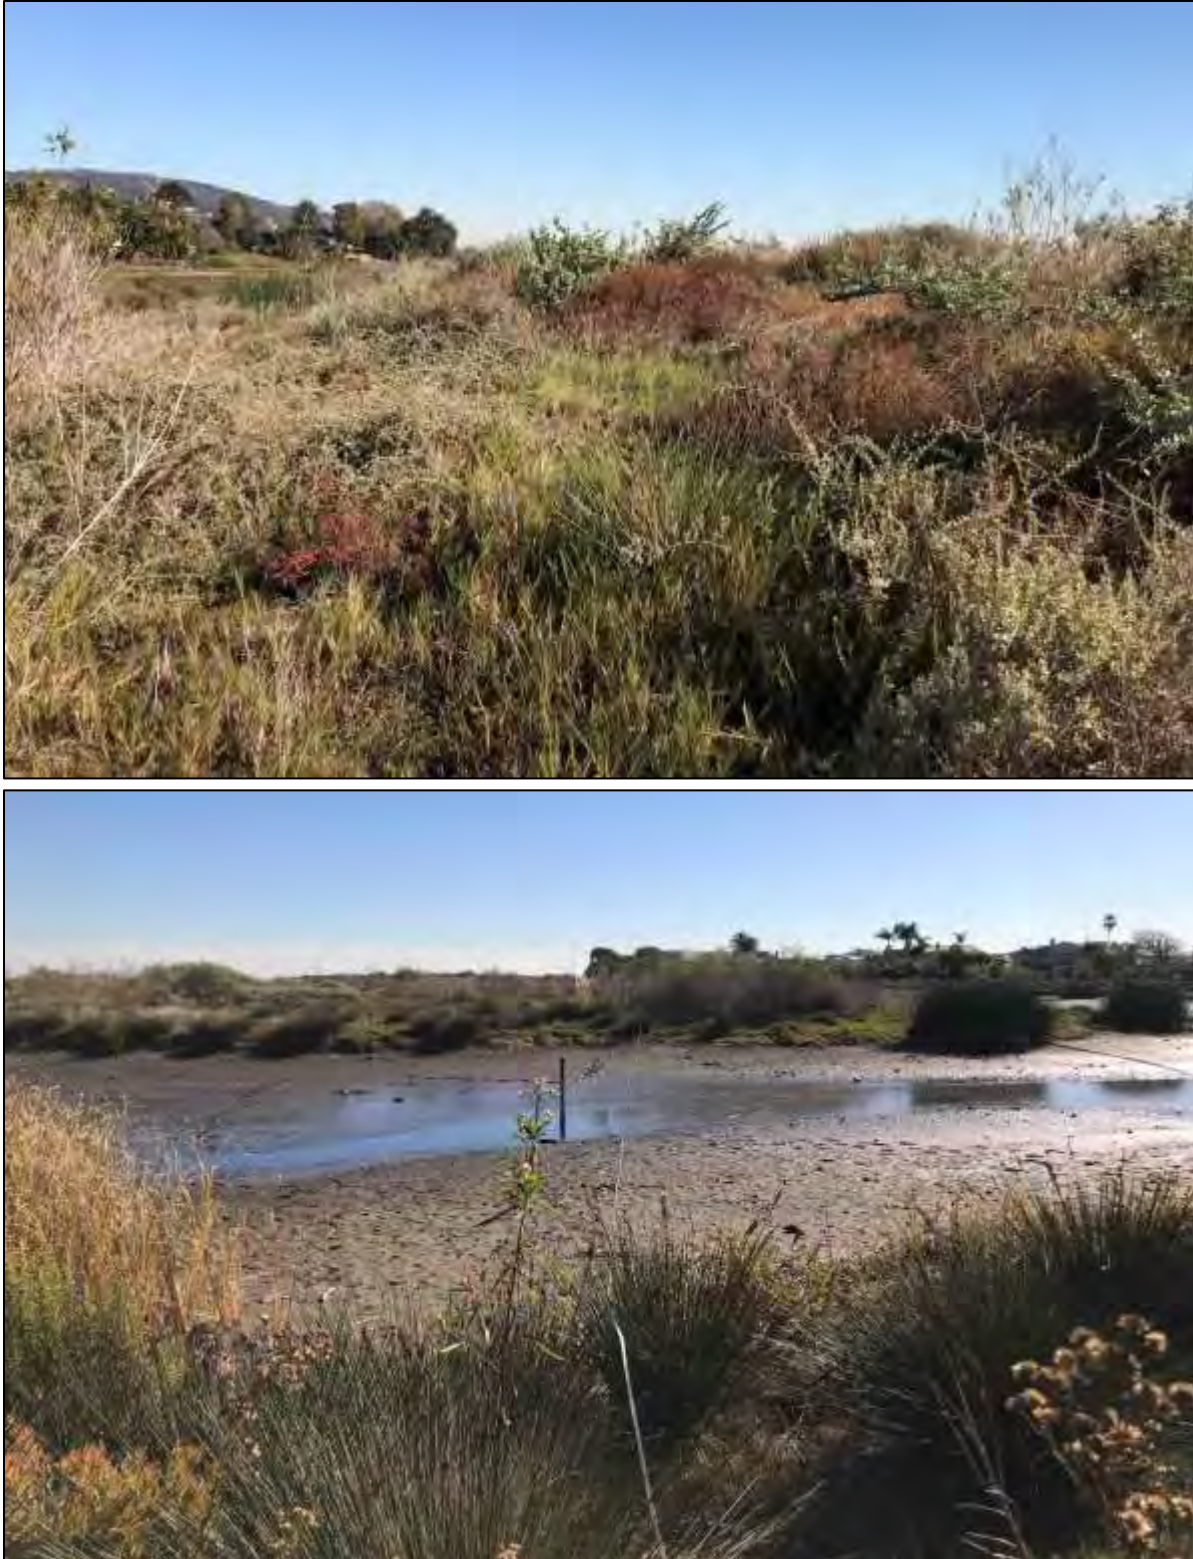
Figure 82. Photographs of the upland habitat (top) and lower wetland habitat (bottom) portion of Transect 1 on 4 December 2018.

In the sixth monitoring year, the average (\pm standard error) native cover across all transects was $78.1 \pm 12.5\%$ and $79.2 \pm 12.0\%$, respectively. The average non-native cover was less than 1% across both Year 6 survey dates. The relative native cover for Year 6 ranged between 96.0 – 100.0%, with a range of 98.1 – 100.0% in the most recent survey (December 2018). Cover for native vegetation species along an individual transect in the most recent survey was the highest on Transect 1, at 89.3% (with a relative native cover of 98.1%), followed by Transect 2, at 87.4% (with a relative native cover of 98.6%). Absolute cover was lowest on Transect 3 at 60.8%, but with a relative native cover of 100.0% (Figure 80). Non-native cover was very low across all transects for both Year 6 surveys, ranging from 0.0 – 2.2% absolute cover, with 0.0 – 1.8% in the most recent survey (December 2018). All transects have shown a general trend over time of increasing native vegetation cover and decreasing bare ground over time, with slight fluctuations depending on season and survey year. Lastly, the species richness at a transect level is higher post-restoration, with six-year survey results indicating 8-16 native plant species representing a variety of plant types including ground cover, subshrubs, and overstory canopy. Figures 81 through 84 display representative photographs from each surveyed transect during Year 6.

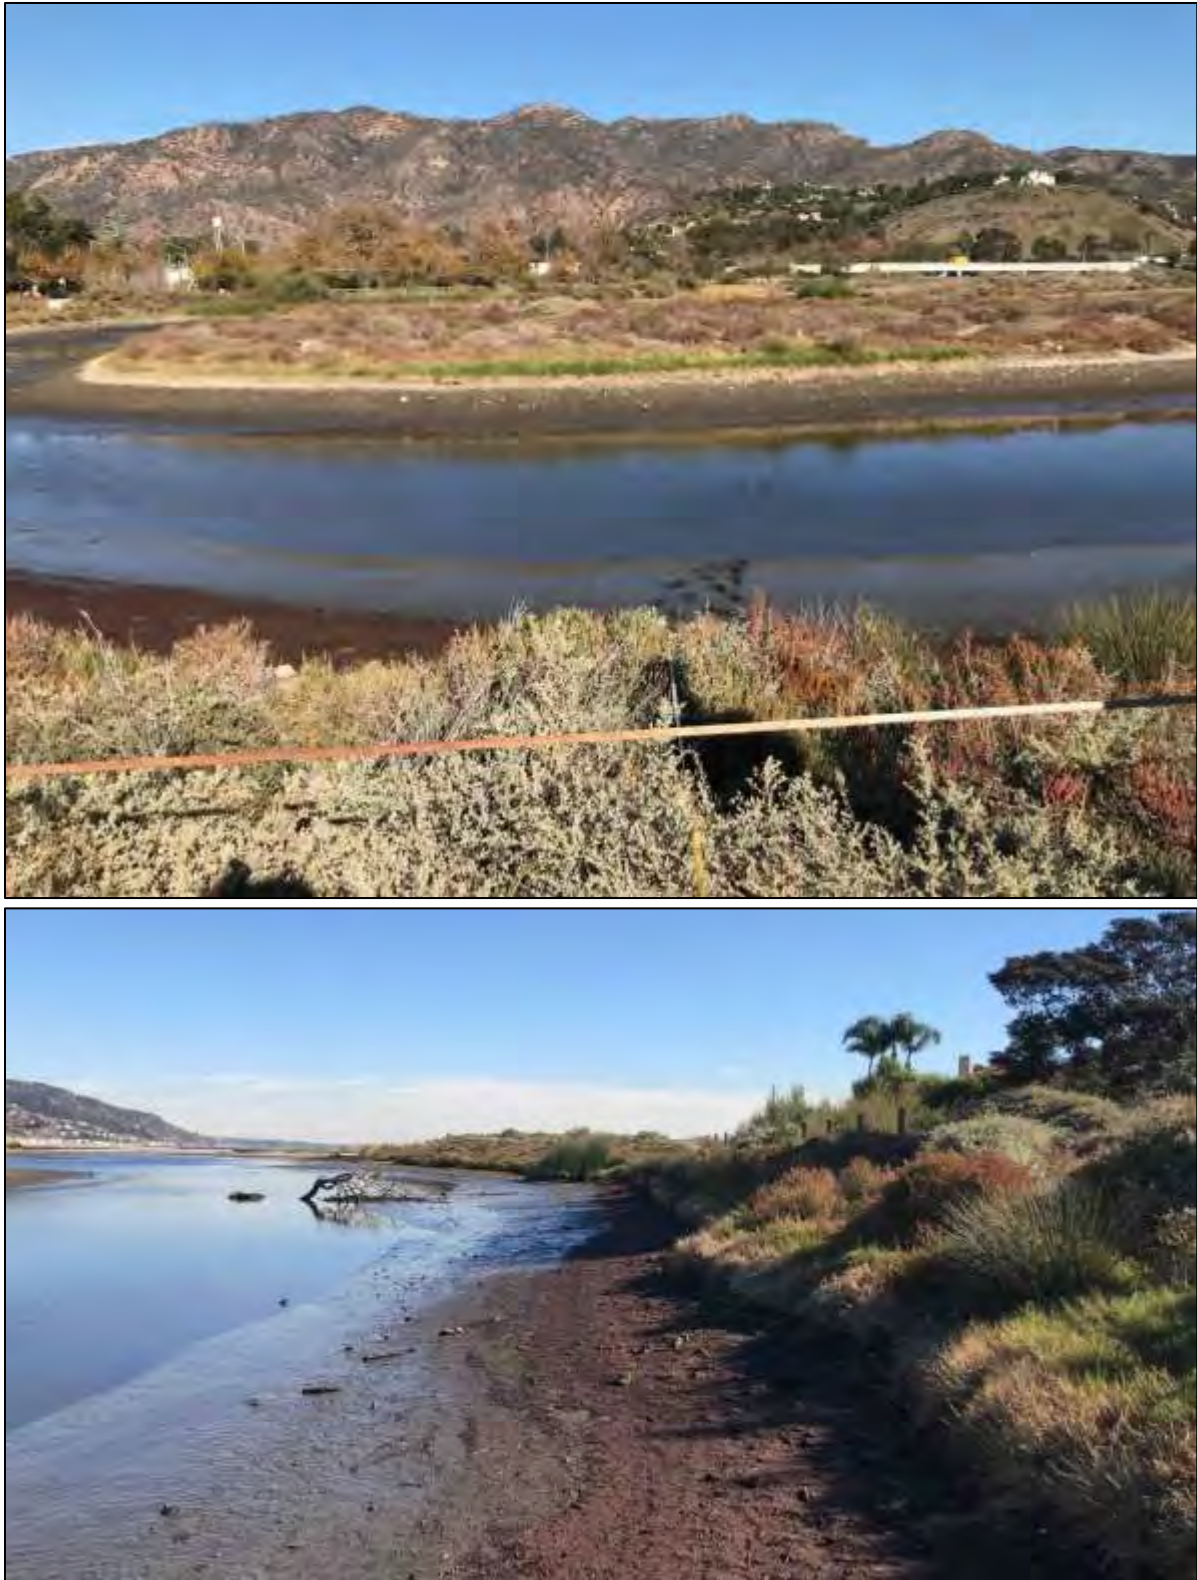
Figure 83. Photographs of the upland habitat adjacent to the pathway (top) and lower wetland habitat (bottom) portion of Transect 2 on 4 December 2018.

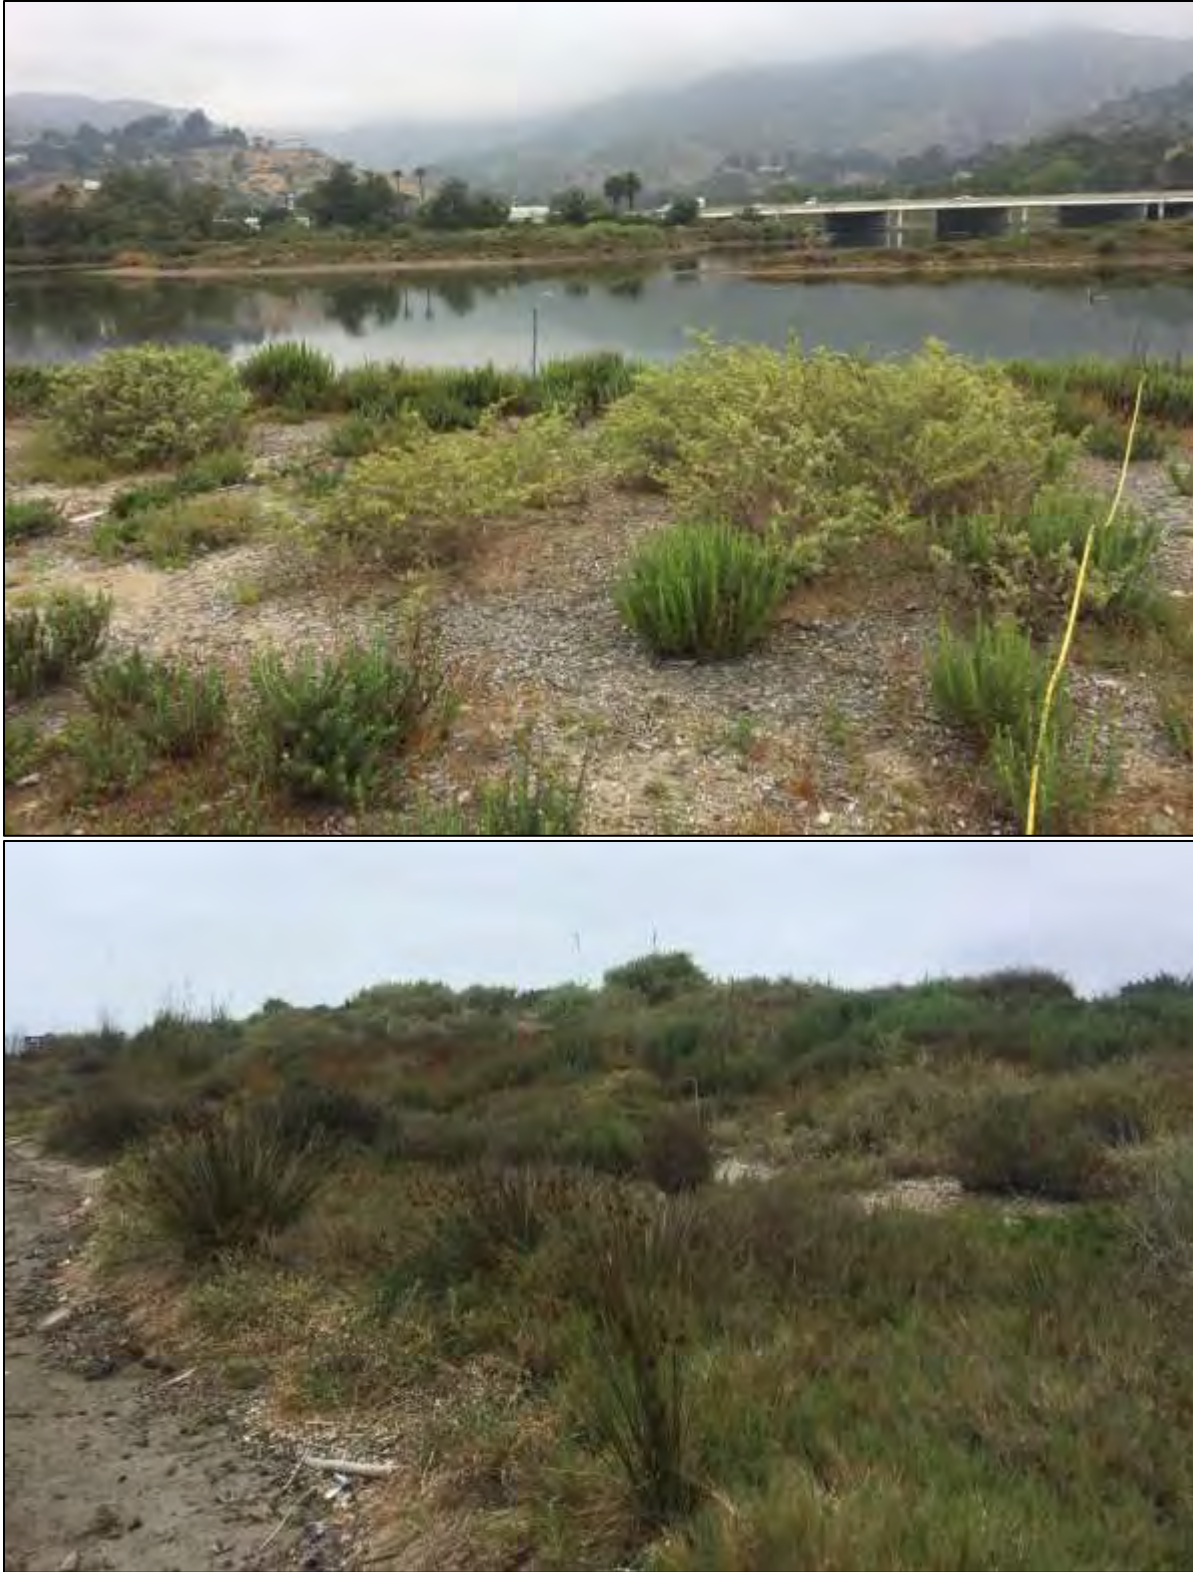
Figure 84. Photographs of the upland habitat (top) and lower wetland habitat (bottom) portion of Transect 3 on 25 June 2019.

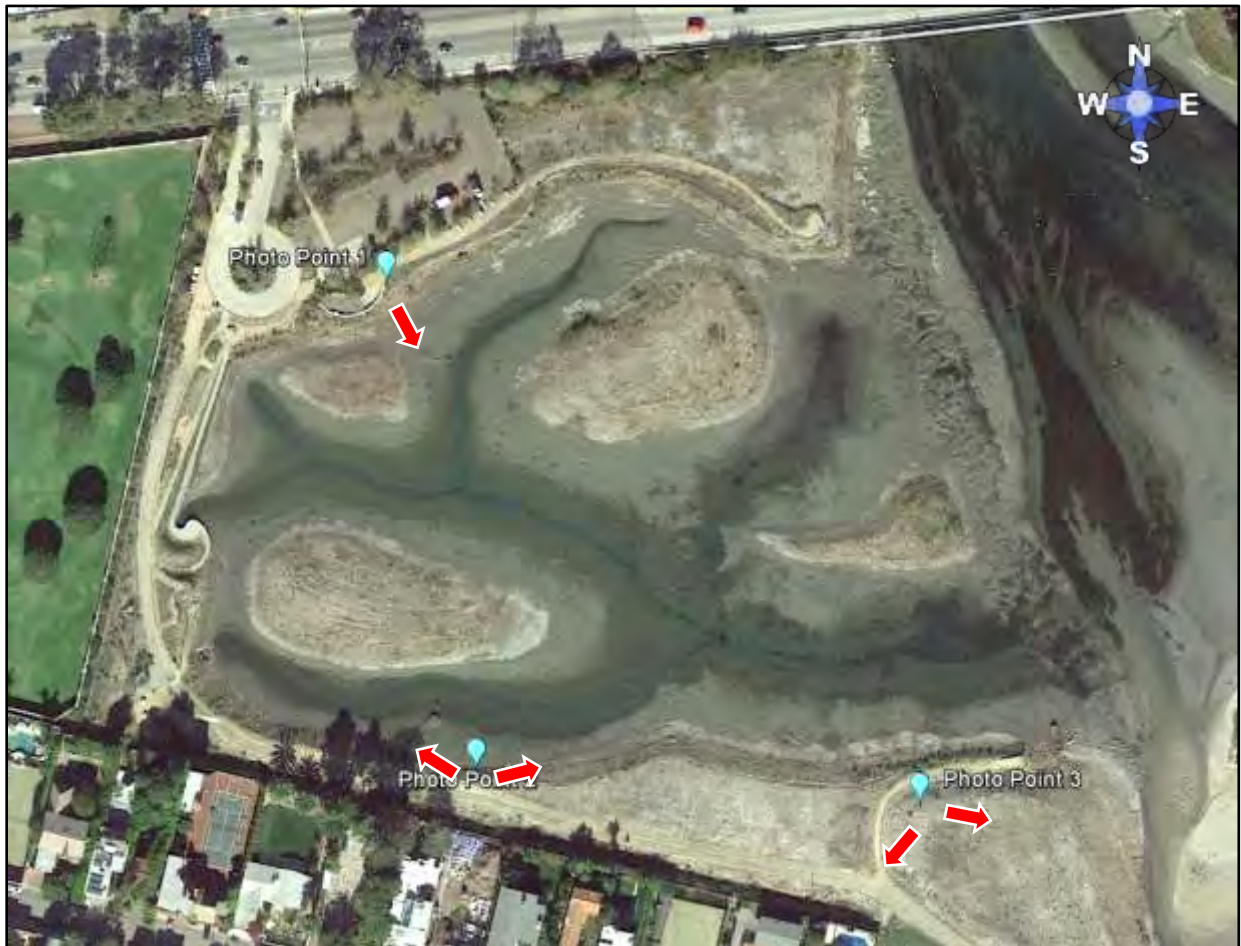
Figure 85. Map of photo-point locations and bearings for the surveys.

Three permanent, photo-monitoring locations (Table 21 and Figure 85) were established to visually document the establishment of vegetation and large-scale landscape changes following restoration. Stations were located using GPS and baseline photographs. The baseline photo-point survey was conducted immediately post-restoration on 15 March 2013 during a low tide; post-restoration surveys were conducted again on 7 May 2014, 18 December 2014, 5 May 2015, 22 December 2015, 16 May 2016, 27 December 2016, 27 June 2017, 23 May 2018, 4 December 2018, and 25 June 2019 (Table 21). Approximate bearing is relative to the center of the photograph; detailed bearing ranges are included on the datasheets.

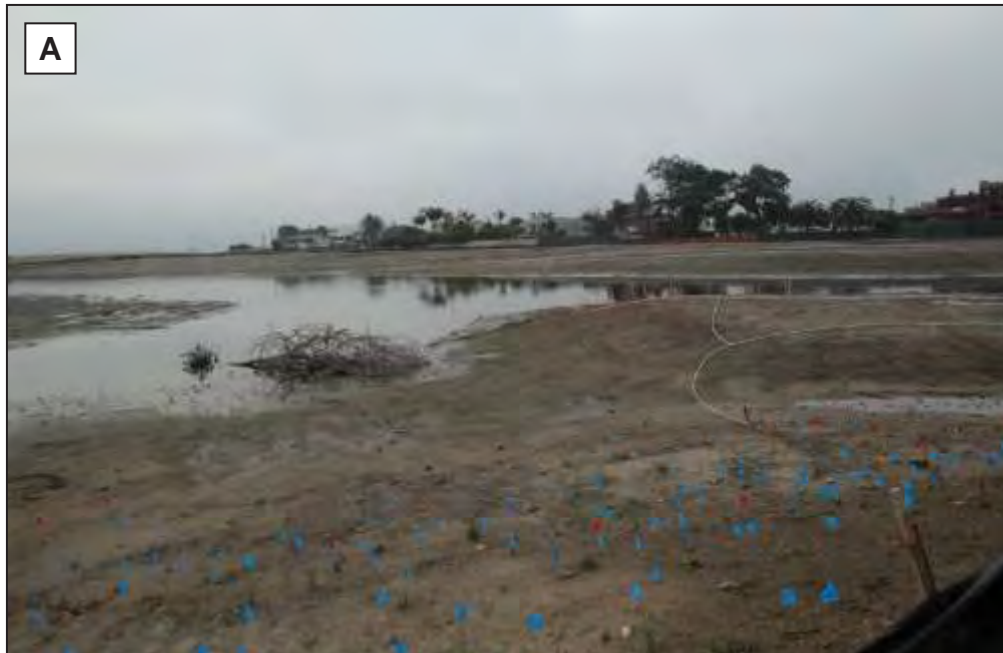
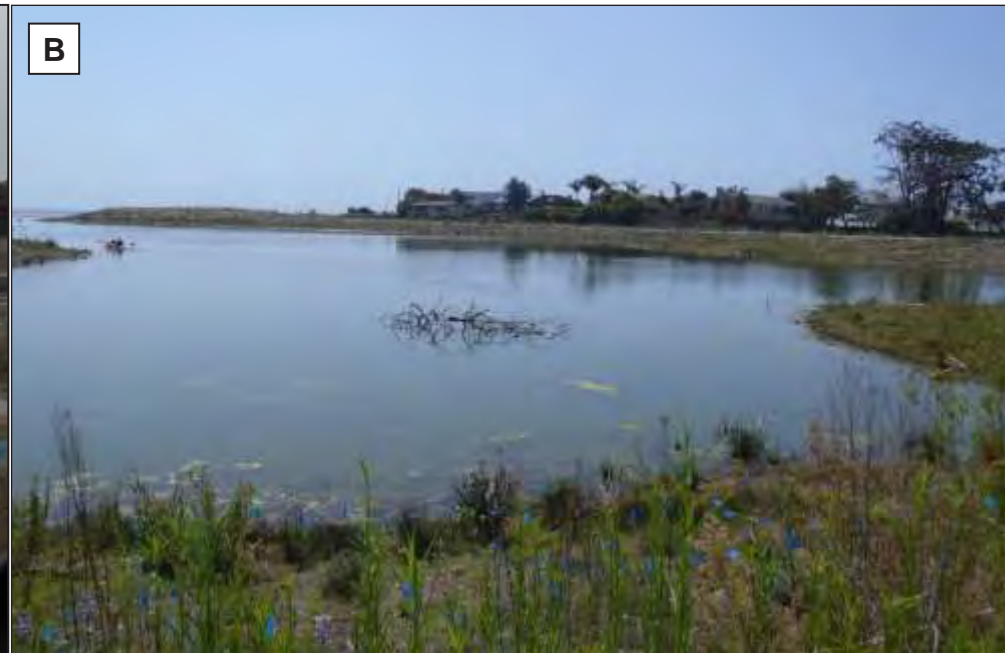
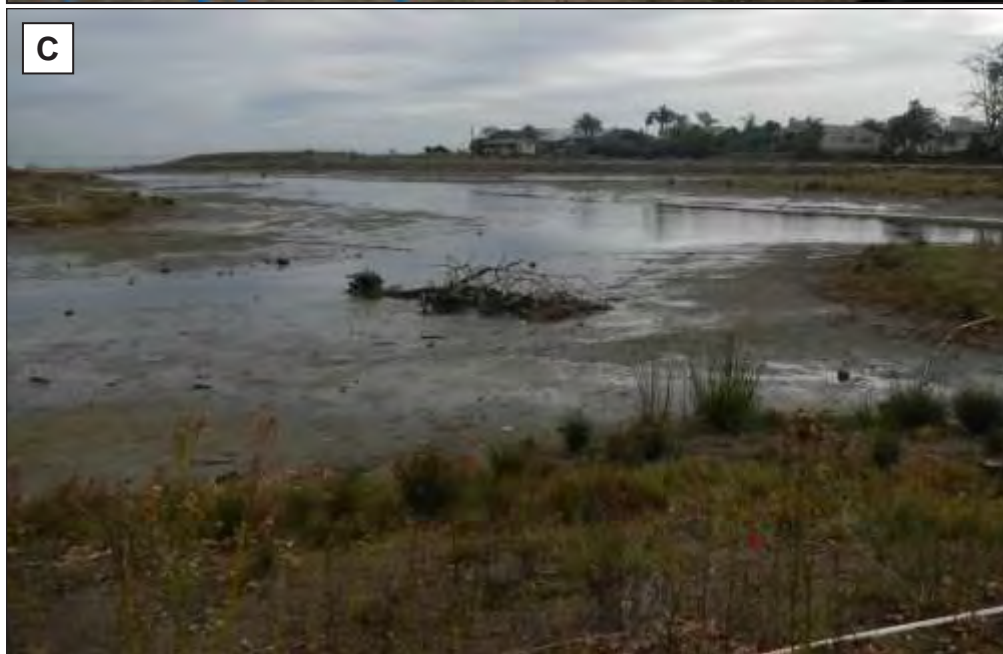
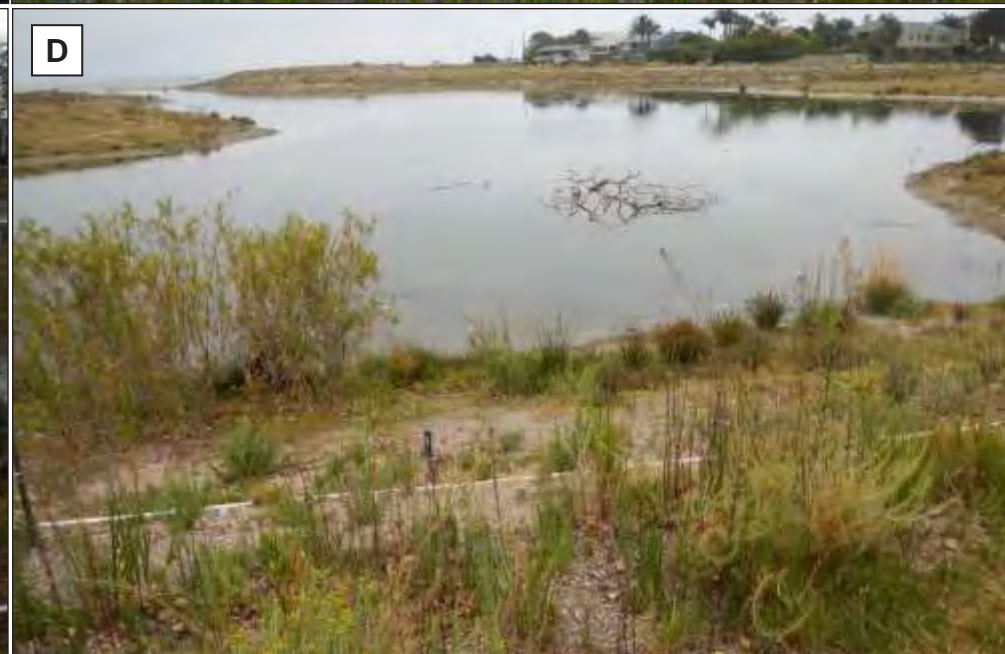
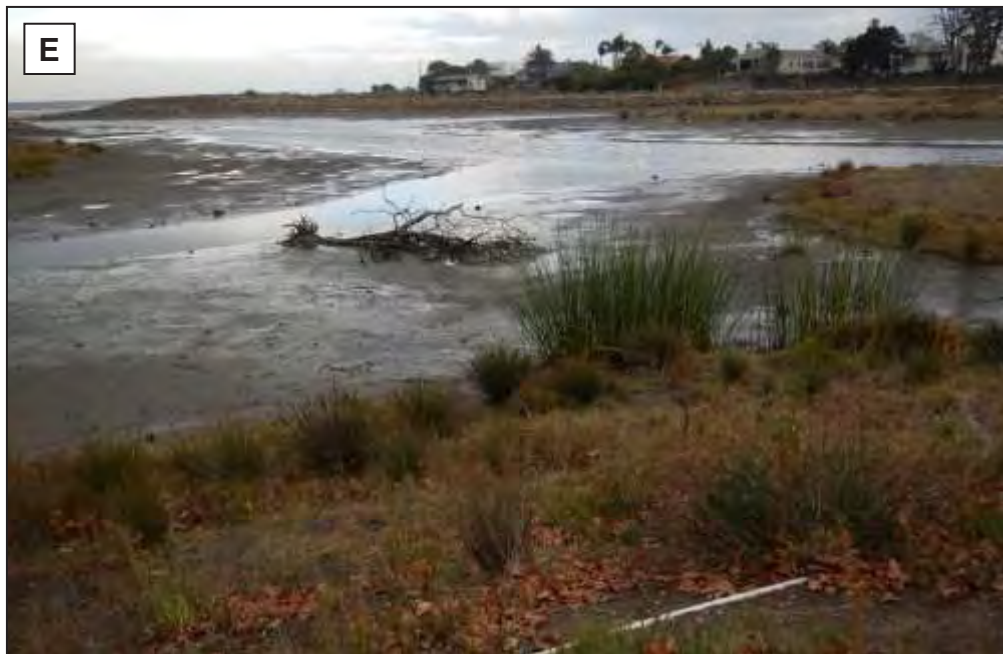
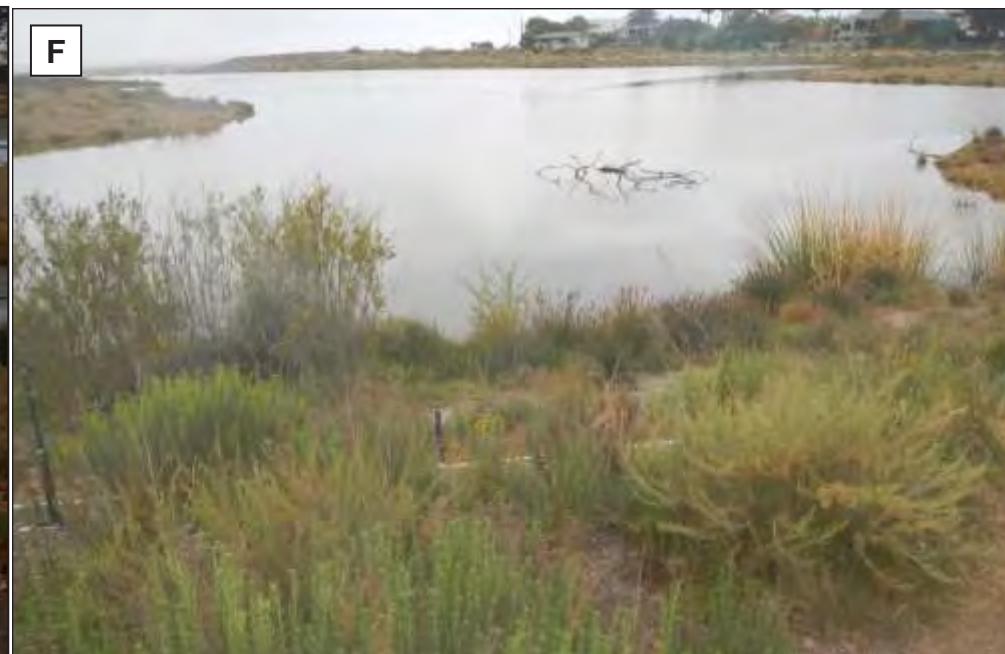
Figure 87. Photo Point 1 at bearing 155° on (A) 15 March 2013; (B) 7 May 2014; (C) 18 December 2014; (D) 5 May 2015.

Figure 87 (continued). Photo Point 1 at bearing 155° on (E) 22 December 2015; (F) 16 May 2016; (G) 27 December 2016; (H) 27 June 2017.

Figure 87 (continued). Photo Point 1 at bearing 155° on (I) 23 May 2018; (J) 4 December 2018; (K) 25 June 2019.

A total of five photos were taken at three locations to assess a range of habitat types across the restoration area. Figures 87 through 91 (A - K) display the photos from the five locations post-restoration on the eleven survey dates, respectively. Photo Point 1 displays the intersection of several channels along with a tree snag for bird roosting. Photographs from this position indicate a wetland assemblage of native plants. Photo Point 2 displays two directions along the public access path to the beach in the southernmost channel. Visible plant species range from upland and transition zone species to lower wetland vegetation. Photo Point 3 (both bearings) show the most increase in plant cover in recent years, which corresponded to the vegetation cover assessments from this location.

Consistent with the evaluation for plant cover transect monitoring and CRAM scores, the post-restoration georeferenced photos show a consistent increase in vegetation over time, with a large increase after the initial post-restoration Photo Point survey. Unlike the prolific growth seen in the first few survey years, photographs from the latter years showed more subtle variations. Figure 86 is a representative recent photo from the Photo Point series. All 15 pages of Photo Point results can be found after the Final Restoration Assessment and Conclusions section, below.

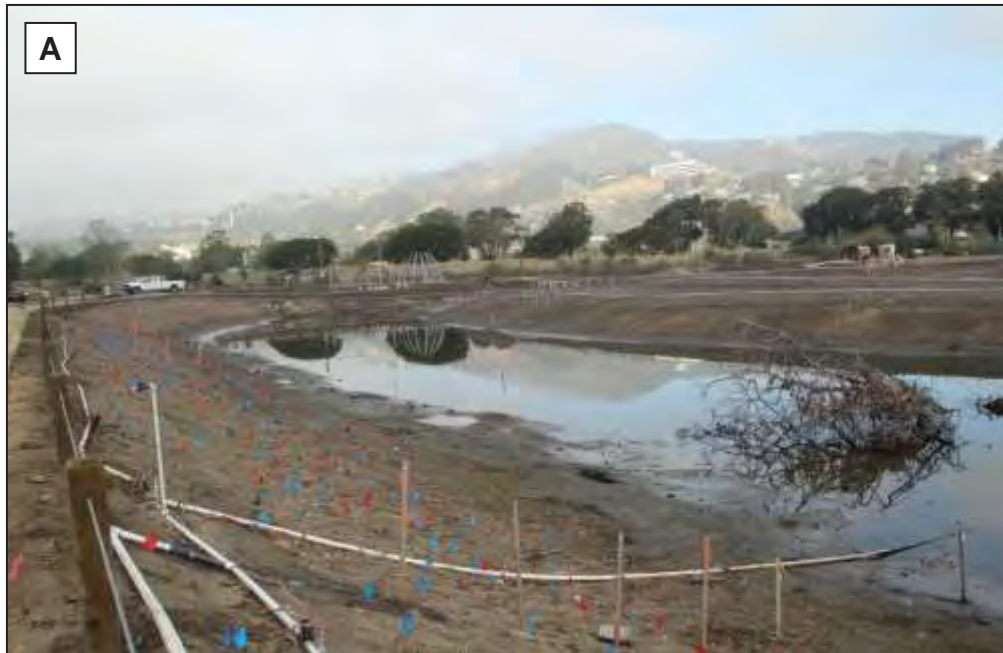
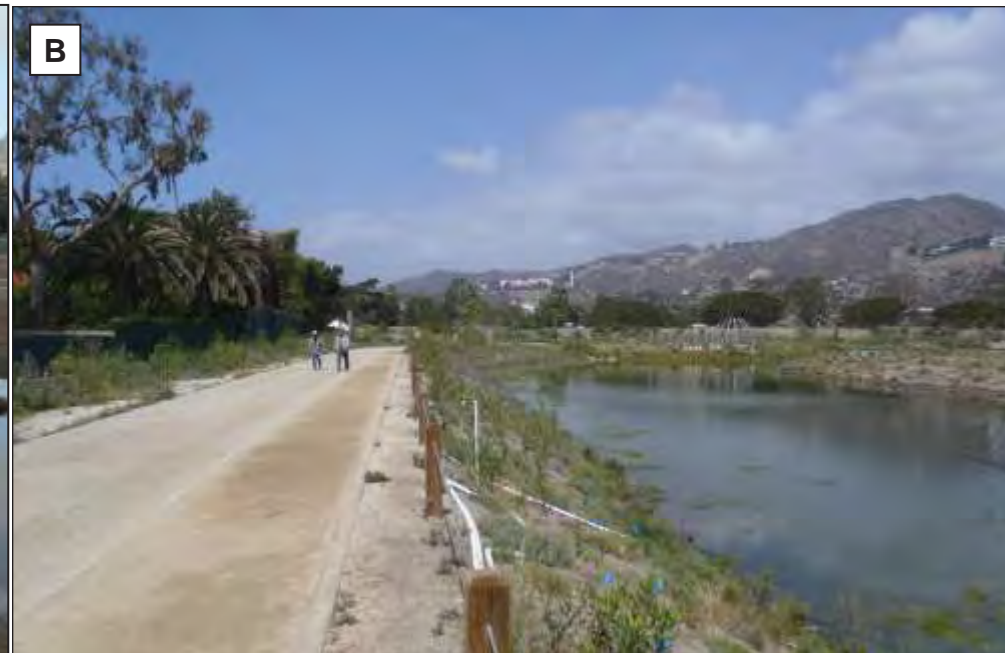
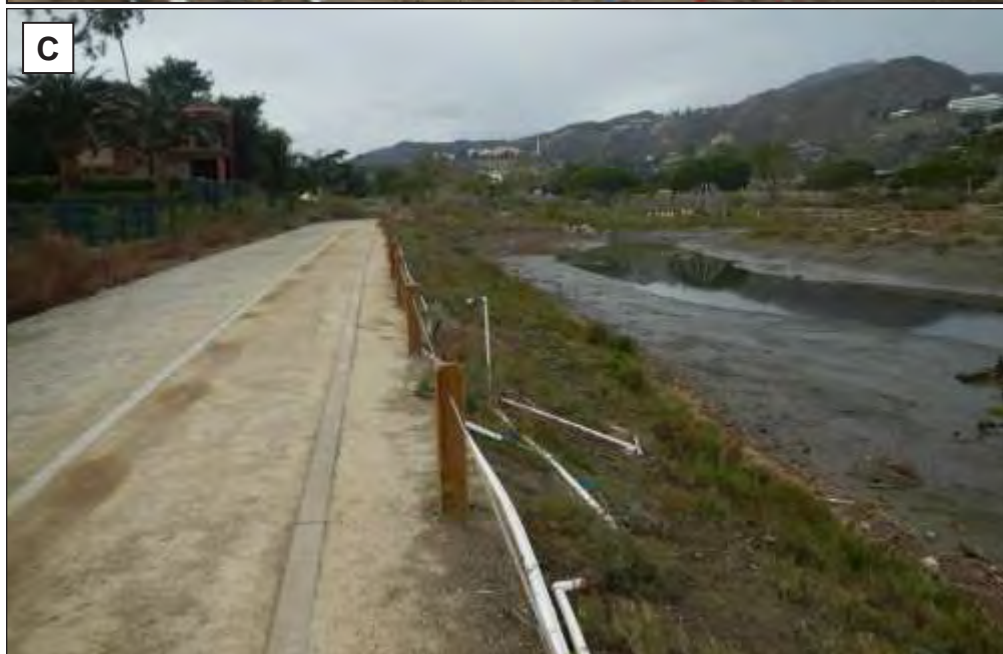
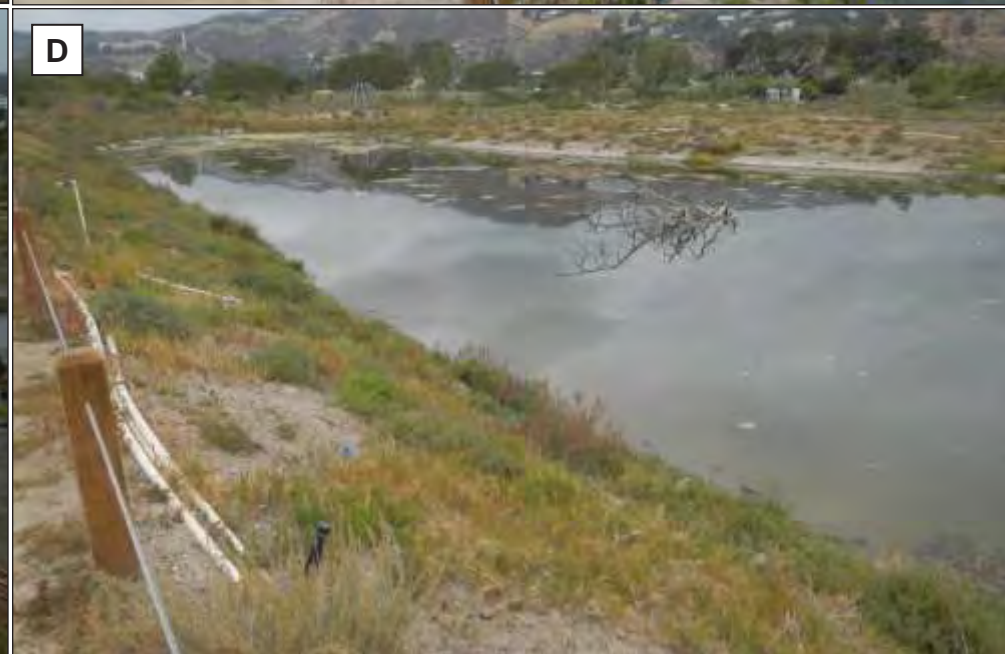
Figure 88. Photo Point 2 at bearing 300° on (A) 15 March 2013; (B) 7 May 2014; (C) 18 December 2014; (D) 5 May 2015.

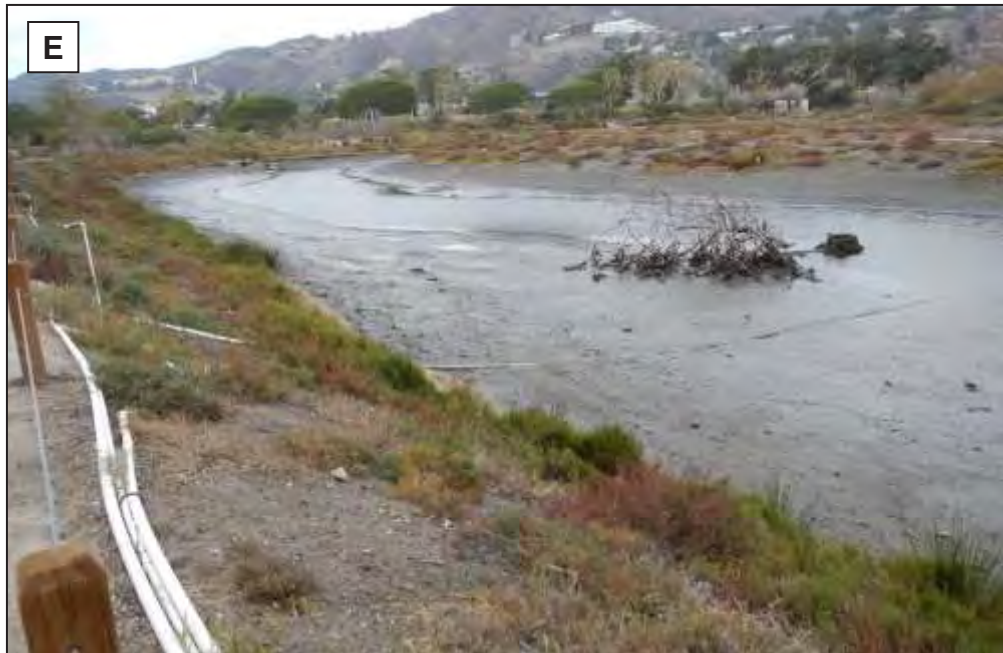
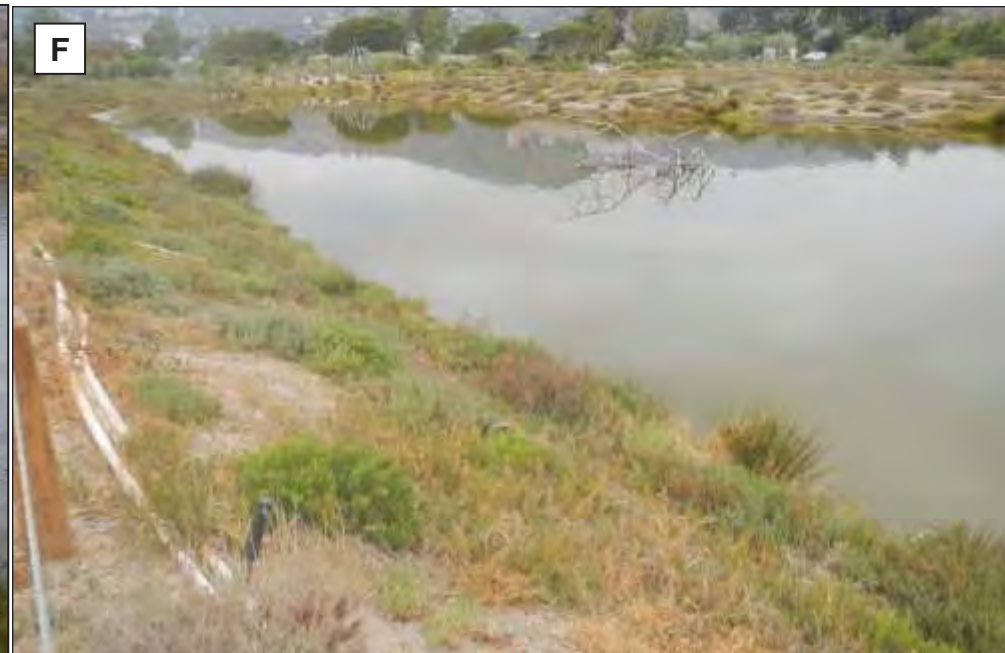
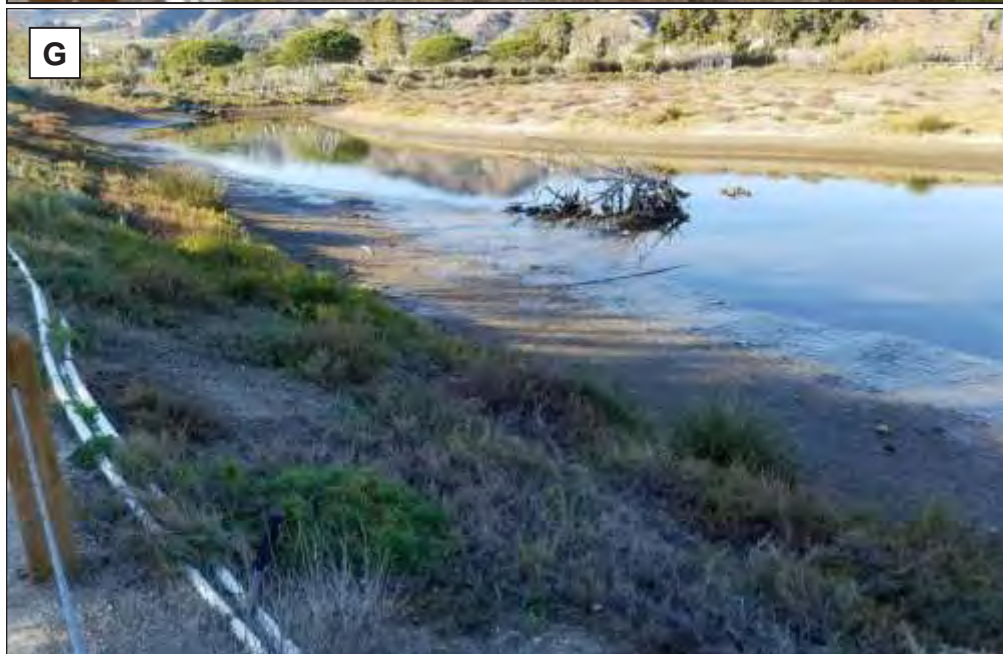
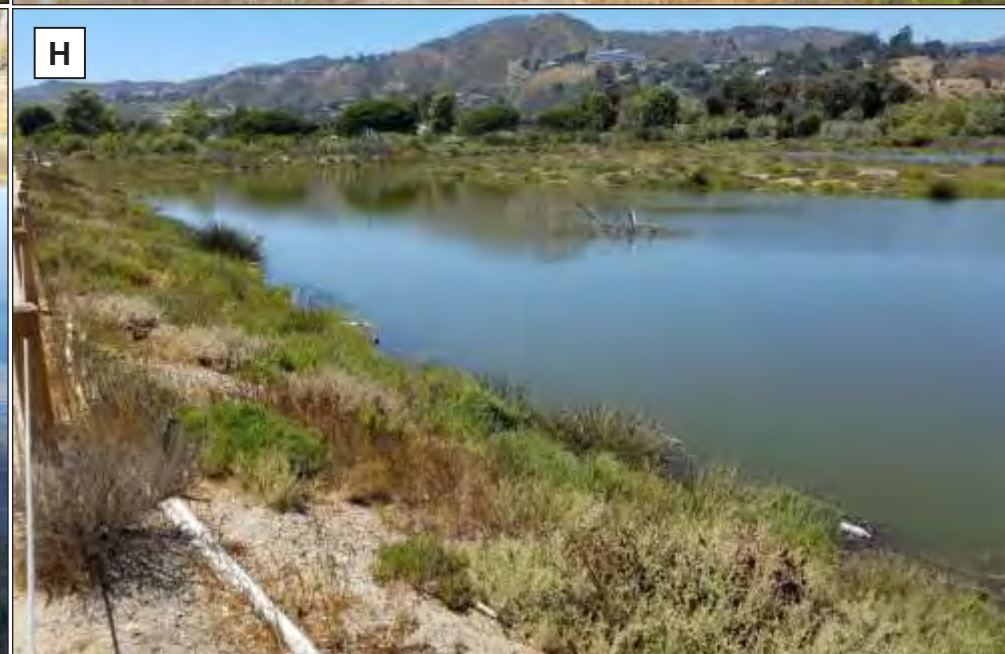
Figure 88 (continued). Photo Point 2 at bearing 300° on (E) 22 December 2015; (F) 16 May 2016; (G) 27 December 2016; (H) 27 June 2017.

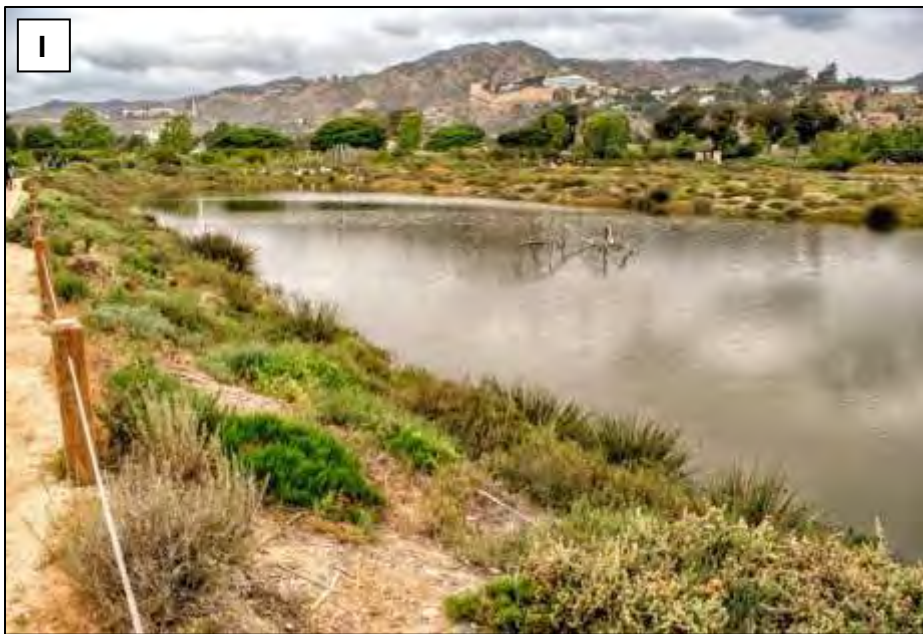
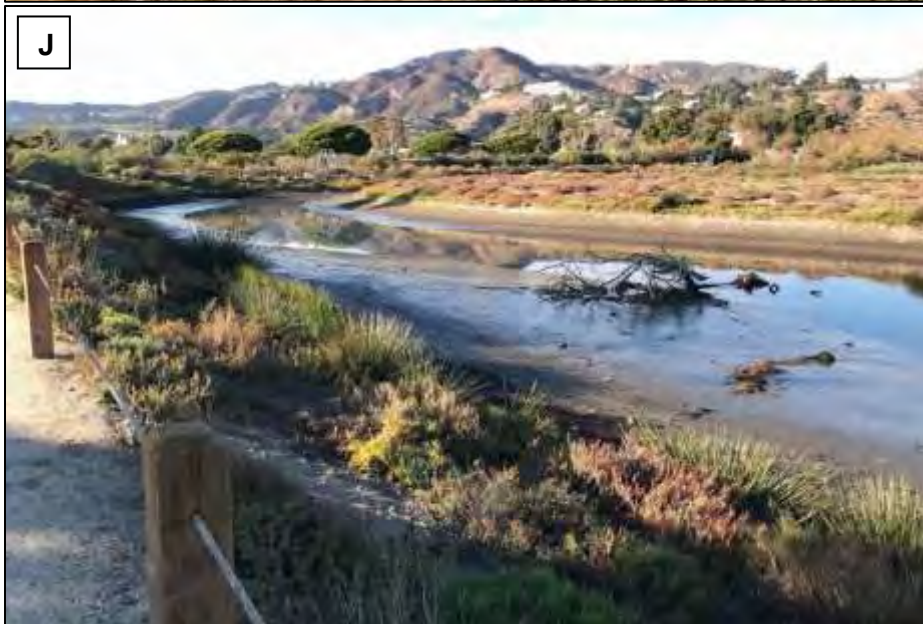
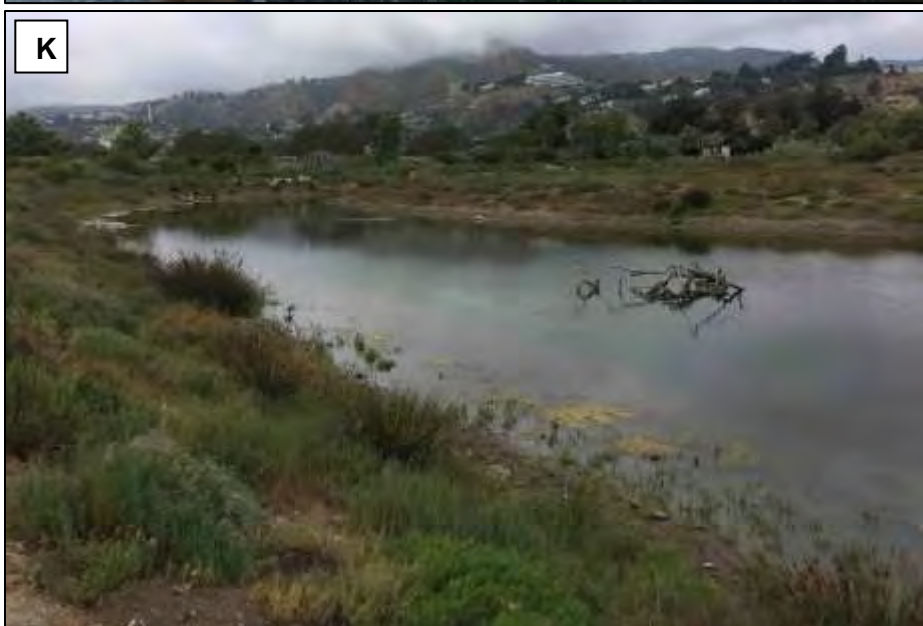
Figure 88 (continued). Photo Point 2 at Bearing 300° on (I) 23 May 2018; (J) 4 December 2018; (K) 25 June 2019.
