Malibu Lagoon Restoration and Enhancement Project

Final Comprehensive Monitoring Report (Year 6)

August 2019

Prepared by: The Bay Foundation (TBF)

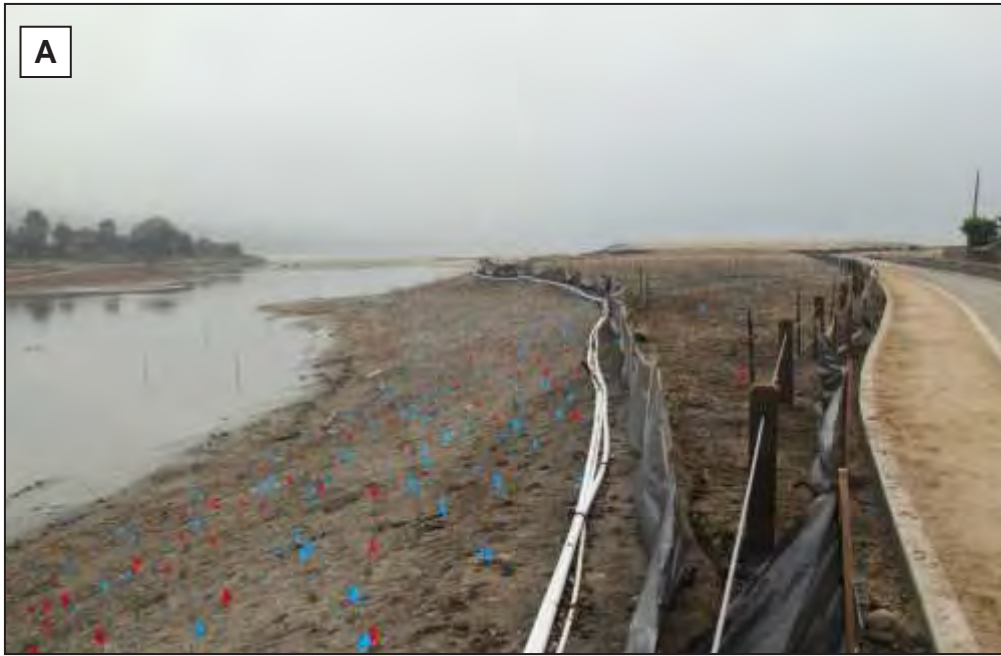
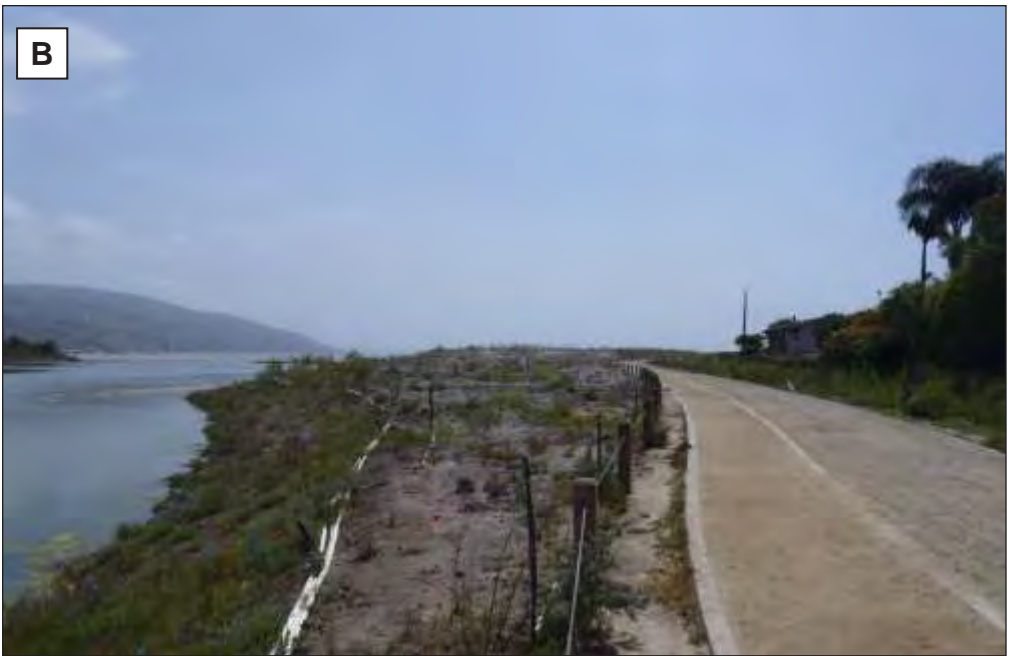
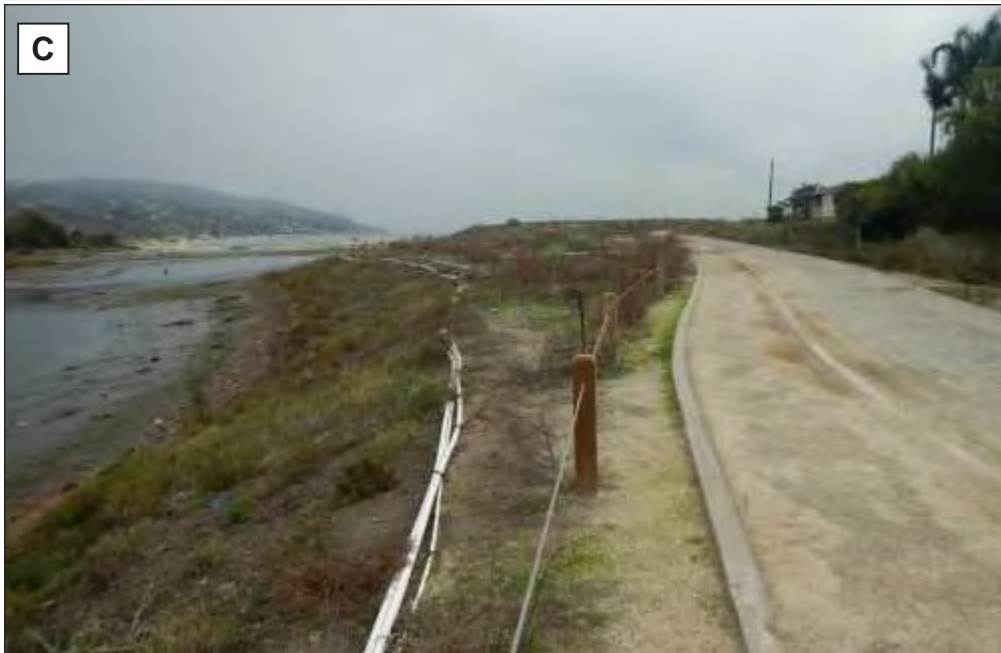
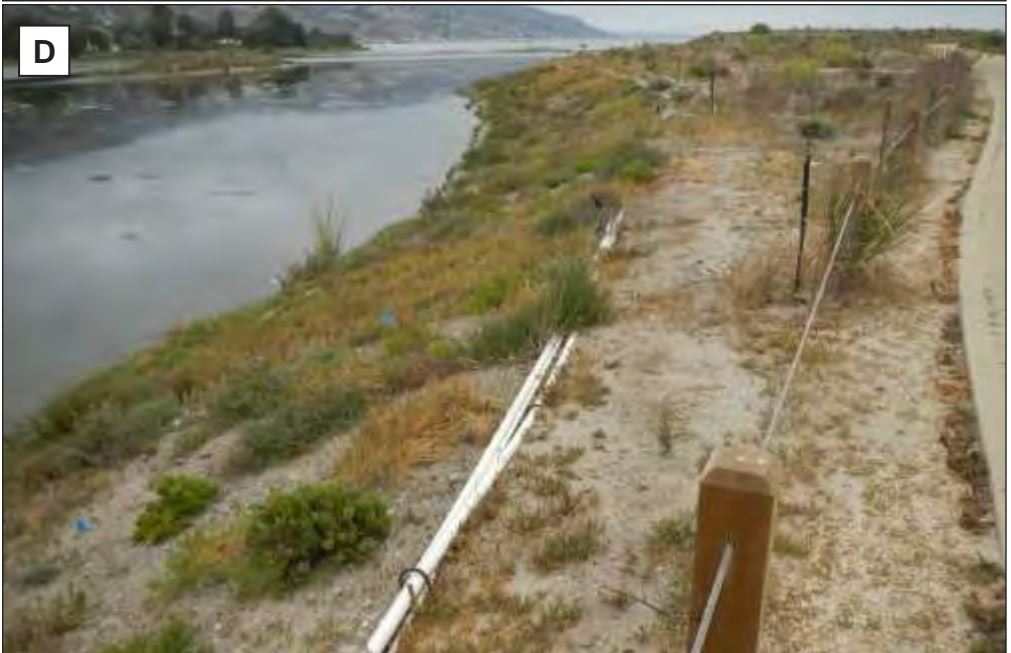
Figure 89. Photo Point 2 at bearing 75° on (A) 15 March 2013; (B) 7 May 2014; (C) 18 December 2014; (D) 5 May 2015.

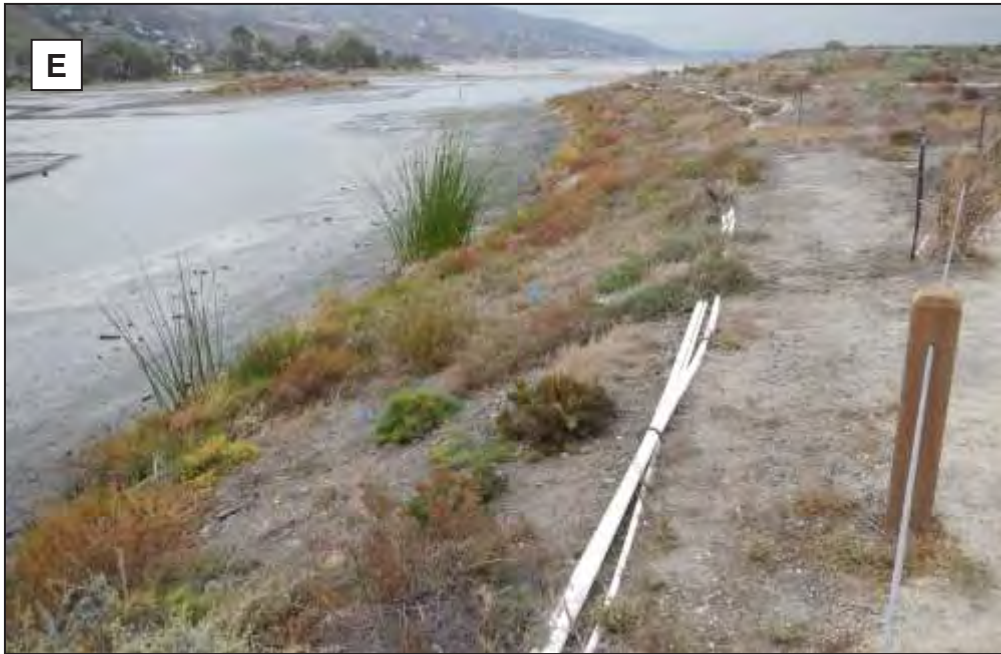
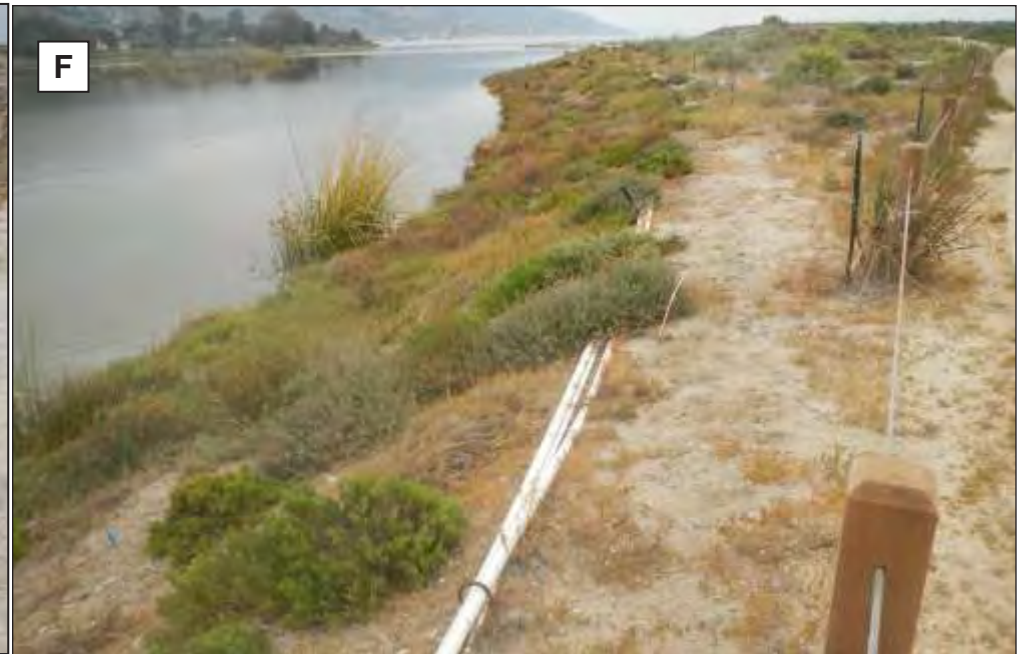
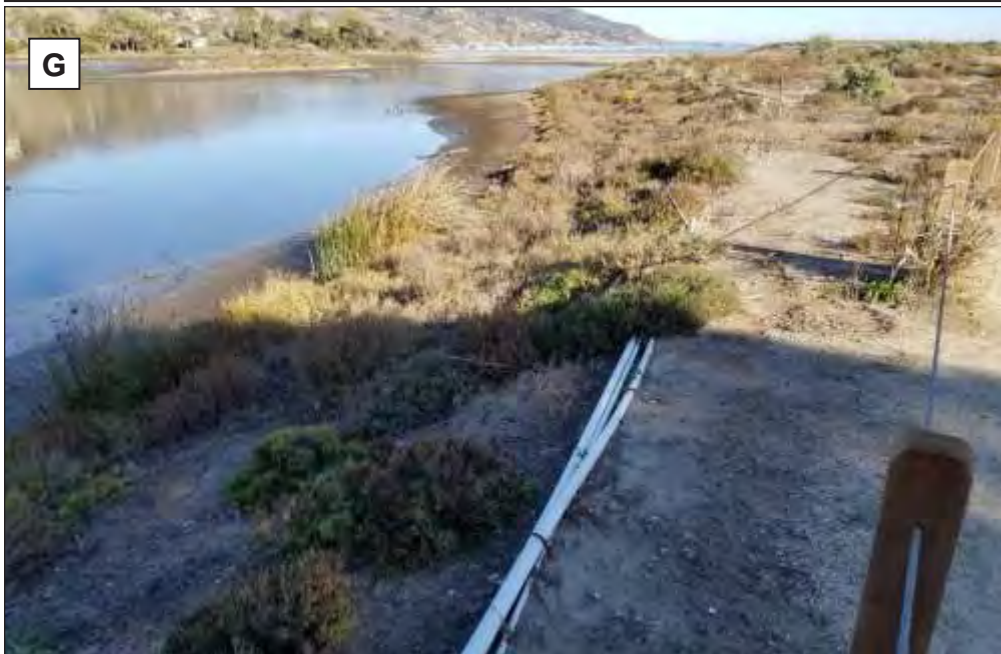
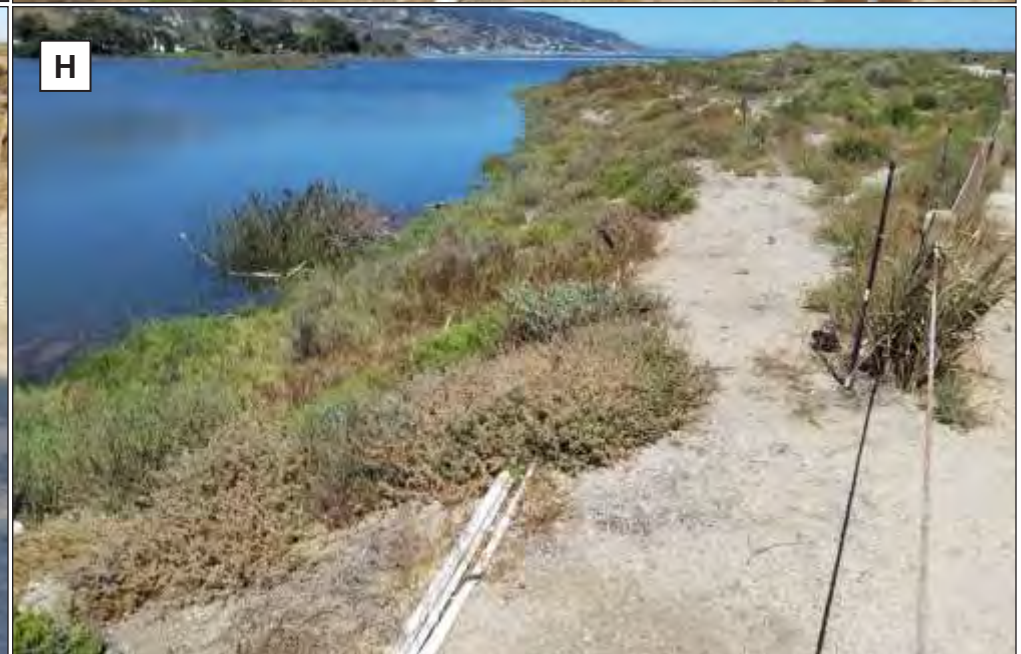
Figure 89 (continued). Photo Point 2 at bearing 75° on (E) 22 December 2015; (F) 16 May 2016; (G) 27 December 2016; (H) 27 June 2017.

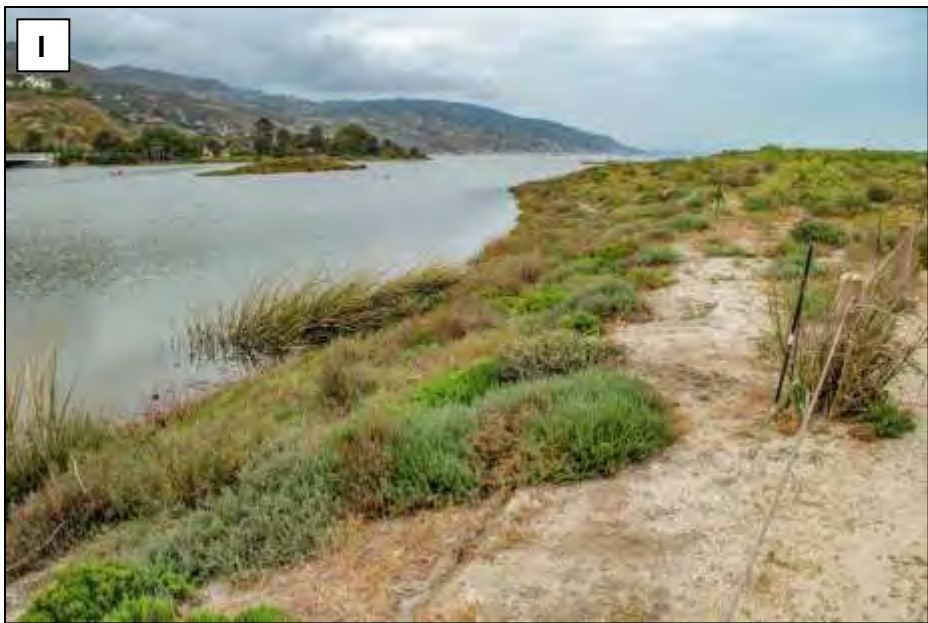
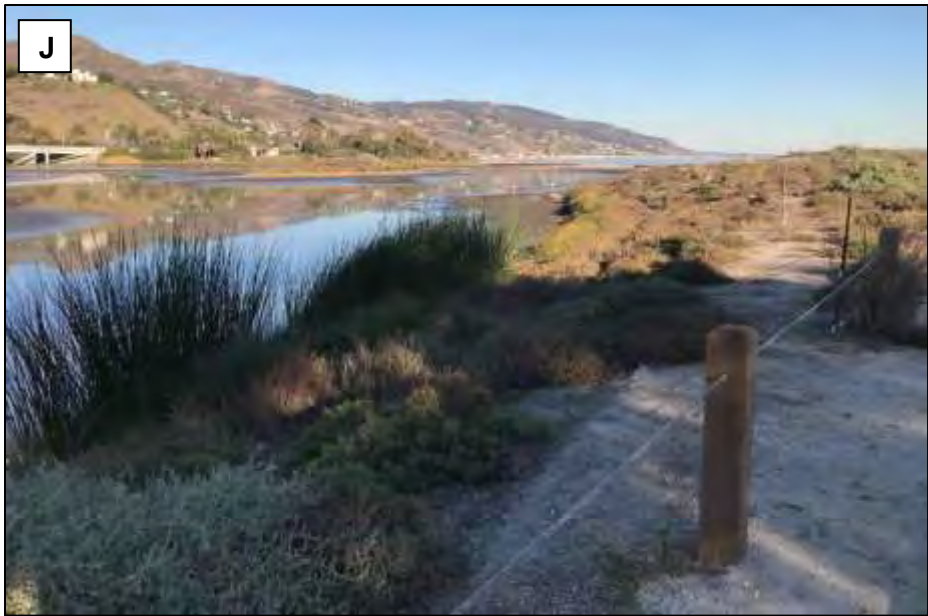
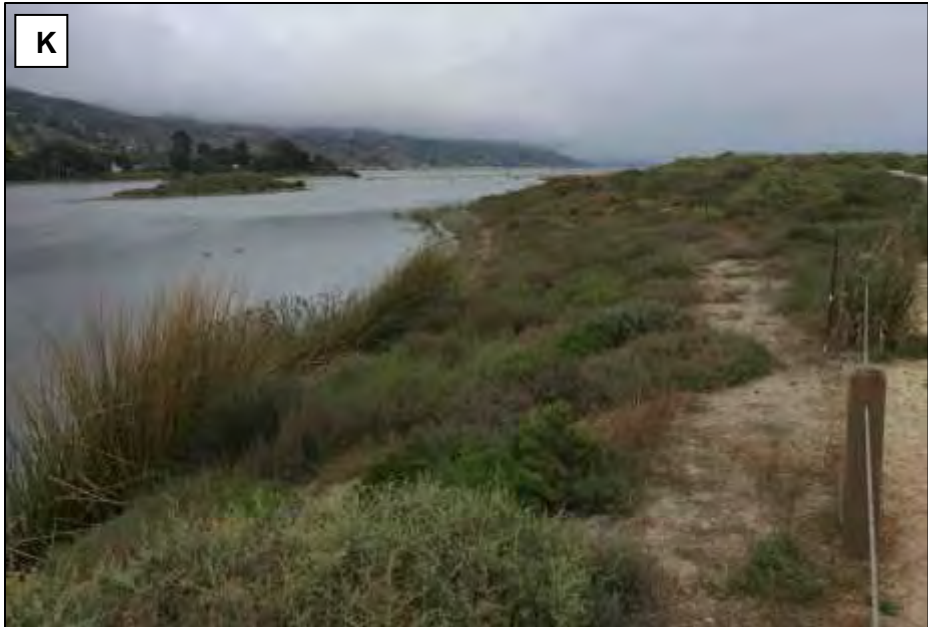
Figure 89 (continued). Photo Point 2 at Bearing 75° on (I) 23 May 2018; (J) 4 December 2018; (K) 25 June 2019.

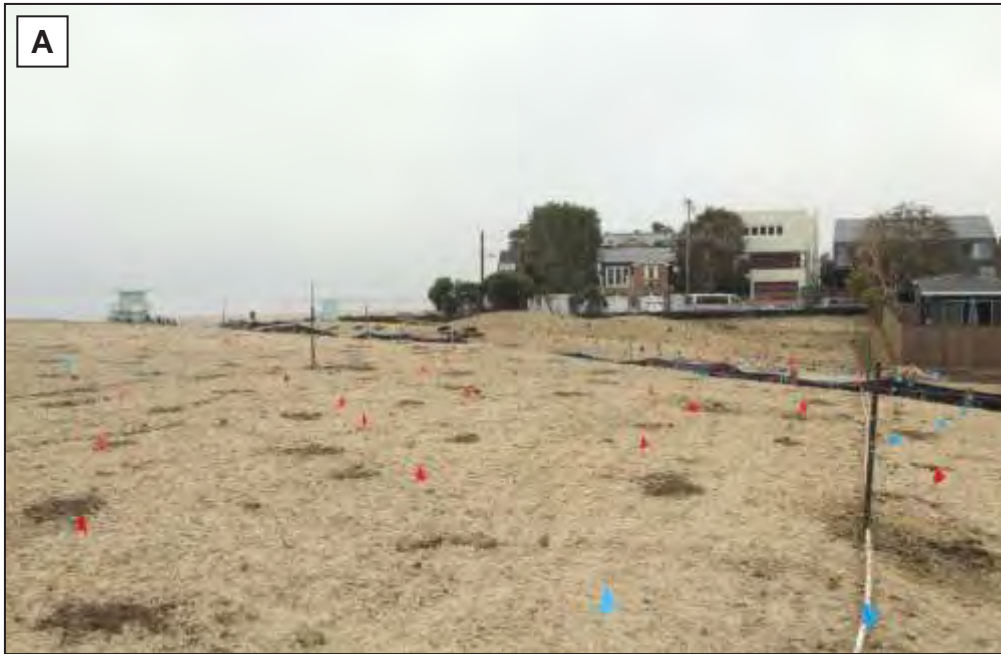
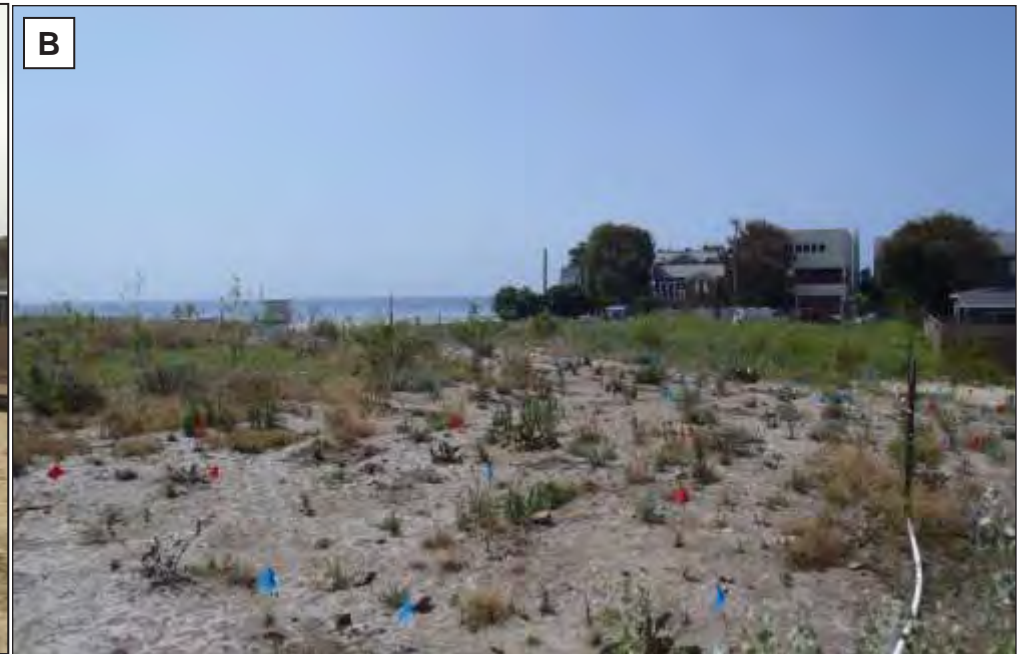
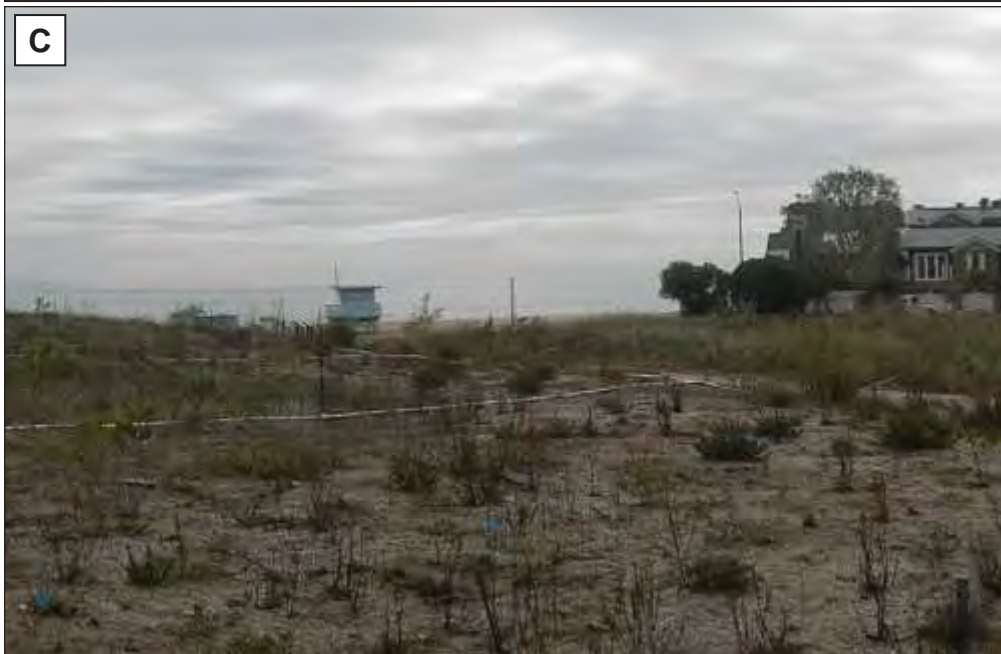
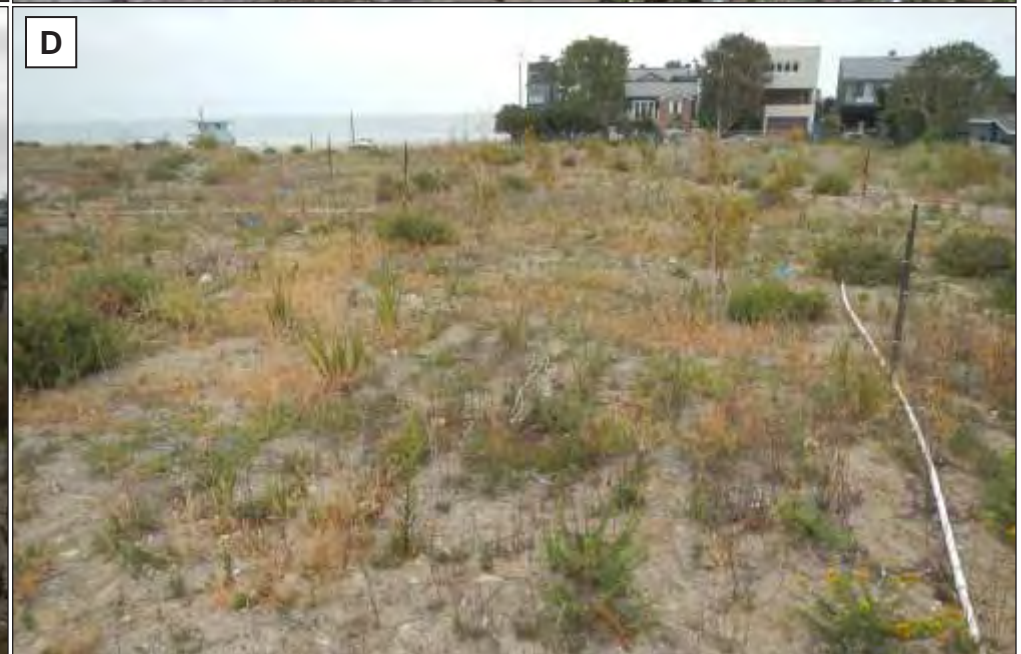
Figure 90. Photo Point 3 at bearing 220° on (A) 15 March 2013; (B) 7 May 2014; (C) 18 December 2014; (D) 5 May 2015.

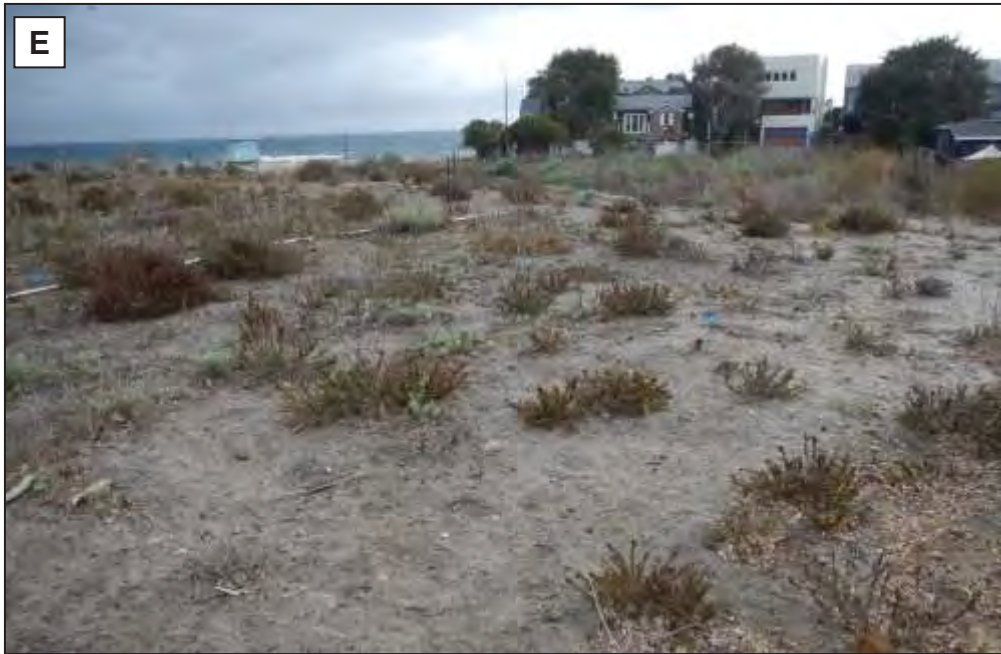
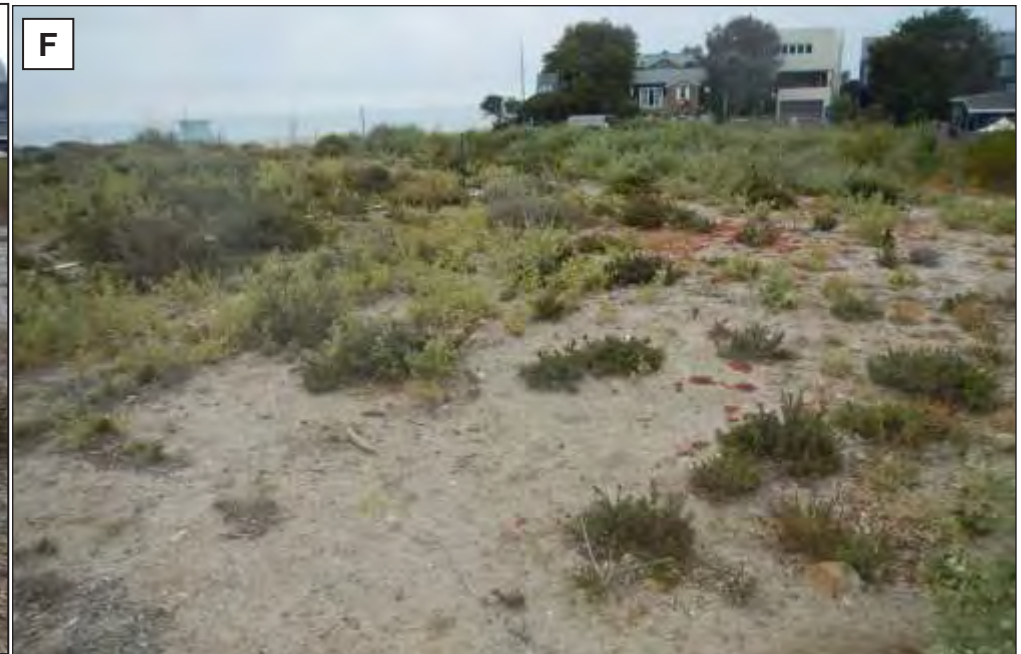
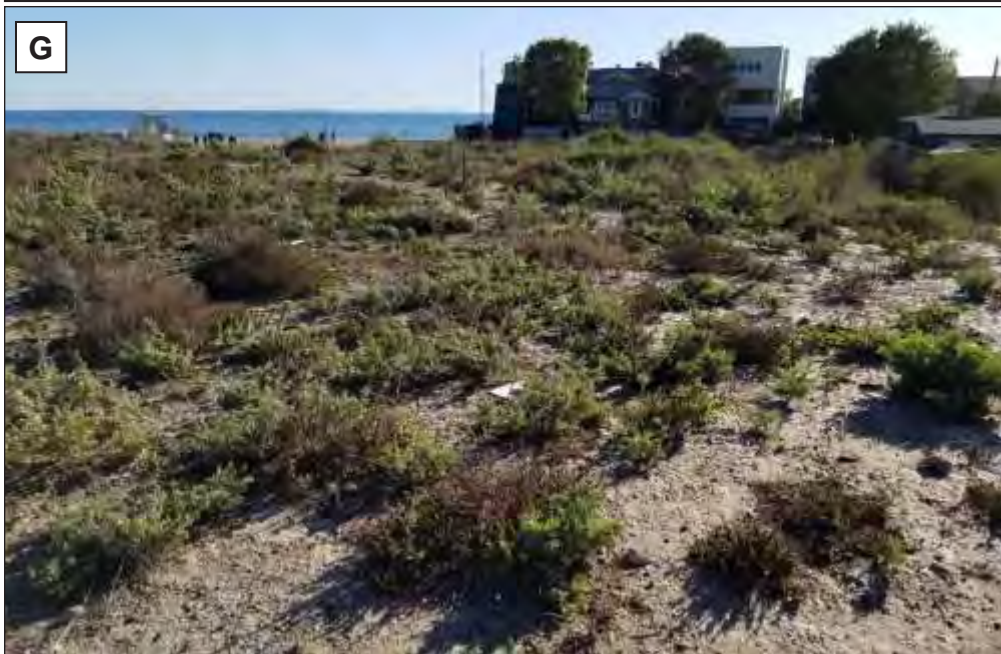
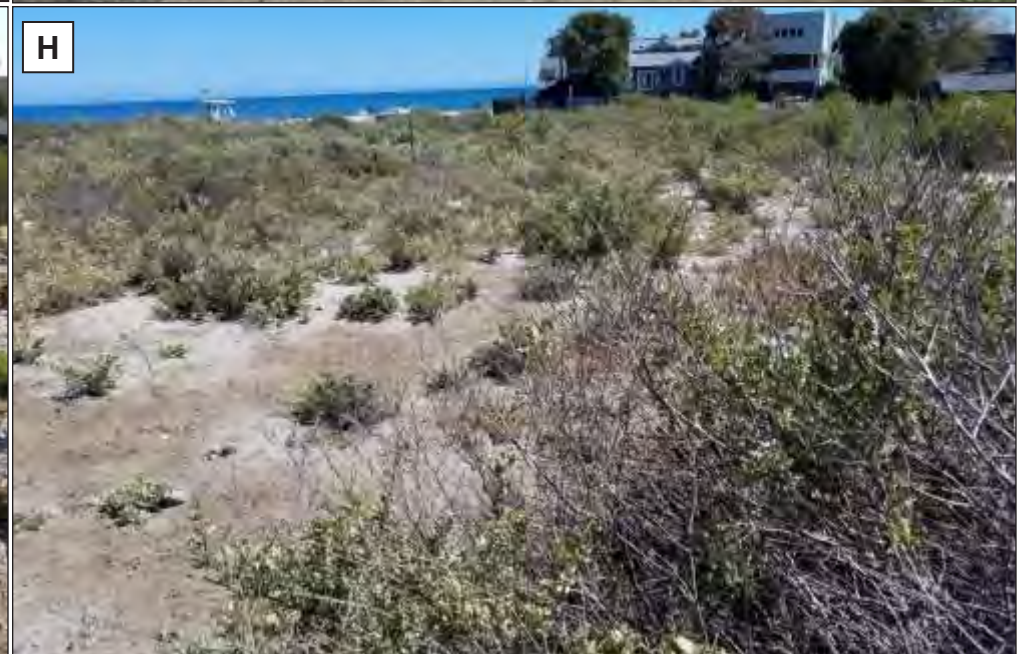
Figure 90 (continued). Photo Point 3 at bearing 220° on (E) 22 December 2015; (F) 16 May 2016; (G) 27 December 2016; (H) 27 June 2017.

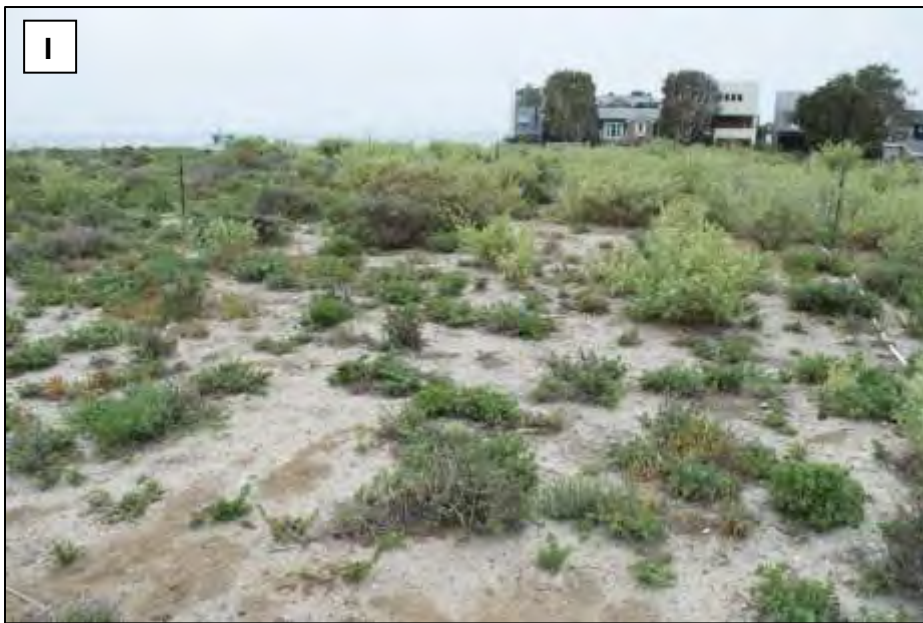
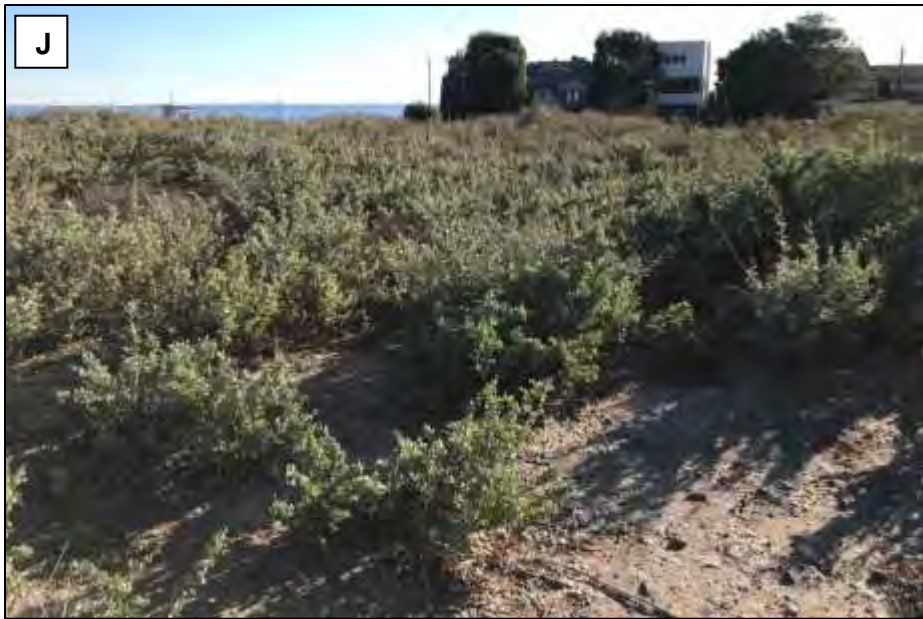
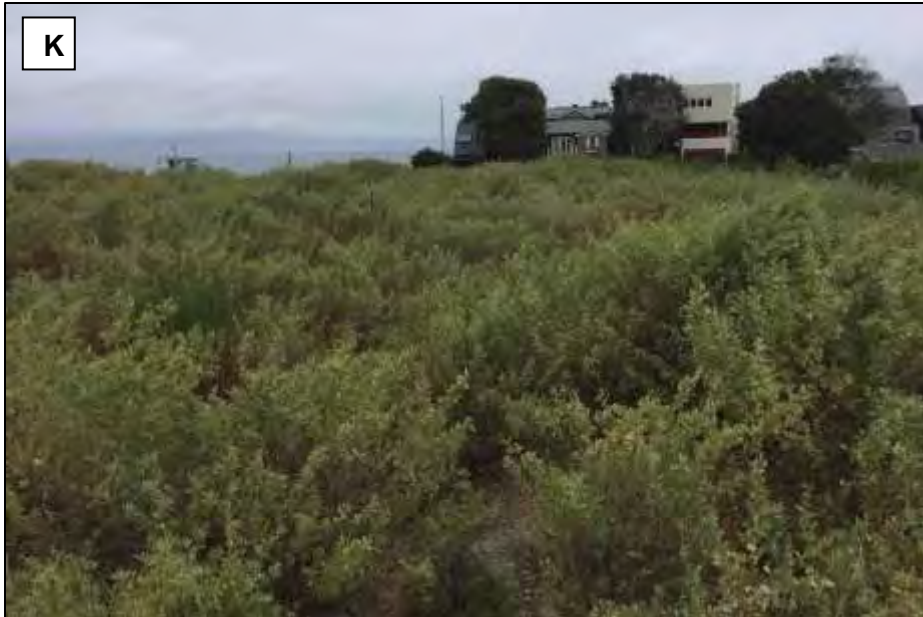
Figure 90 (continued). Photo Point 3 at Bearing 220° on (I) 23 May 2018; (J) 4 December 2018; (K) 25 June 2019.

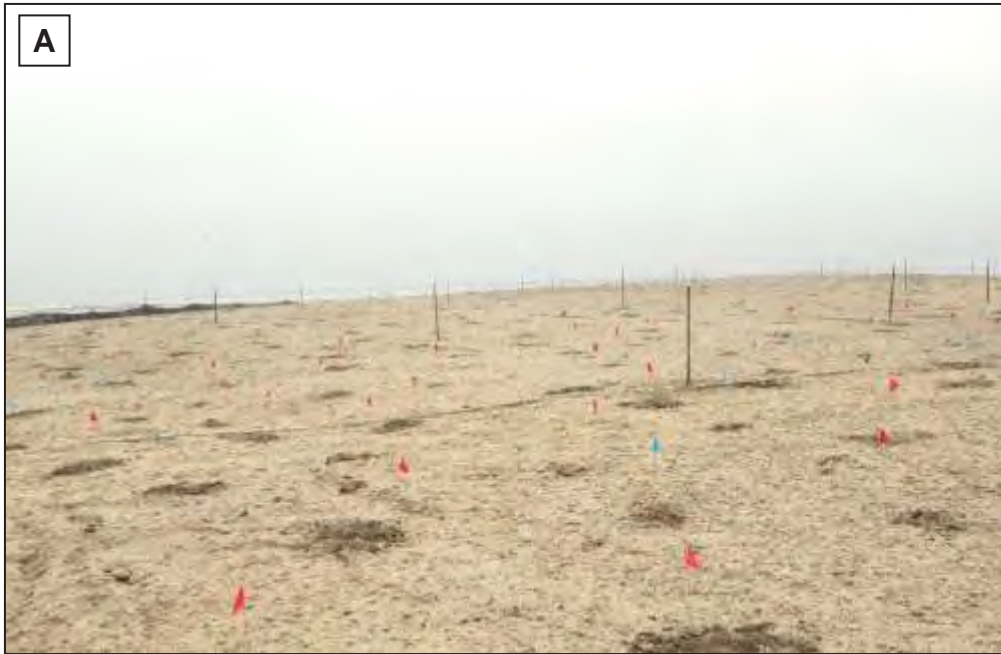
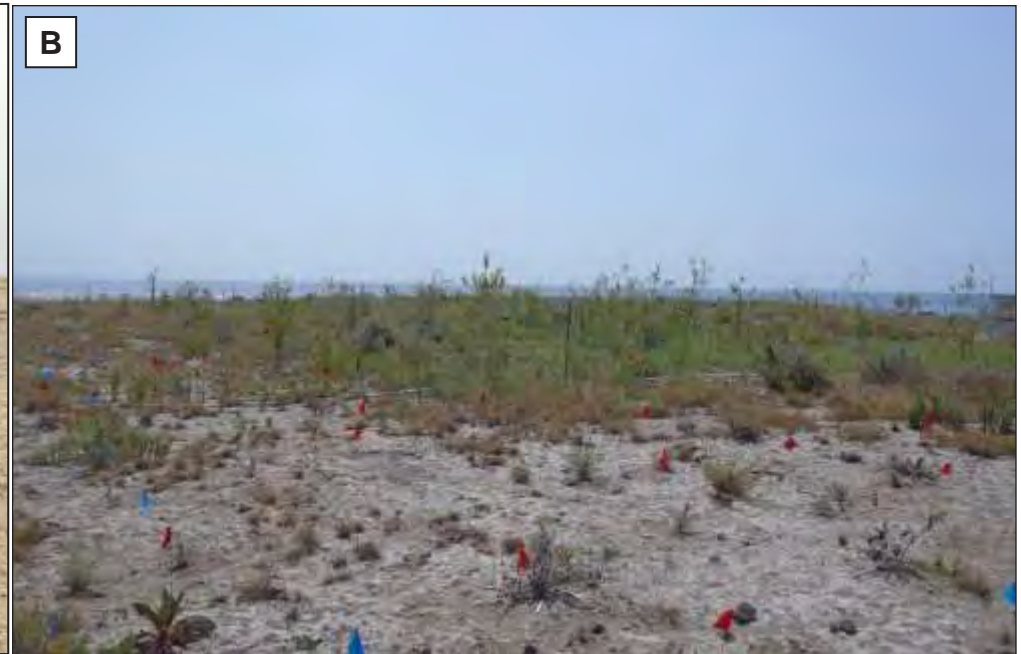
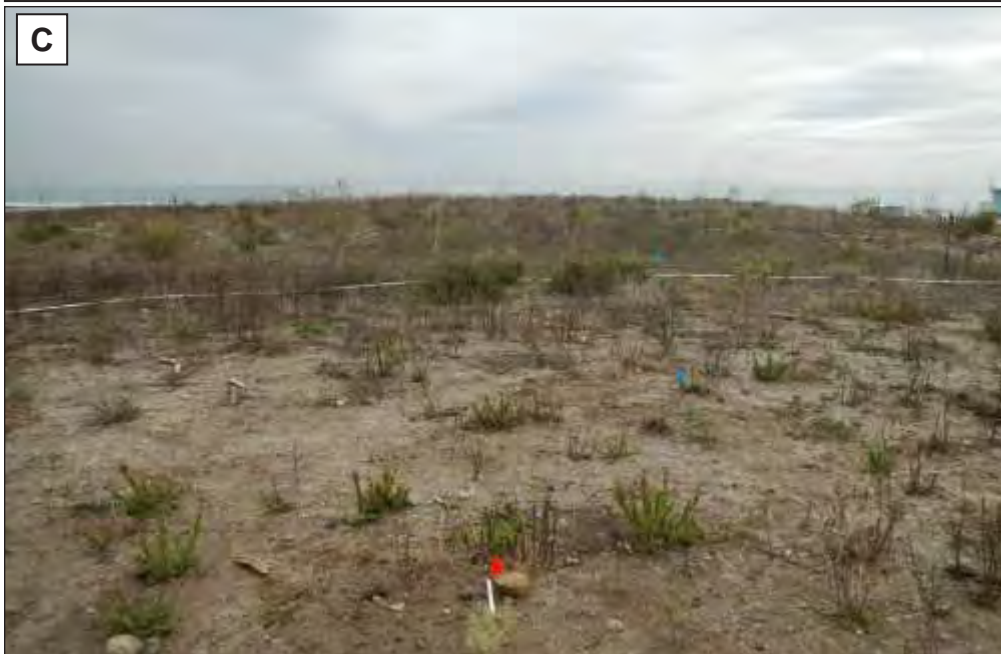
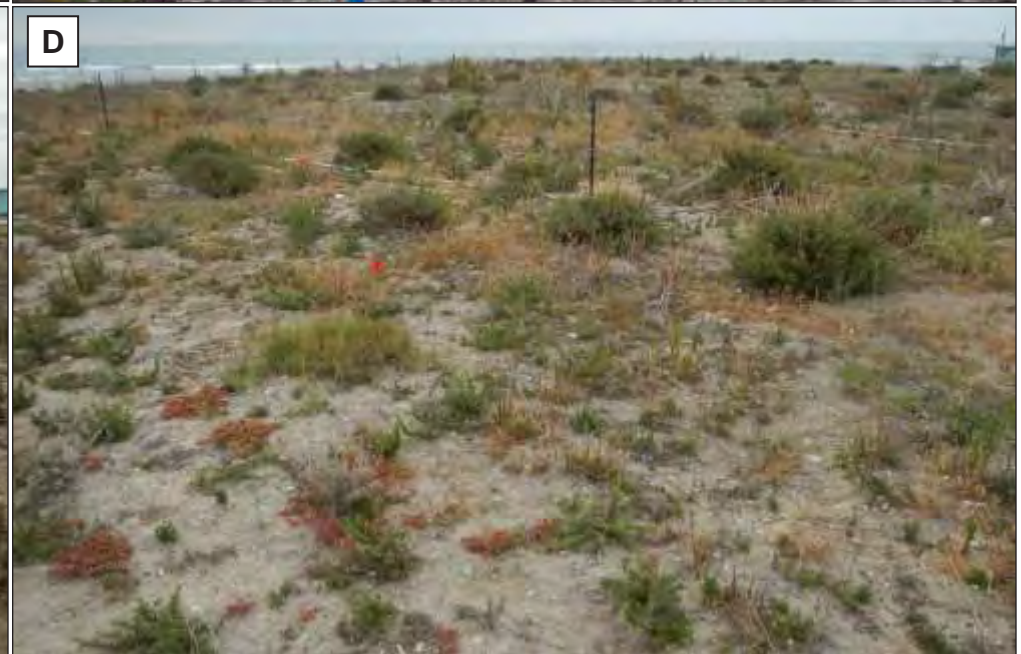
Figure 91. Photo Point 3 at bearing 100° on (A) 15 March 2013; (B) 7 May 2014; (C) 18 December 2014; (D) 5 May 2015.

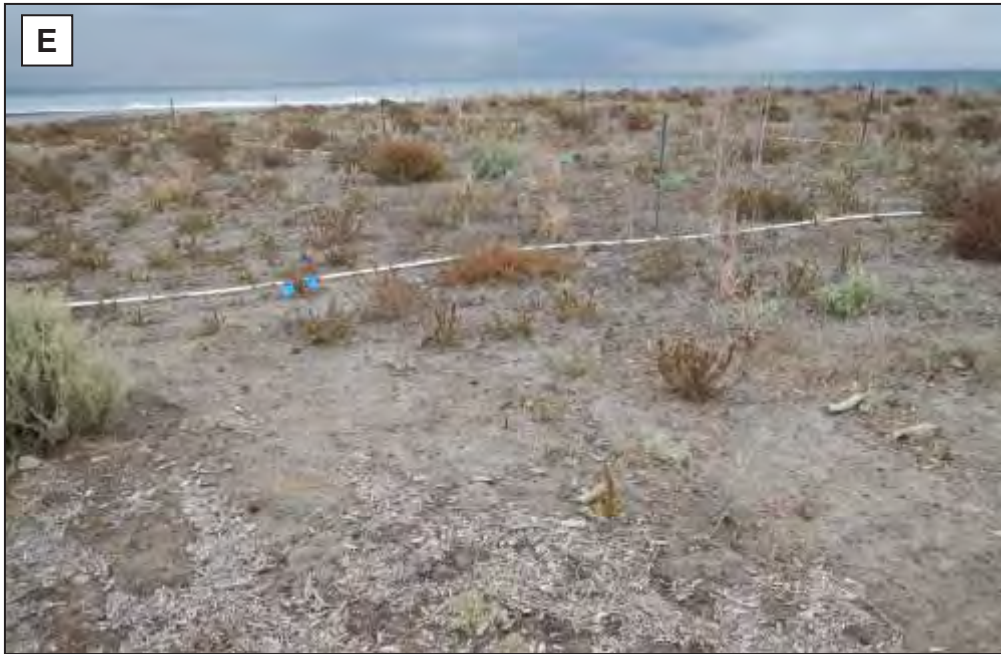
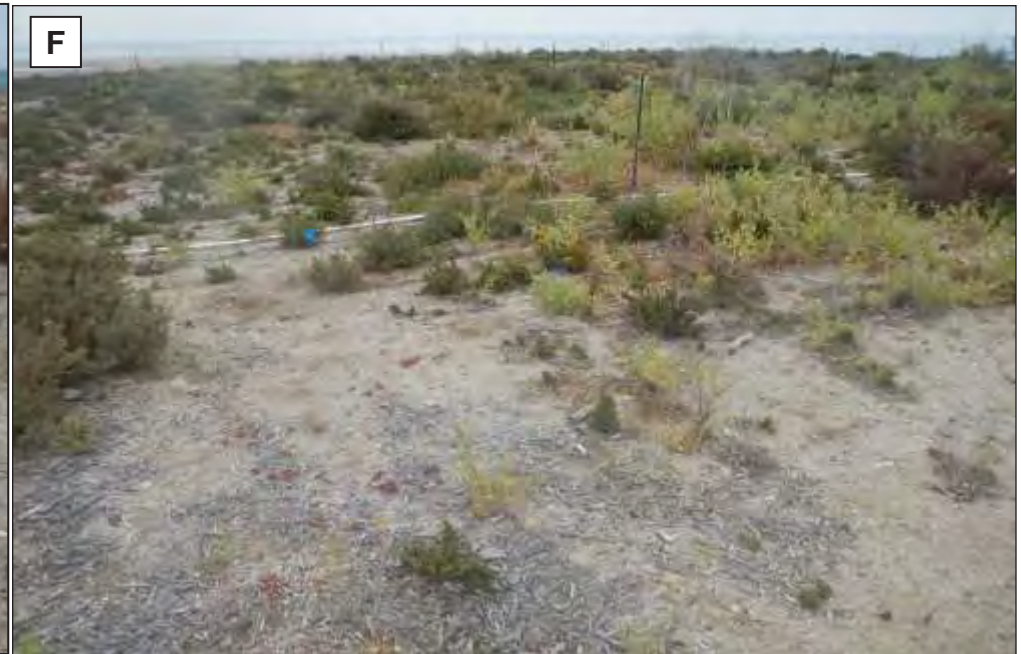
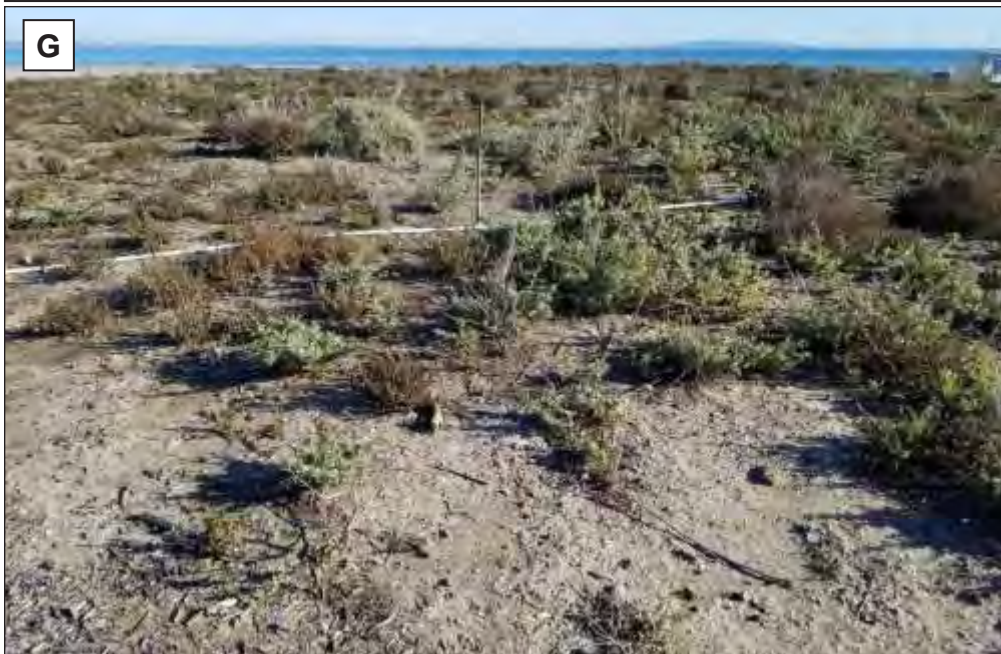
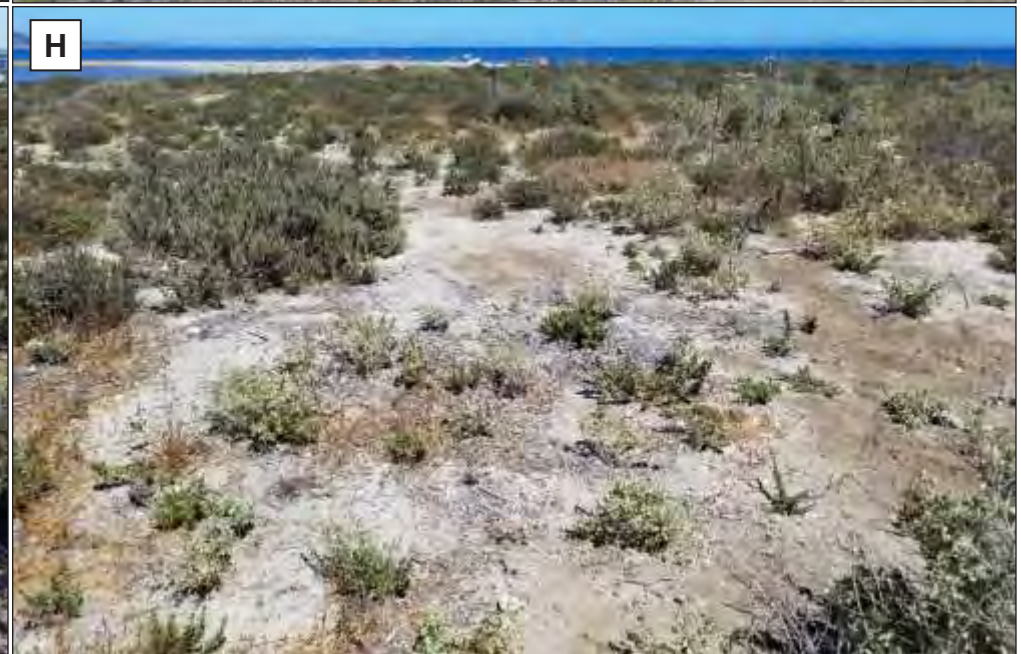
Figure 91 (continued). Photo Point 3 at bearing 100° on (E) 22 December 2015; (F) 16 May 2016; (G) 27 December 2016; (H) 27 June 2017.

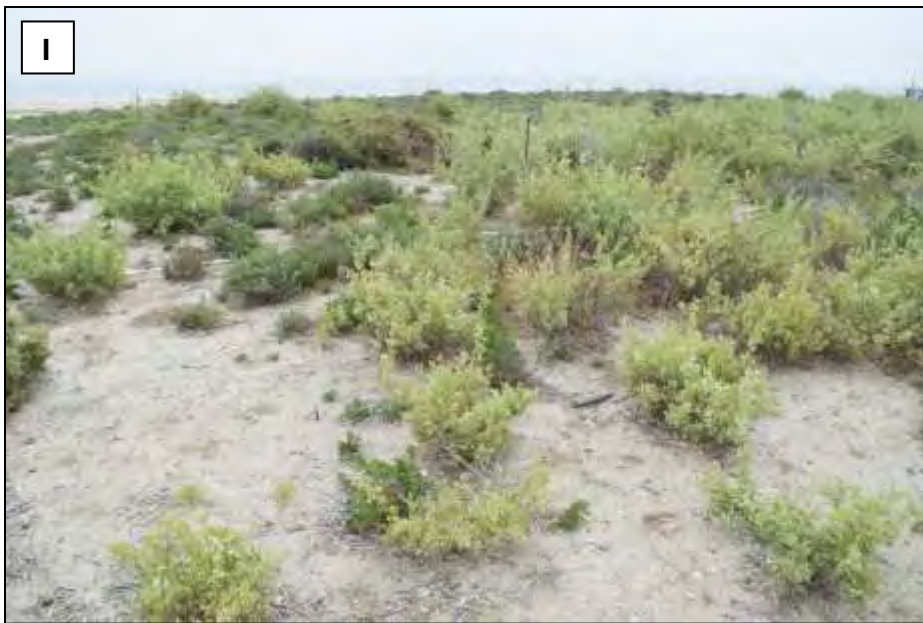
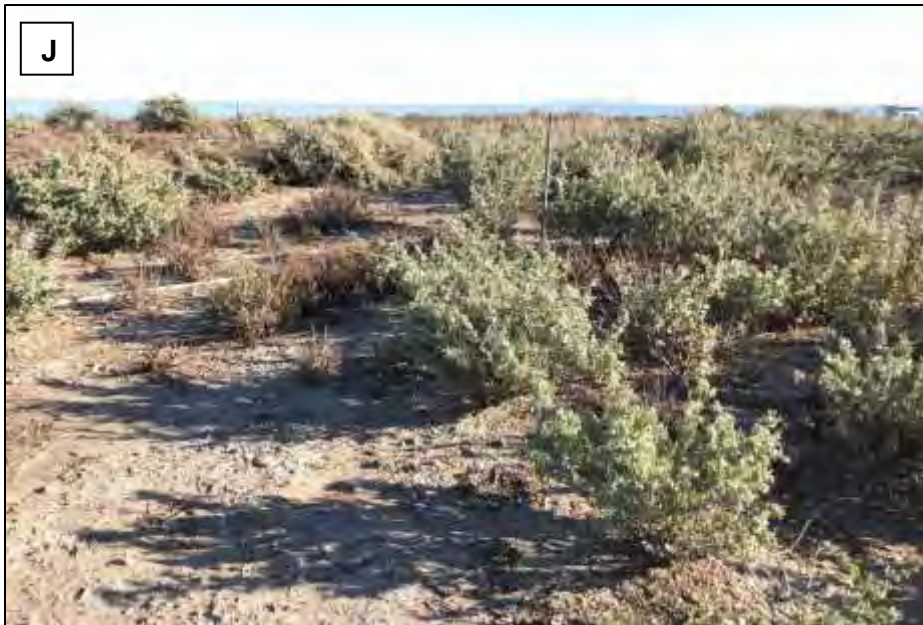
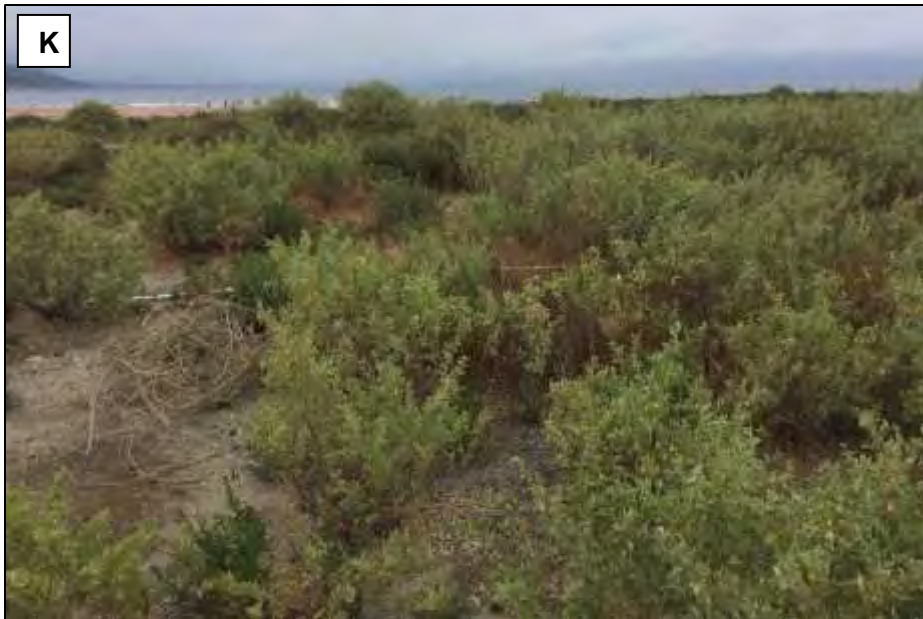
Figure 91 (continued). Photo Point 3 at Bearing 100° on (I) 23 May 2018; (J) 4 December 2018; (K) 25 June 2019.

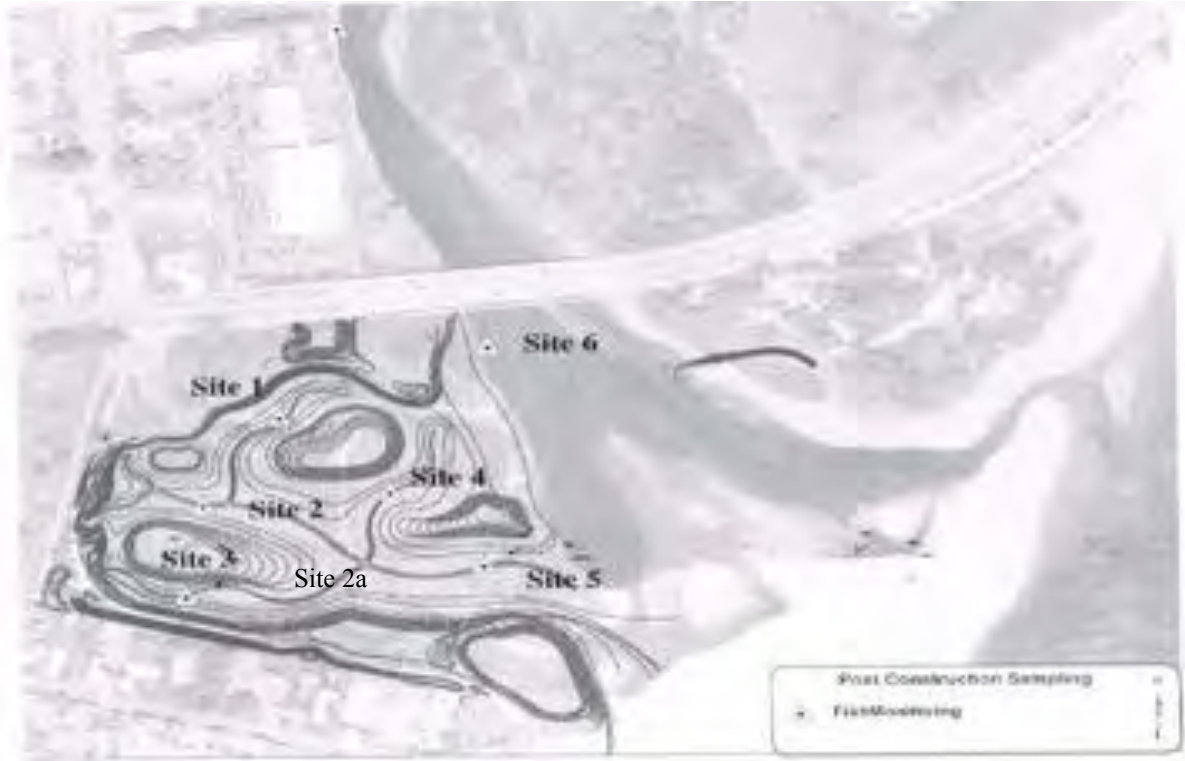
Figure 1. Map of the Permanent Monitoring Sites, Malibu Lagoon Restoration (Established in January 2013 and revised in May 2014)

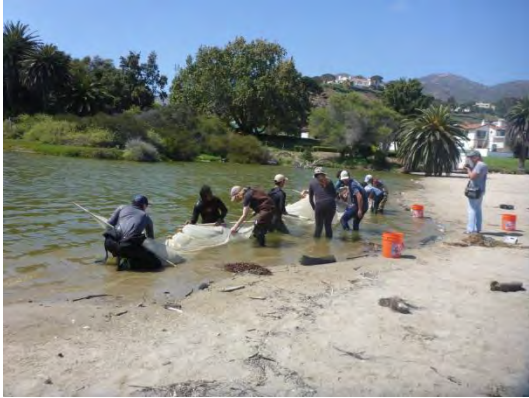
**Spot seine near beach face
close to breach location**

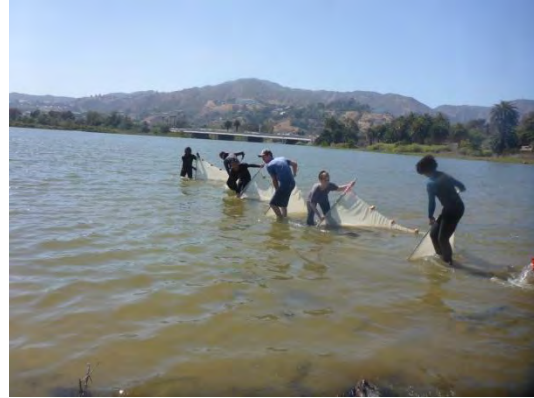
**Spot seine along berm
between breach point and
nesting habitat**
