Malibu Lagoon Restoration and Enhancement Project

Final Comprehensive Monitoring Report (Year 6)

August 2019

Prepared by: The Bay Foundation (TBF)

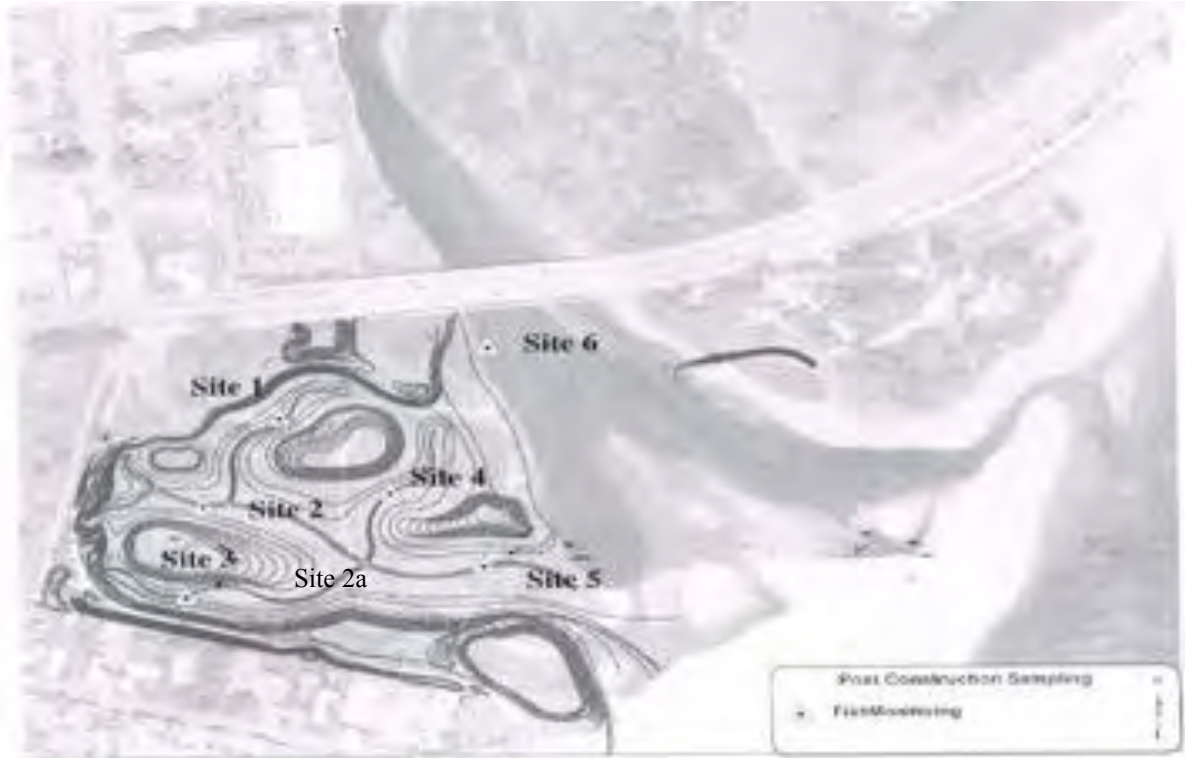
Figure 1. Map of the Permanent Monitoring Sites, Malibu Lagoon Restoration (Established in January 2013 and revised in May 2014)

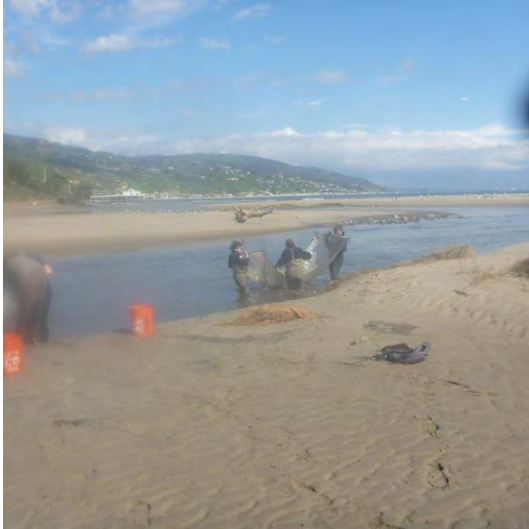
**Spot seine near beach face
close to breach location**

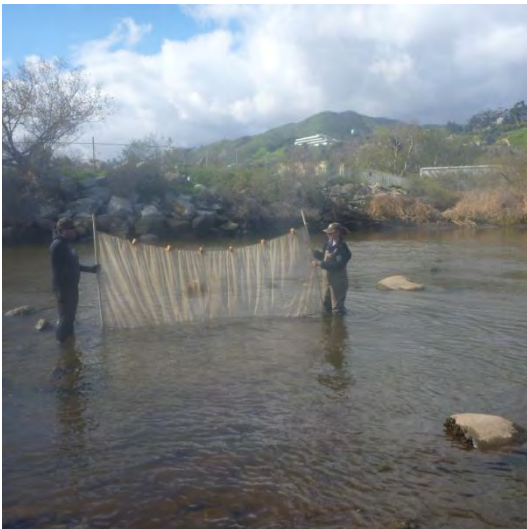
**Spot seine in main channel
at N end of parking lot near
drainage**

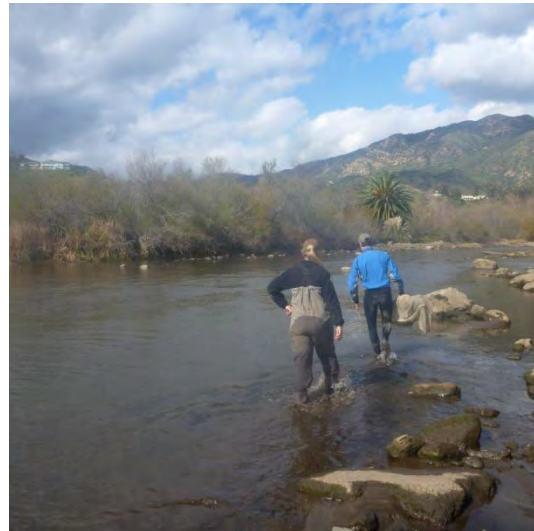
**Spot seine on eastern beach
upstream of PCH Bridge**

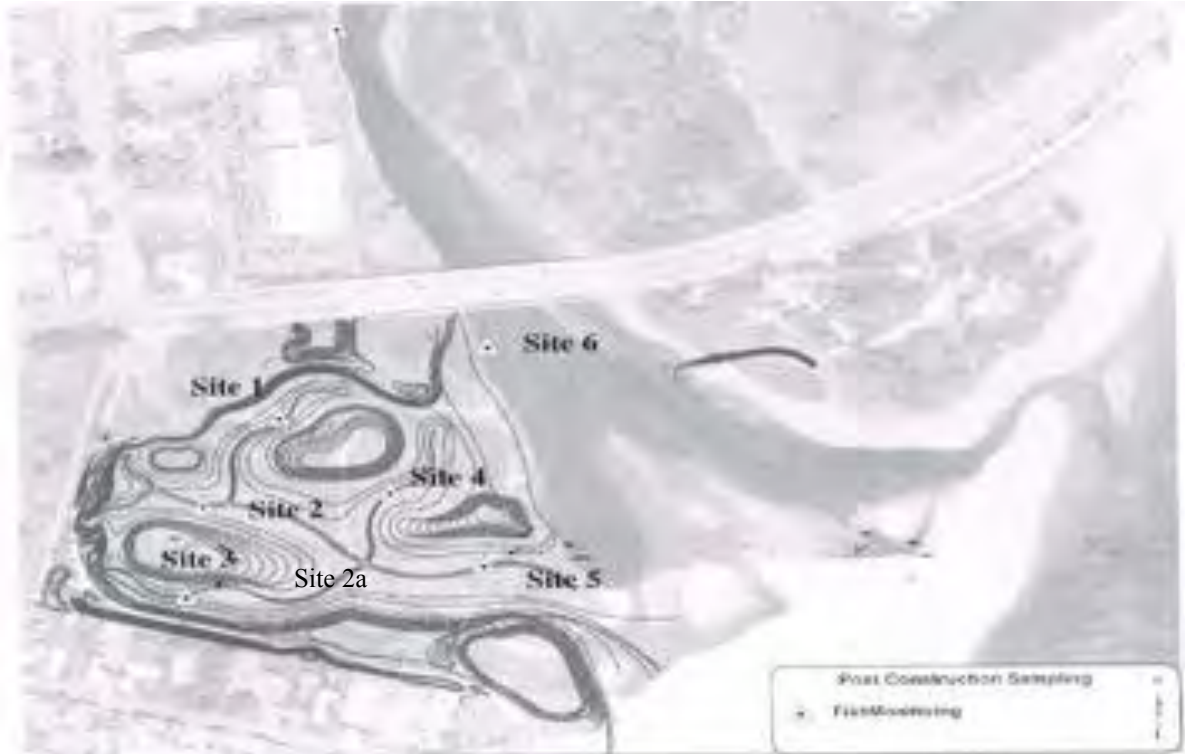
Figure 1. Map of the Permanent Monitoring Sites, Malibu Lagoon Restoration (established in January 2013 and revised in May 2014).

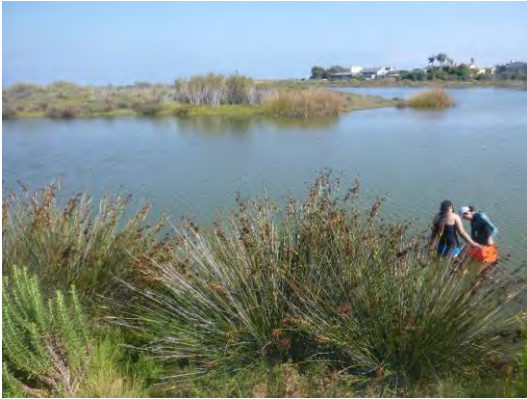
Site 1 (blocking nets missing)

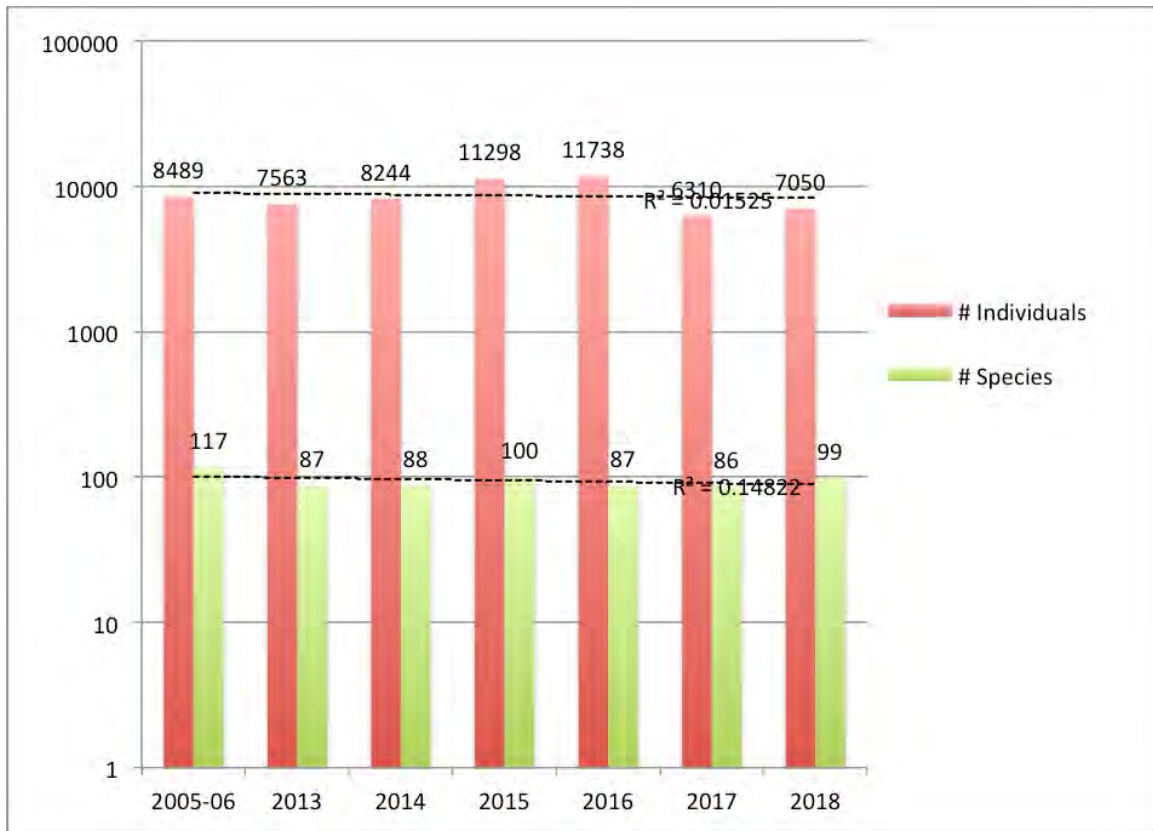
Figure 1. Total number of individuals vs. number of species on quarterly surveys at Malibu Lagoon, 2005-2018.

Overall, total counts of individuals and species on quarterly surveys show a slight negative trend from pre-restoration conditions (Figure 1), though this is likely insignificant⁶ and complicated by the fact that there was just one year of pre-restoration surveys, during 2005-06. The cumulative number of species and identifiable subspecies detected across all years of quarterly surveys was 172⁷, but only 85-100 species were recorded each year, illustrating the high inter-annual variability of species detected on these survey (Figure 1). Site-wide species richness, which dropped in the first two years post-restoration (117 species, to 87 and 88, respectively), rebounded somewhat by 2015 and 2018 (100 and 99 species, resp.). However, as noted above, these comparisons of sheer numbers and species totals is of limited interpretive use, and these counts should not be treated as statistically significant, since they are based on so few visits. Rather, they should simply be used to detect possible trends, which can be confirmed in future years and further analysis⁸.
