Santa Monica Beach Restoration Pilot Project

Year 3 Annual Report

September 2019

Prepared by: The Bay Foundation

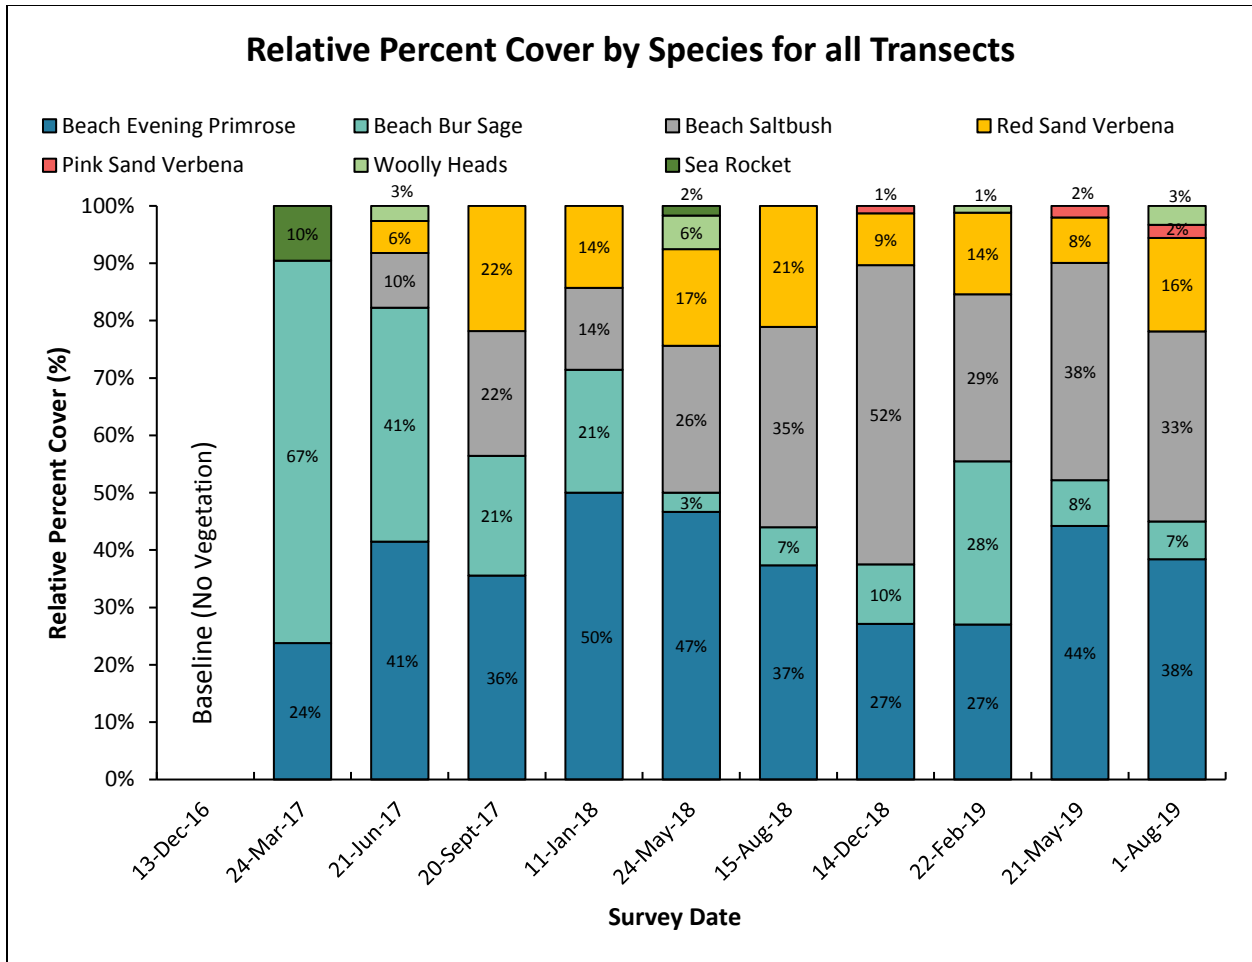
Figure 15. Relative percent cover by species for all transects (live vegetation only, 13-Dec-16 was baseline survey with no vegetation identified).

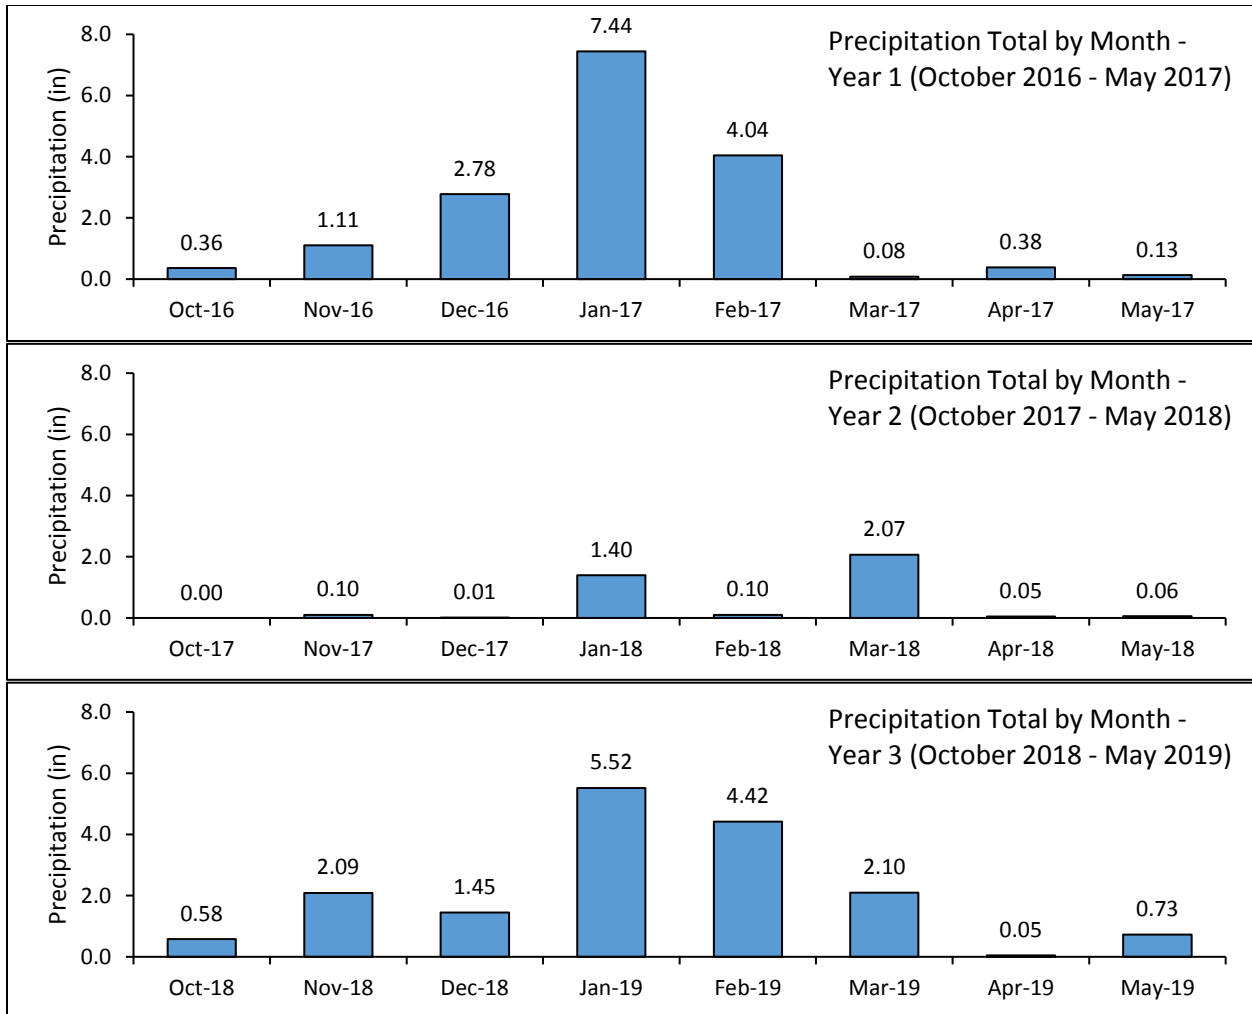
Figure 27. Monthly precipitation totals (inches) for the wet weather months (October-May). Daily precipitation data were downloaded from AccuWeather Premium and originally recorded at the LAX rain gauge.

The total rainfall for the wet weather months (October through May of the following year) was 16.32 inches during Year 1, 3.79 inches in Year 2, and 16.94 inches in Year 3, as measured by the Los Angeles International Airport (LAX) rain gauge (Figure 27). Year 2 had noticeably less precipitation than Years 1 and 3. Higher rainfall occurred in January during Years 1 and 3 (7.44 and 5.52 inches, respectively) and March of Year 2 (2.07 inches).

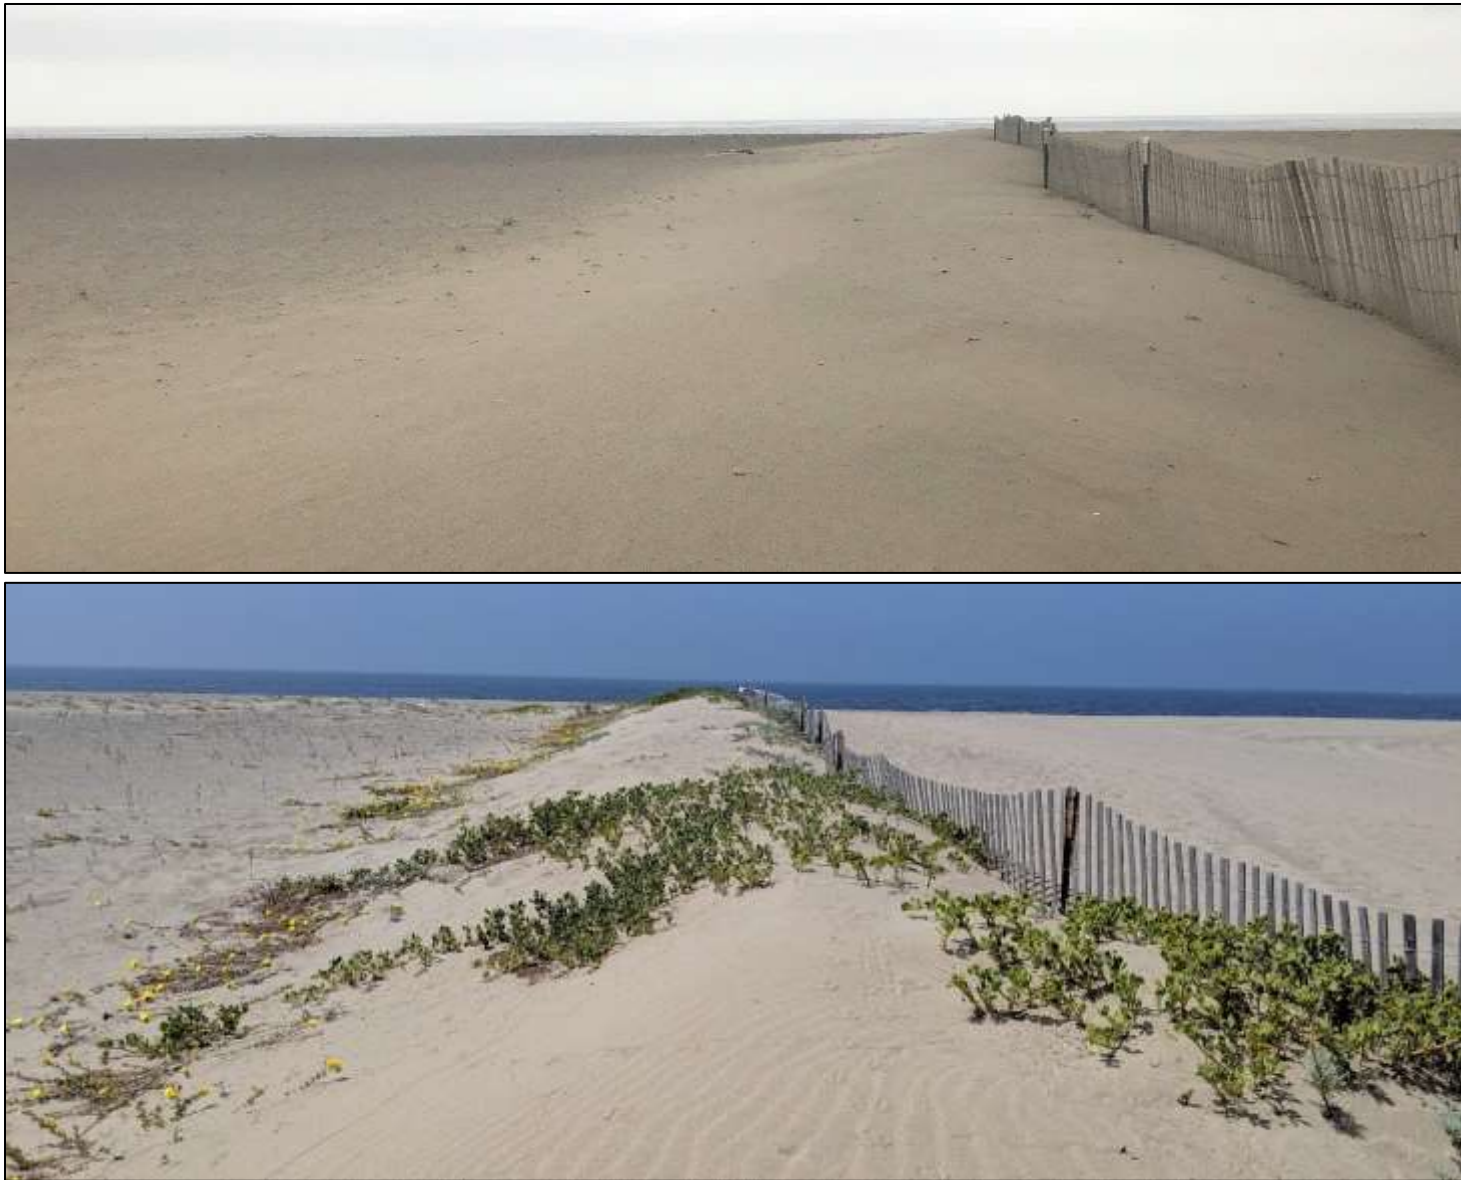
Figure 36. Photograph of sand build-up along the northern fence line in the restoration area (Top: 9 May 2017 and Bottom: 25 April 2019).

Figure 37 shows buildup of sand along the northern fence perimeter in May 2017 and again in April 2019, where an increase of vegetation, especially red sand verbena is present. Berm changes parallel to the ocean have also been observed in photographic documentation and monitoring data with seasonal variations present. The beach berm ridge is higher in elevation and more prominent in the restoration site. Figure 38 shows a time-series of the berm changes observed post-restoration. Additional surveys will continue to track the berm fluctuations over time. The continued rise in elevation of the berm in multiple elevation profiles and supporting topographical surveys indicate promising results that the site is potentially becoming more resilient to coastal flooding than other sections of the beach that retain a low, flat profile. Future surveys will continue to inform changes in the restoration site and berm morphology over time. Additional data may also provide the opportunity to begin modelling sea level rise scenarios under new restoration conditions compared to control sites.

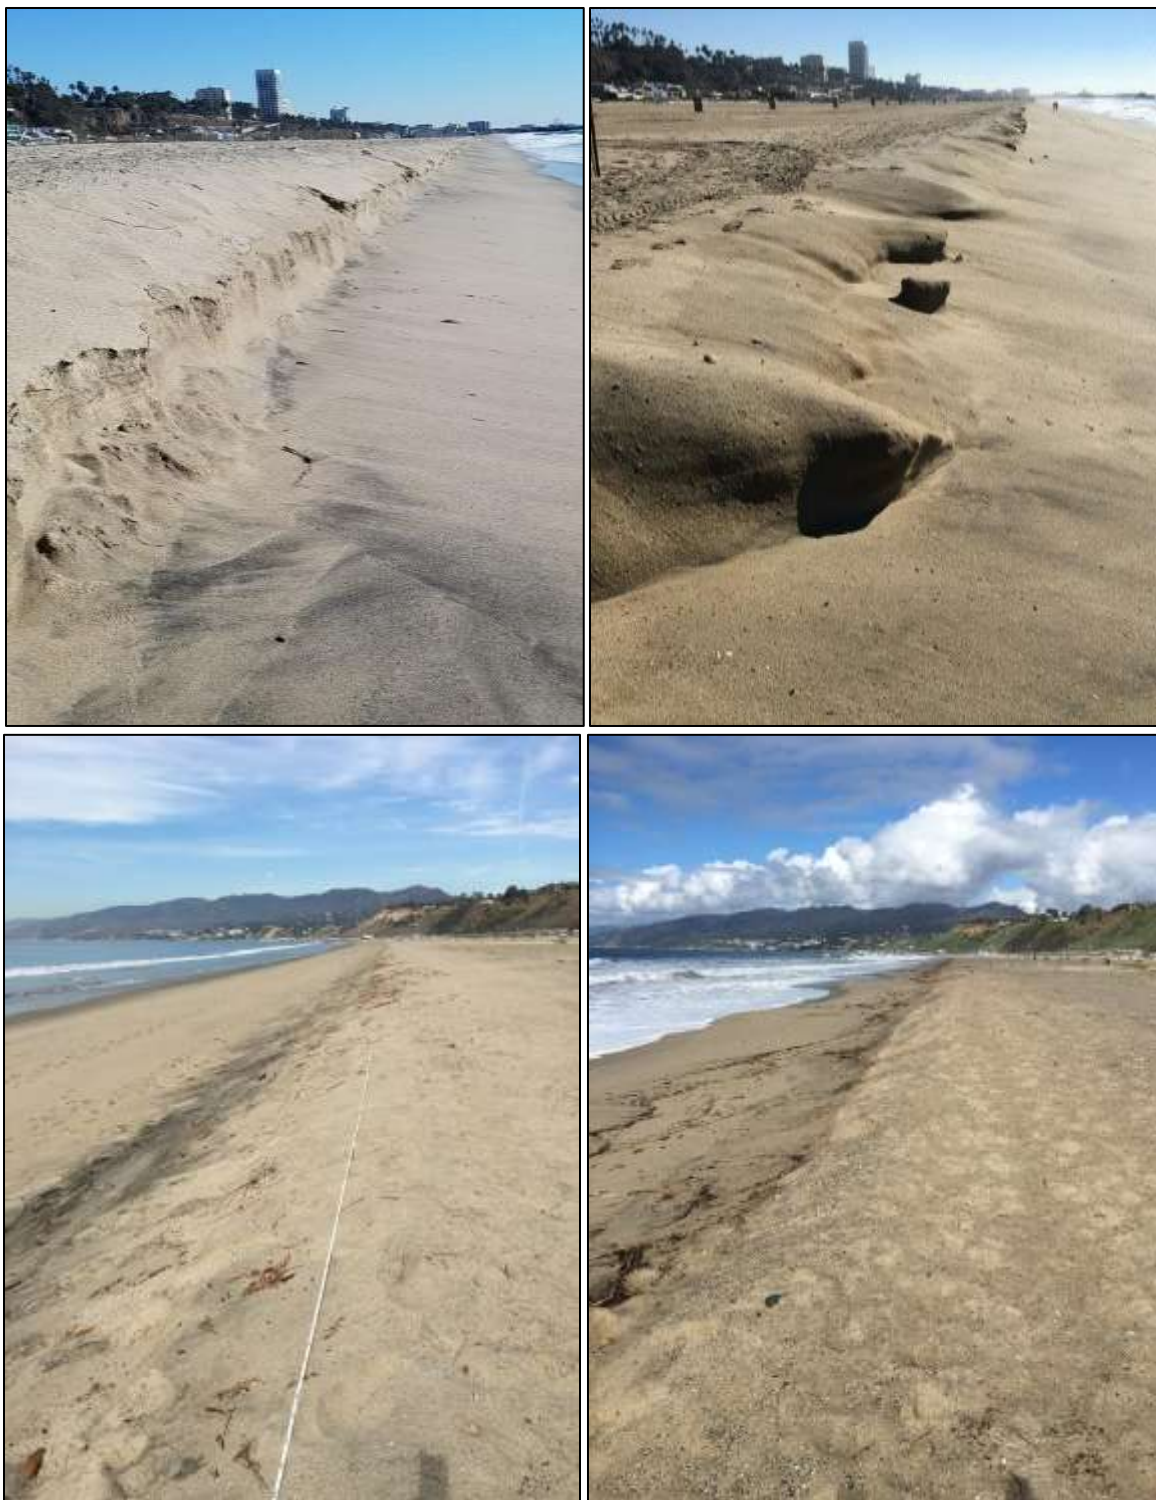
Figure 37. Berm topography (top left: 17 December 2016, top right: 25 January 2017, bottom left: 8 March 2018, and bottom right: 3 March 2019).

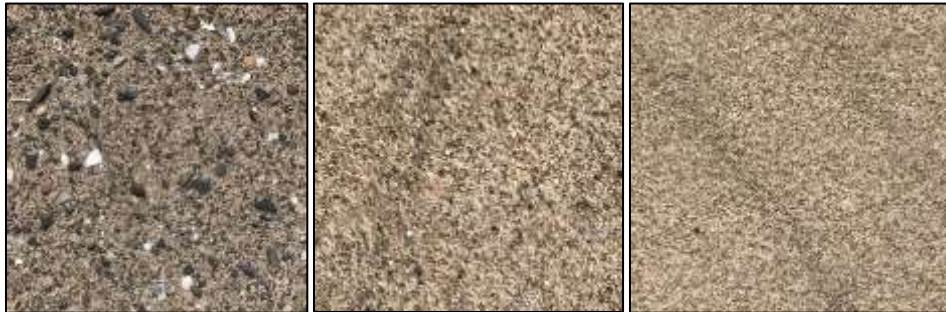
Figure 38. Sand grain in restoration site (left: pebbles; middle: coarse sand; right: medium to very fine sand).

Sand within the restoration site varied from pebbles (very fine) to very fine sand (Figure 38). Small dunes and plant hummocks were observed to form with larger sized sediment at the base of the hummocks and finer grain sizes on top due to wind driven transport (Figure 39). Dry sand samples collected (averaged for 15 and 30 m) saw variable trends between surveys, with a small increase in very coarse sand and pebble percent composition within the restoration area (Figure 40). The latest surveys in November 2018 and May 2019 shows that coarse sand continues to be the most dominate grain size type. Additional data over multiple survey years are necessary to confirm trends.

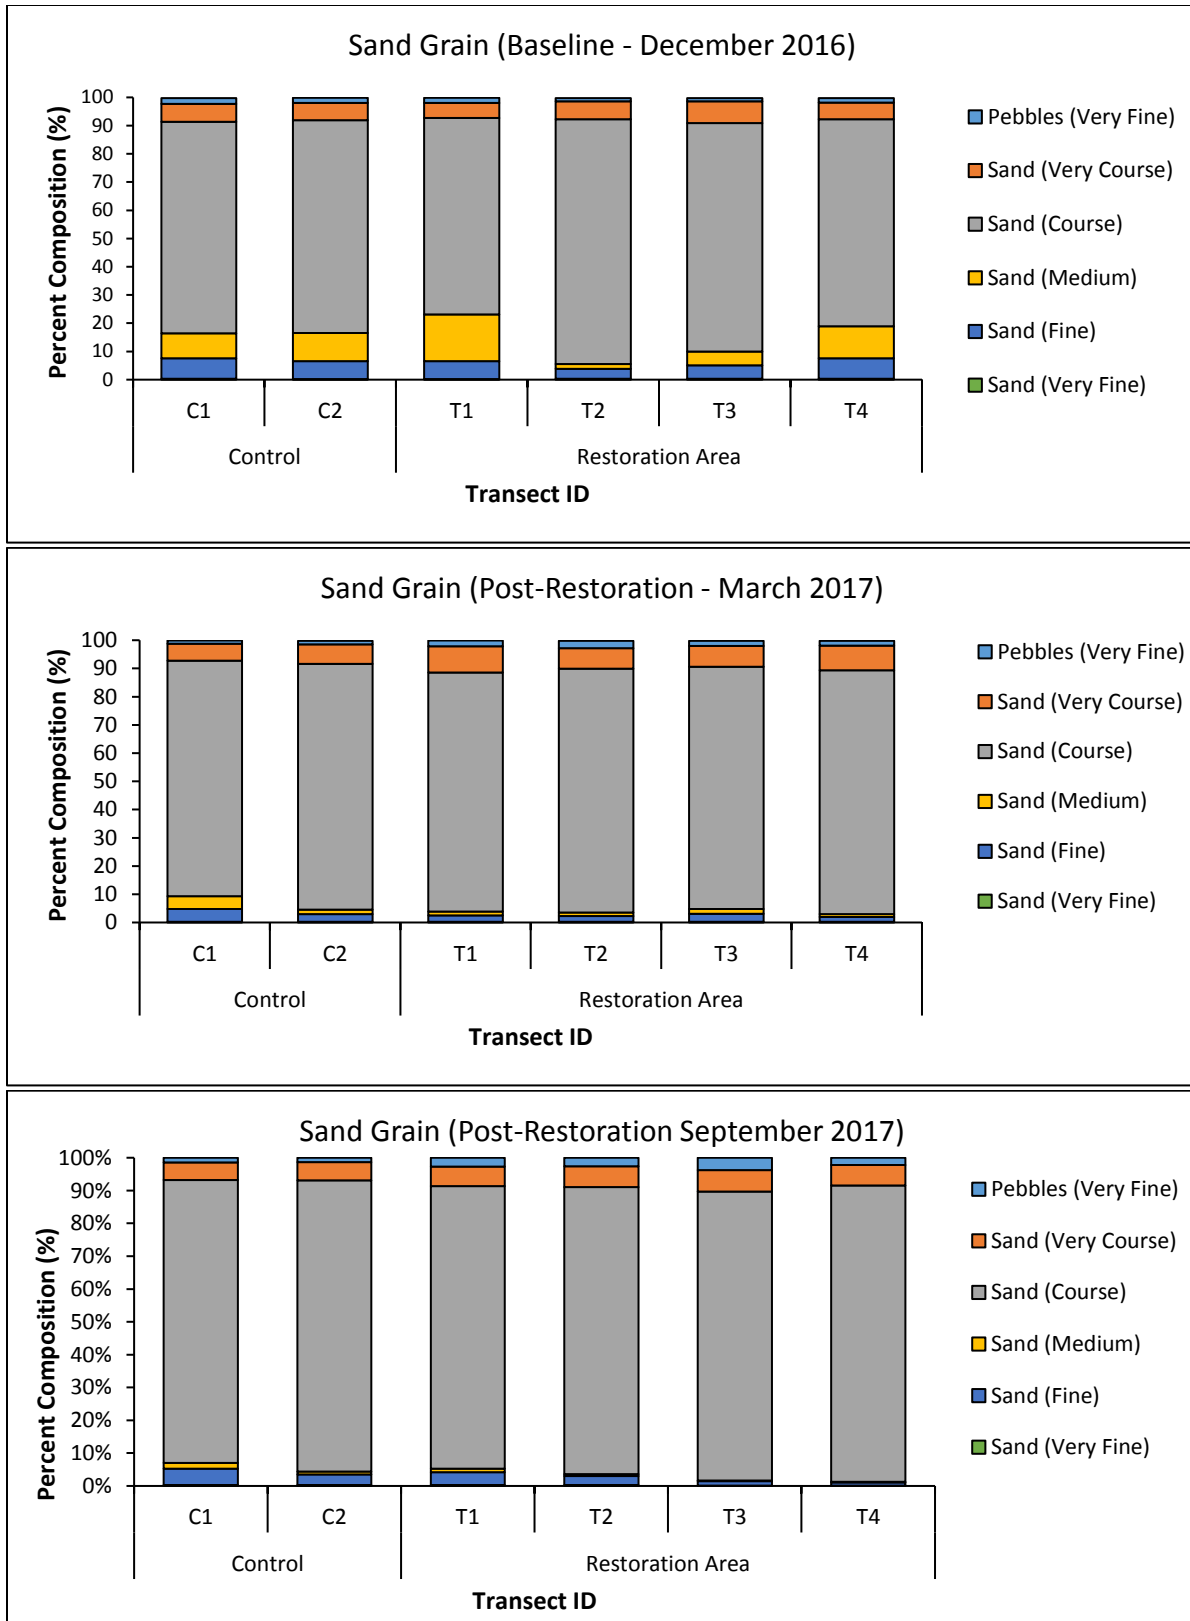
Figure 40. Baseline (top) followed by post-restoration sand grain results for all transects (dry sample averages).

Figure 40 (cont'd). Baseline (top) followed by post-restoration sand grain results for all transects (dry sample averages).

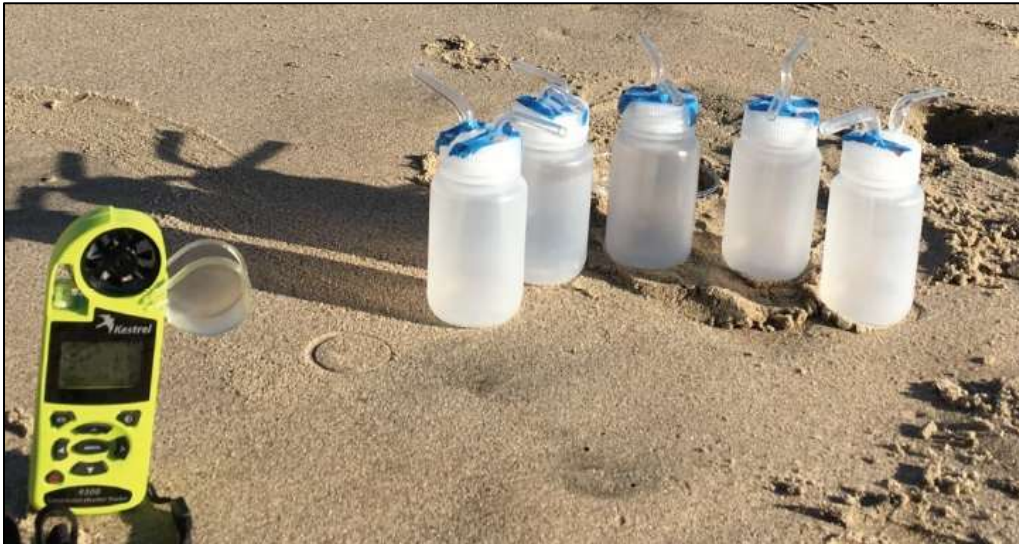
Figure 42. MWAC samplers deployed at restoration site.

Sand transport measurement protocols were attempted using Modified Wilson and Cooke (MWAC) samplers to determine actual in-field sand transport rates (Figure 42). MWAC samplers were deployed for 30 minutes to one hour on multiple field surveys and failed to collect sand. This protocol will continue to be attempted during future surveys, targeting high wind conditions to maximize sand collection success. Additionally, data collected in the field combined with sand grain analyses was used in an empirical model to calculate wind-blown sand transport (Hsu 1981). Hsu's calculations will provide a future method to cross-validate predictive wind-driven sand transport as compared to MWAC samplers for direct measurement. Observationally, a shift in coarser sand and cobble was seen in the restoration site towards the ocean, where high king tides over washed portions of the site during the winter (Figure 43).

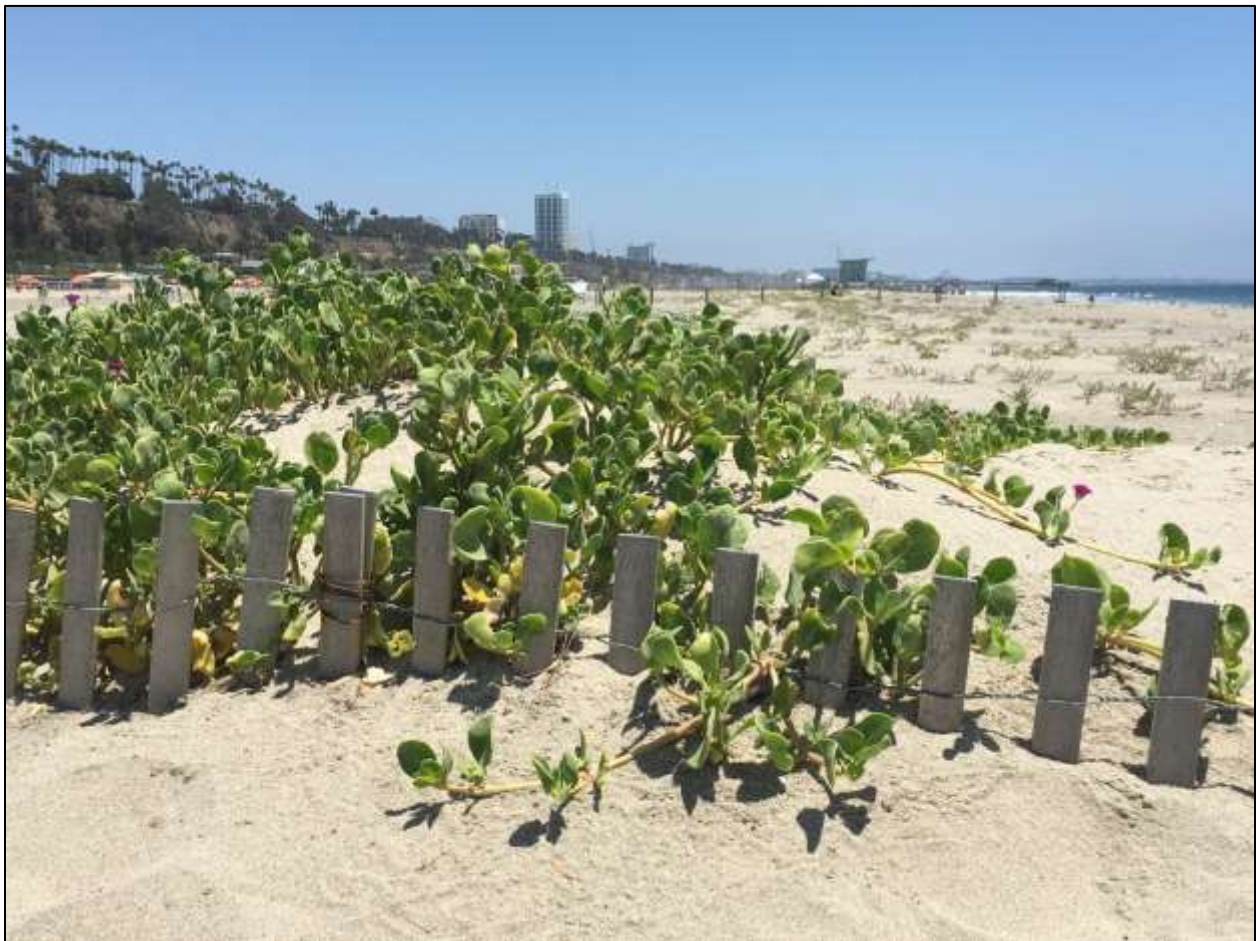
Figure 47. Vegetation overtopping the sand fence (originally a 3-foot high fence) along north edge of the restoration area (19 June 2019).

New adaptive management options are under consideration for Year 4, including the potential for supplemental seeding to increase the diversity and cover of vegetation on site, and installation of additional small lengths of sand fence within the project area. Considerations such as stakeholder and agency input, scientific recommendations, and timing implementation to avoid disturbance to western snowy plovers are all being evaluated for Year 4.
