Ballona Wetlands Restoration: Community Iceplant Removal Project

Year 6 Annual Report

October 2022

Coastal Development Permit No. 5-15-1427

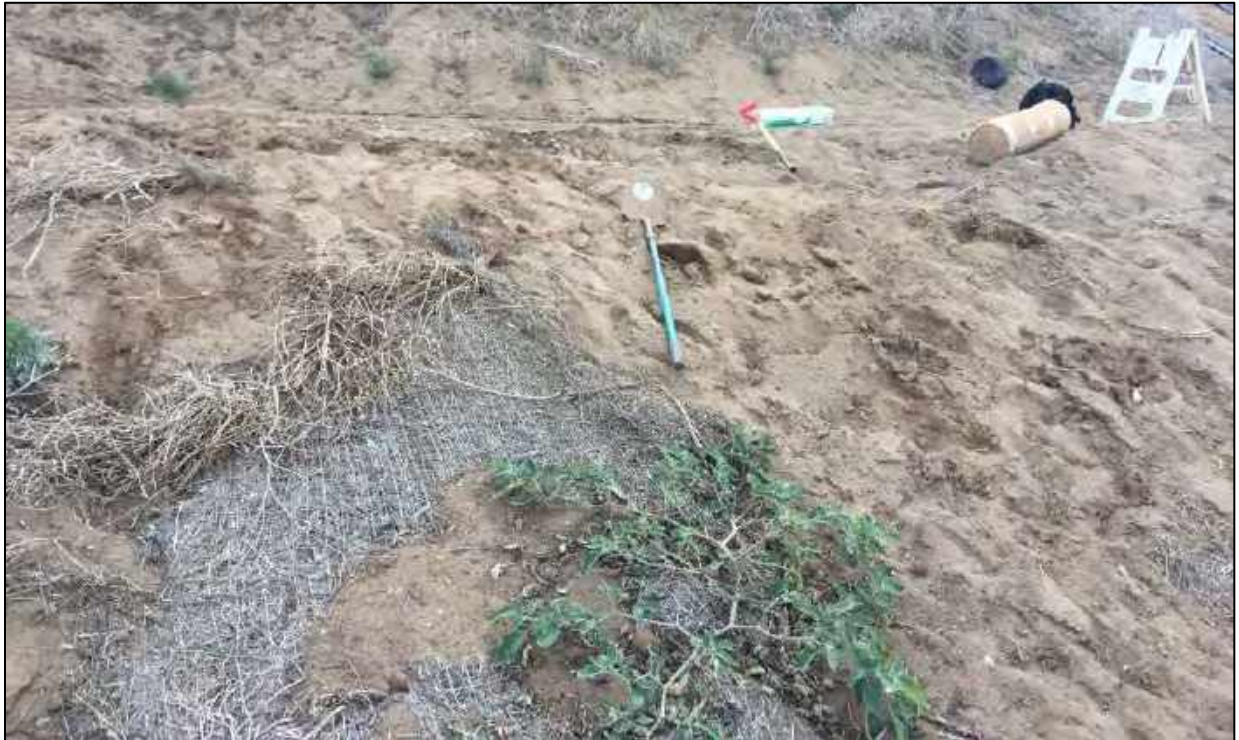
Figure 6. Photos taken of hillside following disturbance (top, 26 November 2019) and during Year 5 revegetation activities (bottom, 18 November 2021).

No supplemental revegetation actions occurred during Year 6; however, species planted the previous reporting year (Year 5) continued to establish and cover much of the hillside (Sites 3-A and 3-B; Figure 7). Notable native species in this area include California sagebrush (*Artemisia californica*), seacliff buckwheat (*Eriogonum parvifolium*), branching phacelia (*Phacelia ramossissima*), and white sage (*Salvia apiana*).

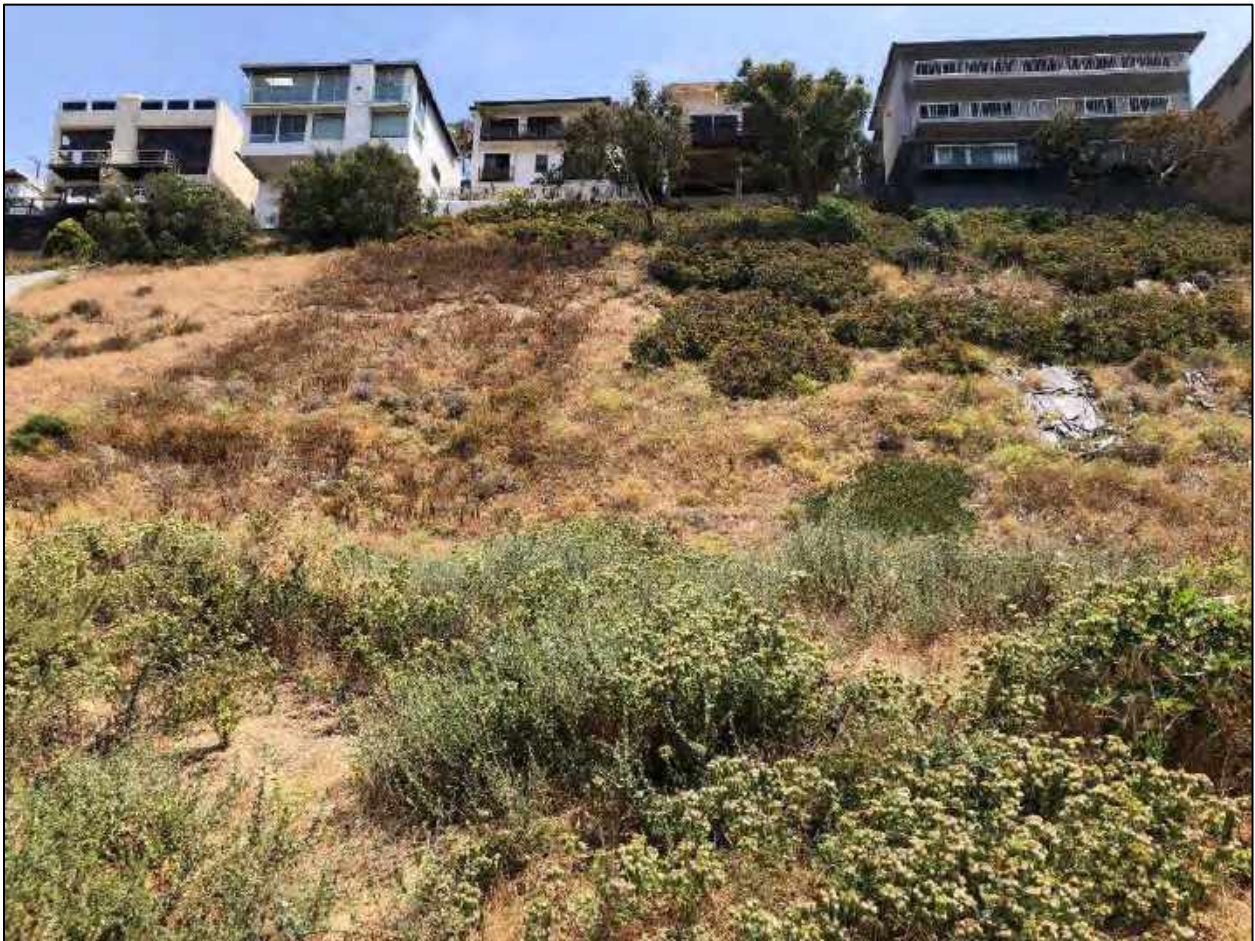
Figure 7. Photo taken of hillside during Year 6, approximately one and a half years after revegetation activities (3 June 2022).

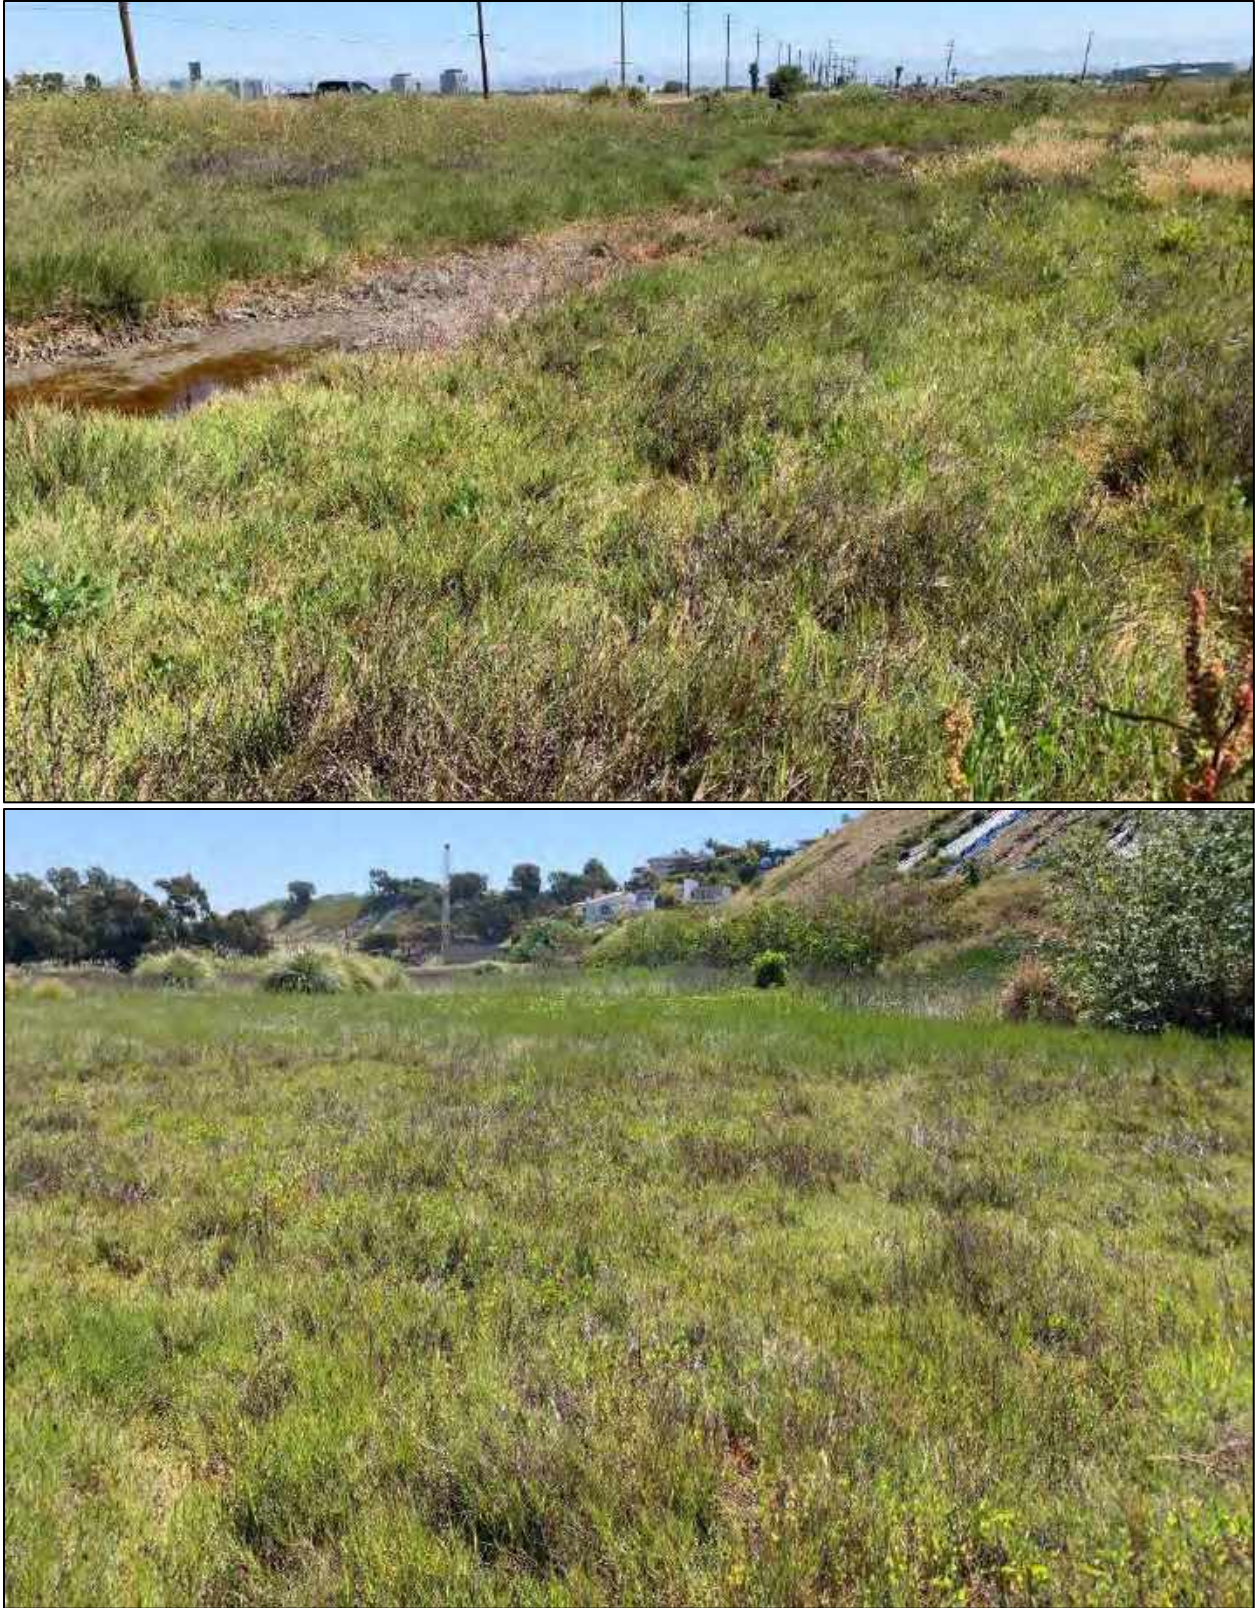
Figure 7. Mixed native and non-native plant assemblages (13 May 2022); mixed native saltgrass and pickleweed and non-native rabbit's foot grass, prickly lettuce, and sowthistle (top); mixed predominantly native saltgrass with some individuals of fat hen and other non-native species (bottom).

Adaptive management recommendation actions are included in other chapters of this report to address non-native vegetation invasion and additional revegetation conducted in Year 5 to further supplement the project areas. The following Figures 7-9 display a variety of representative locations within the restoration project footprint following iceplant removal with various combinations of native and non-native vegetation assemblages.

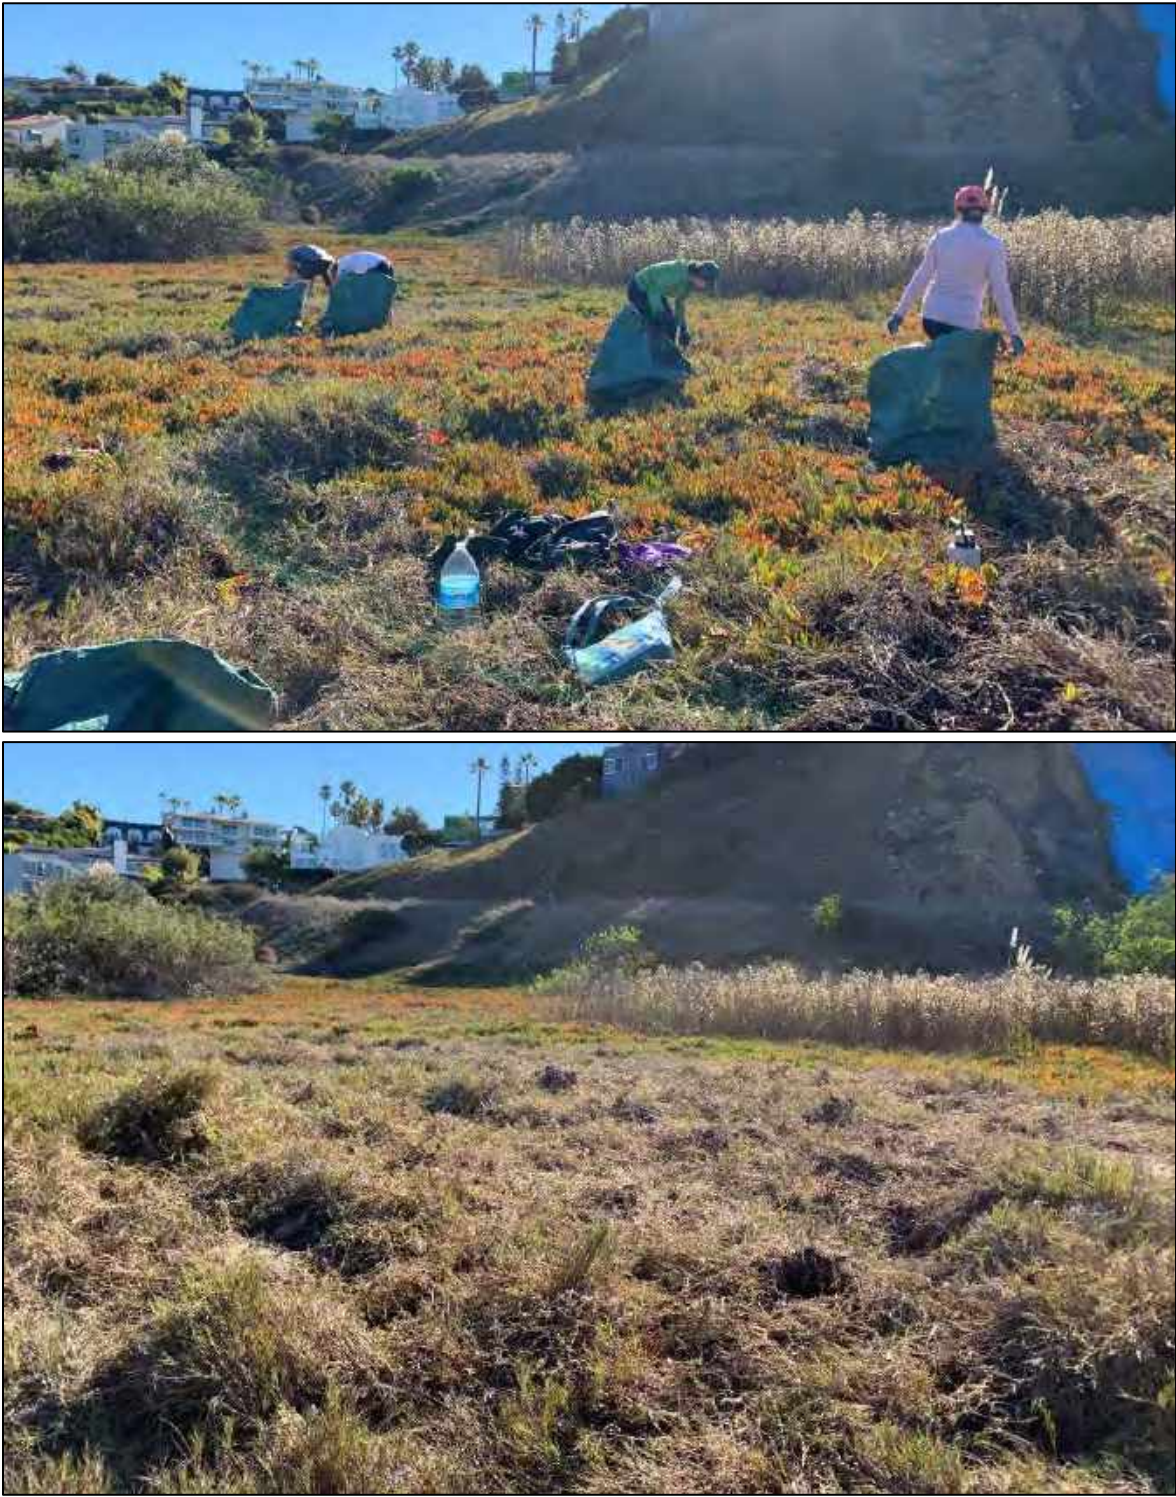
Figure 8. Predominantly non-native vegetation assemblage dominated by iceplant prior to hand removal on 11 December 2021 (top) and after (bottom). Note photograph locations are approximate.

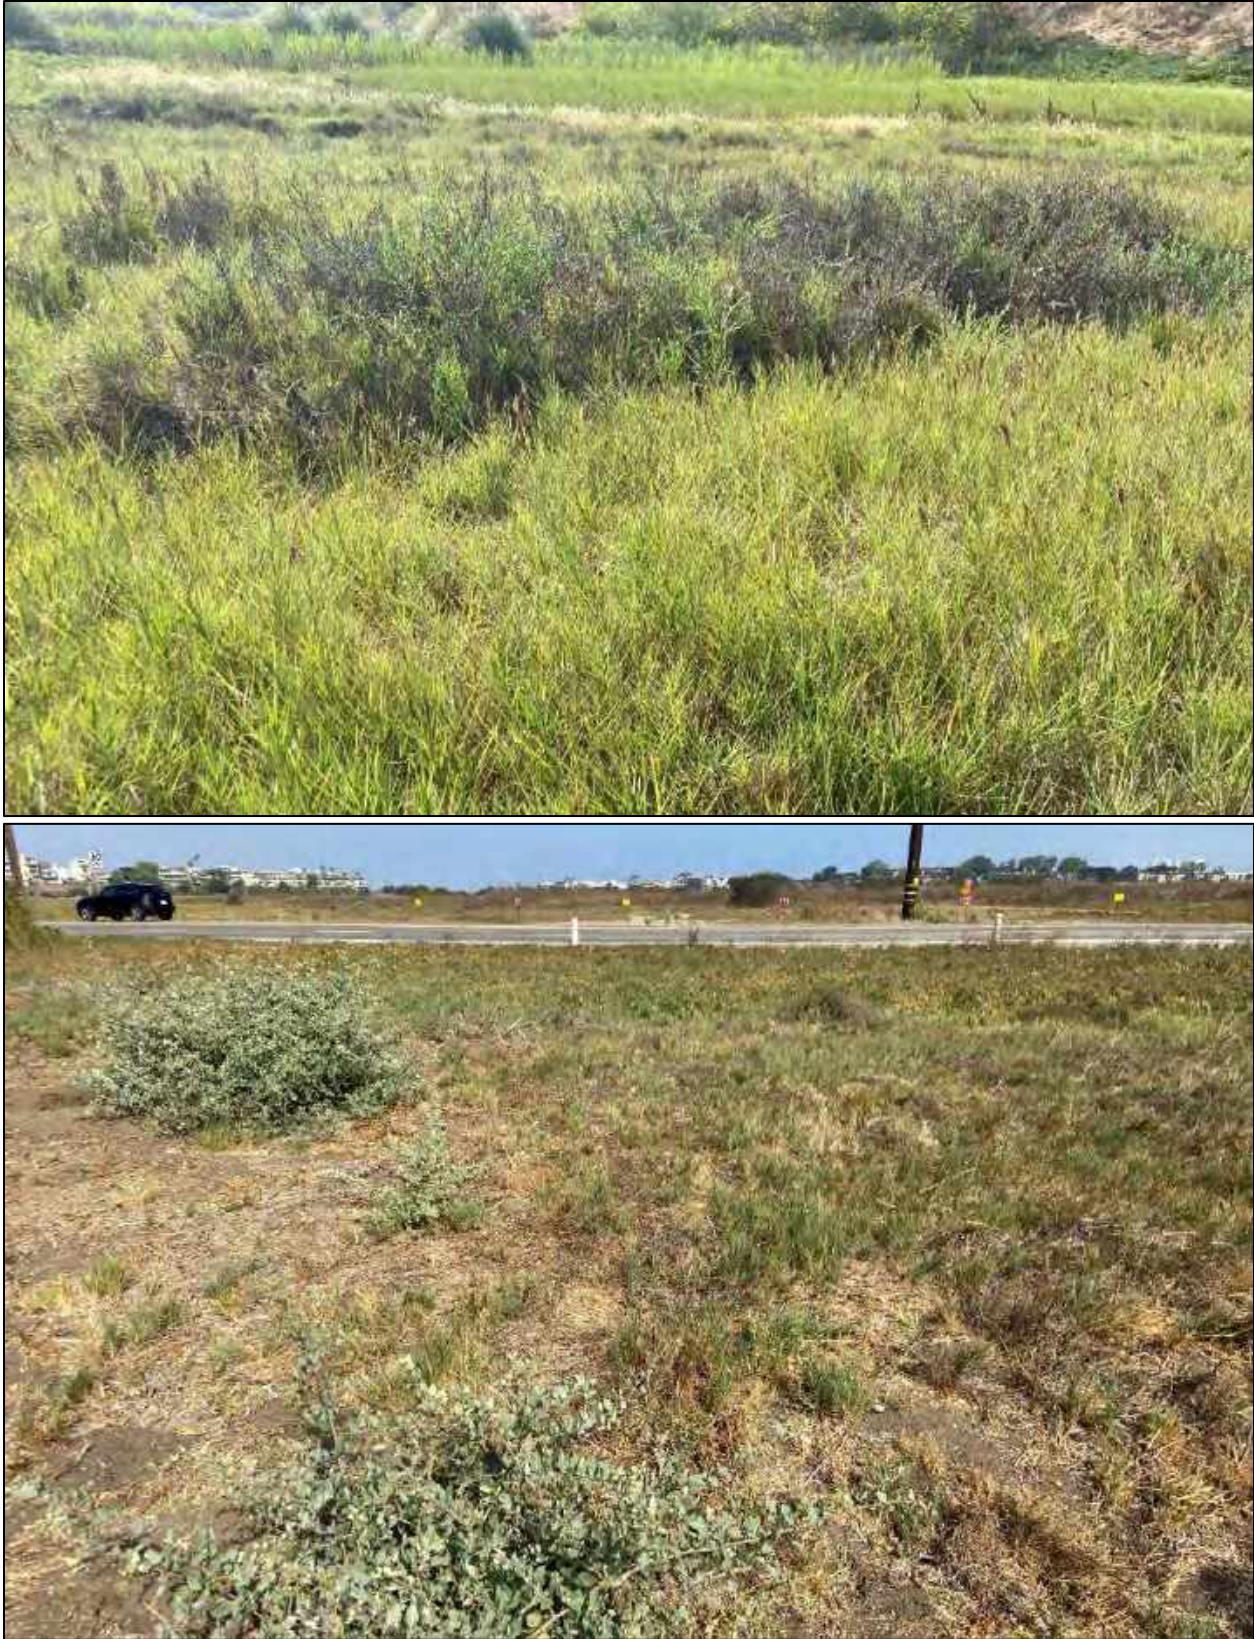
Figure 9. Vegetation assemblages consisting primarily of mixed native saltgrass and pickleweed (top) and mixed native saltgrass and big saltbush (bottom) (7 July 2021).

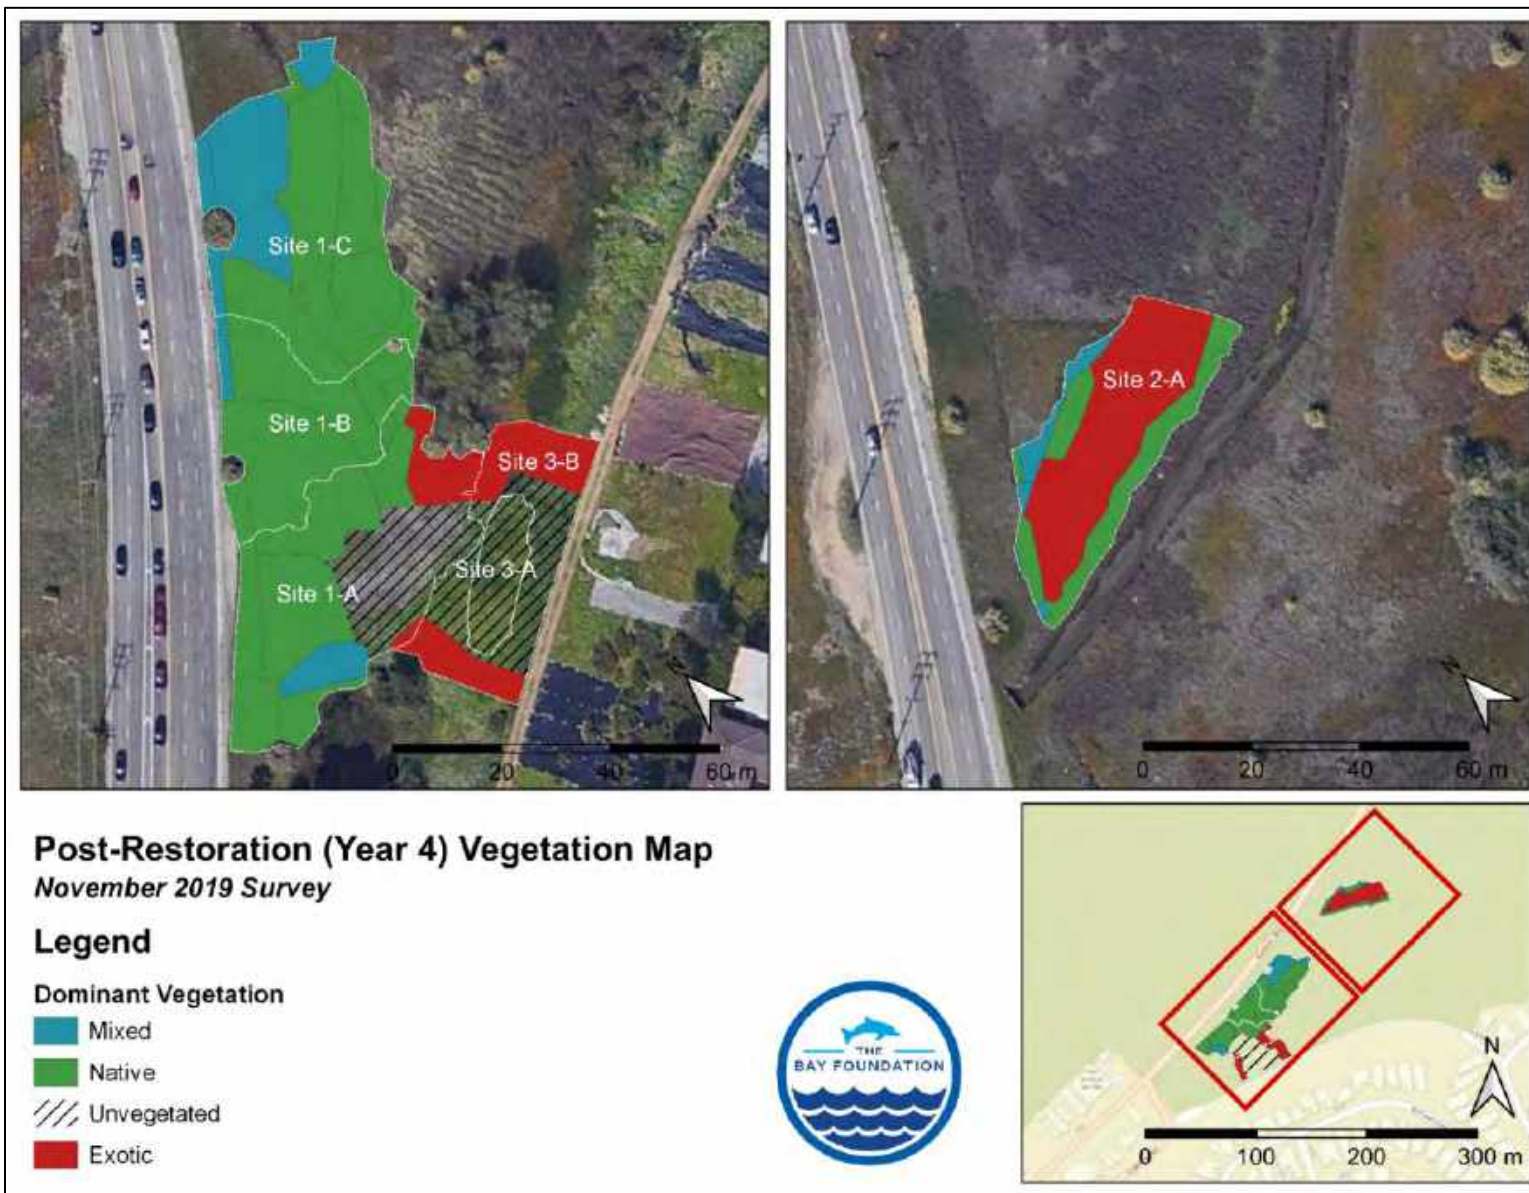
Figure 10g. Map displaying dominant vegetation type within GIS polygons during the Fall 2019 survey on 21 November 2019.

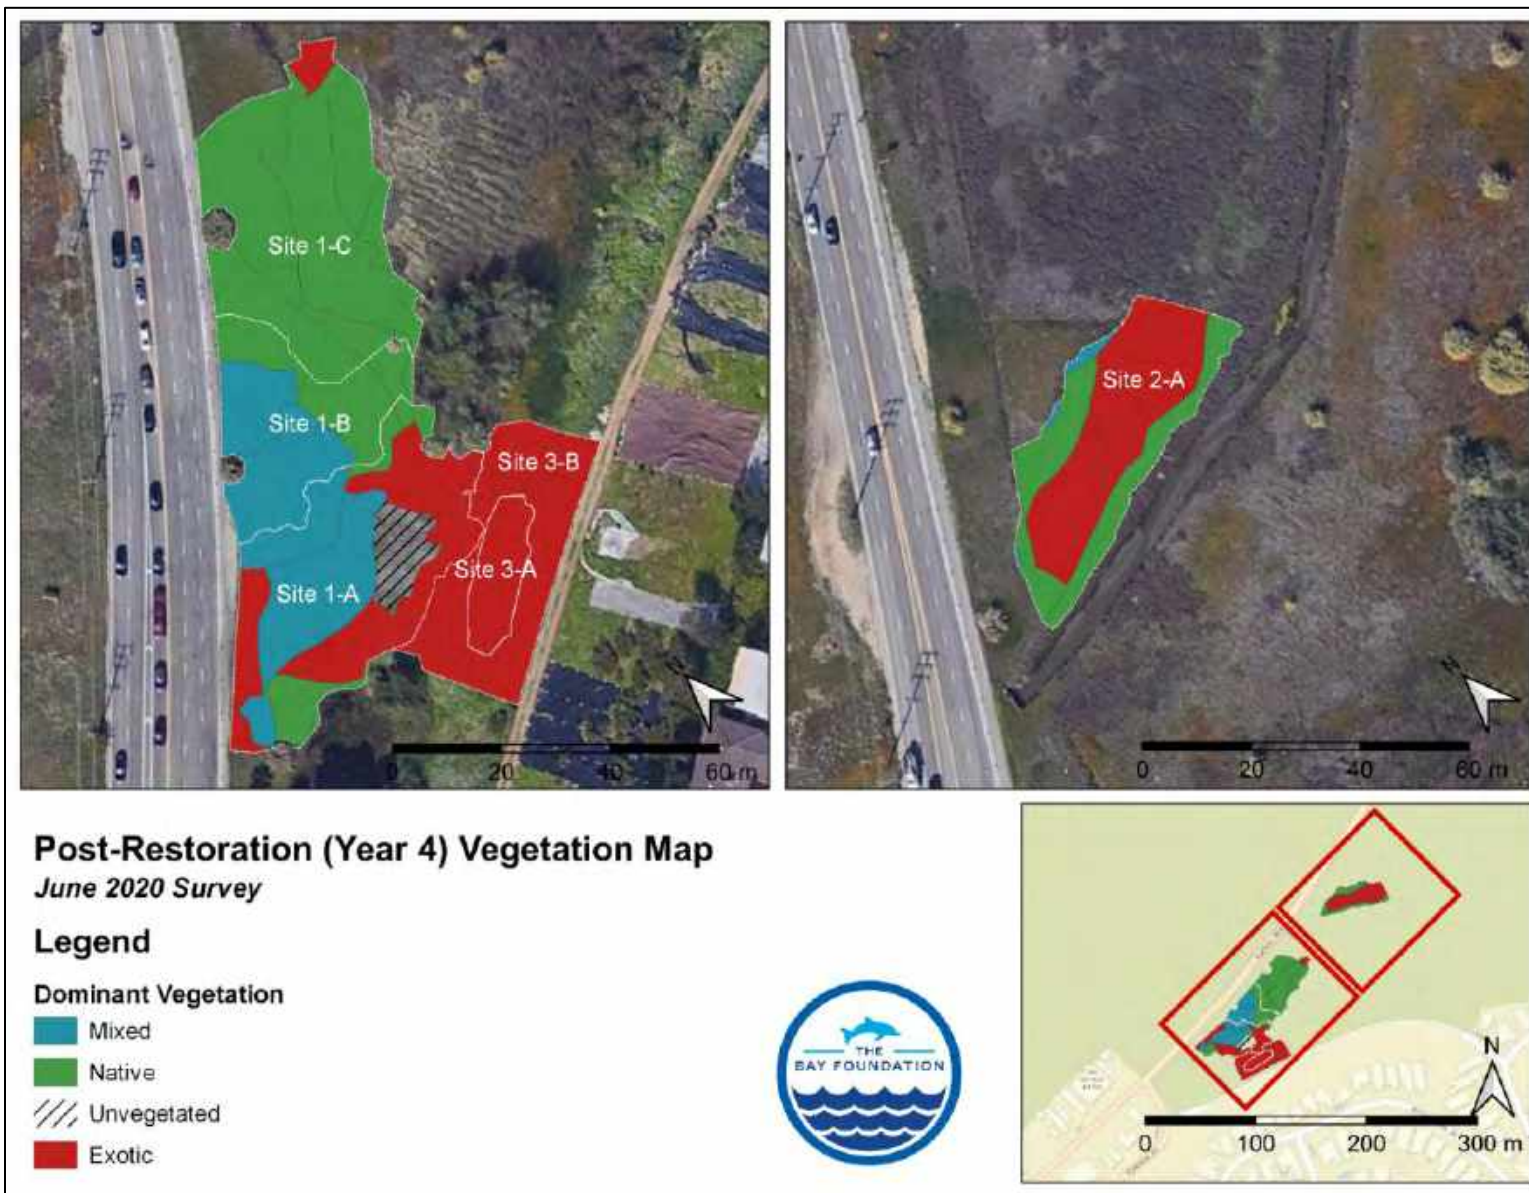
Figure 10h. Map displaying dominant vegetation type within GIS polygons during the Summer 2020 survey on 10-11 June 2020.

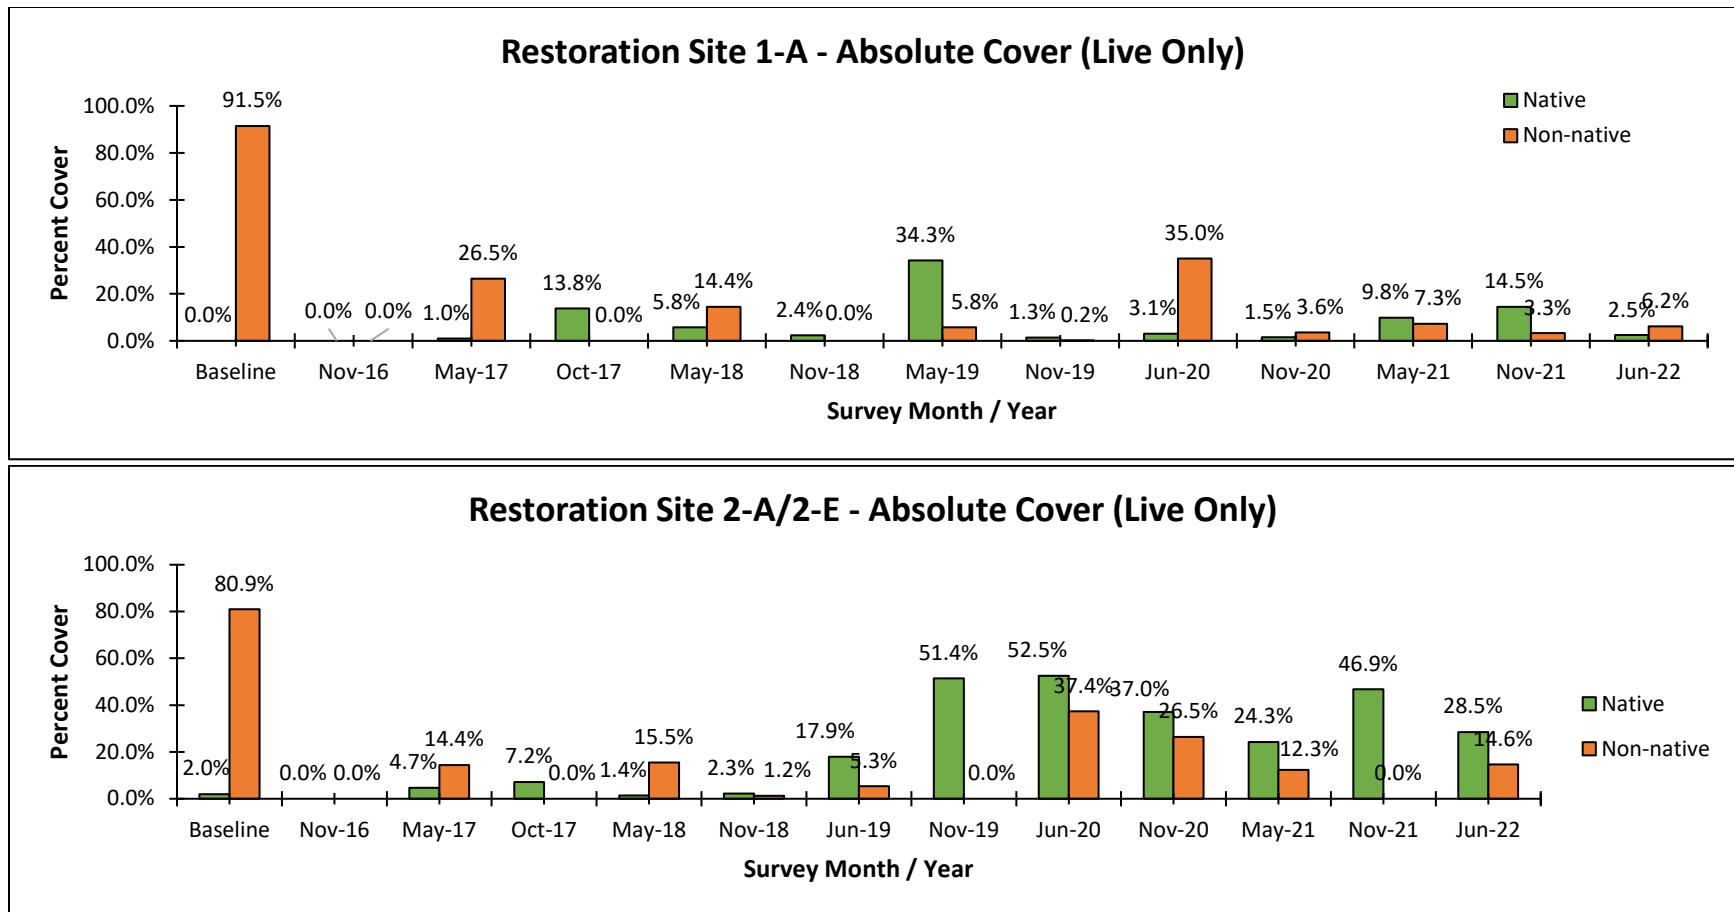
Figure 12. Vegetation data cover results from Site 1-A (top) and Site 2-A (bottom) absolute vegetation cover (live only).

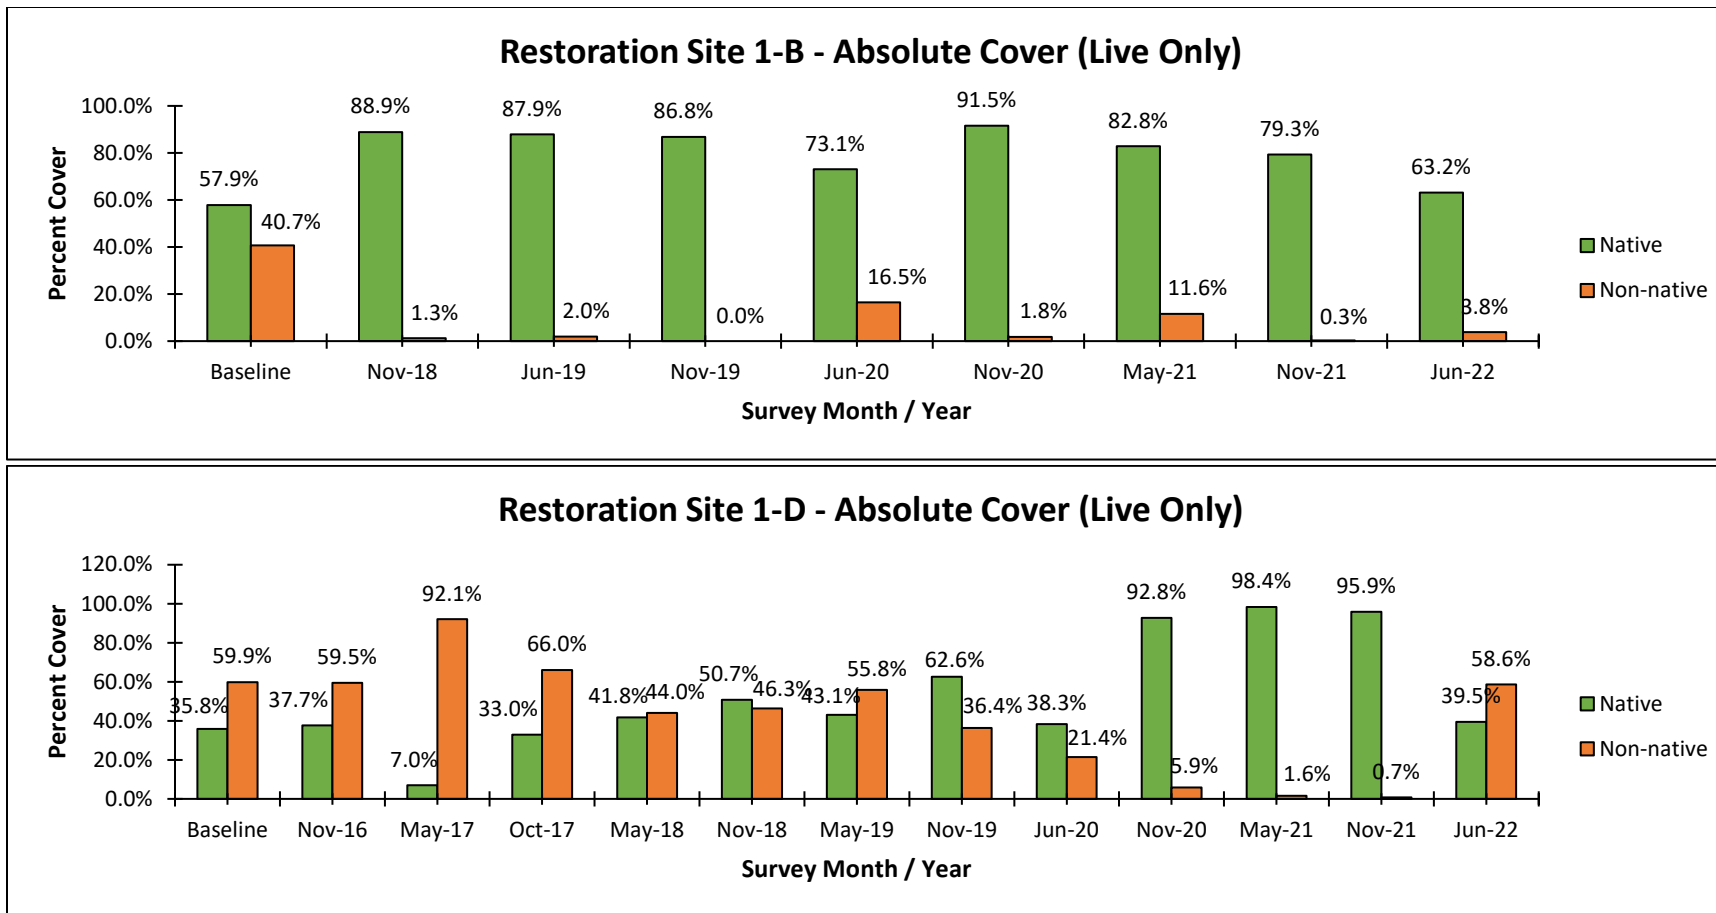
Figure 13. Vegetation data cover results from Site 1-B (top; restored in Year 3, June 2018) and newly restored Site 1-D (bottom). Site 1-D was reported as Control 2 in previous reports prior to restoration actions.

Restoration Site 1-D was newly restored during Year 5 (surveys beginning November 2020). Pre-restoration baseline conditions fluctuated by season and year, with a high non-native cover of 92.1% in May 2017, and a high native cover of 62.6% in November 2019. In Year 6, native cover remained high at 95.9% in November 2021, but decreased to 39.5% in the June 2022 survey. Conversely, non-native cover remained low after restoration activities, with 0.7% cover during the November 2021 survey and

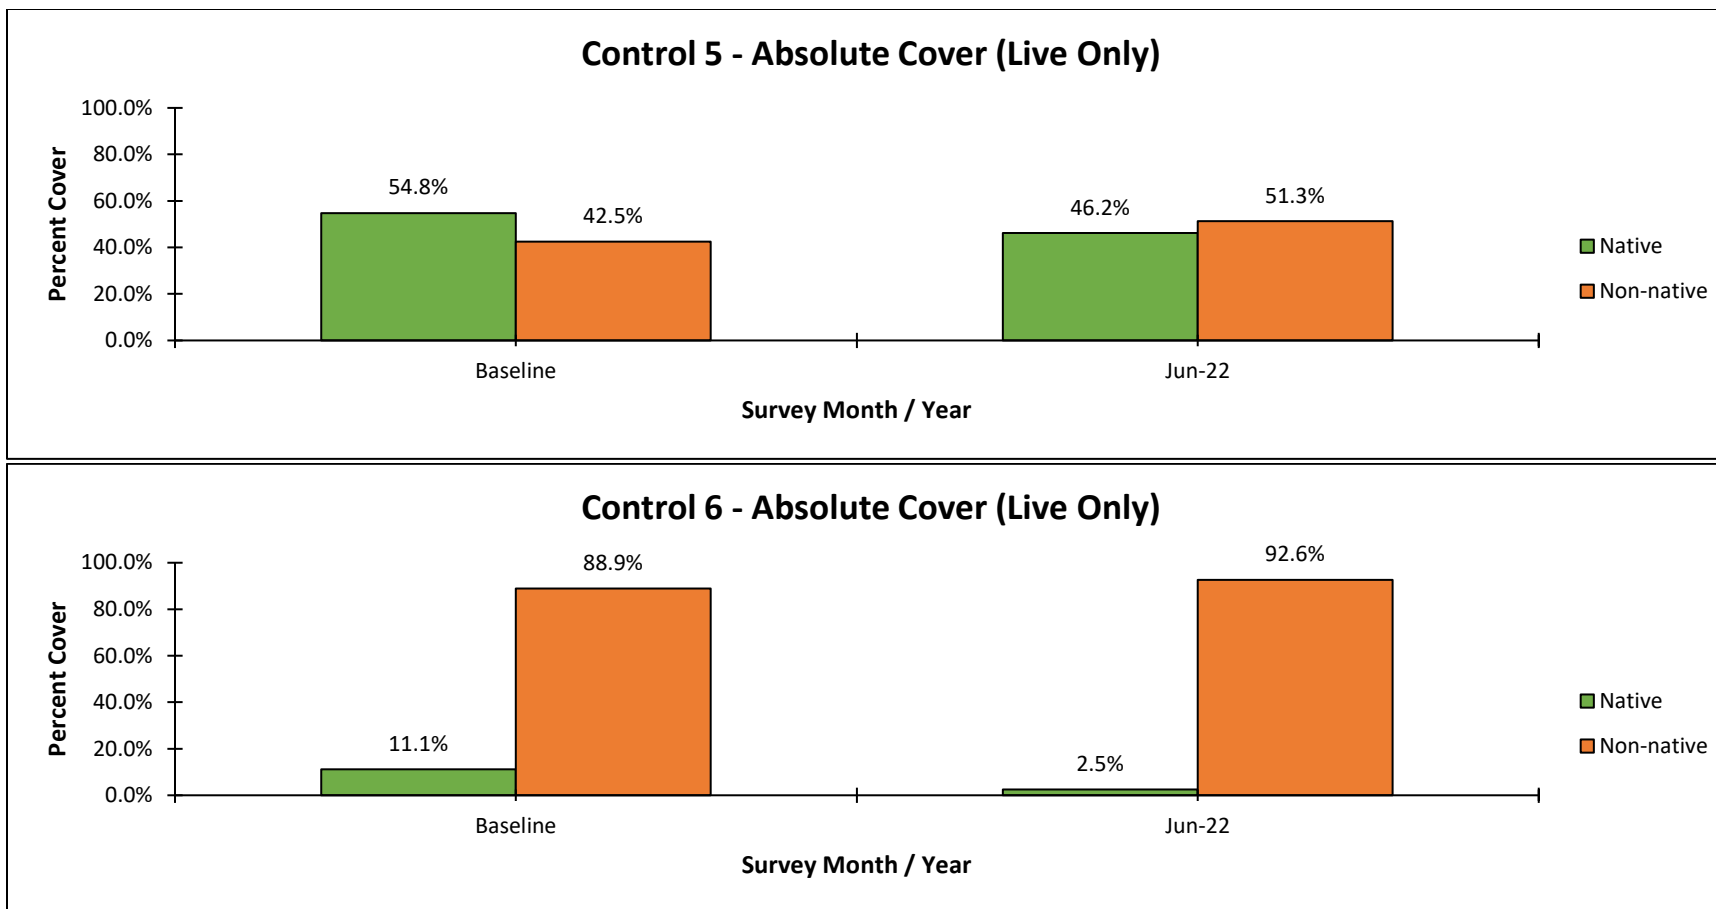
Figure 17. Vegetation data cover results from Control Sites 5 (top) and 6 (bottom), both controls were established in November 2021.

Control results (transects not altered during restorations) indicated some stability in the predominantly native areas. Results from four control areas are presented in Figures 16 and 17. In Year 6, two new control areas, one with intermixed non-native and native cover (Control 5) and another with predominantly non-native cover (Control 6), were added to track fluctuations of non-native species over time as compared to the restoration areas. Control Sites 1 and 3 were all predominantly native, with a native cover range of 73.8-100% in Control 1 and 60.5-93.9% in Control 3, across all survey dates and years (Figure 16). Additionally, the control results identified varying resistance to invasion, with a range of 0-21.4% non-native cover across Control 1 and 3 transects. These control transect results are indicative of the variability in percent cover within predominately native areas located outside of the restoration project footprint area, but within the Reserve during the time period surveyed. The newly established Control Site 5 represents an intermixed area of non-native and native cover, with native cover ranging from 46.2-54.8% and non-native cover ranging from 42.5-51.3% (Figure 17). The native species in the area are mainly patches of saltgrass and salt heliotrope (*Heliotropium curassavicum*). The recently established Control 6 Site is an area of low native and high non-native vegetation cover, primary consisting of iceplant. Native cover started at 11.1% in the baseline survey and decreased to 2.5% in the most recent June 2022 survey. Non-native vegetation cover fluctuated from 88.9% in the baseline survey to 92.6% in the June 2022 survey (Figure 17).

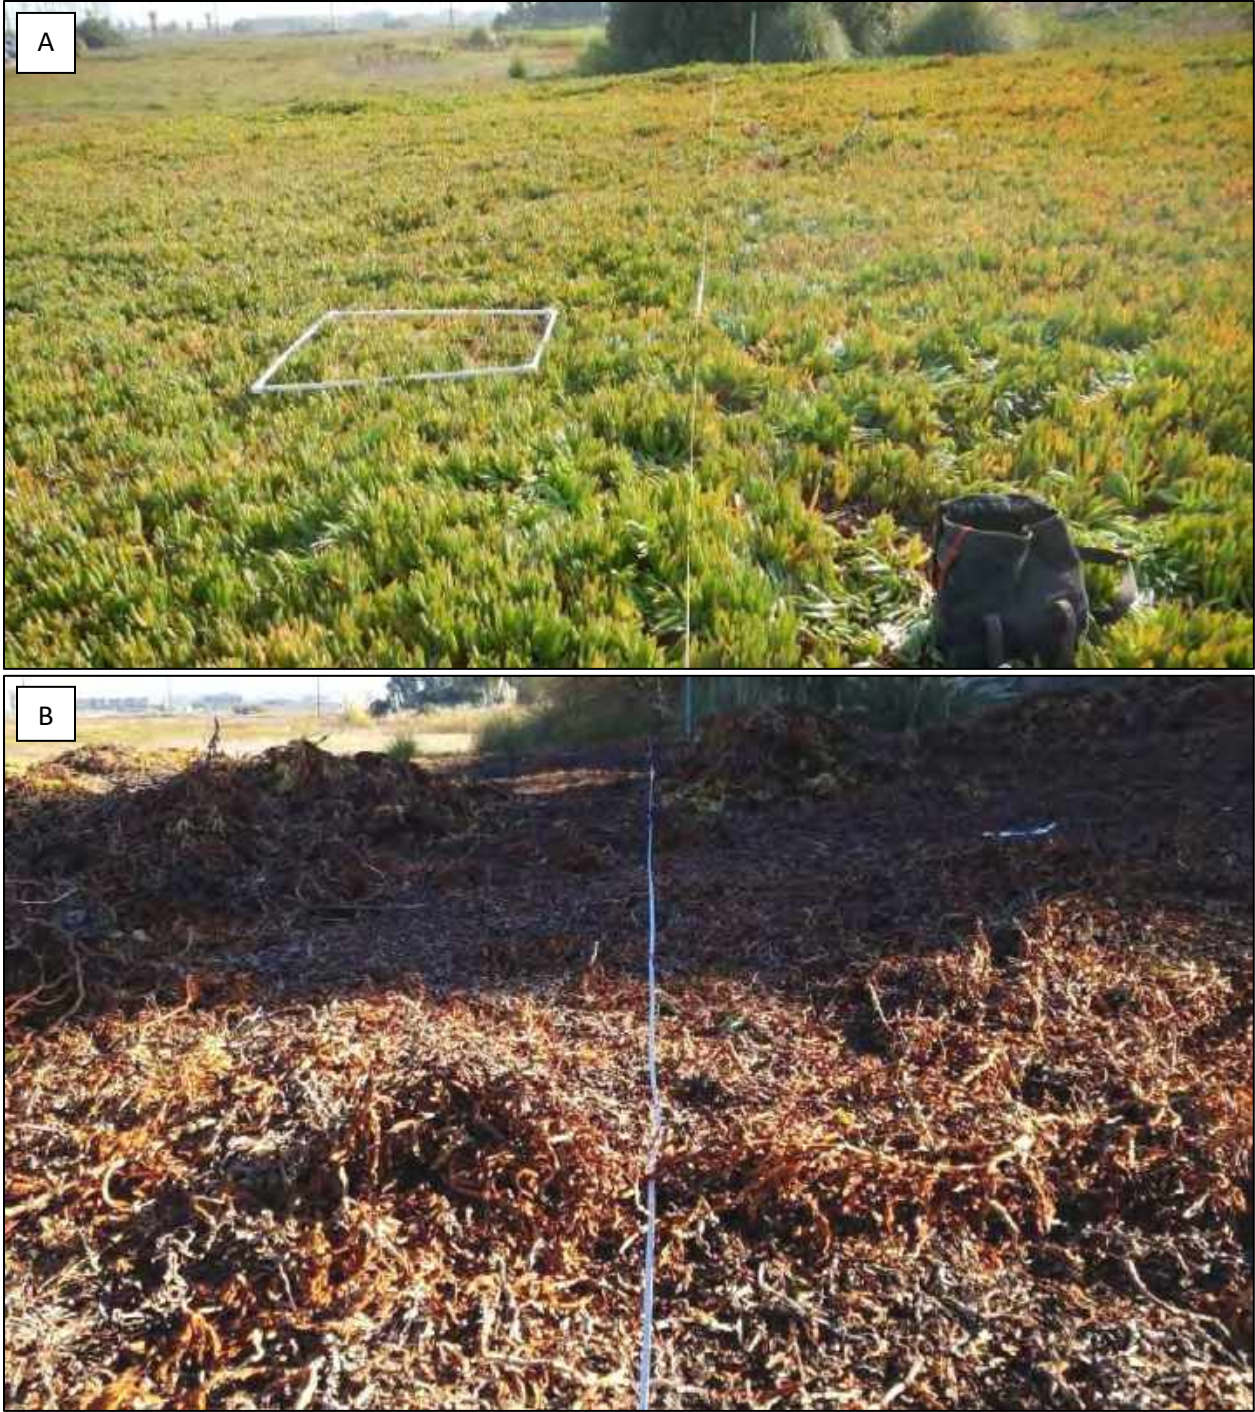
Figure 18. Photographs of Transect 5 pre-restoration on 23 August 2016 (A, top) and immediately post-restoration on 29 November 2016 (B, bottom).

Photographs in Figures 18 through 22 illustrate the vegetation transition over time in Site 1-A from a monoculture of iceplant (18, top), to dead iceplant immediately post-restoration (16a, bottom), to a mix of a variety of native and non-native vegetation species (Figures 18 – 24). In Figure 20, saltgrass is discernable in October 2017, and then in May 2018, the most visible species is Geraldton carnation weed. Year 3 post-restoration observations showed minimal non-native species, with the area dominated by the native annual species, Canadian horseweed (Figure 21). Year 4 was predominantly bare ground in the November 2019 survey, and had small patches of Canadian horseweed in the June 2020 survey (Figure 22). The Year 5 November 2020 survey was conducted immediately prior to restoration activities, including weeding and planting of native container stock vegetation. Figure 23, left shows the November 2020 survey, with bare ground dominant and small patches of natives and non-natives. Figure 23, right, shows the May 2021 survey approximately six months after restoration activities and is dominated by annual brome grasses, but with patches of native plants that were installed as container stock at the end of 2020. Figure 24, left shows the November 2021 survey, with small patches of saltgrass and brome grasses. Figure 24, right shows the June 2022 survey, with a continued dominance of annual brome grasses and patches of native plants.

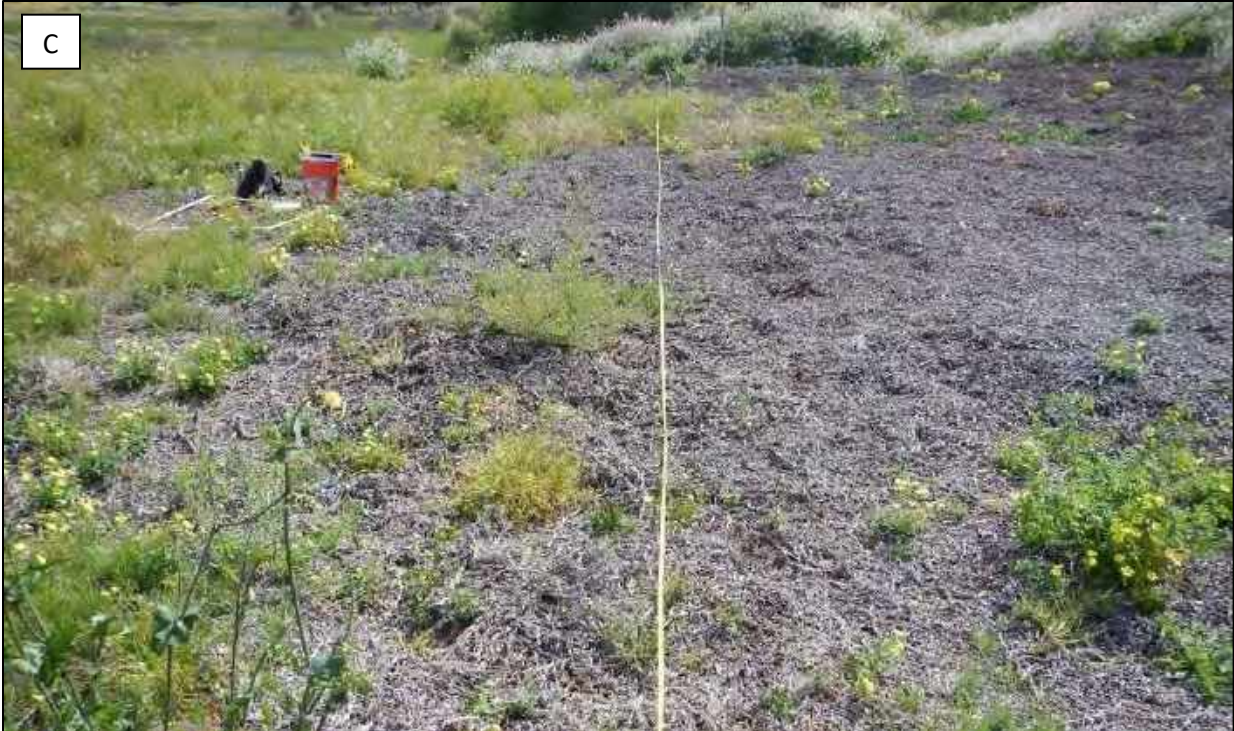
Figure 19. Photographs of Transect 5 post-restoration on 1 May 2017 (C).

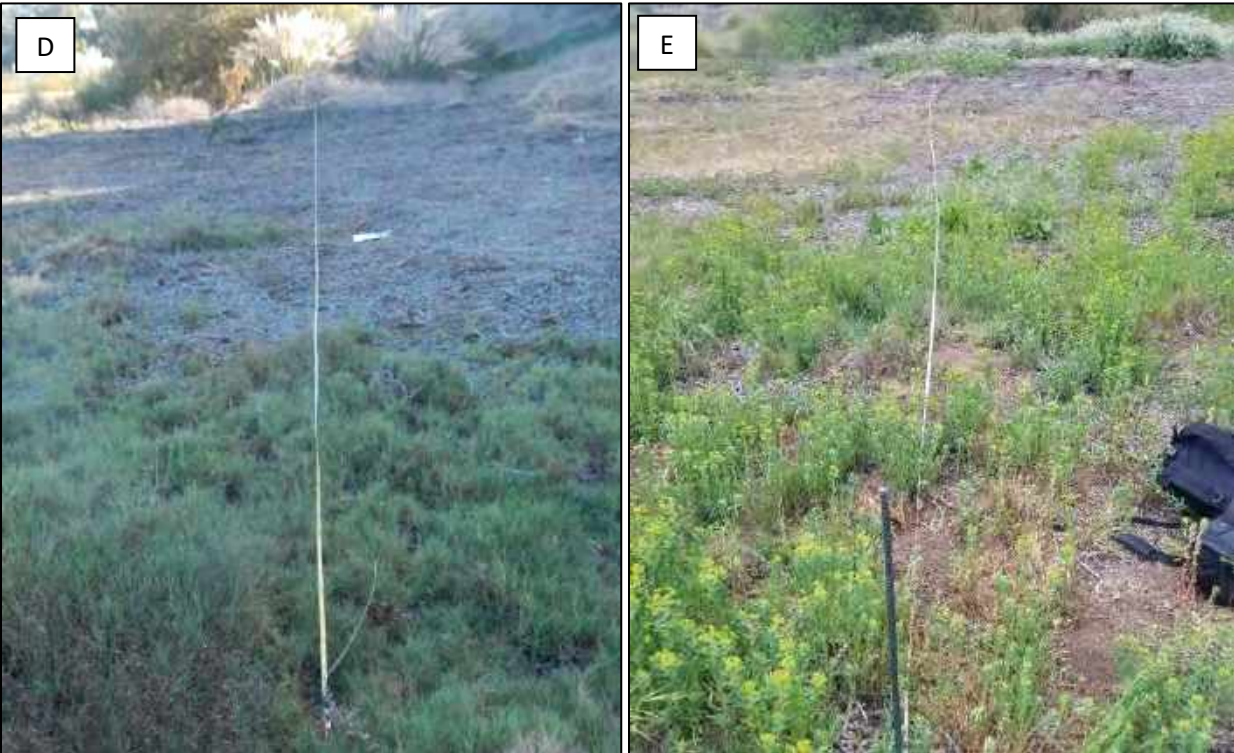
Figure 20. Photographs of Transect 5, Year 2 post-restoration, on 7 October 2017 (D), and 1 May 2018 (E). Note: photograph (D) was taken at a slightly different starting location, hence the saltgrass patch present in (D) and not after. Subsequent photo start point locations (E and after) were corrected.

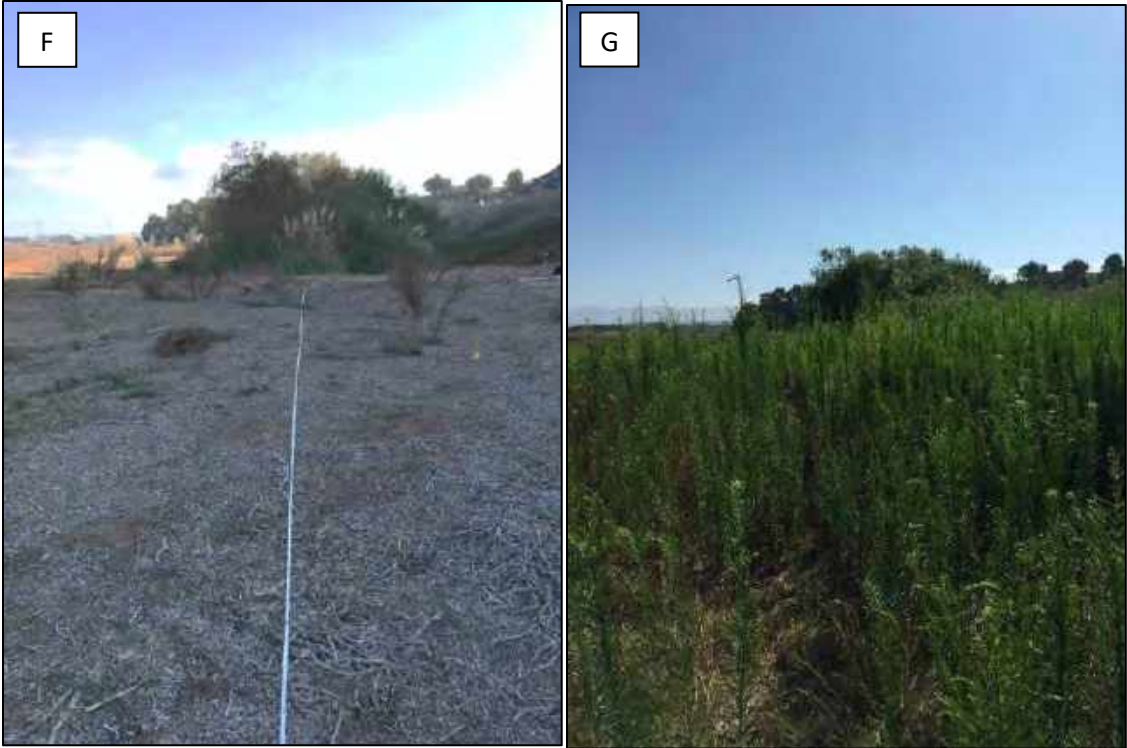
Figure 21. Photographs of Transect 5, Year 3, post-restoration on 28 November 2018 (F), and 24 July 2019 (G).
