Ballona Wetlands Restoration: Community Iceplant Removal Project

Year 6 Annual Report

October 2022

Coastal Development Permit No. 5-15-1427

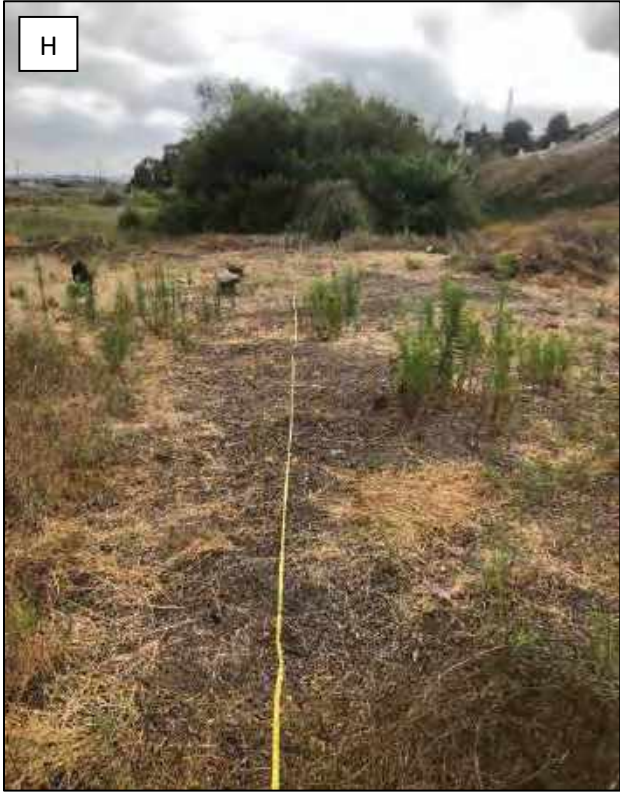
Figure 22. Photograph of Transect 5, Year 4, post-restoration on 16 July 2020 (H).

Photographs in Figures 18 through 22 illustrate the vegetation transition over time in Site 1-A from a monoculture of iceplant (18, top), to dead iceplant immediately post-restoration (16a, bottom), to a mix of a variety of native and non-native vegetation species (Figures 18 – 24). In Figure 20, saltgrass is discernable in October 2017, and then in May 2018, the most visible species is Geraldton carnation weed. Year 3 post-restoration observations showed minimal non-native species, with the area dominated by the native annual species, Canadian horseweed (Figure 21). Year 4 was predominantly bare ground in the November 2019 survey, and had small patches of Canadian horseweed in the June 2020 survey (Figure 22). The Year 5 November 2020 survey was conducted immediately prior to restoration activities, including weeding and planting of native container stock vegetation. Figure 23, left shows the November 2020 survey, with bare ground dominant and small patches of natives and non-natives. Figure 23, right, shows the May 2021 survey approximately six months after restoration activities and is dominated by annual brome grasses, but with patches of native plants that were installed as container stock at the end of 2020. Figure 24, left shows the November 2021 survey, with small patches of saltgrass and brome grasses. Figure 24, right shows the June 2022 survey, with a continued dominance of annual brome grasses and patches of native plants.

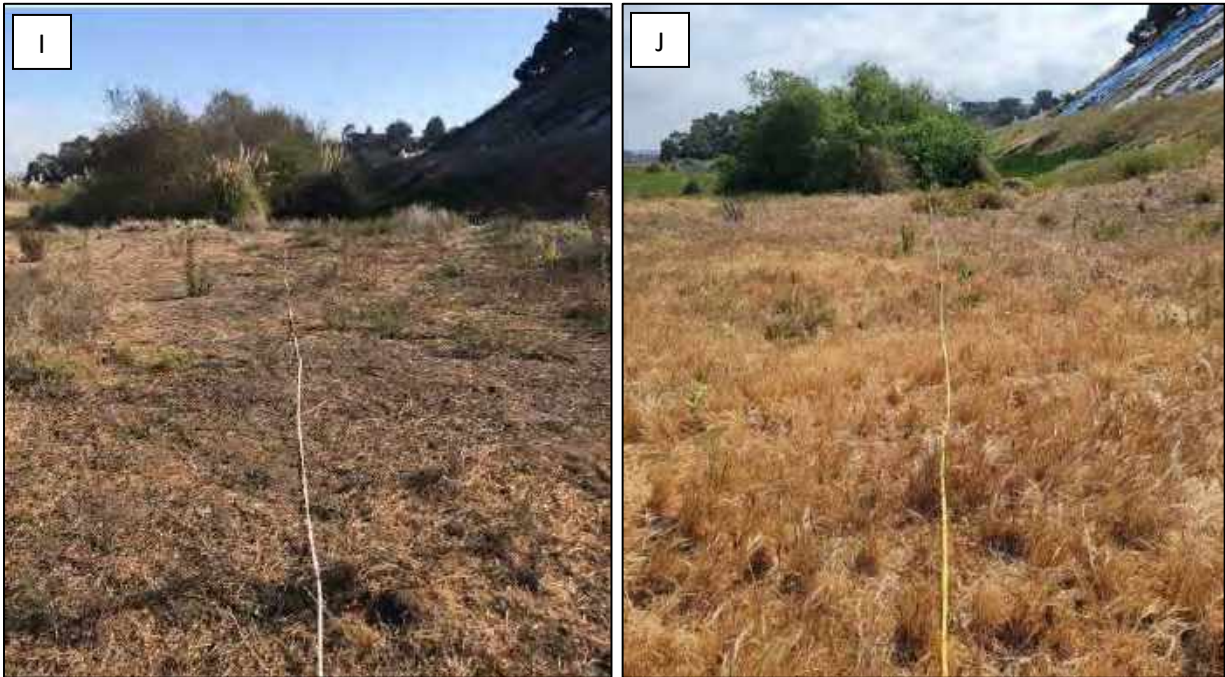
Figure 23. Photographs of Transect 5, Year 5, post-restoration on 12 November 2020 (I), 18 May 2021 (J).

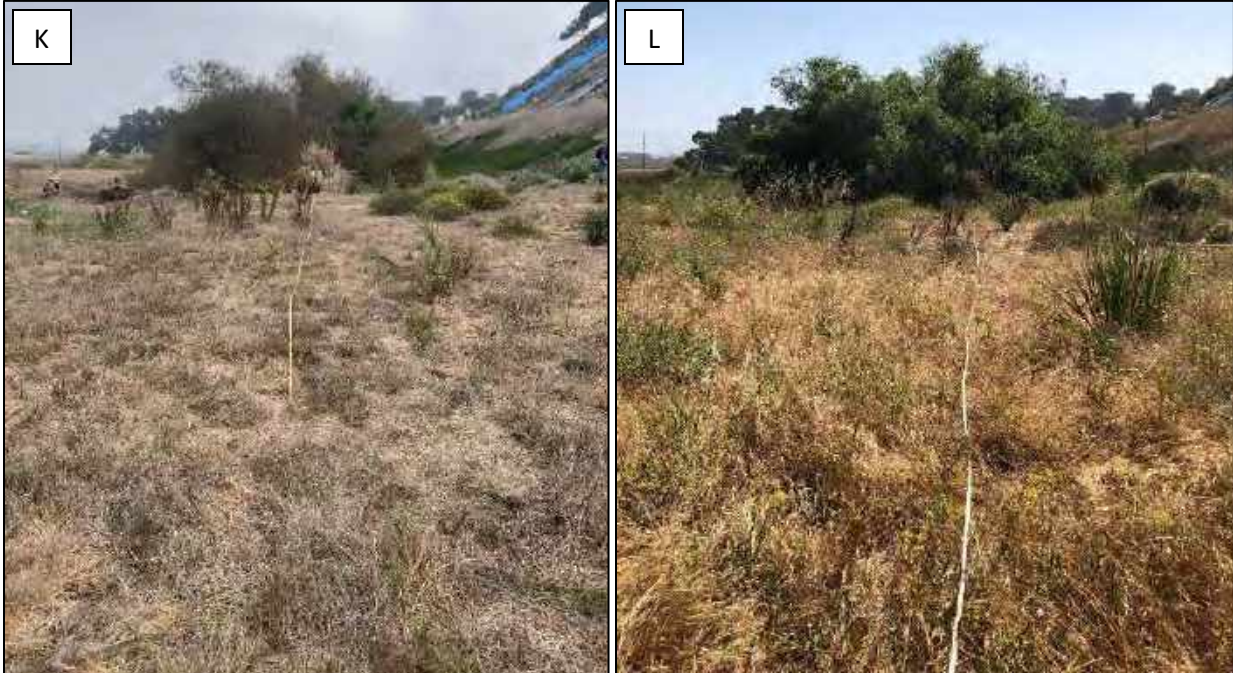
Figure 24. Photographs of Transect 5, Year 6, post-restoration on 17 November 2021 (K), 1 June 2022 (L).

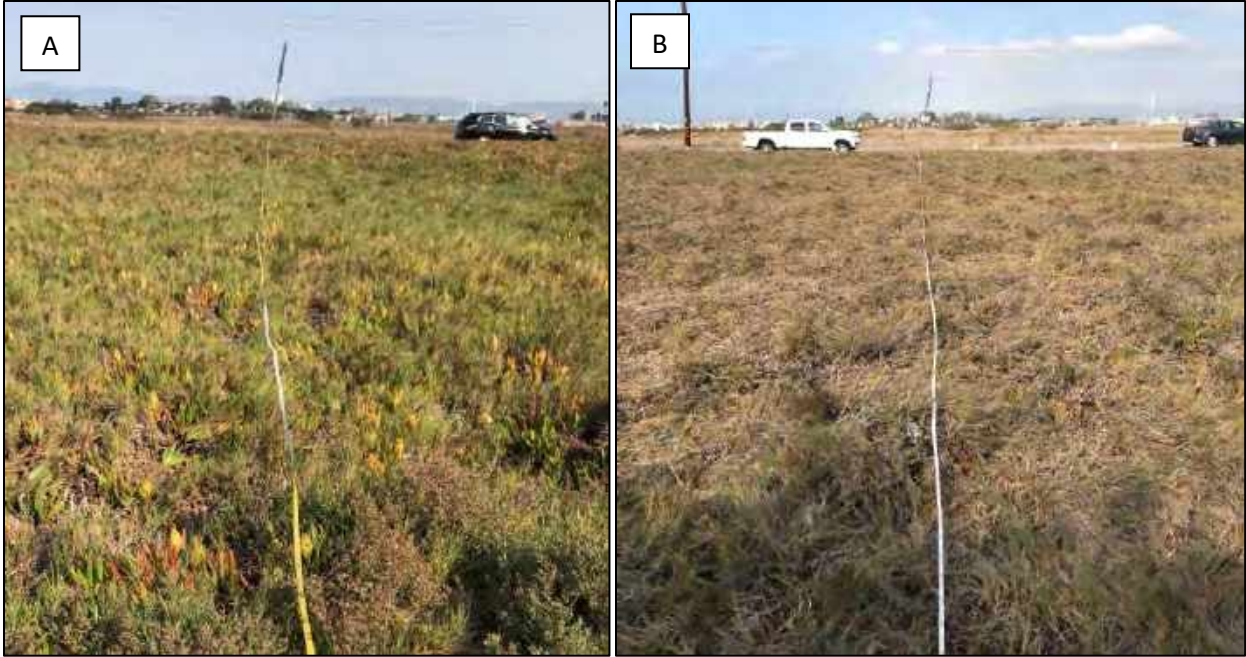
Figure 25. Photograph of beginning of Transect 7 at baseline conditions (pre-restoration) on 9 August 2018 (A) and within weeks of post-restoration on 28 November 2018 (B).

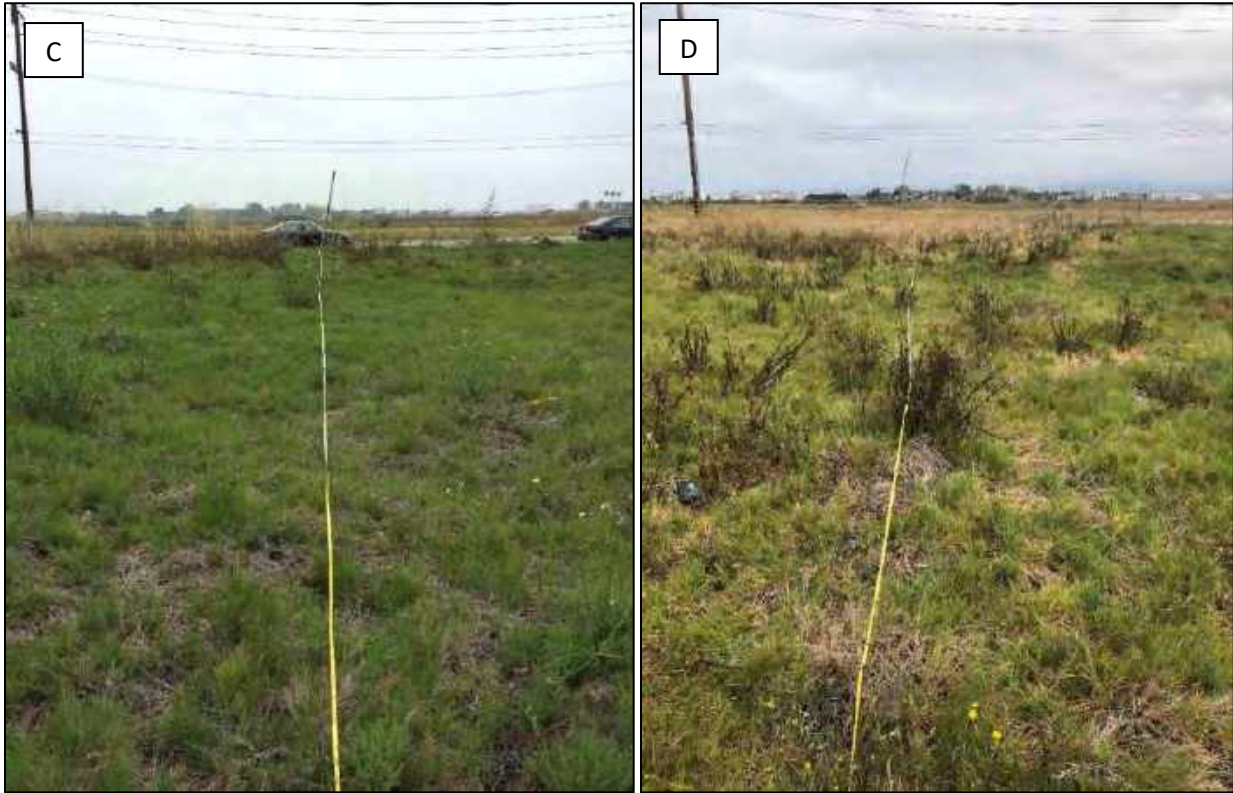
Figure 26. Photograph of Transect 7 post-restoration on 5 June 2019 (C) and 21 July 2020 (D).

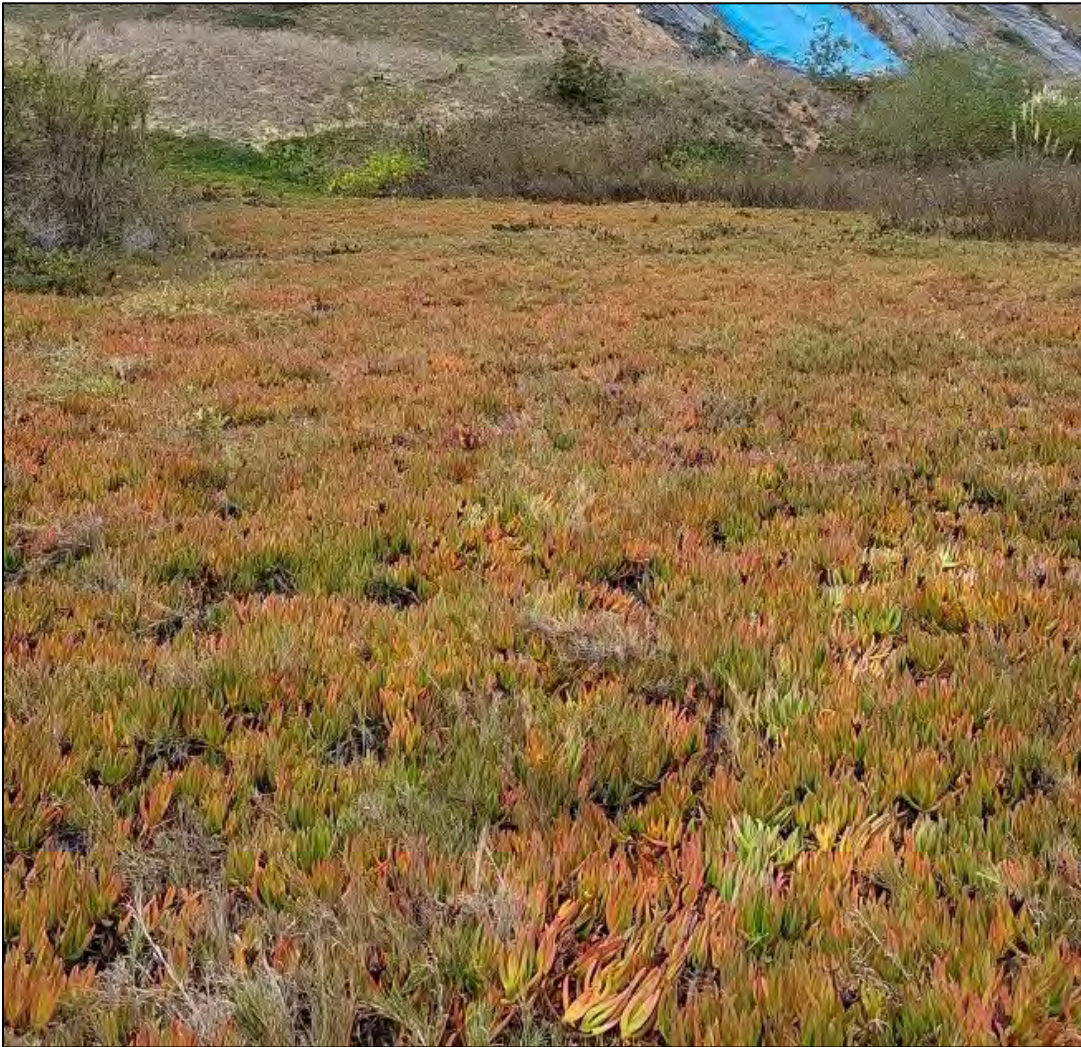
Figure 29. Photo of adjacent non-restored area of project site on 17 November 2021 showing predominantly iceplant with intermixed saltgrass and other species.

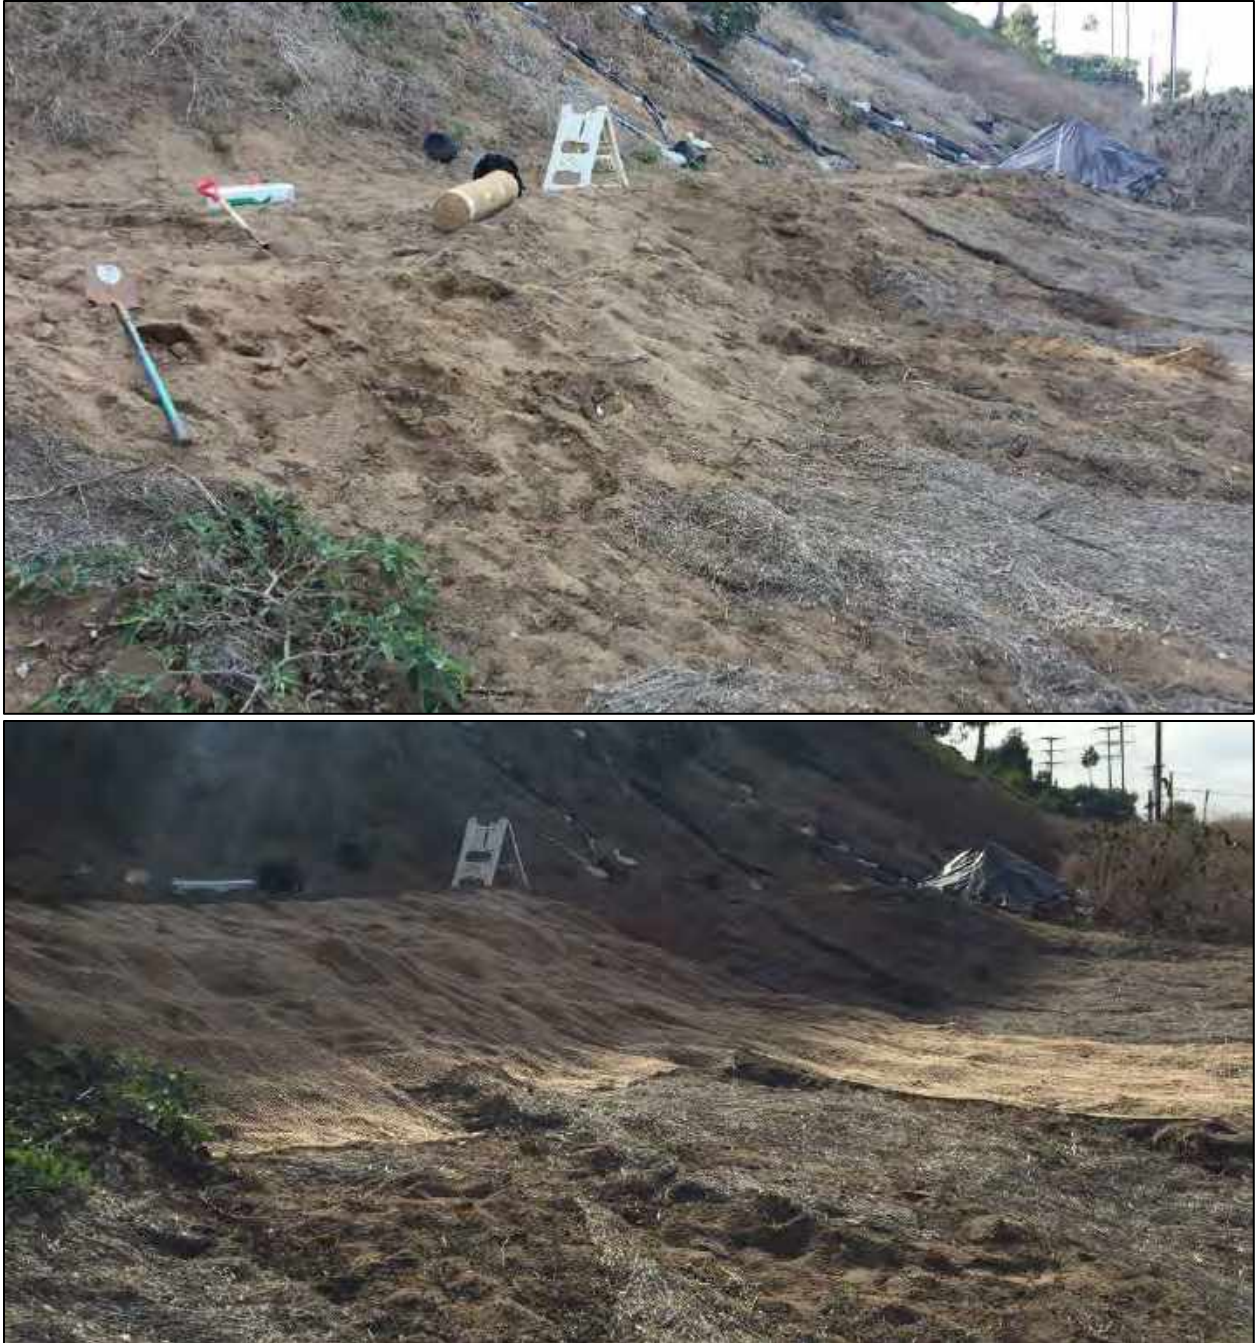
Figure 34. Photographs taken of the impacted area of the hillside with disturbed soils and tracks before emergency measures were taken (top) and after erosion control mats were placed (bottom) (26 November 2019).

Year 6 showed positive development in the previously impacted area, as native species planted and seeded last reporting year (Year 5) continued to establish within the area. Weedy non-native annuals continued to be a challenge and were intermixed with native shrubs and herbs. Non-native annuals will require continued maintenance into Year 7.

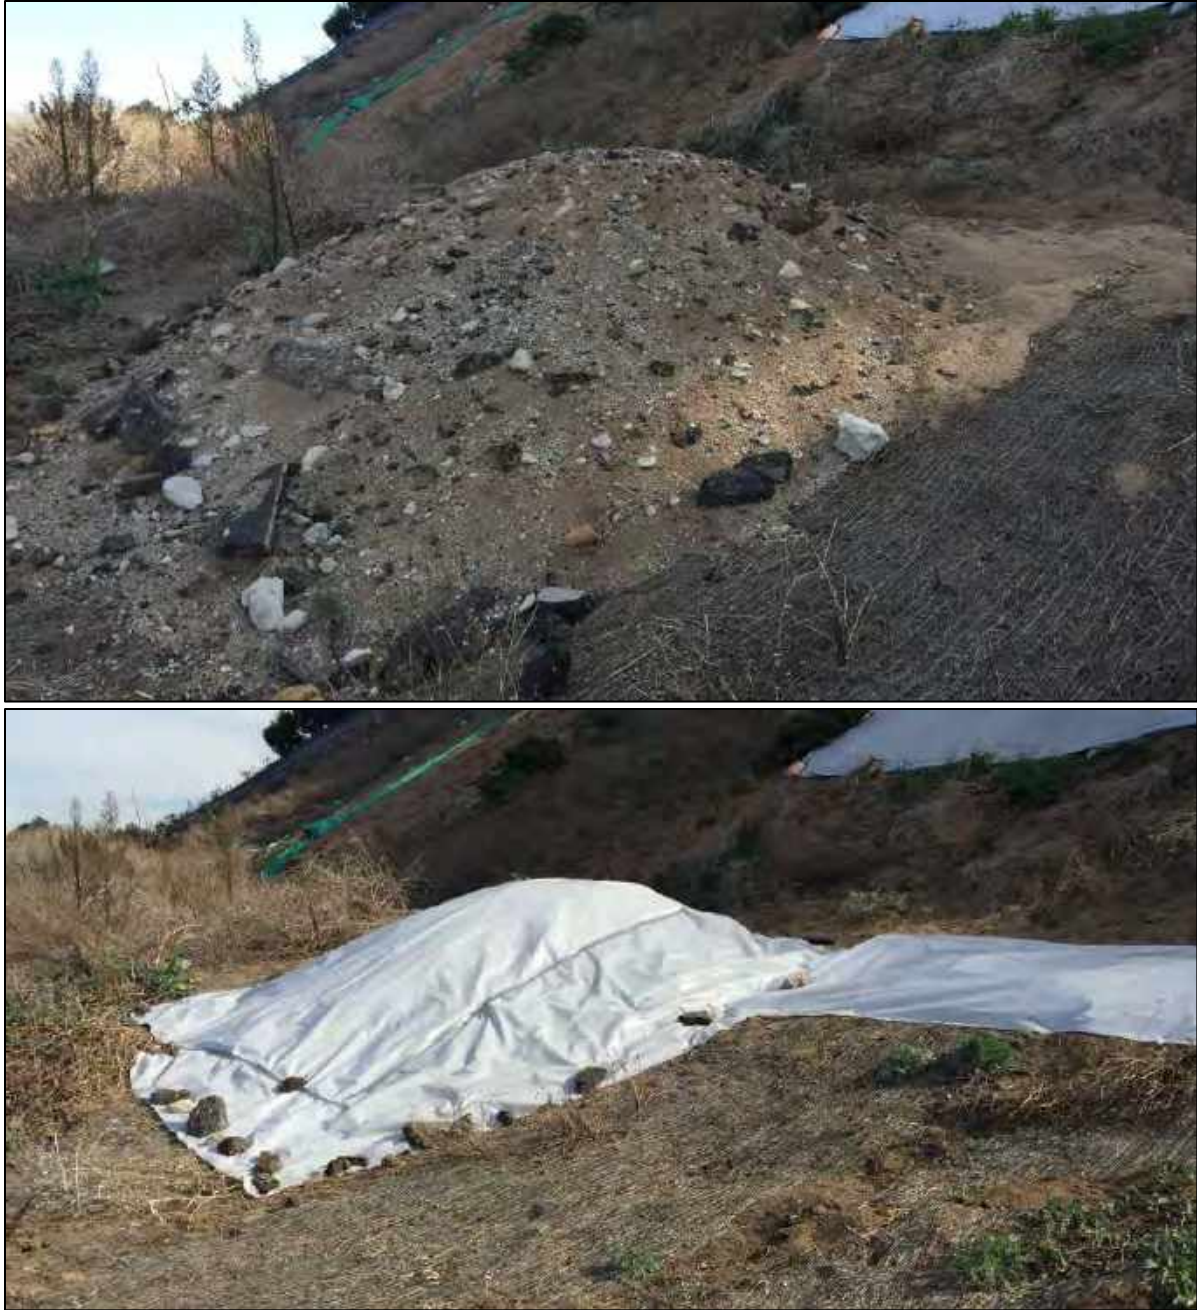
Figure 35. Photographs taken of one of the dumped sediment and trash piles in the restoration area before being covered (top) and after (bottom) (26 November 2019).

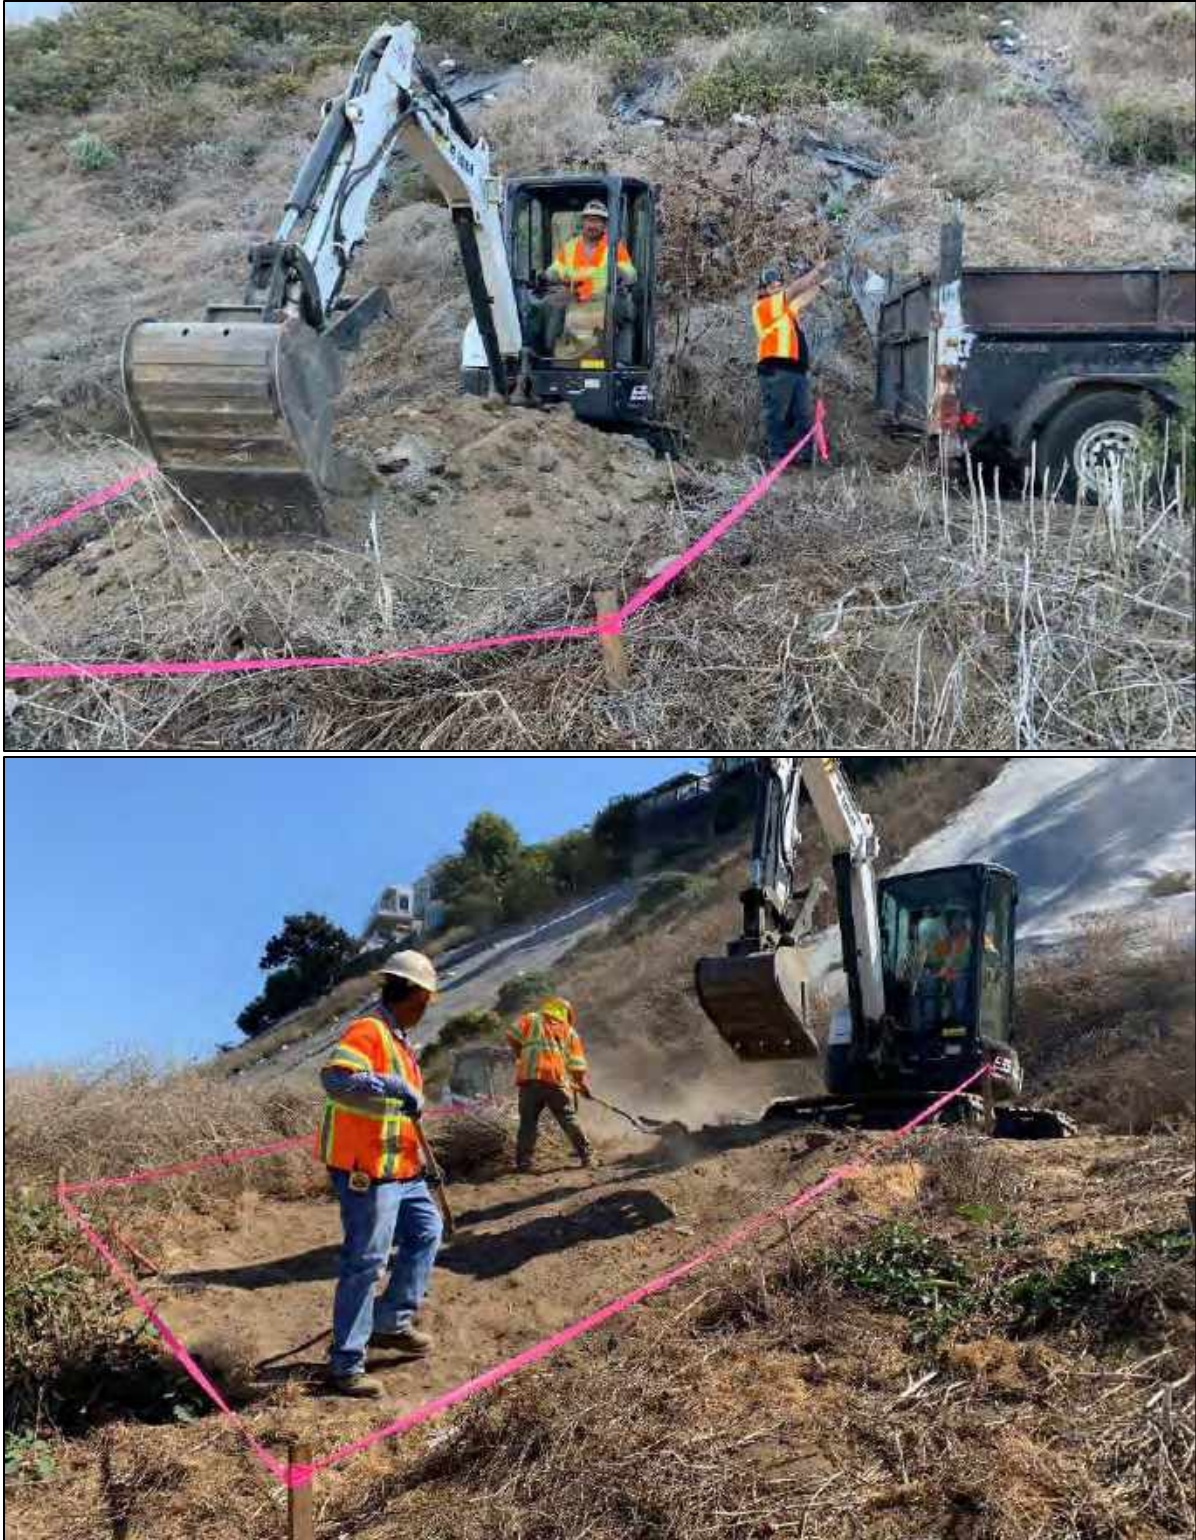
Figure 36. Photographs of the sediment and trash piles immediately before (top) and after (bottom) after removal from the restoration site (13 October 2020).

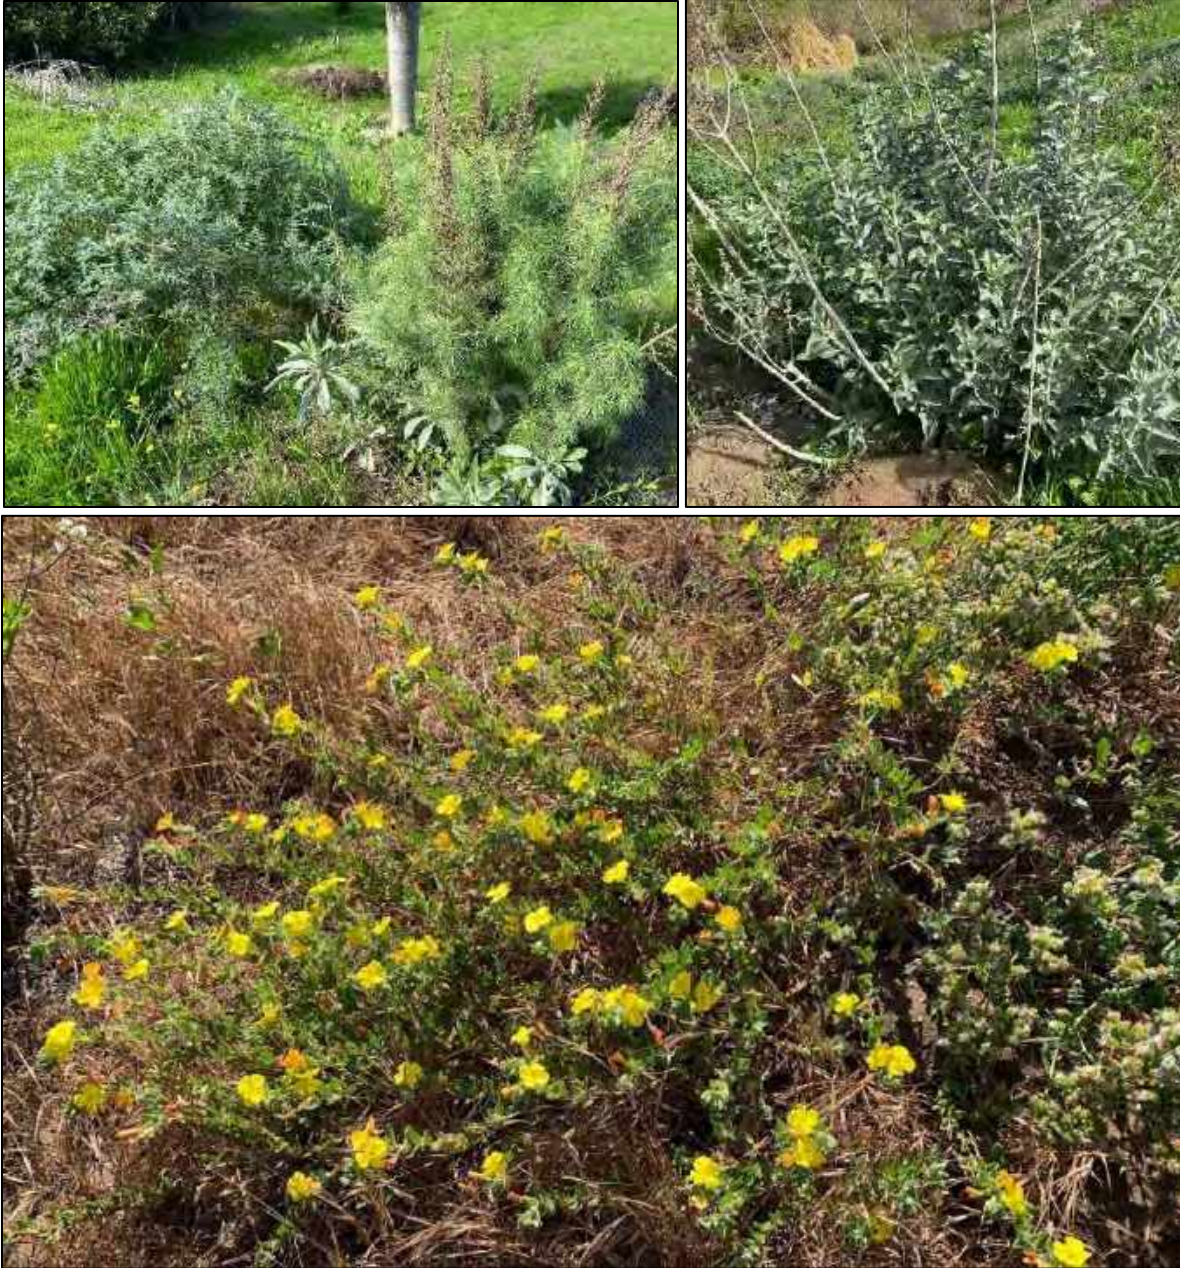
Figure 37. Native container stock plants established on site including an assemblage of branching phacelia, California sagebrush, and white sage (top left), white sage (top right), beach evening primrose (bottom).

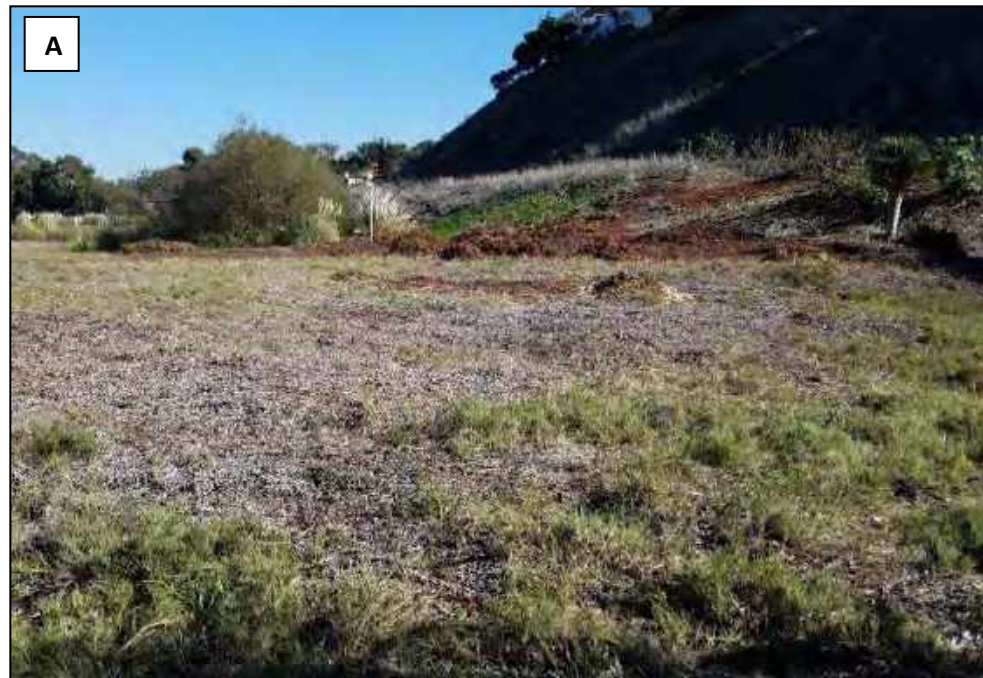
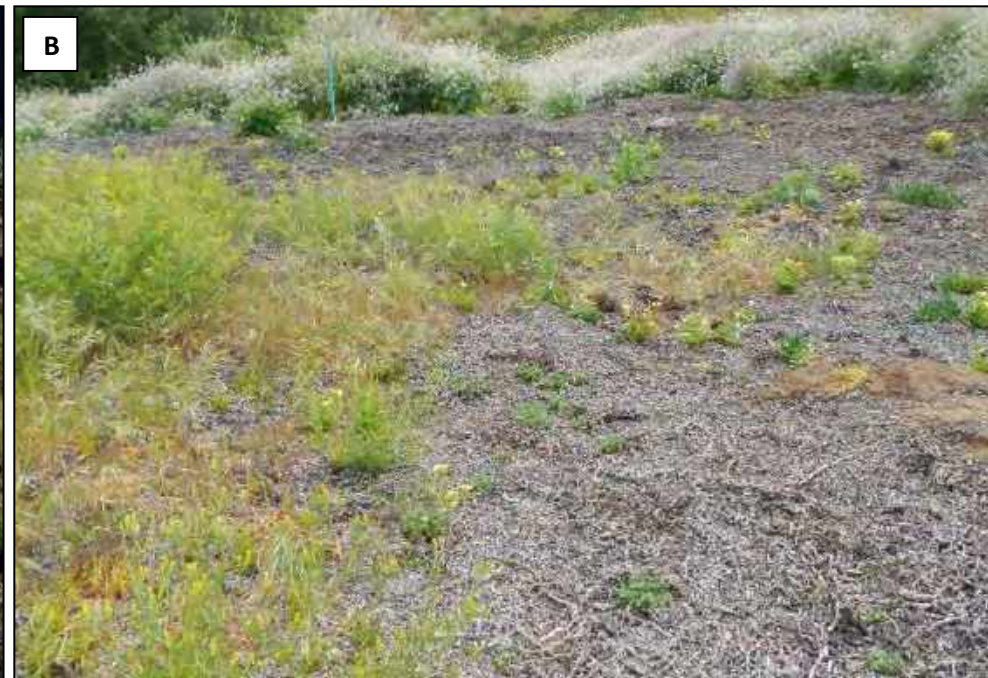
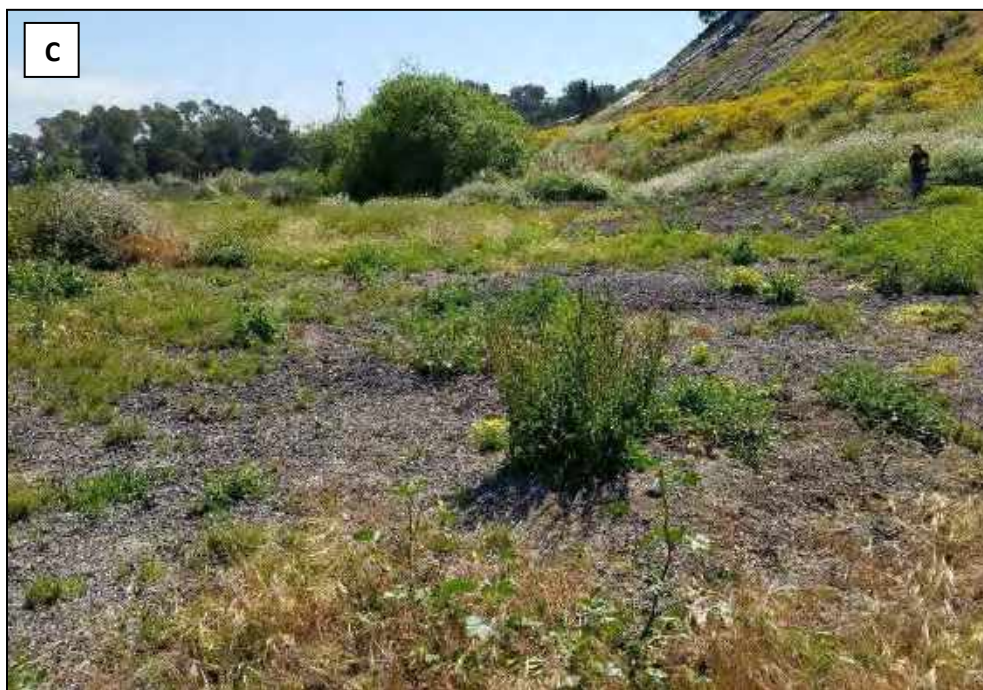
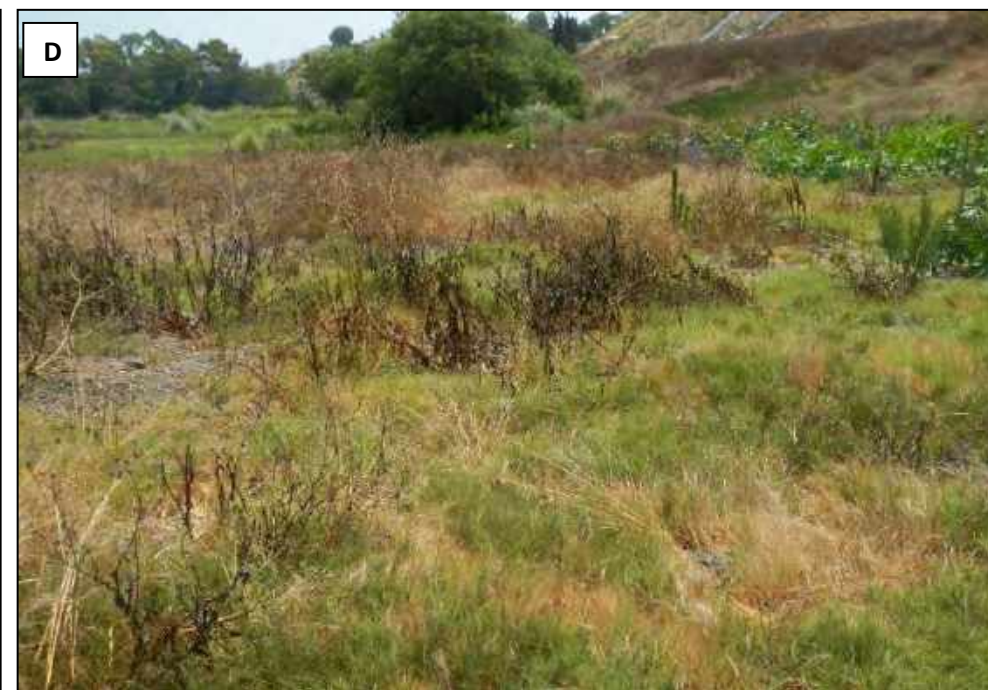
Figure A-1. Photo Point 1 at bearing 70° on (A) 29 November 2016; (B) 25 April 2016; (C) 2 May 2017; (D) 12 July 2017.

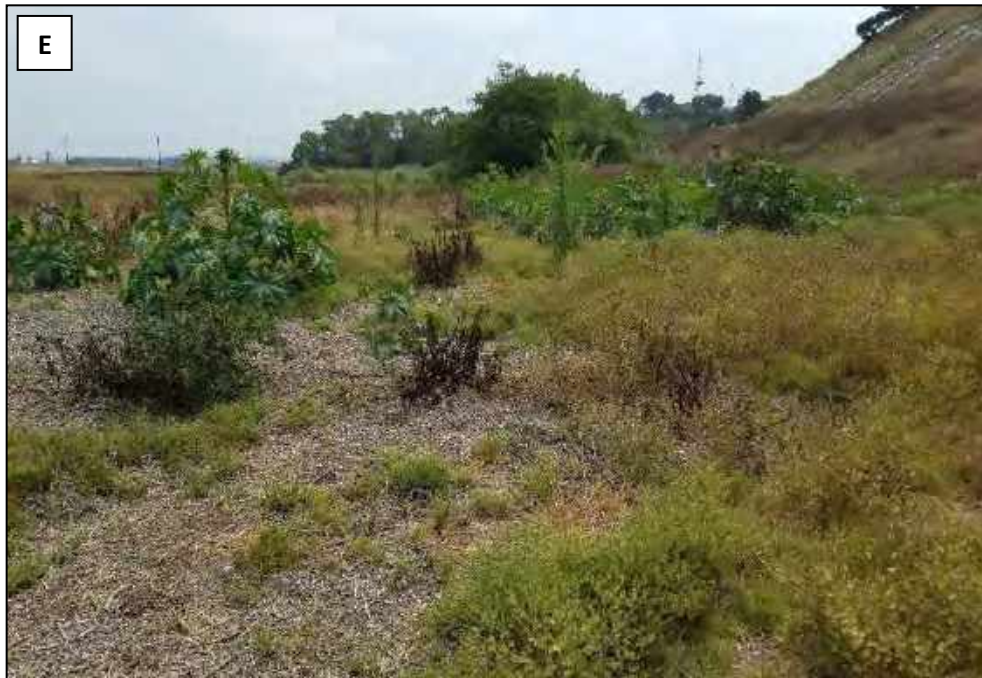
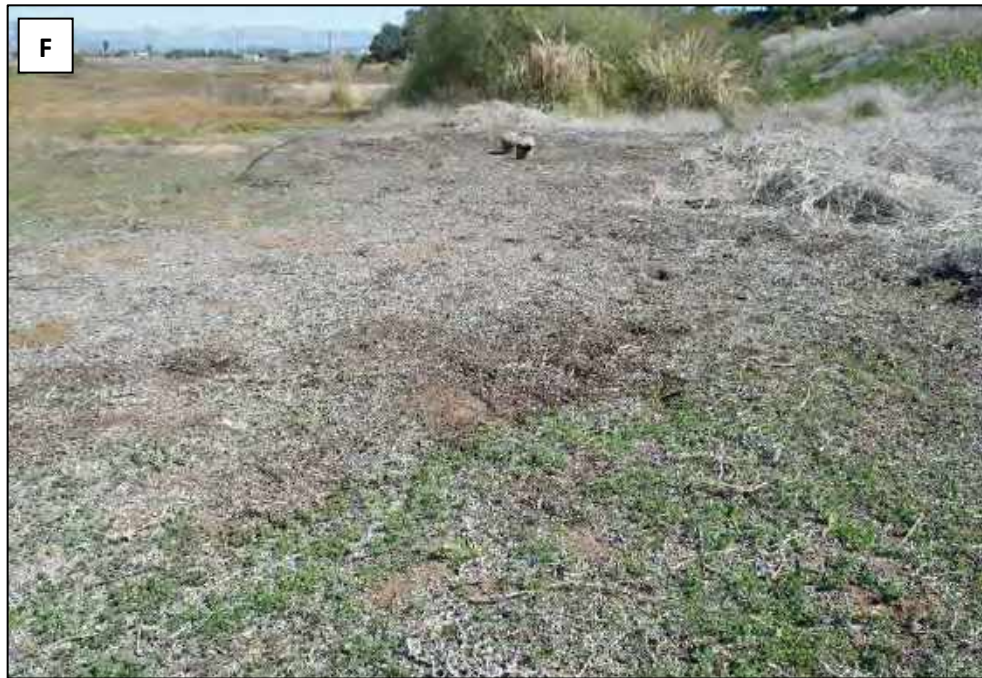
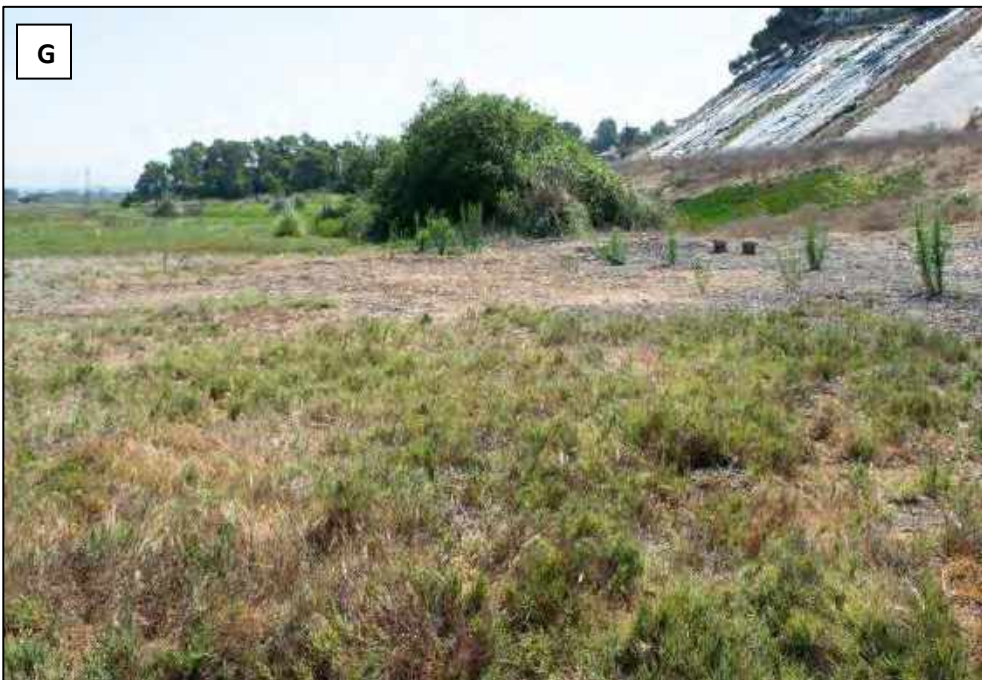
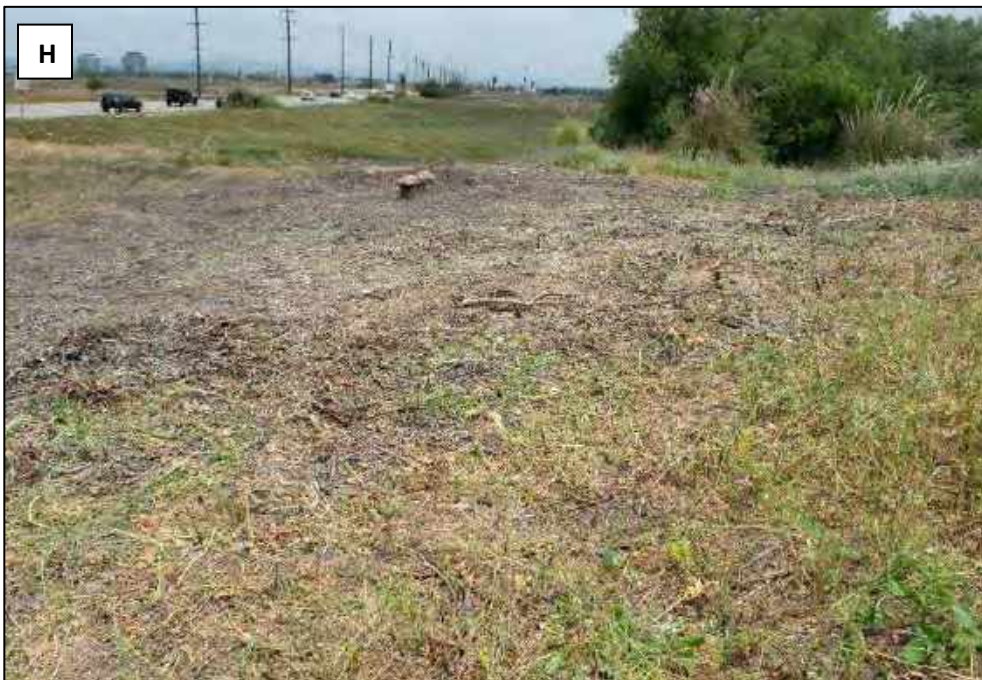
Figure A-2. Photo Point 1 at bearing 70° on (E) 12 August 2017; (F) 6 March 2018; (G) 18 May 2018; (H) 31 July 2018.

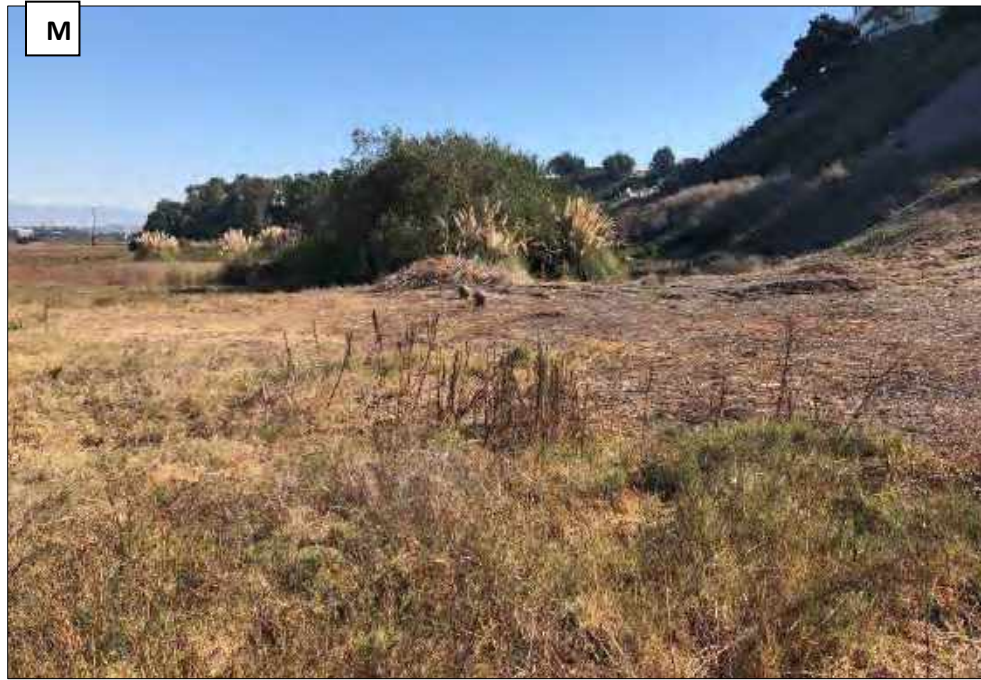
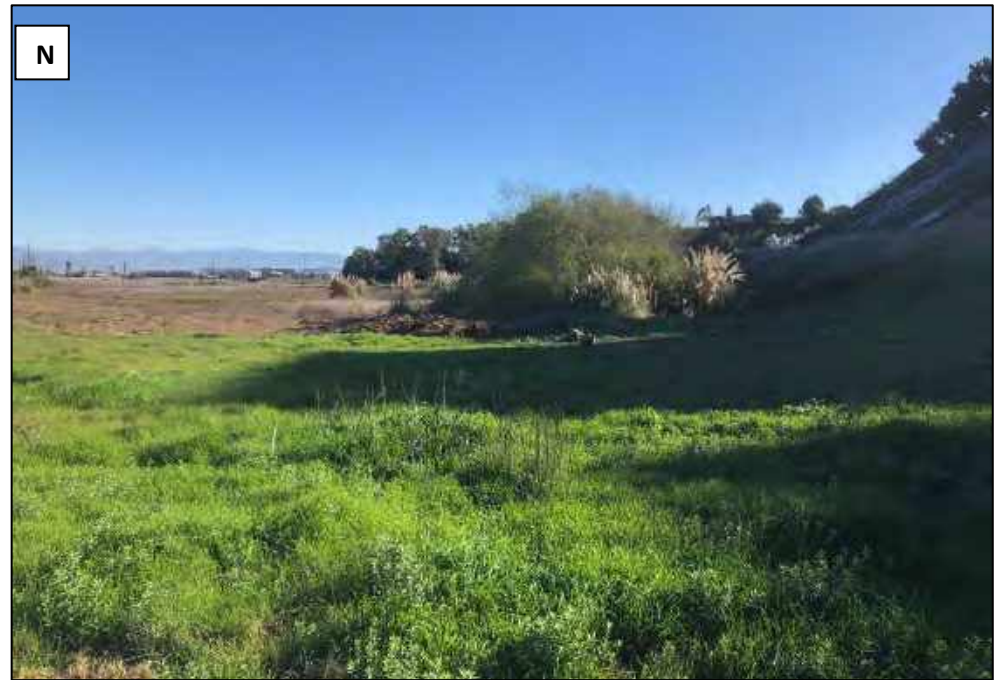
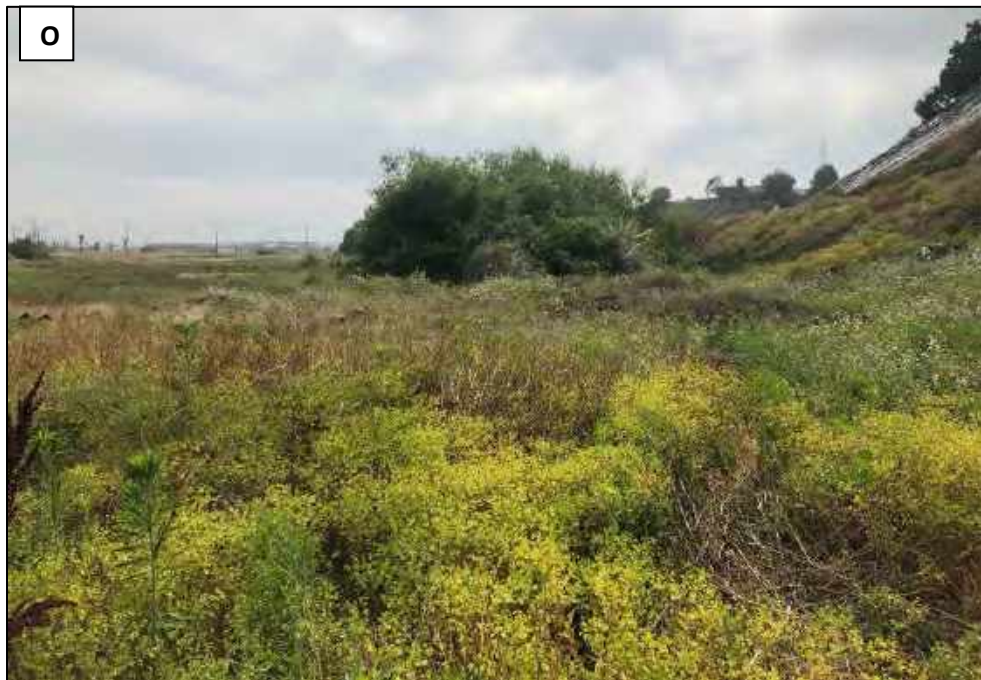
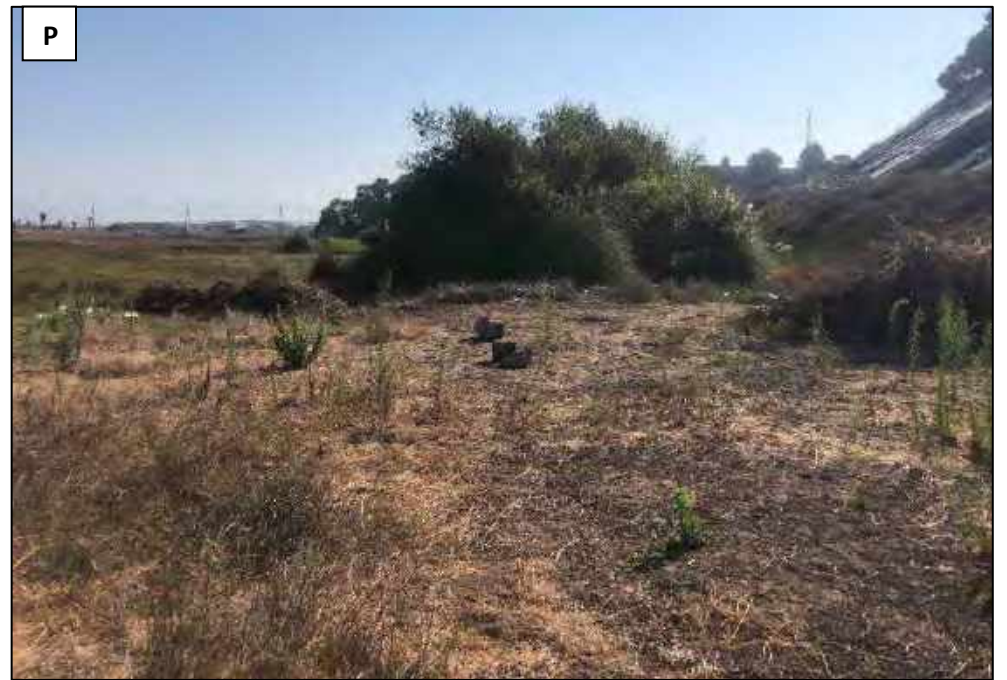
Figure A-4. Photo Point 1 at bearing 70° on (M) 31 October 2019; (N) 11 February 2020; (O) 2 June 2020; (P) 28 August 2020.

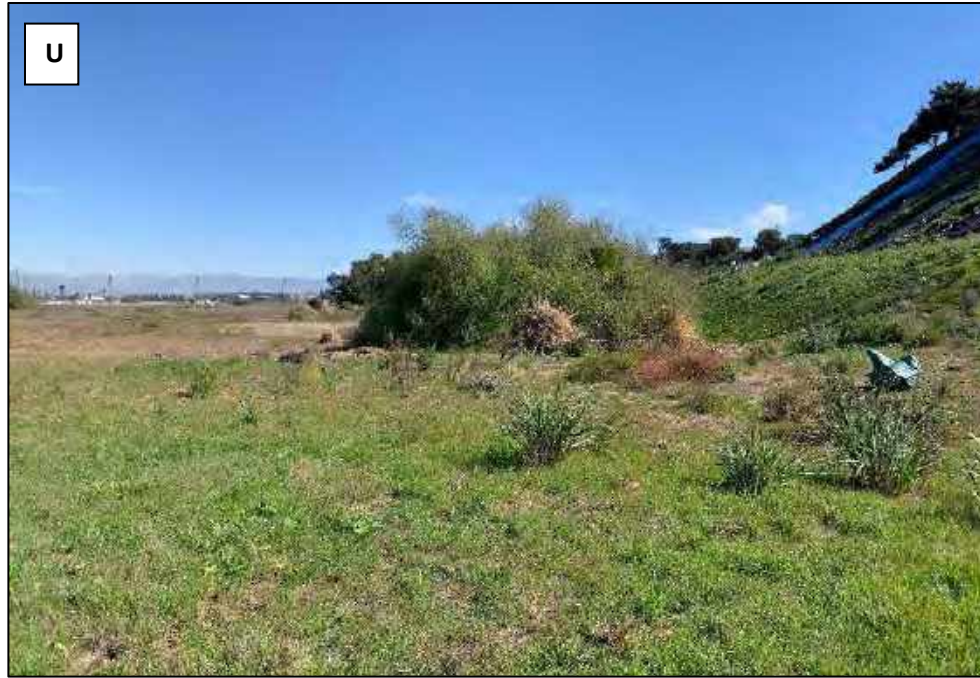
Figure A-6. Photo Point 1 at bearing 70° on (U) 28 February 2022.
