Ballona Wetlands Restoration: Community Iceplant Removal Project

Year 6 Annual Report

October 2022

Coastal Development Permit No. 5-15-1427

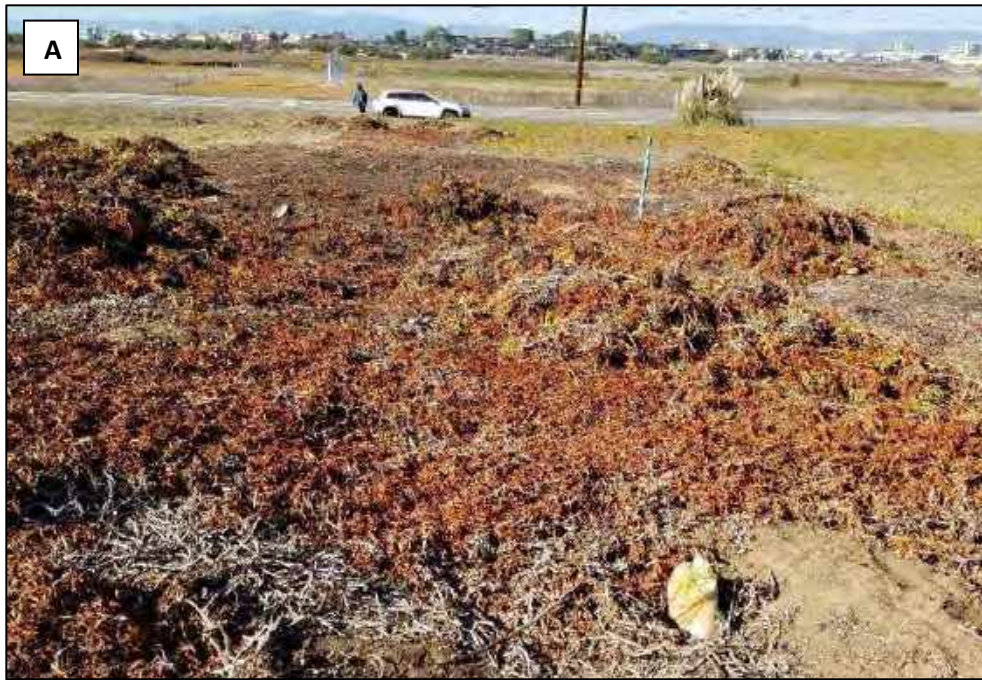
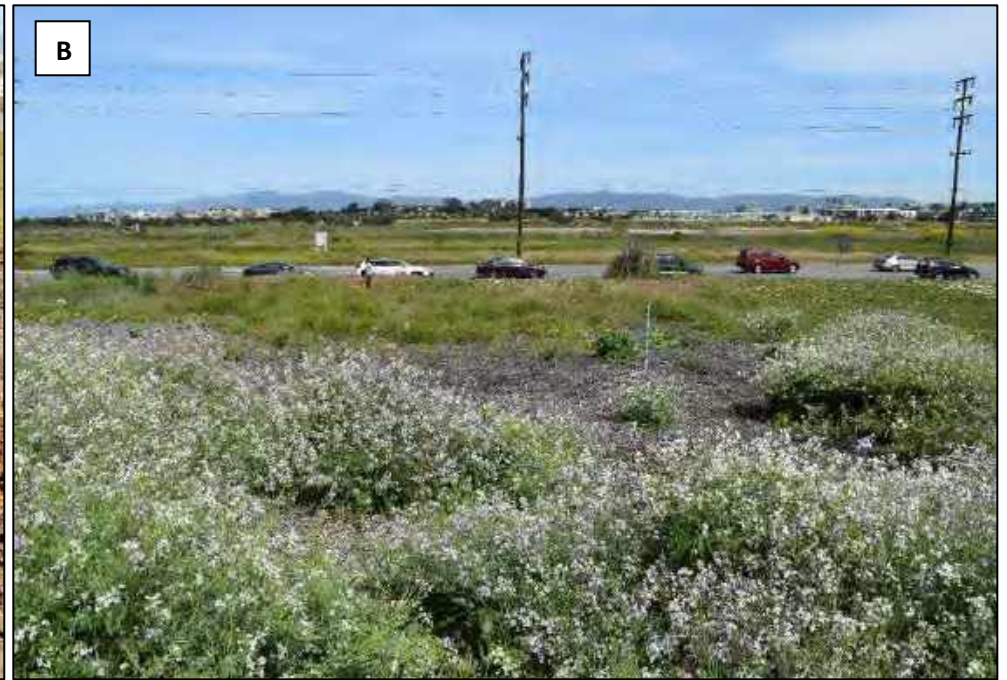
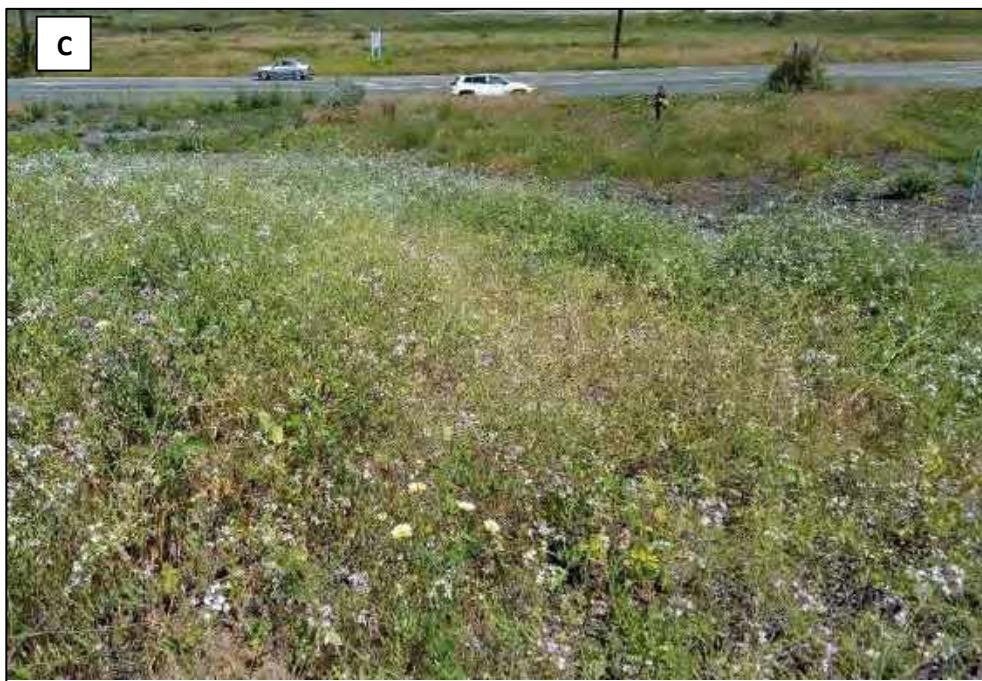
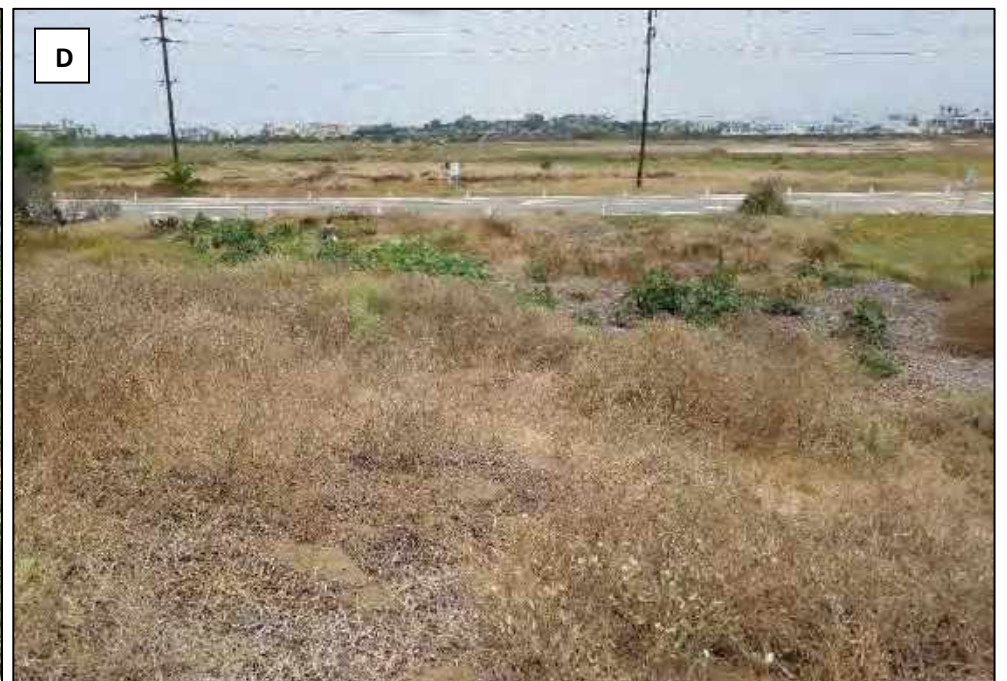
Figure A-7. Photo Point 2 at bearing 300° on (A) 29 November 2016; (B) 25 April 2017; (C) 2 May 2017; (D) 12 July 2017- different than Year 2 report, bearing accurate.

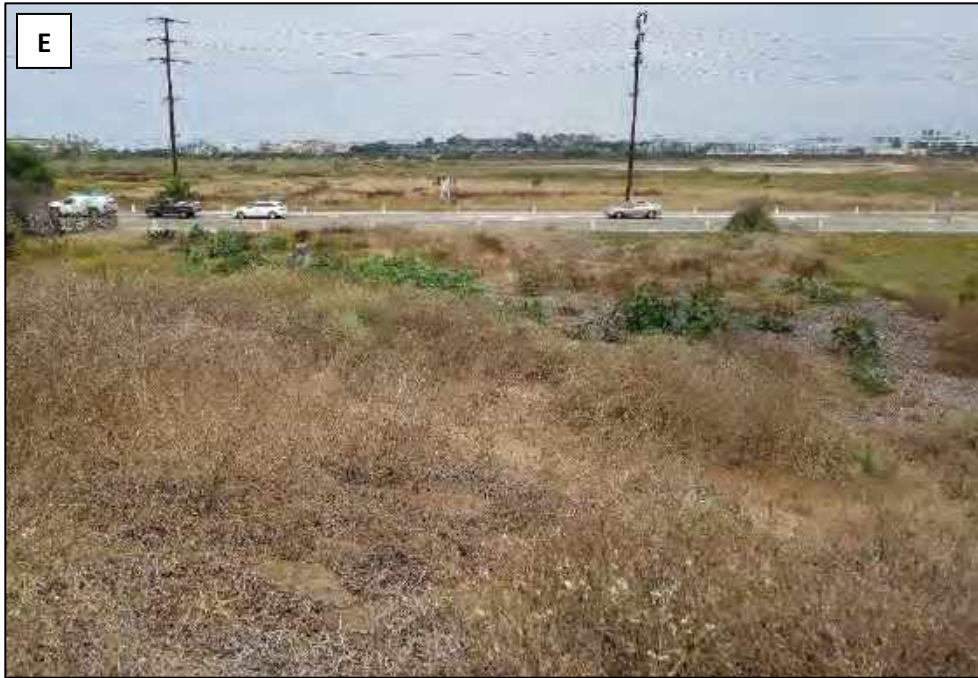
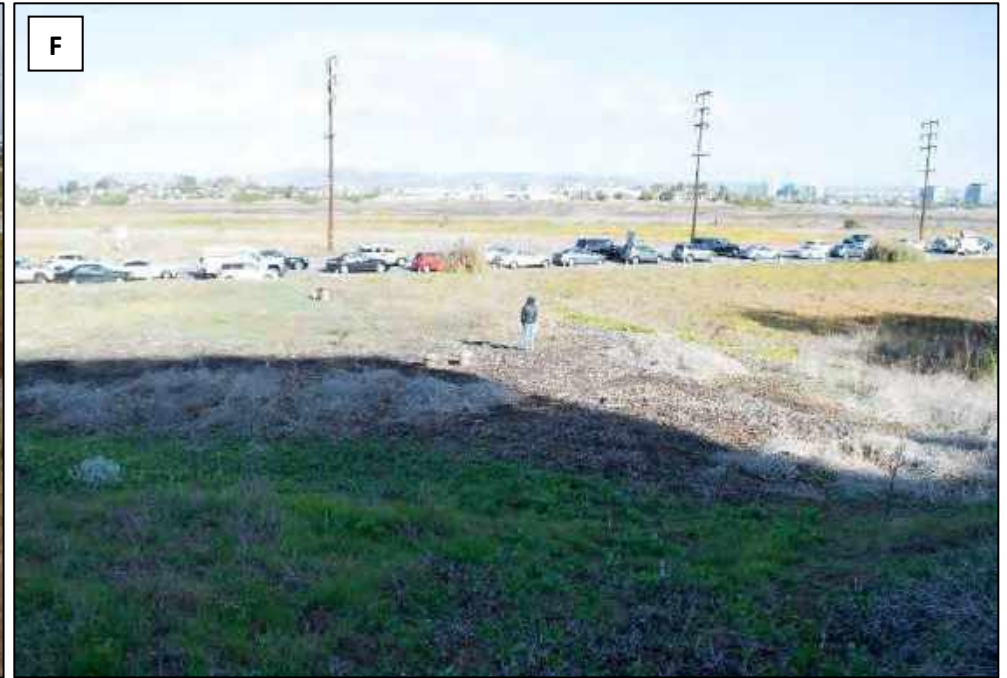
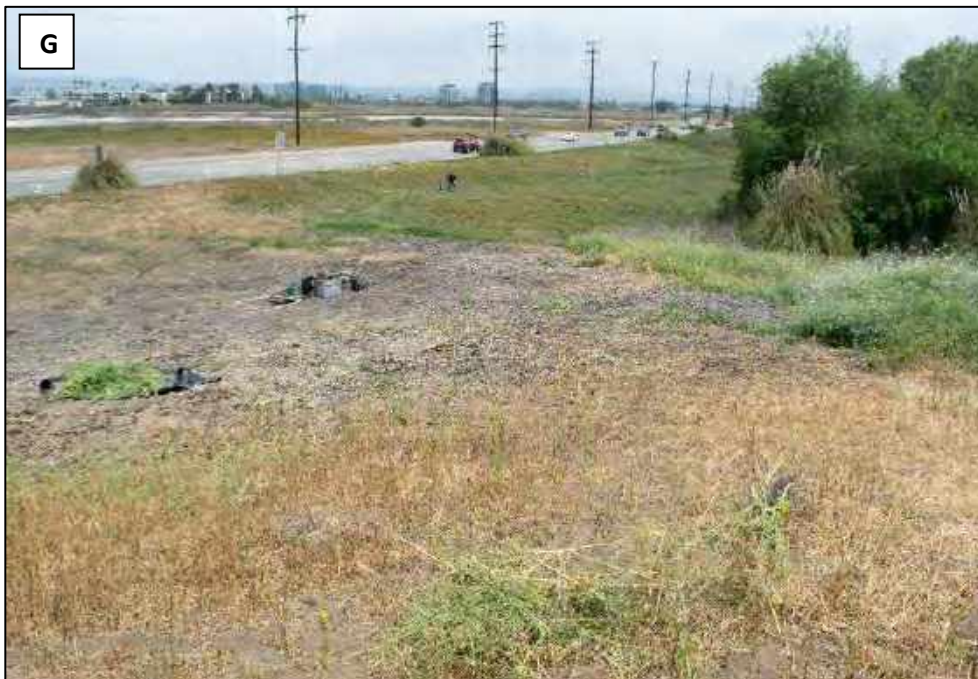
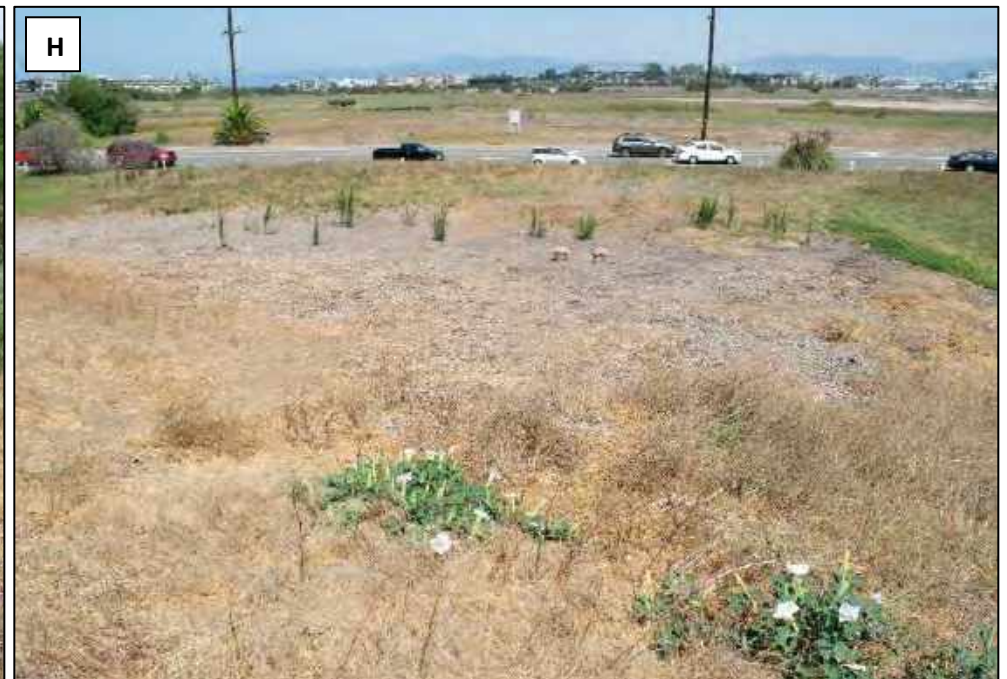
Figure A-8. Photo Point 2 at bearing 300° on (E) 12 August 2017; (F) 27 February 2018; (G) 18 May 2018; (H) 31 July 2018.

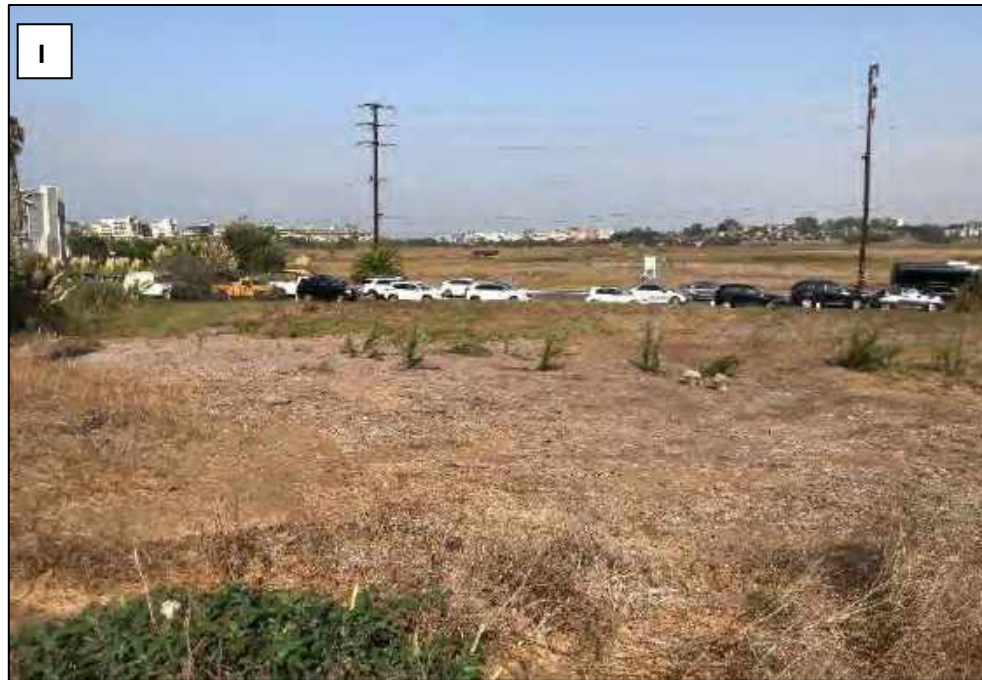
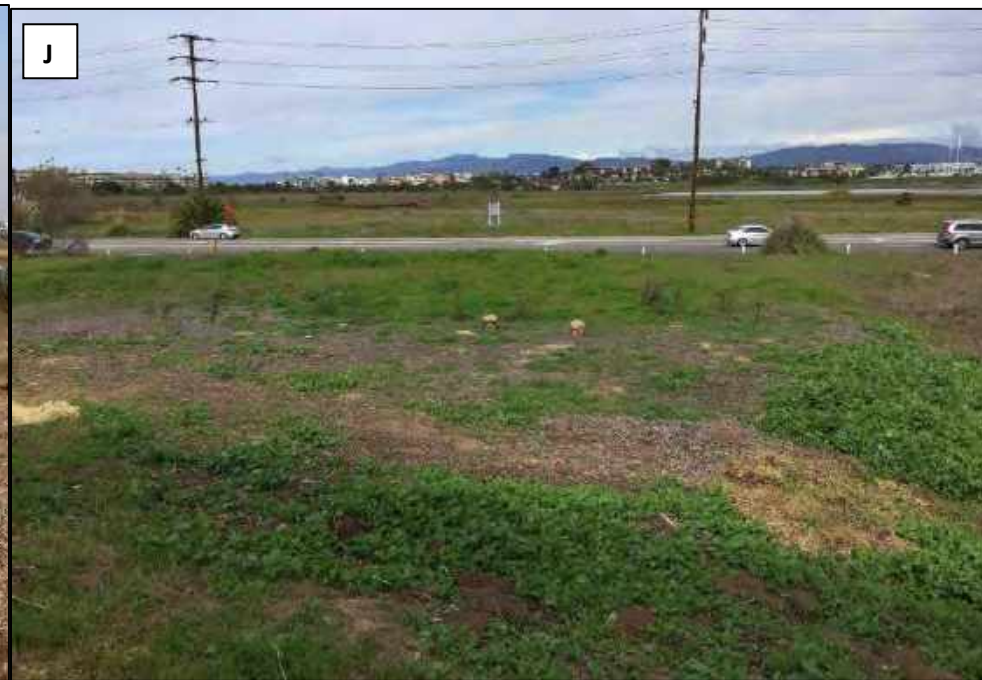
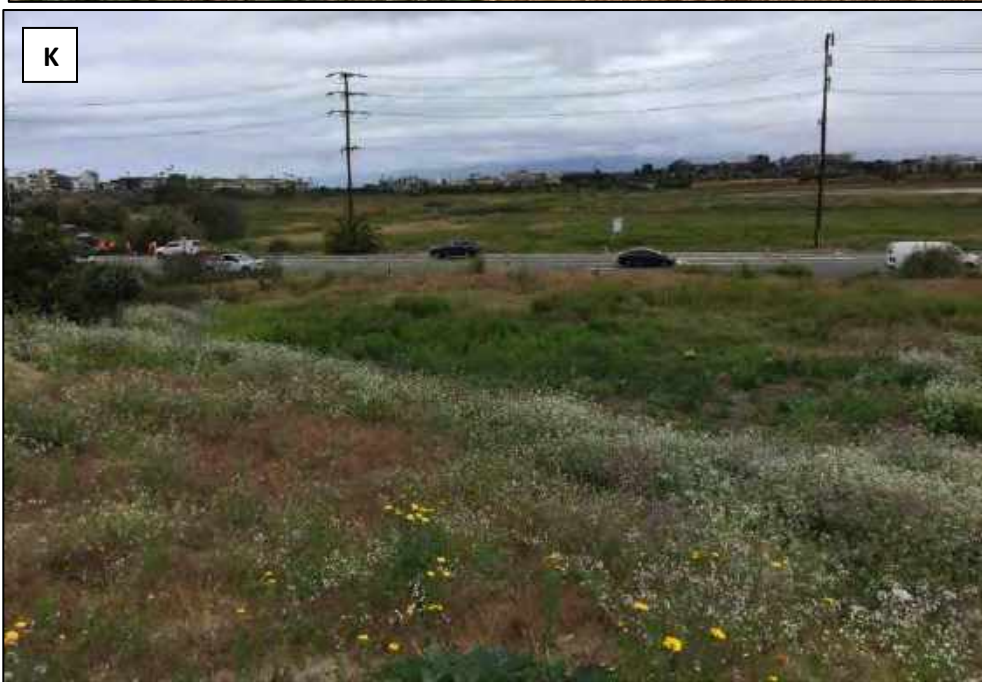
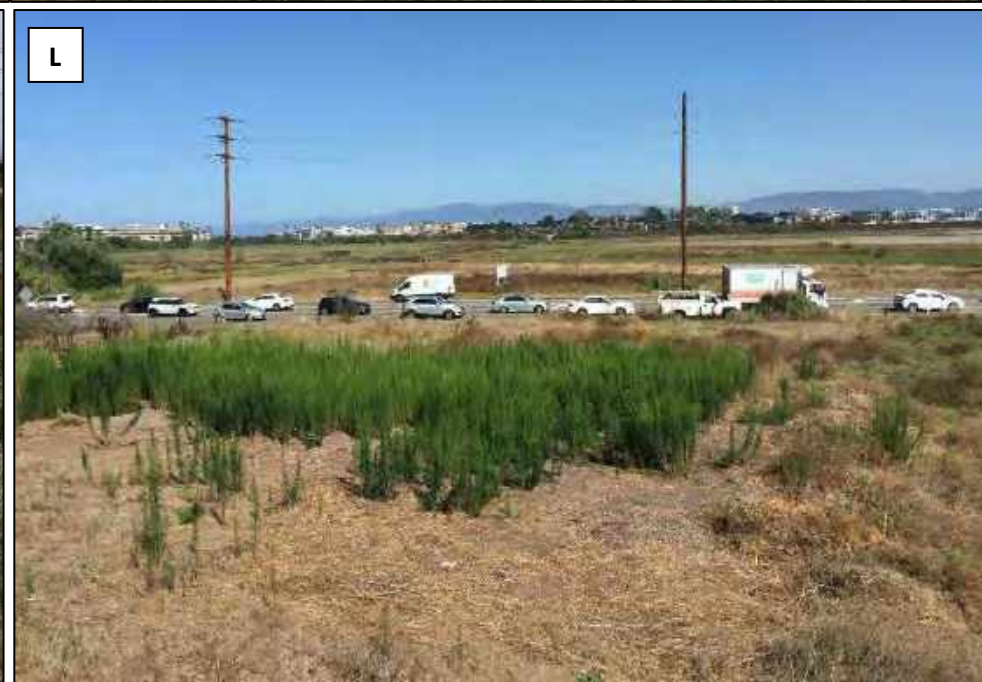
Figure A-9. Photo Point 2 at bearing 300° on (I) 20 September 2018; (J) 21 February 2018; (K) 30 April 2019; (L) 24 July 2019.

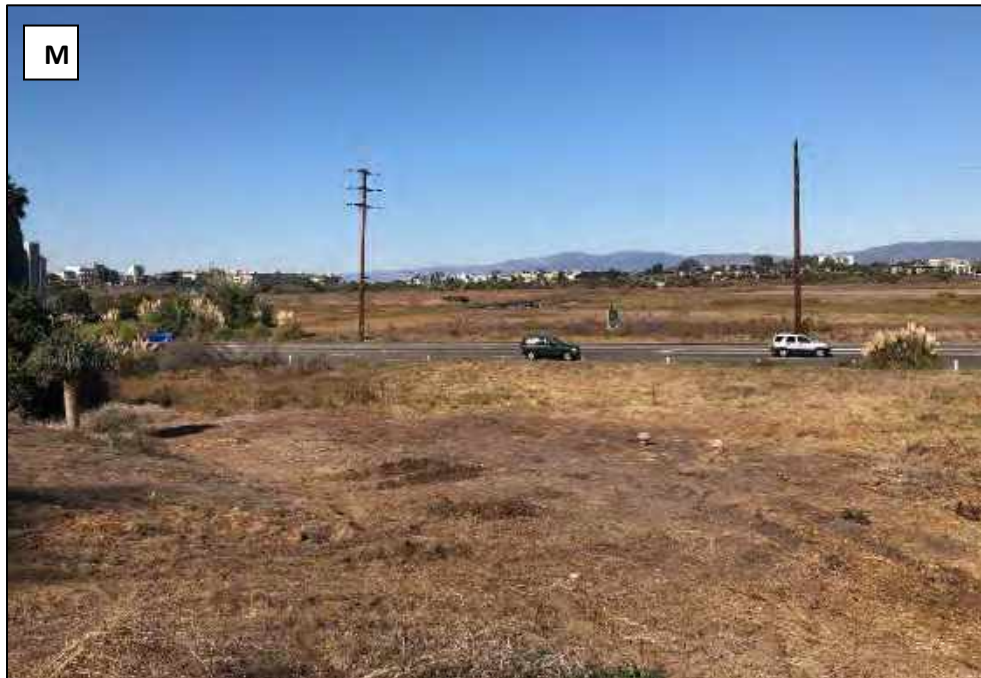
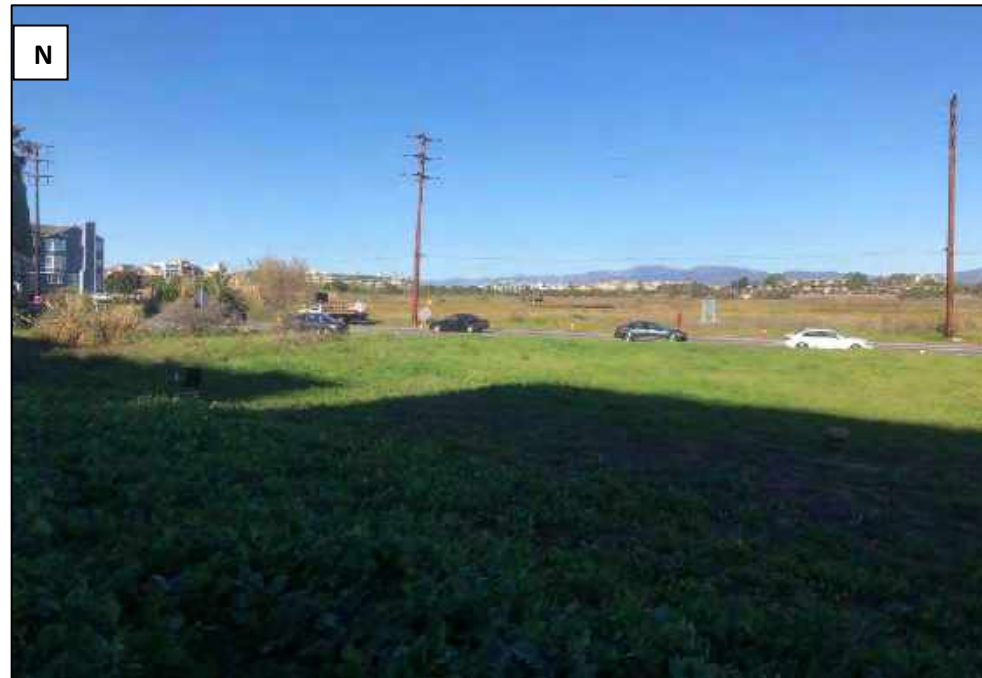
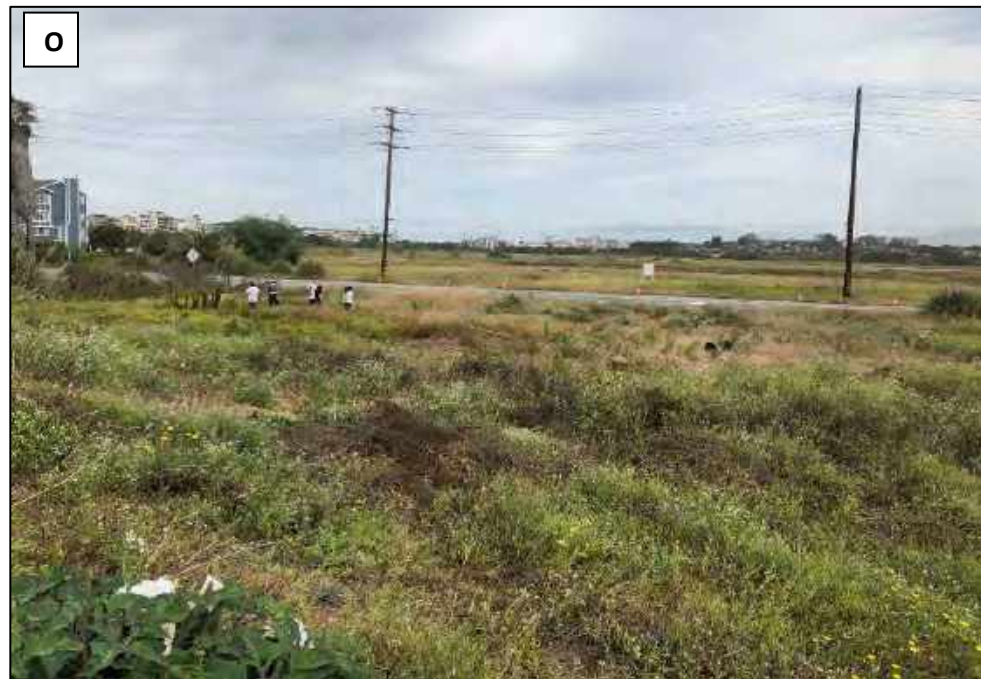
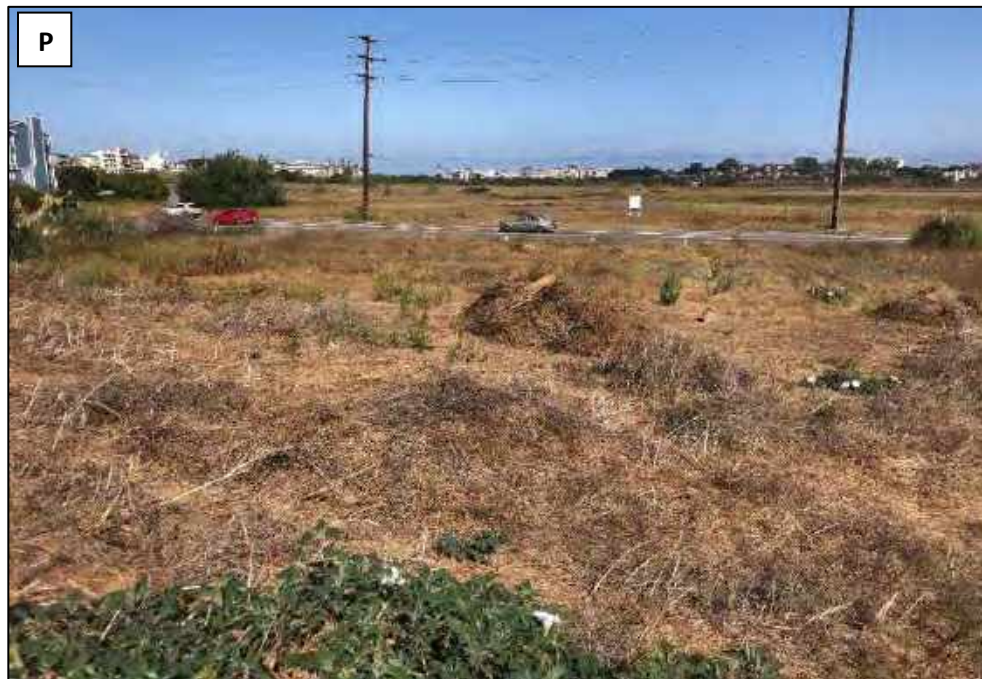
Figure A-10. Photo Point 2 at bearing 300° on (M) 31 October 2019; (N) 11 February 2020; (O) 2 June 2020; (P) 28 August 2020.

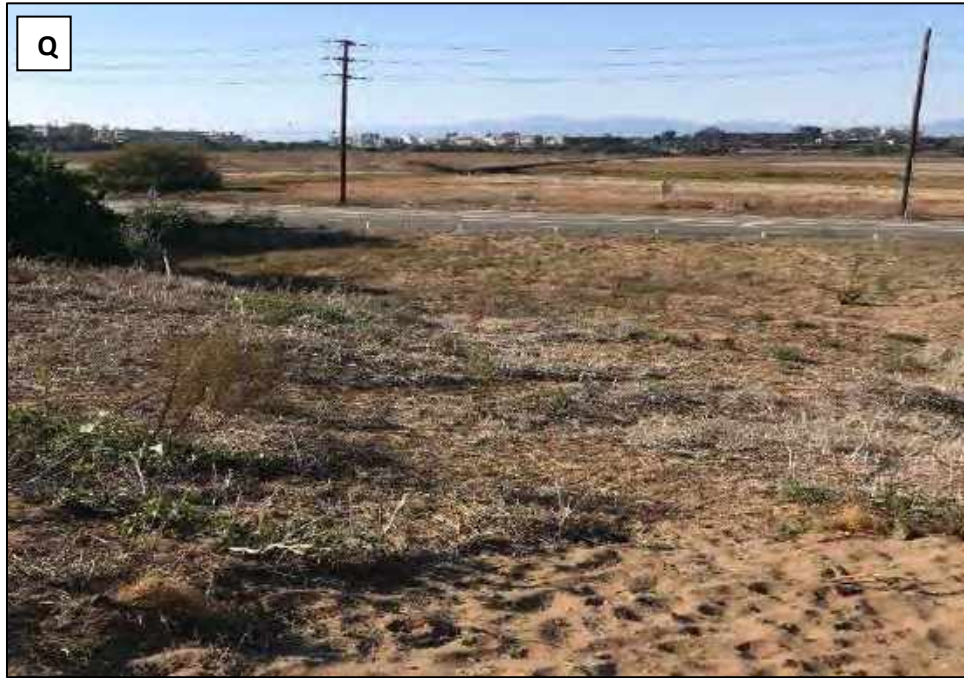
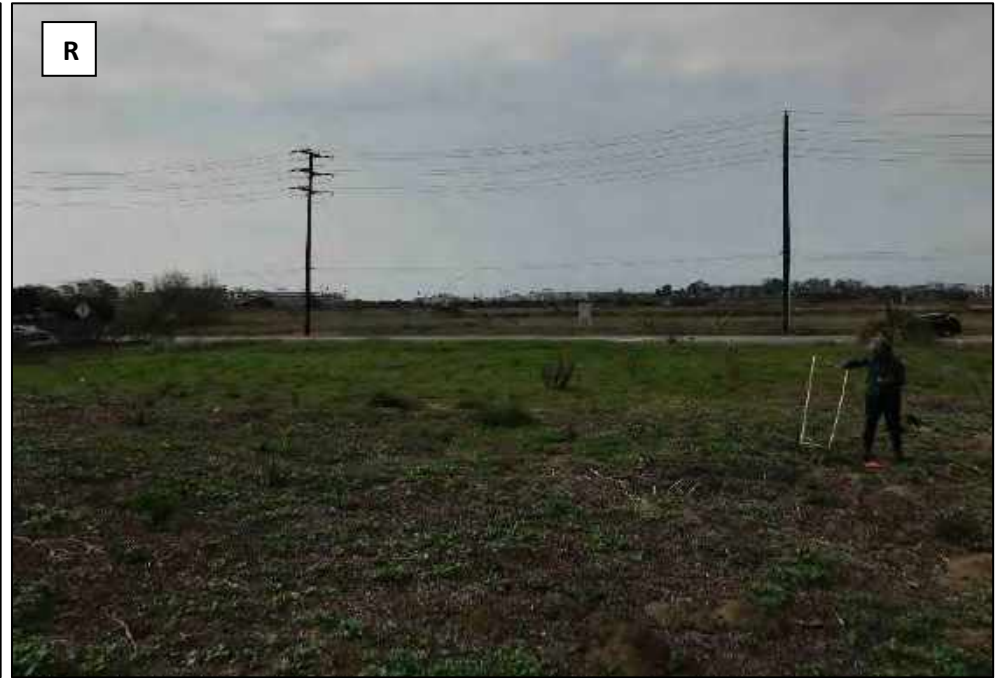
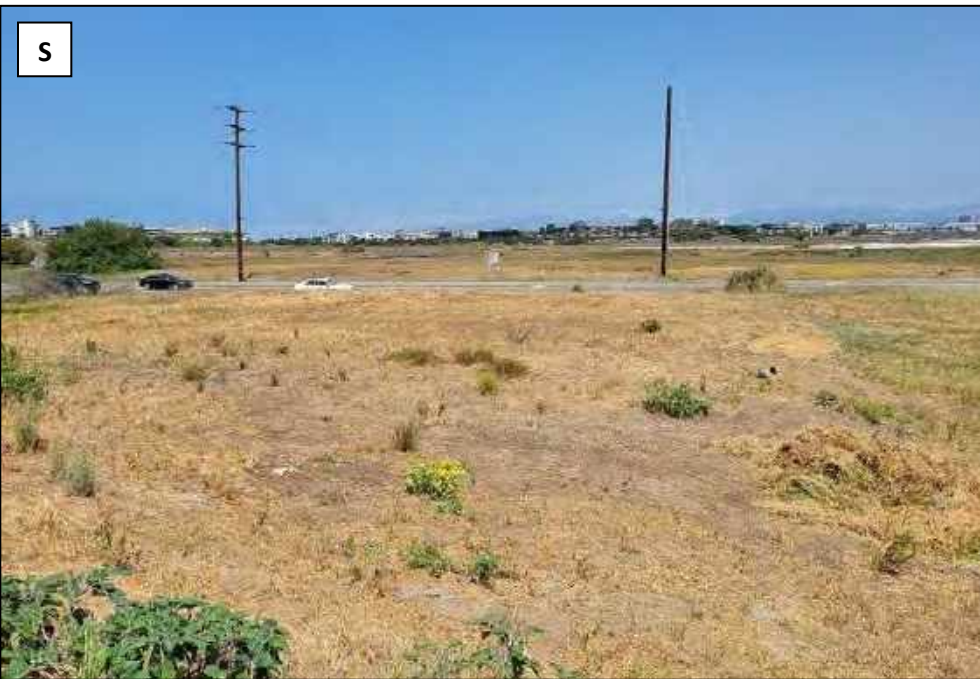
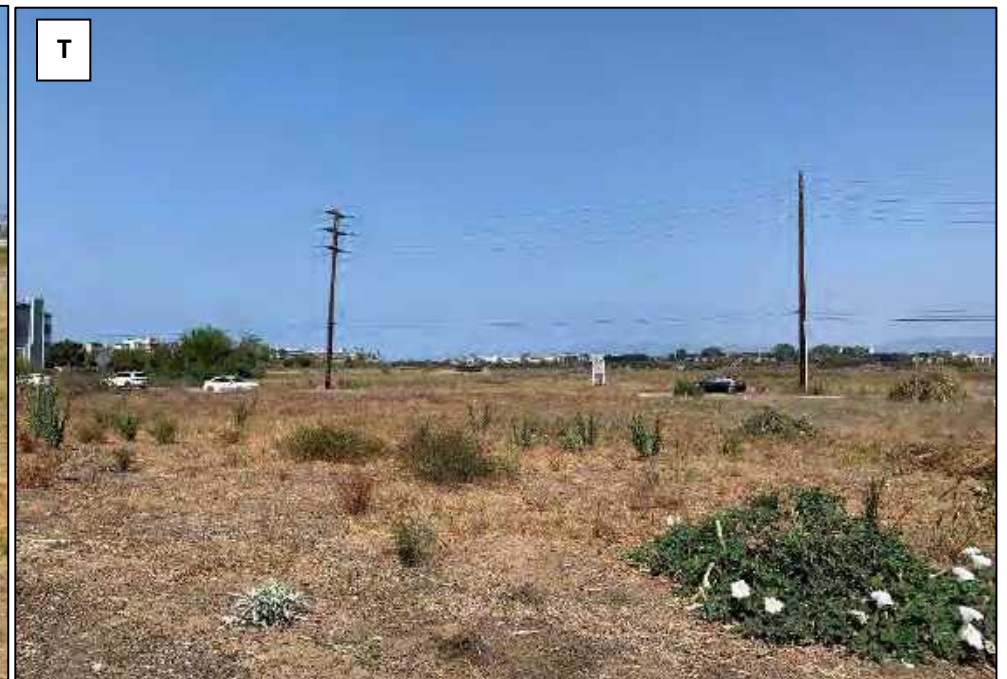
Figure A-11. Photo Point 2 at bearing 300° on (Q) 12 November 2020; (R) 9 February 2021; (S) 18 May 2021; (T) 24 August 2021.

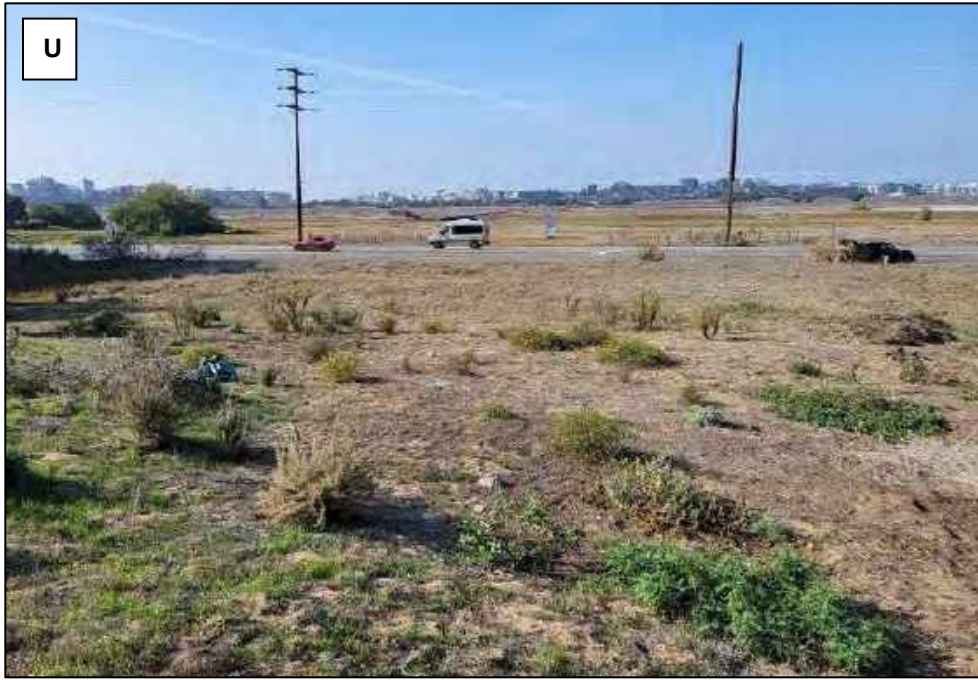
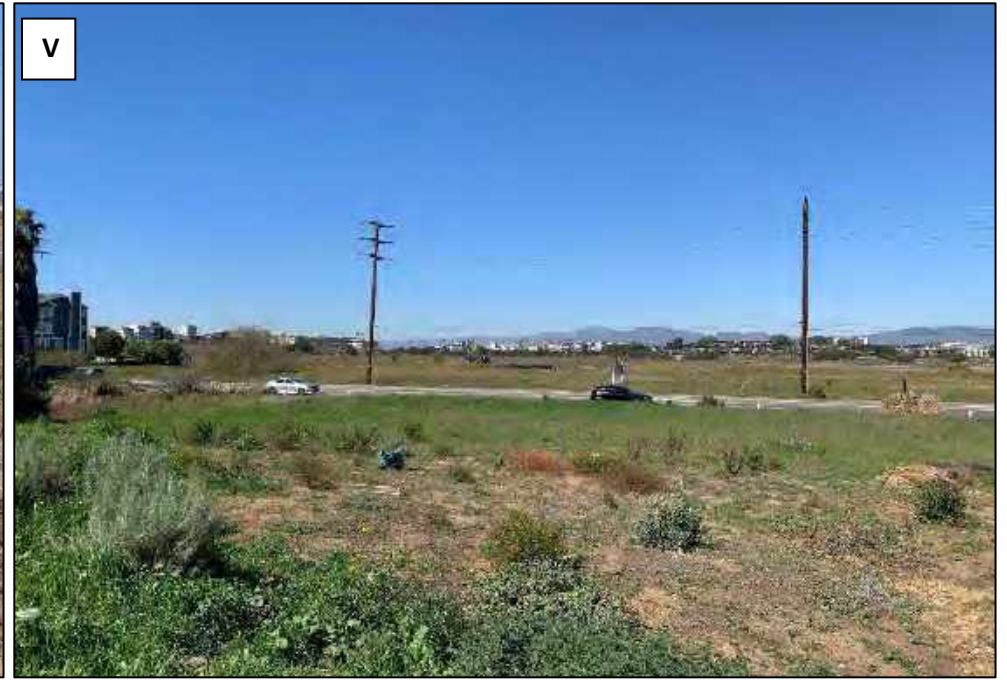
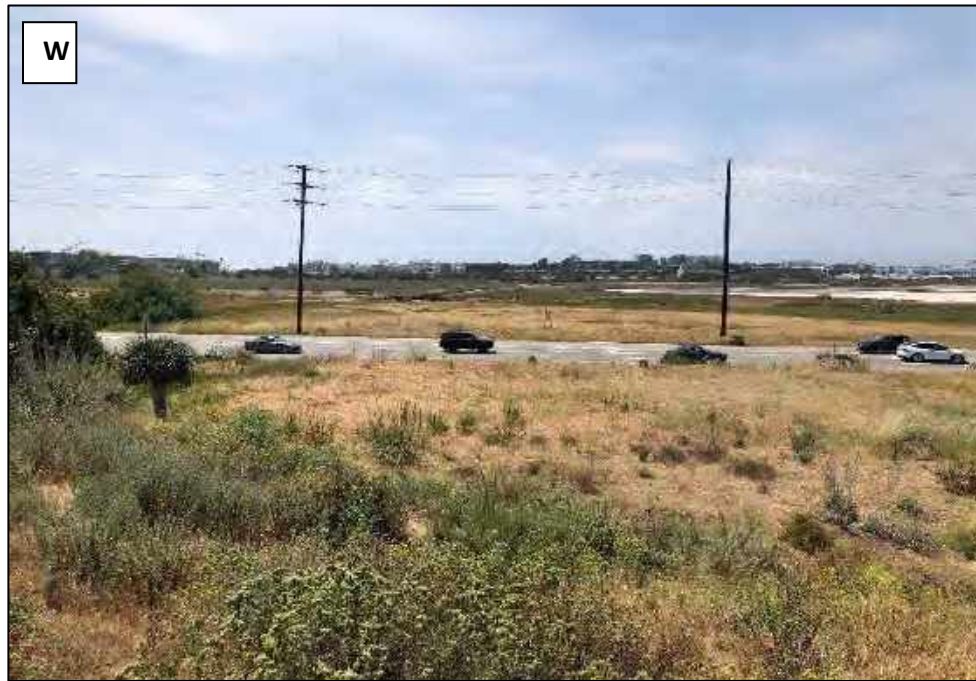
Figure A-12. Photo Point 2 at bearing 300° on (U) 17 November 2021; (V) 28 February 2022; (W) 03 June 2022.

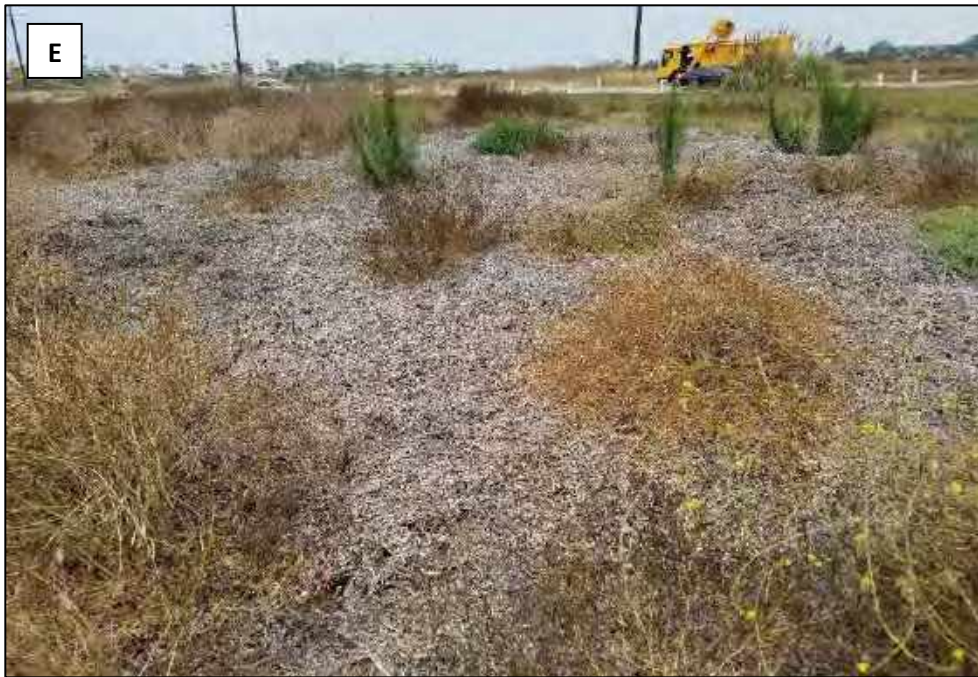
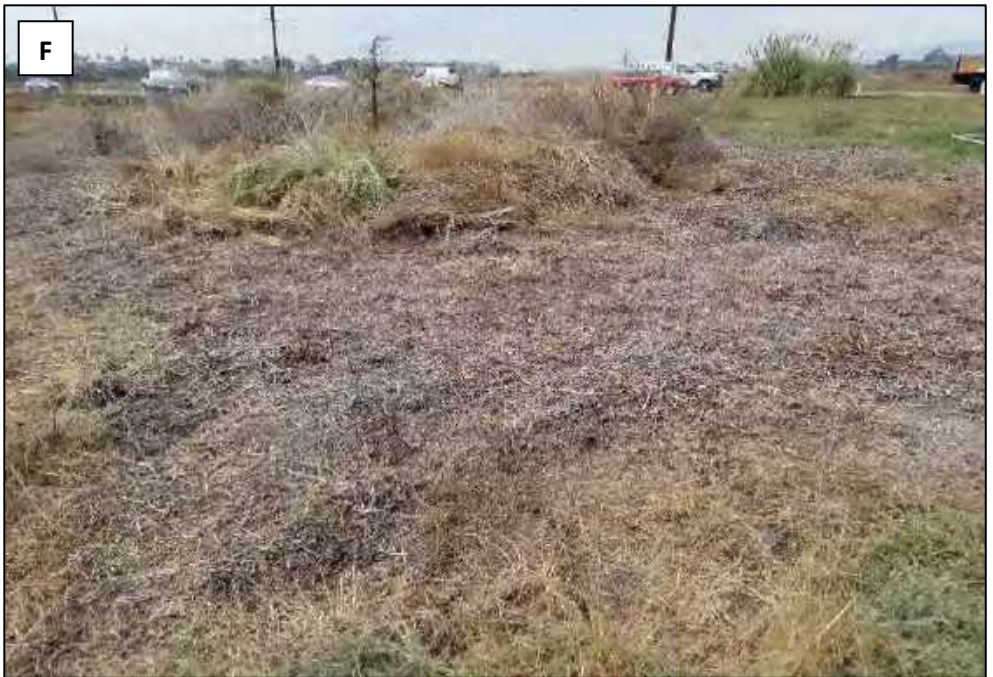
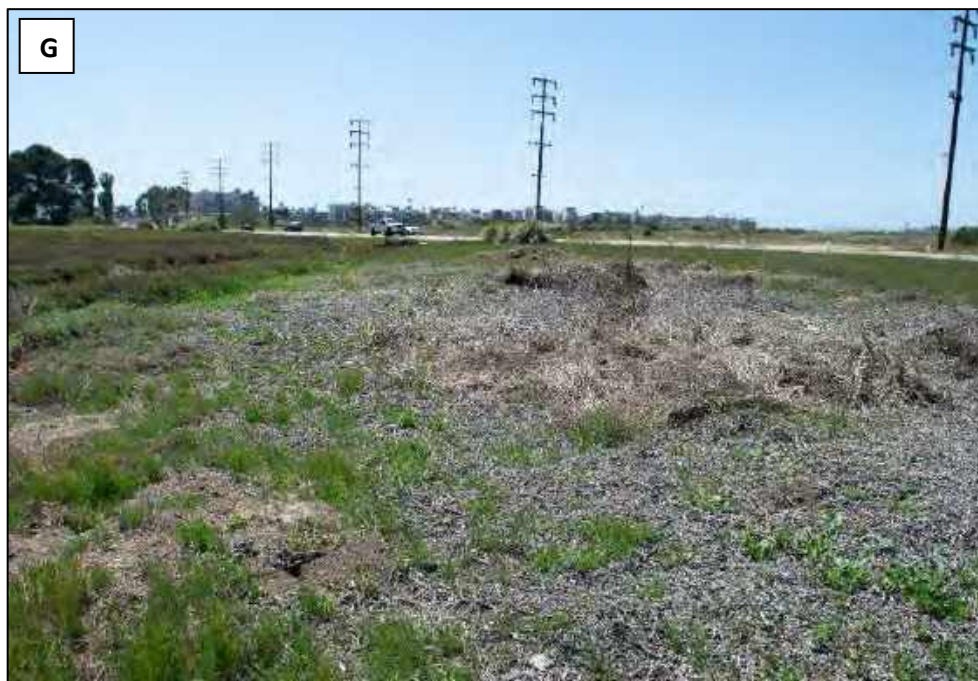
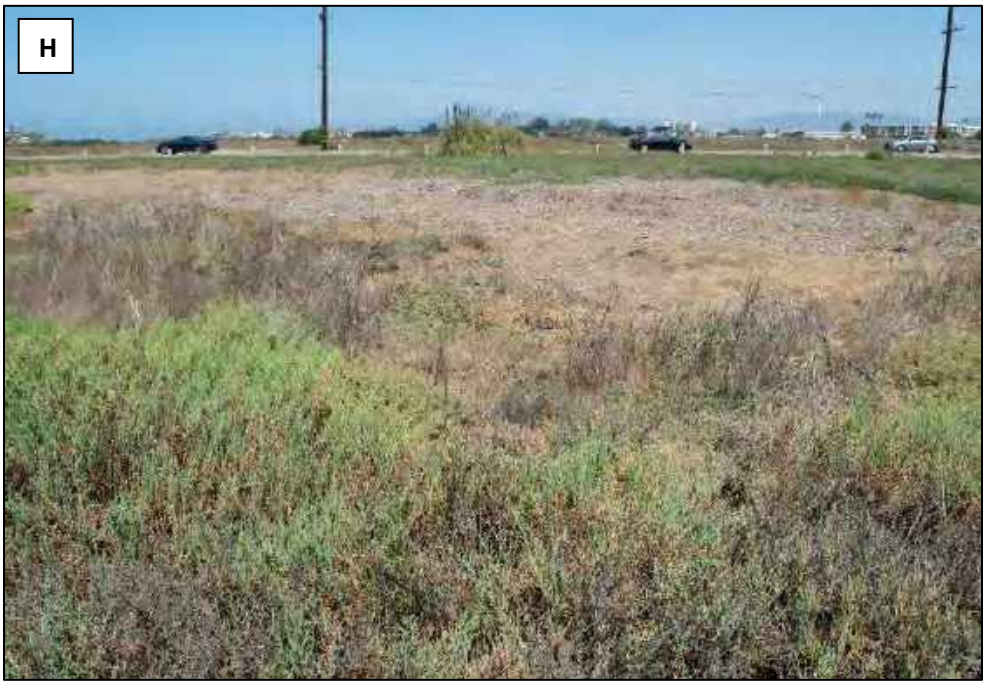
Figure A-14. Photo Point 3 at bearing 270° on (E) 12 August 2017; (F) 16 November 2017; (G) 18 April 2018; (H) 31 July 2018.

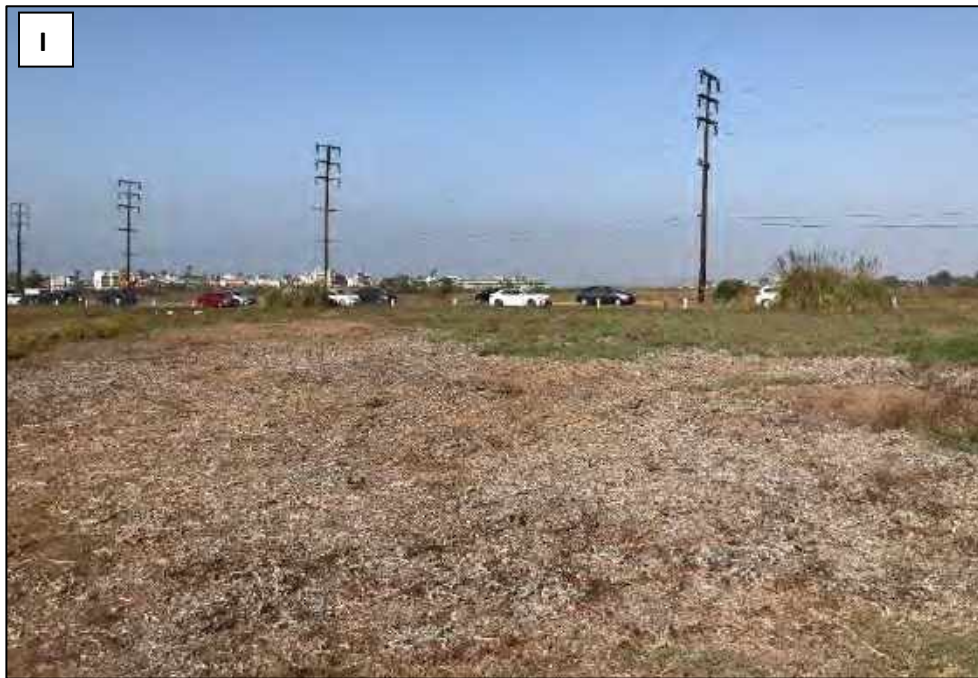
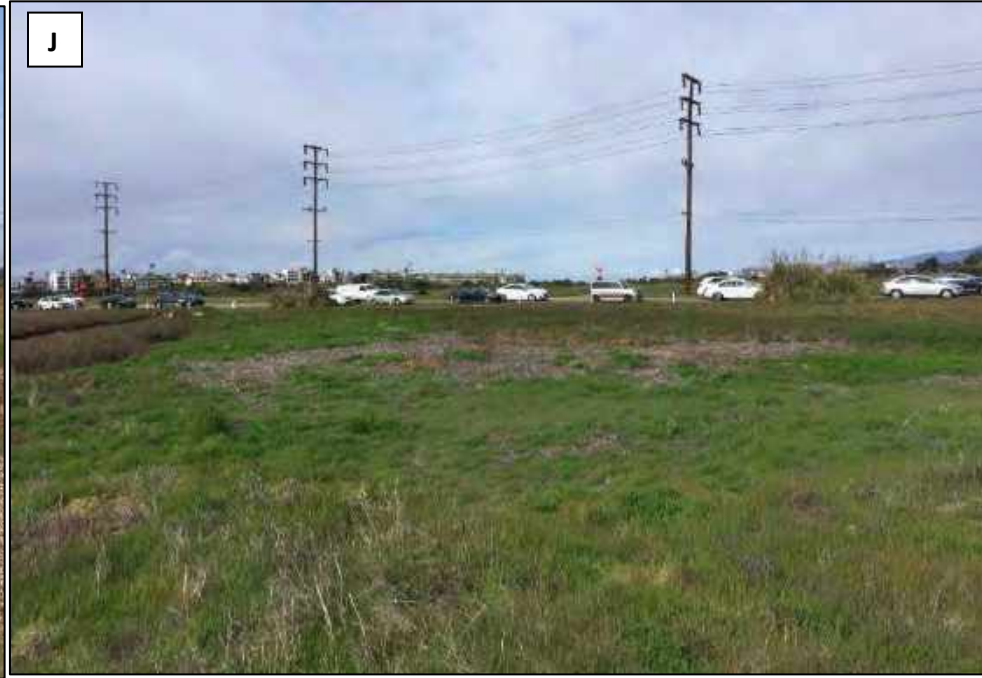
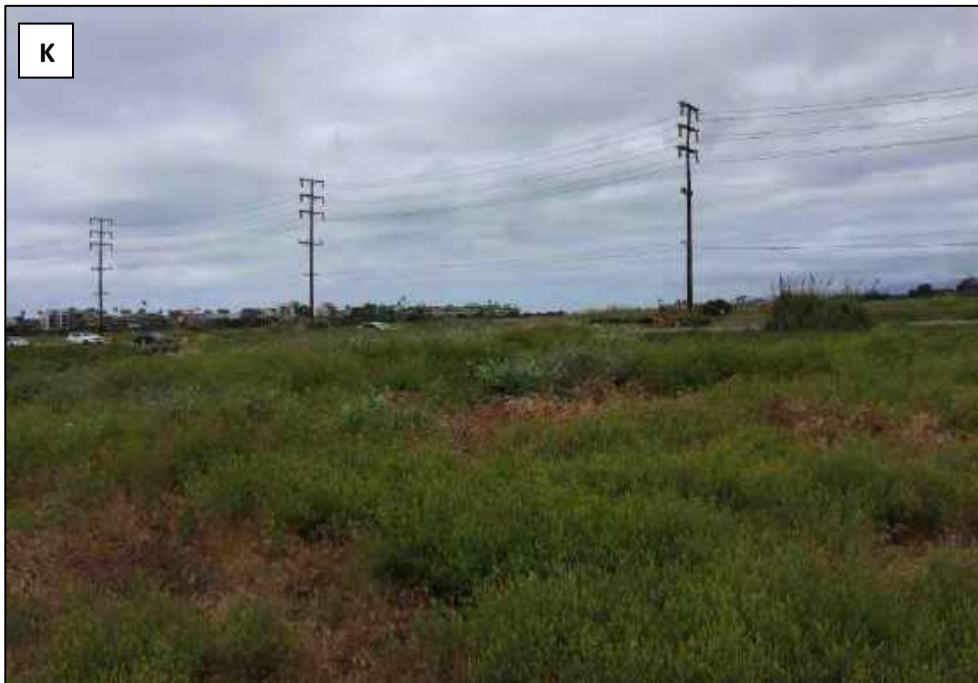
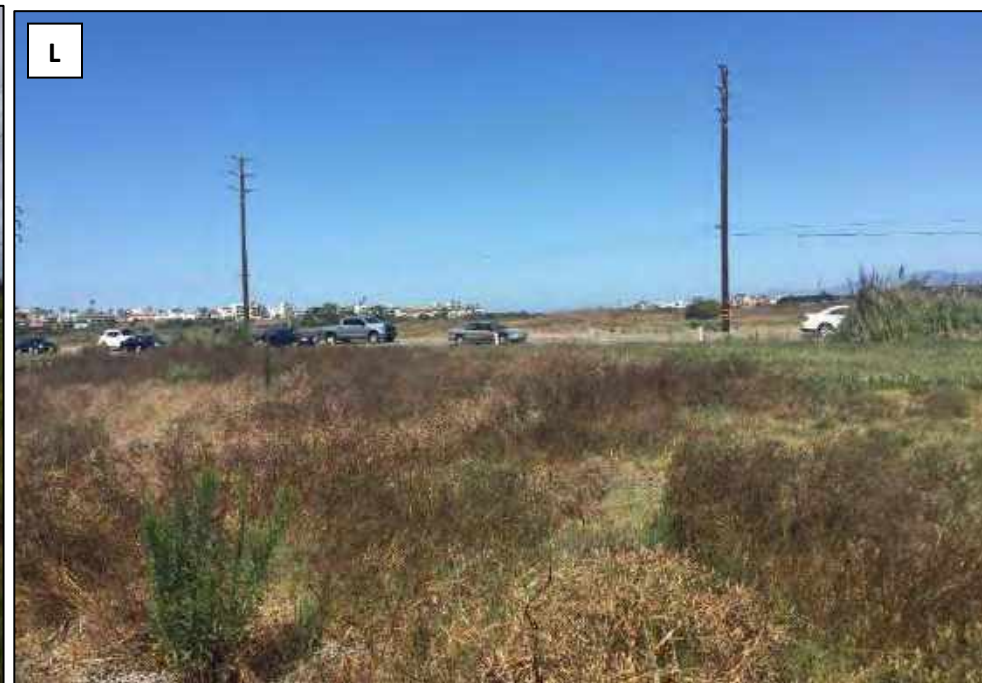
Figure A-15. Photo Point 3 at bearing 270° on (I) 20 September 2018; (J) 21 February 2018; (K) 30 April 2019; (L) 24 July 2019.
