Ballona Wetlands Restoration: Community Iceplant Removal Project

Year 6 Annual Report

October 2022

Coastal Development Permit No. 5-15-1427

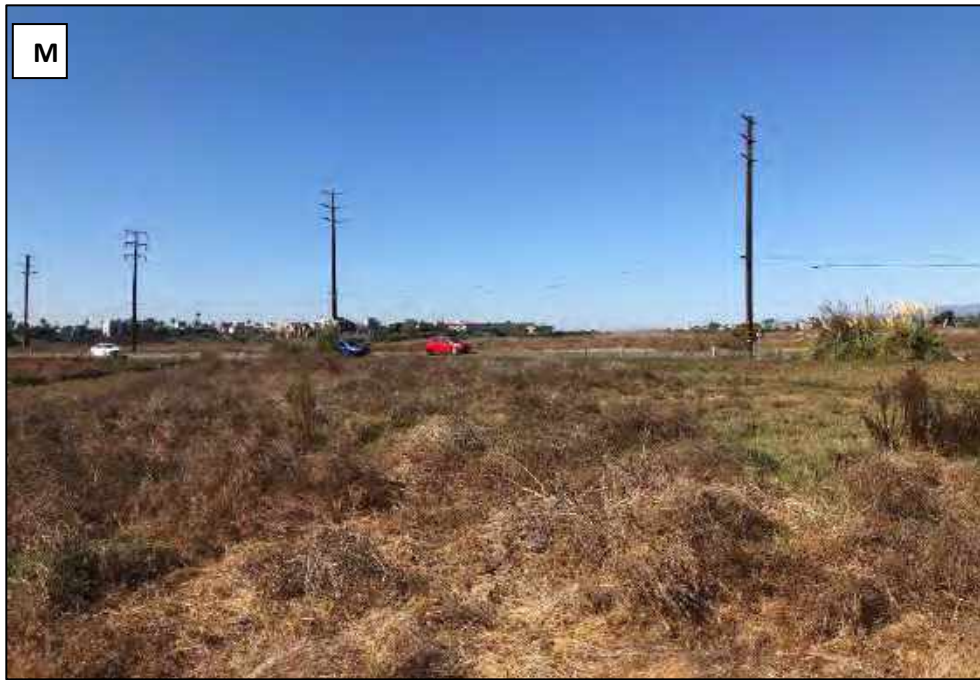
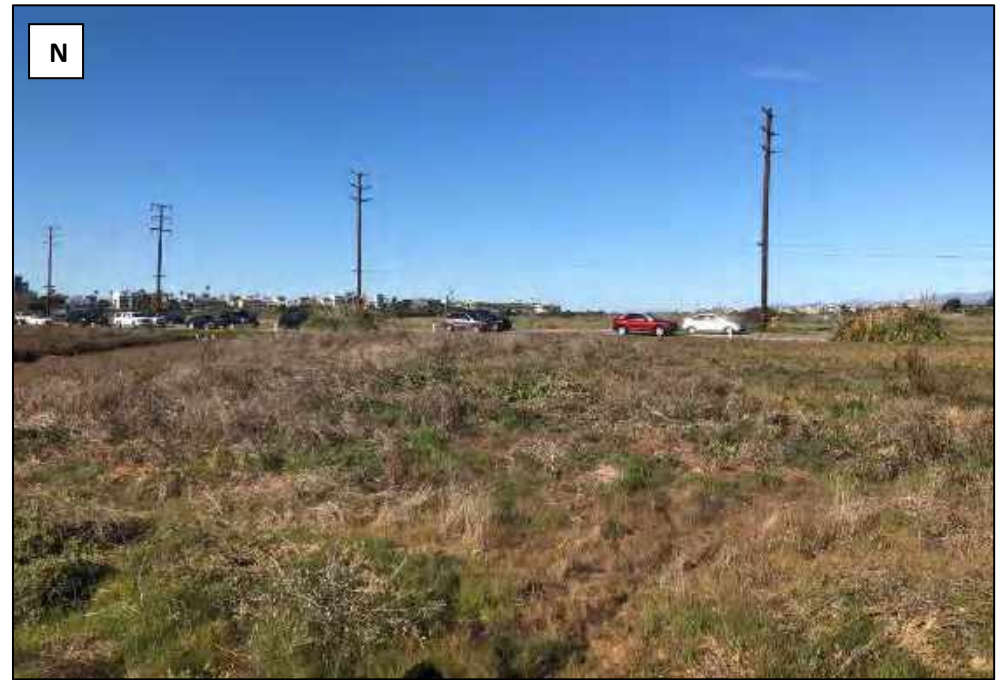
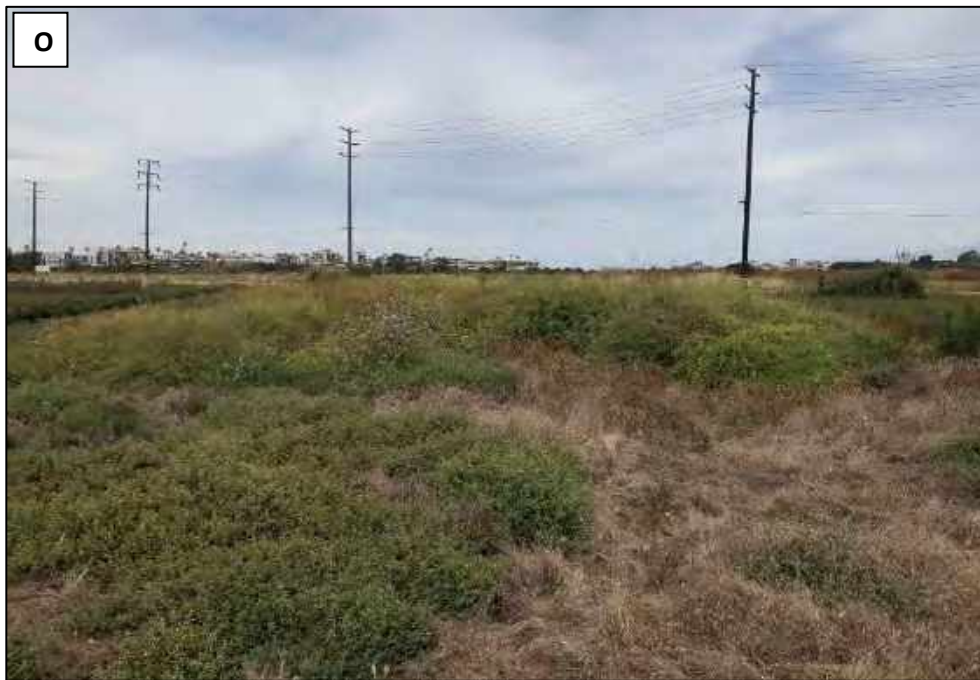
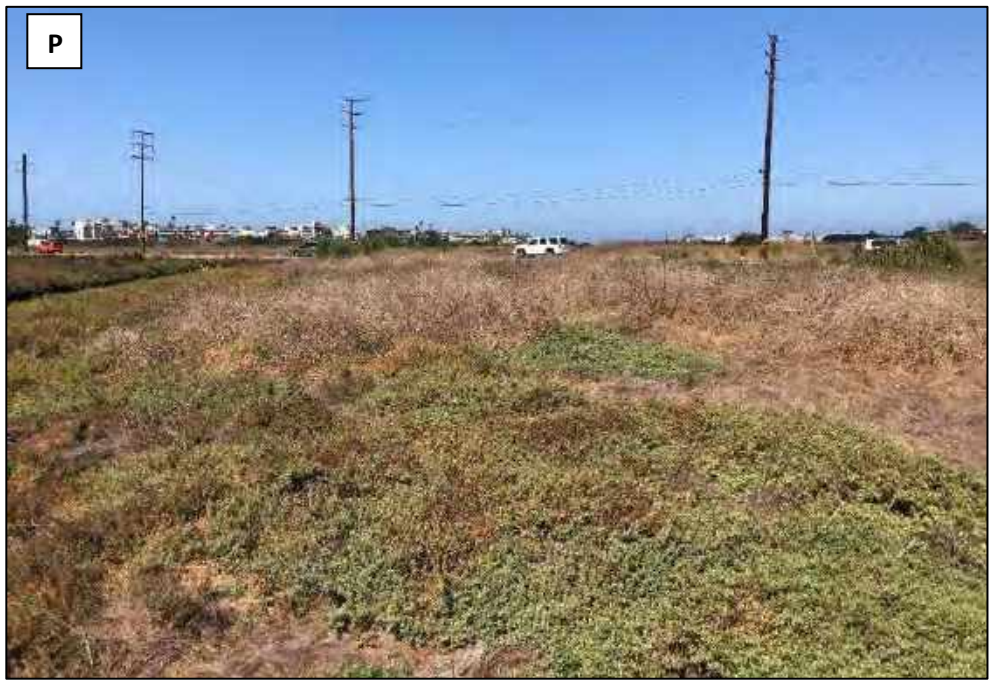
Figure A-16. Photo Point 3 at bearing 270° on (M) 31 October 2019; (N) 11 February 2020; (O) 2 June 2020; (P) 28 August 2020.

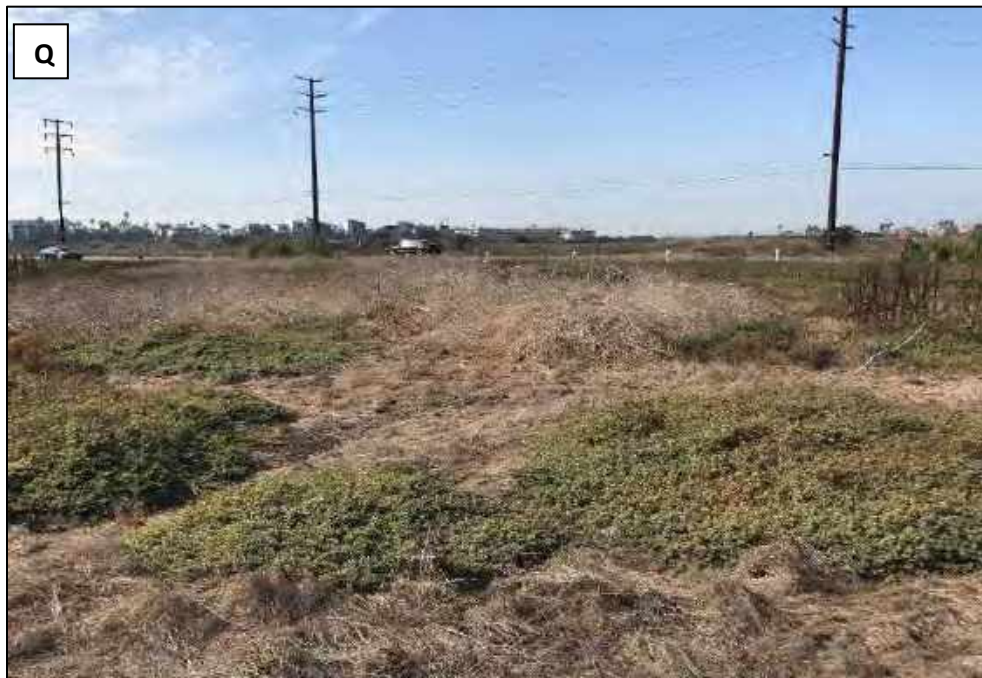
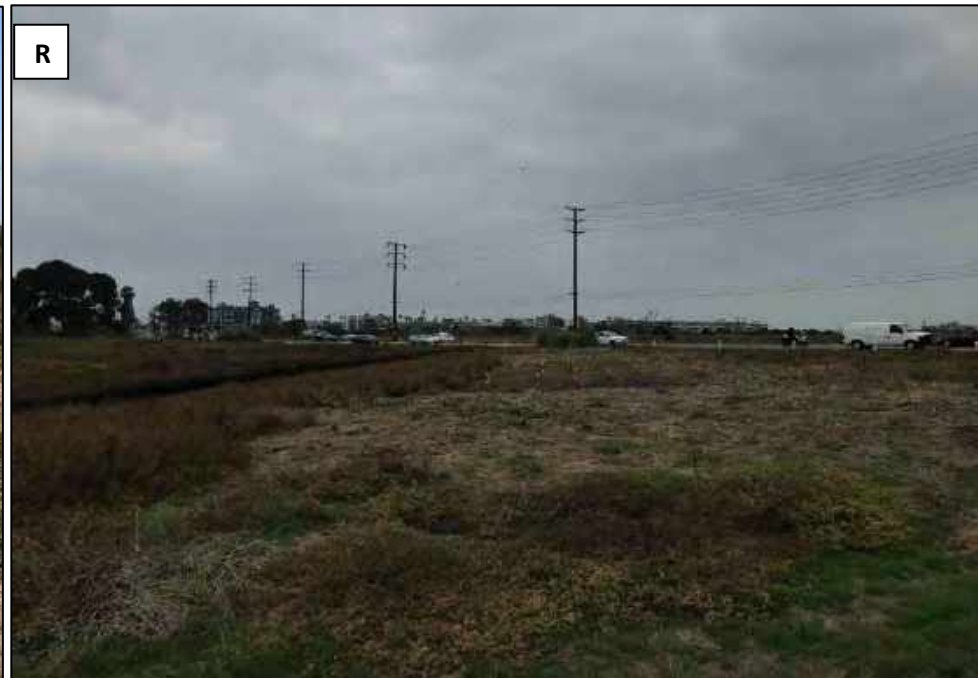
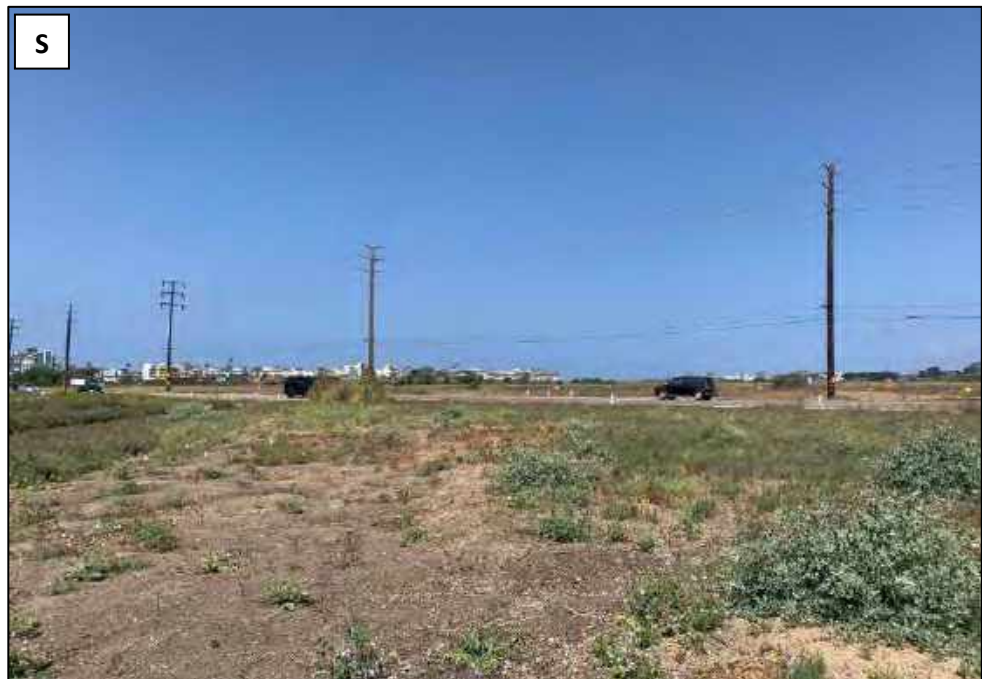
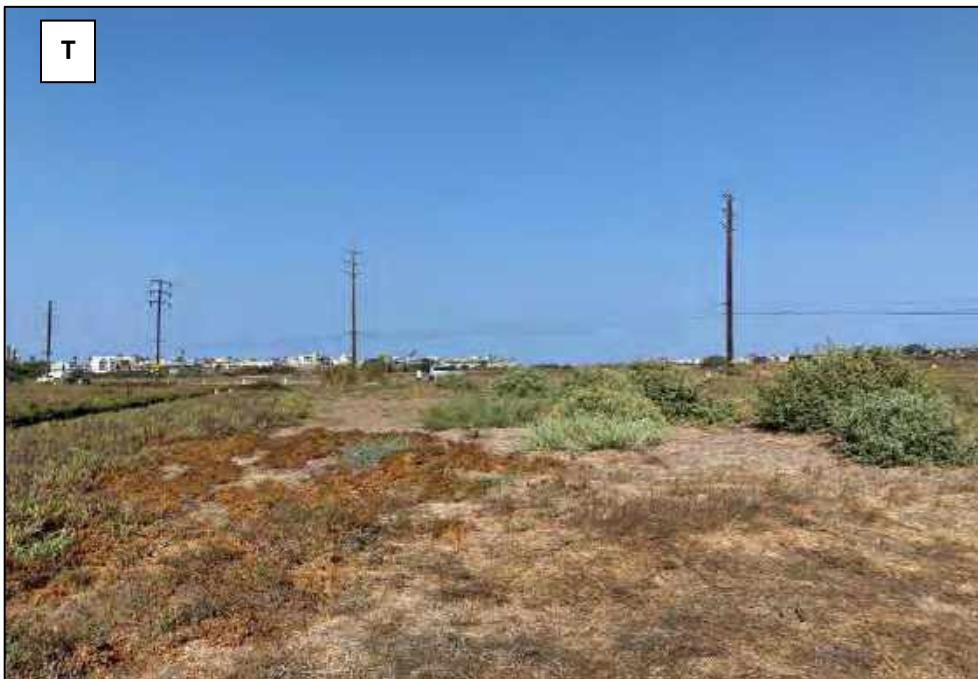
Figure A-17. Photo Point 3 at bearing 270° on (Q) 12 November 2020; (R) 9 February 2021; (S) 20 May 2021; (T) 24 August 2021.

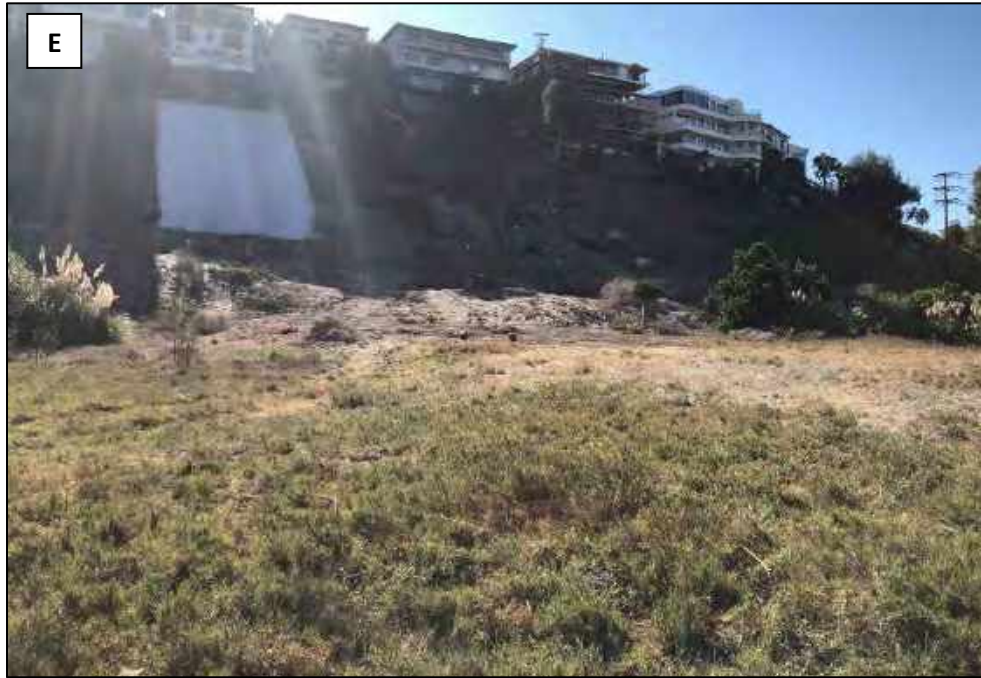
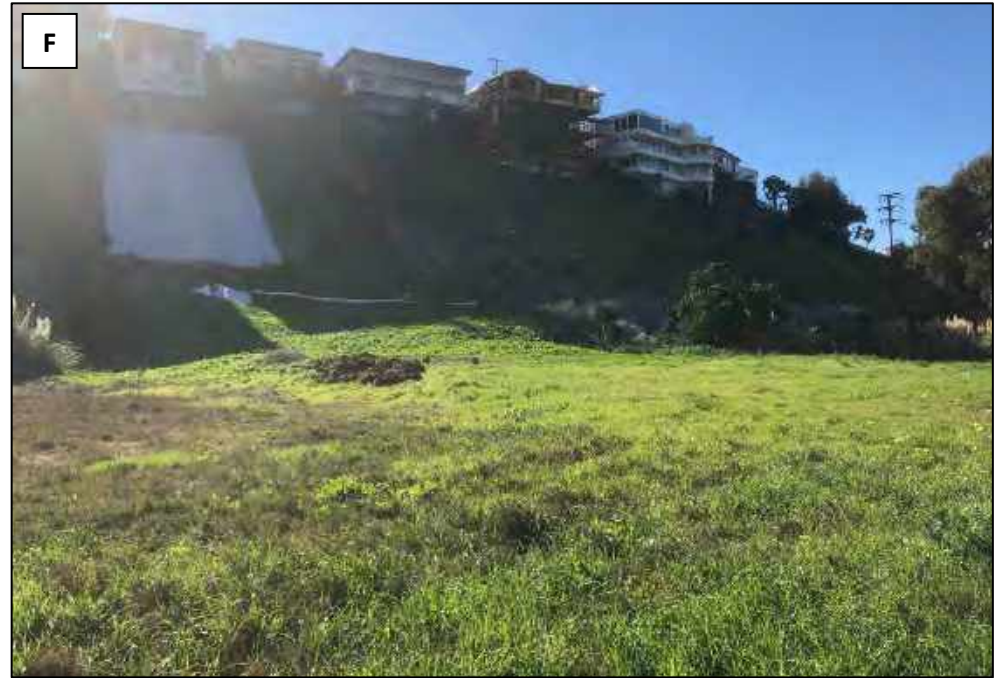
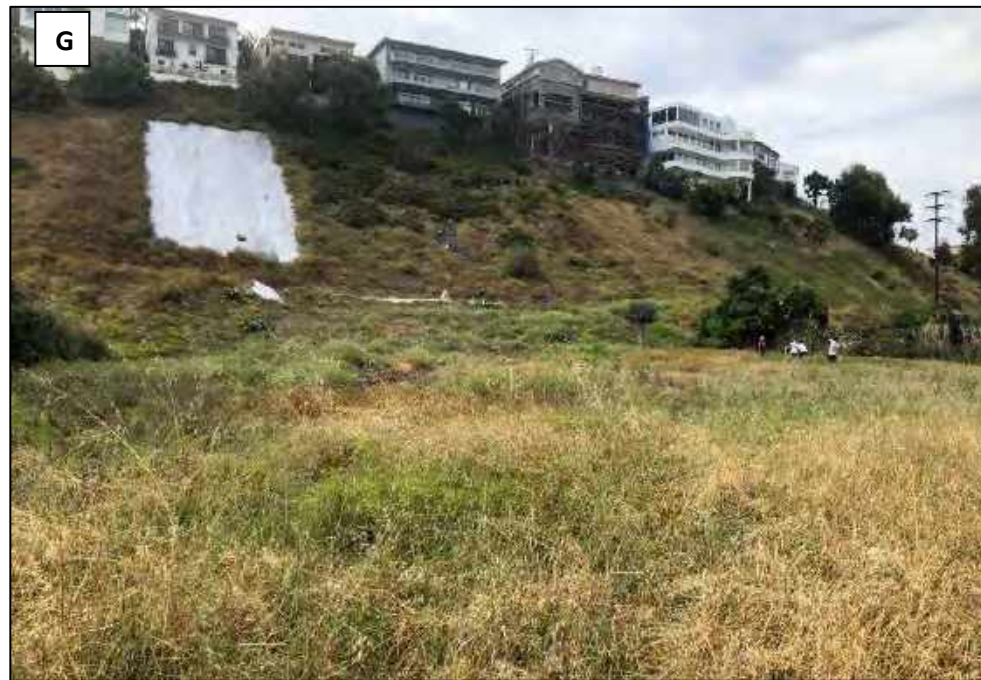
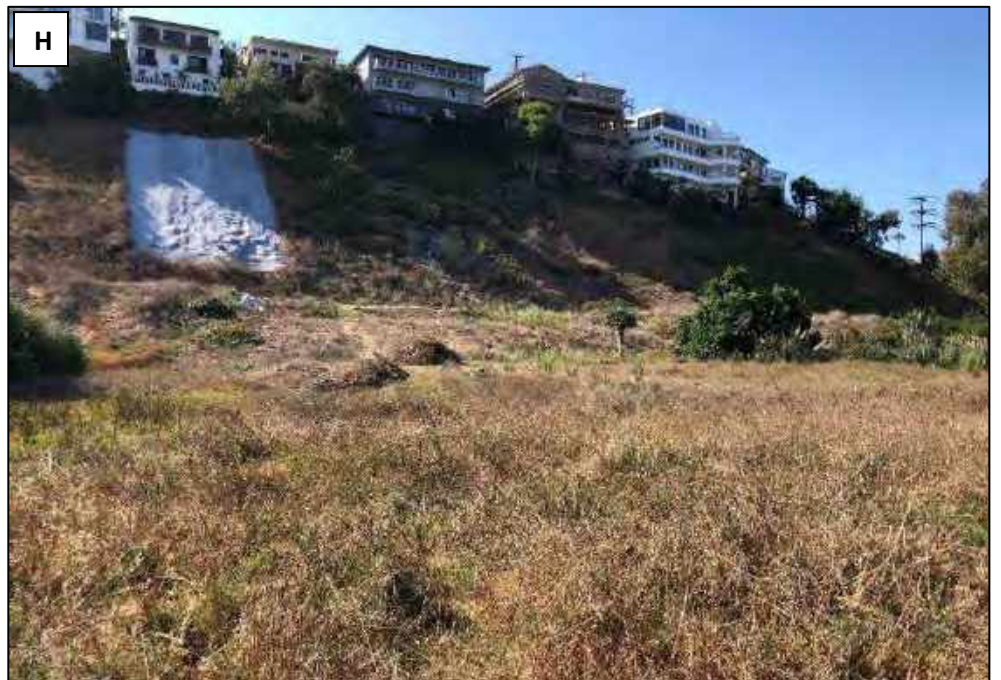
Figure A-21. Photo Point 4a at bearing 173° on (E) 31 October 2019; (F) 11 February 2020; (G) 2 June 2020; (H) 28 August 2020.

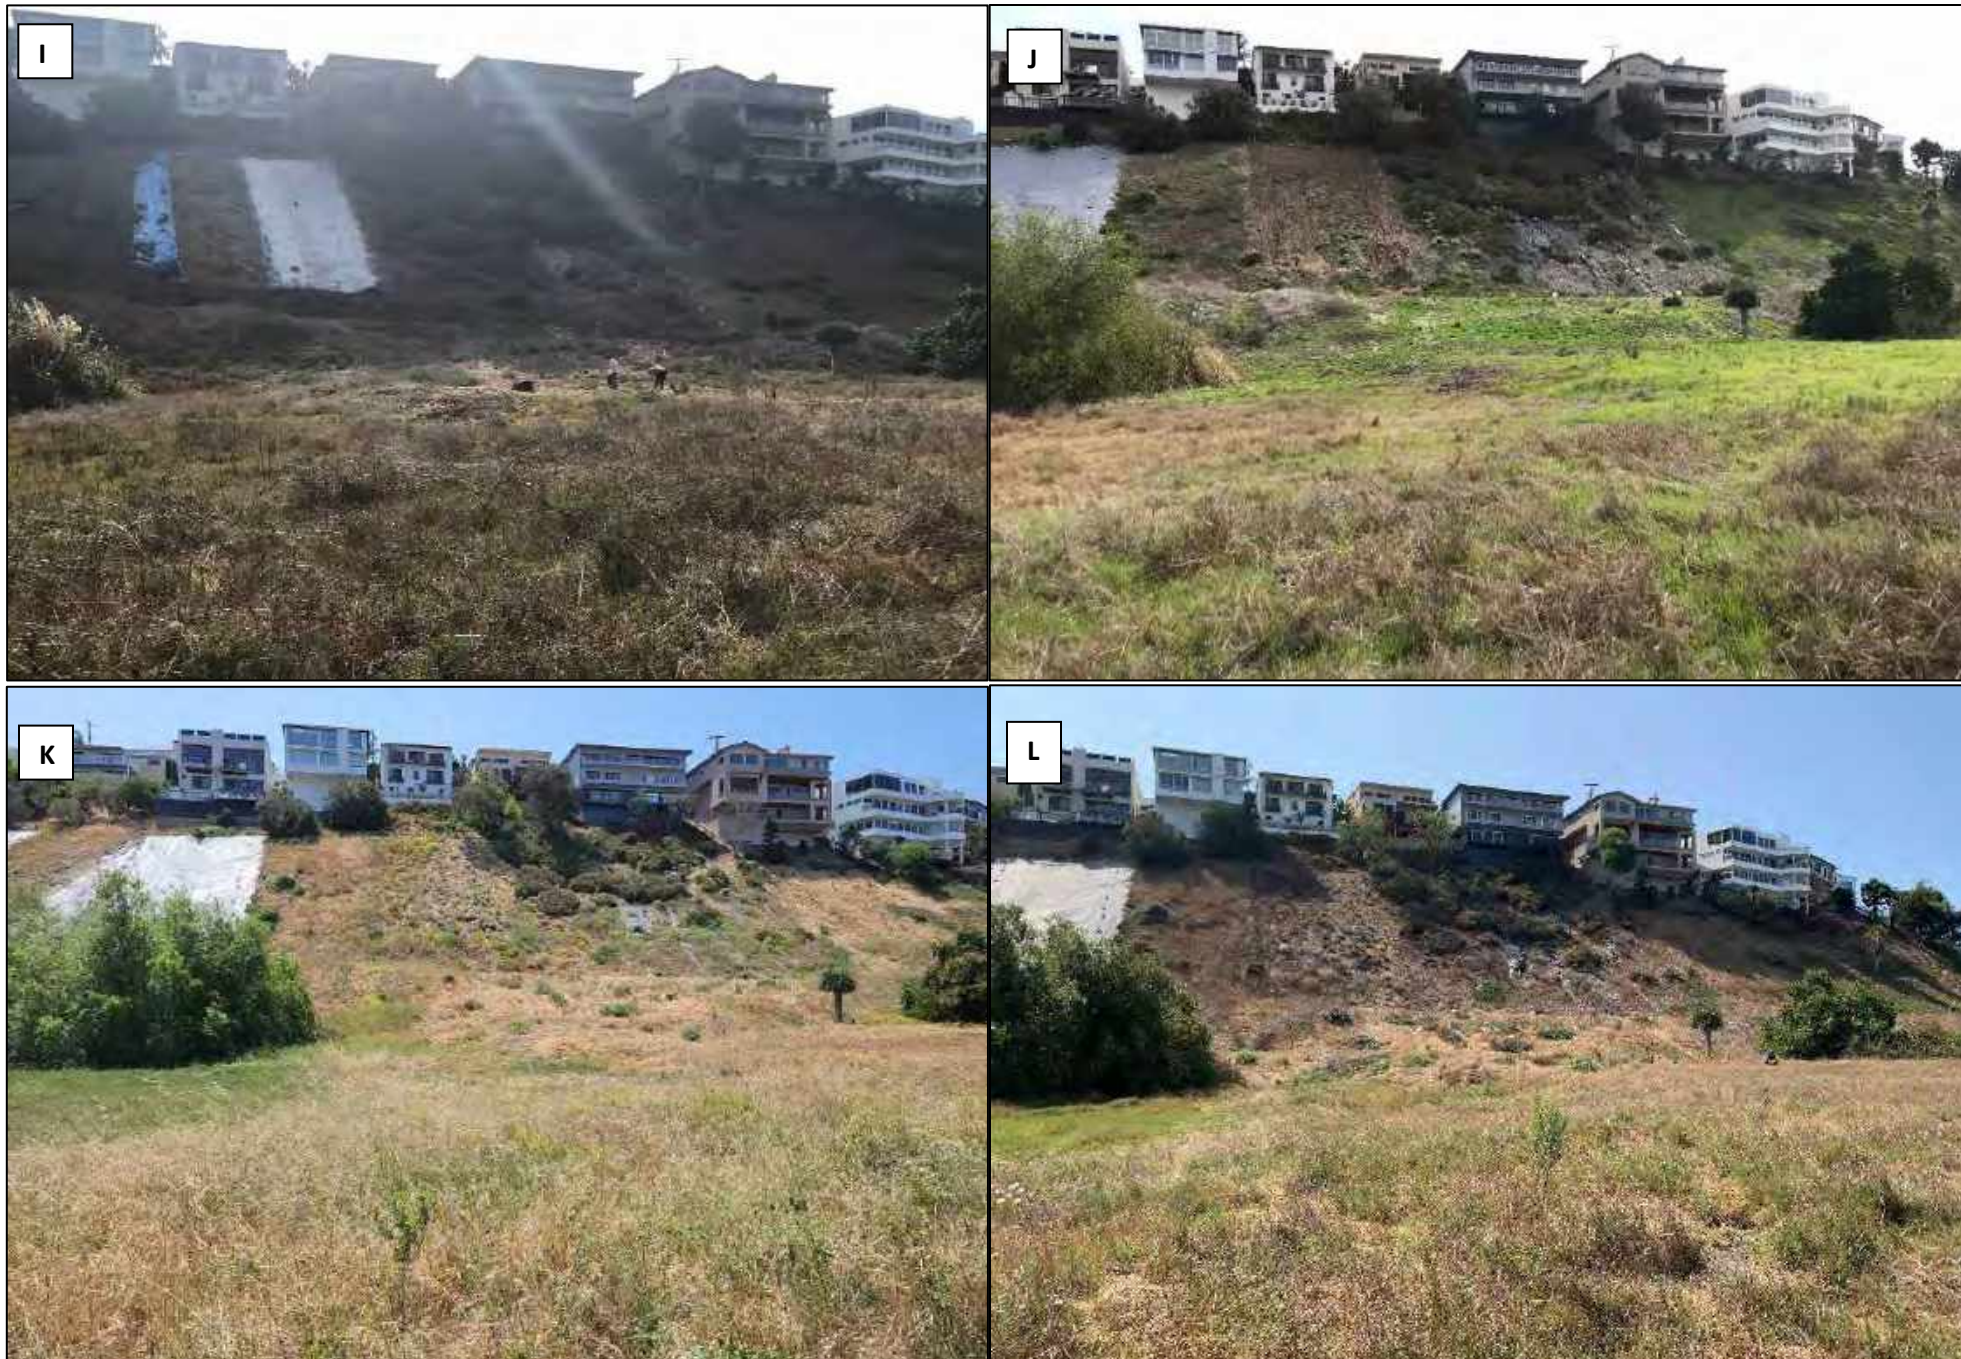
Figure A-22. Photo Point 4a at bearing 173° on (I) 12 November 2020; (J) 9 February 2021; (K) 18 May 2021; (L) 24 August 2021.

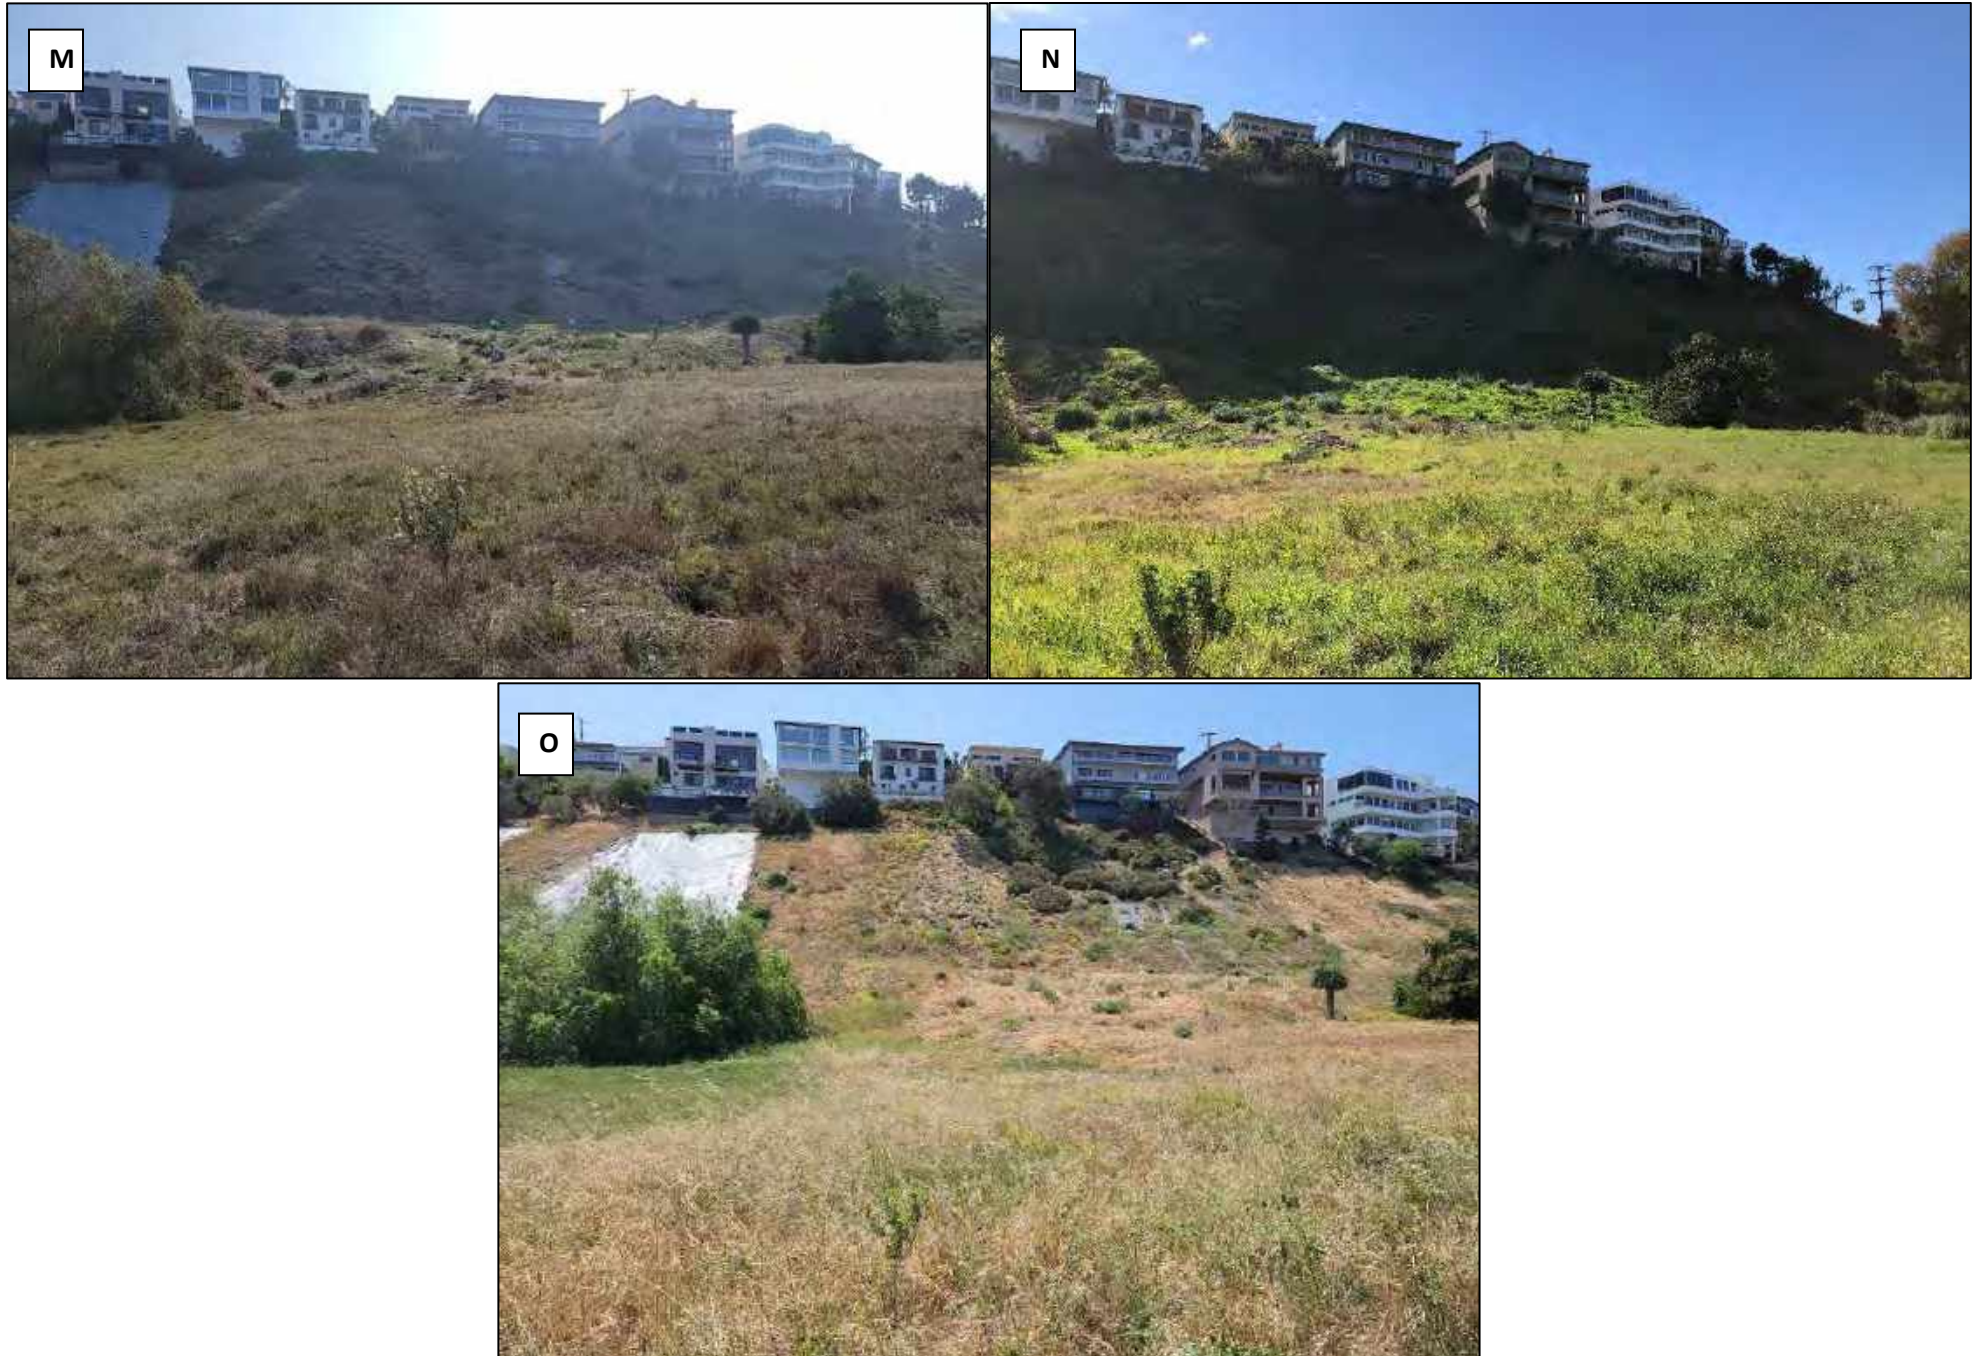
Figure A-23. Photo Point 4a at bearing 173° on (M) 17 November 2021; (N) 28 February 2022; (O) 03 June 2022.

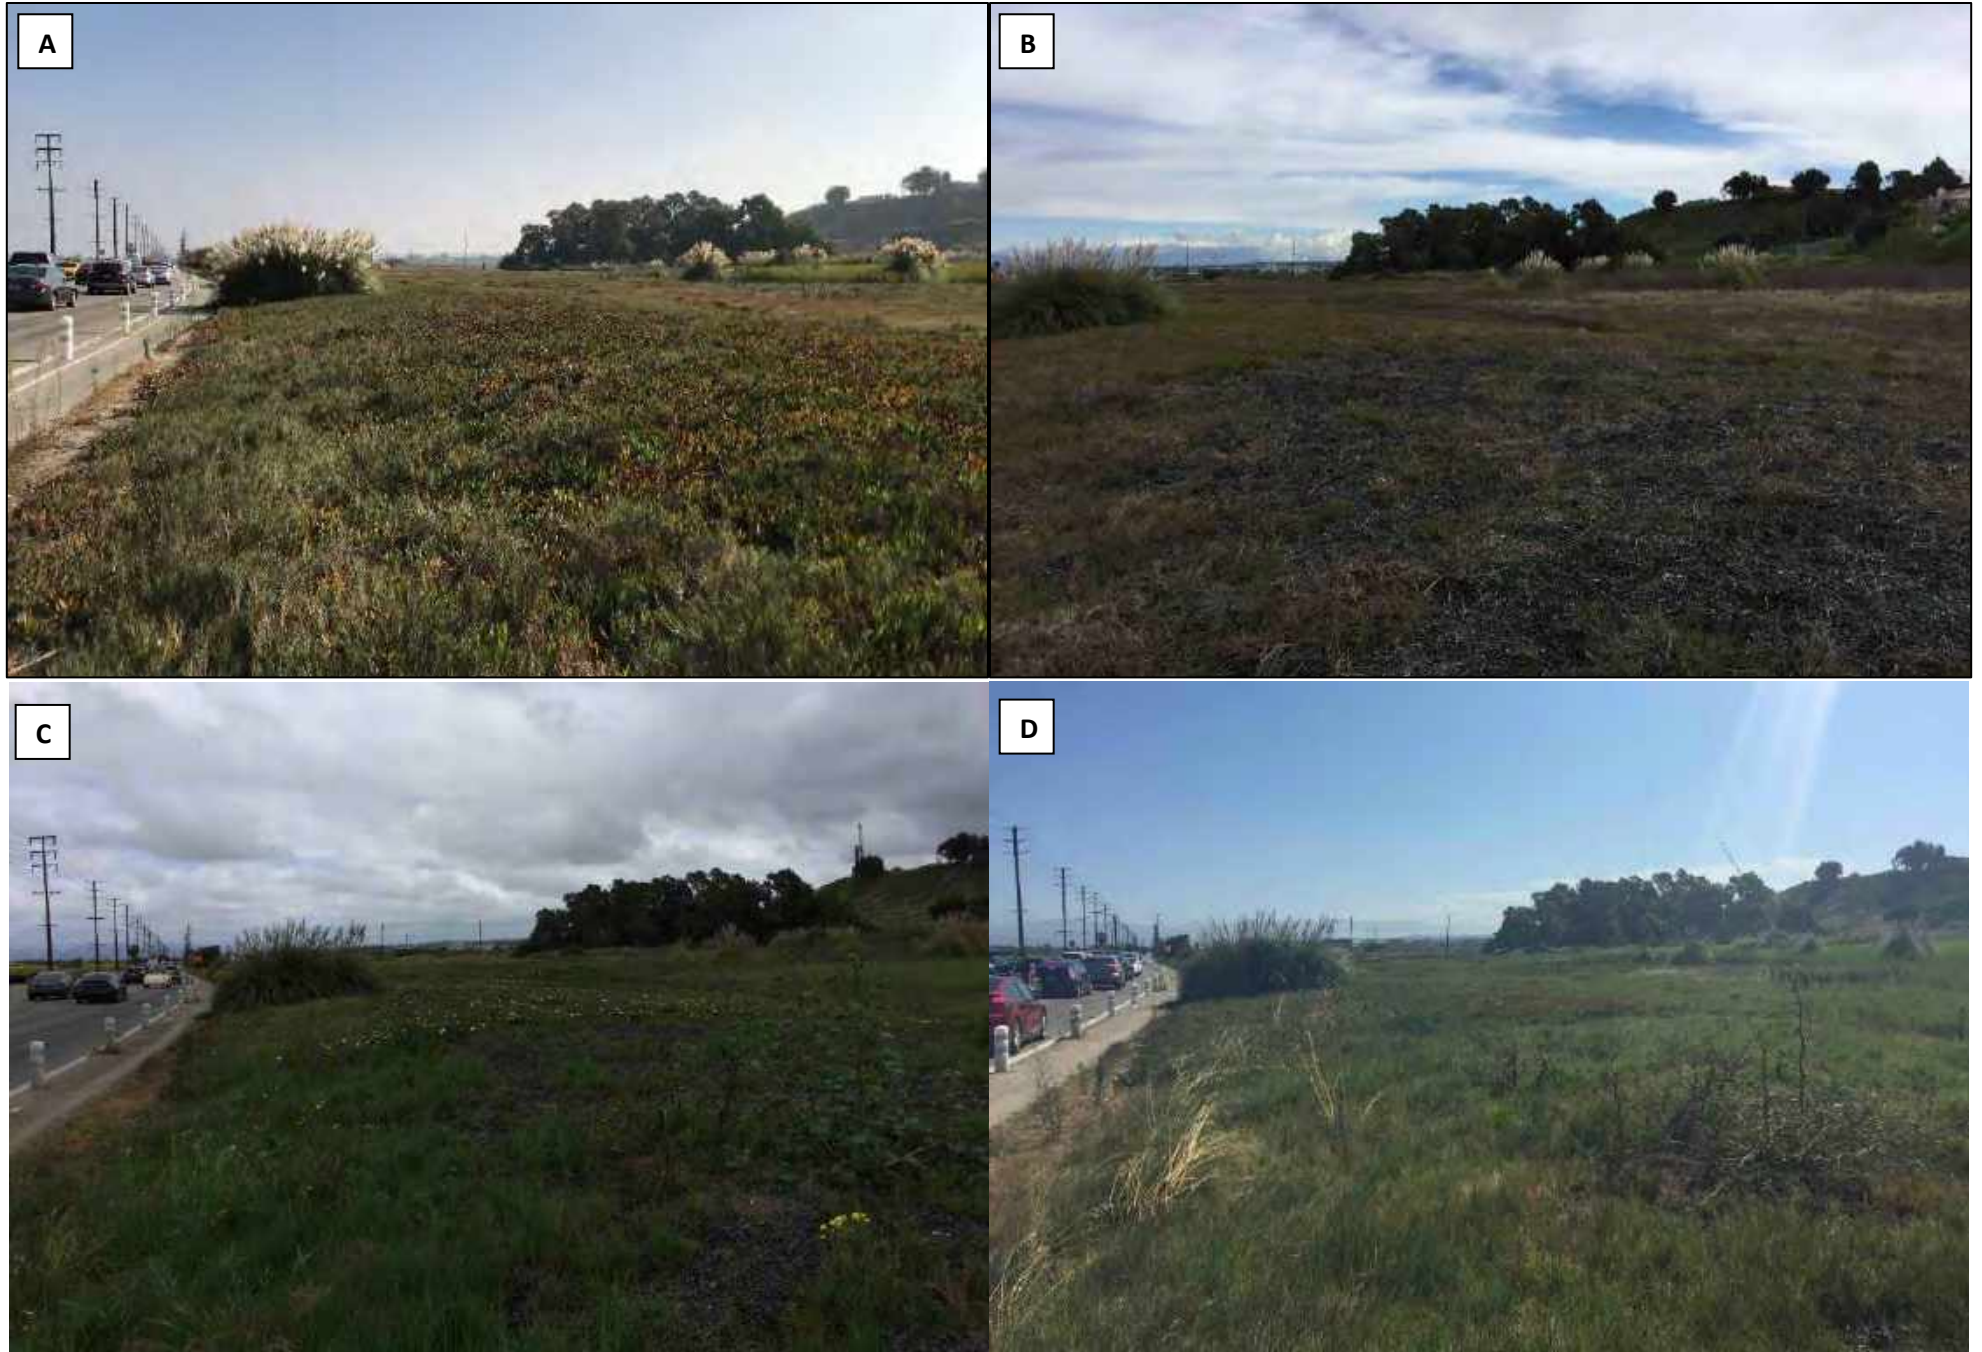
Figure A-24. Photo Point 4b at bearing 61° on (A) 20 September 2018; (B) 21 February 2019; (C) 30 April 2019; (D) 24 July 2019.

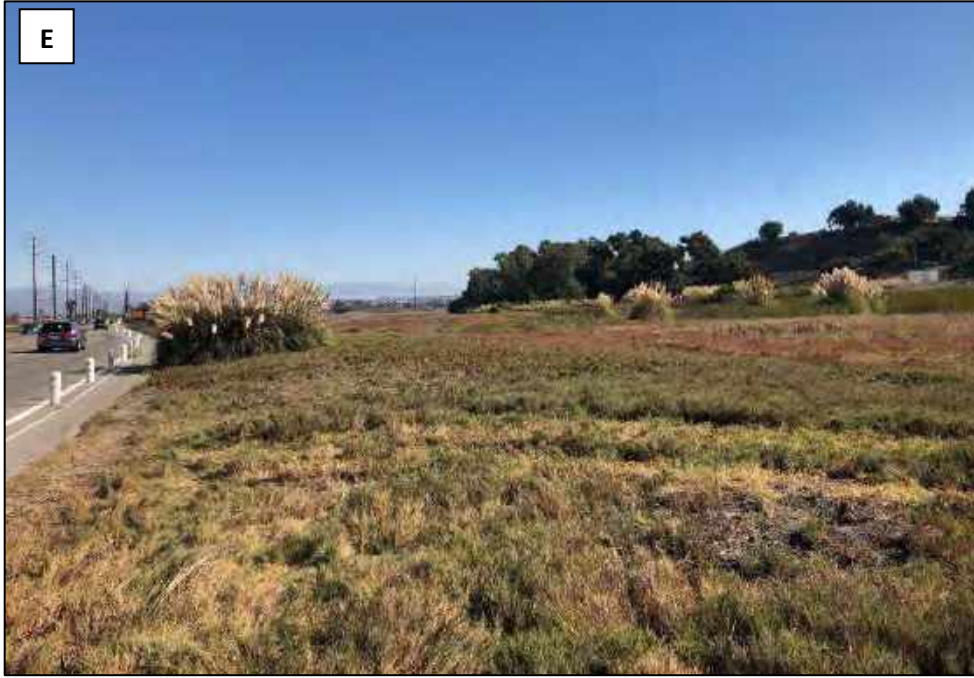
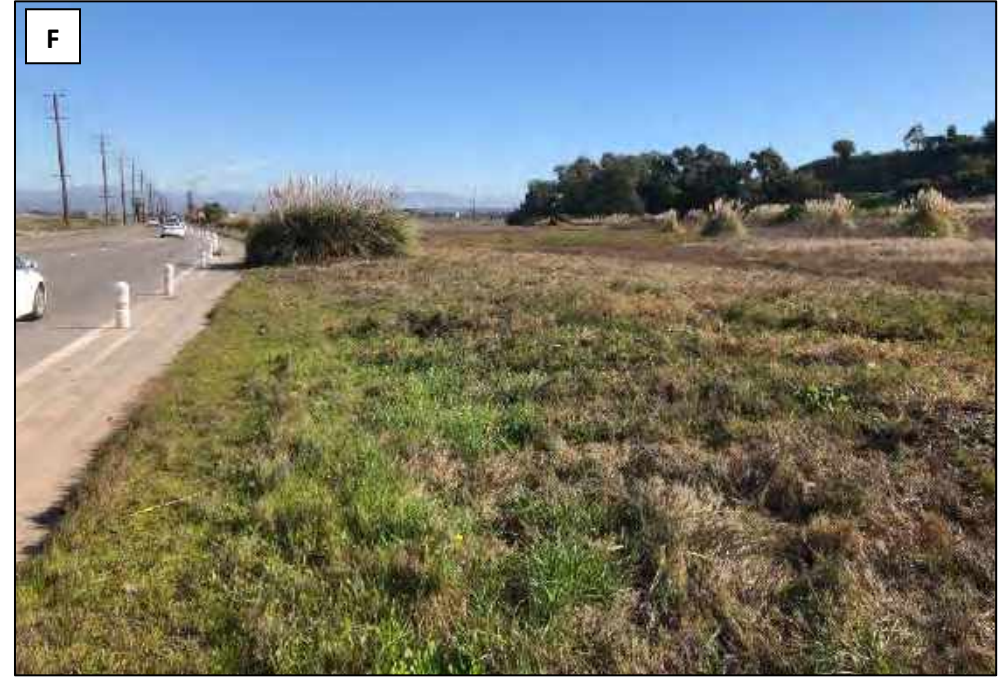
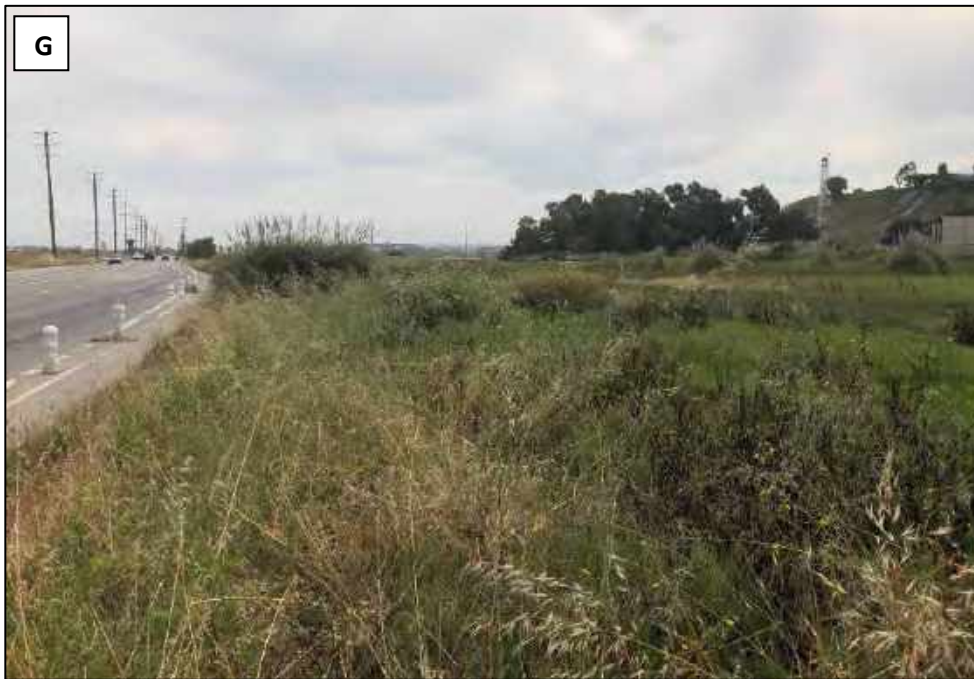
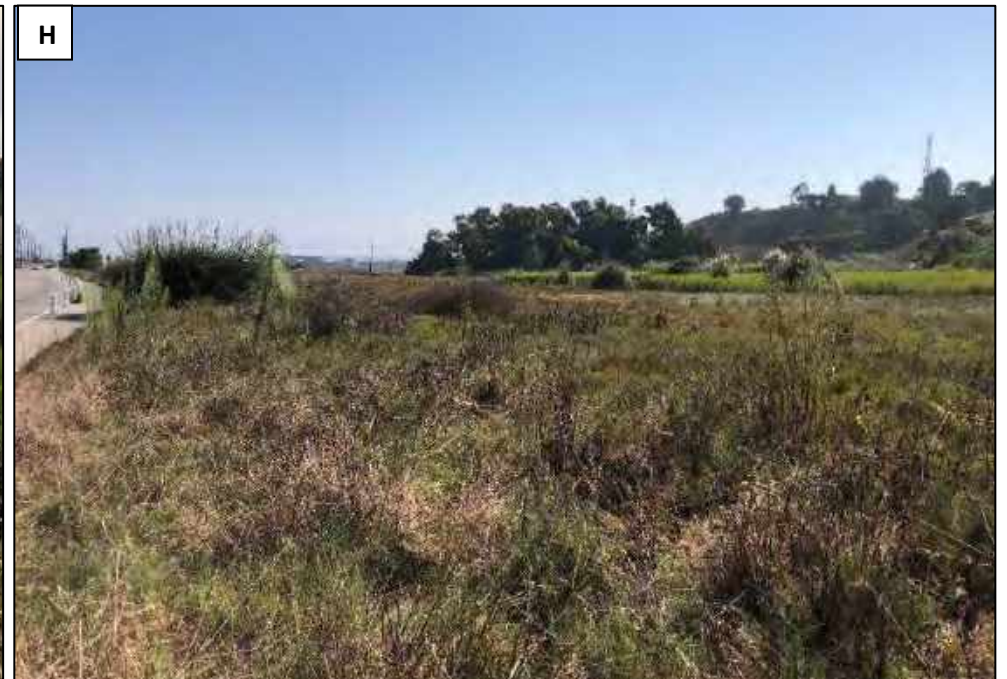
Figure A-25. Photo Point 4b at bearing 61° on (E) 31 October 2019; (F) 11 February 2020; (G) 2 June 2020; (H) 28 August 2020.

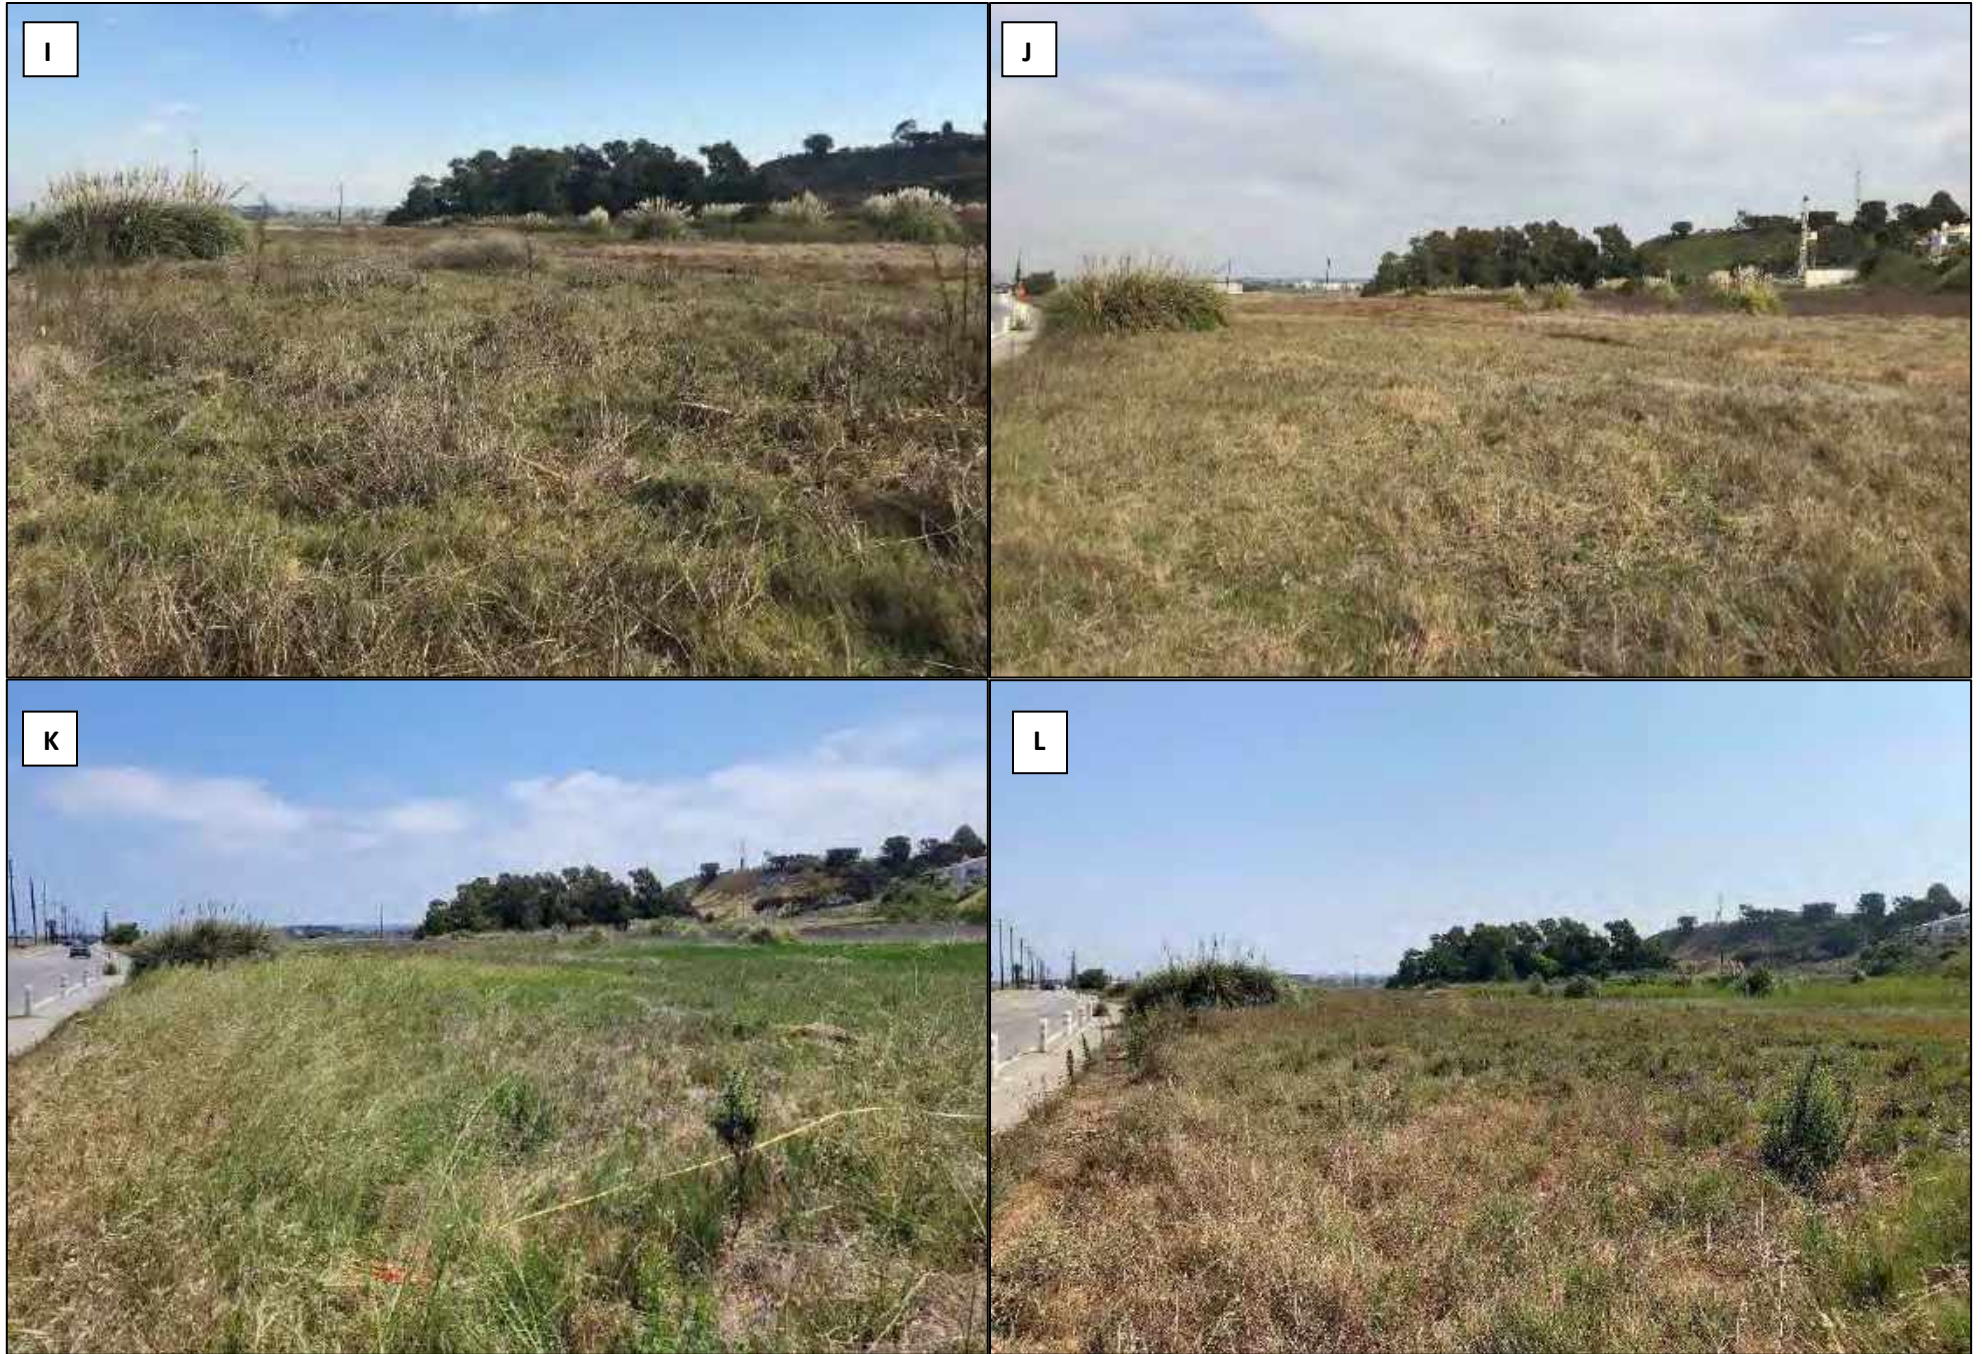
Figure A-26. Photo Point 4b at bearing 61° on (I) 12 November 2020; (J) 9 February 2021; (K) 18 May 2021; (L) 24 August 2021.
