Ballona Wetlands Restoration: Community Iceplant Removal Project

Year 6 Annual Report

October 2022

Coastal Development Permit No. 5-15-1427

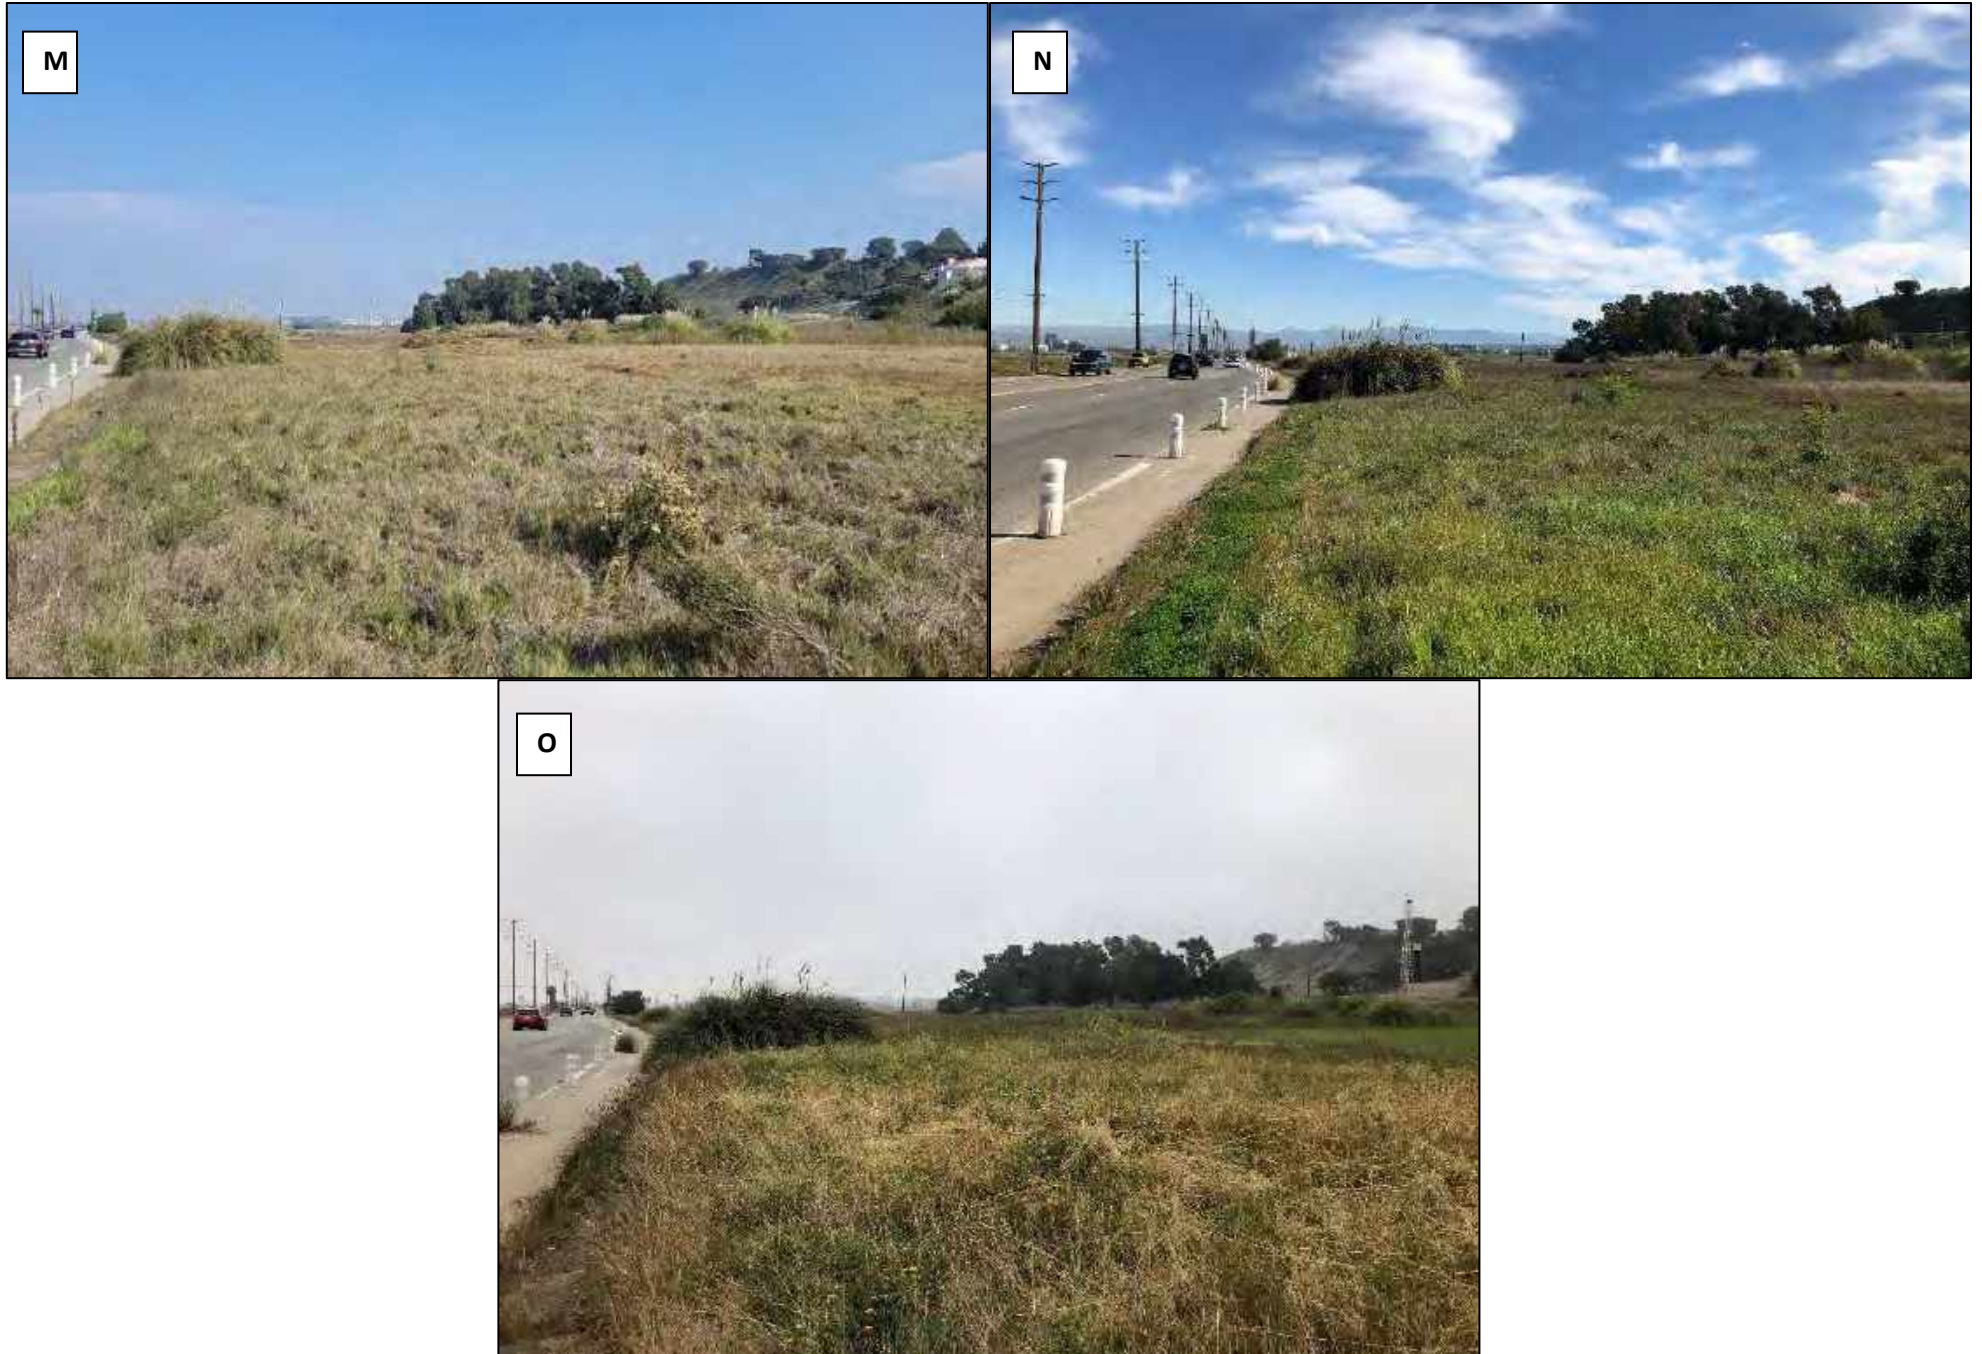
Figure A-27. Photo Point 4b at bearing 61° on (M) 17 November 2021; (N) 28 February 2022; (O) 03 June 2022.
