Malibu Living Shoreline Project

Year 1 Annual Report

May 2022

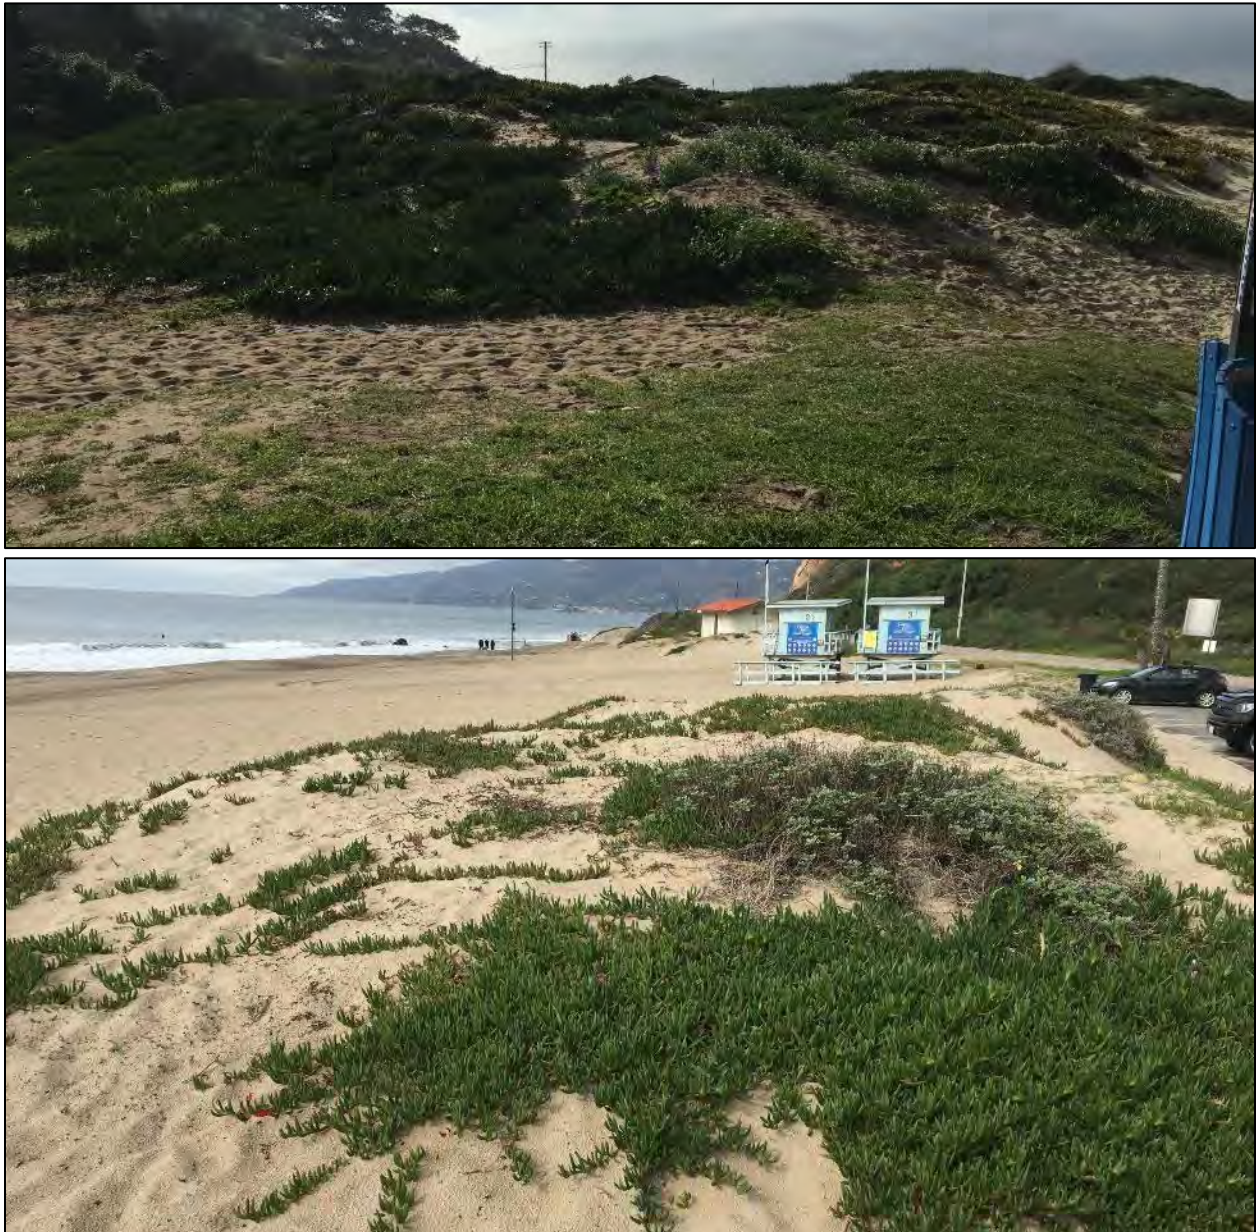
Historically, large expanses of dunes once covered the coastal zone at both Zuma and Point Dume County Beaches. Due to urbanization, an increase in development, and beach grooming (raking) practices, the majority of these historical dunes have disappeared. The Los Angeles County Department of Beaches and Harbors (LACDBH) built up some sand dunes in recent years to protect coastal infrastructure at Zuma and Point Dume Beaches in Malibu, but they were largely covered by monocultures of non-native, invasive species such as iceplant (Figure 1).

Figure 1. Representative site photographs from Zuma Beach adjacent to the lagoon (above) and Point Dume Beach adjacent to the parking lot (below).

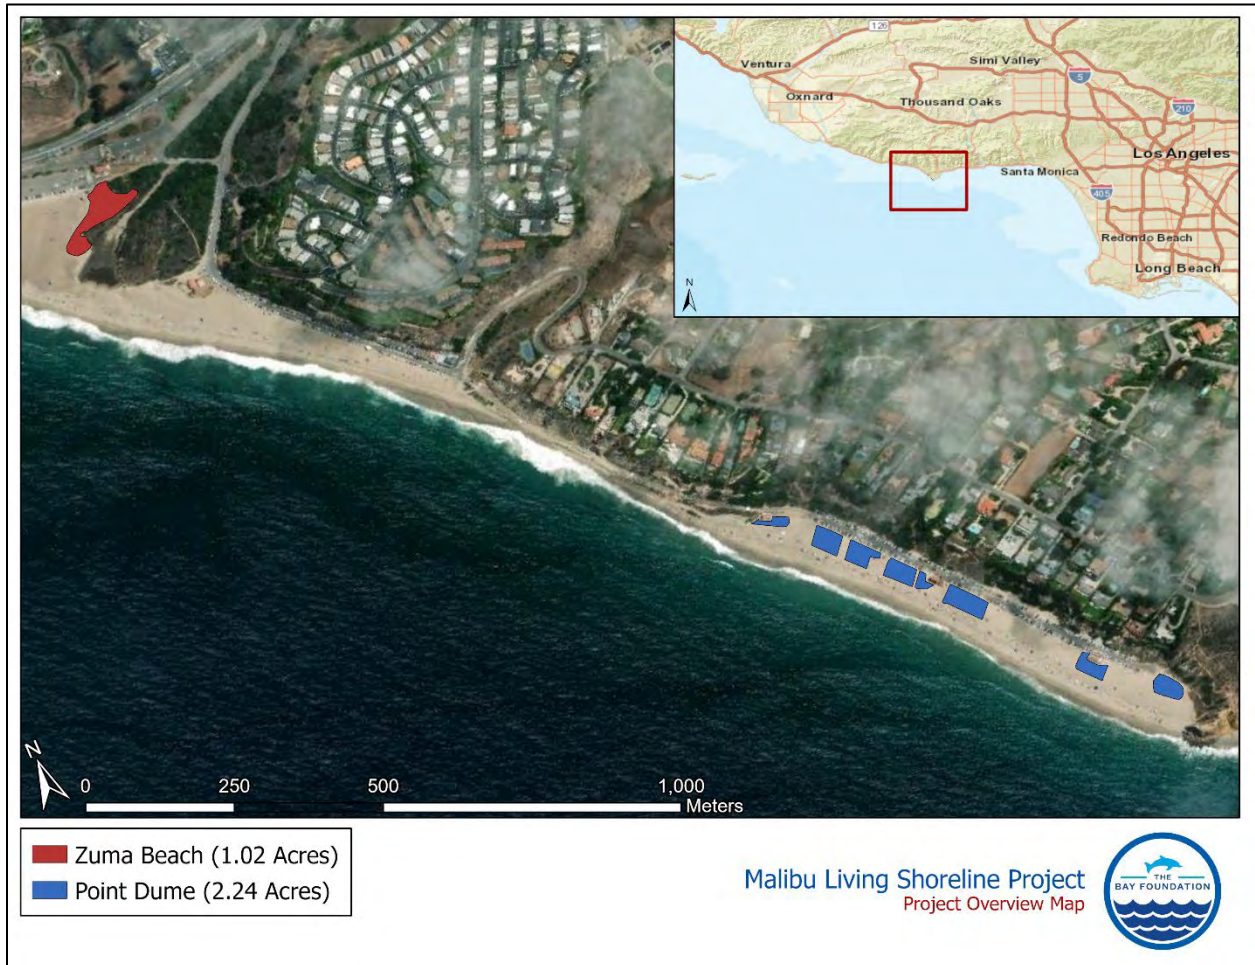
Figure 2. Overview map of both restoration areas implemented as part of the Malibu Living Shoreline Project.

Both Zuma Beach and Point Dume Beach reside in the City of Malibu and are managed by the Los Angeles County Department of Beaches and Harbors. Historically, dune systems were a prominent feature of this area; over time with increased development and urbanization, these dune features disappeared. The project site consists of 3.26 total acres of sandy beach and dune habitat (Figure 2). Restoration activities were conducted on 1.02 acres at the Zuma Beach site, adjacent to Zuma Lagoon, and 2.24 acres at the Point Dume Beach site (Figure 3).

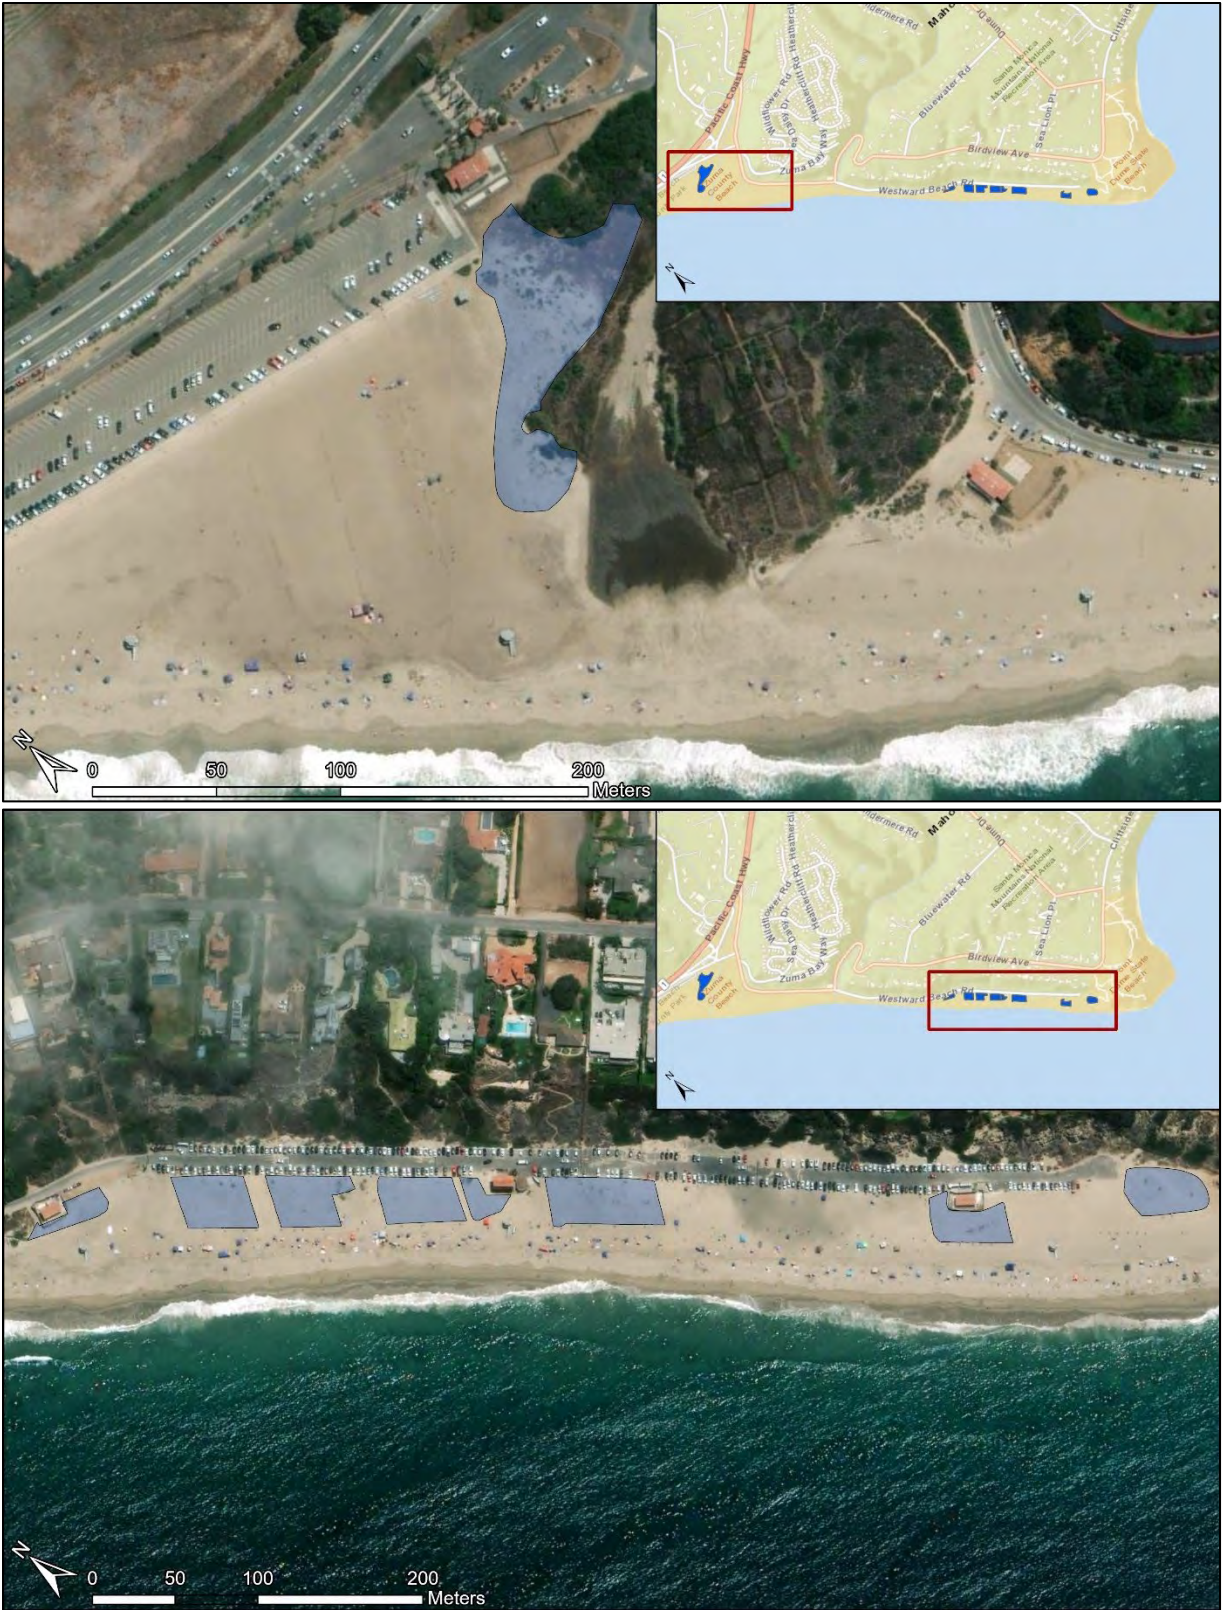
Figure 3. Zuma Beach (top) and Point Dume Beach (bottom) project footprints.

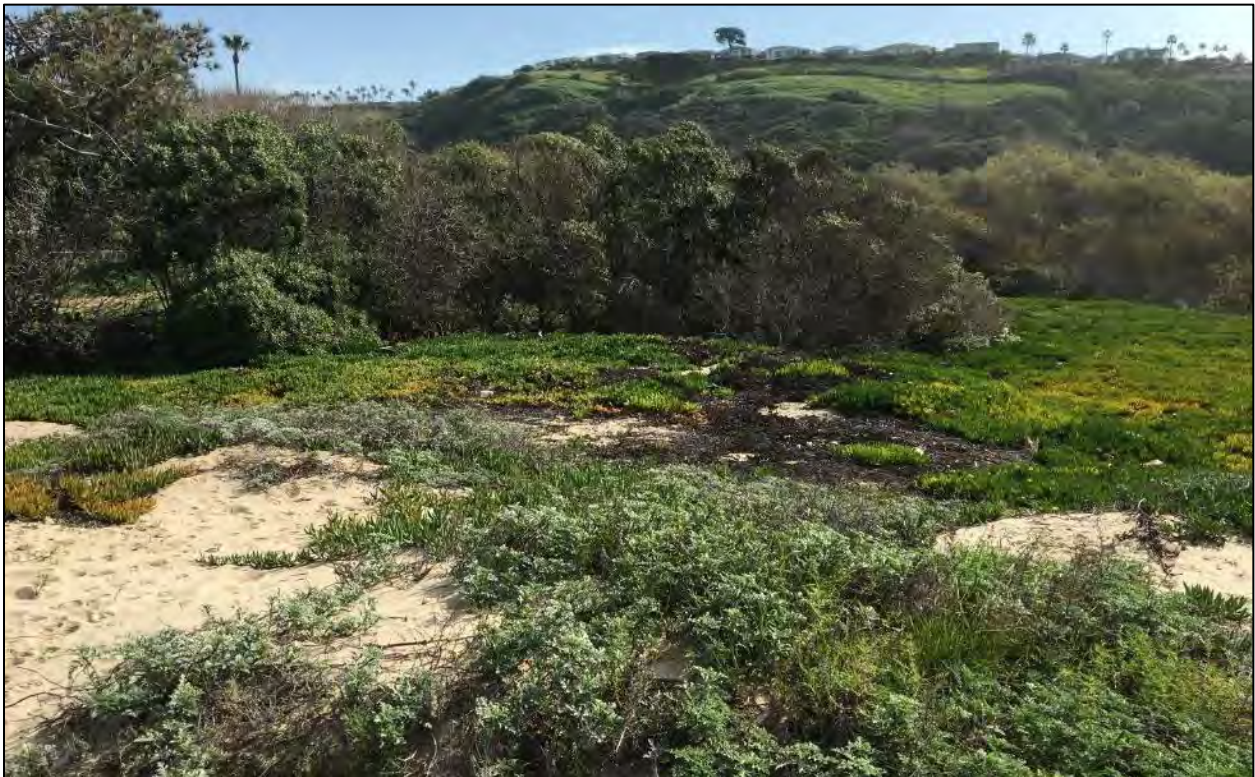
Major habitats identified during baseline surveys within the restoration area for Zuma Beach included dune transition (including some back dune), back dune, southern foredune, and mechanically groomed beach. Back dunes and dune transition habitats on site occur on sandy soils that are sufficiently stabilized (i.e., little or no blowing sand) due to their position in the lee of foredunes. The lack of sand movement leads to a buildup of nutrients and inclusion of some fine sediments (i.e., silt, clay, or organic components) in the soil. This soil structure allows for the potential to restore a wide range of native forbs and shrub species not found in foredunes or coastal strand areas. In Figure 4, the foreground is a mix of native and non-native species in a more stabilized dune area, with iceplant in the background. In Figure 5a, the photograph is closer to the transition habitat area and is dominated by iceplant.

Figure 4. Representative pre-restoration photograph of back dune habitat (foreground) and dune transition habitat (background) at Zuma Beach.

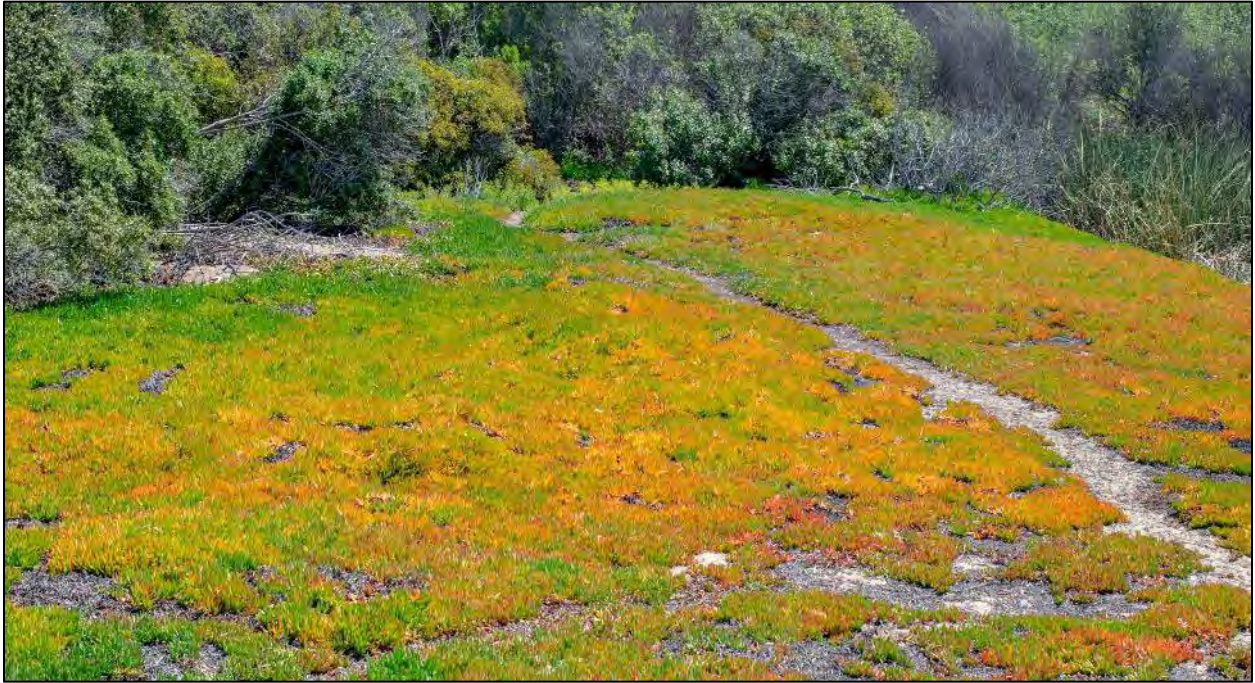
Figure 5a. Representative pre-restoration photograph of dune transition habitat at Zuma Beach.

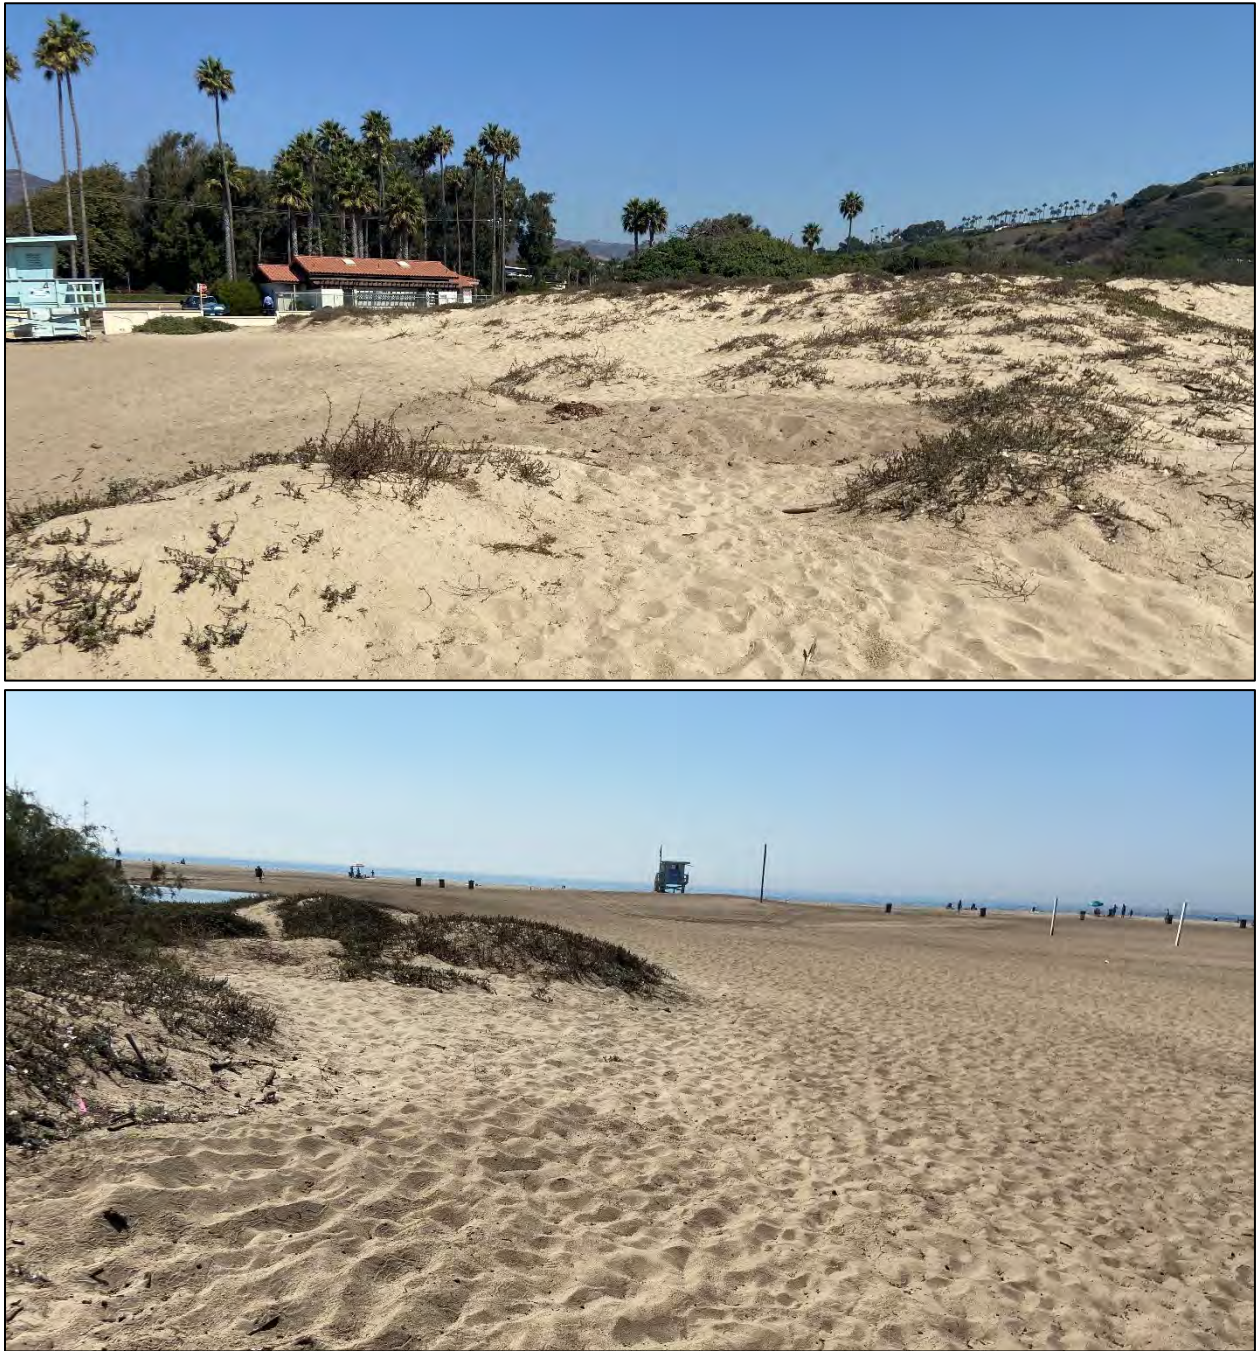
Figure 5b. Representative pre-restoration photo of foredune habitat (top) and mechanically groomed sandy beach adjacent to foredune habitat (bottom) at Zuma Beach.

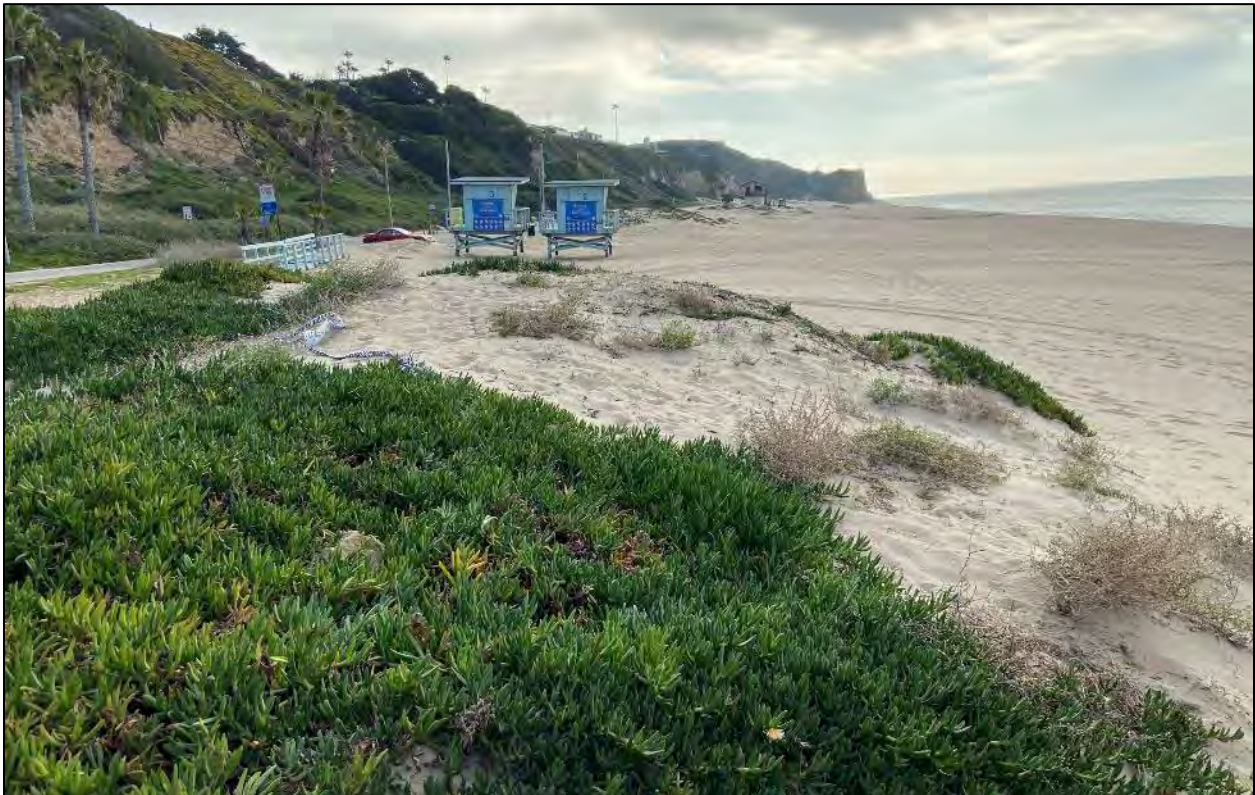
Prior to restoration actions, the project area at Point Dume was comprised of small, sporadic, and patchy dunes lining the edge of the beach and buffering the parking lot (Figures 6 and 7). The site historically supported foredune, dune, and back dune habitats in front of the bluffs. Almost no native coastal strand or foredune vegetation species were identified during baseline surveys, with several exceptions of small intermixed native plant patches. Those areas that were vegetated were covered with non-native, invasive species such as iceplant and sea rocket (Cal-IPC 2020). The pre-restoration conditions of the dune habitat were poor; thus, restoration actions served to increase ecosystem values, critical habitat, and the ability of the site to build healthy and stable dune ecosystems to protect against sea level rise (Figure 8). Additionally, dunes serve to protect existing beach infrastructure such as parking lots, restrooms, and lifeguard facilities. There was sufficient sand supply and natural wind and wave conditions to restore natural processes that support dunes (Rios and CRC 2019). Both sites border the 16-square mile Point Dume State Marine Protected Area, and US Fish and Wildlife Service has also designated this area as critical habitat for the federally threatened western snowy plover.

Figure 6. Representative pre-restoration photograph from Point Dume Beach (north).

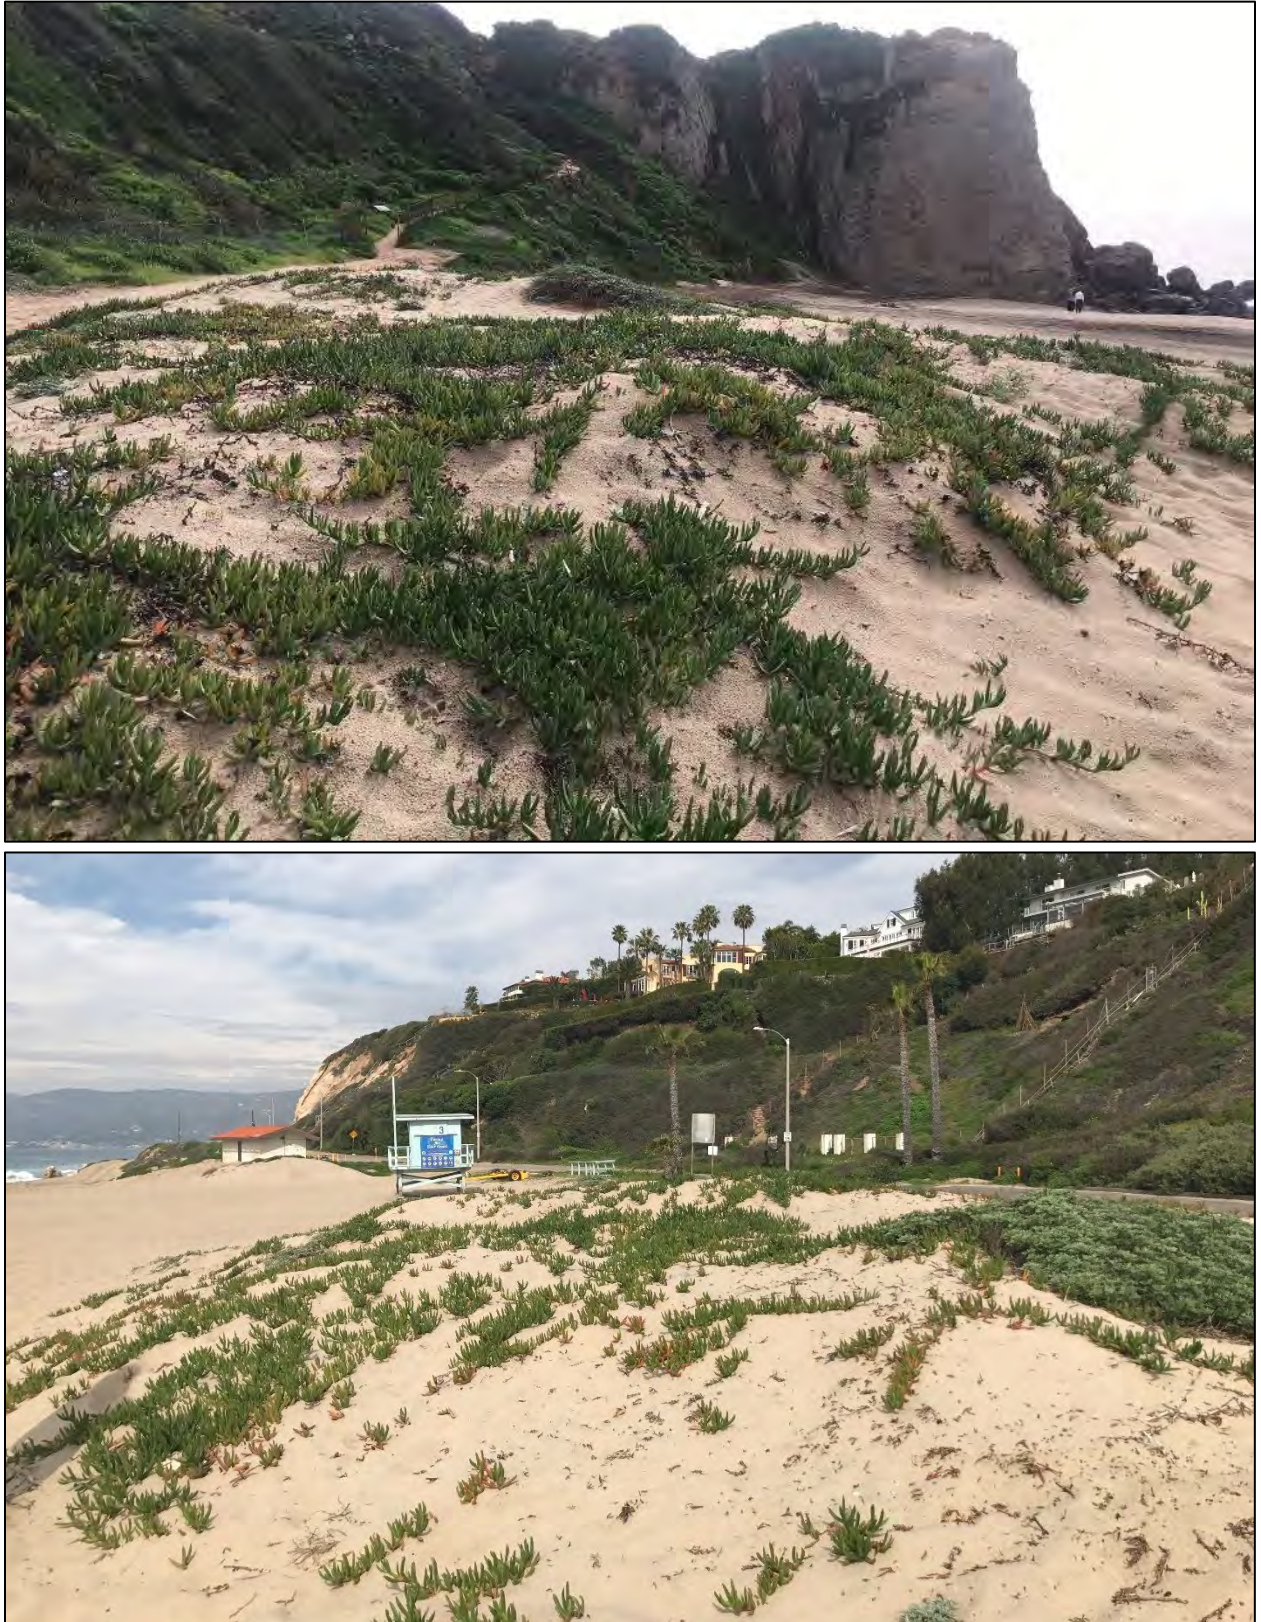
Figure 7. Representative pre-restoration photographs from Point Dume Beach (south).

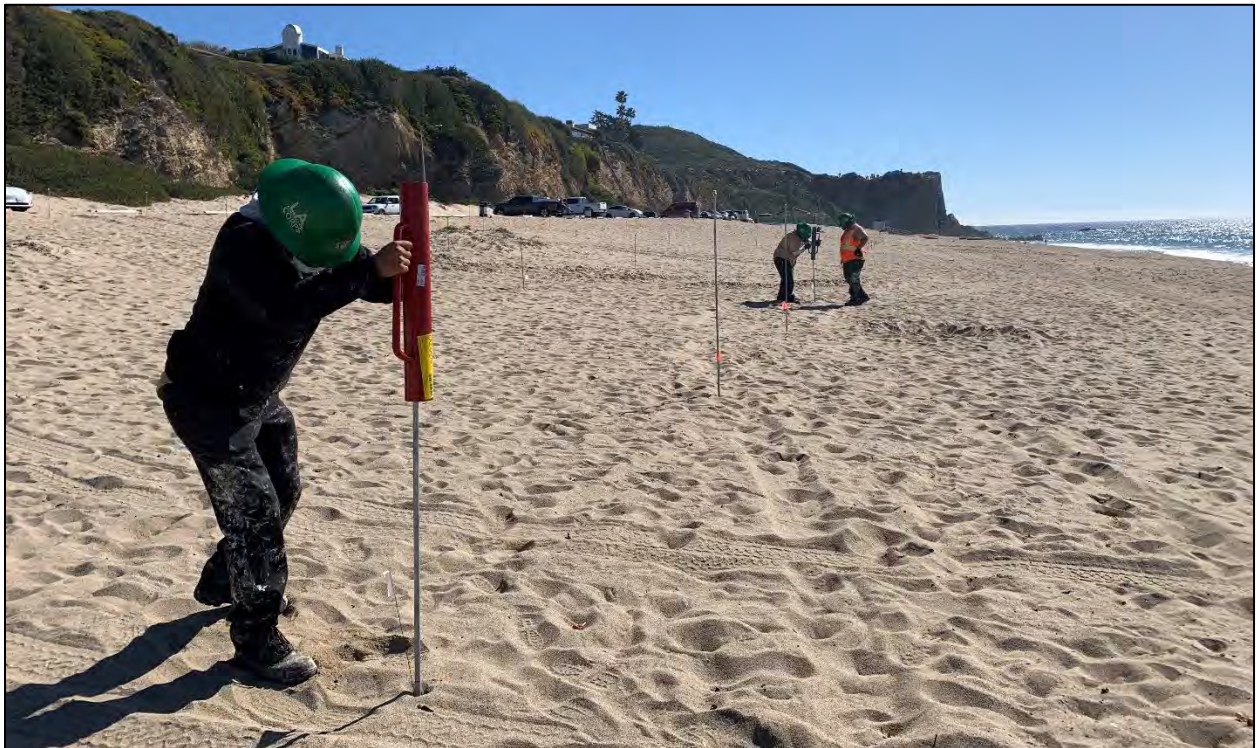
Boundaries were defined and established at both sites using symbolic fencing (Figure 10). Symbolic post and rope fence utilized sustainable materials to the highest extent possible and were installed around most of the perimeter of the project site. This perimeter establishment serves several purposes, including delineating areas to be restricted from mechanical grooming (raking), encouraging safe recreational activities, and minimizing excessive disturbance to the dune areas, especially during initial establishment in the first several years.

Figure 10a. LACC crew members pounding in posts to delineate the Point Dume project boundary (5 February 2021).

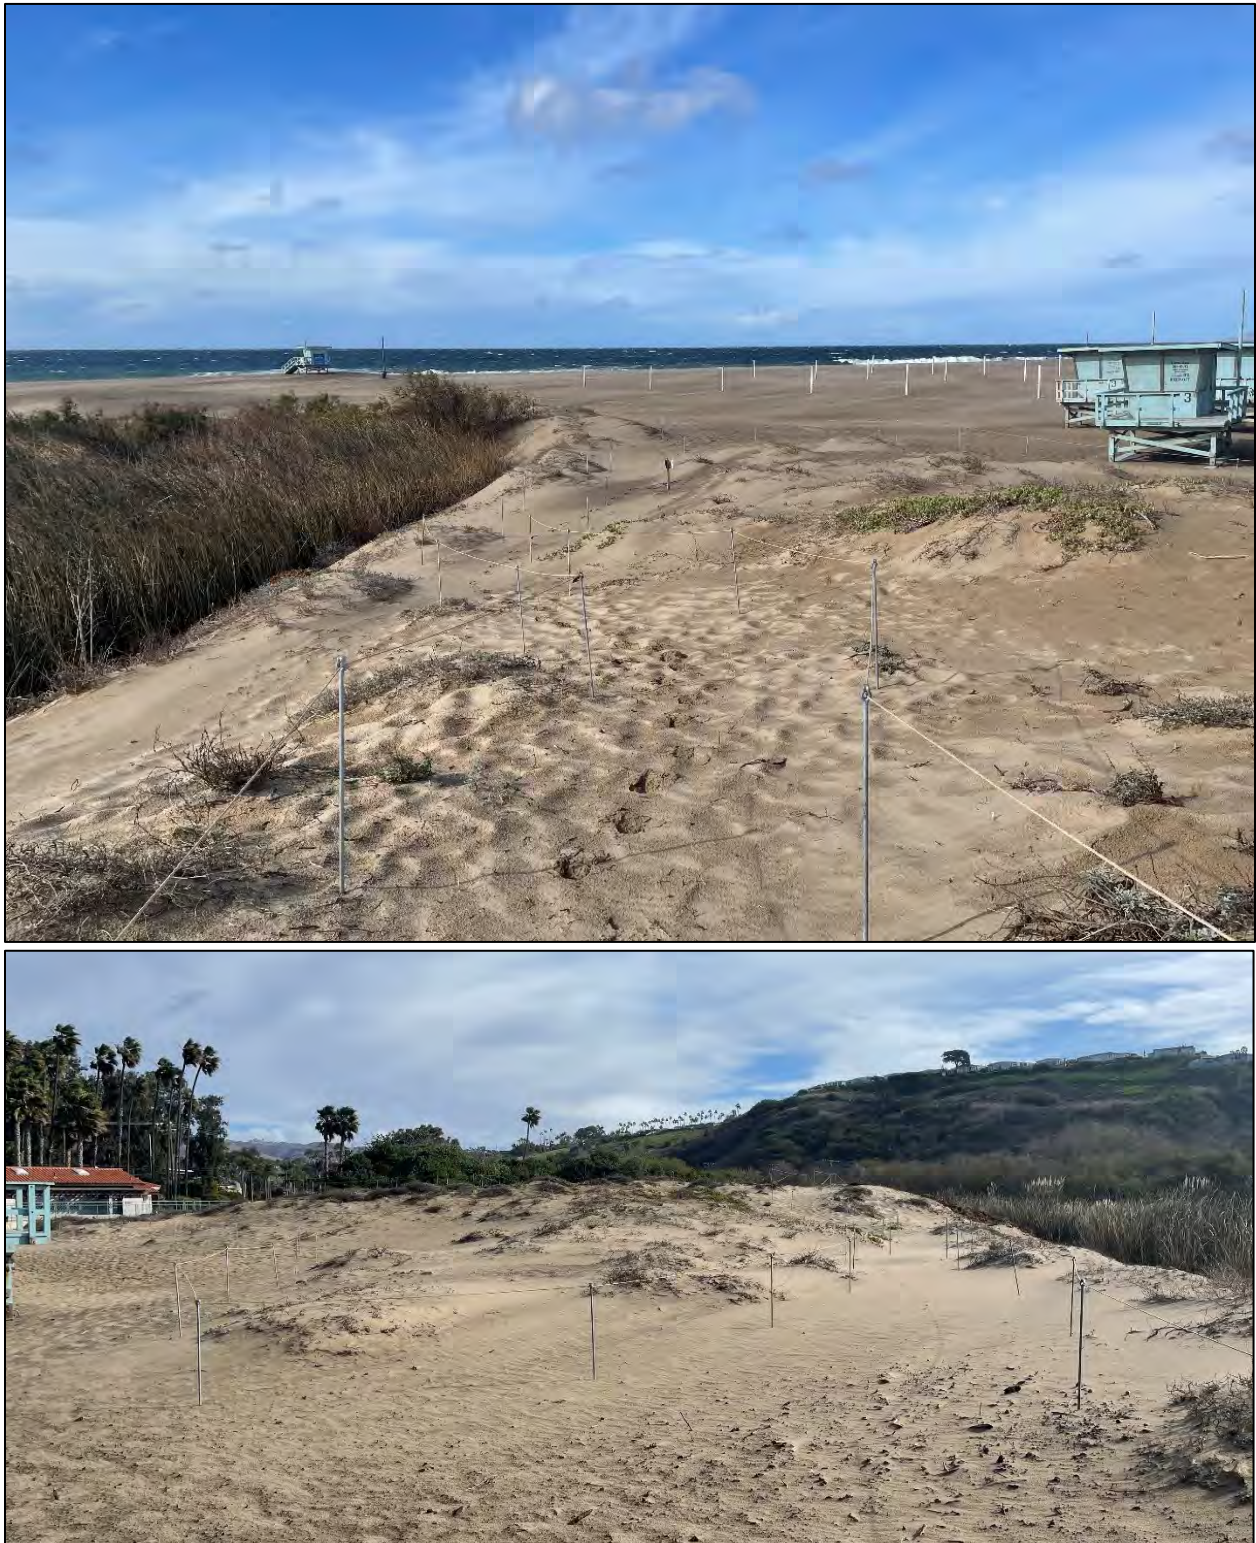
Figure 10b. Photos of post and rope delineation and pathways at the Zuma Beach site (25 January 2021).

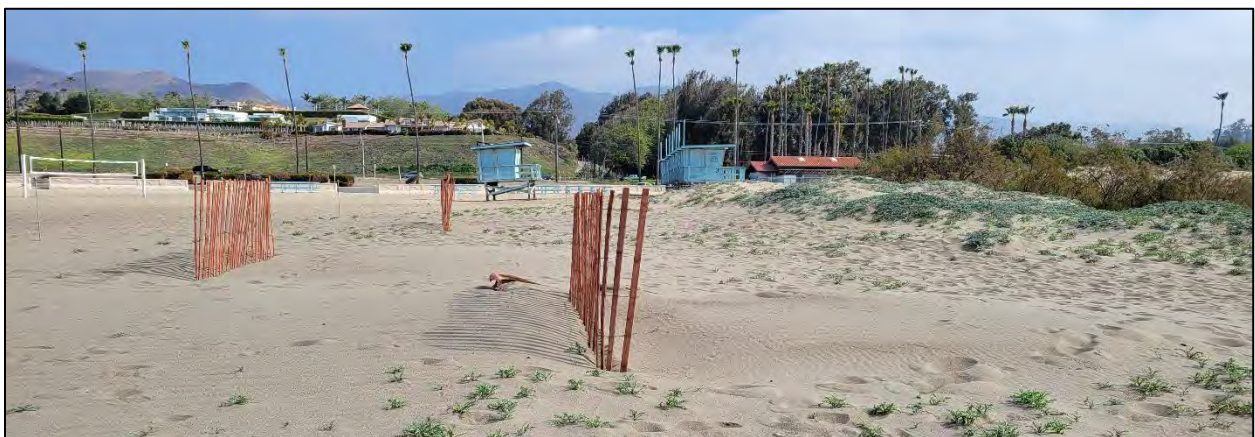
1. Sand fencing. Sand fencing is a proven technique for stabilizing areas with high levels of blowing sand and was determined to be most effective in the coastal strand areas and in strategic locations, particularly in the Point Dume restoration area. Sand fencing can be effectively mixed with re-vegetation techniques to delineate restoration areas, slow sand movement, accrete sand, build topographic complexity, and create areas suitable for plant establishment. Short lengths of sand fencing (approximately 5-10 ft) were installed perpendicular to predominant wind direction to enhance rapid dune establishment, and in strategic locations to reduce potential for erosion (Figures 11-12). Evaluation of sand fencing is ongoing and may be eventually pulled up over time and removed through adaptive management once the dunes are stabilized.

Figure 11. Sand fence segments installed at Zuma Beach (30 March 2021).

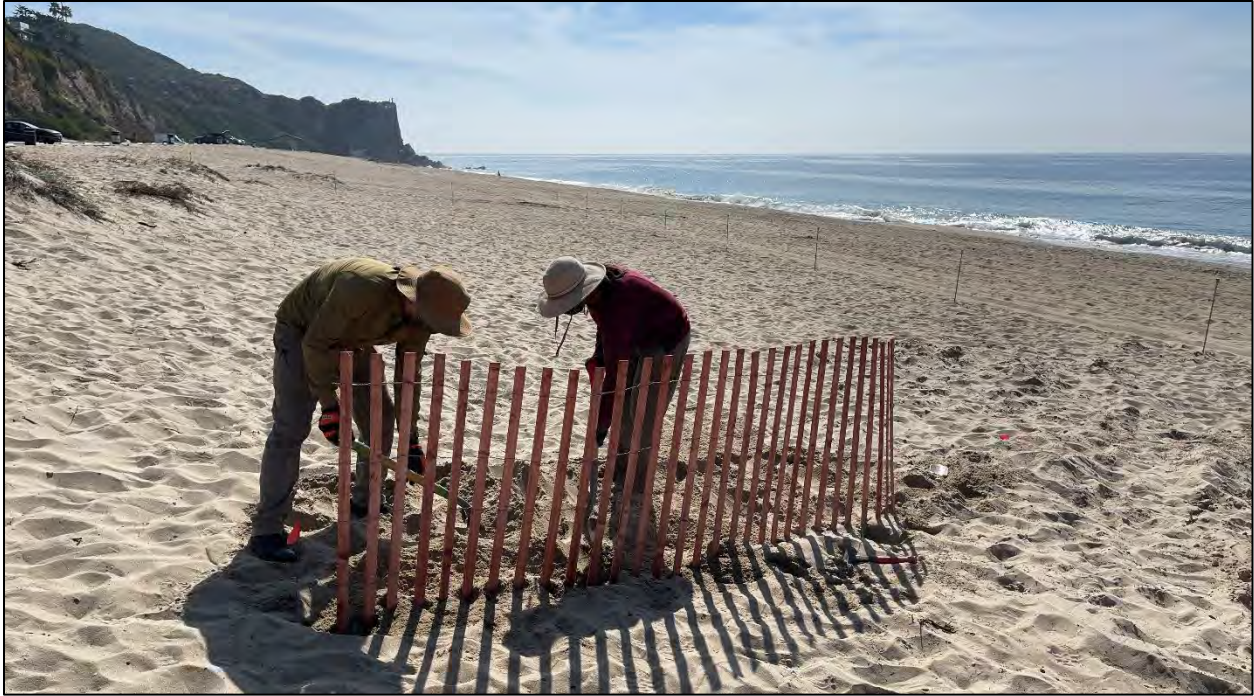
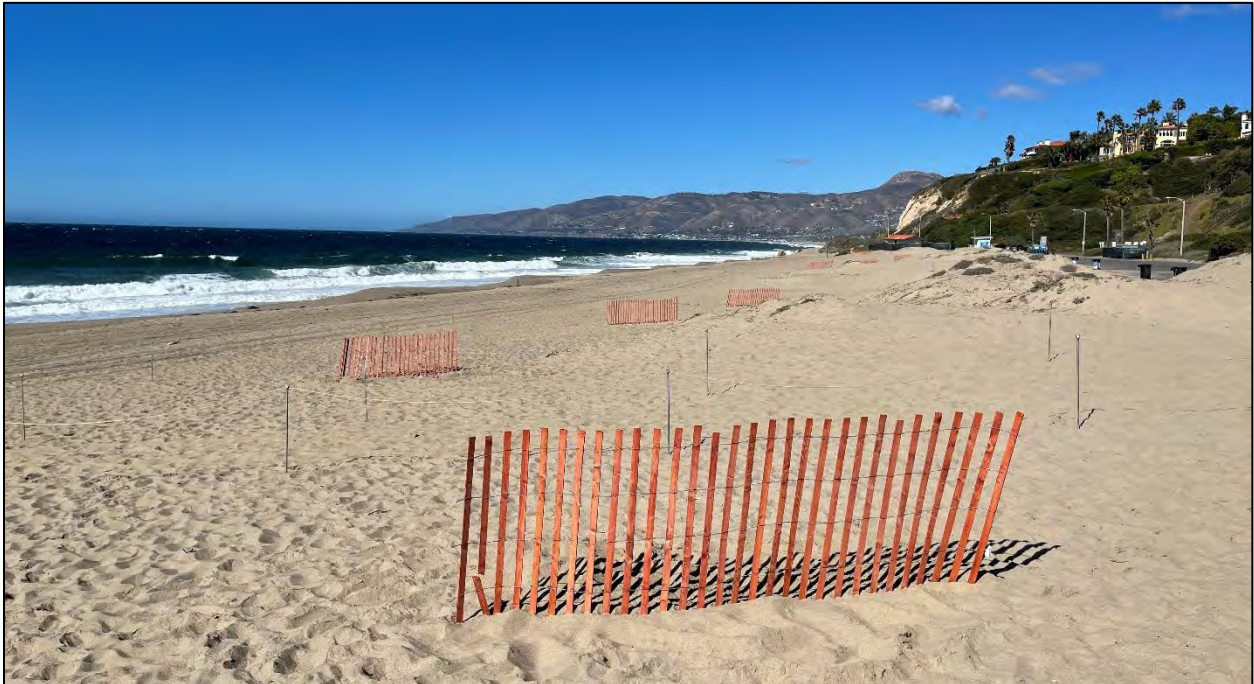
Figure 12a. Photos of sand fencing segments installed at Point Dume Beach (top: 11 February 2021; bottom: 12 February 2021).

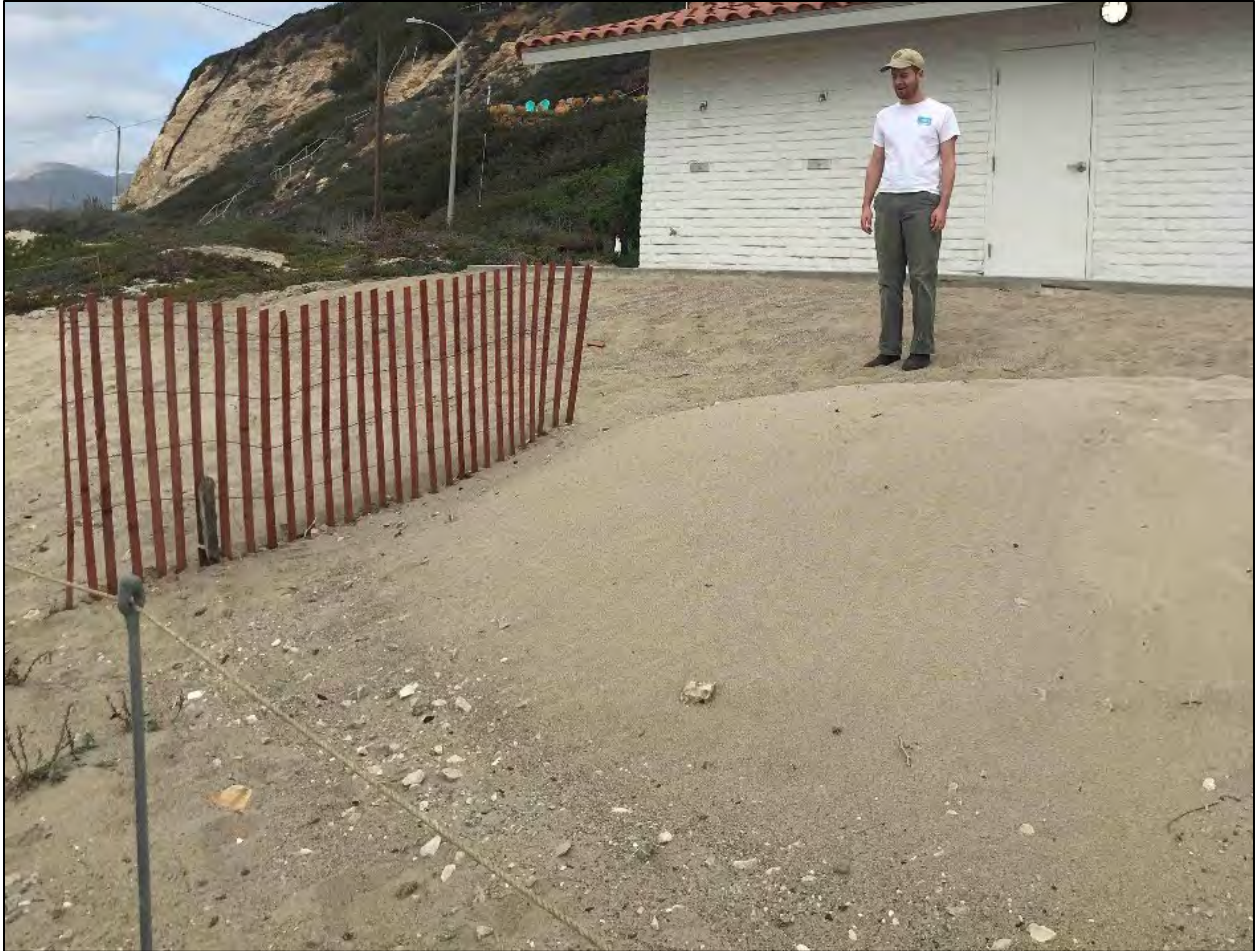
Figure 12b. Photo of sand accretion from sand fencing installed at Point Dume Beach approximately 9 months after implementation on 9 November 2021.

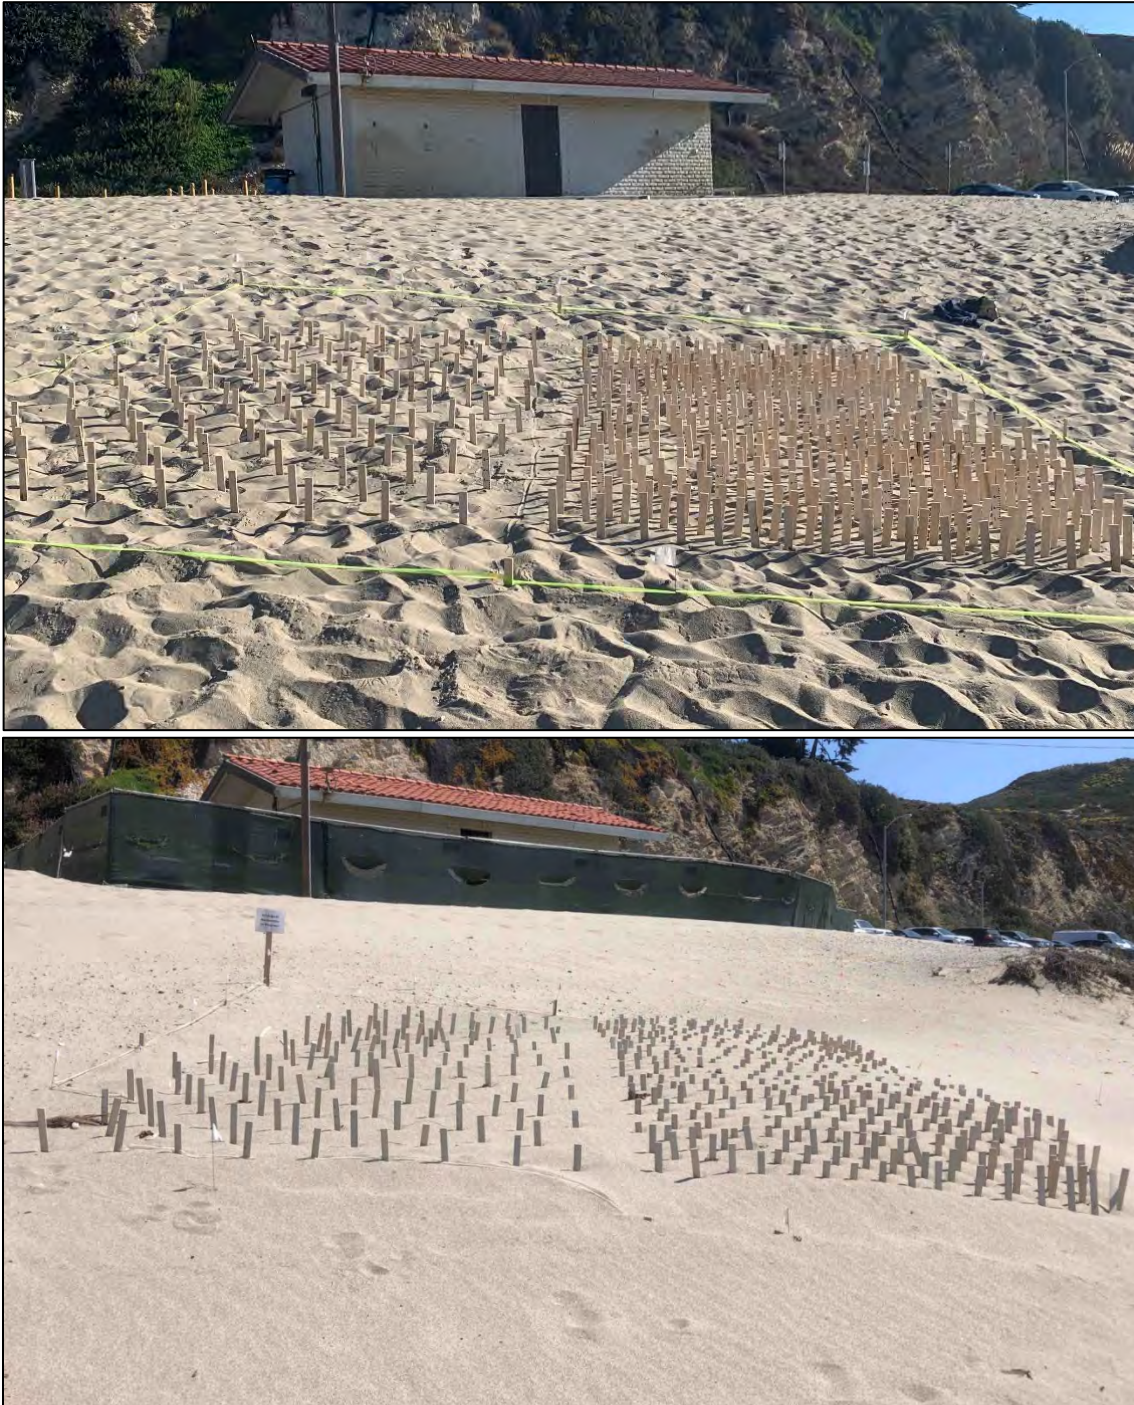
2. Wooden slats or “Biomimicry Stakes”. Recently, restoration practitioners have been using groupings of wooden slats, or biomimicry stakes to build topographic complexity in degraded dunes. This technique is being tested at Cardiff State Beach and at the mouth of the Tijuana River Estuary. The wooden slats are installed perpendicular to the prevailing wind direction and aim to mimic the sand trapping capabilities of native dune plants, to accrete sand and build hummocks. Preliminary results suggest that biomimicry stakes effectively accrete sand, though further assessments and testing of this method are warranted. Groups of wooden slats were installed at the Point Dume location in conjunction with strategic sand fencing to maximize sand retention and encourage plant growth (Figure 14). The wooden slats (~1 foot tall) were installed 18 December 2020 in five 20 by 20 ft plots using two densities in each plot (6 in and 12 in spacing). A subset of the stakes within each plot served as measurement stakes with cm markings to assess the accretion of sand over time. Sand accretion measurements were taken on 4 February 2021, 4 March 2021, and 26 March 2021. After approximately 3.5 months, the lower density plots (12 in spacing) had accumulated an average of 12.8 cm of sand and the higher density plots (6 in spacing) had accumulated an average of 34.1 cm of sand. Figure 14 displays sand accumulating within one treatment plot 7 weeks after initial installation. Wooden

Figure 13. Photo of a biomimicry stake plot the day of installation (top; 18 December 2020) and photo of the same plot after accumulating sediment for approximately three months (bottom; 26 March 2021). The plot was located within the Point Dume Beach project area and had the stakes pulled up due to sediment accumulation two additional times (credit: Lexi Neary, LMU Coastal Research Institute).

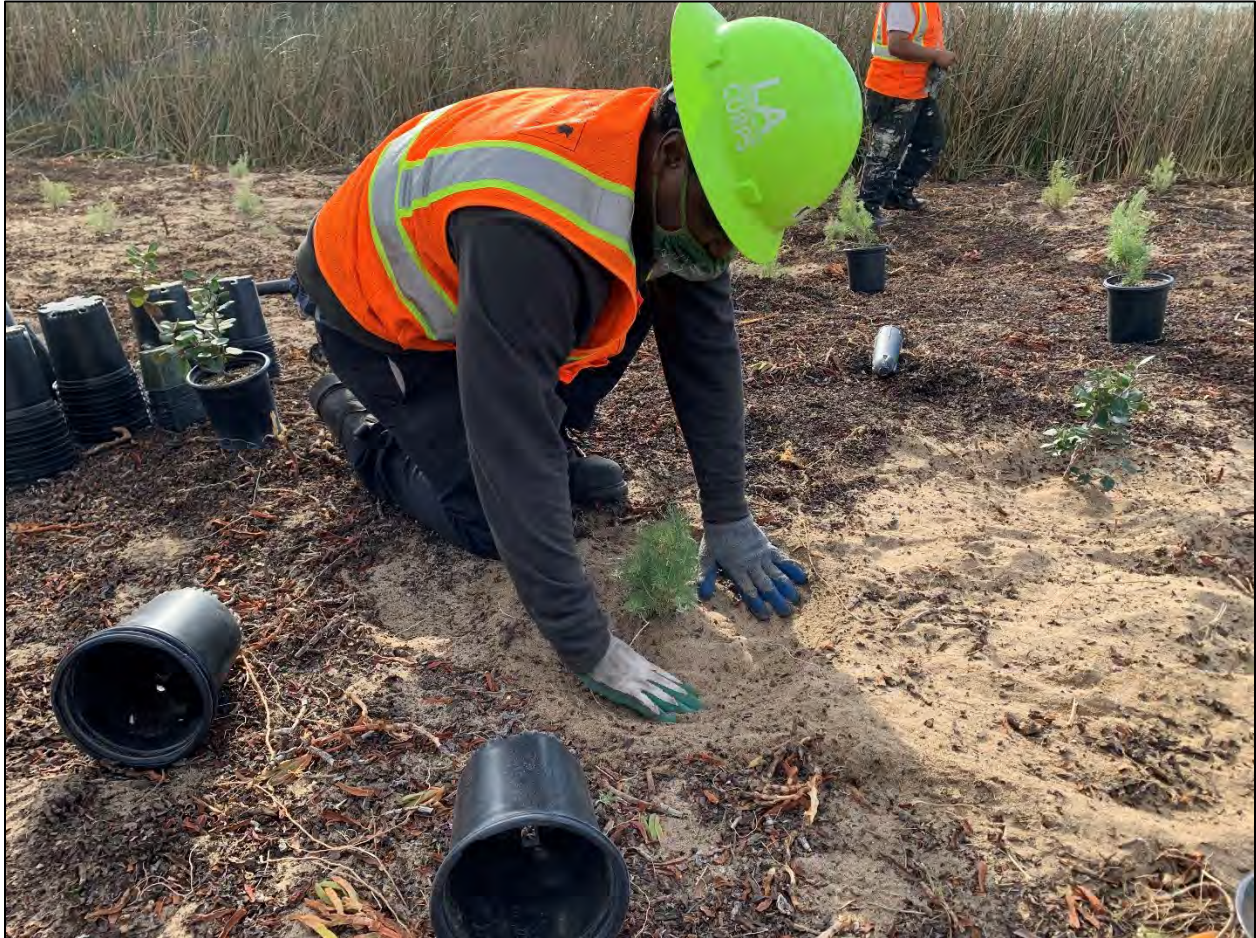
Figure 14. LACC planting native container stock on 13 January 2021.

3. Re-vegetation. Native dune plants are a sustainable long-term choice for building coastal dunes and retaining and stabilizing sand in California and elsewhere. California native dune plants also benefit greatly from protection from driving and trampling, so directing foot and vehicle traffic around vegetated areas is important. The project site was seeded and planted in accordance with the project Implementation and Monitoring Plan (Figure 14). Please see the re-vegetation section below for details.
