Malibu Living Shoreline Project

Year 1 Annual Report

May 2022

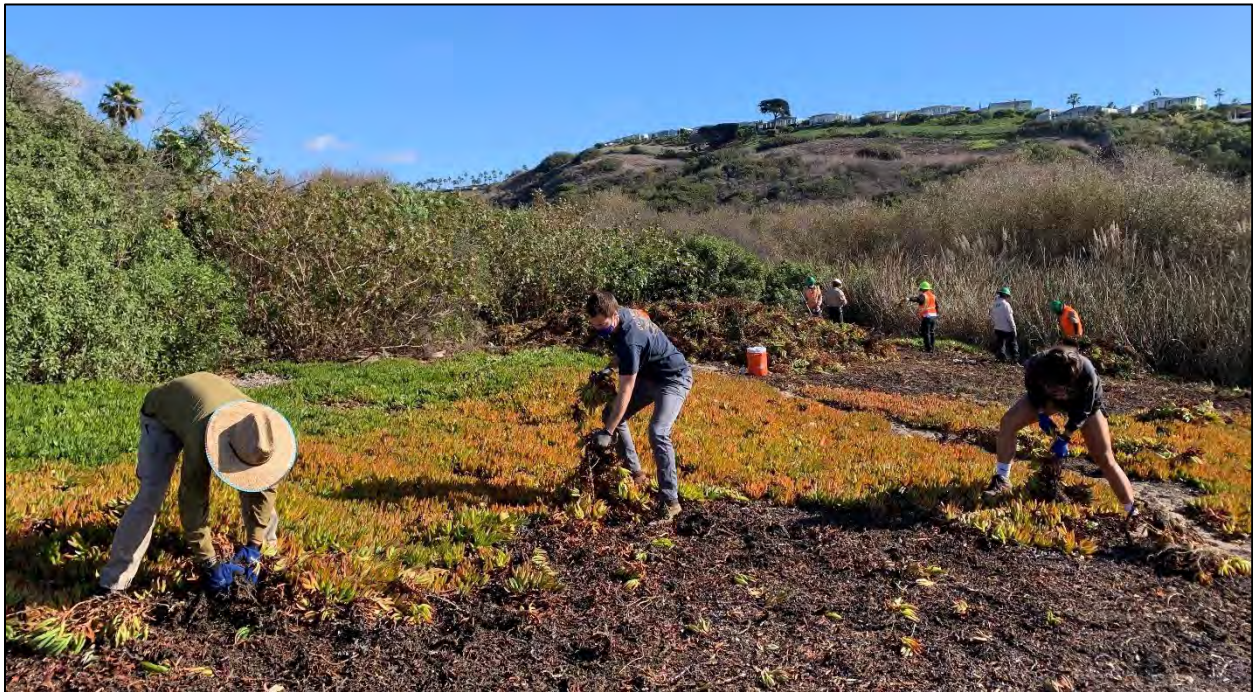
Figure 15. TBF and LACC removing non-native ice plant at Zuma Beach (17 December 2020).

As part on implementation actions, a total of approximately 25 tons (50,000 lbs) of non-native plants were removed from the project areas at Zuma Beach and Point Dume Beach (Figure 15). The majority of this was comprised of a large iceplant monoculture in the stabilized back dune and dune transition areas at Zuma Beach. Figure 16 displays photos taken before and after iceplant removal in this area. In addition, TBF staff and interns continued site maintenance by removing non-native vegetation that sprouted up since initial restoration efforts. Figure 17 displays photos taken before and after removal of non-native sea rocket that sprouted within the Zuma Beach project area. Due to COVID-19 restriction, volunteers were not able to be utilized for restoration actions or site maintenance the start of project implementation (December 2020) through the end of this reporting period (December 2021); however, planning and coordination for outreach and restoration events along with partners, LACDBH and the City of Malibu, is ongoing. Volunteer events are scheduled to begin in March 2022.

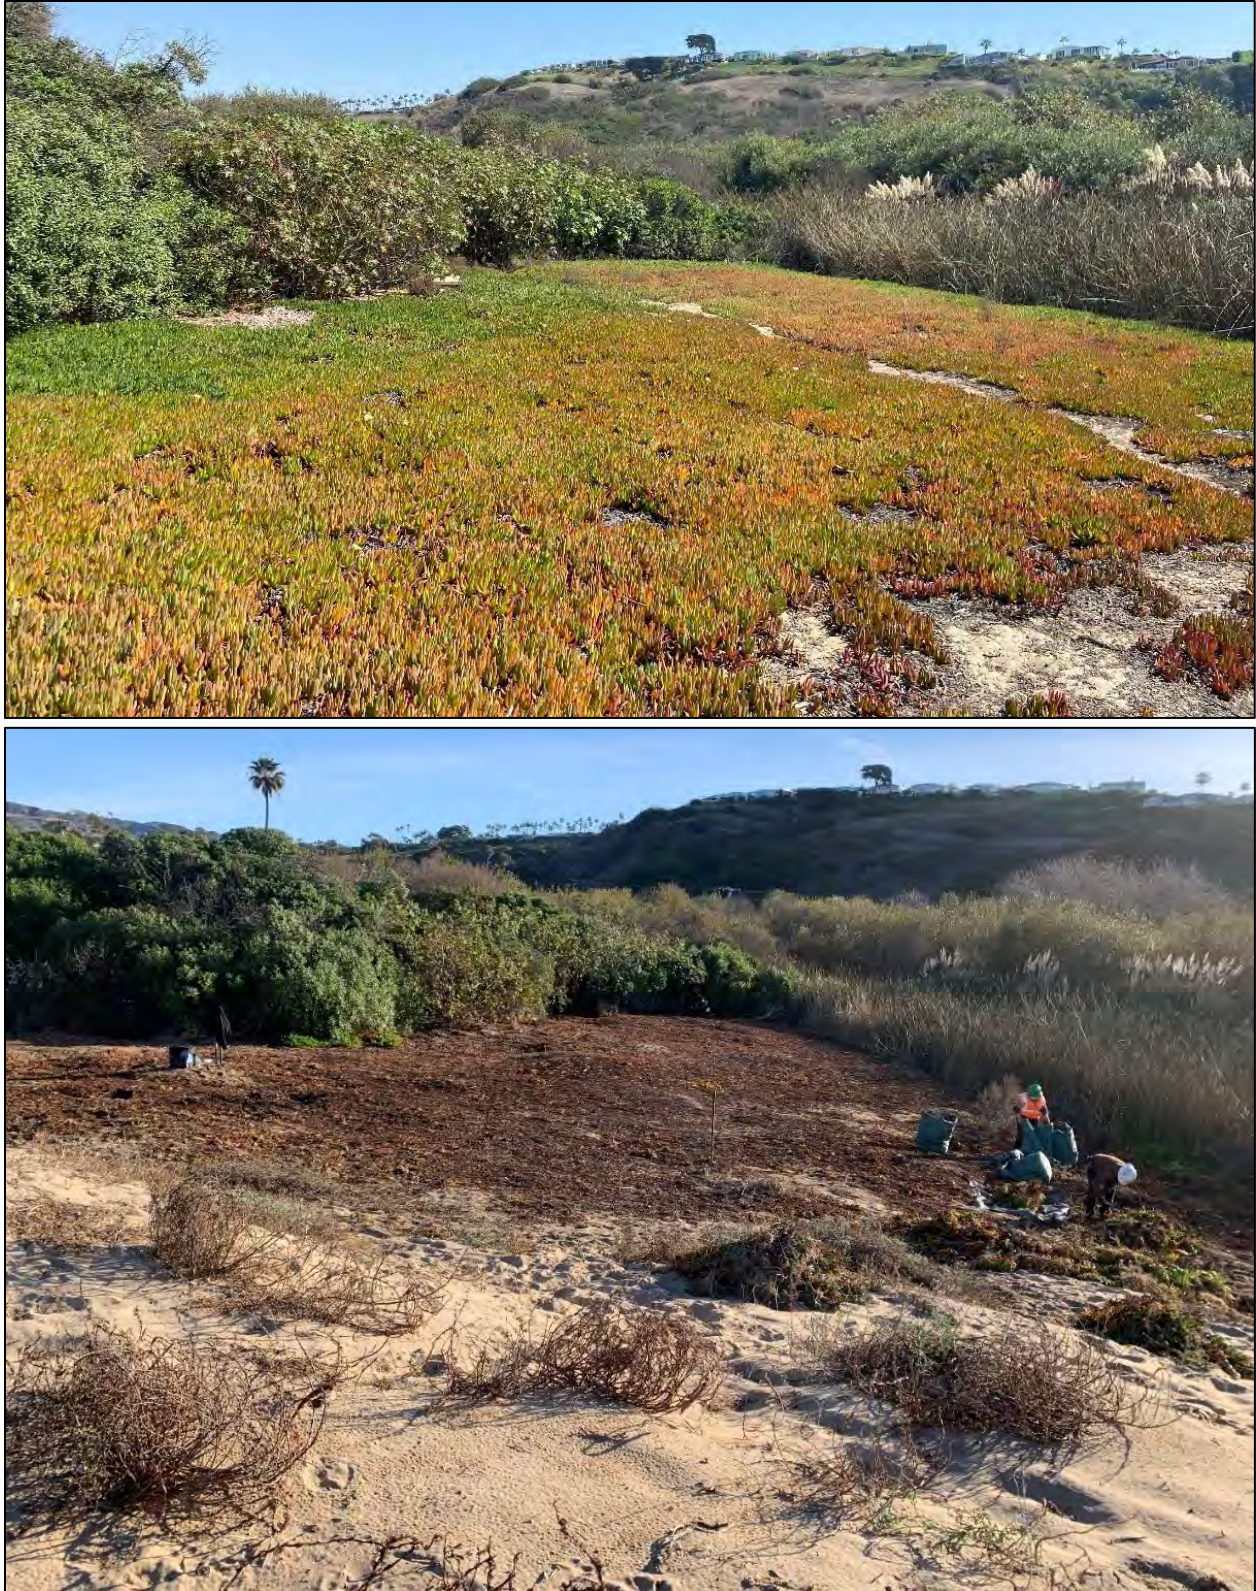
Figure 16. Photos taken before (top) and after (bottom) removal of ice plant monoculture at Zuma Beach (top: 2 October 2020; bottom: 30 December 2020).

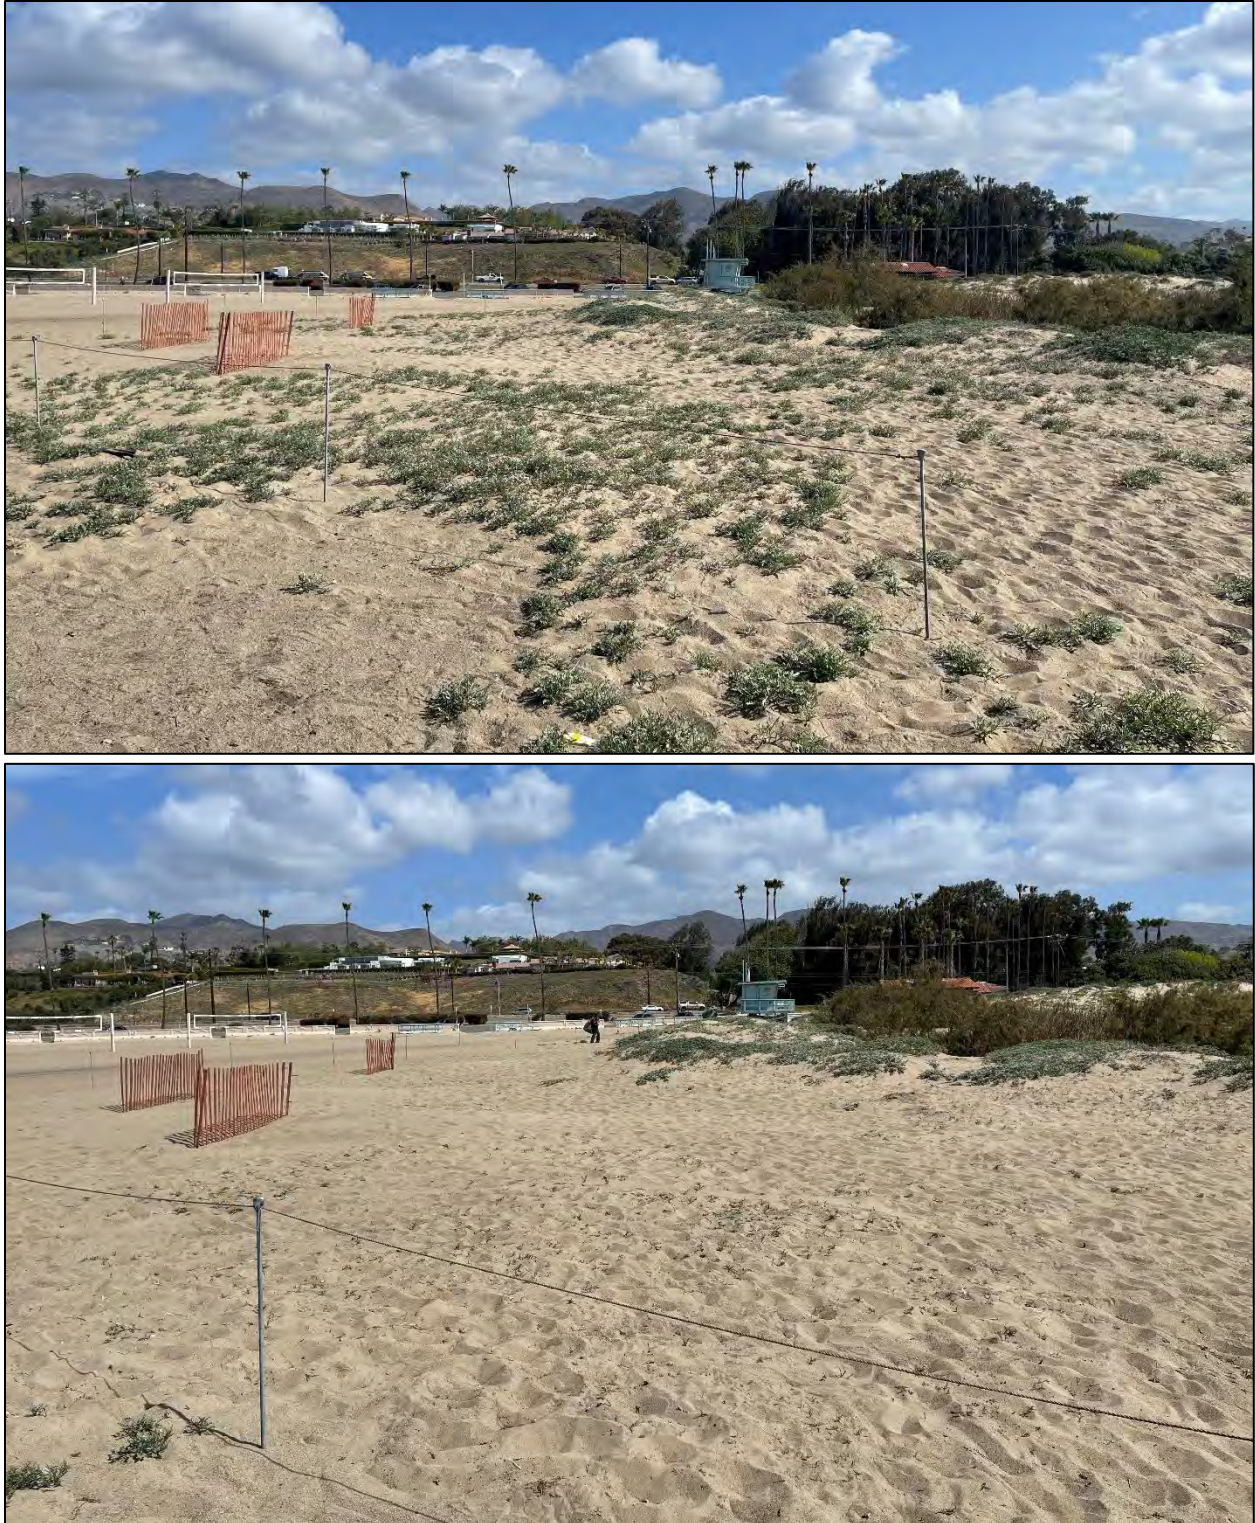
Figure 17. Photos taken before (top) and after (bottom) removal of non-native sea rocket during post-restoration site maintenance (14 April 2021).

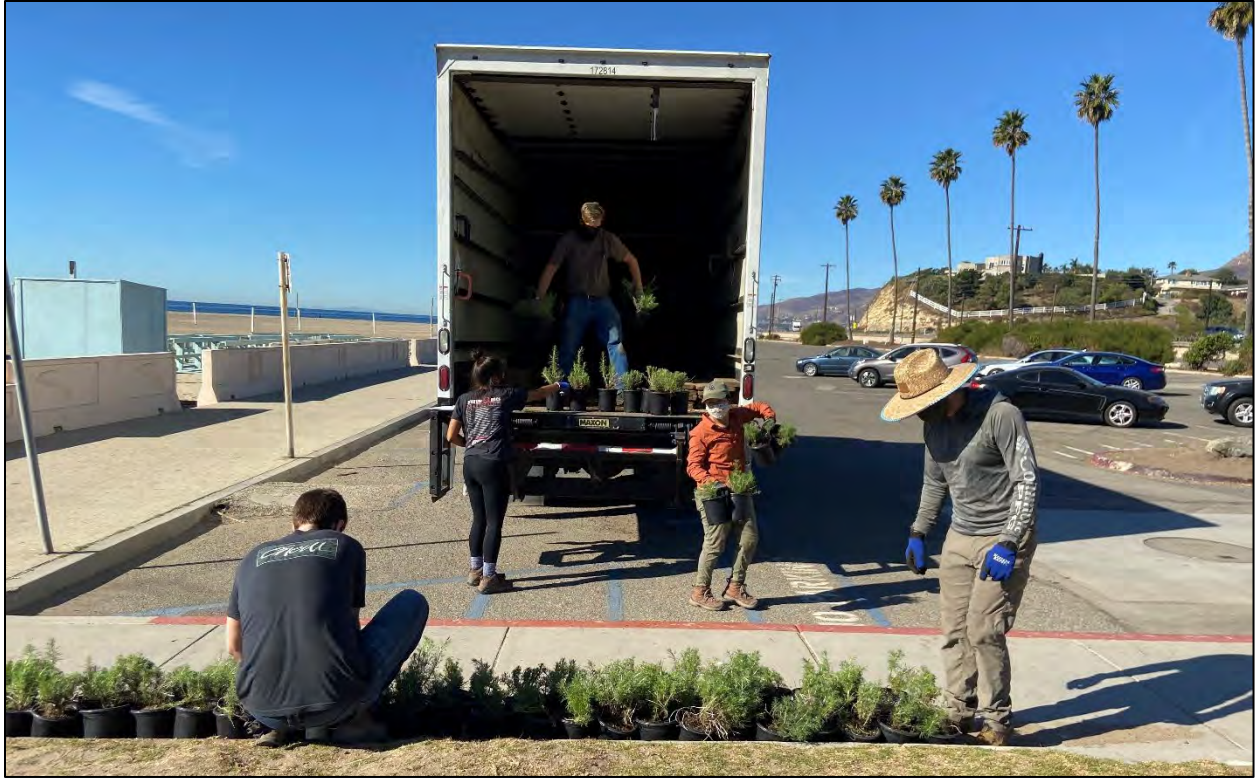
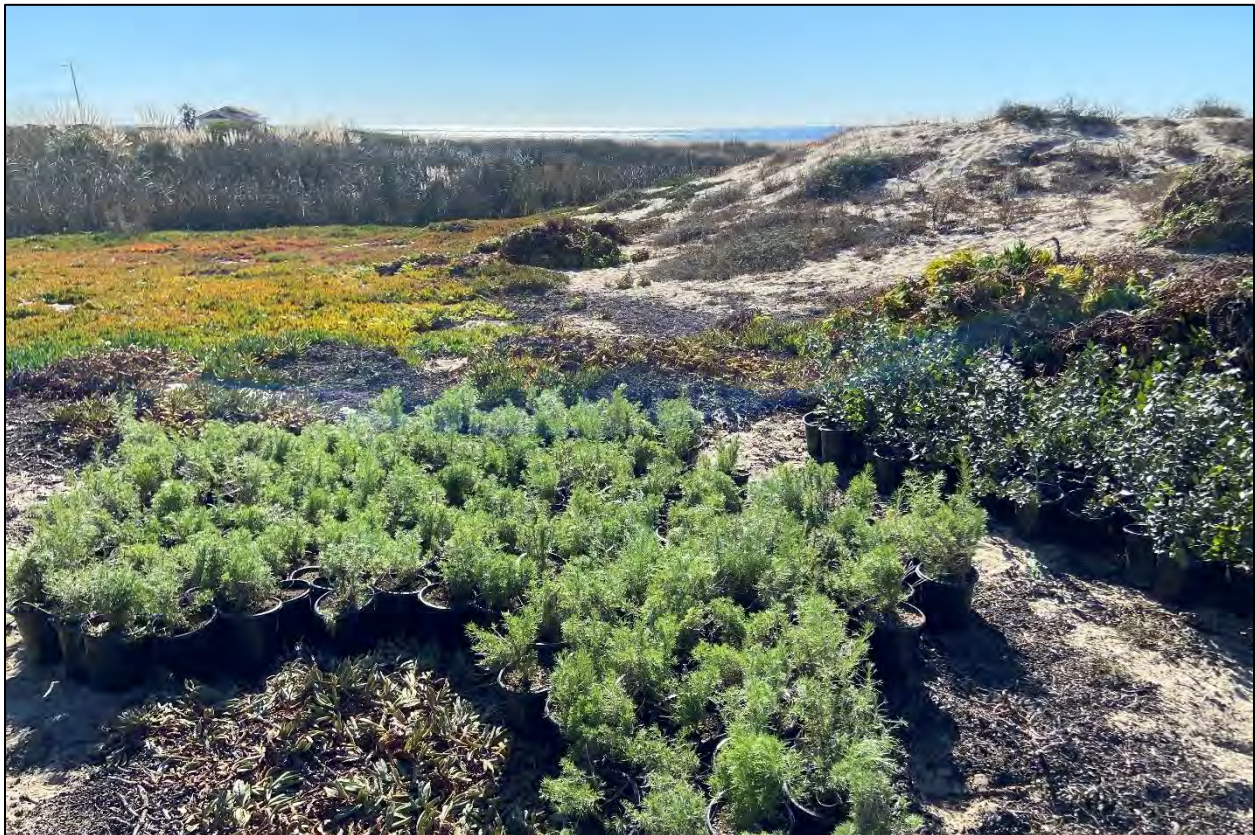
Figure 18. Photos taken during planting of container stock in the dune transition area at Zuma Beach.

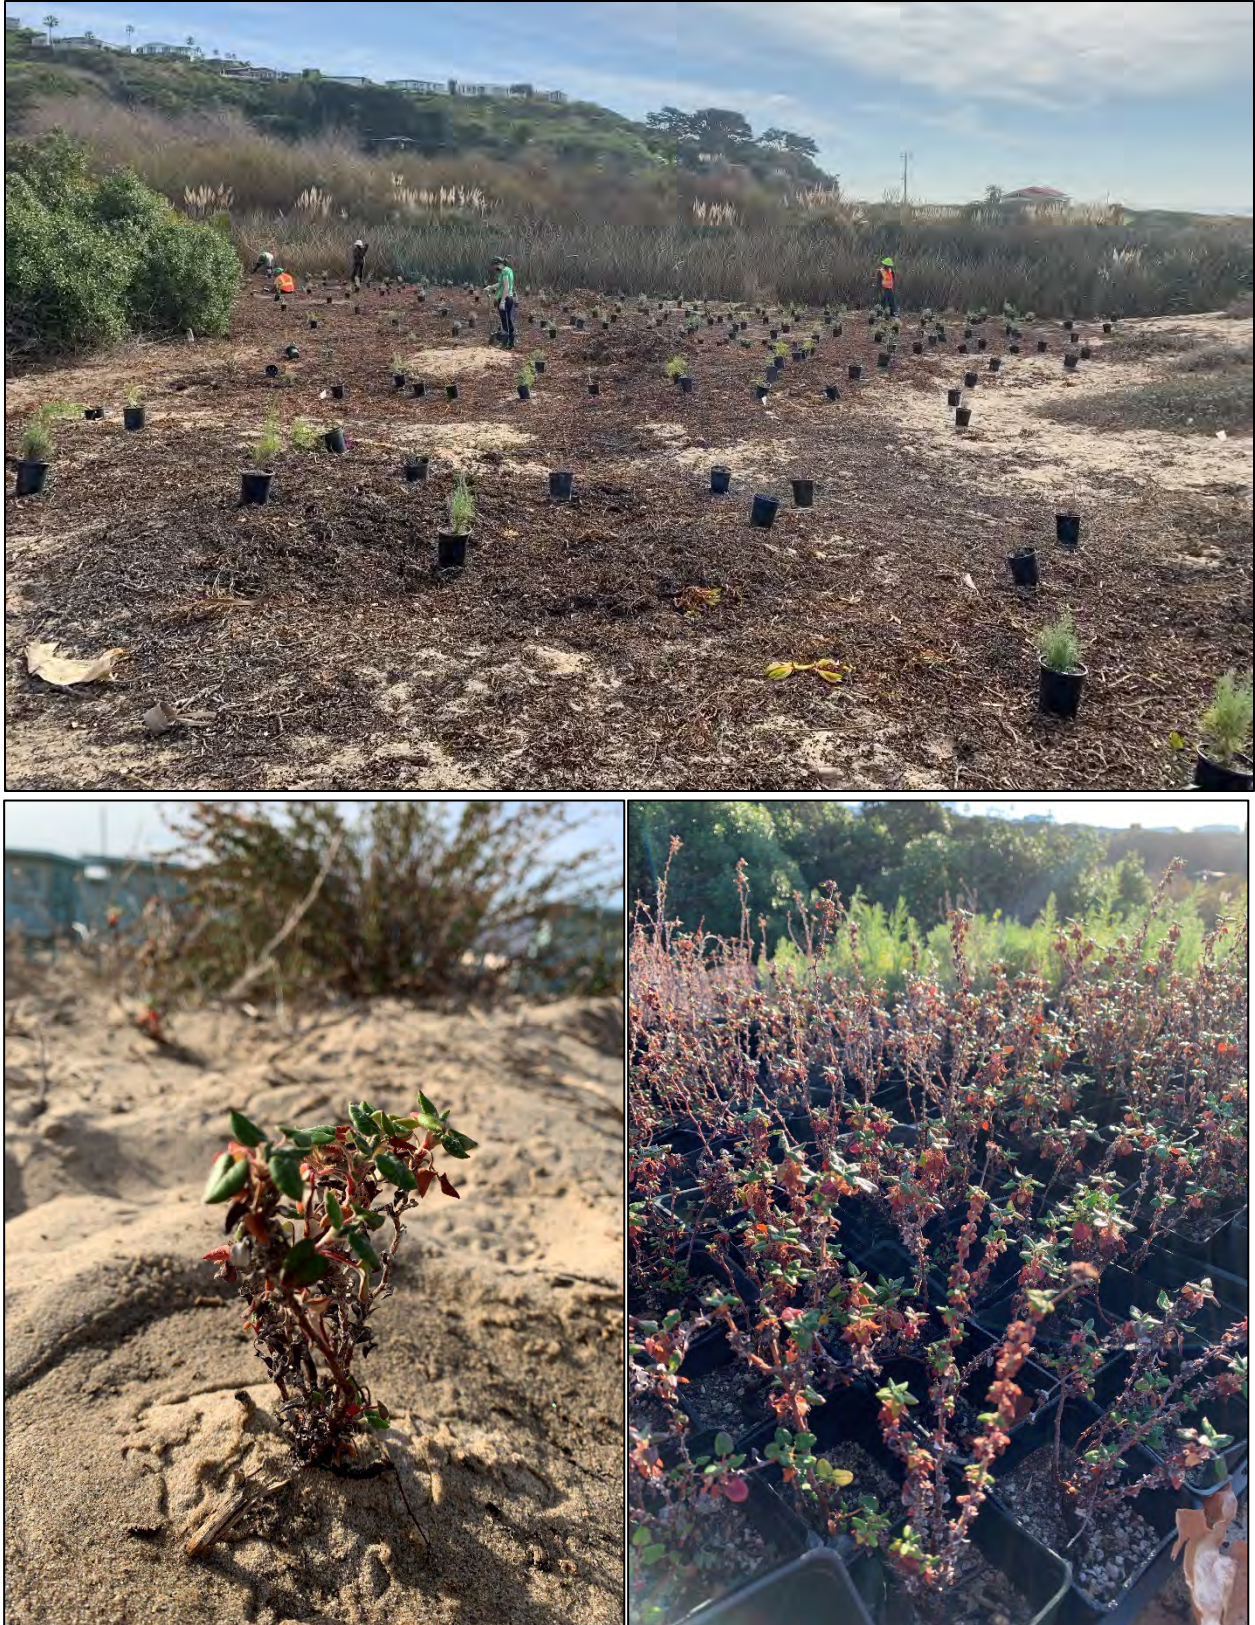
Figure 19. Photos taken during planting of container stock in the dune transition area at Zuma Beach (12 December 2020).

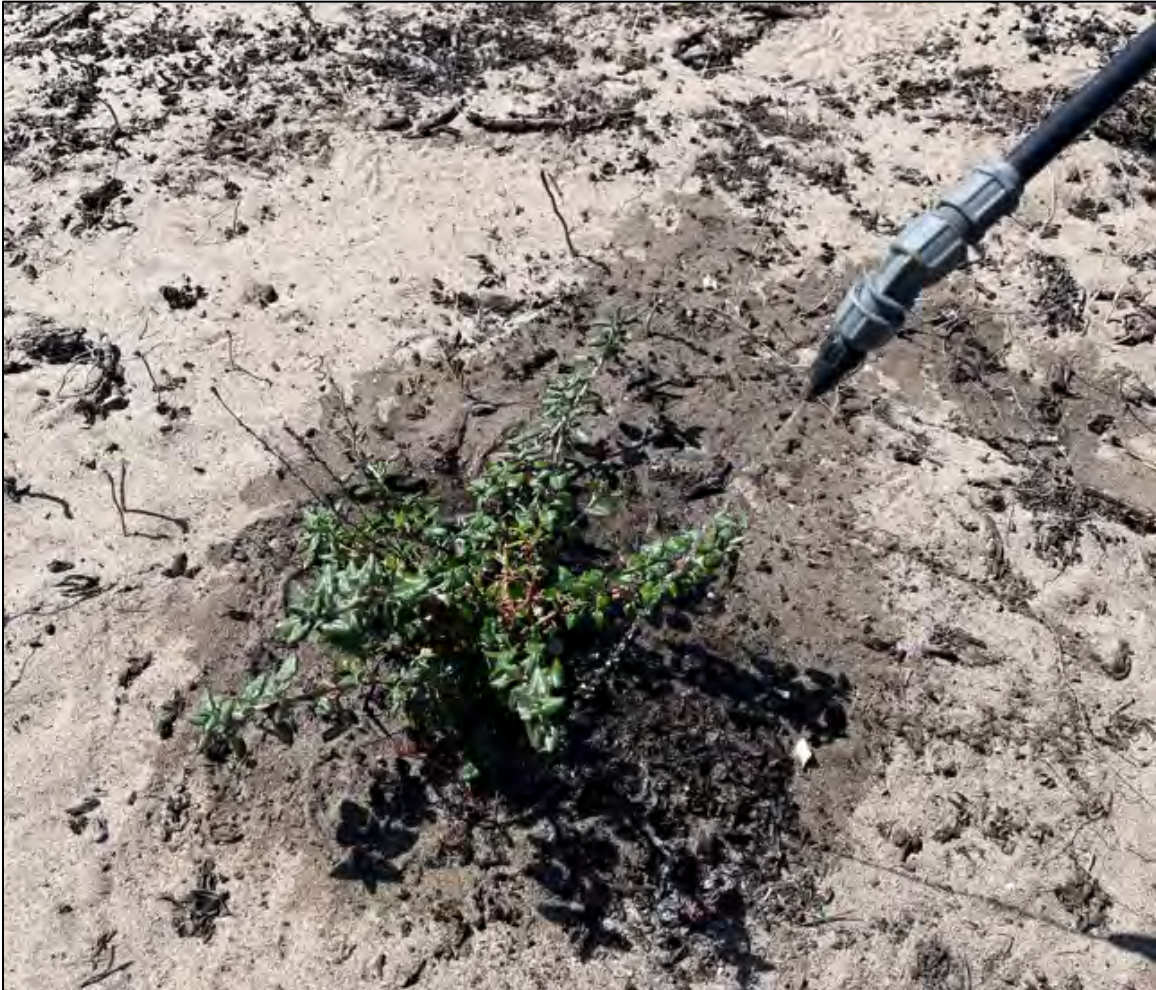
Figure 20. Photo of TBF staff watering container stock with a backpack sprayer in the Zuma dune transition area.

The dune transition and back dune areas required supplemental irrigation in the first growing season for good initial plant establishment, especially for areas with container stock. In particular, upland habitats in the northwestern portion of the Zuma Beach site required supplemental irrigation, due to not meeting rain event conditions identified in the Implementation and Monitoring Plan. Planted container stock was watered using watering cans and backpack sprayers on 12 and 13 January and 14 and 23 April 2021 (Figure 20). In total, approximately 250 gallons of water were used on site at Zuma Beach only.

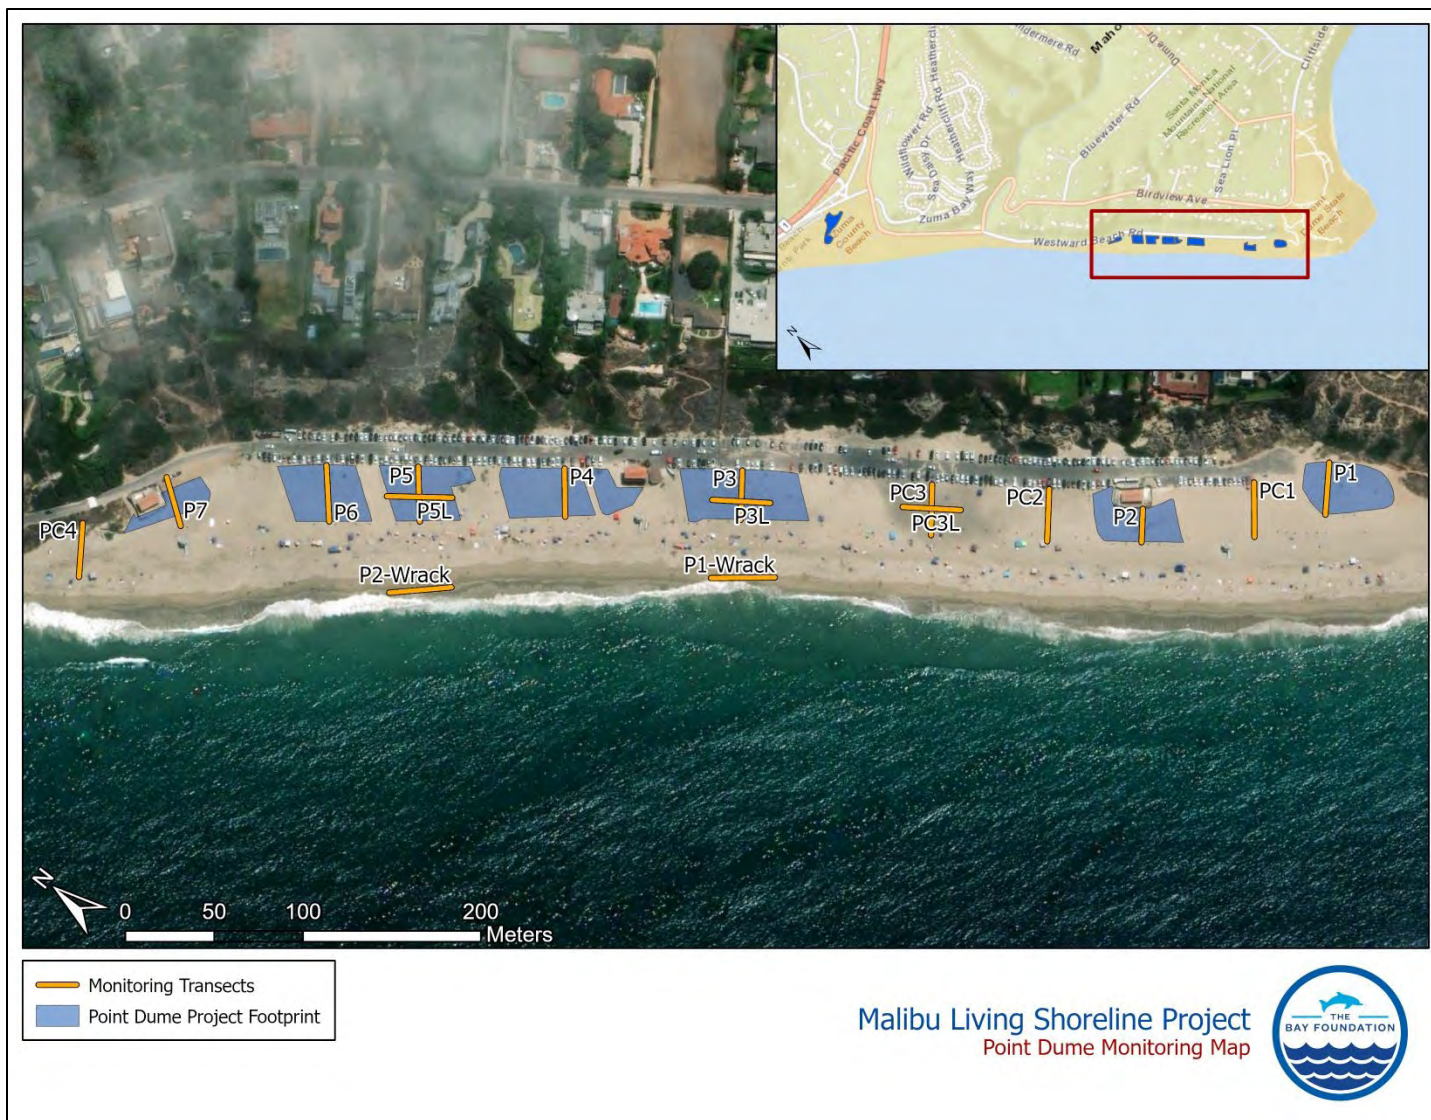
Figure 21. Dune habitat restoration (P1, P2, P3, P3L, P4, P5, P5L, P6, P7) and control (PC1, PC2, PC3, PC3L, PC4) transects and approximate locations of wrack transects located at Point Dume Beach.

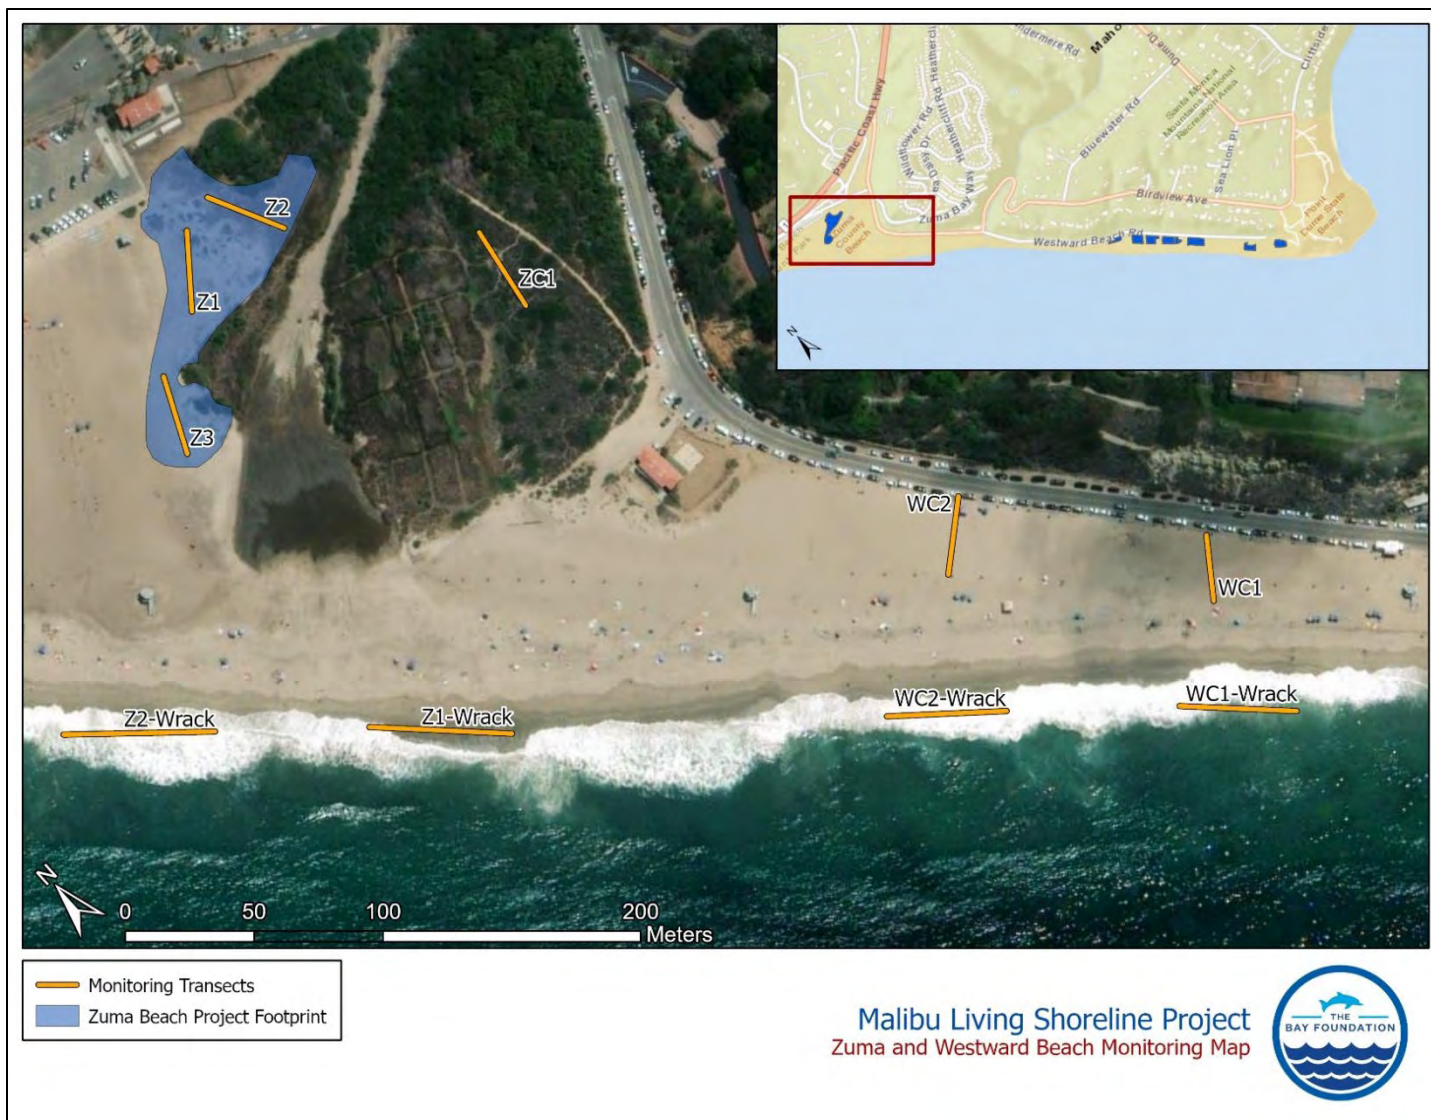
Figure 22. Dune habitat restoration (Z1 and Z3), dune transition habitat restoration (Z2), dune transition habitat control (ZC1) transects, and approximate location of wrack transects at Zuma Beach; and sandy beach control transects (WC1 and WC2), and approximate location of wrack control transects located at Westward Beach.

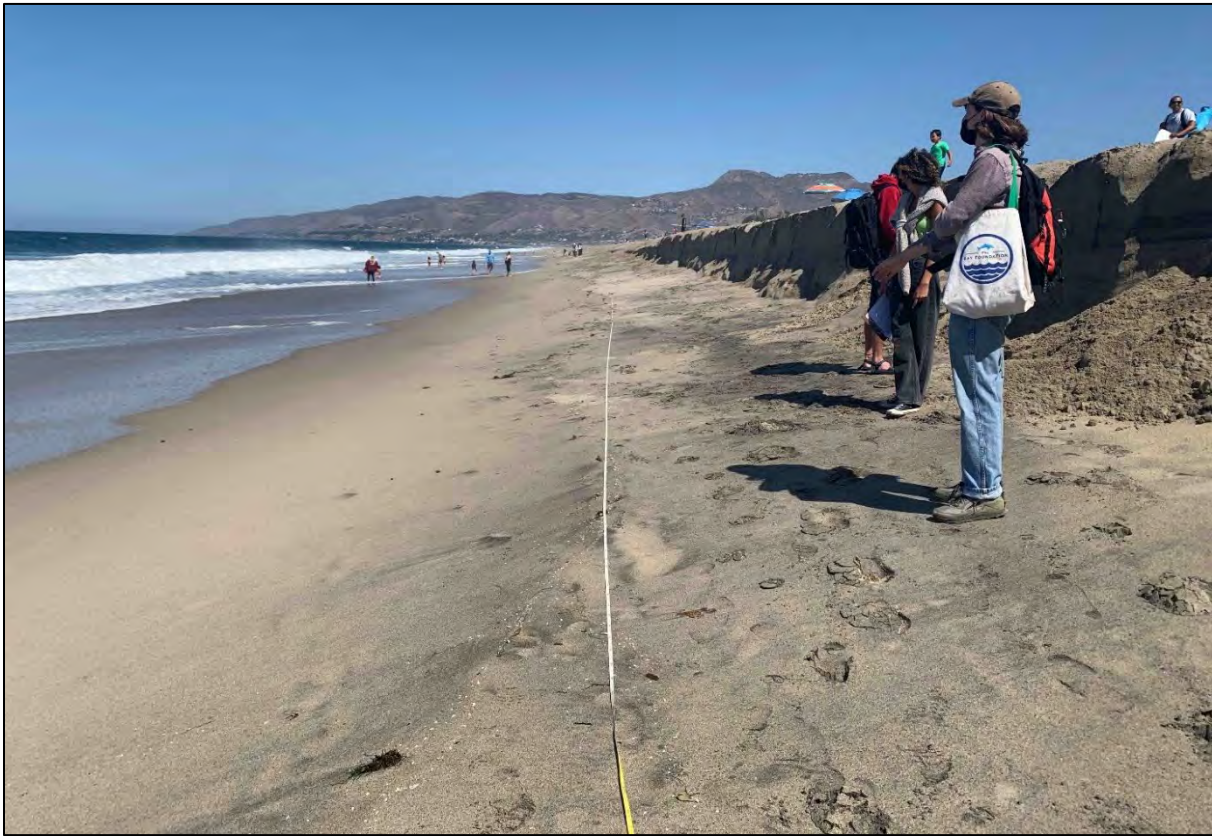
Figure 23. Photo of wrack control transect at Westward Beach on 10 June 2021.

A total of six line-intercept transects were surveyed, consisting of two transects each in the swash zone directly in front of the two restoration sites (four total) and two transects in the swash zone of the control area, located at Westward Beach (Figure 23). These transects also recorded any trash, tar,

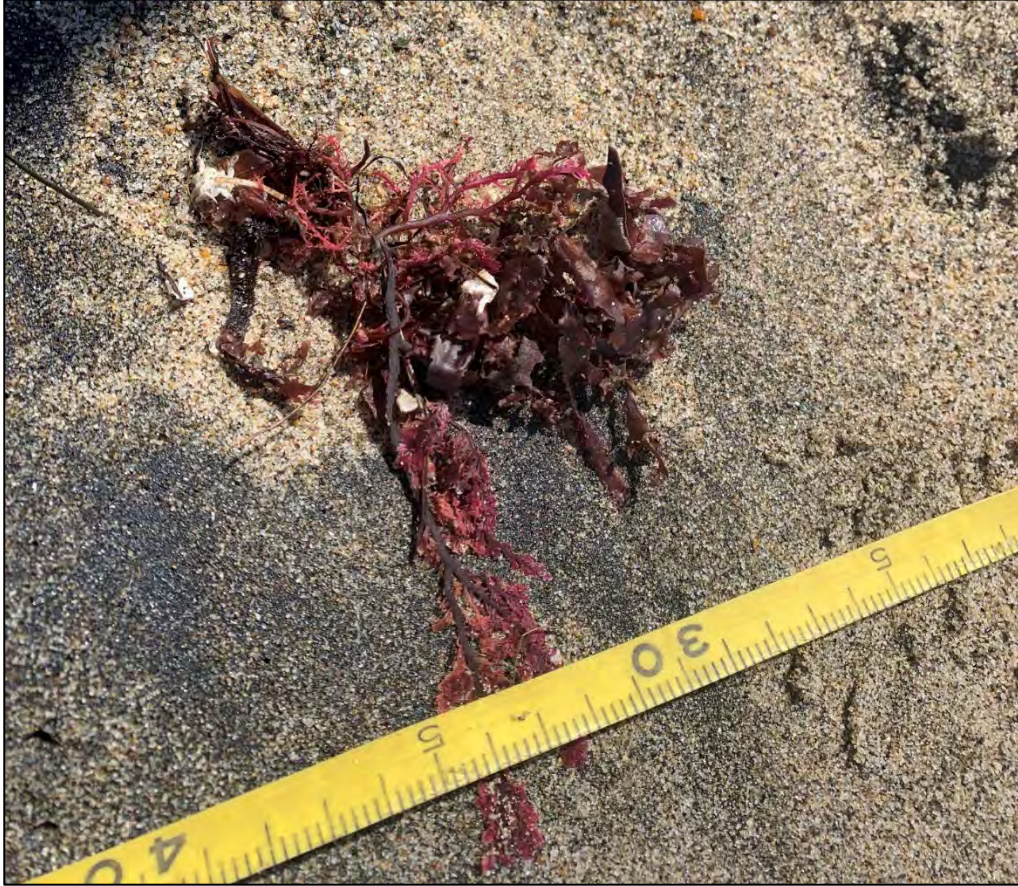
Figure 25. Erect red algae with branching tree-like form observed during post-implementation wrack survey on 18 June 2021.

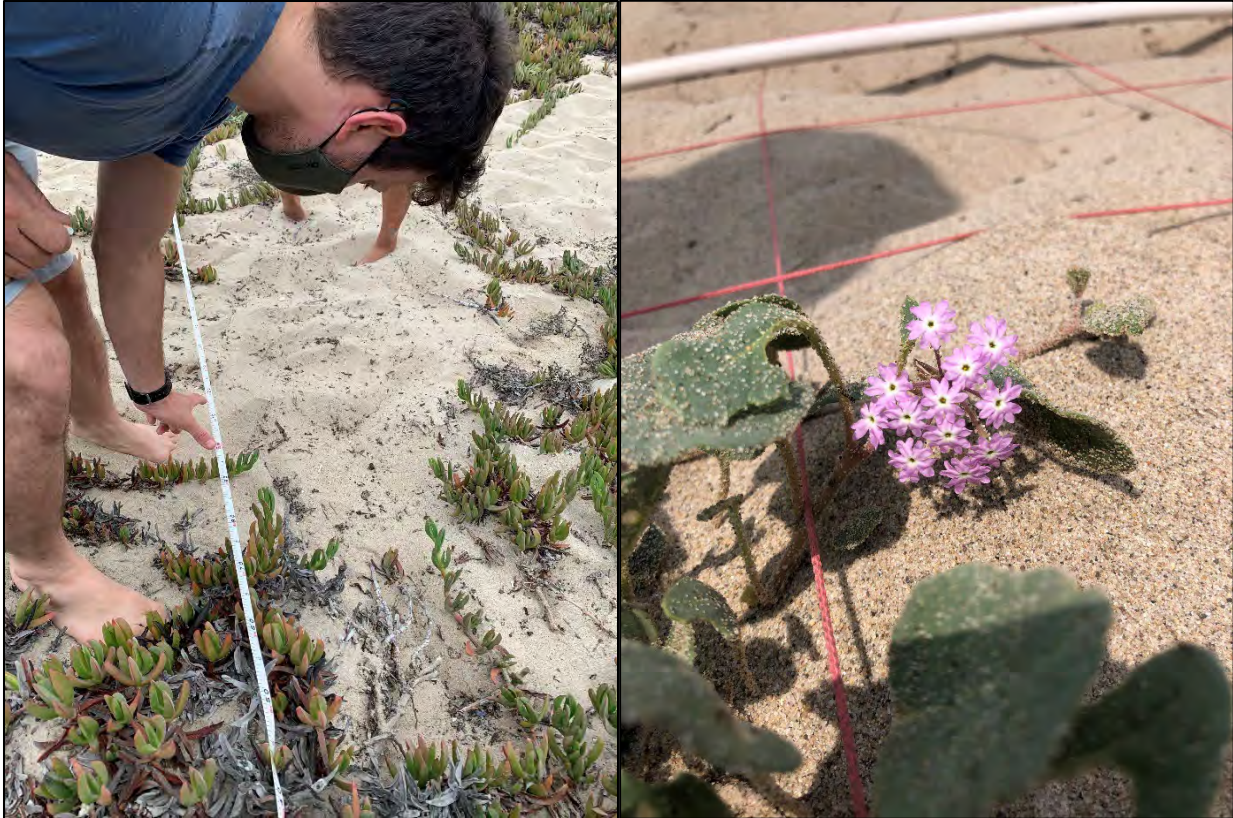
Figure 26. Photos taken during baseline vegetation cover surveys (9 October 2020).

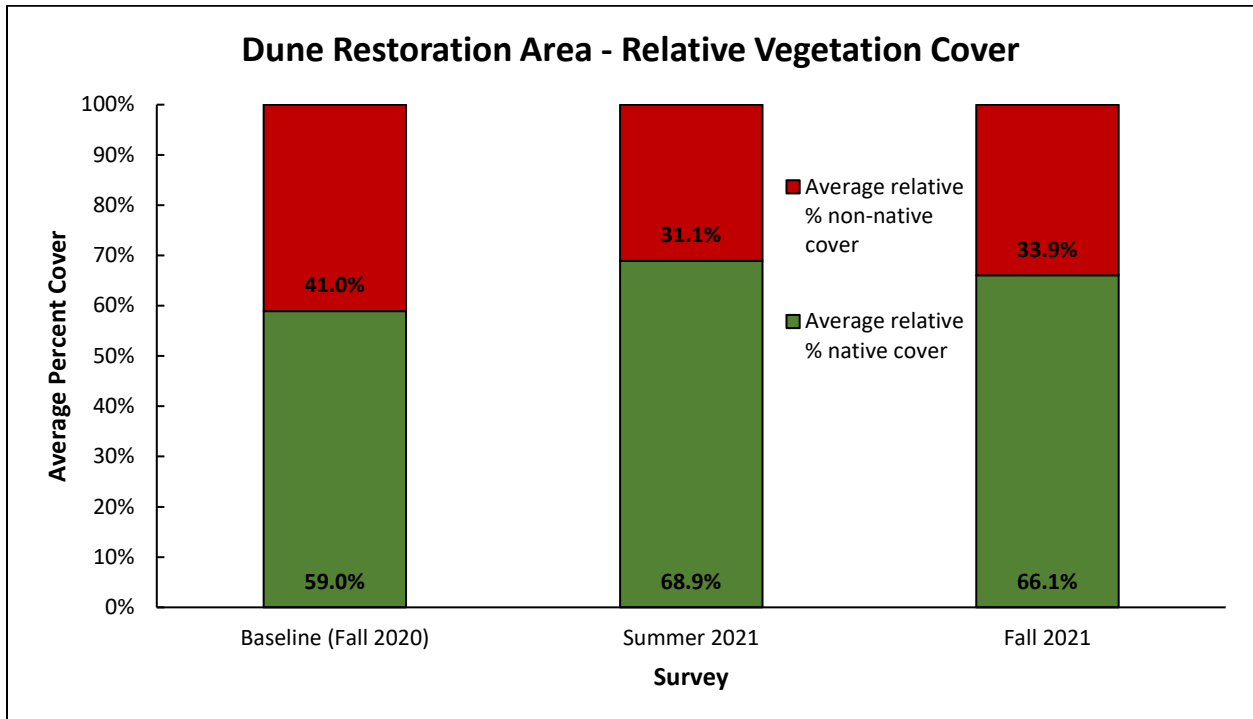
Figure 28. Average relative percent cover for all dune habitat transects located within the project area at Zuma Beach and Point Dume Beach.

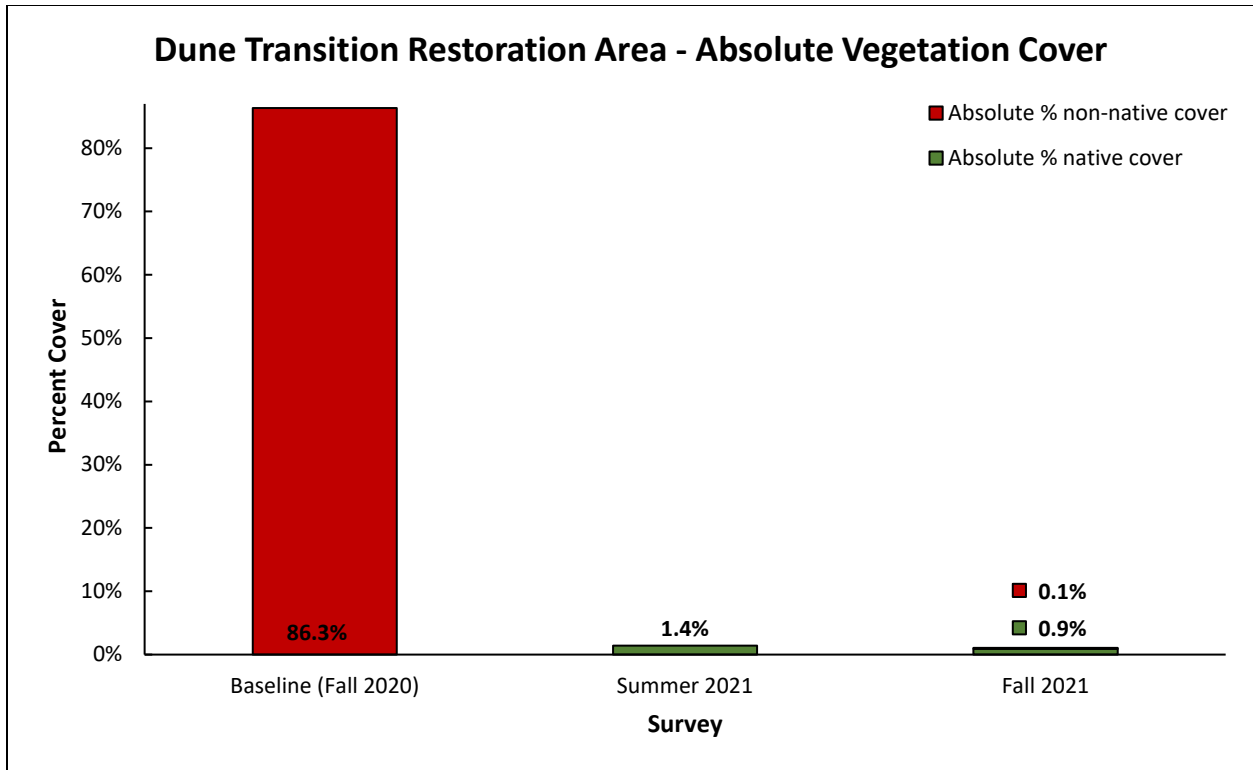
Absolute percent non-native cover for the dune transition habitat transect located within the project area at Zuma Beach (Z2) was 86.3% during the baseline survey (Figure 31). The non-native cover was primarily comprised of a monoculture of non-native iceplant. Following the removal of the iceplant, as part of project implementation, absolute non-native cover fell to 0.0% in Summer 2021 survey and remained close to zero (0.1%) in the Fall 2021 survey. No iceplant was observed in the dune transition habitat transect (Z2) in Fall 2021. The non-native cover was comprised of European sea rocket that had sprouted following iceplant removal. Absolute native cover was 0.0% in the baseline survey and remained extremely low in subsequent surveys (1.4% and 0.9% in the Summer and Fall 2021 surveys, respectively) (Figure 31). Relative native and non-native cover displayed a similar pattern, with 100% relative non-native cover in the baseline survey, 100% relative native cover in the first post-implementation survey (Summer 2021), and a ratio of 12.5% / 87.5% non-native to native cover in the Fall 2021 survey (Figure 32). The slight return of non-native cover in the most recent survey included non-native annuals which were subsequently pulled during maintenance activities. Non-native annuals will likely need to be maintained (hand pulled) while the native vegetation community establishes.

Figure 31. Absolute percent cover for the dune transition habitat transect located within the project area at Zuma Beach.

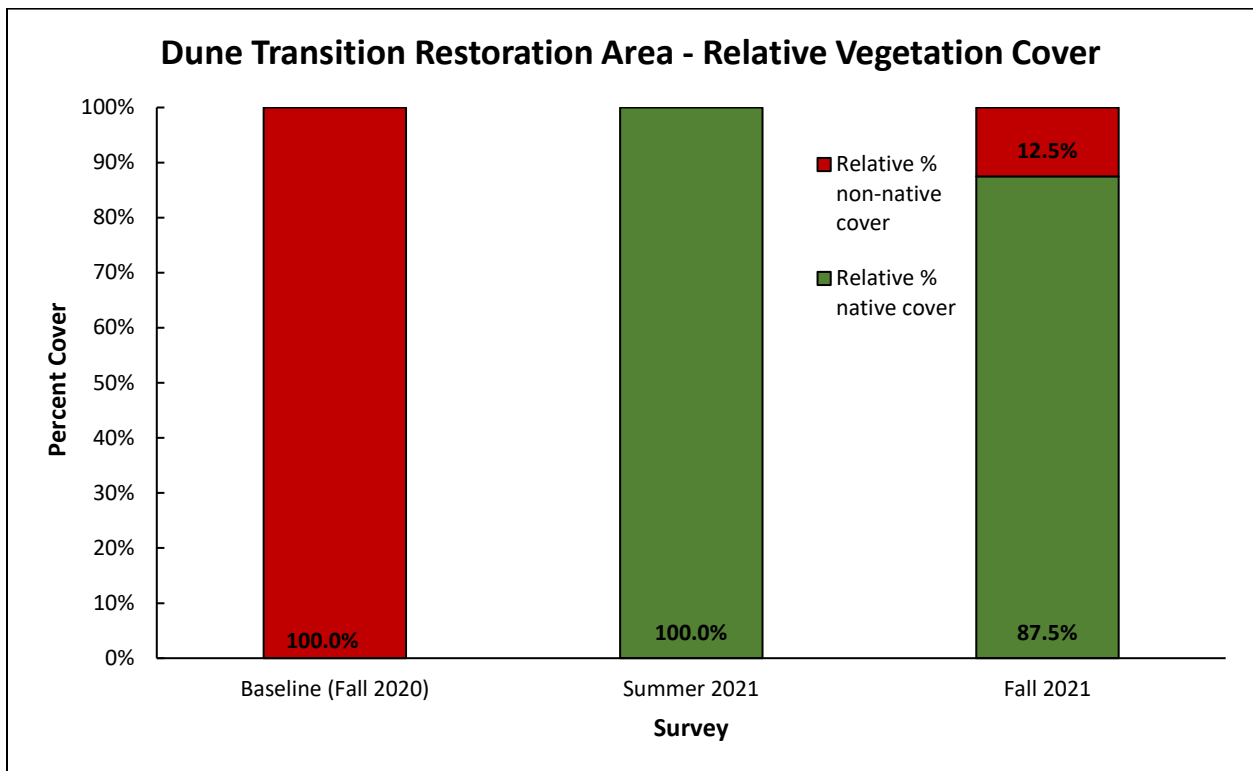
Figure 32. Relative percent cover for the dune transition habitat transect located within the project area at Zuma Beach.

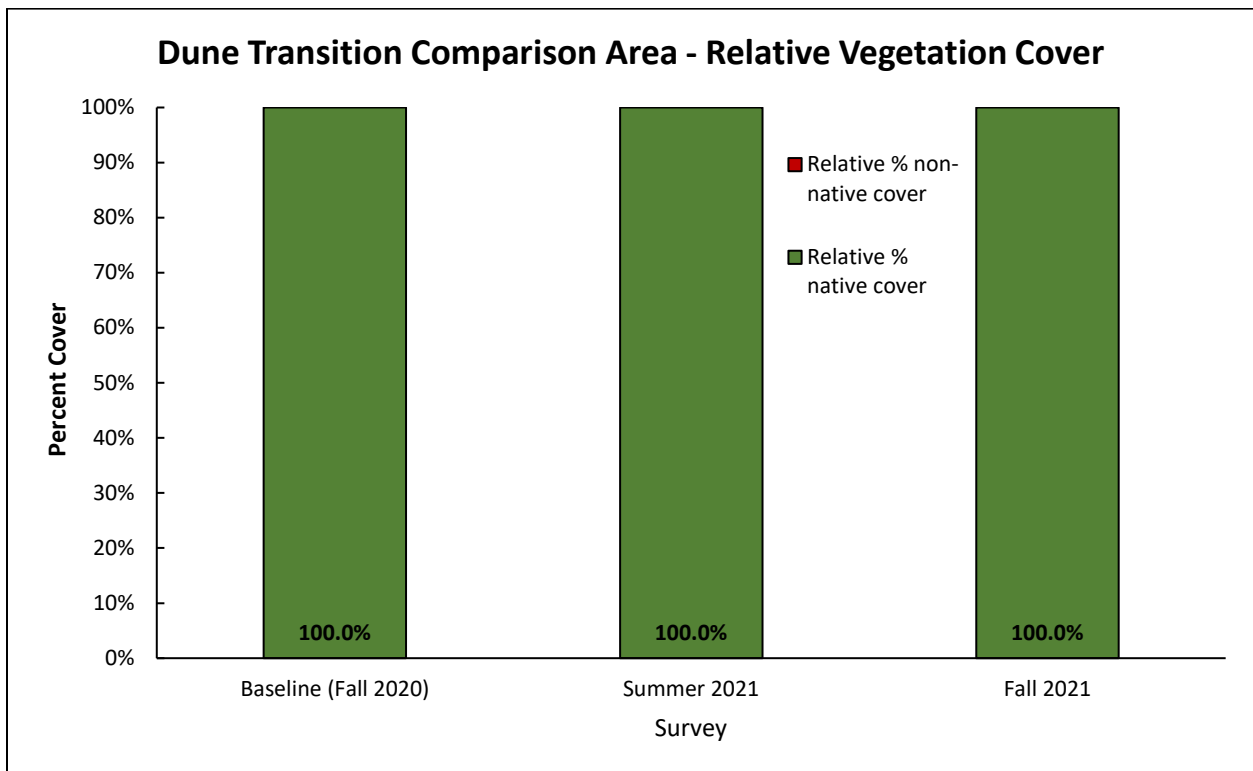
Figure 34. Relative percent cover for the dune transition habitat control transect located adjacent to the project area at Zuma Beach.

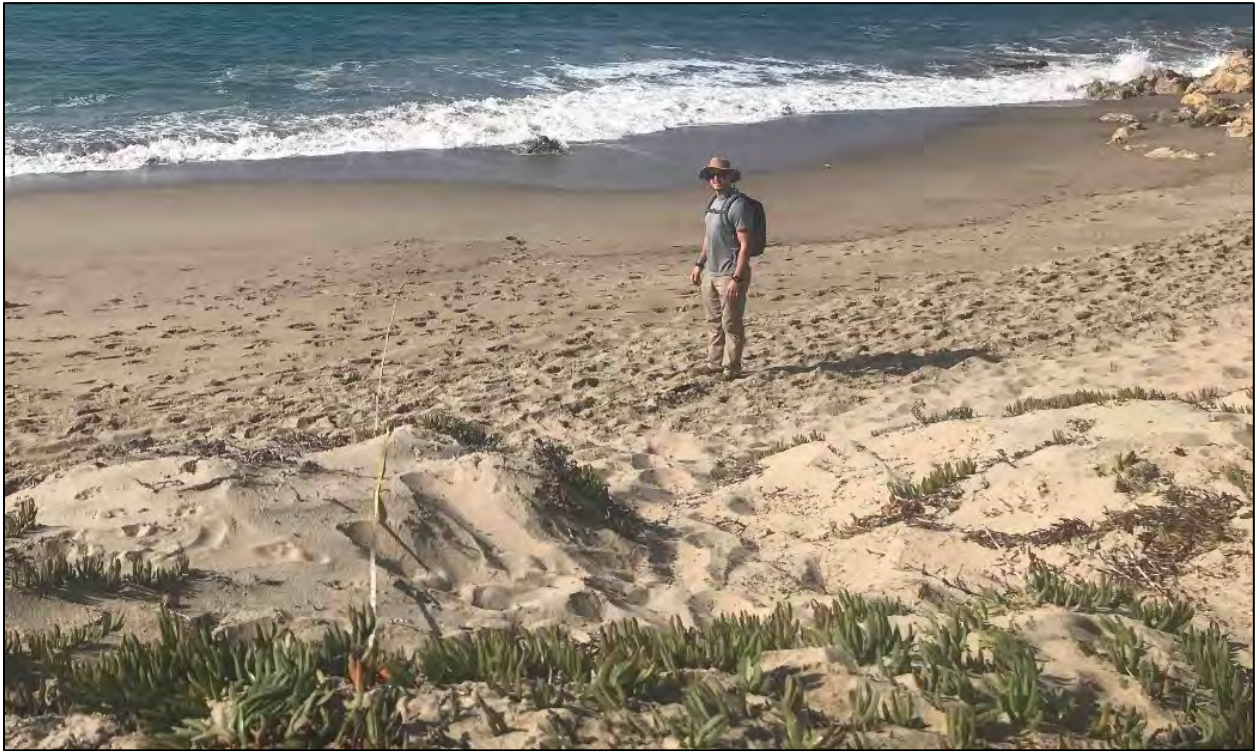
Figure 35. Representative photo of non-native iceplant within the ungroomed back dune area of control transect PC4 at Point Dume. This transect was added during the Fall 2021 survey (9 November 2021).
