Malibu Living Shoreline Project

Year 1 Annual Report

May 2022

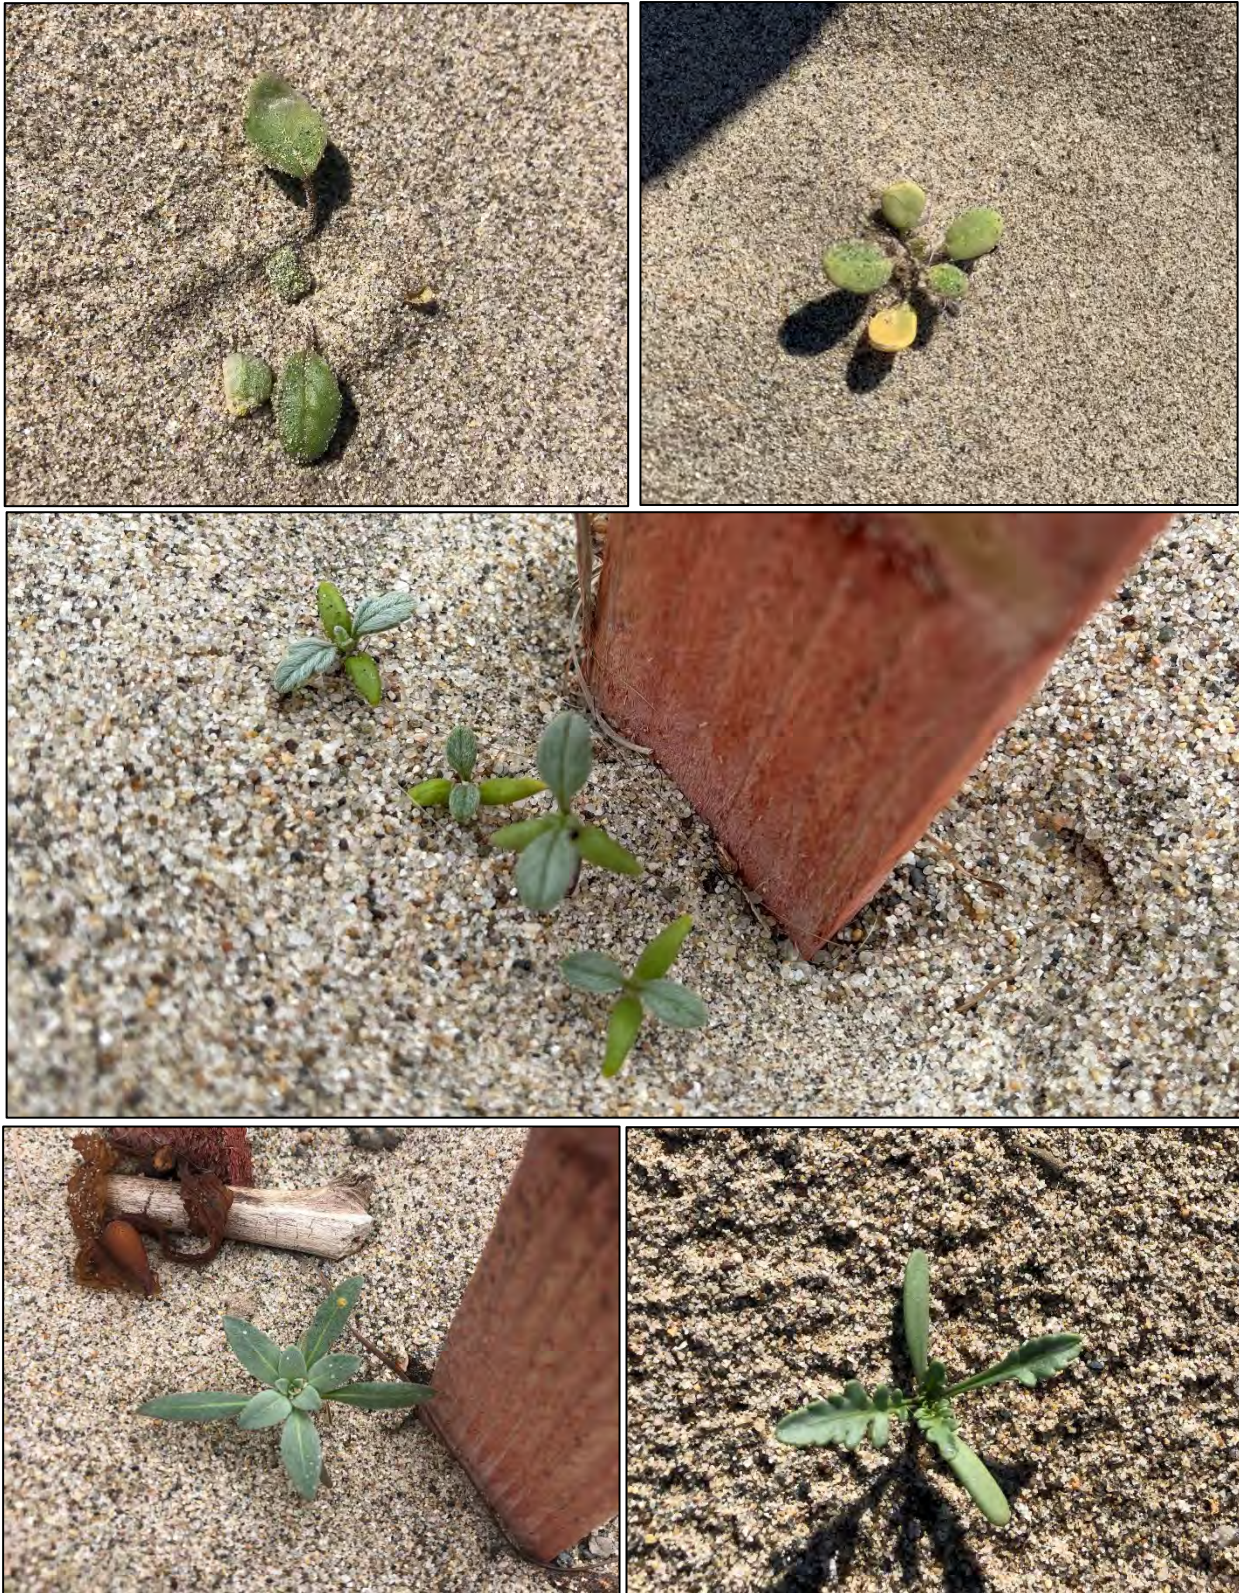
Figure 36. Photos of various seedlings. Top left: native pink sand verbena (*Abronia umbellata*); top right: native red sand verbena (*Abronia maritima*); middle: native beach bur (*Ambrosia chamissonis*); bottom left: native beach evening-primrose (*Camissoniopsis cheiranthifolia*); bottom right: non-native sea rocket (*Cakile maritima*).

All surveys (baseline, Fall, and Summer 2021) recorded no seedlings across all restoration and control transects, thus no data are displayed; however, seedlings were frequently observed within the restoration area outside of the transect survey boundaries during post-implementation surveys and other on-site activities. Native seedlings were often observed directly adjacent to the sand fence segments. Native seedlings observed on-site include red sand verbena (*Abronia maritima*), pink sand verbena (*Abronia umbellata*), beach bur, and beach evening-primrose (Figure 36). Non-native seedlings observed within the restoration area consisted of sea rocket (Figure 36).

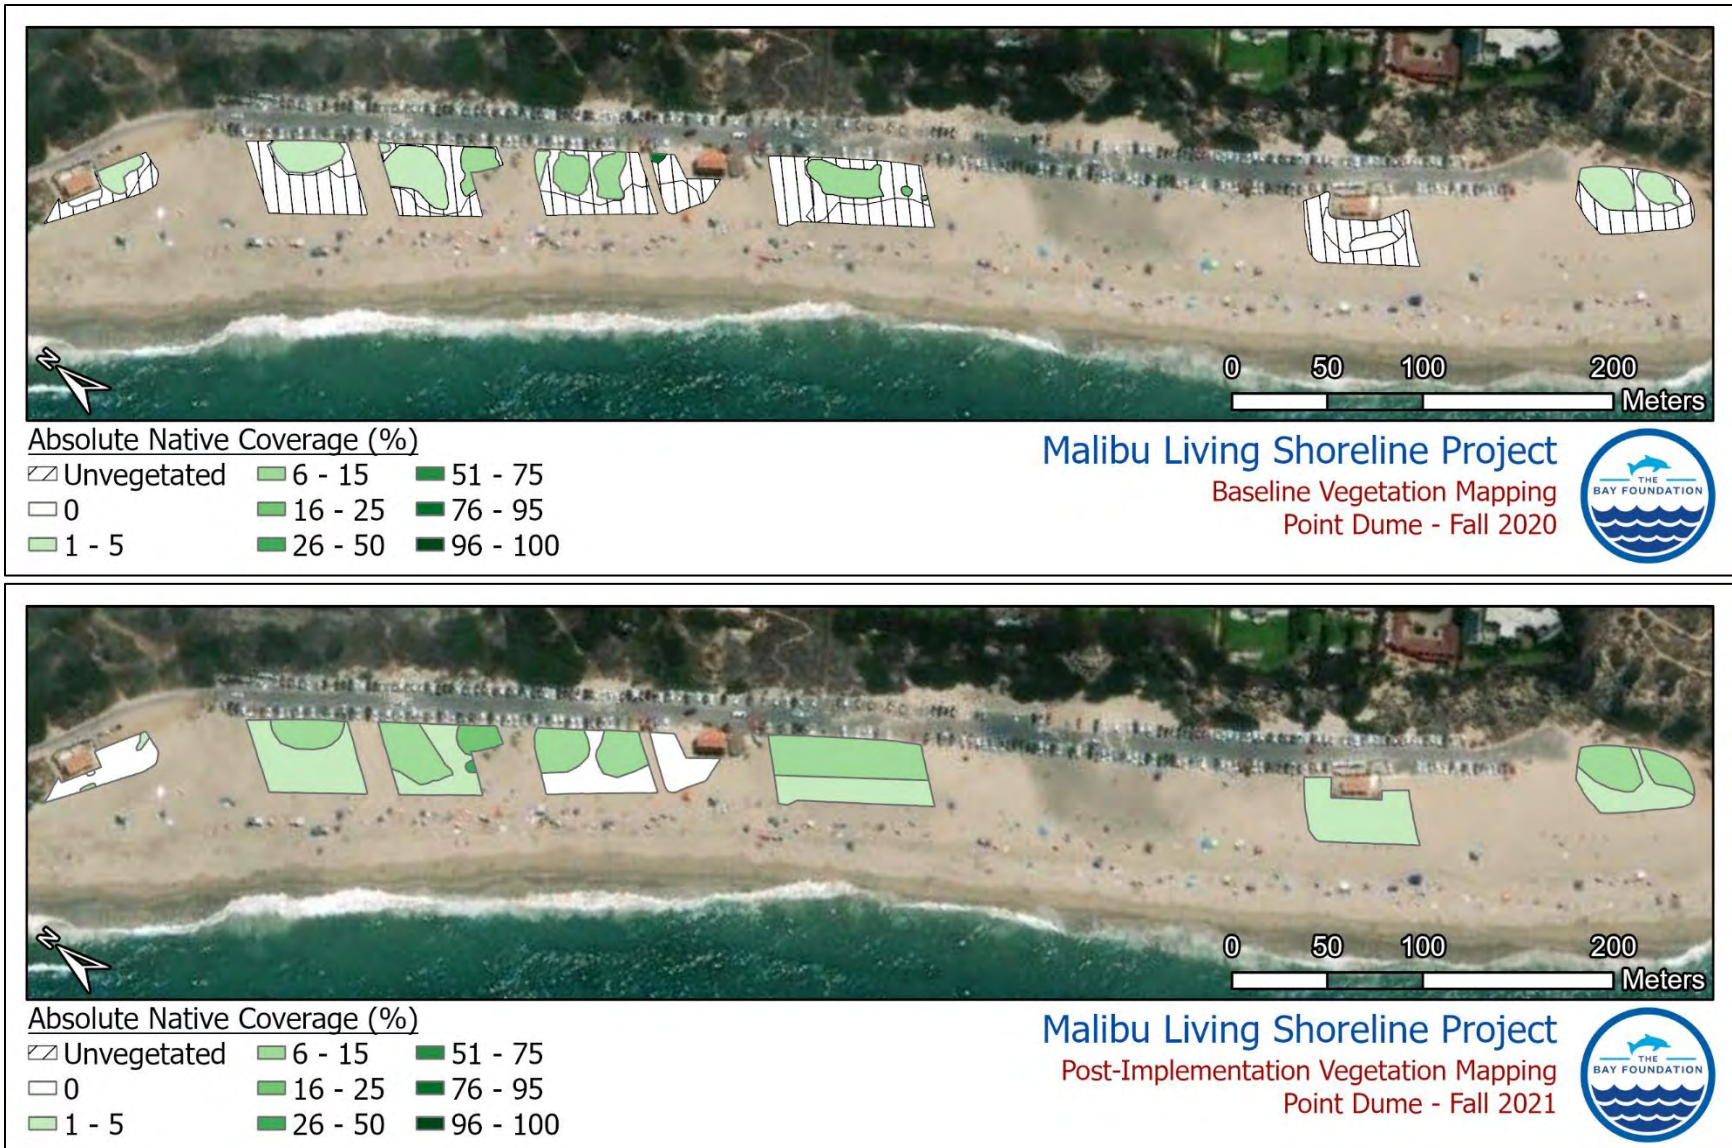
Figure 39. Absolute native vegetation cover within the Point Dume Beach restoration area for the baseline (Fall 2020) survey (top) and for the Fall 2021 survey (bottom).

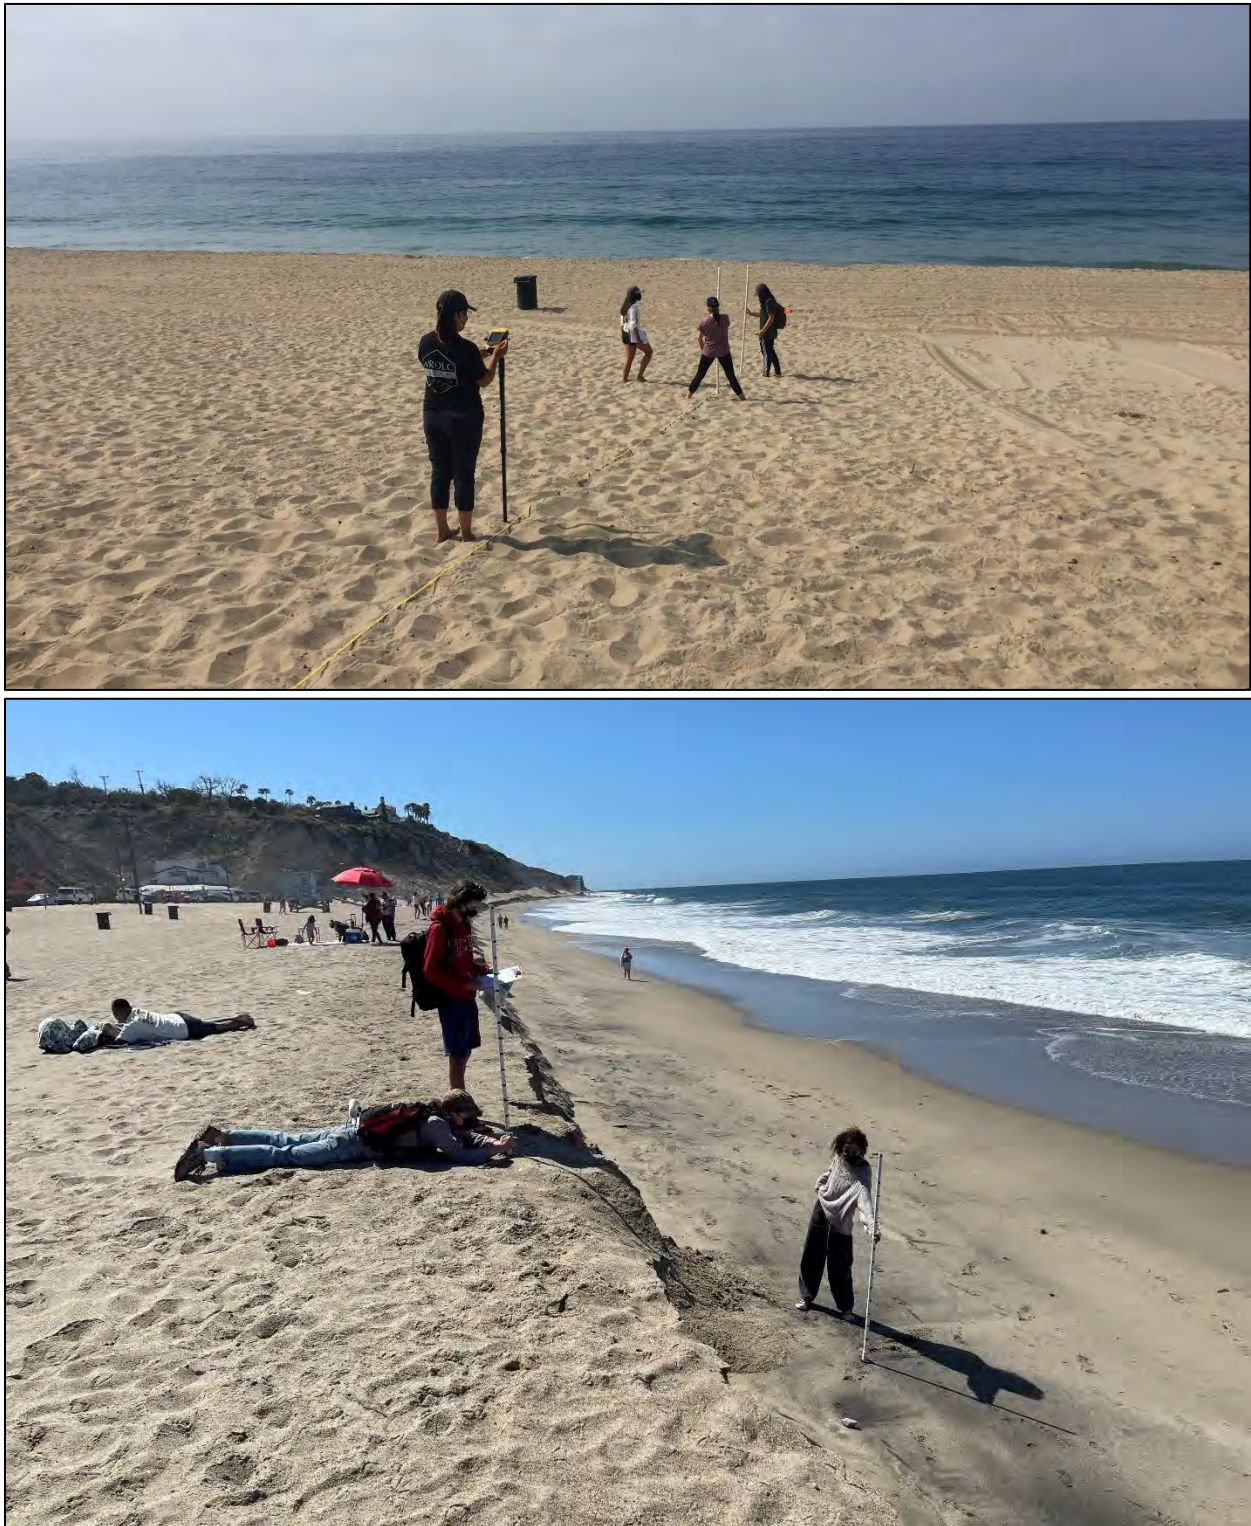
Figure 42. Photos of TBF staff and interns performing elevation surveys using a GPS Trimble and elevation poles.

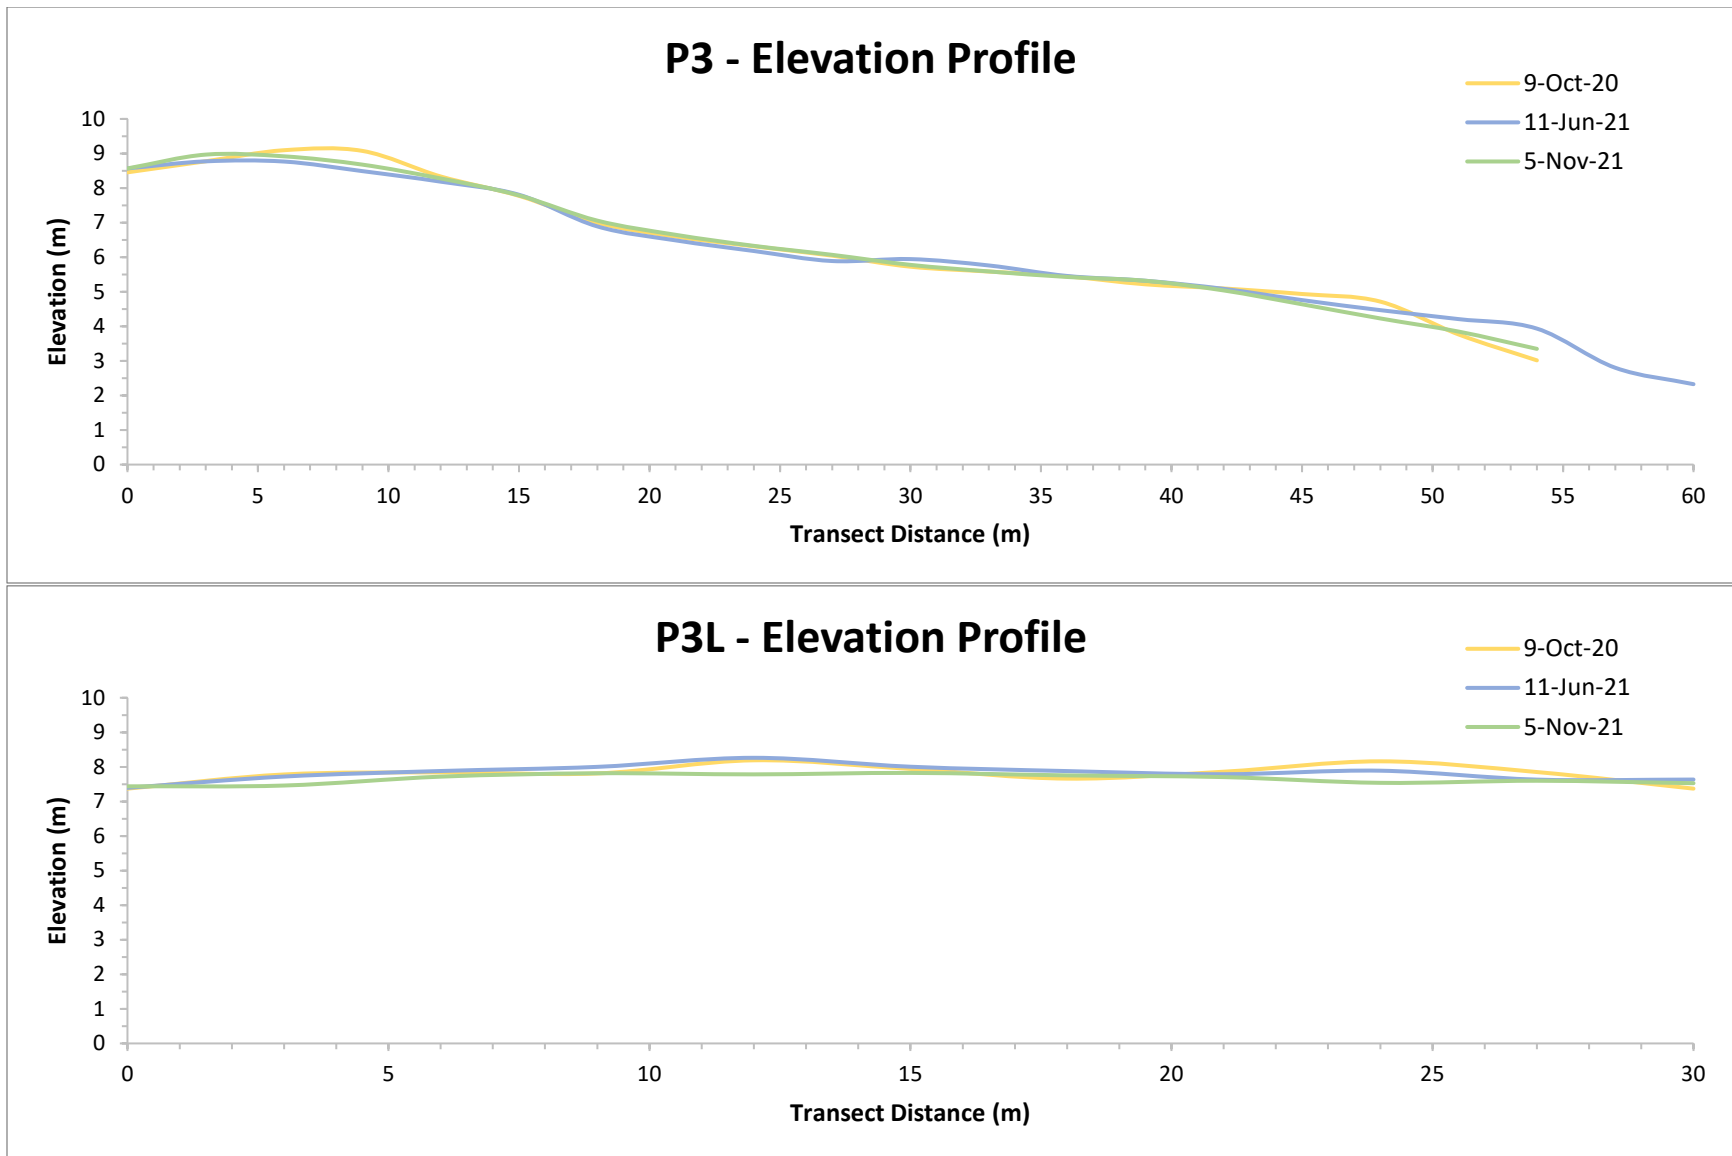
Figure 44. Restoration transect P3 (top) and P3L (bottom) elevation profiles during Fall 2020 (October 2020; baseline), Summer 2021 (June 2021), and Fall 2021 (November 2021) surveys. Note: this is a lateral transect that runs parallel to the ocean.

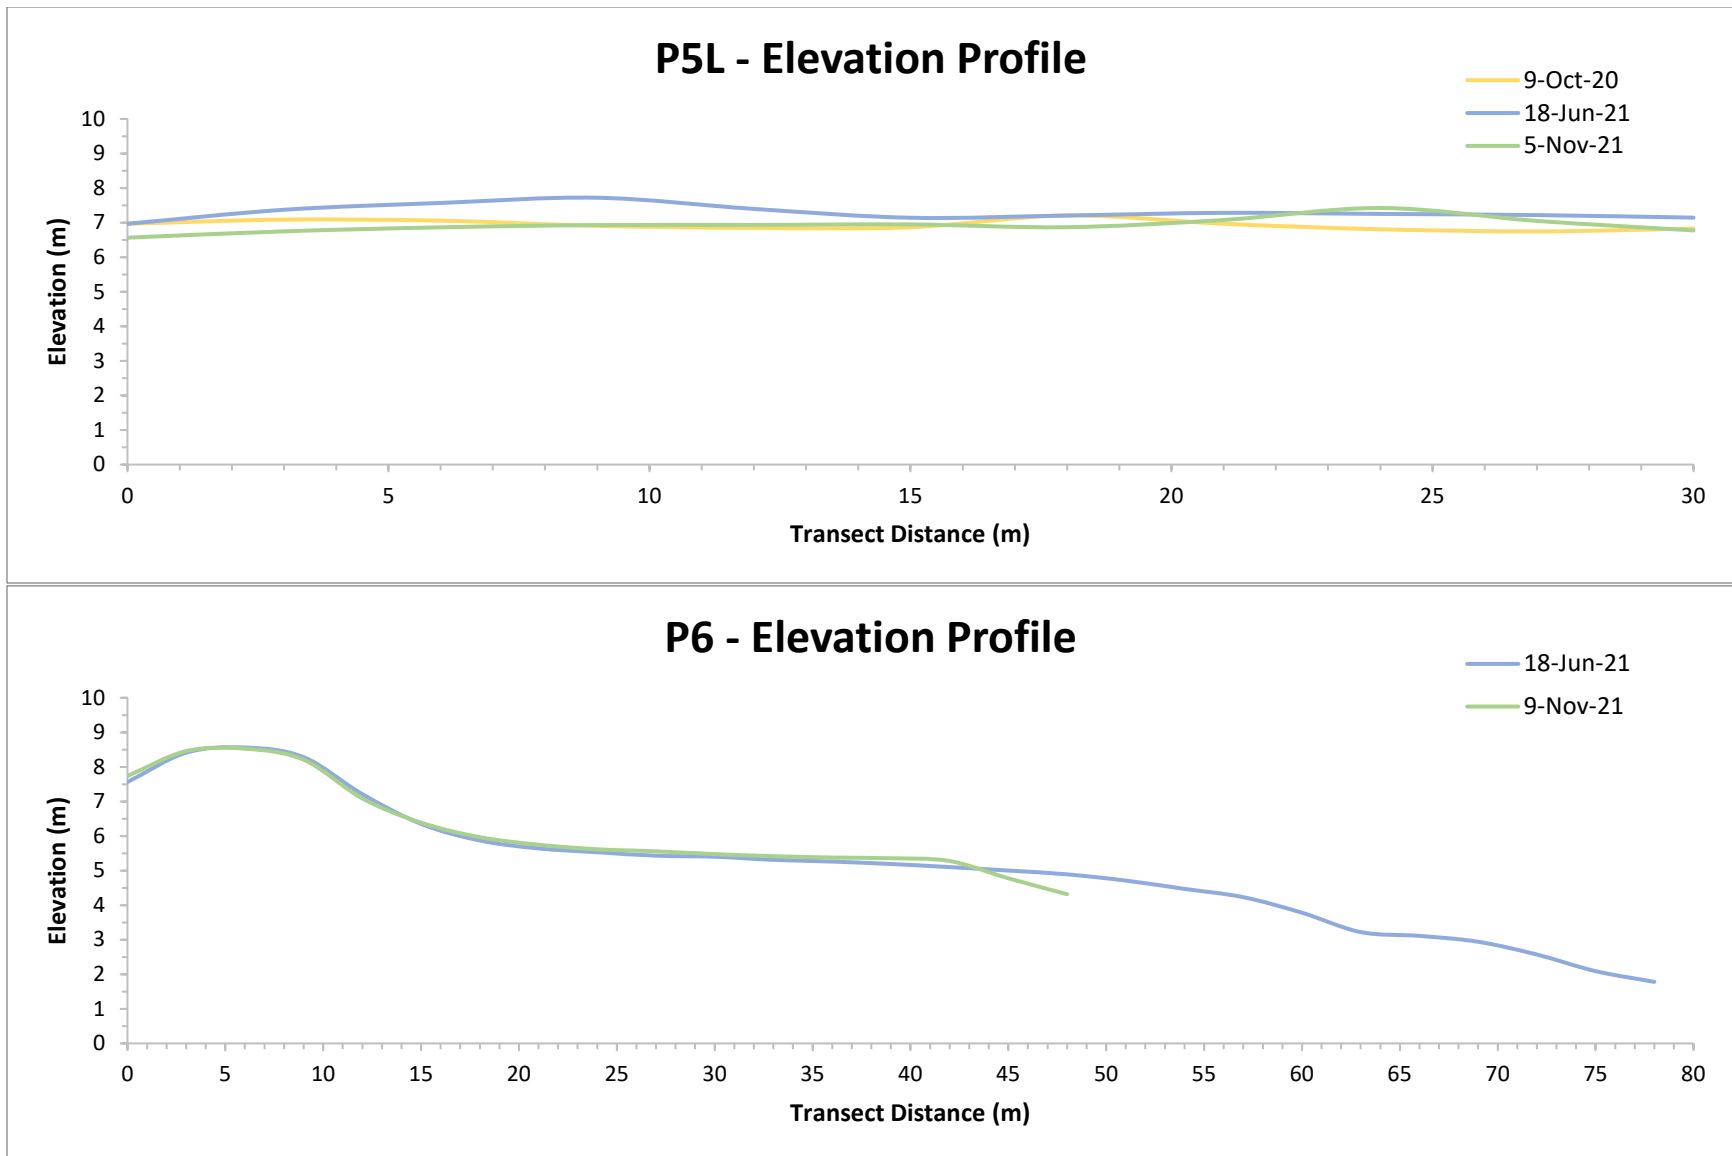
Figure 46. Restoration transect P5L (top) and P36 (bottom) elevation profiles during Fall 2020 (October 2020; baseline), Summer 2021 (June 2021), and Fall 2021 (November 2021) surveys. Note: P5L is a lateral transect that runs parallel to the ocean. Baseline data for P6 were removed during the QAQC process.

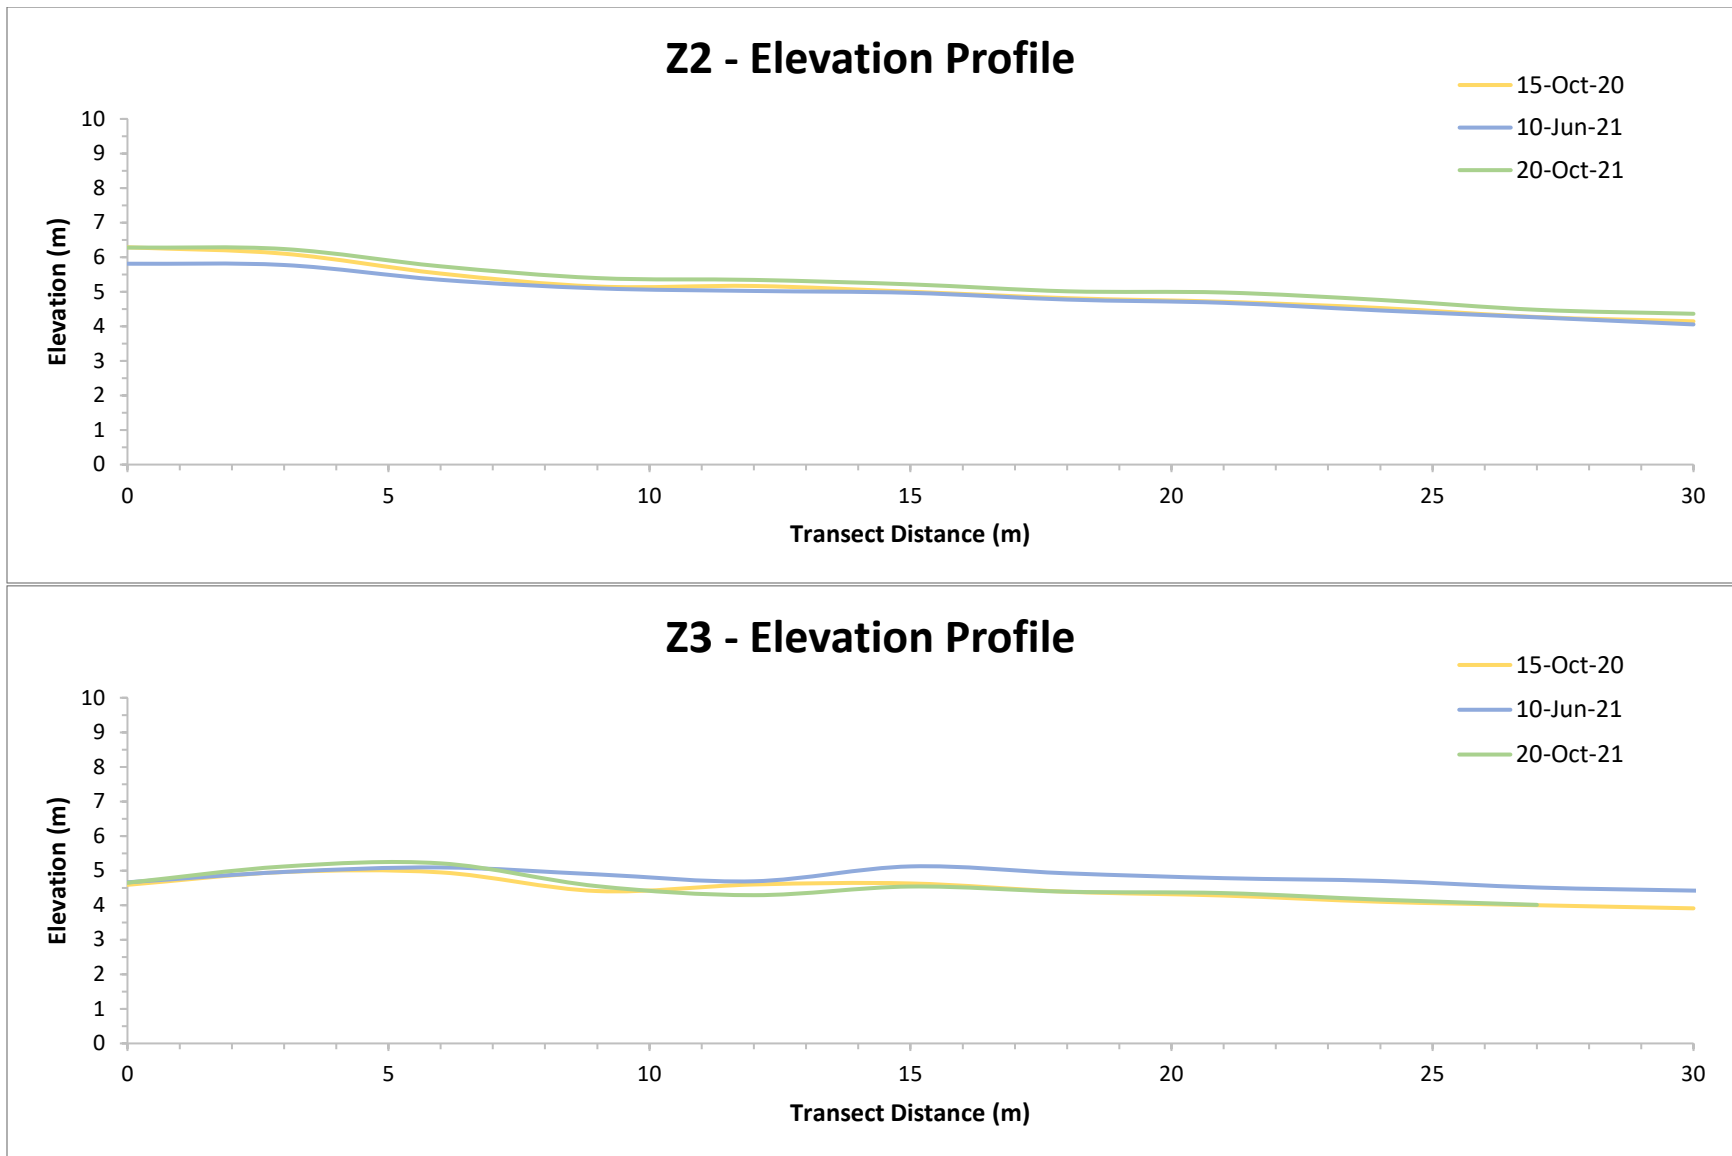
Figure 48. Restoration transect Z2 (top) and Z3 (bottom) elevation profiles during Fall 2020 (October 2020; baseline), Summer 2021 (June 2021), and Fall 2021 (October 2021) surveys.

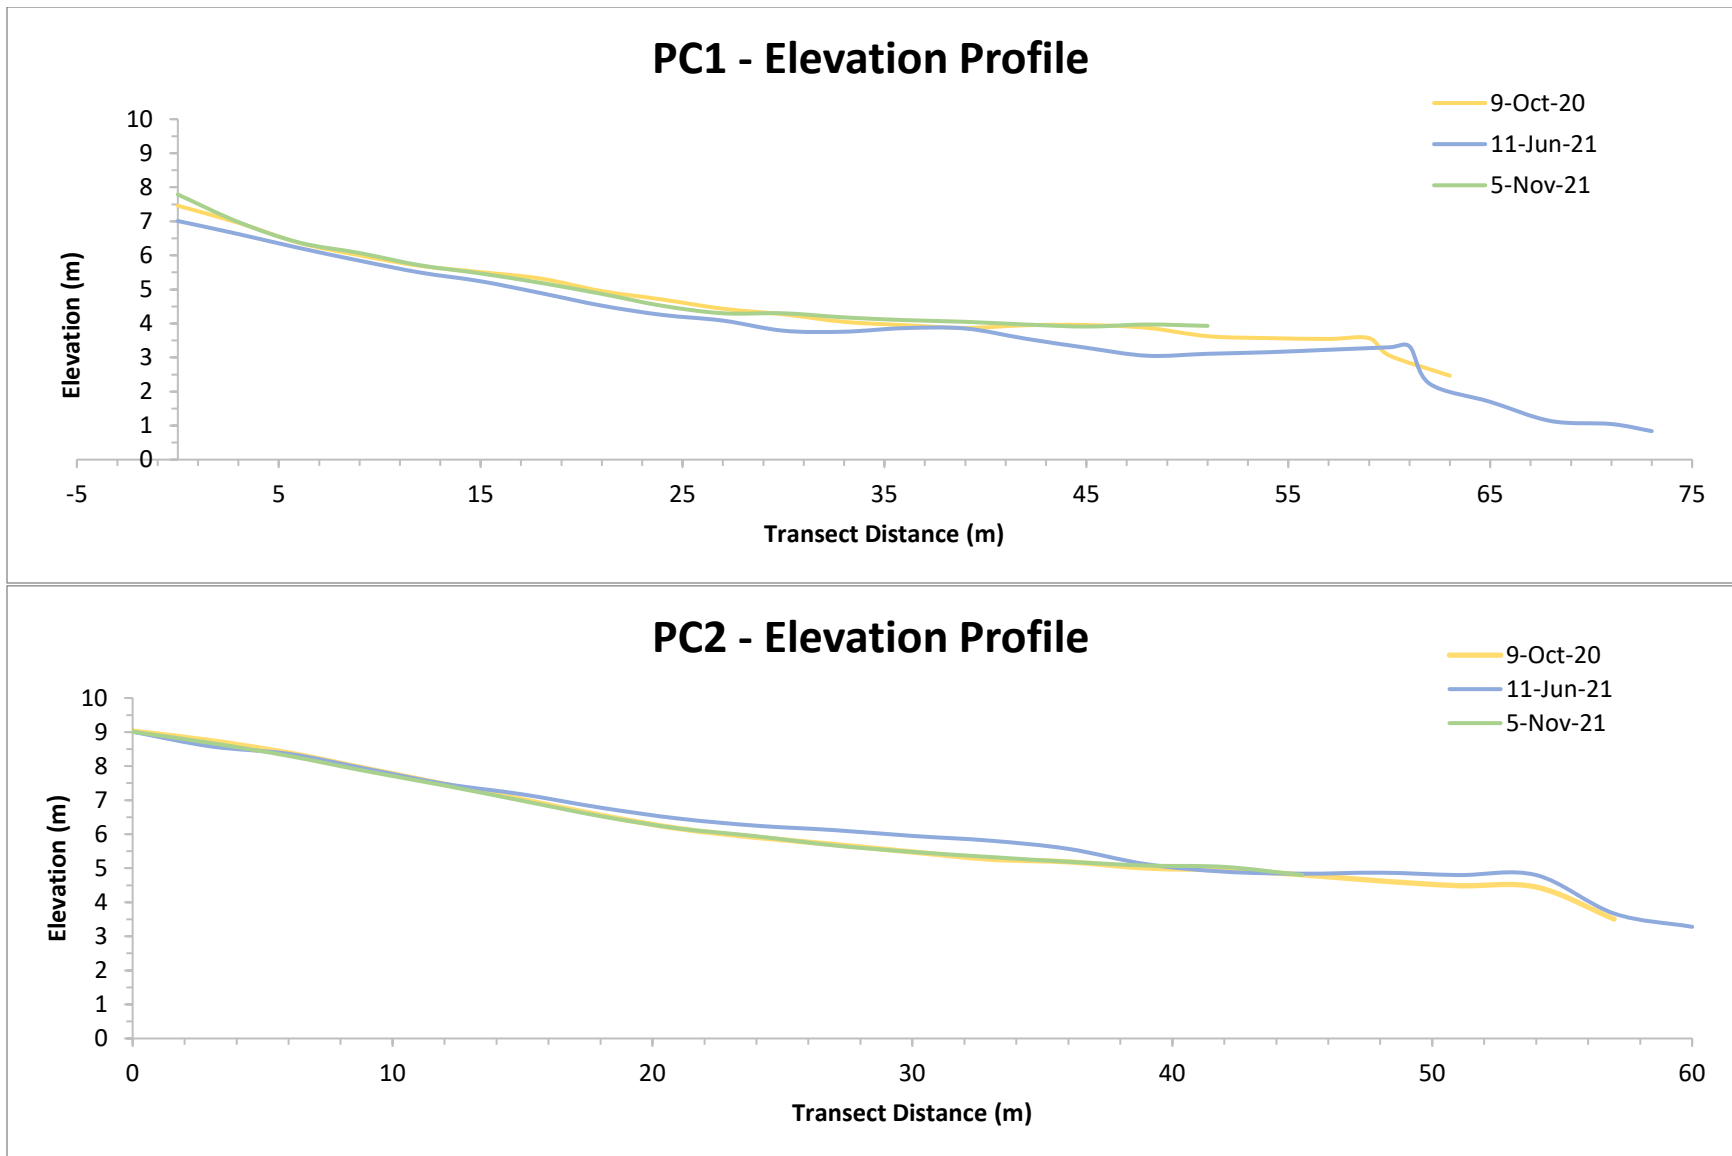
Figure 49. Control transect PC1 (top) and PC2 (bottom) elevation profiles during Fall 2020 (October 2020; baseline), Summer 2021 (June 2021), and Fall 2021 (November 2021) surveys.

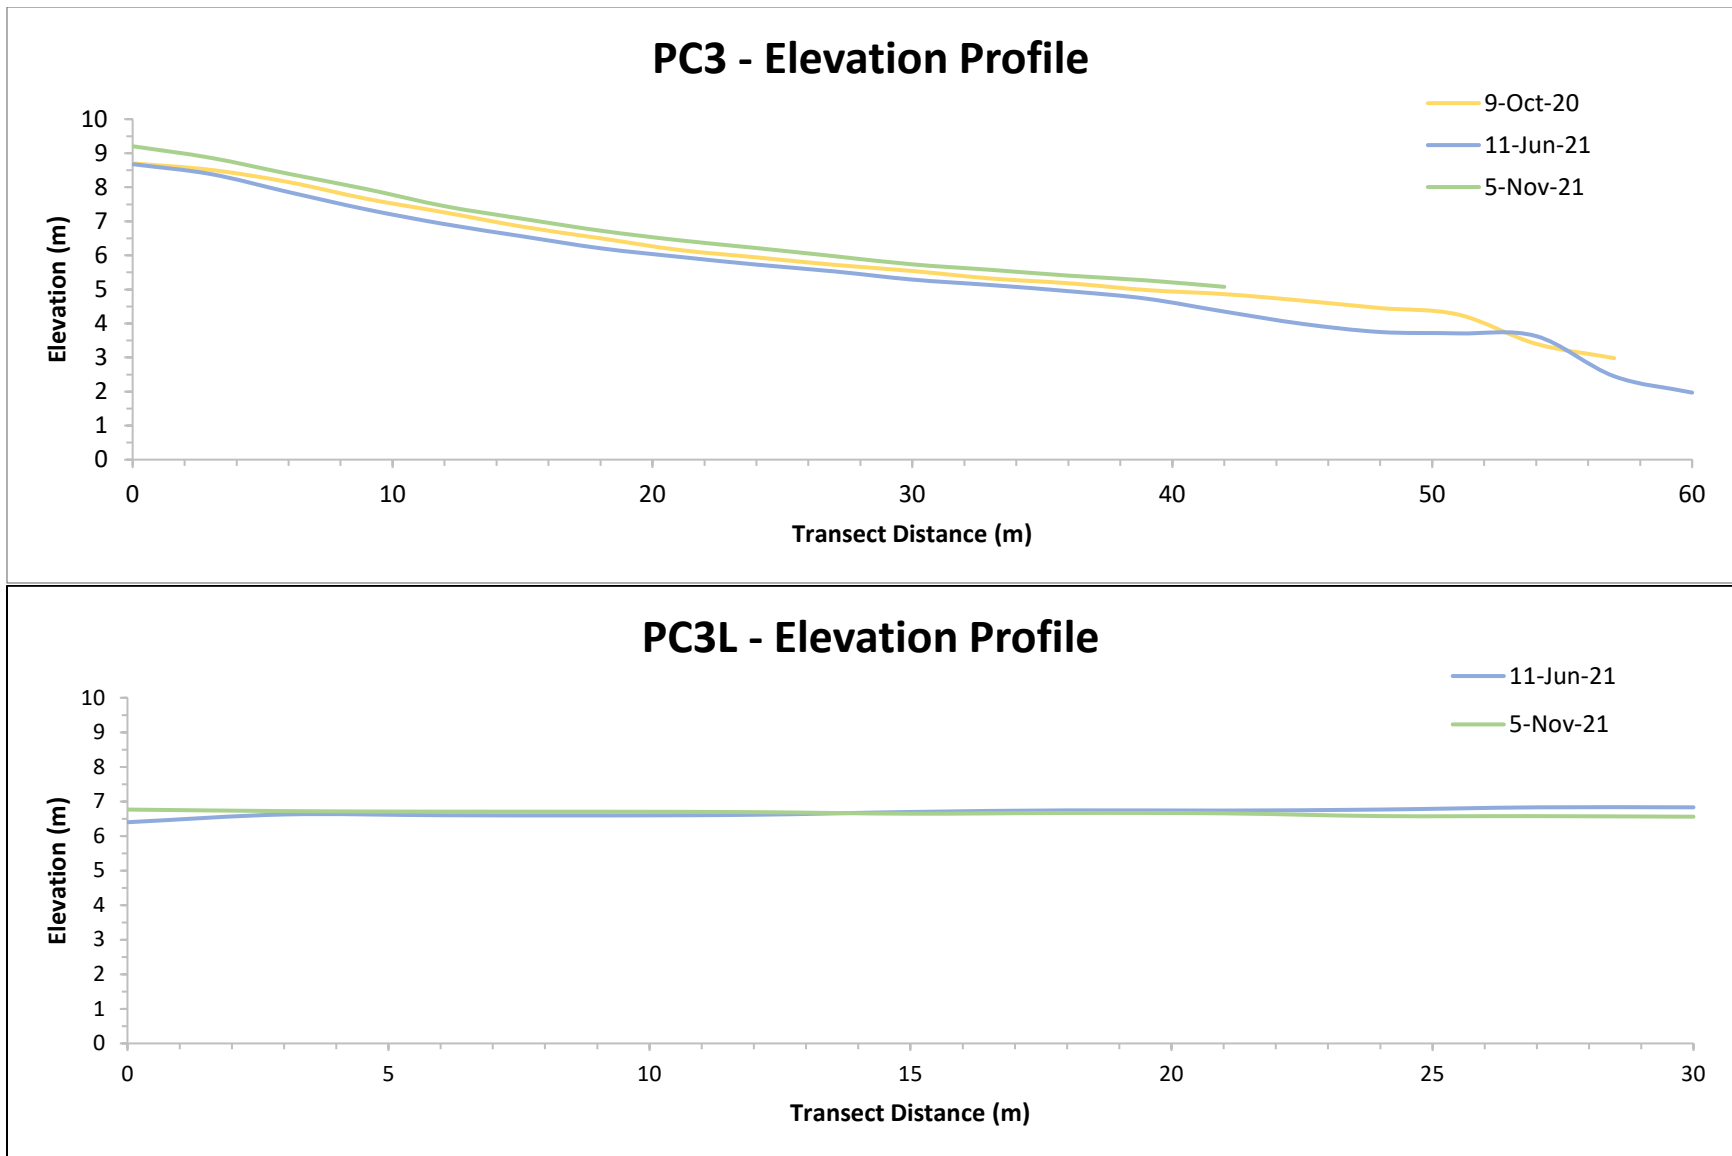
Figure 50. Control transect PC3 (top) and PC3L (lateral transect) (bottom) elevation profiles during Fall 2020 (October 2020; baseline), Summer 2021 (June 2021), and Fall 2021 (November 2021) surveys. *Note: PC3L was added during Summer 2021, thus no baseline data are displayed.*

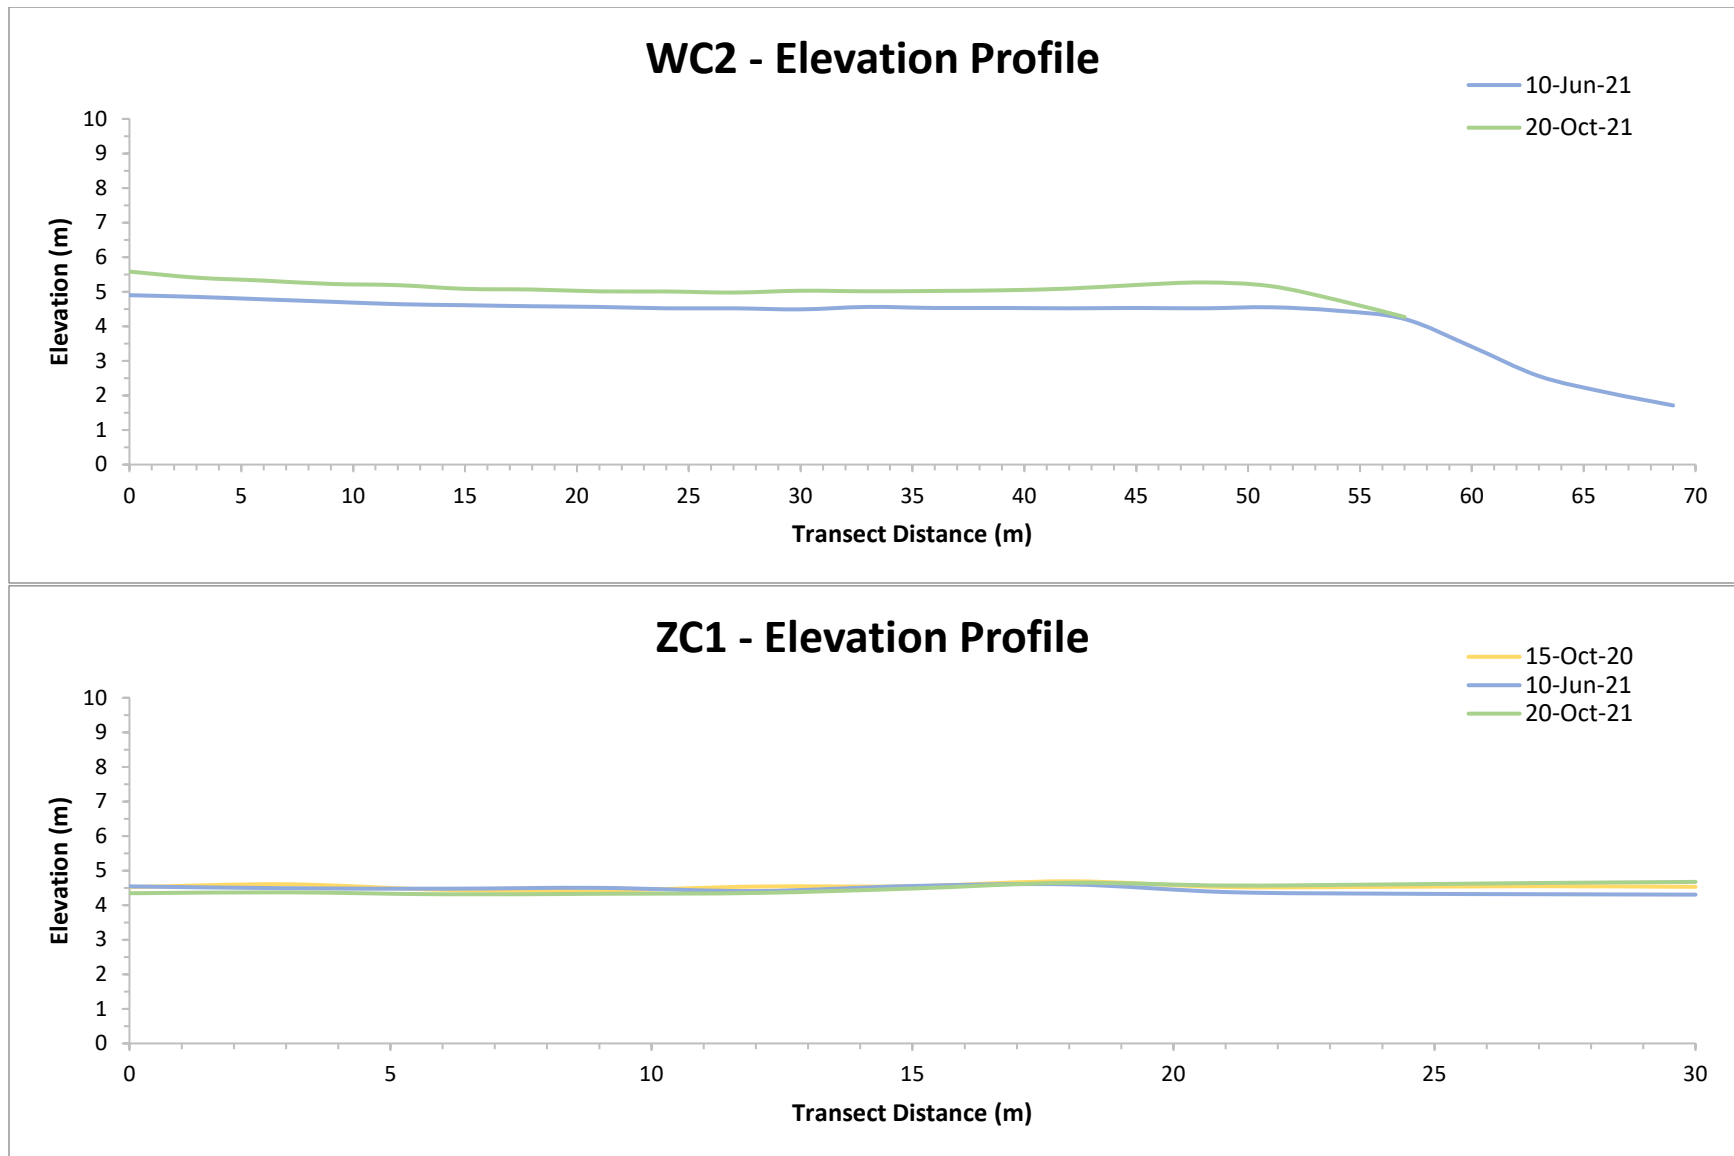
Figure 52. Control transect WC2 (top) and ZC1 (bottom) elevation profiles during Fall 2020 (October 2020; baseline), Summer 2021 (June 2021), and Fall 2021 (October 2021) surveys. Note: baseline data for WC2 were removed during the QAQC process.

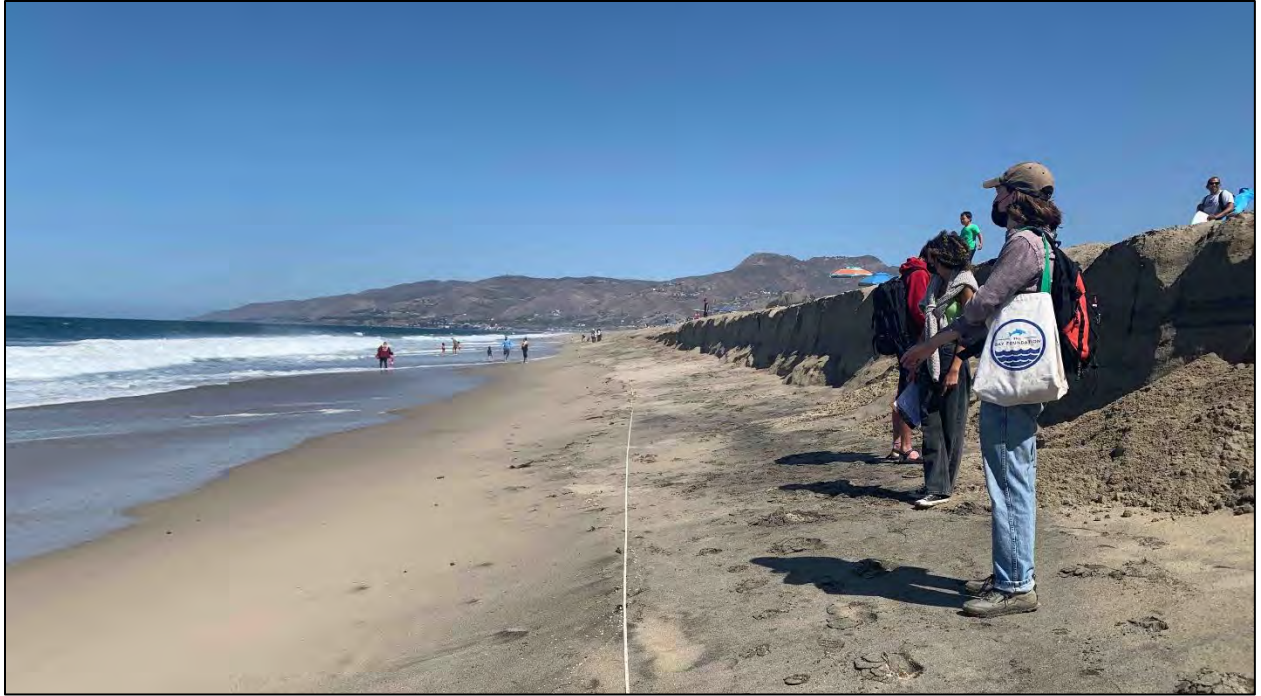
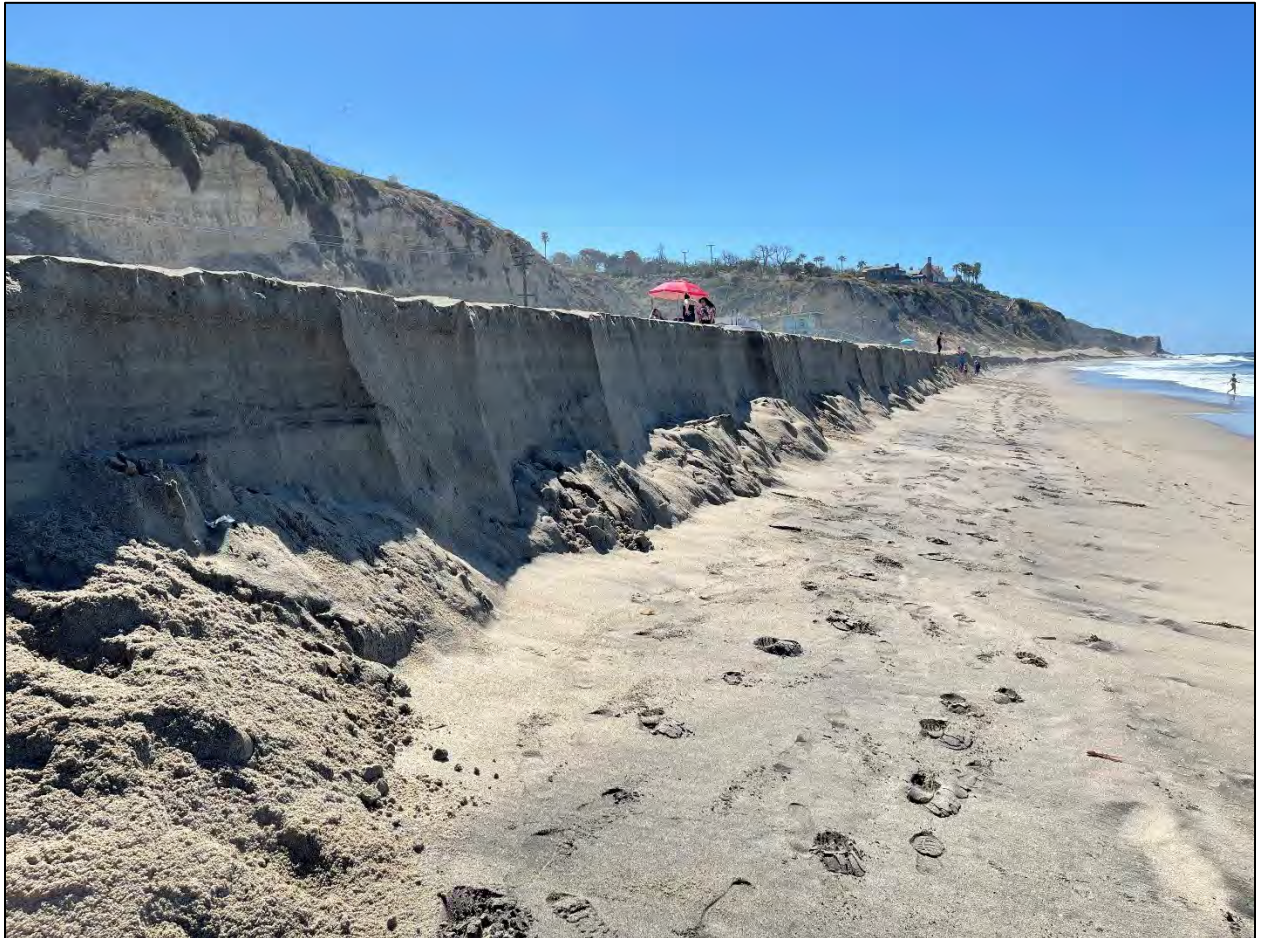
Figure 53. Photo showing steep berm drop-off at Westward Beach control site, outside the restoration area on 10 June 2021.

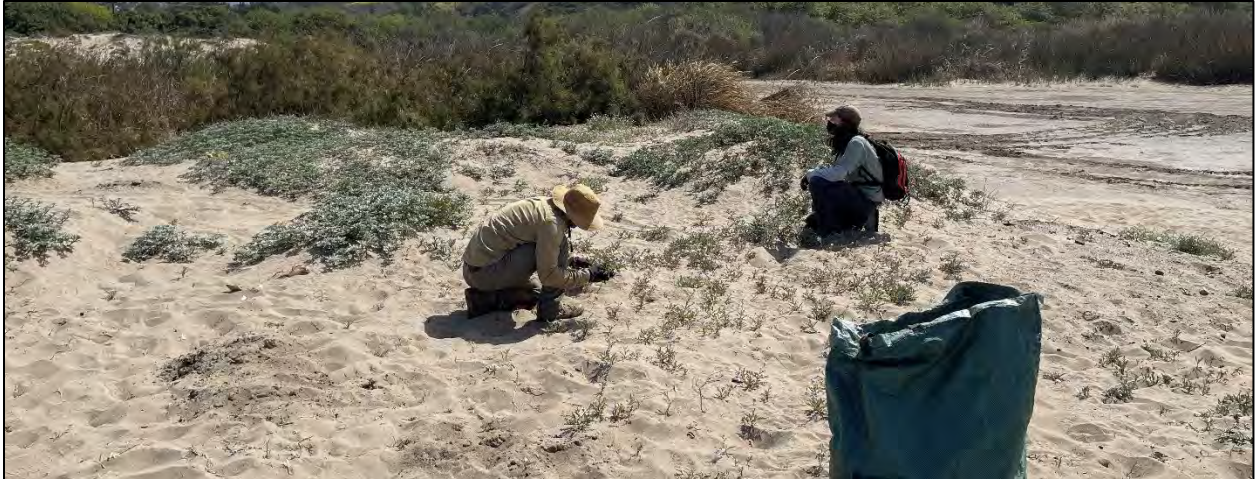
Figure 54. TBF staff pulling non-native sea rocket on 14 April 2021.

In Year 1, European sea rocket (annual non-native) was the primary species that sprouted post-implementation and required hand removal during site maintenance days (Figures 17 and 54). Areas of the restoration site that were previously groomed beach had the most European sea rocket. Several years of hand removal will likely be necessary to deplete the seed bank. Other non-native species that required hand removal during maintenance days included but were not limited to Bermuda grass, Geraldton carnation weed, castor bean, Russian thistle, and iceplant.

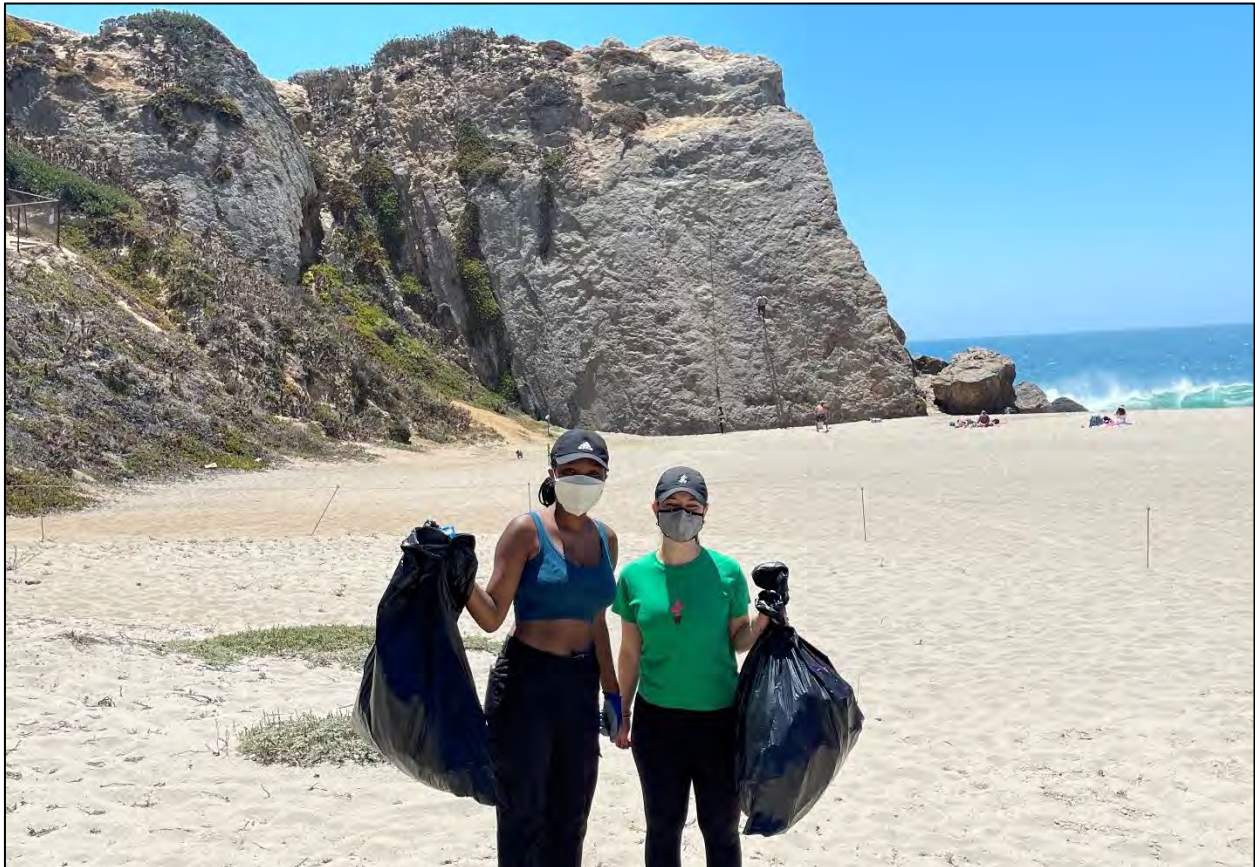
Figure 55. TBF interns removing trash from the project site on 3 August 2021.

Trash identified within the project area was also removed during maintenance days (Figure 55). Minimal trash was found within the Point Dume Beach site. Slightly more trash was seen within and adjacent to the Zuma Beach site, particularly within the non-native Ngaio trees neighboring the site, where several houseless individuals had tents set up. Trash removed during maintenance days consisted of chips bags, food wrappers, bottles, plastic bags, Styrofoam, and small pieces of plastic.
