Malibu Living Shoreline Project

Year 1 Annual Report

May 2022

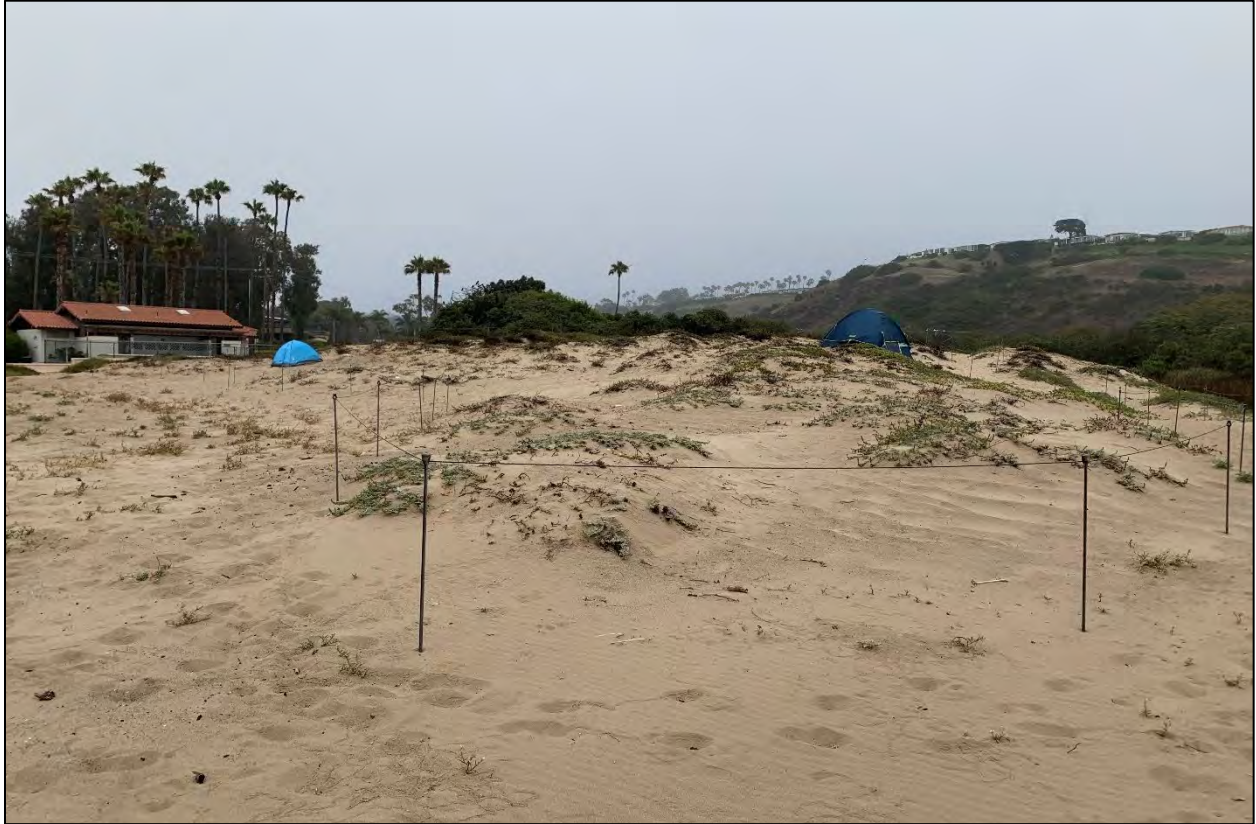
Figure 56. Two tents observed within the Zuma Beach project area on 18 June 2021.

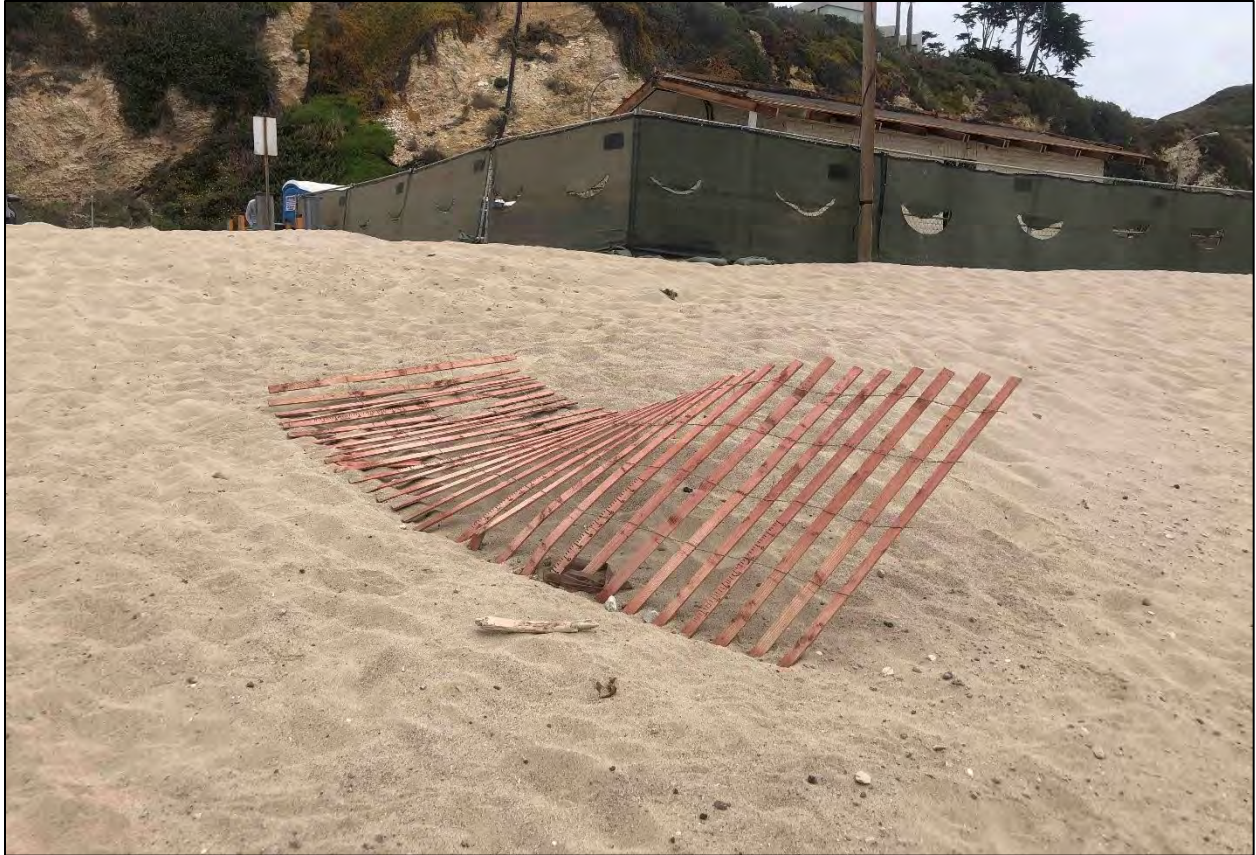
Figure 57. Fallen sand fence (26 April 2021).

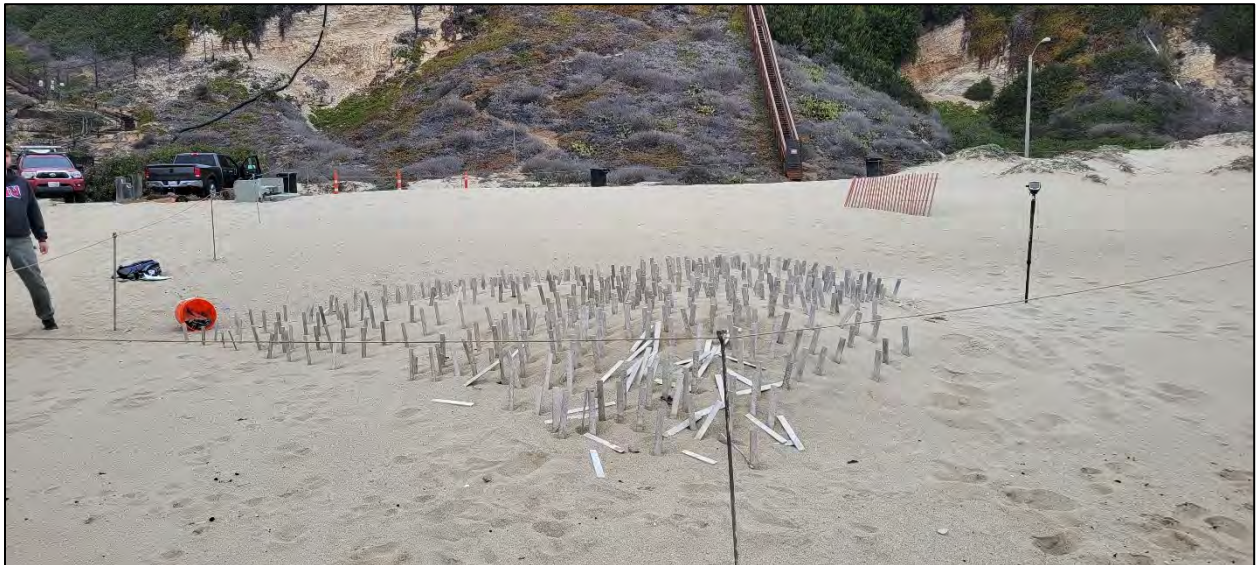
Figure 58. Fallen and disturbed biomimicry stake plot (9 November 2021).

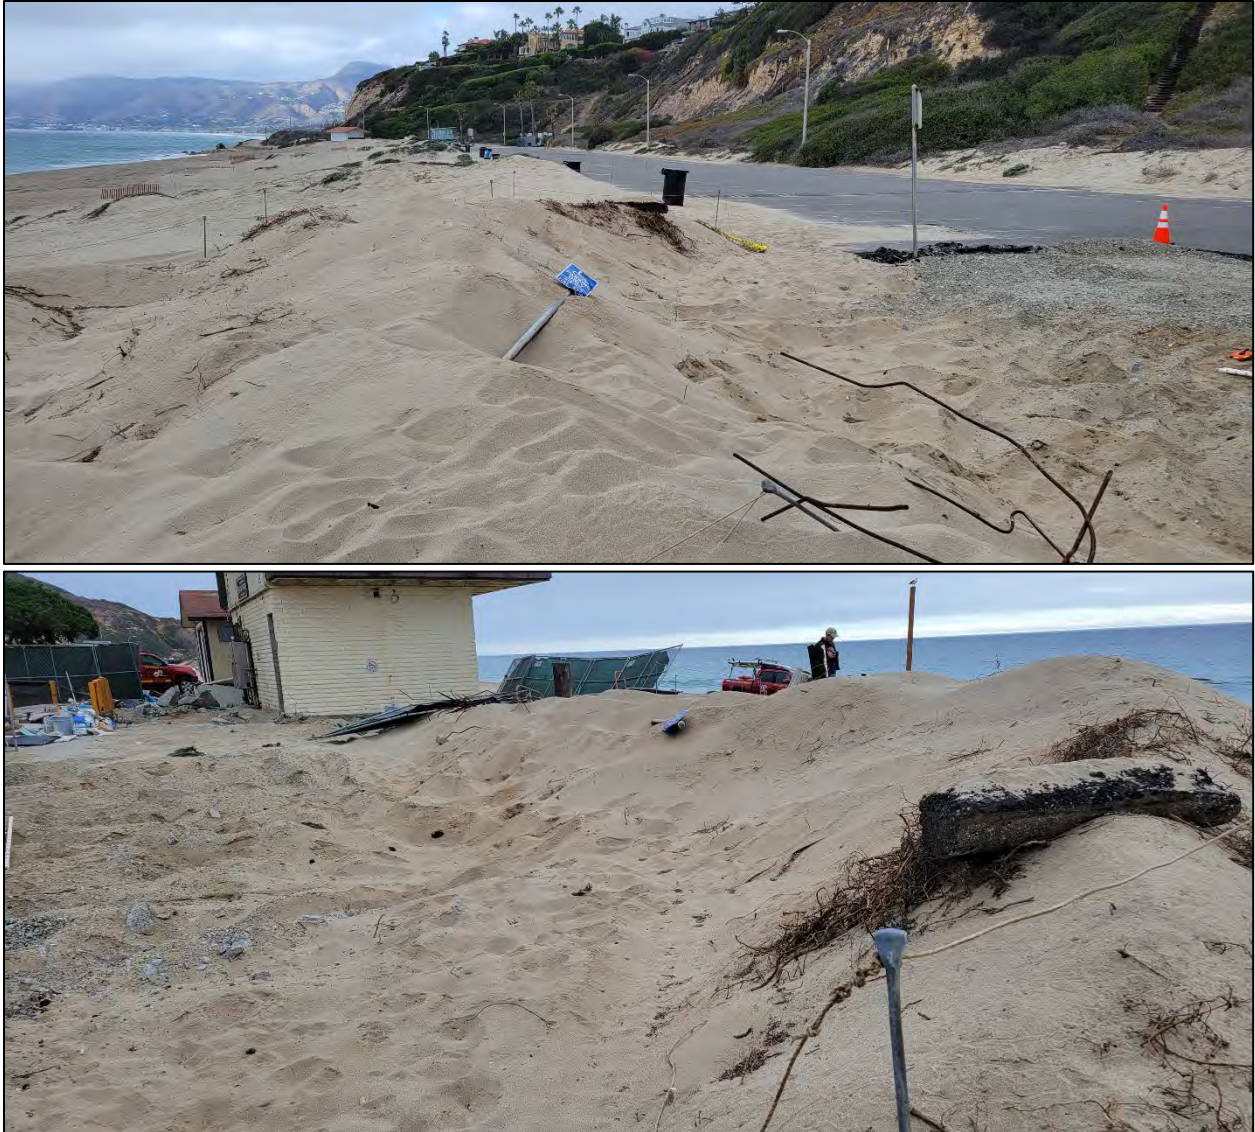
Figure 59. Disturbance of the Point Dume project area caused by a contractor who was working on the adjacent restroom (10 November 2021).

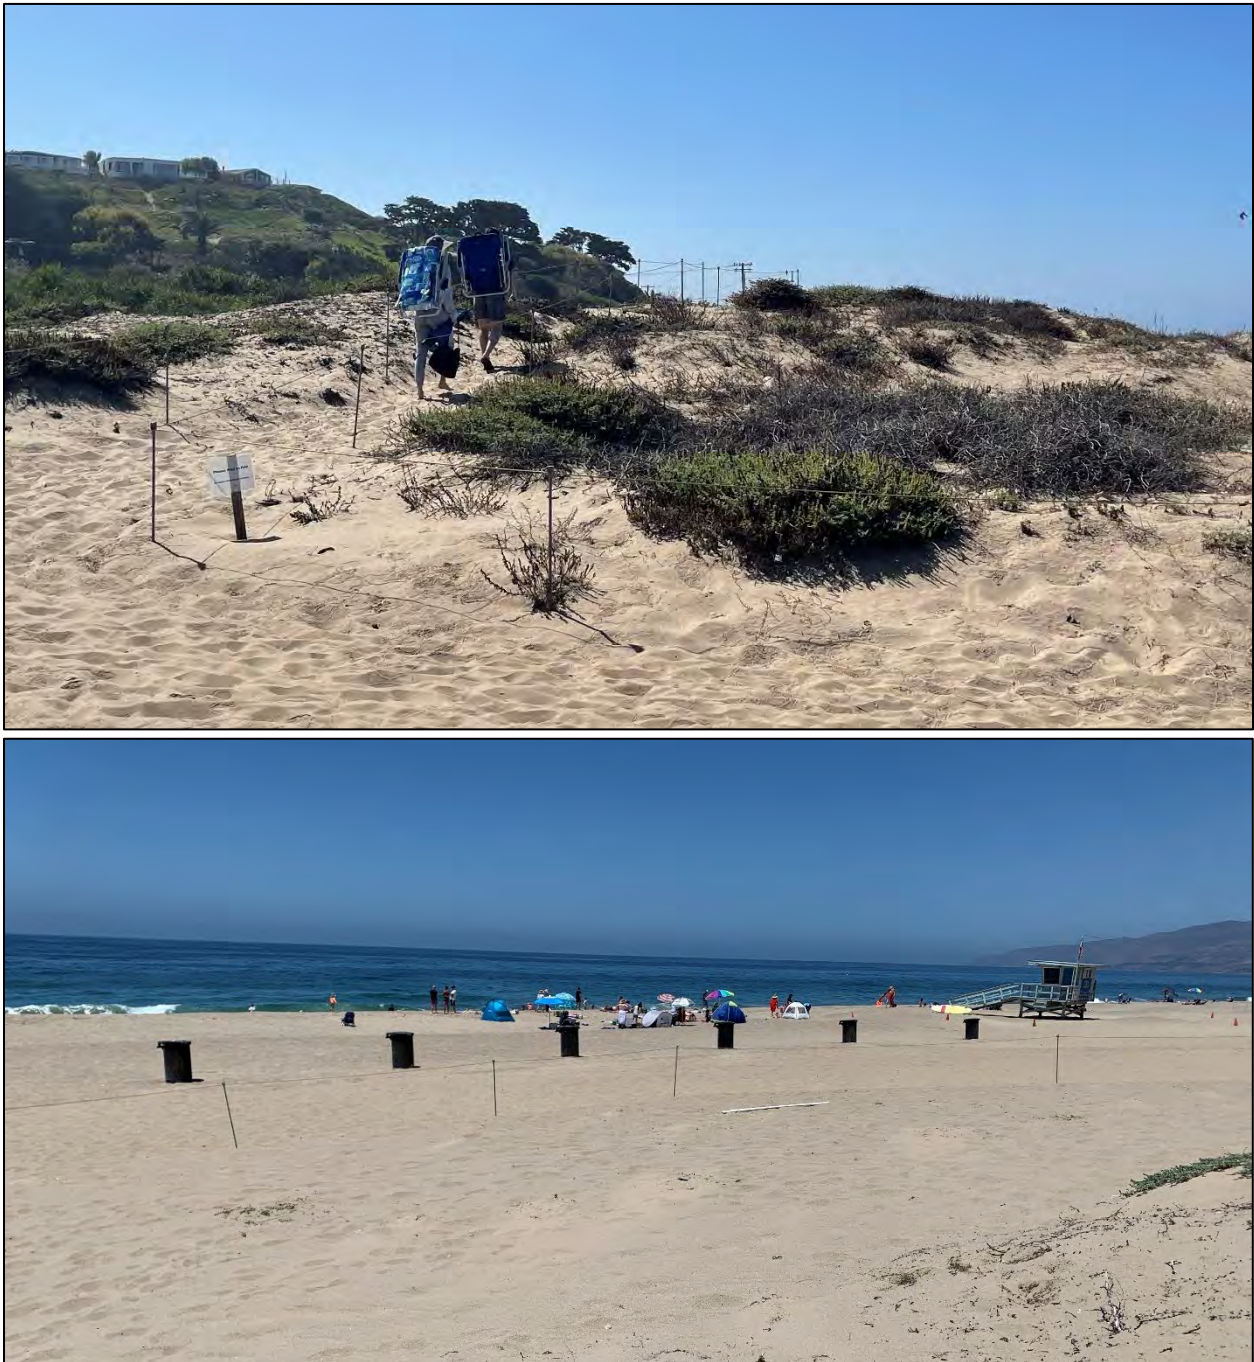
Figure 60. Beach visitors walking through the pathway at the Zuma Beach project site (top; 5 August 2021) and setting up their towels and umbrellas adjacent to the Point Dume project site (bottom; 29 June 2021).

Lastly, an important goal of the restoration project is to evaluate whether heavy recreational use of beaches in Los Angeles and natural habitats to benefit birds and wildlife can coexist. The project area includes post and rope delineated pathways to help guide visitors through the site while also minimizing trampling of native vegetation particularly in the early years of establishment. Visitors were frequently seen utilizing the delineated pathways and seldom observed within the restored portion of the project area (Figure 60, top). In addition to using the pathways, visitors were also observed walking and running adjacent to the site or laying out their towels nearby to simply enjoy a day at the beach (Figure 60, bottom). While performing on-site activities, TBF staff were also frequently approached by visitors and members of the community who were eager to learn more about the project. Interpretive signage is anticipated to be installed in Spring 2022 and will serve to further enhance the beach experience for
