Malibu Living Shoreline Project Annual Report

August 2023

Tower, JA, MJ Rios, K Plouffe, J Arney and M Griffith. 2023. Malibu Living Shoreline Project Years 2 and 3 Annual Report. Technical report prepared by The Bay Foundation for the California Coastal Commission, City of Malibu, Los Angeles County Department of Beaches and Harbors, and California Coastal Conservancy. 26 pages.

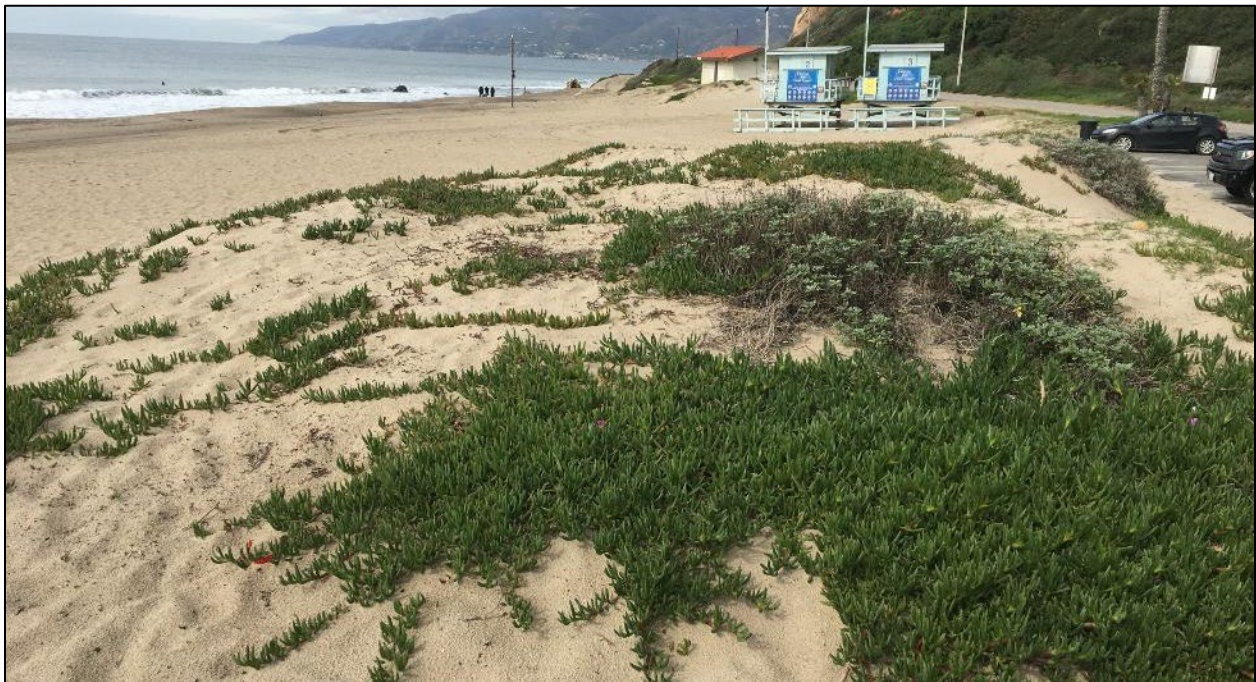
Figure 1. Westward Beach with *Carpobrotus edulis* (Aizoaceae), a non-native, prior to restoration implementation.

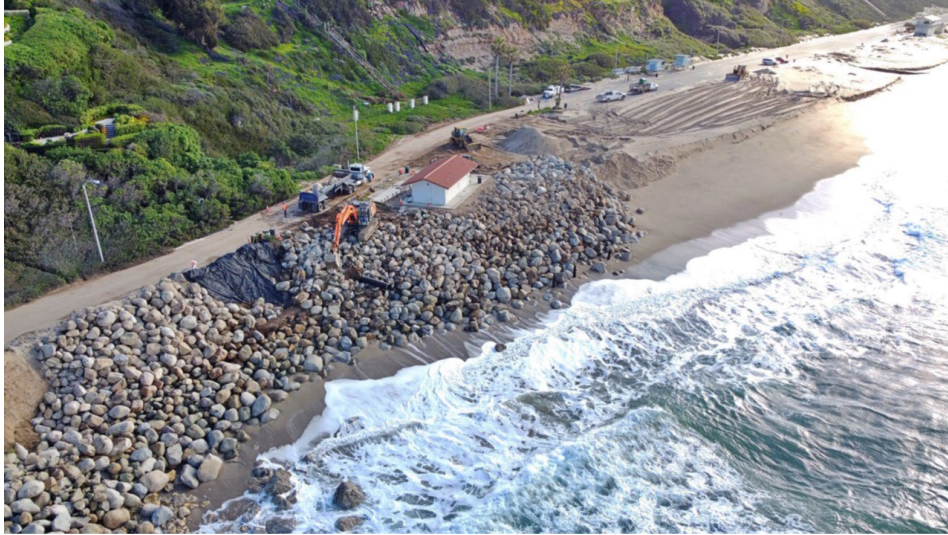
restoration areas since implementation (ex: photo point 1, [Appendix C1](#)). The winter of 2023 was a great season for plant growth, but was also destructive to beach morphology. High tides coupled with intensified storm action washed away much of the sand, particularly in front of the area of transects P7 and PC4 (example: [Appendix C2](#)). These areas have been fortified with sand taken from other parts of Pt Dume Beach and rip-rap by LA County Beaches and Harbors (Fig. 4). Additional rounds of photo point monitoring are needed to assess potential topographical change in other parts of the restoration area.

Figure 4. Photo of 2023 after heavy winter storms and mitigation with rip-rap. Photo courtesy of LA County Beaches and Harbors.

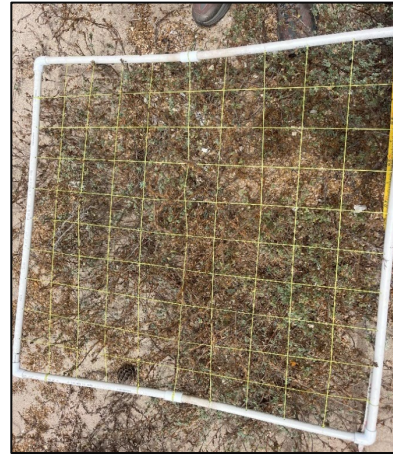
Figure 5. Image of quadrat used for percent cover surveys.

Absolute percent vegetation cover estimates are used to assess native and non-native vegetation. Species richness and diversity are assessed, using 1m² fixed quadrats every 5m along 25m transects (Fig. 5). Species were classified as native or non-native. The average absolute percent cover of native and non-native plants in restored and unrestored areas were calculated as described in [SOP 3.2 Vegetation Cover Surveys](#) (TBF 2015b).

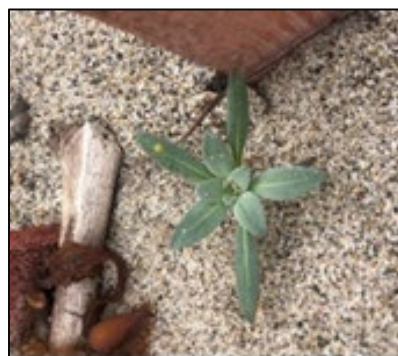
Figure 7. Seedling of CA native Beach Evening Primrose (*Camissoniopsis cheiranthifolia*, Onagraceae), which was the most common species observed in the seedling census of 2023.

Seedling recruitment was largely unsuccessful in both restoration areas in 2022, with only one individual of Beach Bur, (*Ambrosia chamissonis*, Asteraceae) observed in Pt Dume (in then transect P4). In contrast, many more seedlings recruited in 2023. All seedlings observed in Pt Dume were CA natives located in the restoration polygons, 21 of which were Beach Evening Primrose (*Camissoniopsis cheiranthifolia*, Onagraceae). A single seedling of *A. chamissonis* was also observed in Pt Dume. In contrast, slightly greater seedling recruitment was observed in the Zuma restoration area, coupled with 2 seedlings also observed in the comparison area (transect ZC1; table 3).

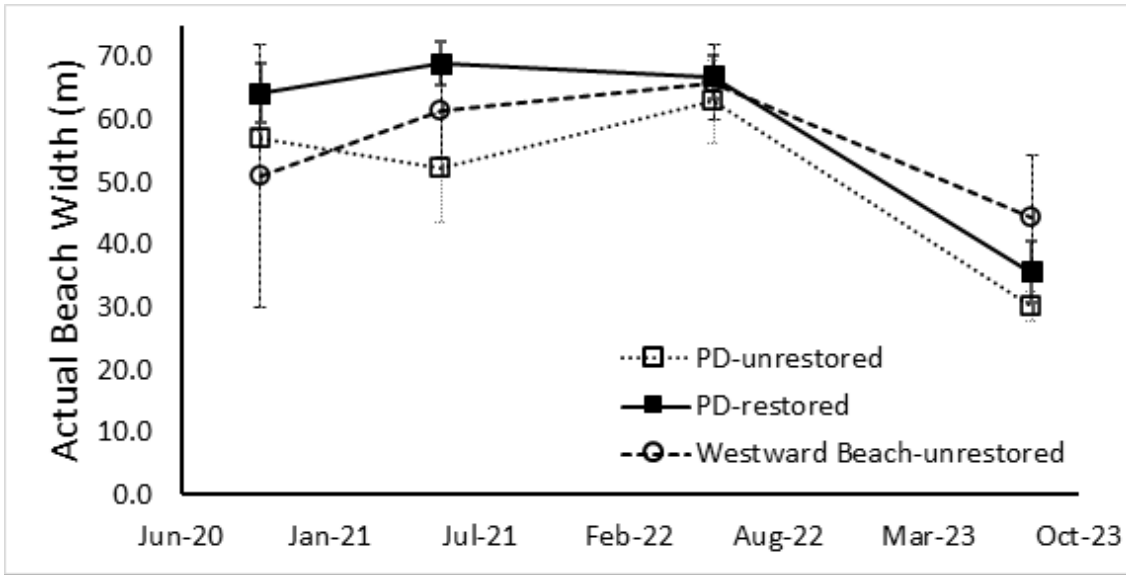
Beach width and Elevation profiles were recorded using transect tape, elevation poles and the Nikon AP-8 Automatic Level viewfinder. Between 2020-2022, sections of Pt Dume beach associated with restored areas were slightly wider, relative to unrestored areas along the same stretch of beach and Westward Beach (Fig. 9). Beach width along all study areas sharply contracted during the winter storms of 2023 (Fig. 10). The restored areas seem to have been more stable with much less variation than the unrestored areas (Fig. 9). This contraction was so severe in the transition area between Westward and Pt Dume beaches that LA County Beaches and Harbors reinforced that section of coastline with rip-rap (Fig. 11).

Figure 9. Mean beach width (m) as a function of time at Pt Dume (squares) and Westward Beach (circles). Restored areas (closed squares) at Pt Dume are distinguished from unrestored areas (open symbols). Error bars indicate the standard error of the mean.

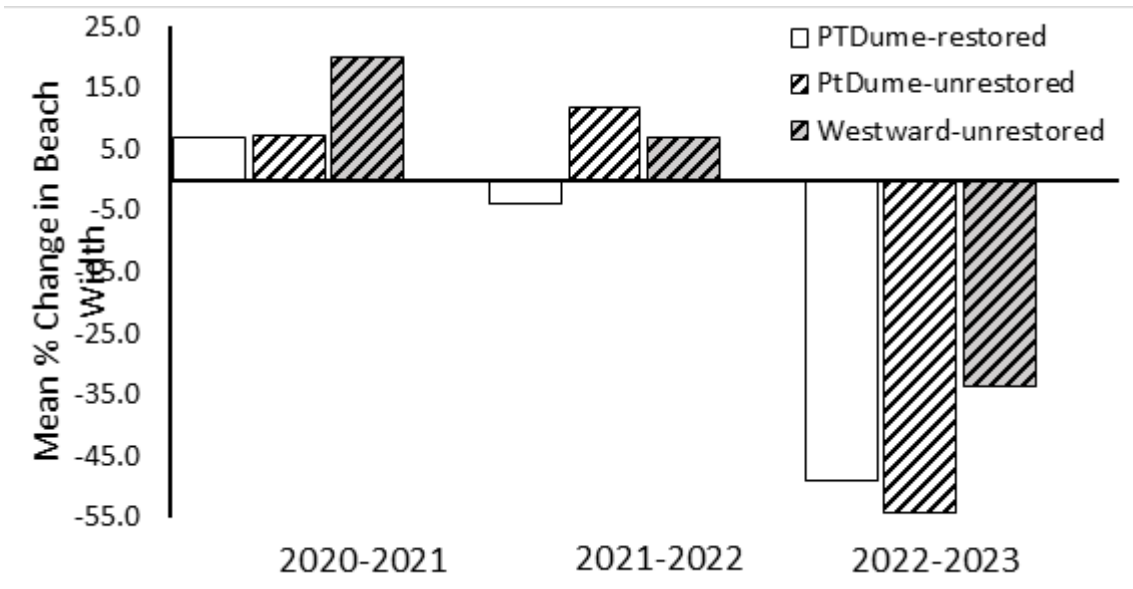
Figure 10. Mean percent change in beach width from year to year in restored areas (open bars) and unrestored areas (hashed bars) in Pt Dume Westward Beach (gray hashed bars).

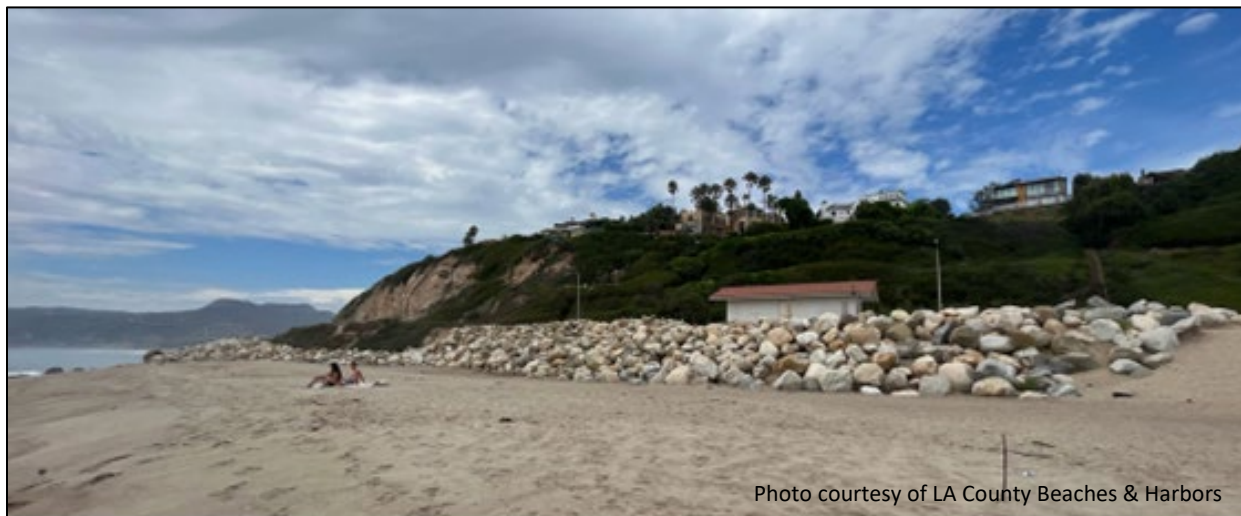
storm action. Unfortunately, the point between Westward and Pt Dume beaches (where the north toilets are located) will likely not see any replenishment with the newly installed rip-rap (Fig 11).

Figure 11. Photo of the transition area between Westward and Pt Dume Beaches, showing the narrow beach and newly installed rip-rap after the 2023 Winter storm damage.

TBF is committed to working closely with LA County Beaches and Harbors to mitigate the storm damage that will ultimately play a role in the long-term defense of the Malibu coast. Supplemental seeding and more volunteer events are recommended to further meet success criteria. TBF is committed to science-based dune creation and restoration, followed by thorough and reproduceable monitoring and adaptive management for the purposes of increasing coastal biodiversity and expanding nature-based coastal resilience to sea level rise and intensified wave action. We are encouraged by the increased native plant cover and diversity, by the slight retention of beach width in restored areas, as well as the accumulation of sand in the widening berm of restored areas. Though these results are still early in the establishment of these coastal dunes, we are buoyed by the trend toward a nature-based solution to the very real threat of coastline erosion.

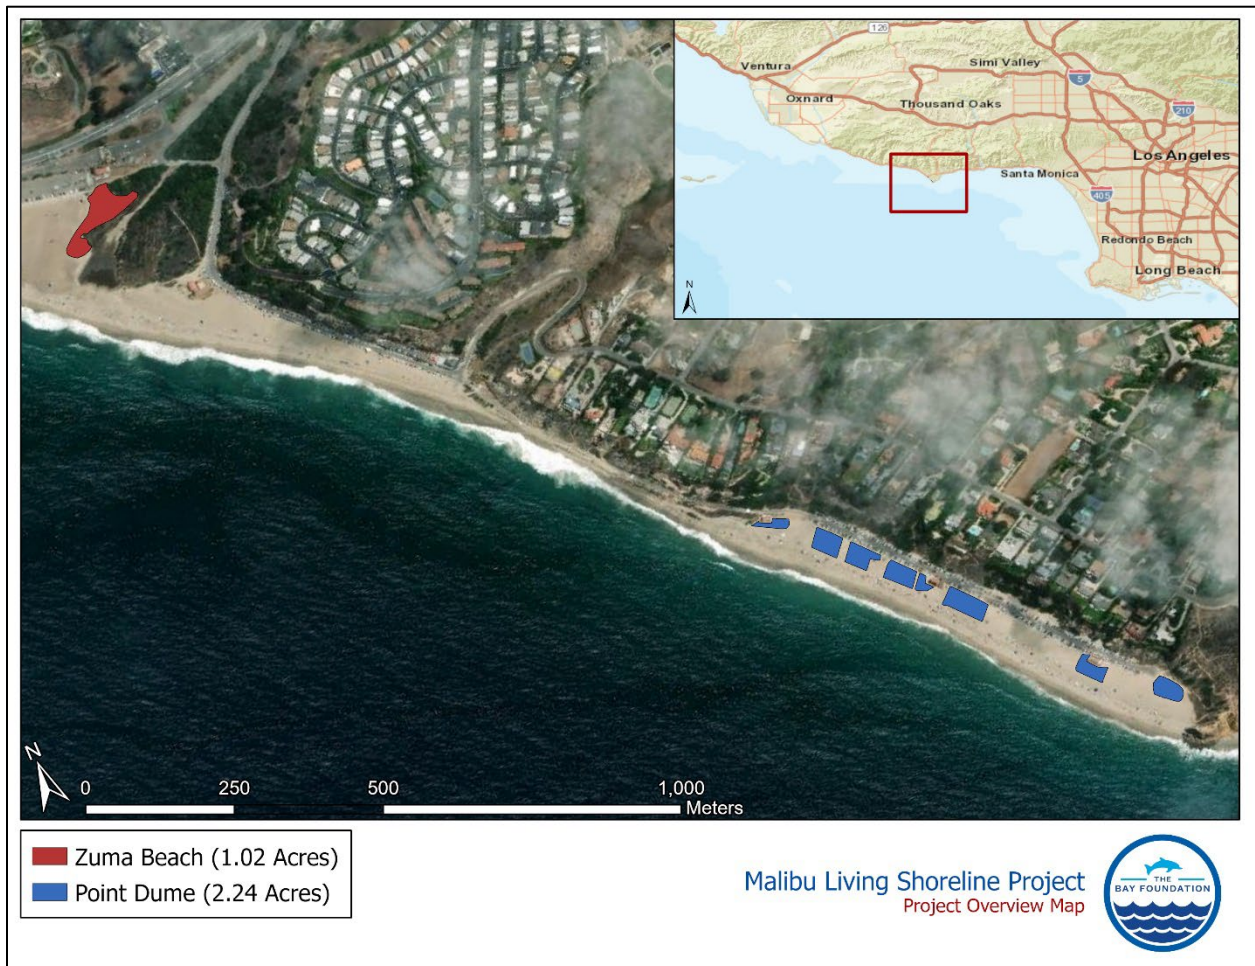
Figure A1. Overview map of both restoration areas implemented as part of the Malibu Living Shoreline Project.

Both Zuma Beach and Point Dume Beach are in the City of Malibu and are managed by the Los Angeles County Department of Beaches and Harbors. Historically, dune systems were a prominent feature of this area; over time with increased development, these dune features disappeared. The project site consists of 3.26 total acres of sandy beach and dune habitat (Figure 2). Restoration activities were conducted on 1.02 acres at the Zuma Beach site, adjacent to Zuma Lagoon, and 2.24 acres at the Point Dume Beach site (Figure 3).

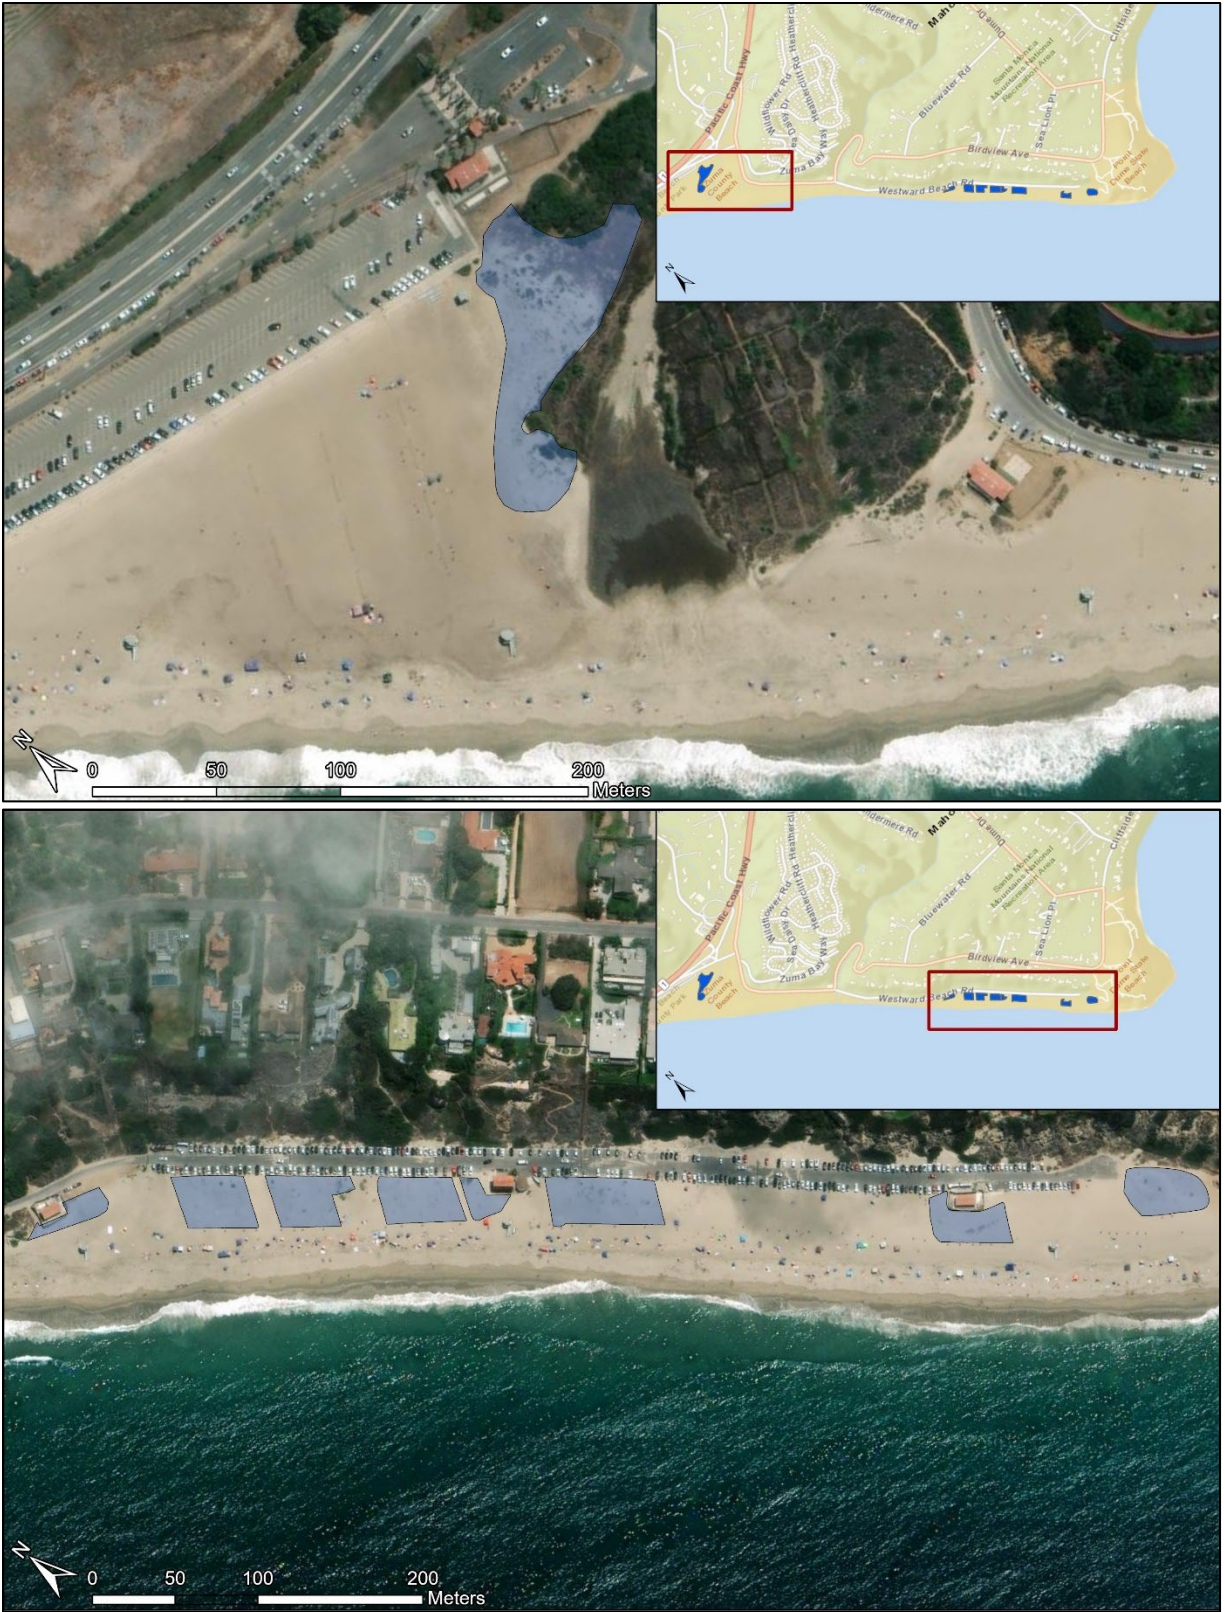
Figure A2. Zuma Beach (top) and Point Dume Beach (bottom) project footprints.

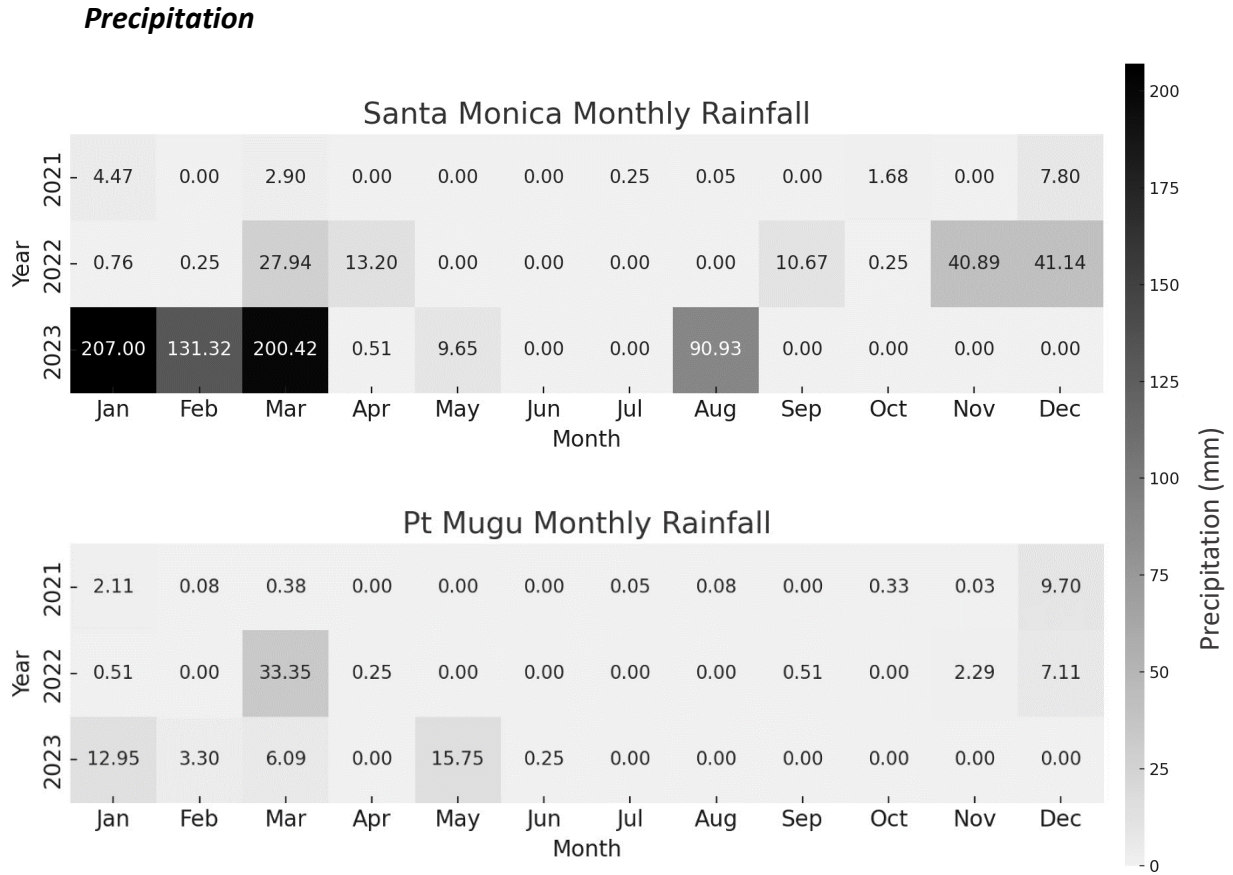
Figure F1. Heatmap of Santa Monica and Pt Mugu monthly precipitation (mm) from 2021-2023. At Pt Mugu, total annual rainfall ranged from 12.76mm in 2021 to 44.02mm in 2022 and 38.34mm in 2023. The annual rainfall in Santa Monica was slightly higher than in Pt Mugu in 2021 (17.15mm), but it was dramatically higher than Pt Mugu in 2022 and 2023 (135.1mm and 639.83mm, respectively). Data from NOAA online database.
