Palos Verdes Kelp Forest Restoration Project

Project Year 9: July 2021 – June 2022 (S-183390001-19133-001)

Prepared for: California Department of Fish and Wildlife

The Bay Foundation

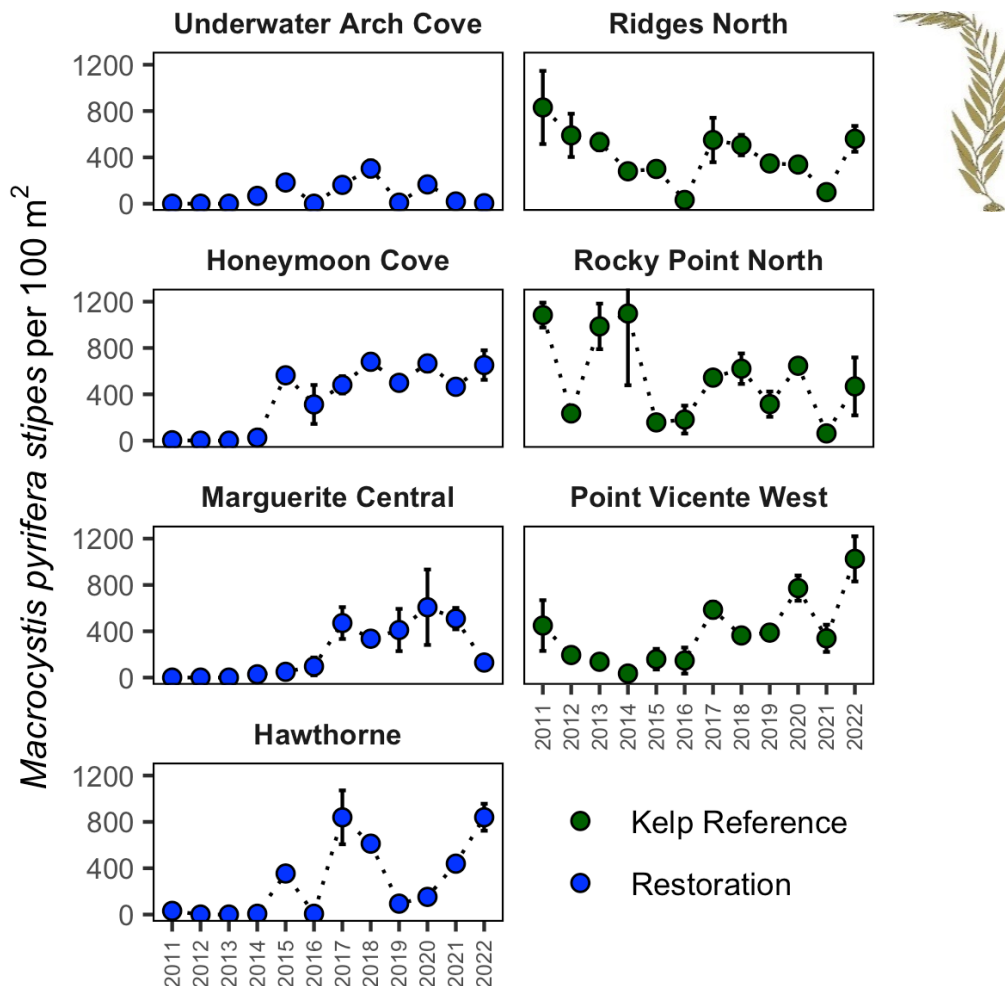
Figure 3. *Macrocyctis pyrifera* stipe density (individuals per 100 m²). Sites Underwater Arch, Honeymoon Cove, and the majority of Hawthorne were restored as of 2015. Restoration began in 2015 at the site

Marguerite Central (previously a control site) and was completed in the Spring of 2017. Stipe density was not significantly different by site designation in 2022 ($t = -1.05$, $p = 0.343$).

As a measure of kelp forest density, we analyze the number of stipes per 100 m² that are greater than one meter in height. The *M. pyrifera* stipe density is provided by VRG during their annual CRANE surveys. The years following restoration activities (2016-2022) showed an immediate increase in the *M. pyrifera* stipe density for all four restoration sites (Figure 3). Increases in stipe density post-2015 are orders of magnitudes higher than the years prior to restoration (2011-2014). *M. pyrifera* densities increased in 2020 across both restoration and kelp reference sites, except for Underwater Arch Cove. *M. pyrifera* densities decreased in 2021 across both restoration and kelp reference sites, except for the Hawthorne restoration site, which showed increases in density compared to 2019 and 2020. In 2022, stipe density increased in all sites except for Underwater Arch Cove and Marguerite Central. Differences in stipe density post-restoration are likely explained by natural inter and intra-annual variation; e.g., kelp canopy cover, transmissivity, temperature, nutrient availability, and upwelling. It should be noted that restoration events did coincide with a natural mass mortality event that contributed to decreased urchin density.

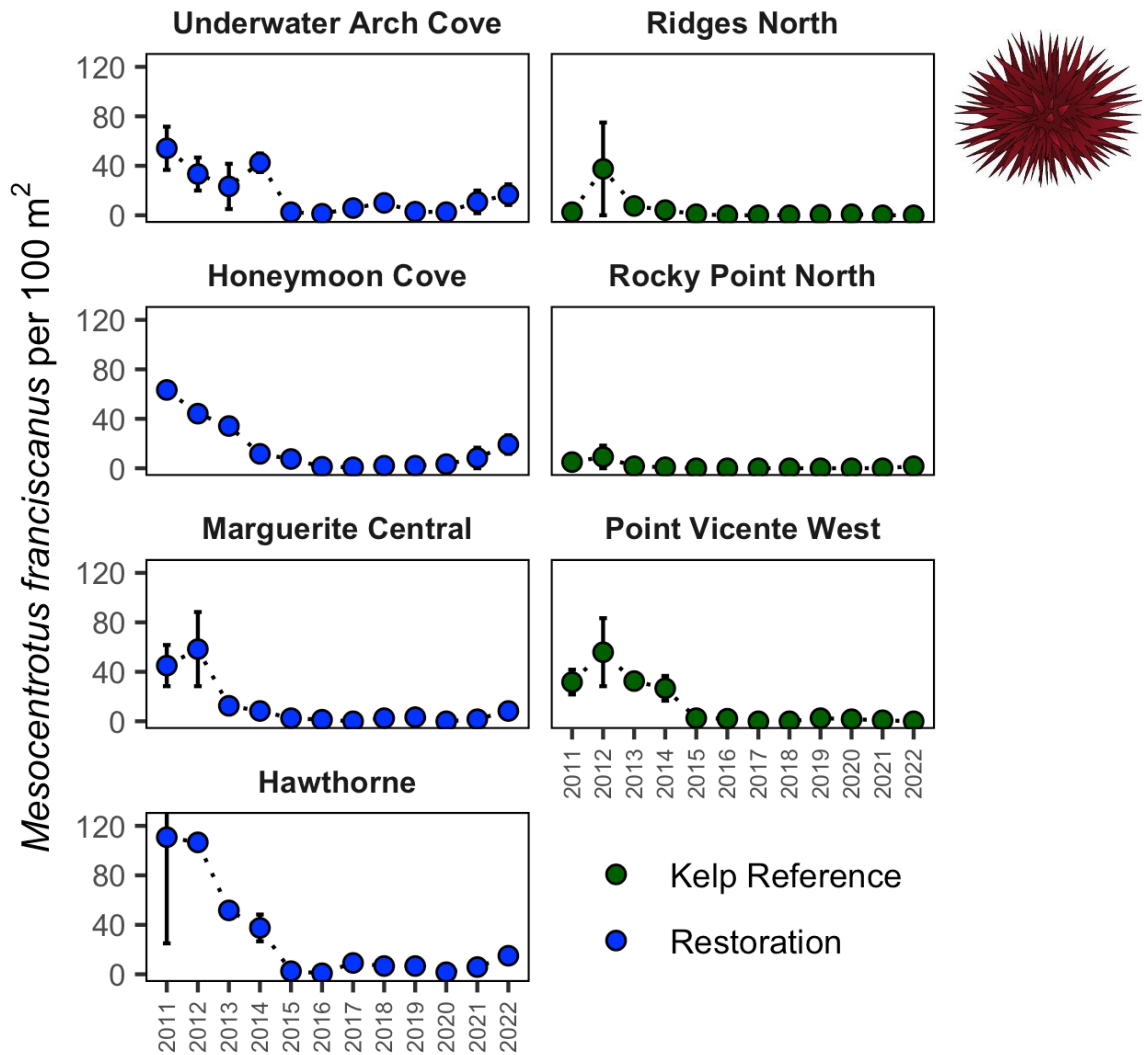
Figure 4. *M. franciscanus* density (individuals per 100 m²). Sites Underwater Arch, Honeymoon Cove, and the majority of Hawthorne were restored as of 2015. Restoration began in 2015 at the site Marguerite Central (previously a control site) and was completed in the Spring of 2017. *M. franciscanus* density was significantly different by site designation in 2022 ($t= 5.98$, $p= 0.007$).

Both *M. franciscanus* and *S. purpuratus* densities began declining in 2013-2014 (Figures 4 & 5). Their numbers remained low until the end of Year 5 when pulses of urchins (mainly *S. purpuratus*) were observed in several areas off the peninsula. Although CRANE surveys show a sharp decline prior to restoration activities at Marguerite Central, TBF fine-scale density data shows that our restoration efforts did decrease purple urchin high-density patches further between 2014-2016. Decreases prior to restoration activities could possibly be a result of early effects of the observed 2014-2015 natural wasting event, or discrepancies in CRANE surveying. TBF suspended *S. purpuratus* suppression from the fall of 2015 through the spring of 2016 to monitor the wasting event. Suppression continued in the late spring of 2016 once lesions on *M. franciscanus* and *S. purpuratus* were no longer found and densities of greater than 2 per m² persisted within our restoration sites. *M. franciscanus* densities also dropped during this time, even though TBF does not cull this species. The decline in abundance was most likely caused by three factors, (1) *M. franciscanus* and *S. purpuratus* wasting event, (2) commercial sea urchin harvesters extracting the *M. franciscanus* for the fishery, and (3) an increase in cryptic behavior. A small uptick in *M. franciscanus* and *S. purpuratus* were recorded during community analysis surveys for Year 5 for both species. In Year 6, we saw a small increase in *M. franciscanus* density and a small decrease in *S. purpuratus* density. In Year 7, we saw a small decrease in both *M. franciscanus* and *S. purpuratus* densities. In Year 8, at restoration sites, we saw increases in the number of *S. purpuratus* observed in Hawthorne and Underwater Arch Cove, but negligible change at Honeymoon Cove and Marguerite sites. In Year 9, for *M. franciscanus*, we saw increased density at all restoration sites, but no change for reference sites. For *S. purpuratus* in restoration sites, we saw an increase in density at Underwater Arch Cove, a decrease at Hawthorne, and stable densities at Honeymoon Cove and Marguerite Central. No changes were observed in *S. purpuratus* densities at reference sites. As for *M. franciscanus* in Year 9, the site types were significantly different with restoration sites showing slight increases, while reference sites displayed negligible change. For *S. purpuratus* in Year 9, the site types were not considered significantly different, although a sharp increase at Underwater Arch Cove was observed.

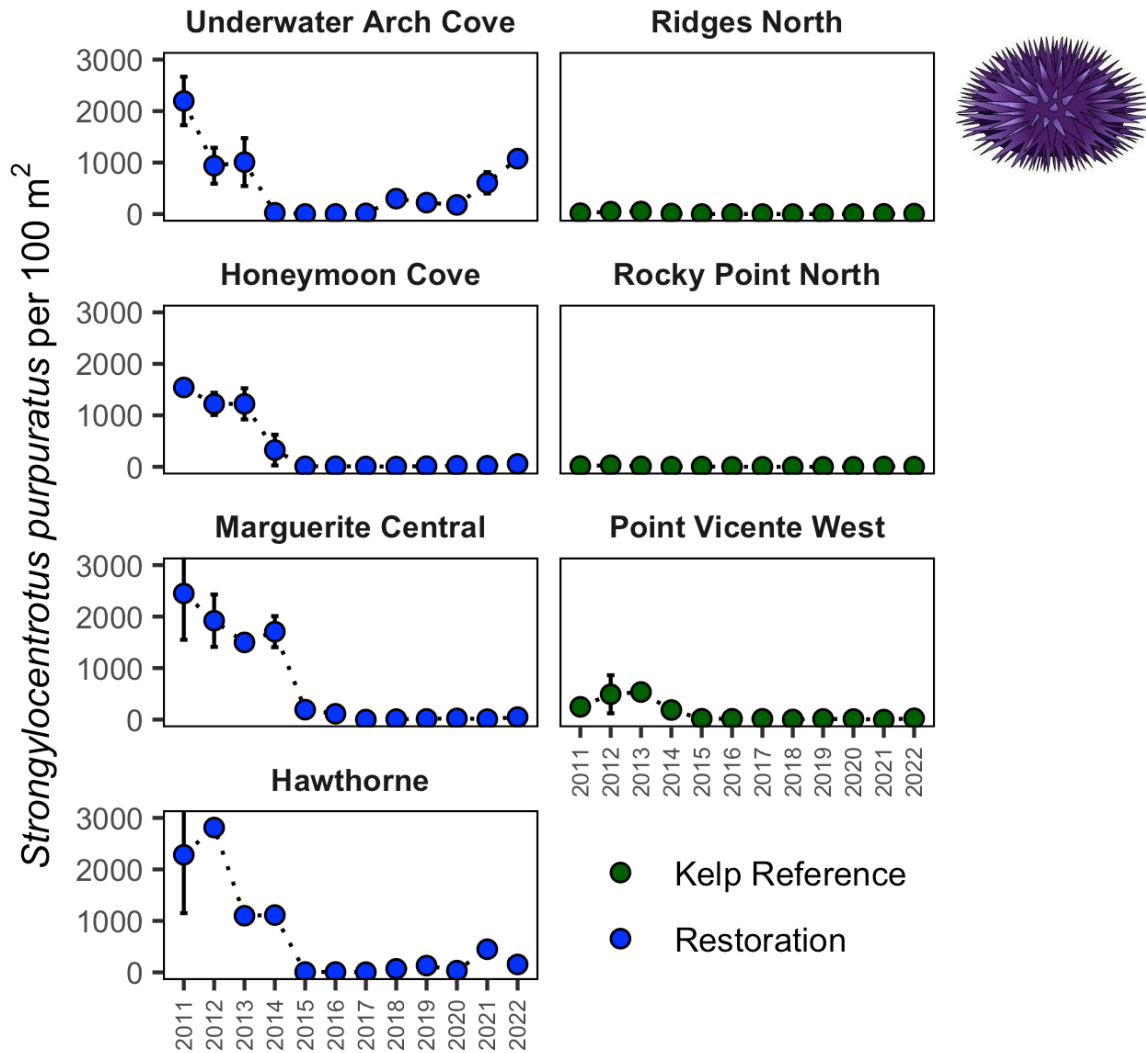
Figure 5. *S. purpuratus* density (individuals/100 m²). Sites Underwater Arch, Honeymoon Cove, and the majority of Hawthorne were restored as of 2015. Restoration began in 2015 at the site Marguerite Central (previously a control site) and was completed in the Spring of 2017. *S. purpuratus* density was not significantly different by site designation in 2022 ($t= 1.29, p = 0.287$).

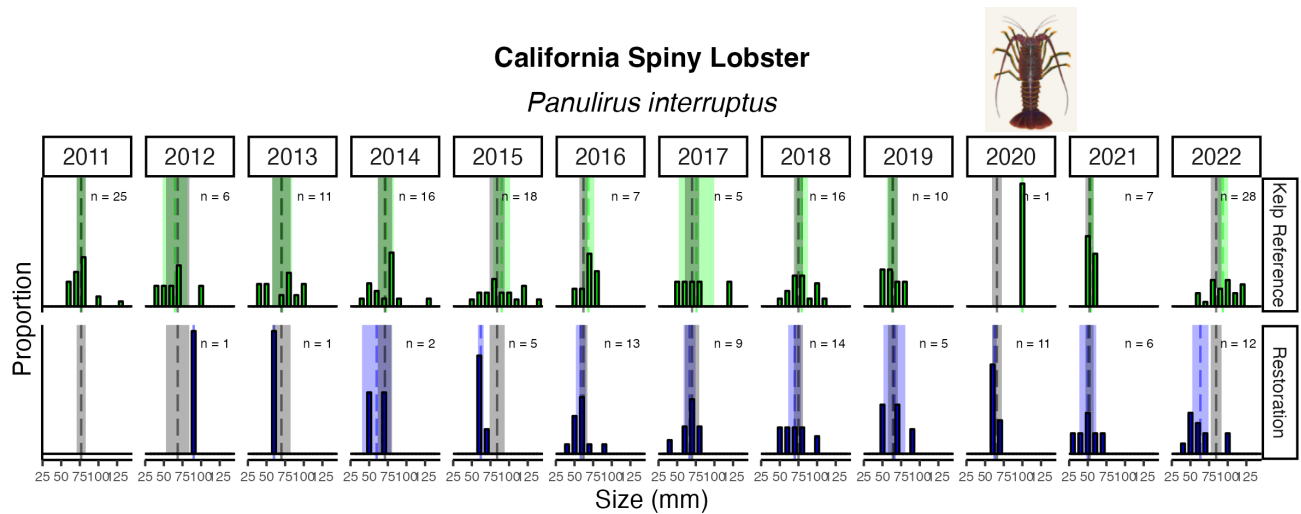
Figure 6. Mean *P. interruptus* density (Individuals per 100 m²) and size at kelp forest reference sites shown in green (Ridges North, Rocky Point North, and Point Vicente West) and restoration sites shown in blue (Underwater Arch, Honeymoon Cove, Marguerite Central and Hawthorne).

Panulirus interruptus (California Spiny Lobster) were quantified in CRANE invertebrate swaths. Prior to *S. purpuratus* removal in restoration sites, *P. interruptus* were not found within the sites (Figure 6). There has been a notable increase in the abundance of *P. interruptus* within restoration sites since 2016. While the abundance in restoration sites declined in 2019, the population observed remained larger than pre-restoration abundance levels. In 2020, the population in restored areas exceeded the population observed in reference sites. In 2021, the population in reference sites was slightly larger than the population observed in restored sites. In Year 9 (2022), abundance levels increased in both restoration and reference sites with numbers in the reference sites surpassing all previous years dating back to 2011. It should be noted that *P. interruptus* abundance is highly variable among sites and years, exemplified by the variability in populations across both kelp reference and restoration sites. This variability could be attributed to two factors: (1) commercial lobster fishing pressure is heavy throughout the Palos Verdes region, (2) *P. interruptus* are mobile and can select for areas based off preferable habitat and oceanographic conditions.

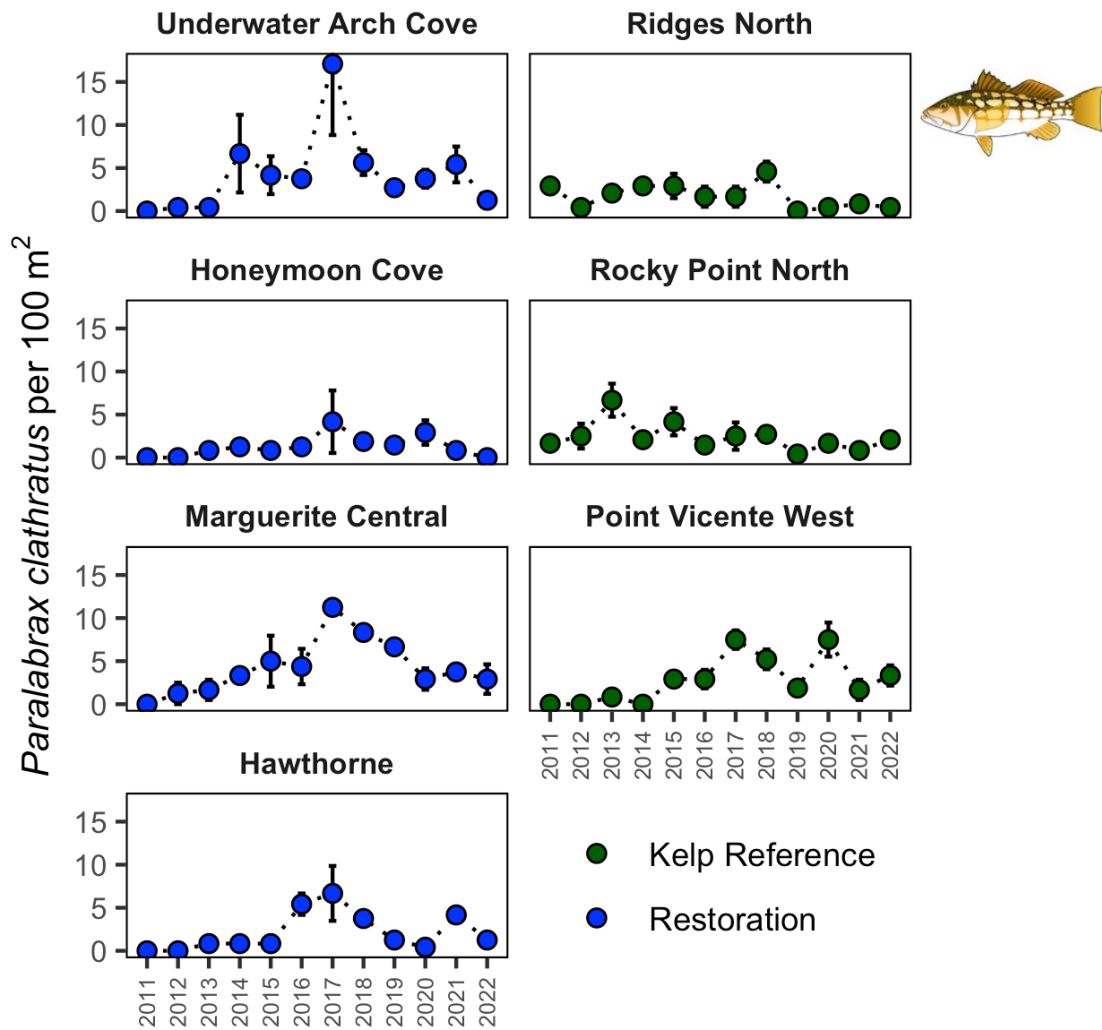
Figure 7. Density of *P. clathratus* by site type: restoration and reference. Sites Underwater Arch, Honeymoon Cove, and the majority of Hawthorne were restored as of 2015. Restoration began in 2015 at the site Marguerite Central (previously a control site) and was completed in the Spring of 2017. *P. clathratus* density was not significantly different by site designation in 2022 ($t = -0.57$, $p = 0.6$).

Kelp bass recruit to kelp canopy and use kelp as a refuge to hide from predators or to ambush prey. Biomass of kelp bass from all years shows that the largest biomass of kelp bass is within the Point Vicente MPA site, which is markedly higher than other reference and restoration sites. This is expected as fishing is not allowed within this area, allowing for fish to grow larger without fishing pressure. All current restoration sites are outside MPAs where fishing is allowed. Restoration sites may have a larger density compared to reference sites, yet smaller biomass, on account of fishing pressure for larger sized individuals, thus leaving a high abundance of smaller sized fish in restoration sites. In 2022, kelp bass biomass was not statistically significant between sites indicating that restoration sites are performing similarly.

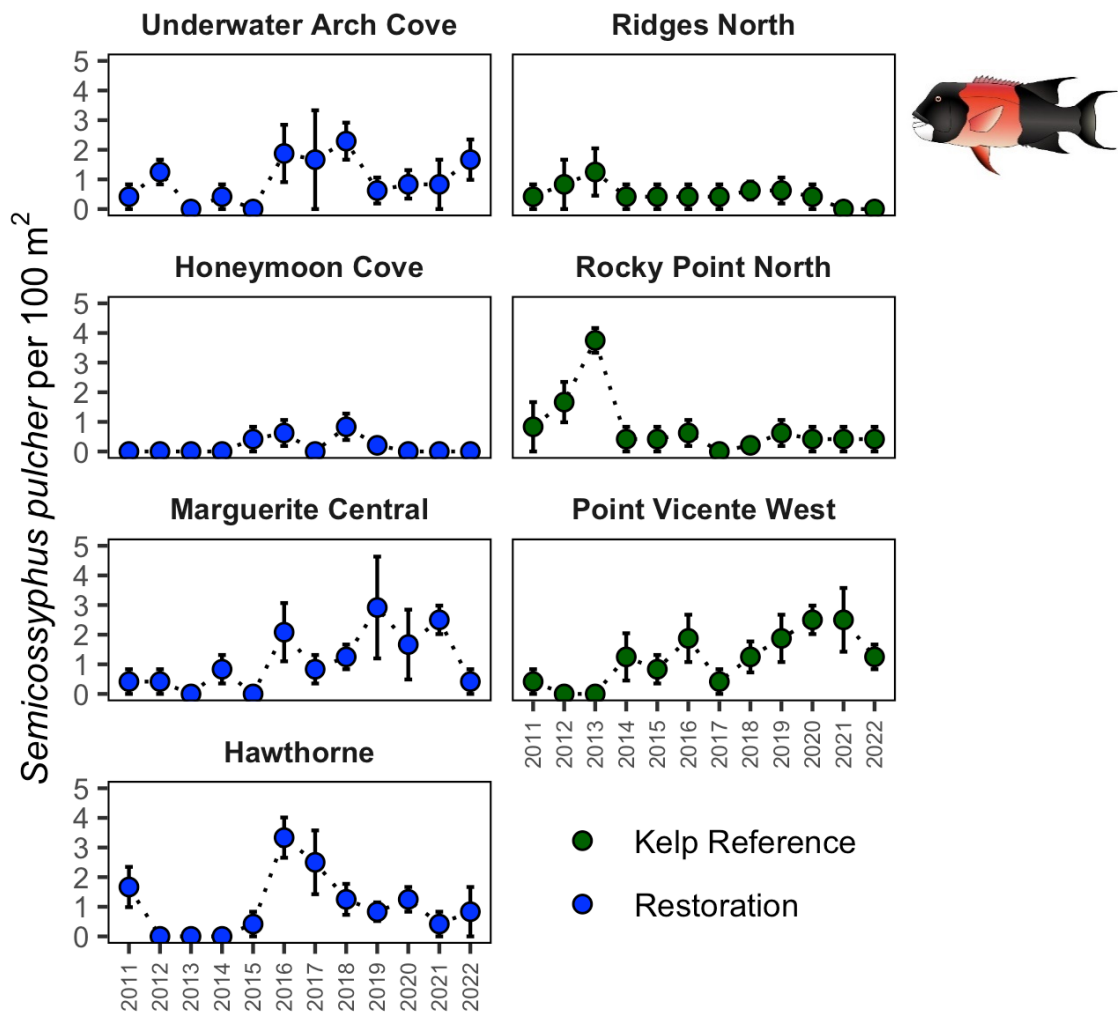
Figure 8. Density of *S. pulcher* by site type: restoration and reference. Sites Underwater Arch, Honeymoon Cove, and the majority of Hawthorne were restored as of 2015. Restoration began in 2015 at the site Marguerite Central (previously a control site) and was completed in the Spring of 2017. *S. pulcher* density was not significantly different by site designation in 2022 ($t = 0.34$, $p = 0.749$).

Semicossyphus pulcher (California sheephead) abundance and biomass has been variable among monitoring years for all sites (Figures 8 & 10). Surveys from 2022 continue to exhibit this annual variation, with various sites displaying slight increases in density and biomass from 2021, while other sites show slight decreases. However, density and biomass in restoration sites depict the same trends as kelp reference sites, with no significant difference by site type.

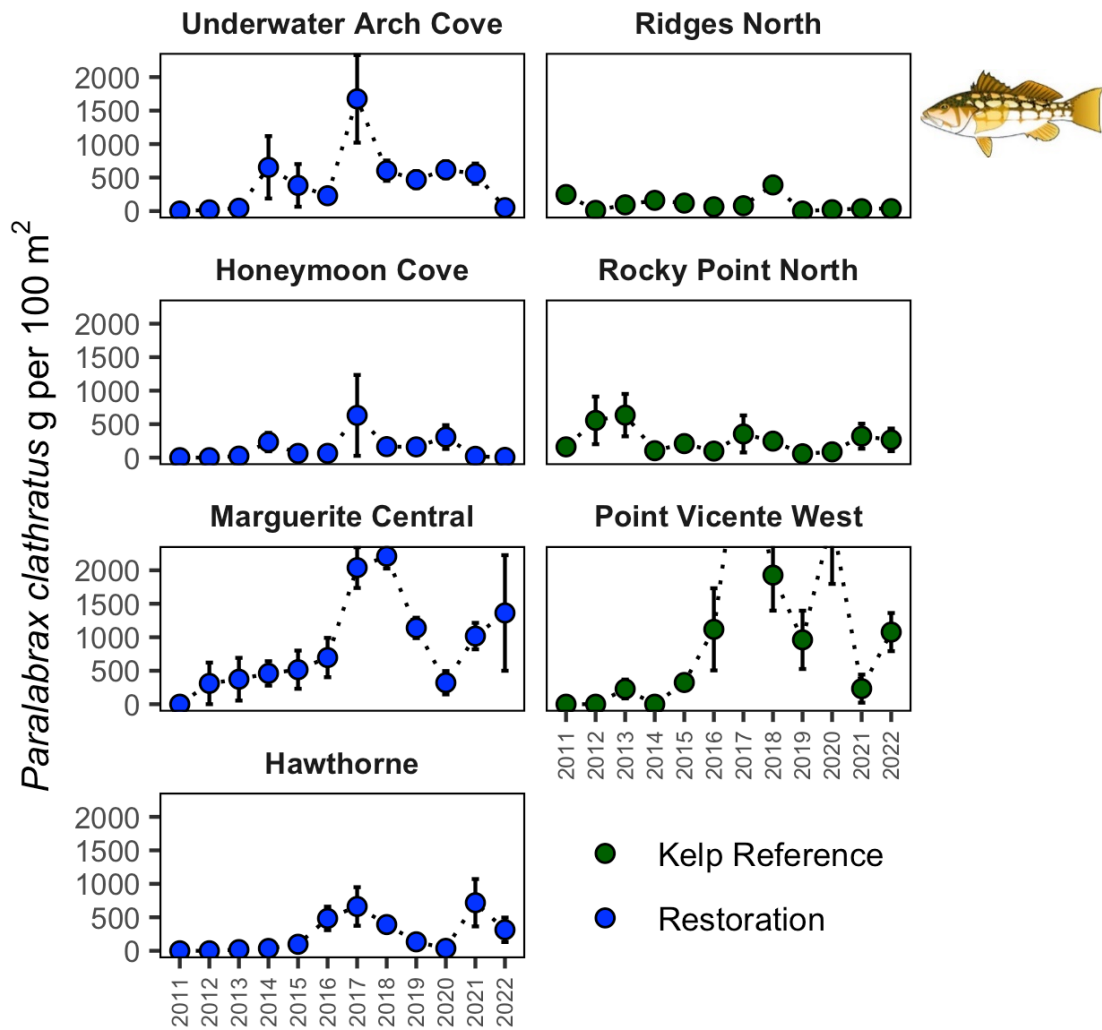
Figure 9. Biomass of *P. clathratus*, per 100 m², by site type: restoration and reference. Sites Underwater Arch, Honeymoon Cove, and the majority of Hawthorne were restored as of 2015. Restoration began in 2015 at the site Marguerite Central (previously a control site) and was completed in the Spring of 2017. *P. clathratus* biomass was not significantly different by site designation in 2022 ($t = -0.06$, $p = 0.955$).

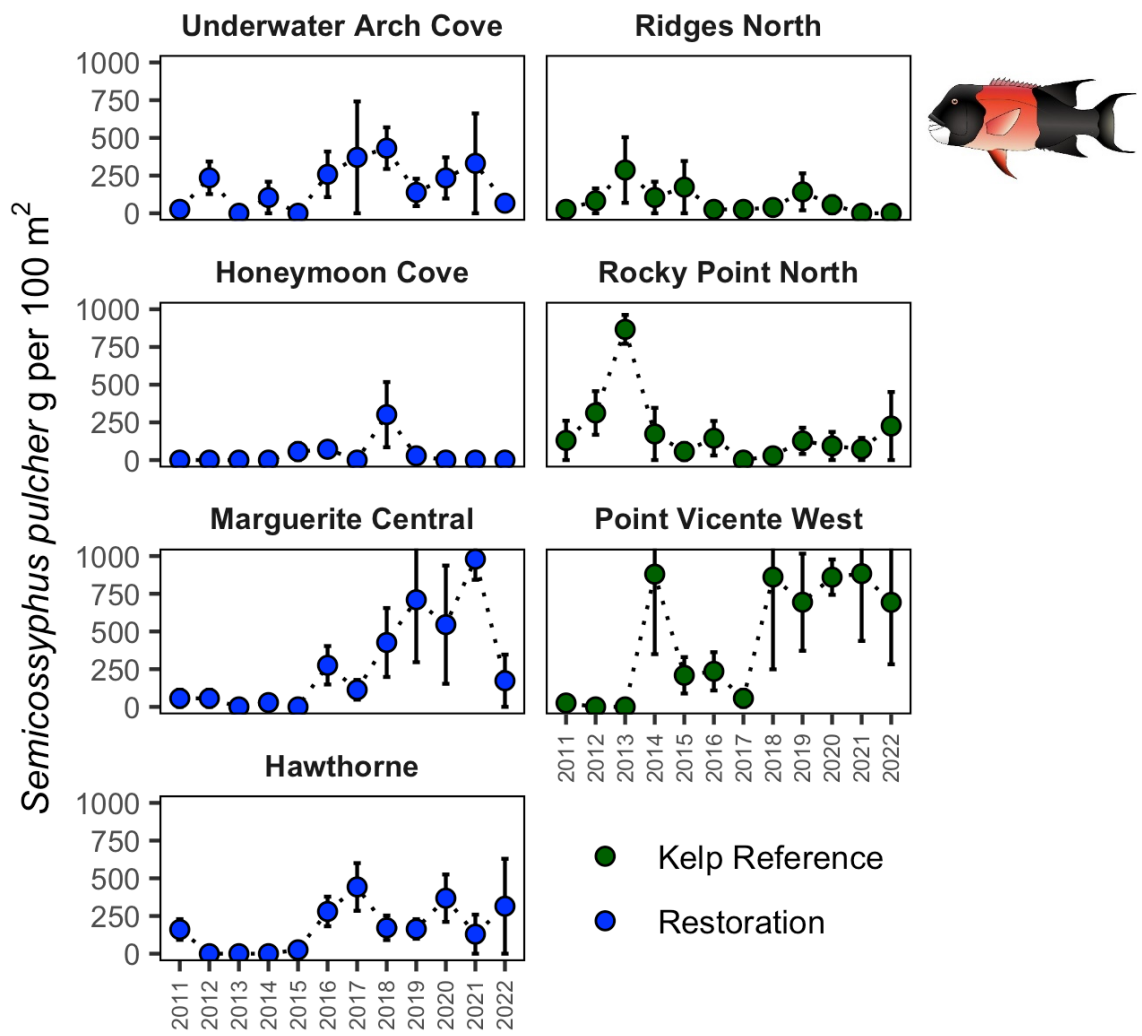
Figure 10. Biomass of *S. pulcher*, per 100 m², by site type: restoration and reference. Sites Underwater Arch, Honeymoon Cove, and the majority of Hawthorne were restored as of 2015. Restoration began in 2015 at the site Marguerite Central (previously a control site) and was completed in the Spring of 2017. *S. pulcher* biomass was not significantly different by site designation in 2022 ($t = -0.78$, $p = 0.504$).

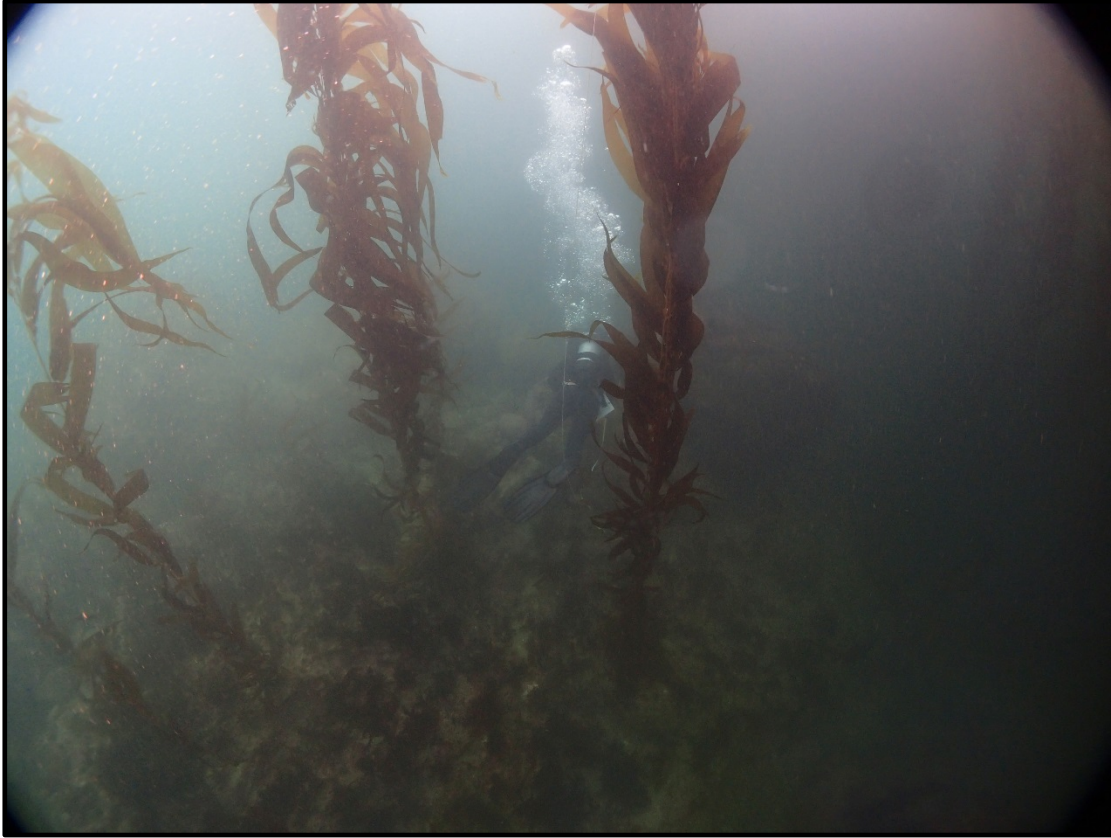
HMC R5 06/22/15

Honeymoon Cove Block R5 (HMC R5) is the site of another TBF project with ongoing monitoring. Divers visit this area annually to conduct subtidal surveys allowing the opportunity to collect photos over time. This block was restored in November 2014.
GPS: 33.765297, -118.424221

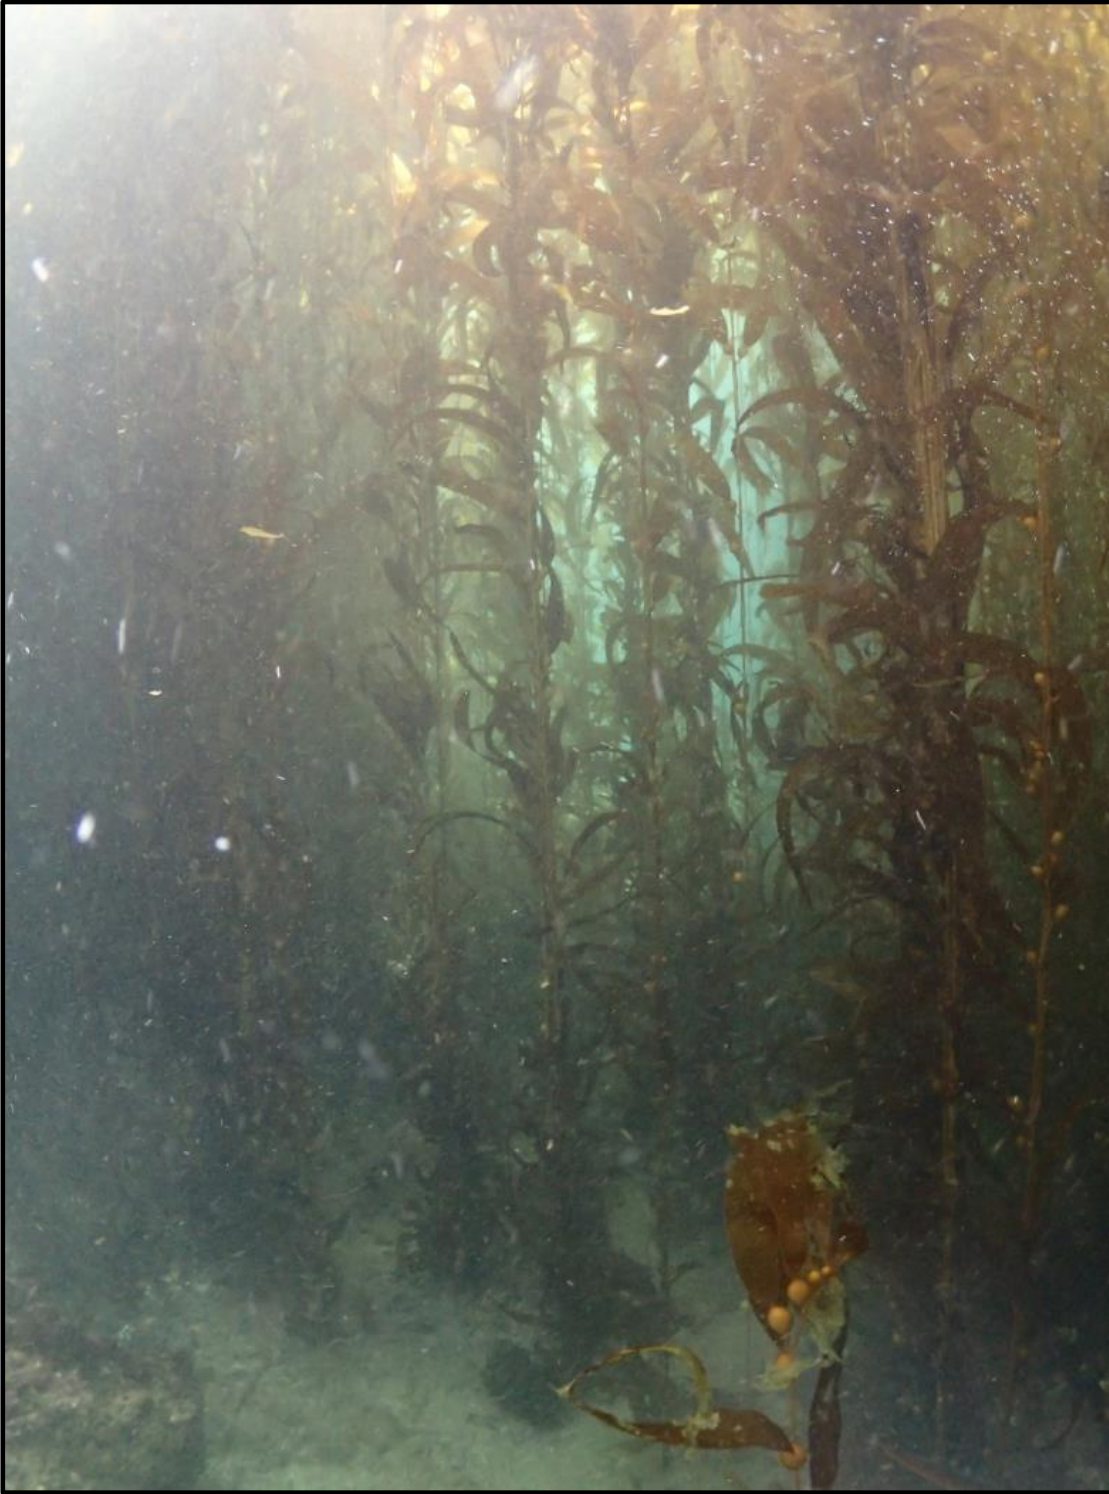
UWAC J1 08/14/14

UWAC J1 restoration was complete in November 2013. GPS: 33.75205979, -118.4156861

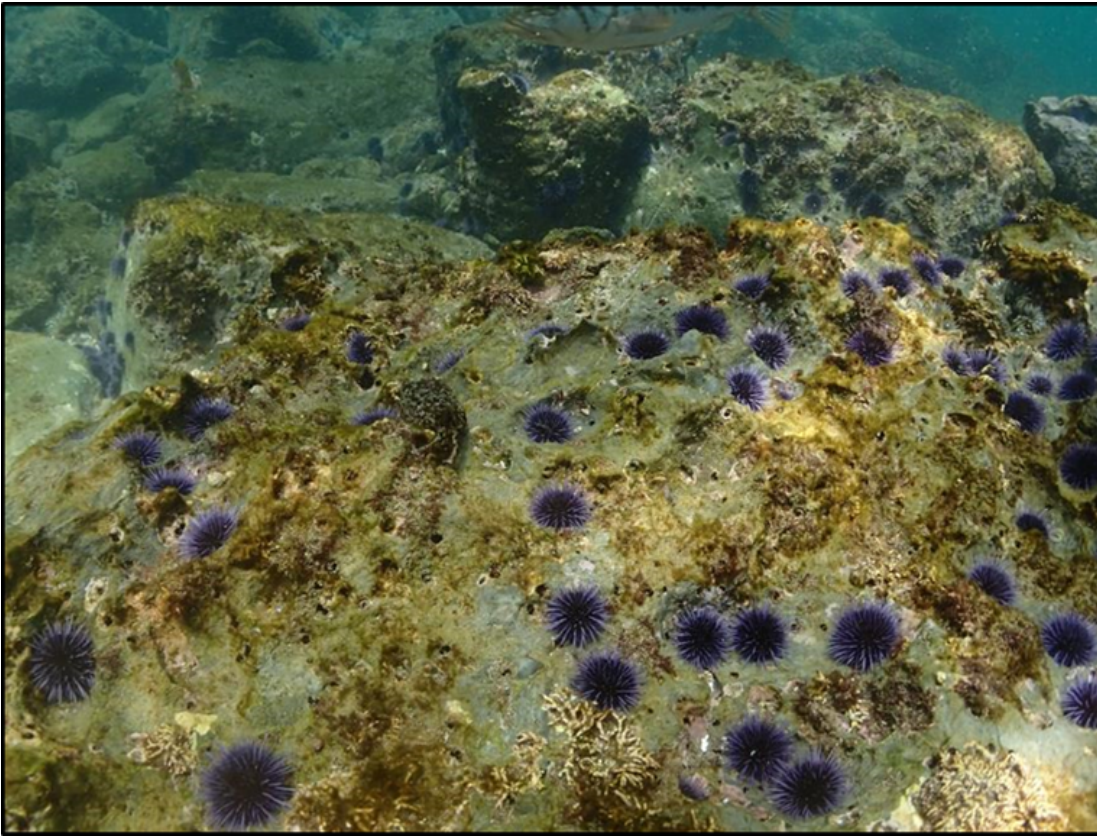
UWAC J2 PRE-RESTORATION 07/12/14

UWAC J2 was restored in July 2014. GPS: 33.7523302, -118.4151245

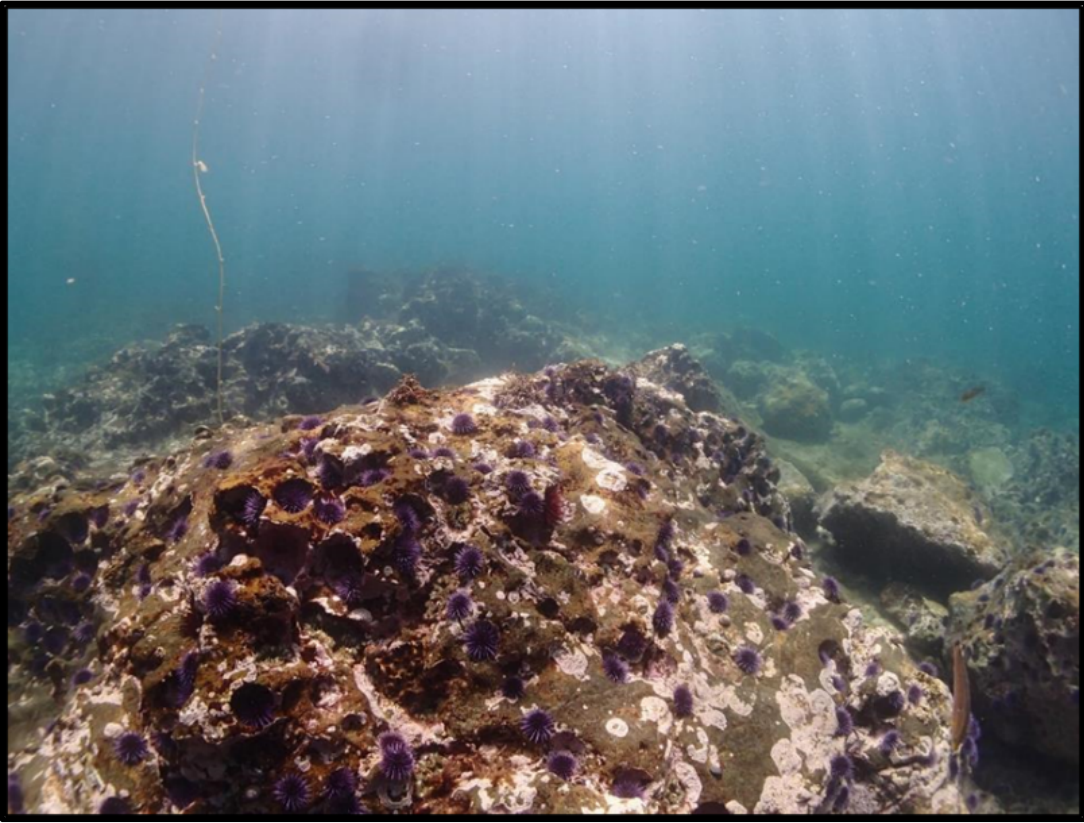
UWAC T7 PRE-RESTORATION 08/14/14

UWAC T7 was restored in September 2014. GPS: 33.7526, -118.414563
