PUMPOUT REPORT 2016

**California Clean Vessel Act
Pumpout Performance Report**

**San Francisco Estuary Partnership
The Bay Foundation**

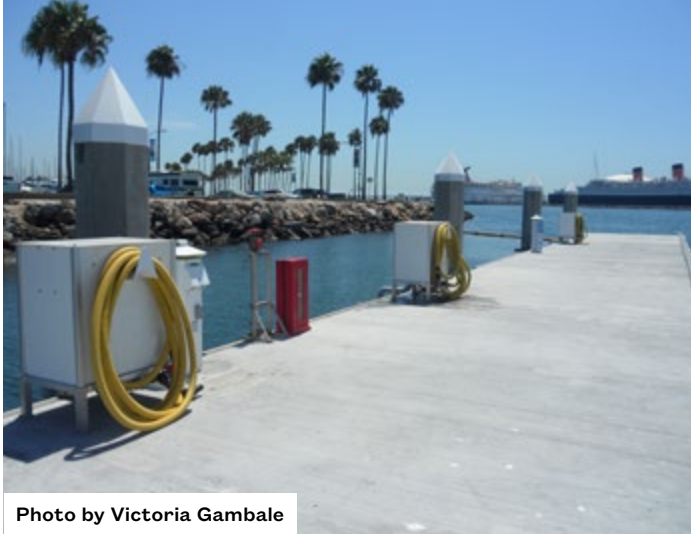
The Shoreline Public Dock had structural issues and the pumpouts historically performed very poorly. These problems have been solved with a newly constructed dock and installation of three new pumpouts. These units are now very reliable for the boating community.
