Malibu Lagoon Restoration and Enhancement Project

Comprehensive Monitoring Report

19 March 2013

Prepared by: Santa Monica Bay Restoration Foundation

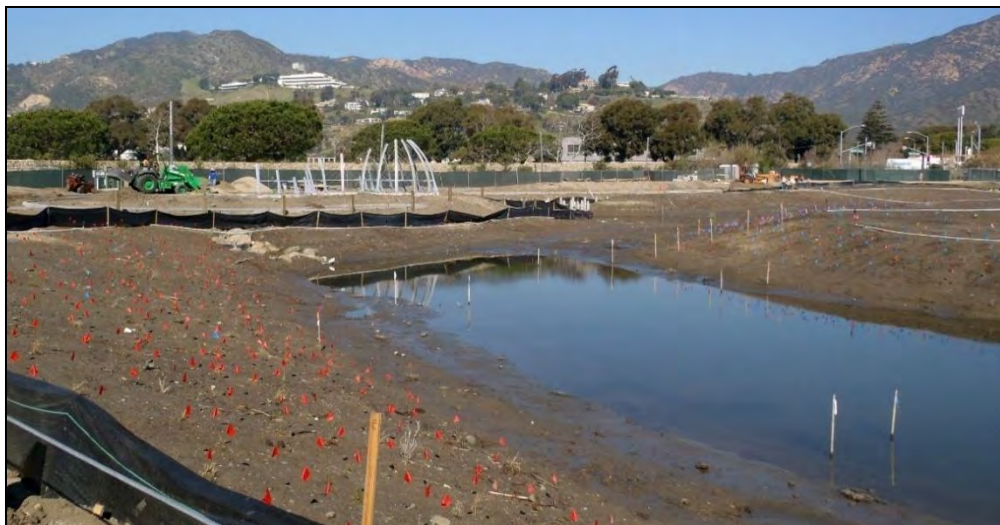
Figure 1. Landscape photo of a portion of the post-restoration CRAM AA for Malibu Lagoon, February 2013.

Two surveys were completed of the wetland habitats: one immediately pre-restoration, and one immediately post-restoration (Figures 1 and 2). CRAM data were collected using the estuarine CRAM method during low tide on 1 June 2012 and 14 February 2013. Detailed field methods followed protocols described in the User Manual (CWMW 2012) and the Estuarine CRAM Field Book (CWMW 2012). The estuarine module was used to be comparable with pre-restoration data collected on 1 June 2012 although Malibu Lagoon is most accurately classified as a ‘bar built estuary’. At the time of both surveys, the bar built estuary module had not undergone a final quality control check and was not publically available. Once the module is publically released, data will be cross-walked and translated for the bar built estuary module.

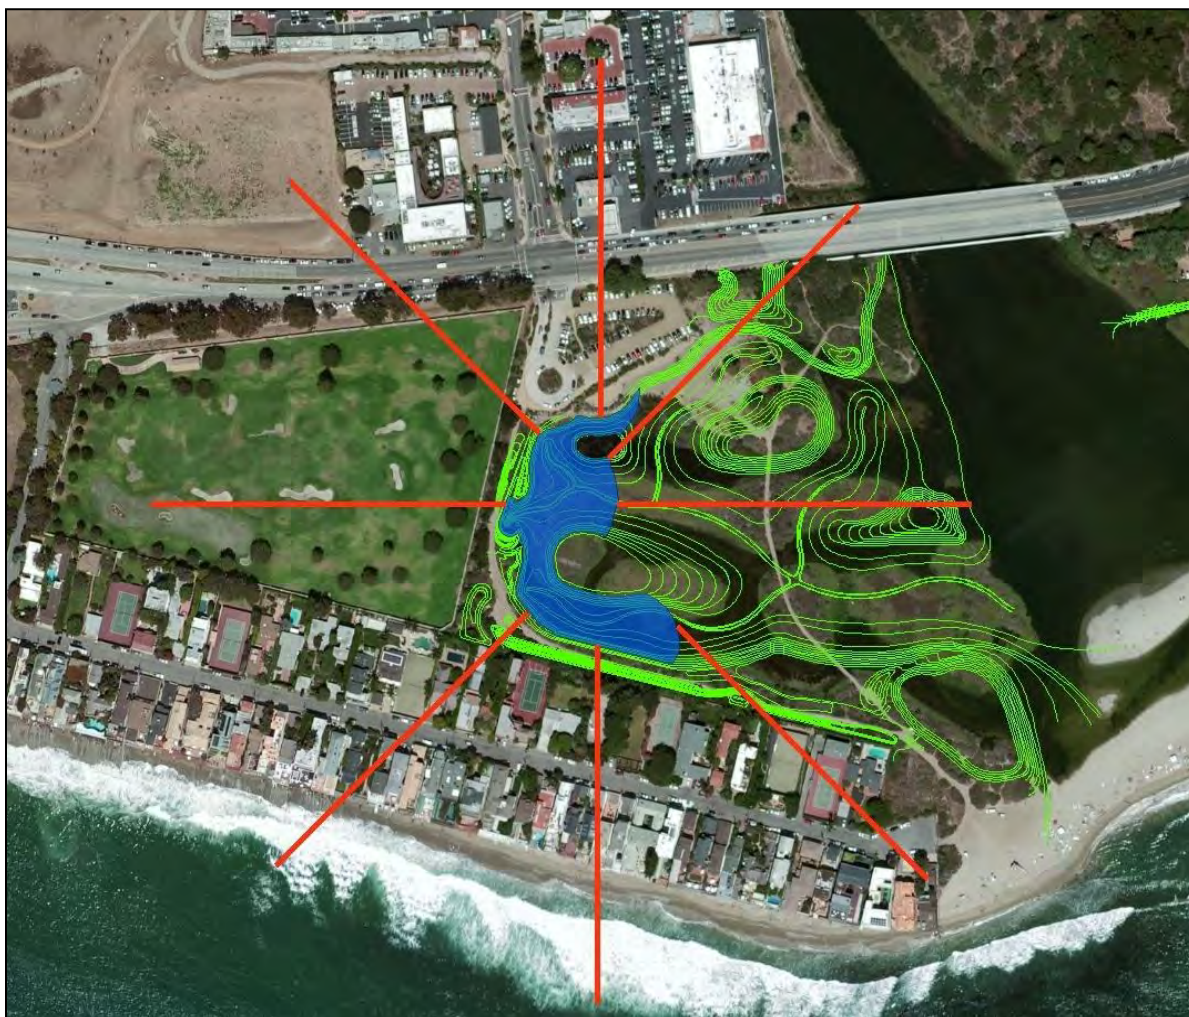
Figure 2. Post-restoration CRAM Assessment Area (blue polygon) at Malibu Lagoon. Green lines indicate elevation contours from the grading plan and red lines indicate radiating (potential) buffer lines.

Figure 2 displays the Assessment Area (AA) and buffer lines for the post-restoration CRAM survey. The AA is approximately one hectare of wetland habitats, following guidelines described in the User Manual. The location of the AA is approximately the same as the pre-restoration survey in June 2011 (results of both surveys are presented below).

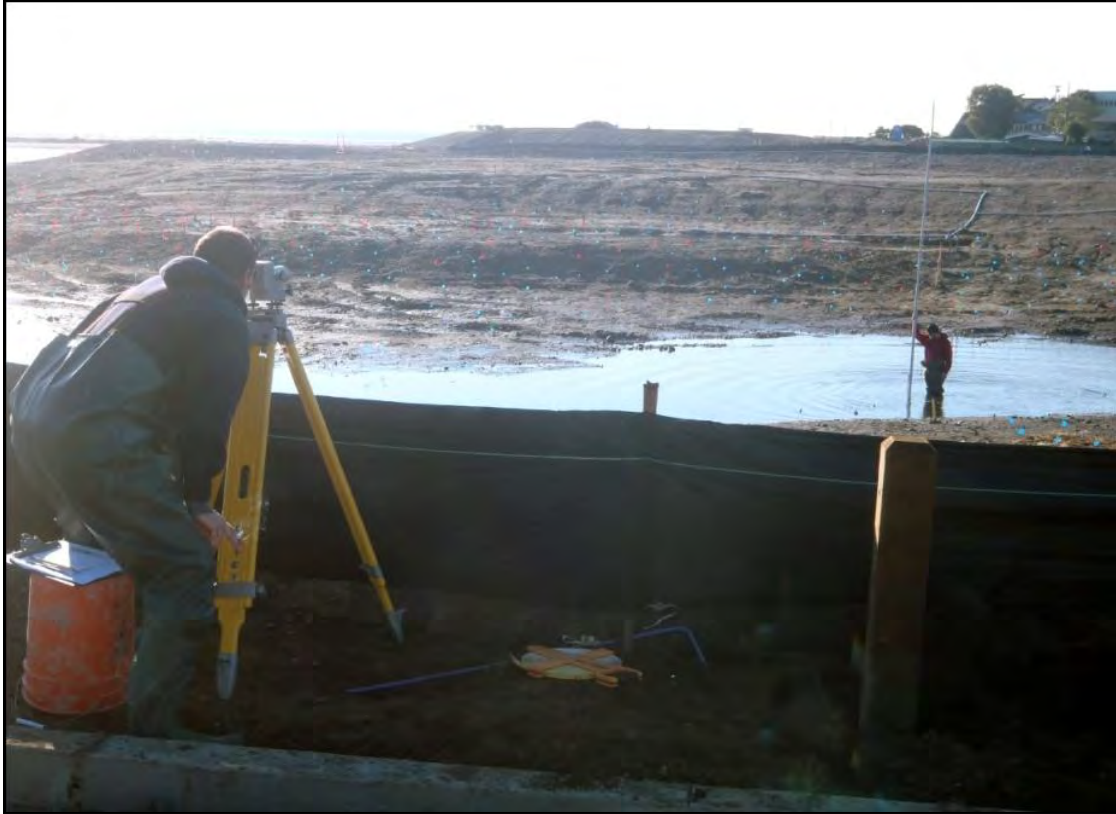
Figure 3. Cross channel elevation surveys at Malibu Lagoon, February 2013.

The five permanent transects (1-5) were surveyed once as part of an initial post-restoration baseline assessment on 14 February 2013 (Figures 3 and 4) and then a second set of quality assurance and quality control surveys (QA/QC) (transects 1, 2, and 5) were conducted on 19 February 2013.

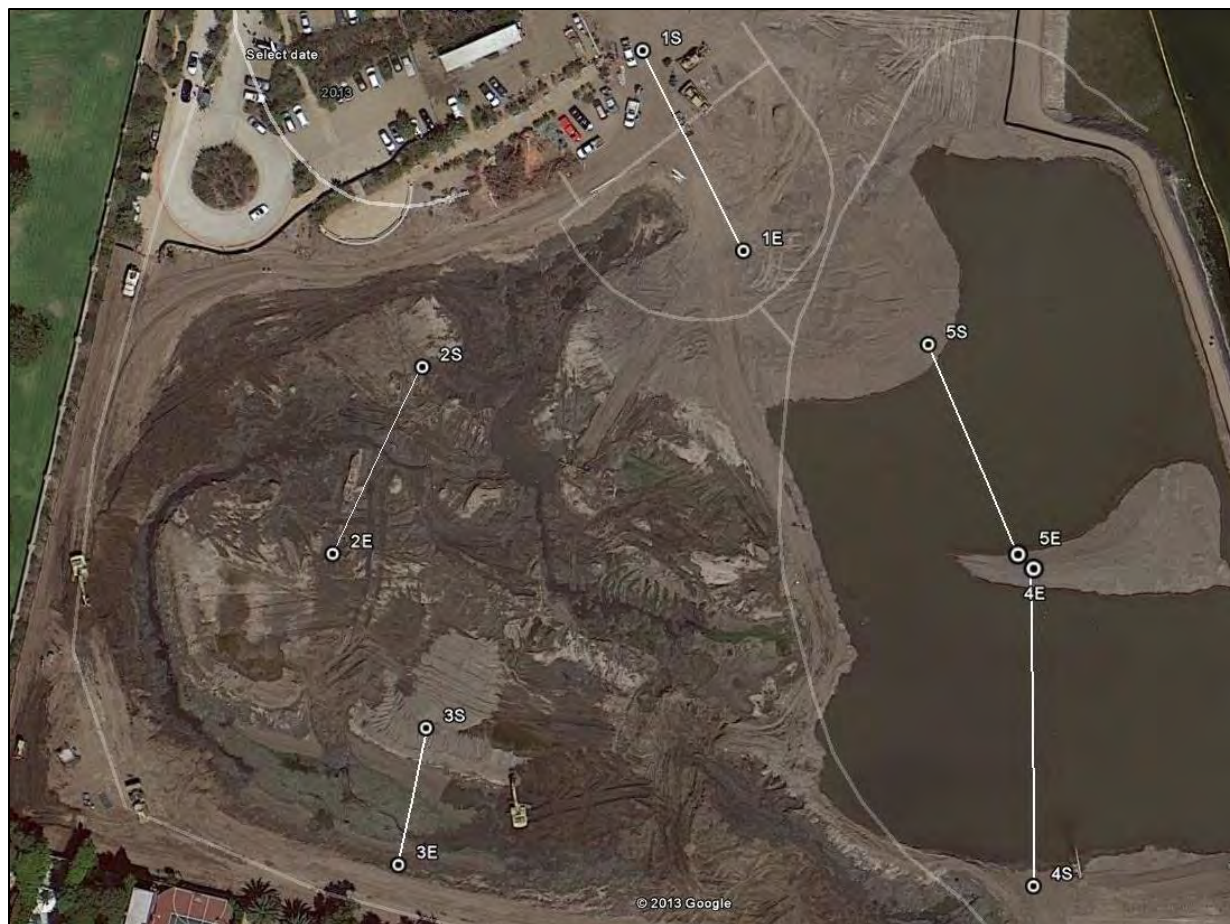
Figure 4. Cross-channel transect locations (Note: Google earth image is from August 2012 during construction. A current geo-rectified aerial was not available at the time of publication).

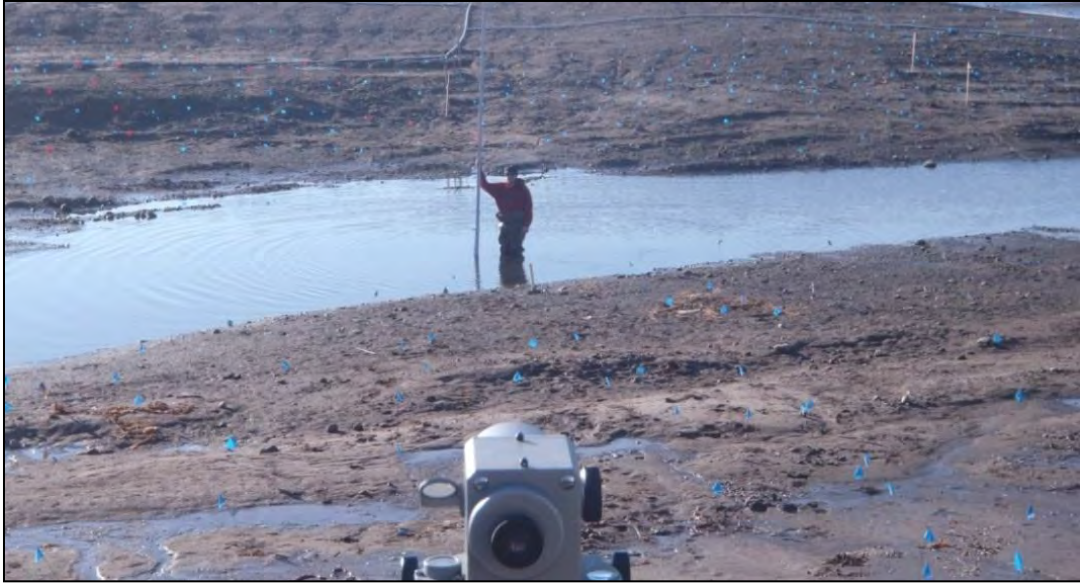
Figure 10. Surveying in the thalweg for the location of a YSI sonde station, post-restoration, February 2013.

Permanent housing for post-restoration monitoring was built for three water quality sondes at Water Quality Stations 2, 5, and 8 (Figures 10-12). They were installed on 15 March, 2013 and those data will be included in subsequent monitoring reports.

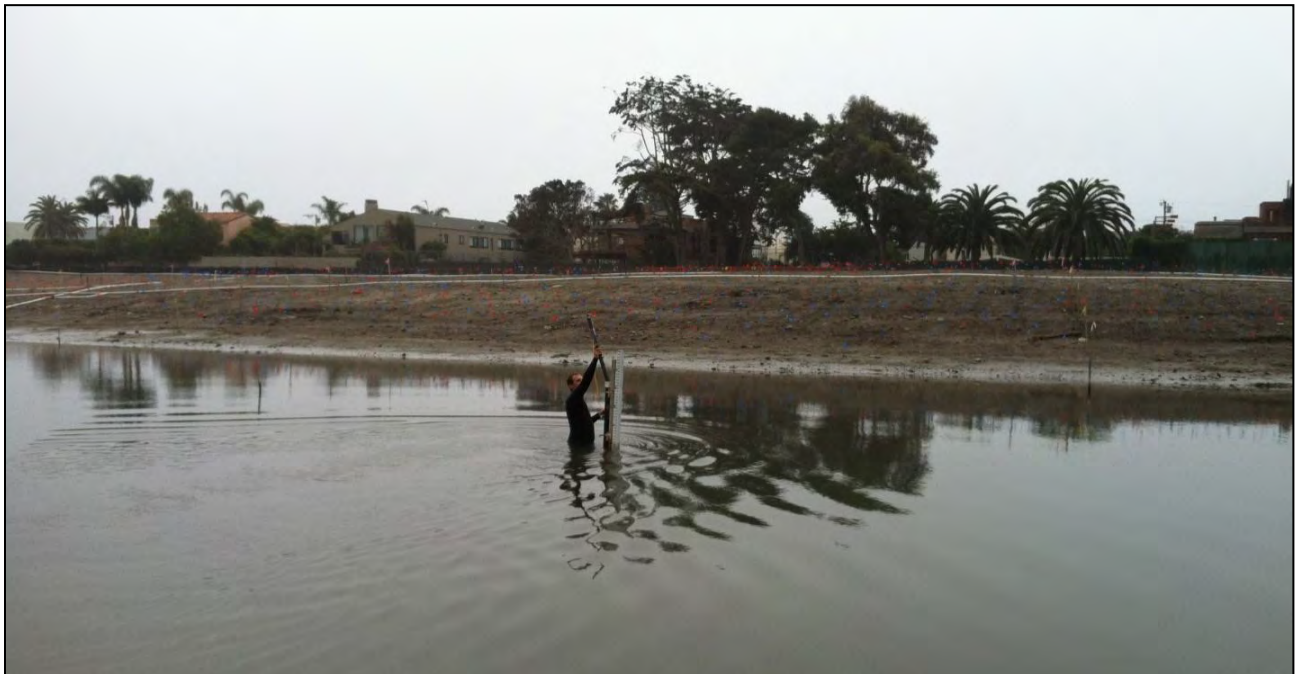
Figure 11. Deploying a YSI sonde at one of the stations, post-restoration, 15 March 2013.

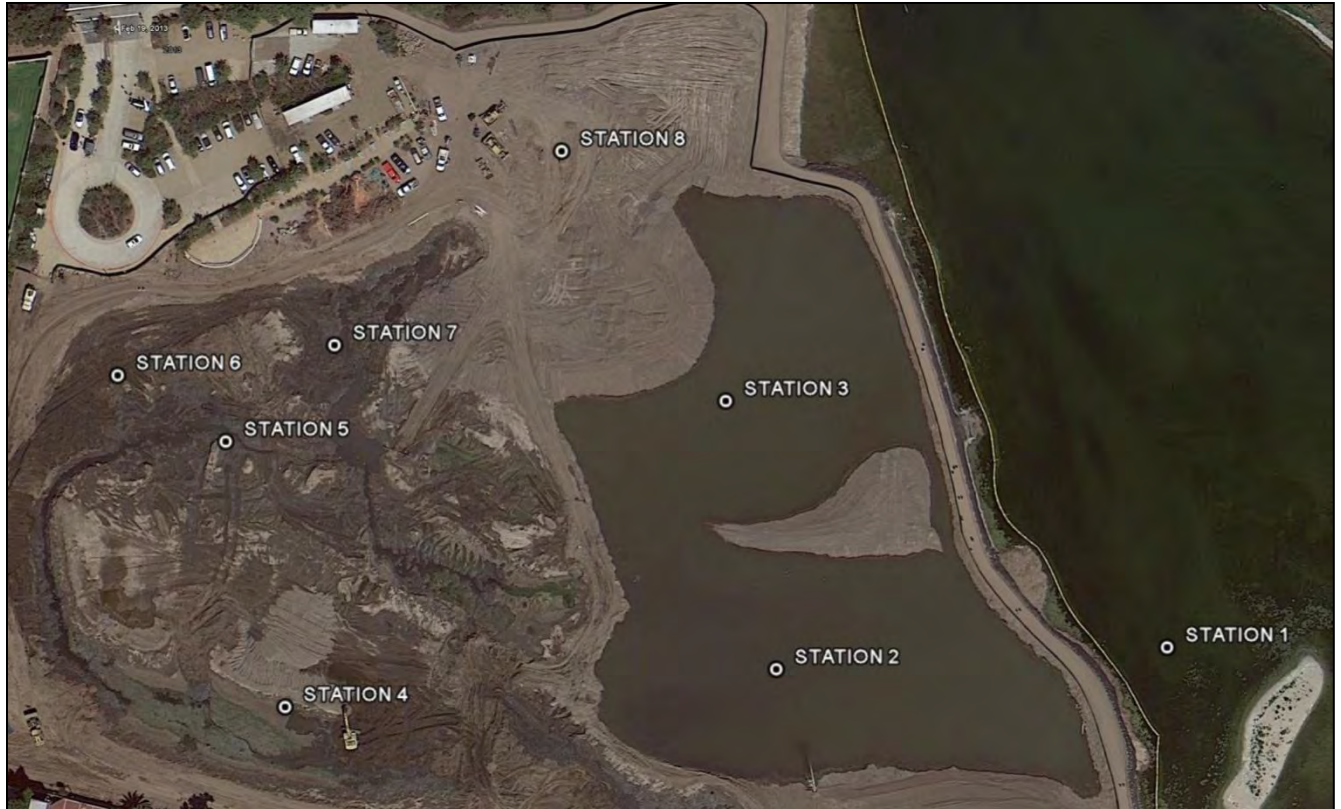
Figure 12. Map of water quality vertical profile and SAV/algae survey stations. Water quality stations 2, 5, and 8 are also the locations of the three permanently-deployed YSI data sondes. Note that each SAV/algae station is comprised of three cross-channel transects approximately 10 meters apart (individual transects not identified on map).

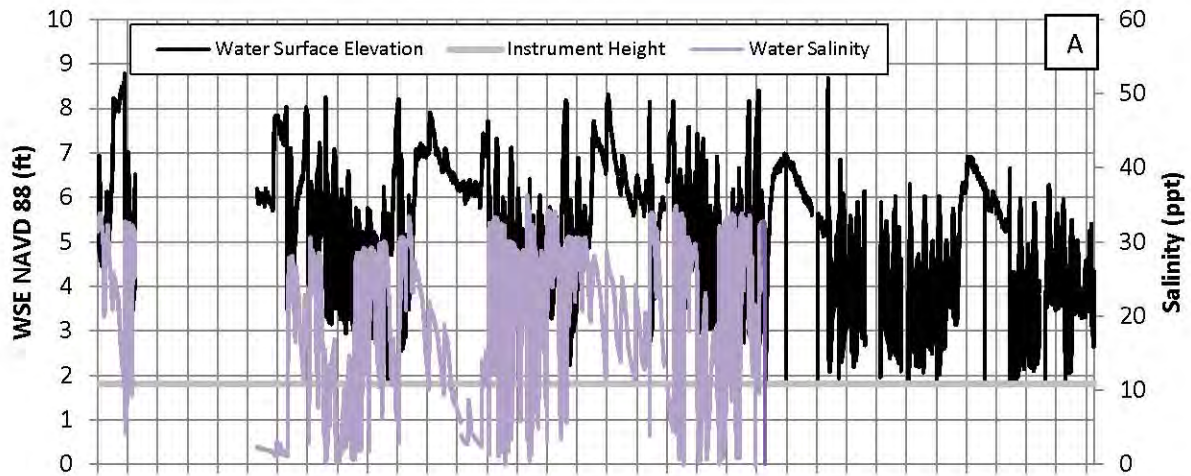
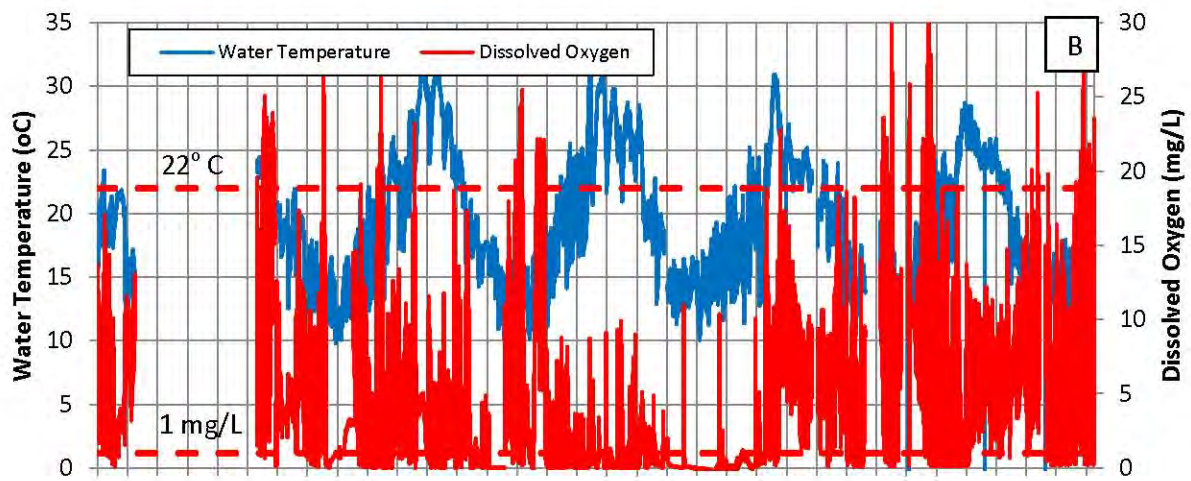
Figure 13A, B, and C. Graphs illustrating continuous water quality parameters from station ML1 (2006 to 2012).

Graphs displaying data from pre-construction monitoring at stations ML1, ML2, and ML6 are presented in Figures 13-15. Figures 13a, 14a, and 15a illustrate the relationship between water salinity (ppt) and water depth (NAVD 88 ft). During closed conditions across the mouth of the main Lagoon, salinity levels lower as freshwater inputs from Malibu Creek raise the water elevations. Figures 13b, 14b, and 15b illustrate the relationship between temperature ($^{\circ}\text{C}$) and dissolved oxygen (mg/L). In general, as temperature increases in a closed lagoon scenario, levels of dissolved oxygen decrease as the primary producer communities (algae) consume the available oxygen. Figures 13c, 14c, and 15c illustrate the relationship between pH and oxidation reduction potential (ORP).

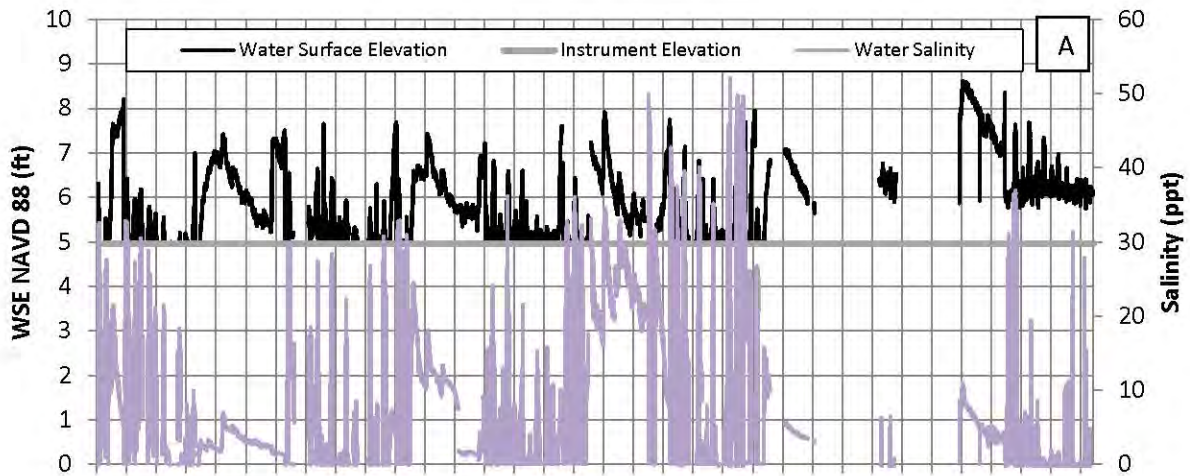
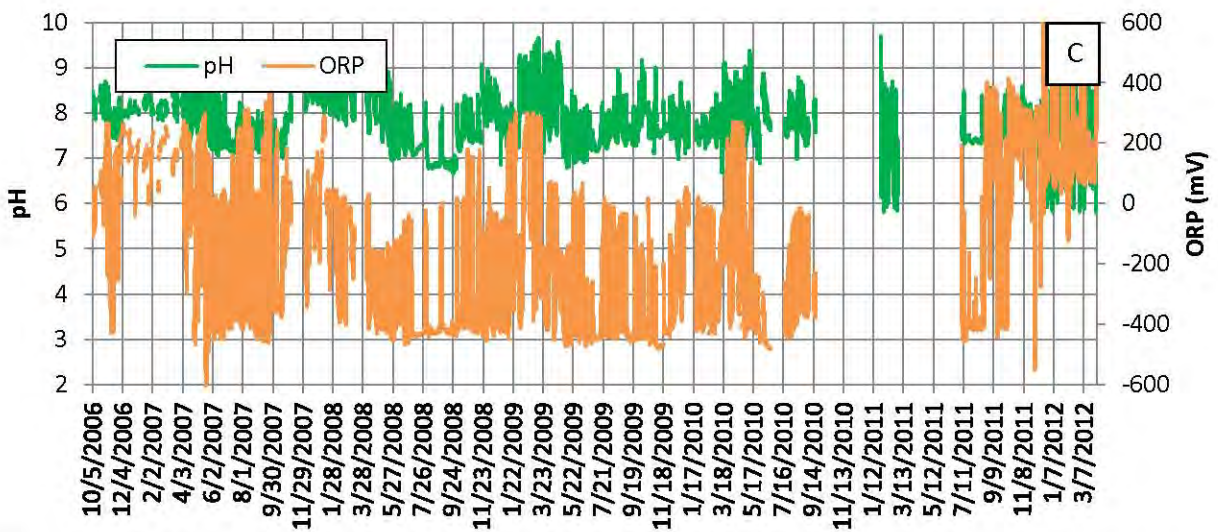
Figure 14A, B, and C. Graphs illustrating continuous water quality parameters from station ML2 (2006 to 2012).

Data which did not meet the QA/QC standards were removed from the analyses. An example includes the removal of ML2 temperature data from Figure 14 due to probe malfunction. Additionally, large data gaps are present when individual probes or sondes are pulled from the field and sent to the manufacturer for maintenance. Examples include the ML6 data from the first half of 2007 (Figure 15) and ML2 data from September 2010 through January 2011 (Figure 14).

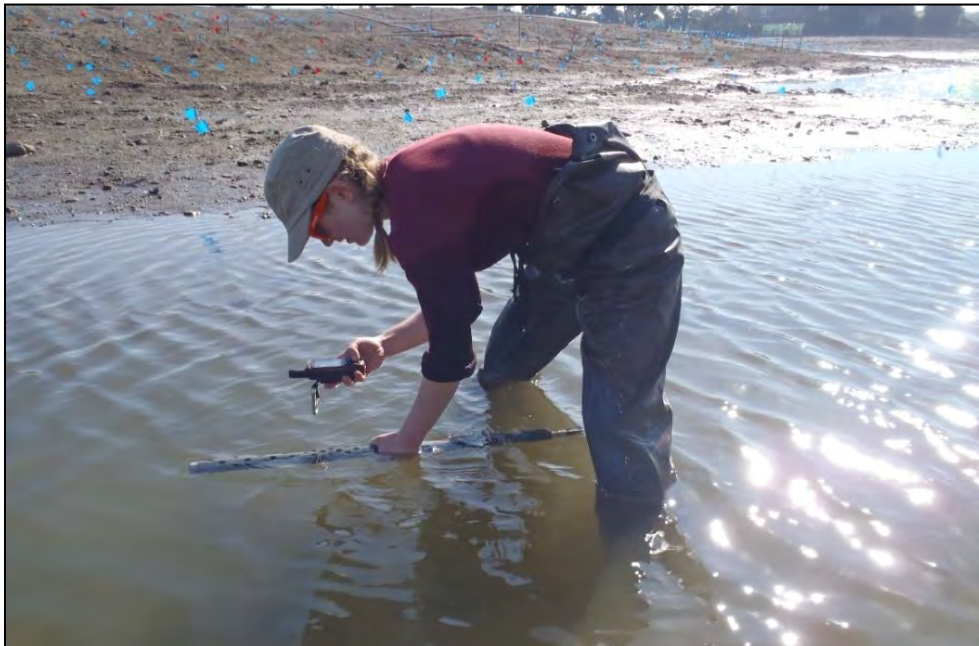
Figure 16. Water quality vertical profile monitoring at Malibu Lagoon, February 2013.

Baseline immediate post-restoration vertical water quality profiles were conducted during a high neap tide on 14 February 2013 at all eight water quality stations (Figures 16 and 17).

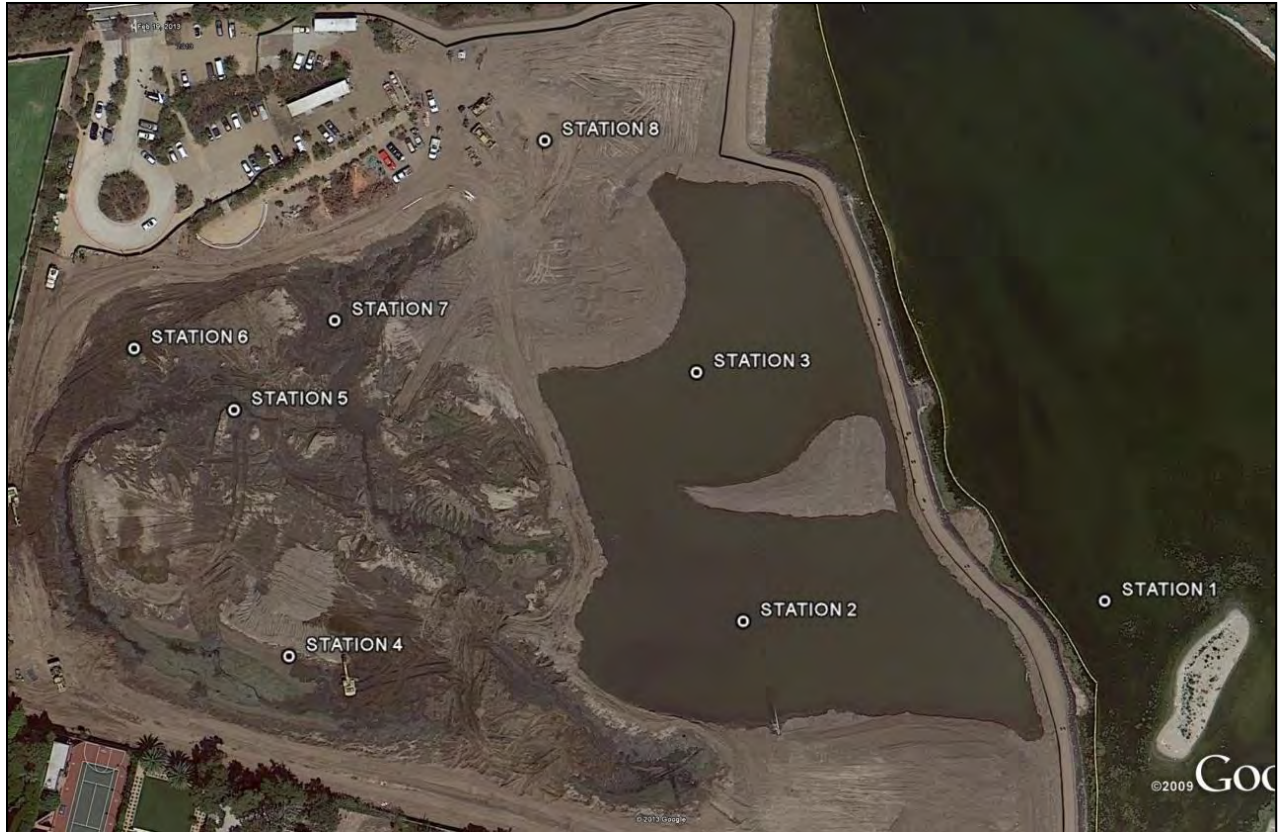
Figure 17. Map of water quality vertical profile stations, SAV/algae sampling stations, and permanent sonde stations (2, 5, and 8).

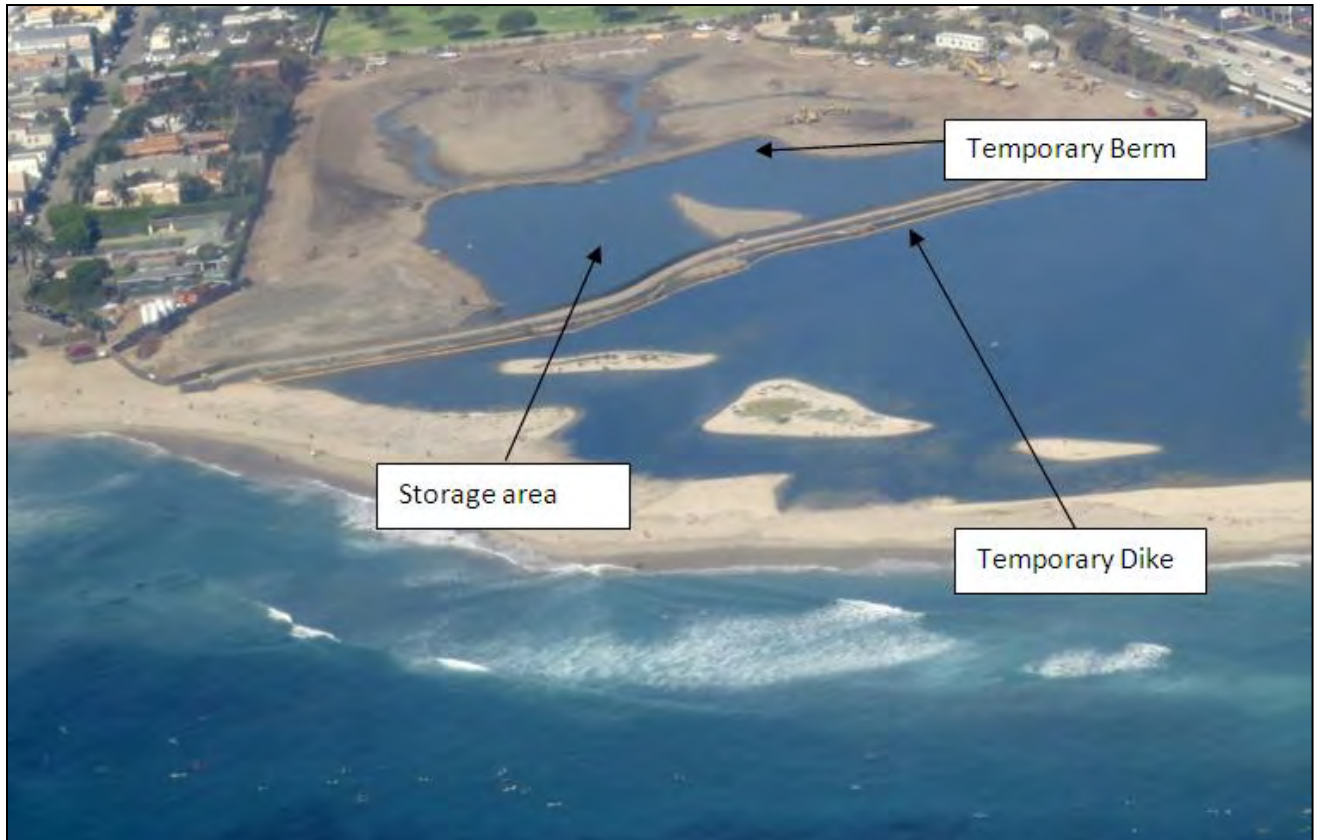
Figure 19. Map indicating the water storage area and temporary dike.

Implementation of the Malibu Lagoon Restoration and Enhancement Project began on 4 June, 2012. In order to facilitate construction and to protect the main river mouth estuary during construction, a temporary dike approximately 10 feet tall and 50 feet wide was built to isolate the construction area from the main lagoon (Figure 19). In order to construct the project it was decided that water from the western channels would be removed to enable reconfiguring and grading the new channels in a dry condition. To accomplish the dewatering activities a large electric pump capable of pumping 600 gallons per minute (GPM) was installed in the western channels to direct water into the treatment plant. The contractor also constructed a series of temporary berms to isolate different sections of the construction area and to create areas for water storage that could be used to slowly feed the treatment plant. A series of large gas powered pumps capable of delivering up to 1100 GPM were used to pump water from the wetted area of the western channels within the construction zone into storage areas. The 600 GPM electric pump then slowly transported water to the treatment plant for filtration and disinfection. This technique of temporary storage and slowly feeding the treatment plant enabled Ford E.C. (the general contractor) to treat and discharge far less water (Figure 19). Pure Effect was the sub contractor used to operate and test the treatment plant. Water quality objectives were outlined in the project NPDES permit (Appendix A and Table 4).

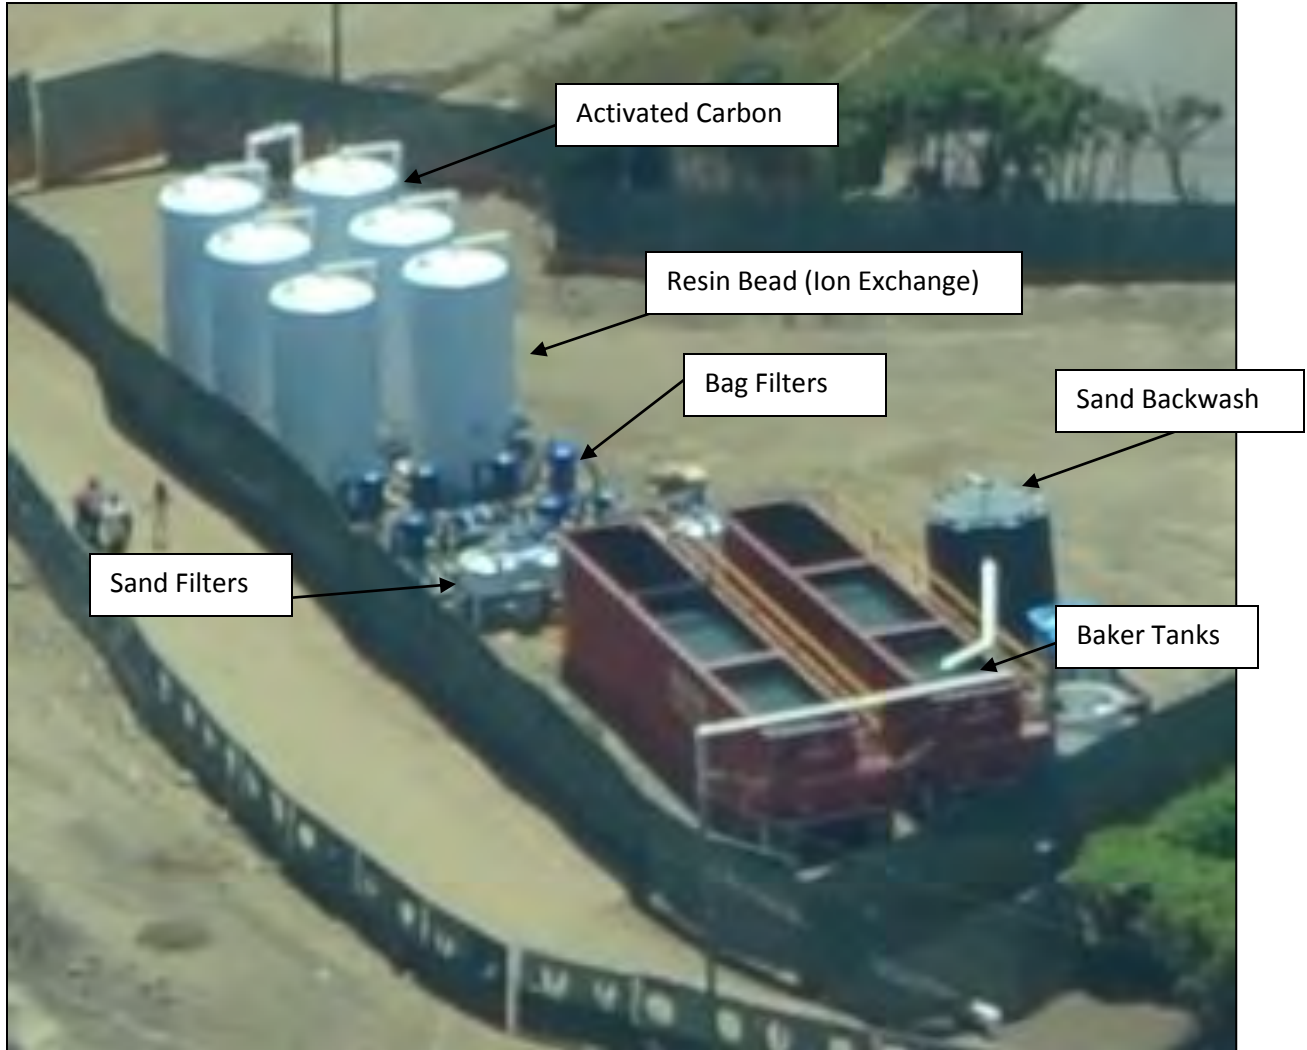
Figure 20. Aerial photo depicting water treatment plant.

The treatment plant was constructed in July to filter and disinfect water from the construction area in the western lagoon before discharging treated water into the ocean (Figure 20). The treatment system was comprised of the following components:

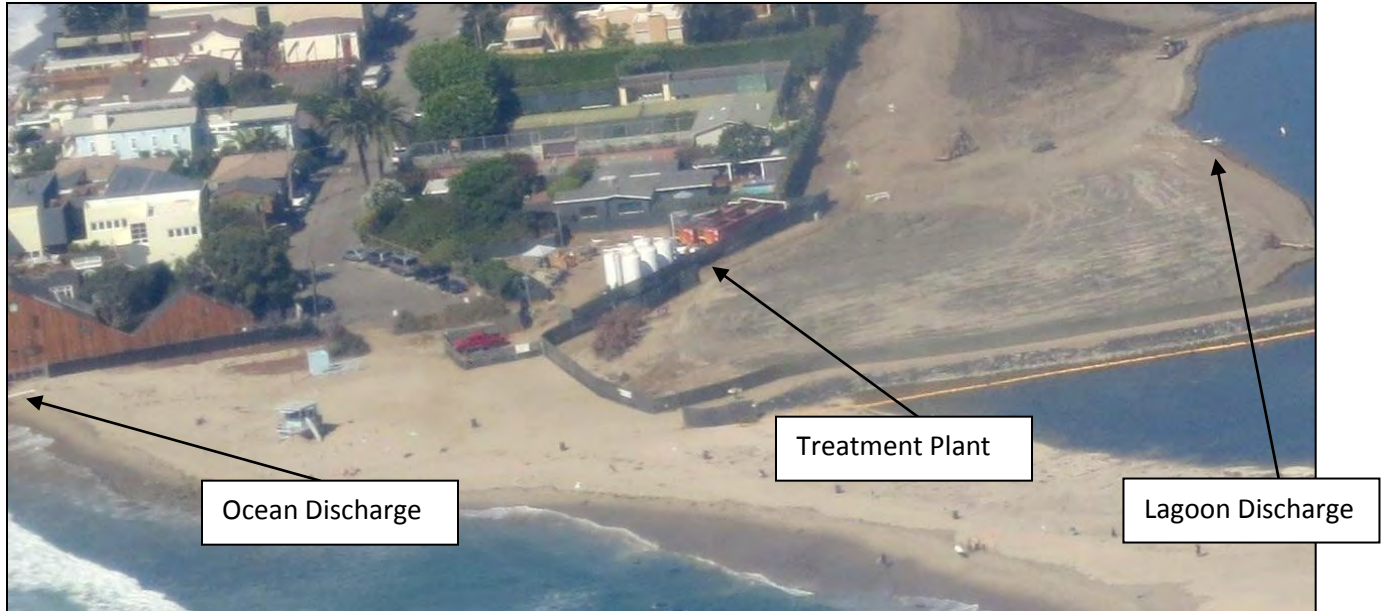
Figure 21. Location of treatment plant and discharge ports.

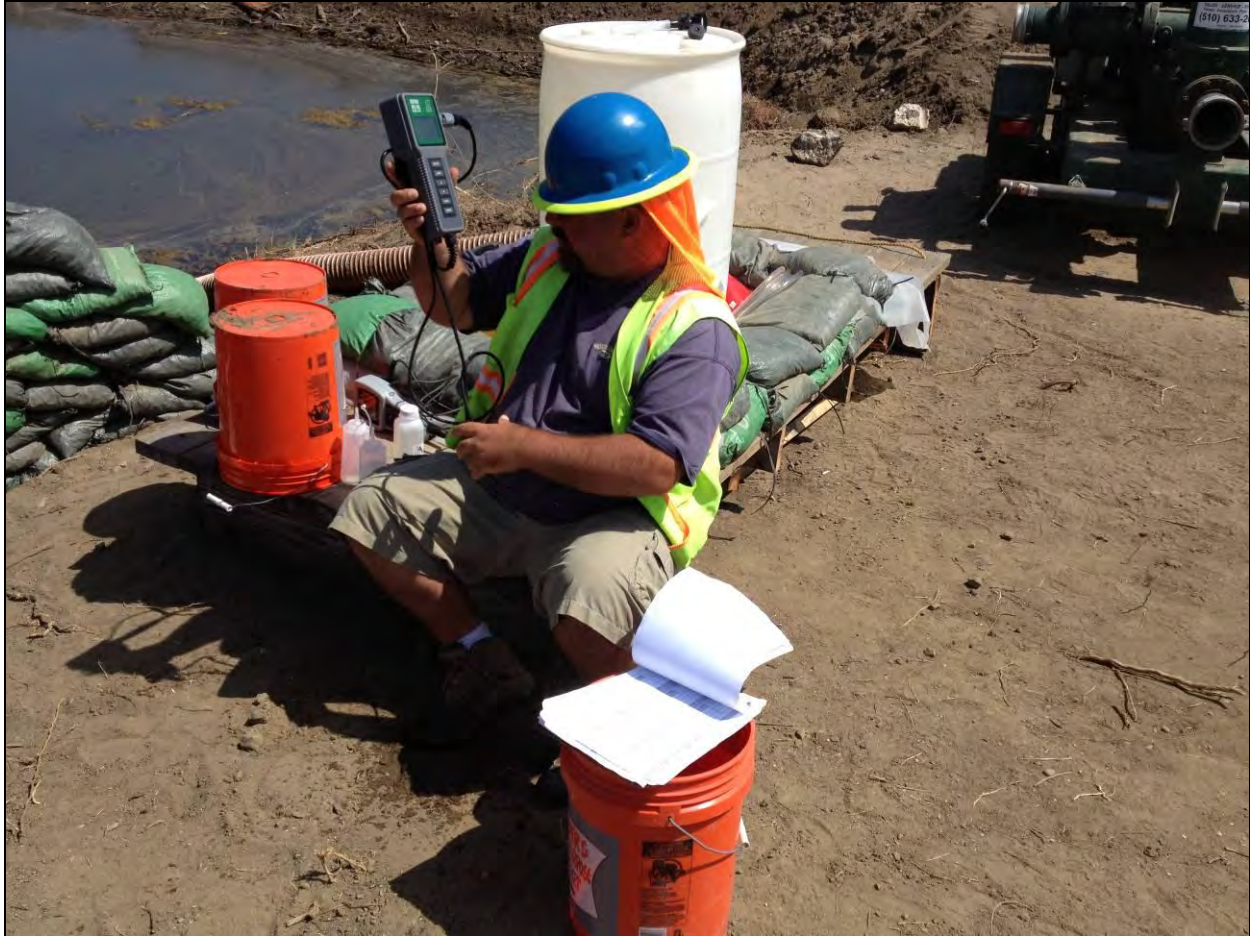
Figure 22. Water quality monitoring of the influent adjacent to the inflow pipe.

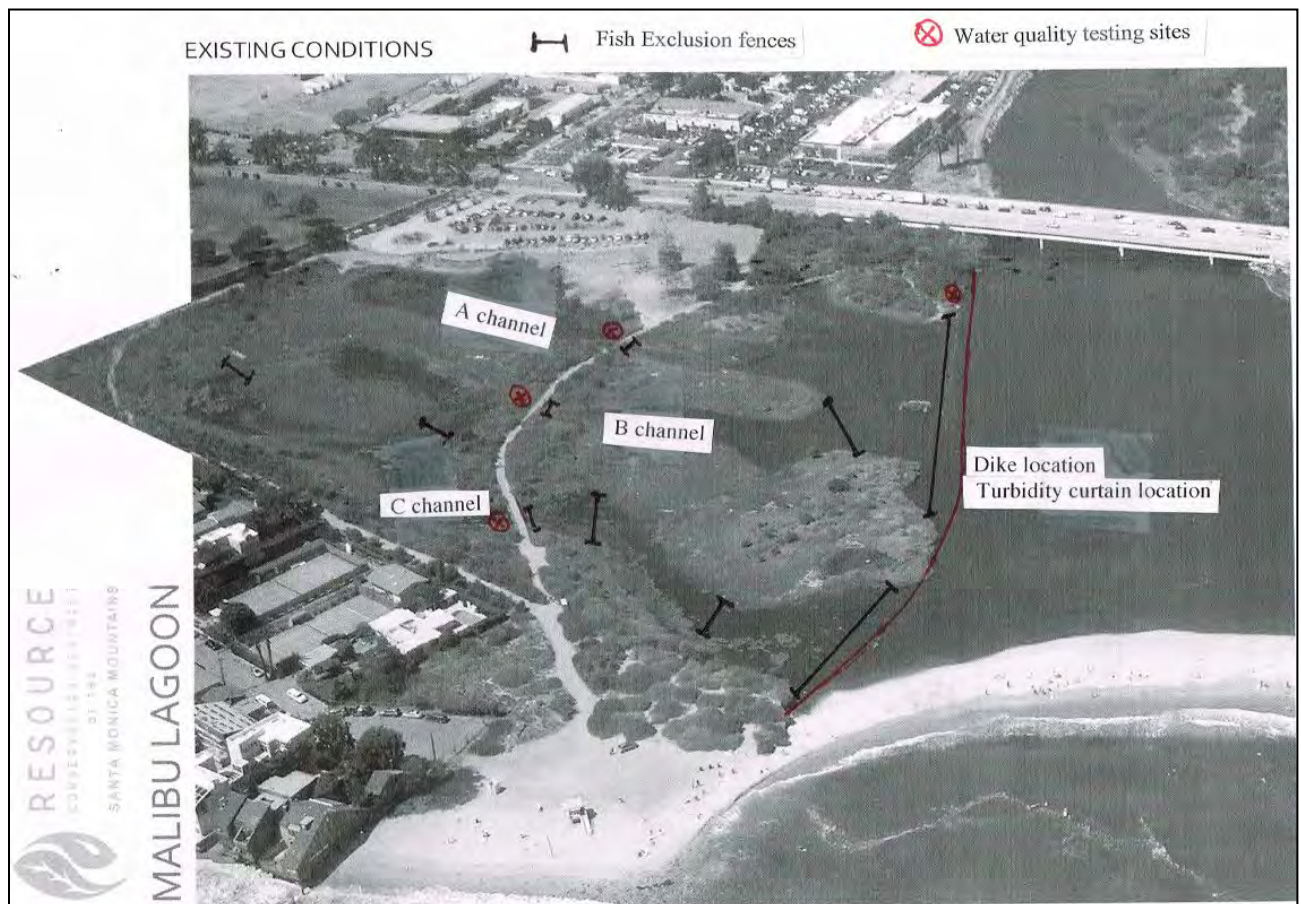
Figure 23. Map of Malibu Lagoon showing locations of fish exclusion fences, water sampling locations and approximate dike location.

The conditions of the work area were influenced by the tidal cycle from 11-15 June 2012 while the dike was completed and the turbidity curtain deployed. High tides during the evenings allowed movement of a few small fishes into the work area when water levels overtopped the fish exclusion fencing prior to the completion of the dike. Figure 23 and 24 show the locations and a photo, respectively, of fish exclusion fences.

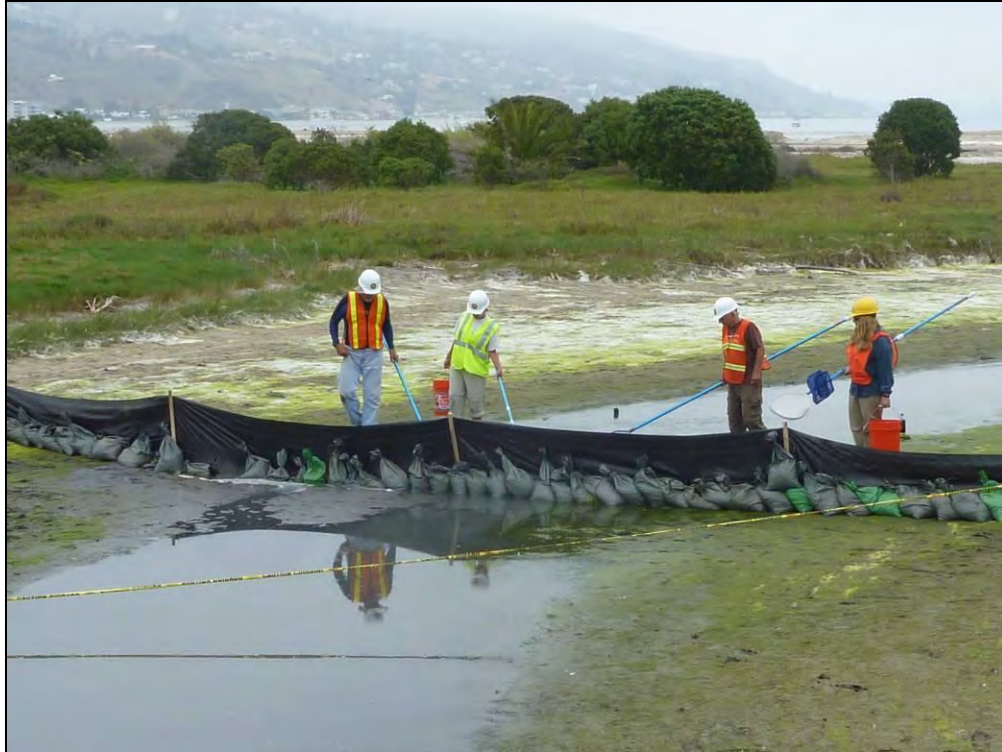
Figure 24. Photo of fish exclusion fence and sandbags.

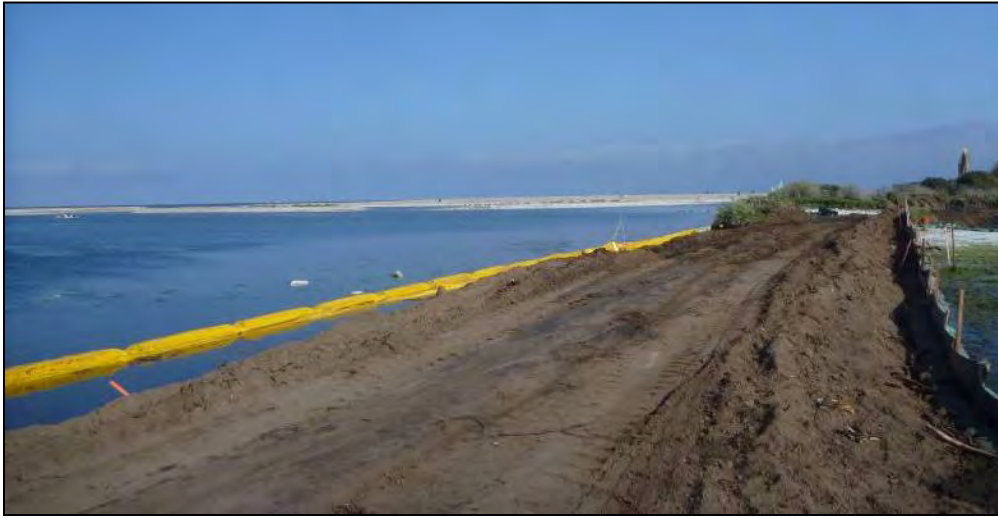
Figure 25. Initial deployment of the turbidity curtain on 14 June 2012.

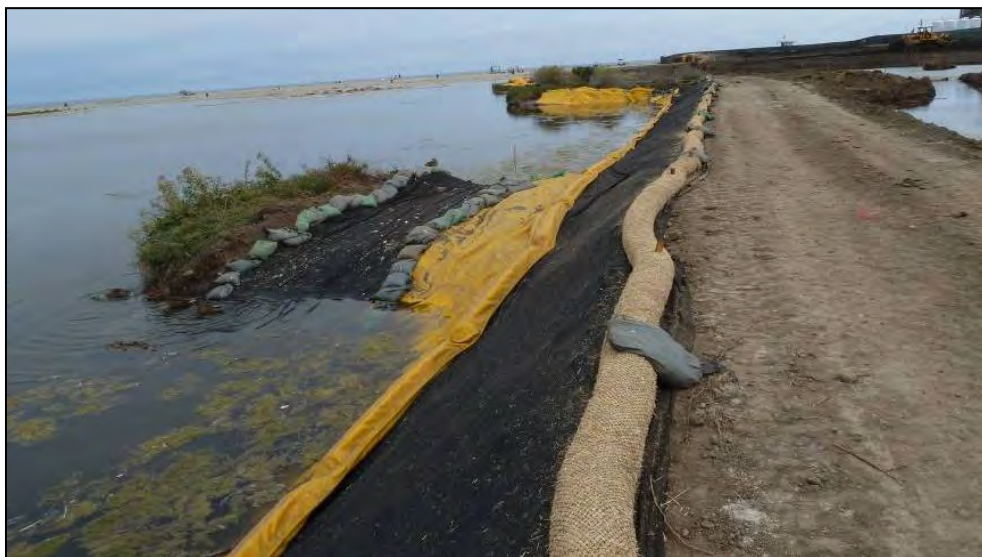
Figure 26. Photo of turbidity curtain while the main Lagoon was tidally influenced (open berm condition).

After careful seining and dip netting all the folds to confirm no additional fish were trapped, the curtain was then pulled up and laid directly along the face of the dike and secured along the bottom and top with gravel bags to prevent water from seeping between the dike and the curtain, and preventing the curtain from slipping down the bank (Figure 26). The turbidity curtain remained in this configuration until 26 June 2012, when the sand bar became sufficiently re-established to prevent connectivity. Over the following days, the lagoon water level rose and stabilized. The upper edge of the turbidity curtain was released on 16 July 2012 so that it could float. The bottom of the turbidity curtain remained secured with sandbags to the base of the dike.

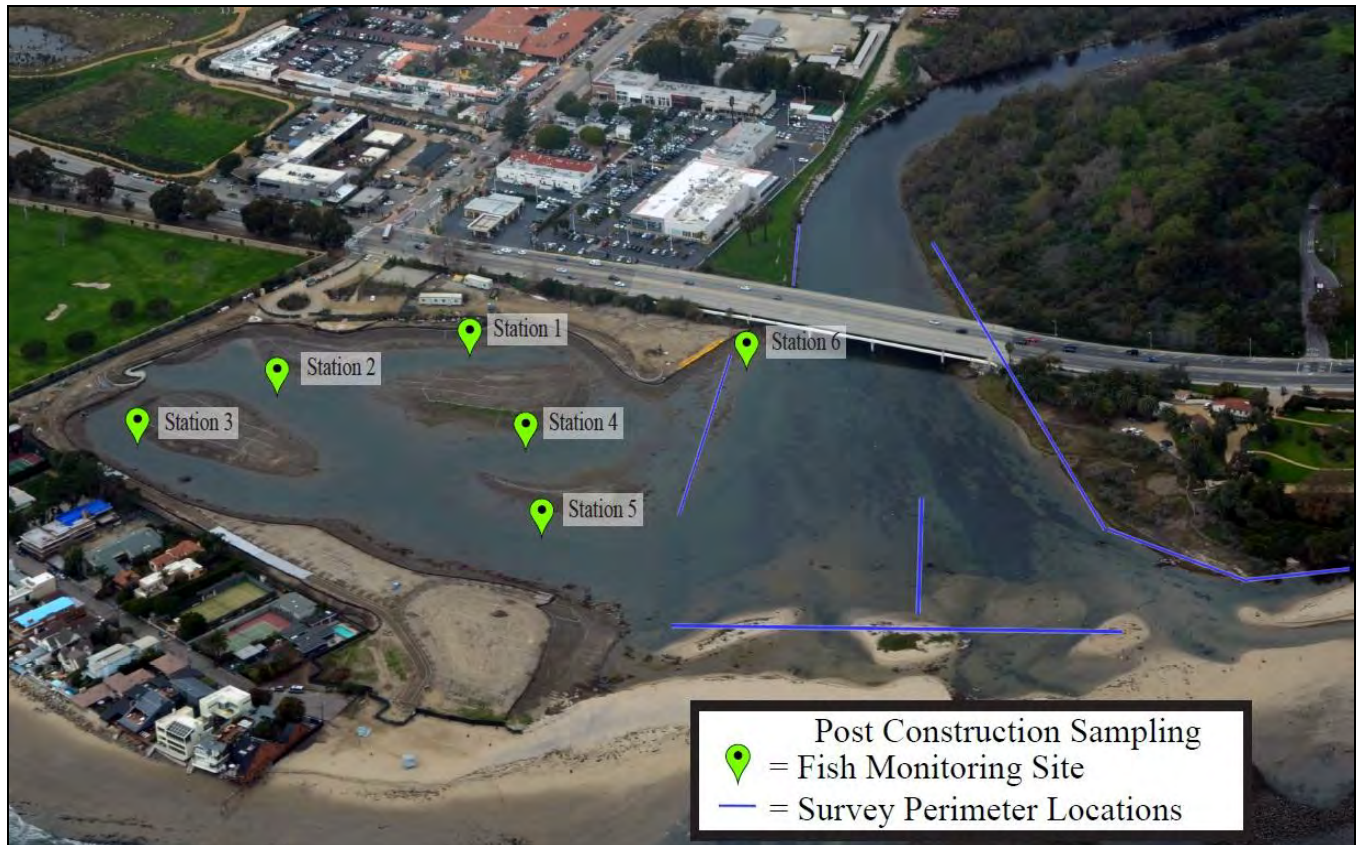
Figure 28. Map of the six permanent fish monitoring stations.

At each station, one transect tape was deployed along the shoreline extending 10 meters. Two 10 x 2 m blocking nets were deployed perpendicular to the shore. Blocking nets (3 x 2 m) were then pulled together to form a triangle, subsequently trapping any fish on the interior of the triangle. Two teams with 3 x 1 m seines walked carefully to the apex of the triangle and pulled from the apex towards the shore. Seines were beached at the edge of the water and all contents examined. All fish were transferred immediately into buckets of clean, cold water standing by each net. Algae presence was noted. Fish were identified to species, Fork Length was measured, and they were released outside of the blocked area. Seine pulls continued until three consecutive pulls were empty. The presence of one oriental shrimp in the pull was considered empty.

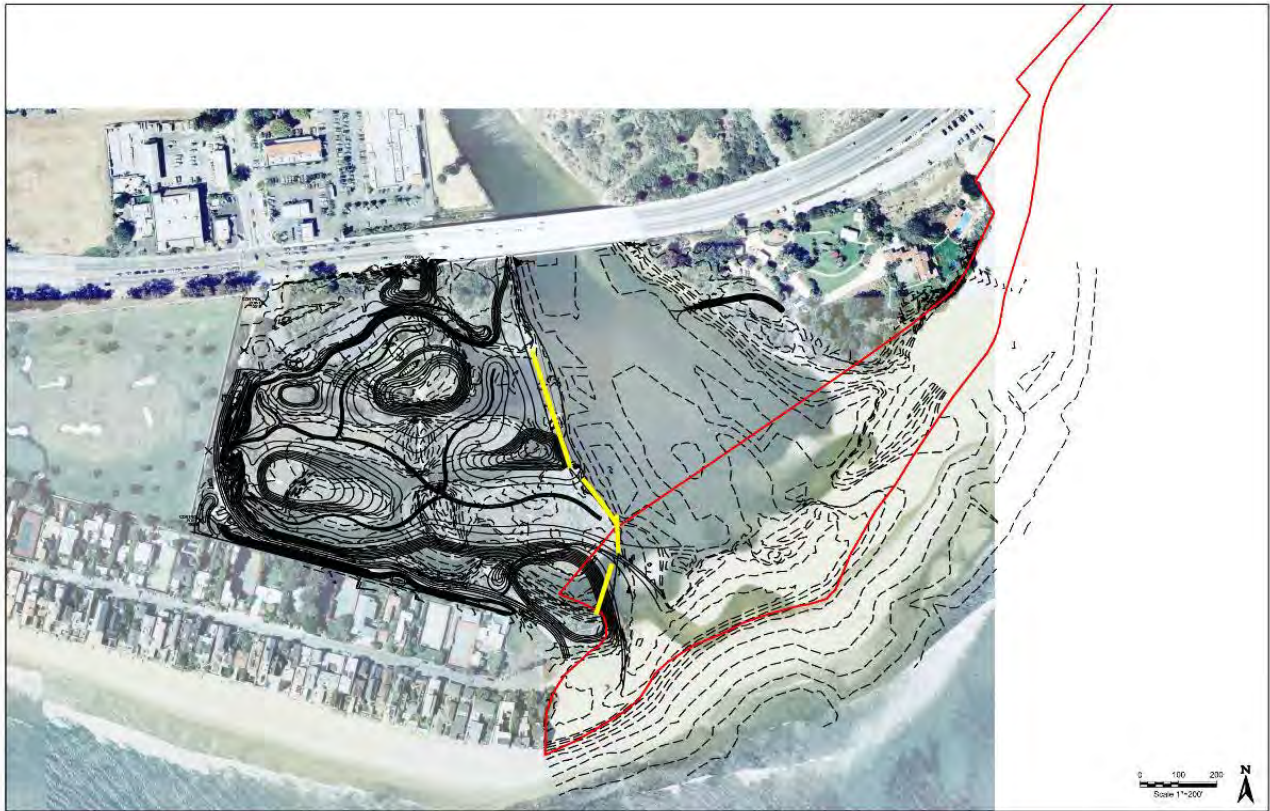
Figure 31. Revised critical habitat for western snowy plover as provided by USFWS on 19 July 2012 (red outline).

In addition, USFWS Critical habitat for the western snowy plover was established and published in the Federal Register on 19 June, 2012, subsequent to the start of the project (Figure 31). The mapping of critical habitat included portions of the Southeast corner of the project area, and Surfrider Beach. The boundary of the newly established critical habitat was demarcated by the biological monitors, the area was cordoned off and work was halted in this area until consultation with and approval by the USFWS and the Army Corps of Engineers occurred. Approval to proceed was received on 19 July 2012.
