Malibu Lagoon Restoration and Enhancement Project

Comprehensive Monitoring Report

19 March 2013

Prepared by: Santa Monica Bay Restoration Foundation

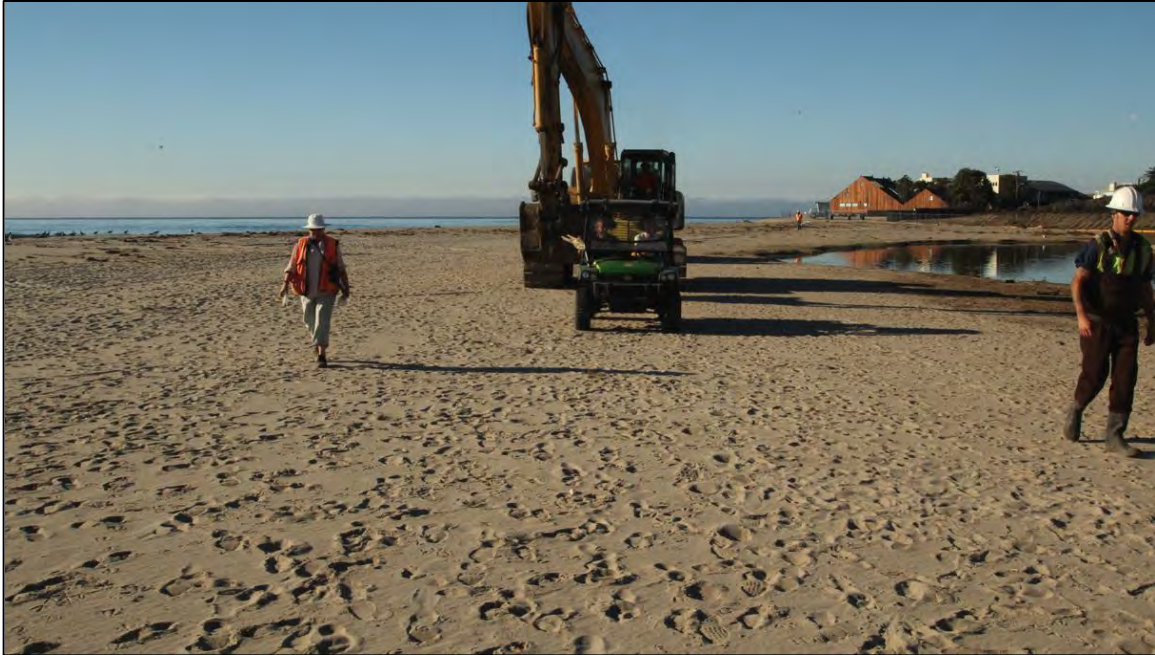
Figure 32. Monitoring for western snowy plover and other special-status species in advance of equipment moving through designated critical habitat areas (photograph by Noa Rishe 2012).

Special Status Birds

The sandy areas of the project site (beach and southeastern corner) can be used by the listed western snowy plover and California least tern, in addition to other special-status species. Therefore monitoring by a permitted project biologist was required prior to and during any equipment activity in or near these areas (Figure 32).

Activities monitored included installation, maintenance, and removal of the dewatering plant outfall pipe; excavator access across Surfrider beach to install submerged trees for fish habitat in the eastern lagoon by the Adamson House boathouse; and invasive weed removal near the Malibu Colony neighborhood. DPR Environmental Scientist Jamie King monitored all activities. Equipment was stopped to allow any western snowy plover that were hunkered down in low-lying spots in the beach to move through the area undisturbed.

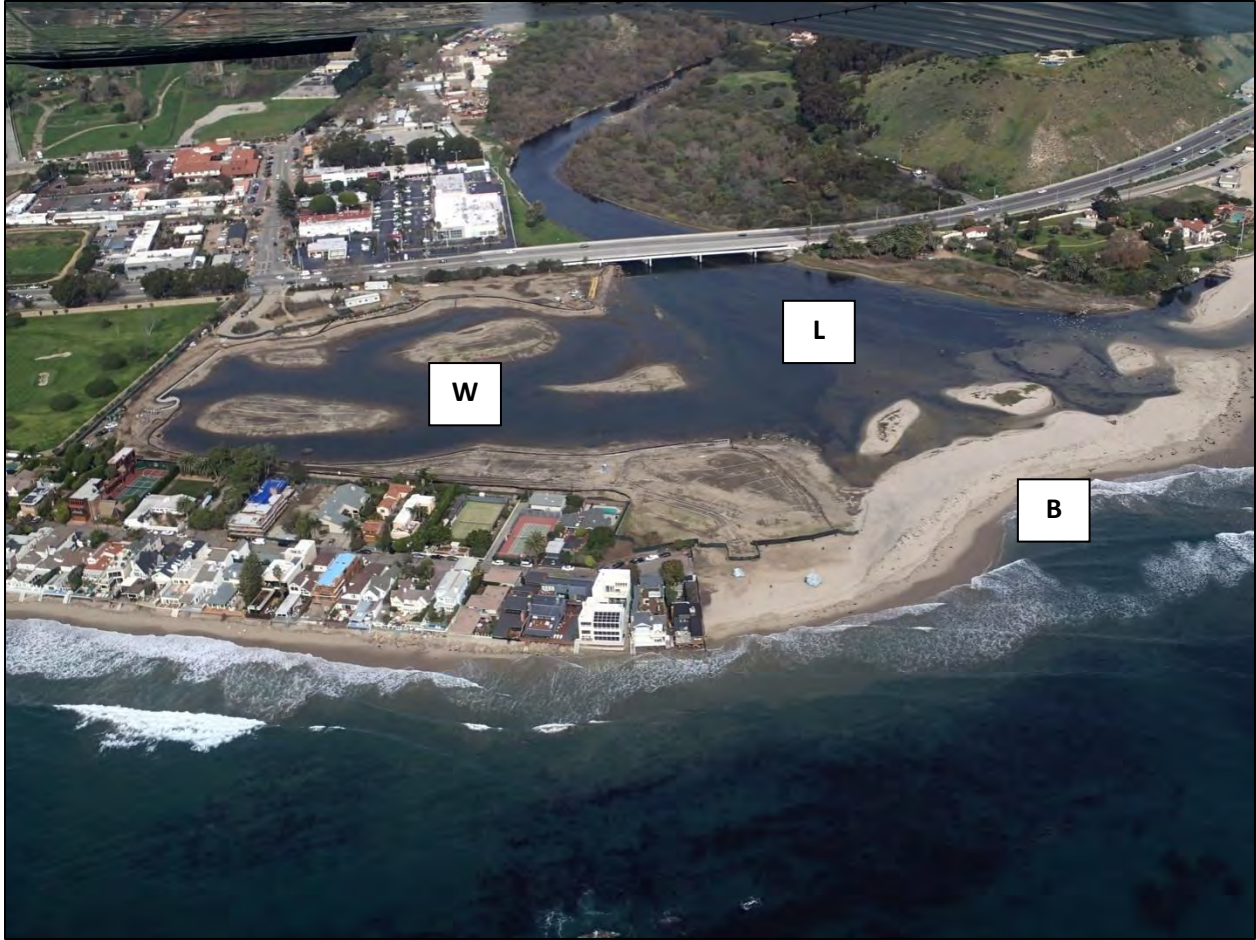
Figure 34. Oblique aerial photograph of Malibu Lagoon (post-restoration), taken 29 January 2013 (courtesy Lighthawk and SMBRF).

During the 2013 visits, surveys were conducted by slowly walking the perimeter of the lagoon to the beach (just inside the perimeter construction fence). The surveyor also walked east along the edge of the main Lagoon, scanning north across the site. All species observed using the site were recorded. Those species only observed flying over were excluded, which included dozens of gulls. Birds flying offshore or using the inshore marine waters were also excluded. Individuals were noted as using one of three main areas: “W”, or the western portion of the estuary, including the vicinity of the parking lot; “L”, the main body of the lagoon unaffected by construction; and “B”, the sandy beach away from the main Lagoon (Figure 34).

During the February 2013 survey, a berm along the western edge of the lagoon separated portions of the lagoon during low tides. This area supports a variety of bird species as roosting habitat. Most of the birds using this berm were also using the main Lagoon during the February 2013 quarterly survey, and were therefore recorded as using the “L” section of the site. Waterbirds now move freely between all areas of the (expanded) lagoon (sections W and L), which now have similar vegetation structures due to the ongoing habitat restoration (Figure 34).

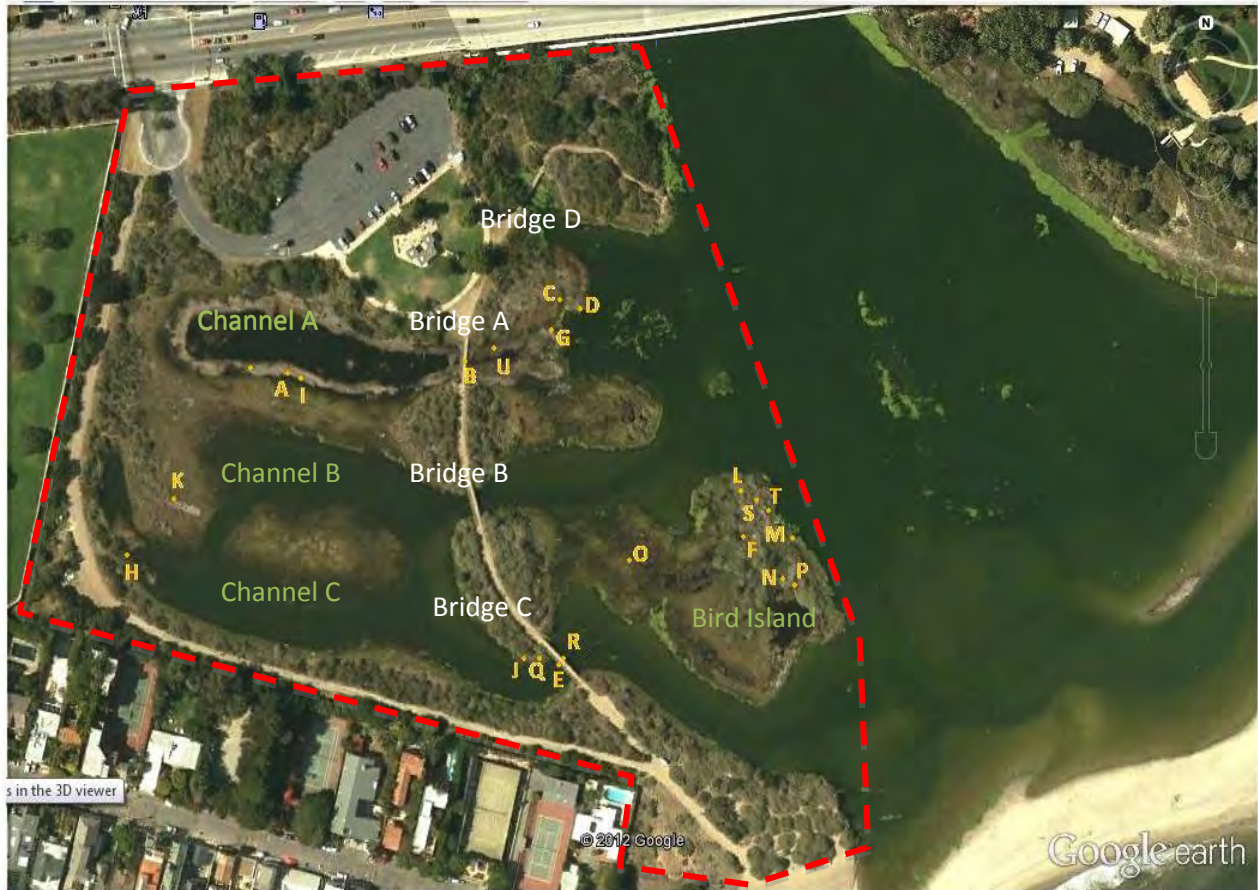
Figure 35. Overview of nest locations. Primary study area shown within the red dashed line.

Twenty-one nests from seven (or eight; see below) species were found and monitored during construction, as summarized in Figure 35 and Table 12, with detail provided in Appendix H. Most, if not all, nests were judged to represent separate pairs (i.e., double clutching was not confirmed during the survey period). As outlined in “Methods” above, each nest was afforded the fullest protection feasible during the construction project, and ultimately, the majority of nests found fledged young successfully (57% of nests and 60% of all eggs). Those that failed were likely lost to flooding, predation, or abandonment due to unrelated (to the construction) causes.

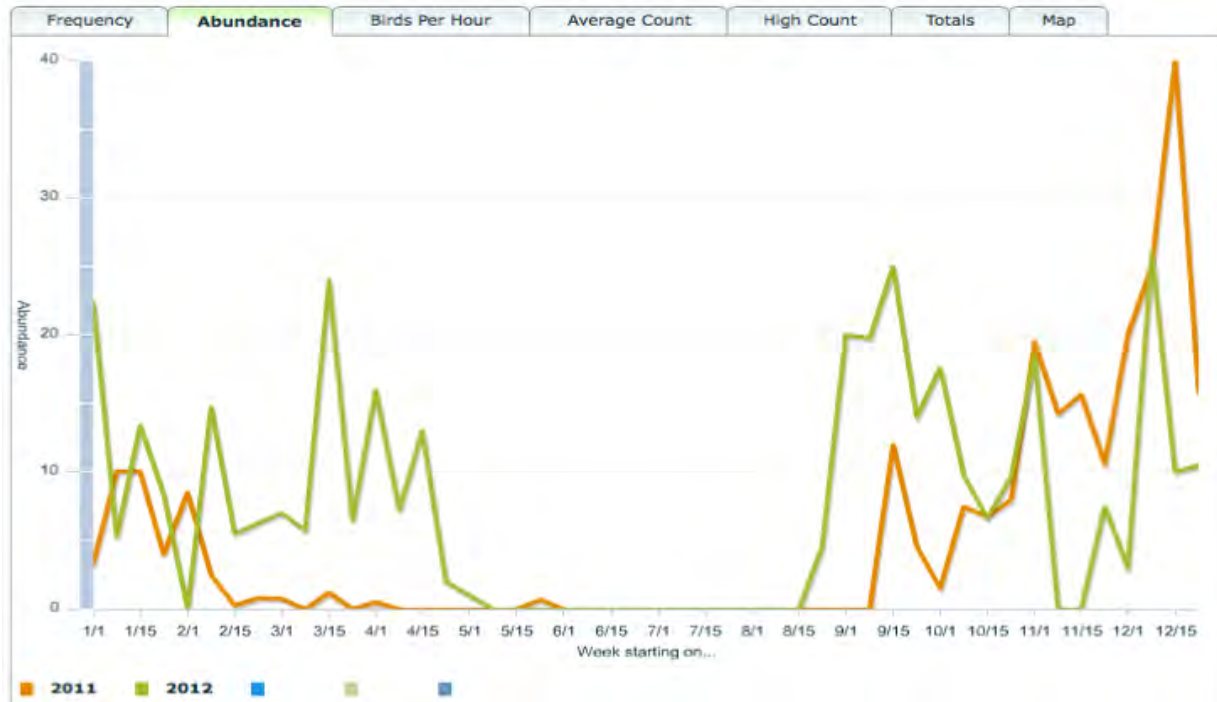
Figure 39. Abundance of Northern Shoveler at Malibu Lagoon, 2011 (orange) and 2012 (green).

To provide more observations through a greater sample size, we queried Ebird for data to augment to field surveys conducted as part of this project. Using ebird, one can readily compare observations made prior to the start of construction in mid-2012 with those made during construction. However, as important caveats, Ebird continues to grow in popularity such that the number of checklists submitted to the database was relatively low prior to around 2010; and the data do not distinguish between the various sections of the site, so birds from the western portion of Malibu Lagoon (i.e., the restoration project site) are lumped in with those observed using the main Lagoon, or even with those on the beach. Evaluating 2011 (prior to restoration) and 2012 (during, and subsequent to restoration), distinct and informative patterns may still be detected. Counts of waterfowl (including ducks and duck-like species such as the American Coot *Fulica americana*) appear to have changed little from 2011 to 2012. See below for graphs of two common species, Gadwall (*Anas strepera*; Figure 38) and Northern Shoveler (*Anas clypeata*; Figure 39).

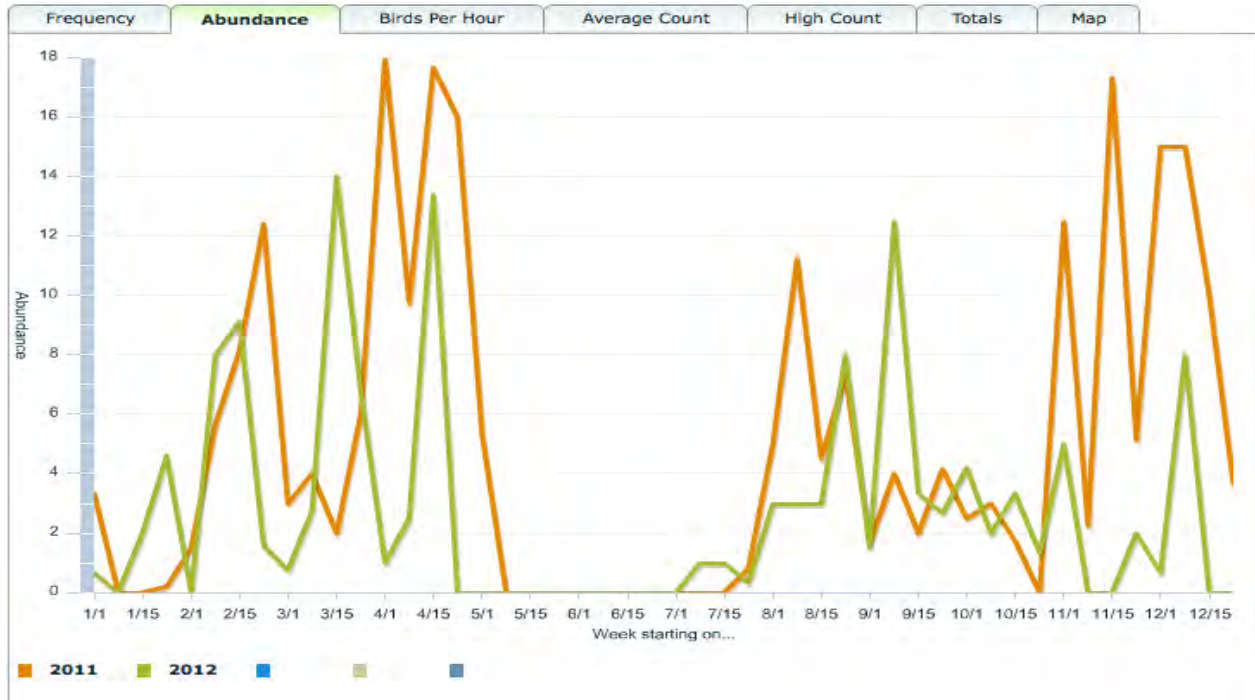
Figure 40. Abundance of Least Sandpiper at Malibu Lagoon, 2011 (orange) and 2012 (green).

Shorebirds also appear to have changed little from 2011 through 2012. Malibu Lagoon has not been consistently productive for shorebirds at least in recent decades, generally supporting just a few dozen individuals during most of the year⁶. Counts of the more common species (Least Sandpiper and Willet) were not dramatically different in late 2012 versus 2011 (Figures 40 and 41). Obviously, more years of data should clarify these trends.

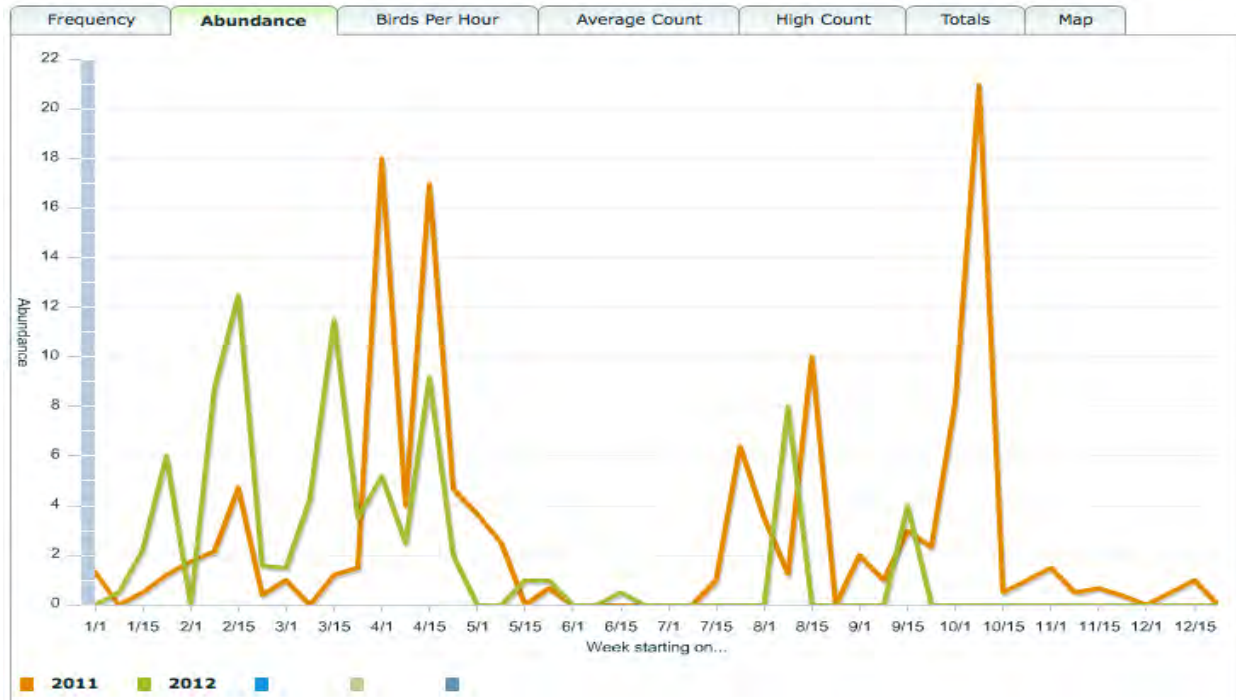
Figure 44. Abundance of Red-winged Blackbird at Malibu Lagoon, 2011 (orange) and 2012 (green).

A key goal of the restoration project was to increase the diversity and variety of native vegetation to benefit multiple wildlife species. As a result, there was a net reduction in the coverage of bulrush beds within the site; hence, the numbers of birds that prefer bulrushes or similar vegetation (such as Red-winged Blackbird, *Agelaius phoeniceus*) would be expected to be less abundant onsite. Indeed, Red-winged Blackbird (Figure 44) and similar freshwater marsh species were rarely encountered during the second half of 2012. As with scrubland species, it is anticipated that these species will utilize appropriate habitats directly adjacent to the site until onsite vegetation matures and increases in size and coverage, which will be monitored through ongoing quarterly surveys.

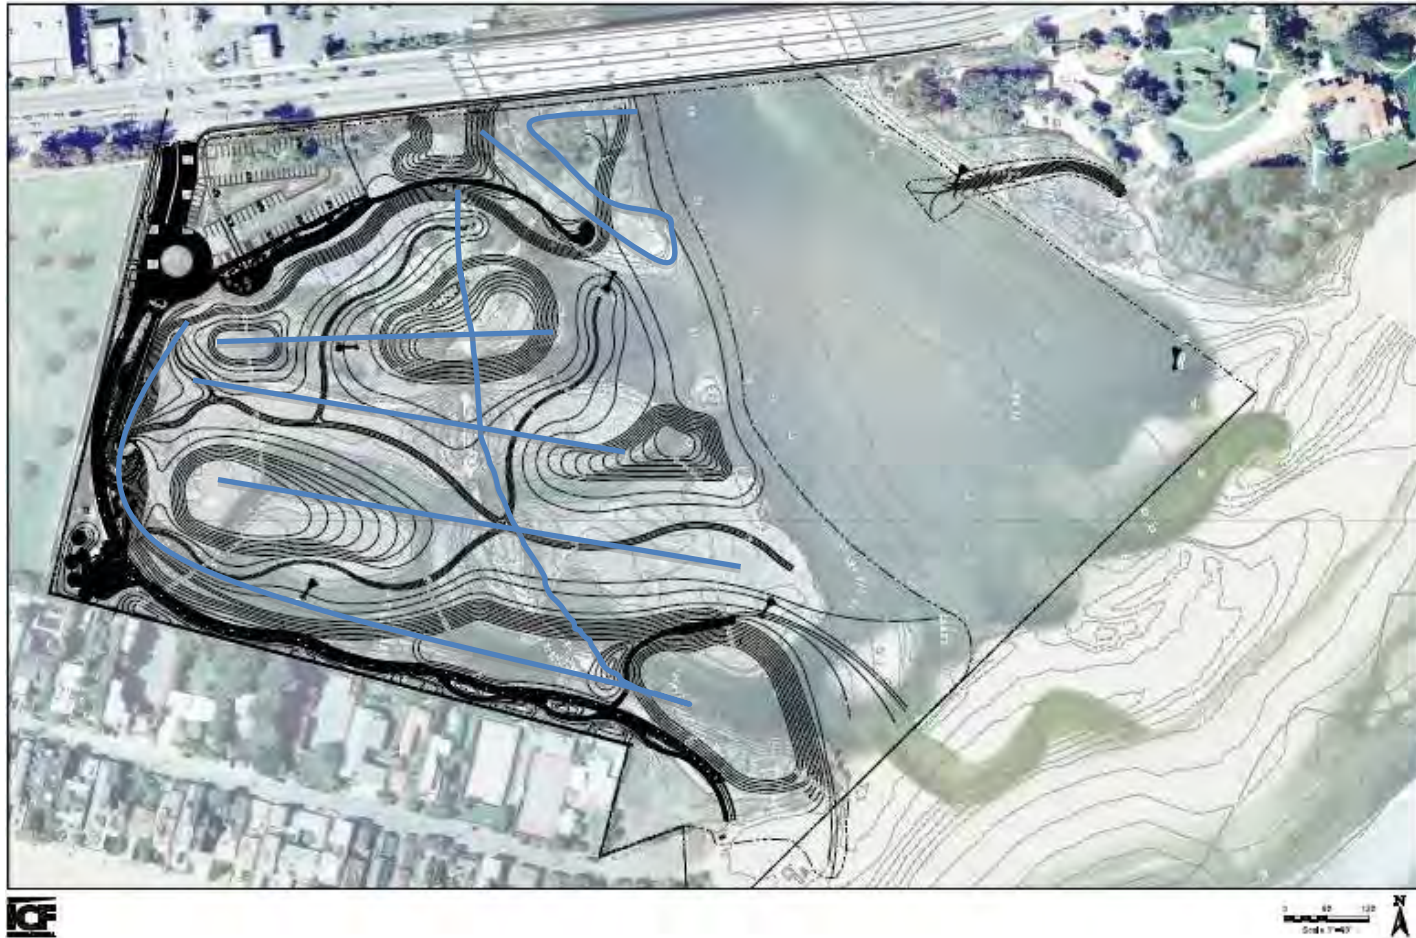
Figure 45. Map including the location of transect lines.

Live traps are commonly used for mammal sampling (Sealander and James 1958, Nichols and Pollock 1983, Slade et al. 1993, Whittaker et al. 1998, Cypher 2001). Two hundred Sherman live traps (24 x 9 x 8 cm) and 16 small carnivore traps were deployed on the evenings of 7-9 June 2012 within two hours of sunset. Due to vandalism and trap theft, a total of 556 trap nights occurred over this time period. Traps were deployed in transects across all habitats throughout the site that were not submerged or in danger of tidal inundation during the trapping period. These included remnant dune, woodland, scrub, high marsh, and ruderal habitats. Figure 45 displays the transect alignments.

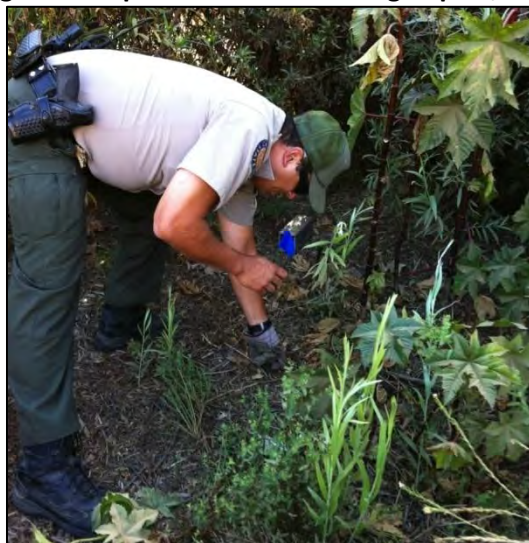
DPR ranger Carlos Matamoros setting and flagging Sherman live traps.

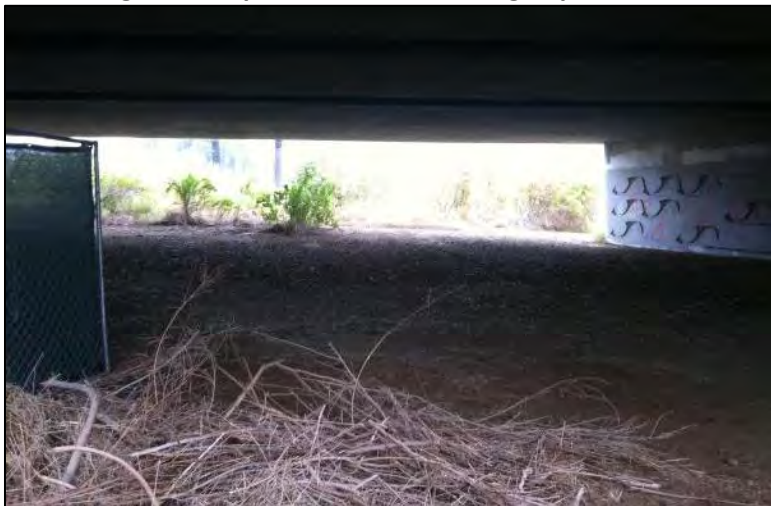
Gates were installed at the NE corner of the project site 6/12/11 to allow wildlife to relocate out and upstream of the construction area (6/13/12).

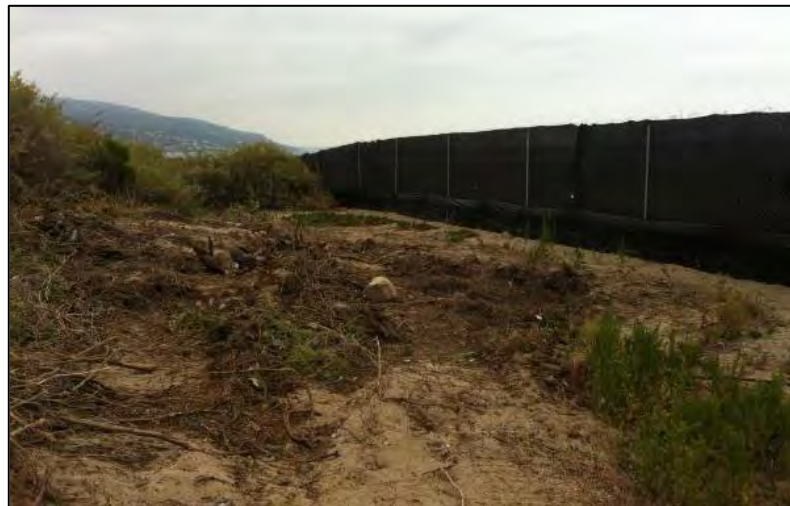
Project area delineated with construction fencing to ensure public safety and delineate work area. Silt fence facilitates animal movement towards adjacent upstream areas and not towards adjacent development (6/14/12).

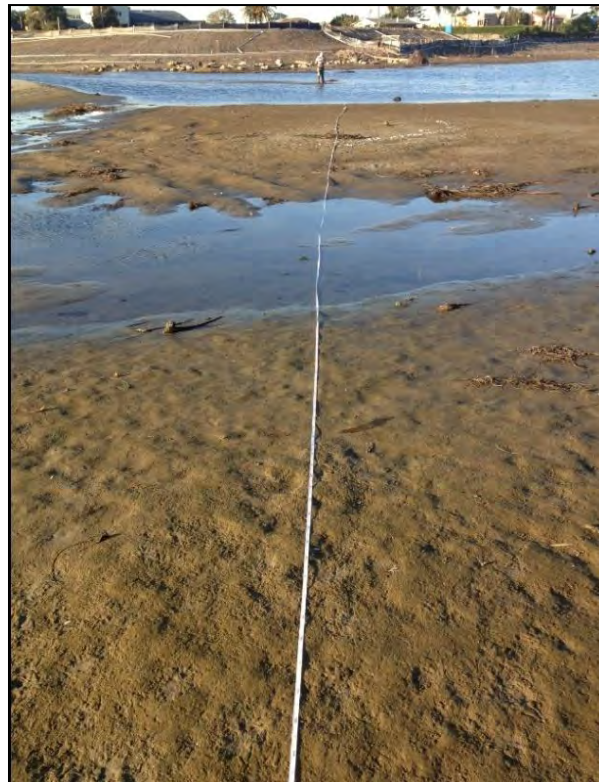
Figure 47. Transect deployed in the main Lagoon for SAV/algae monitoring, February 2013.

Monitoring will be conducted during the fall for a period of five years after construction, at a minimum. For the initial baseline post-restoration surveys, floating, mat, and attached submerged aquatic vegetation (SAV) and macroalgae were monitored at eight stations (Figure 47) on 14 February 2013 during a low tide. Three transects were surveyed using a line-intercept method at each station. Transects were averaged by station using the length of each transect to determine total percent cover (\pm standard error).

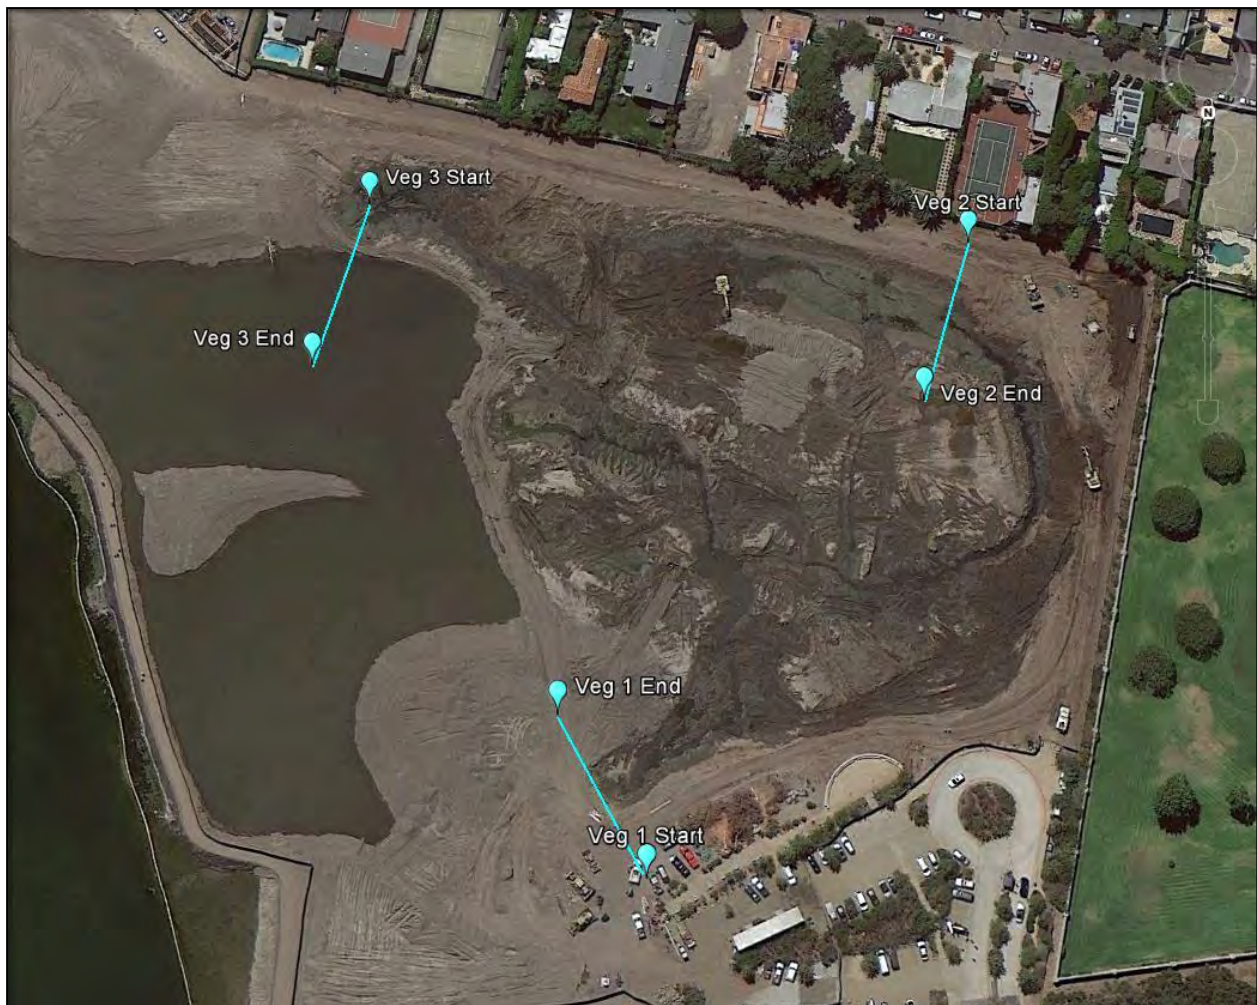
Figure 48. Map of vegetation transect locations and start/end points.

Data for absolute percent cover of native/nonnative species was collected along three randomly placed 50-meter transects (Figure 48 and 49) using the line-intercept method on 15 March 2013. These baseline data were the first set of post-restoration vegetation surveys.

Each transect location was recorded with a submeter global positioning system (GPS) unit and photographed at each end. Species data were collected to an accuracy of 0.01 m along each 50-meter transect. Absolute percent cover was calculated based upon the total distance for each species within all transects combined for a site-wide (transect-based) total (e.g. 15 m of native vegetation cover out of 150 total meters from all transects would be a 10% native vegetation cover). Data are displayed as a bar graph.

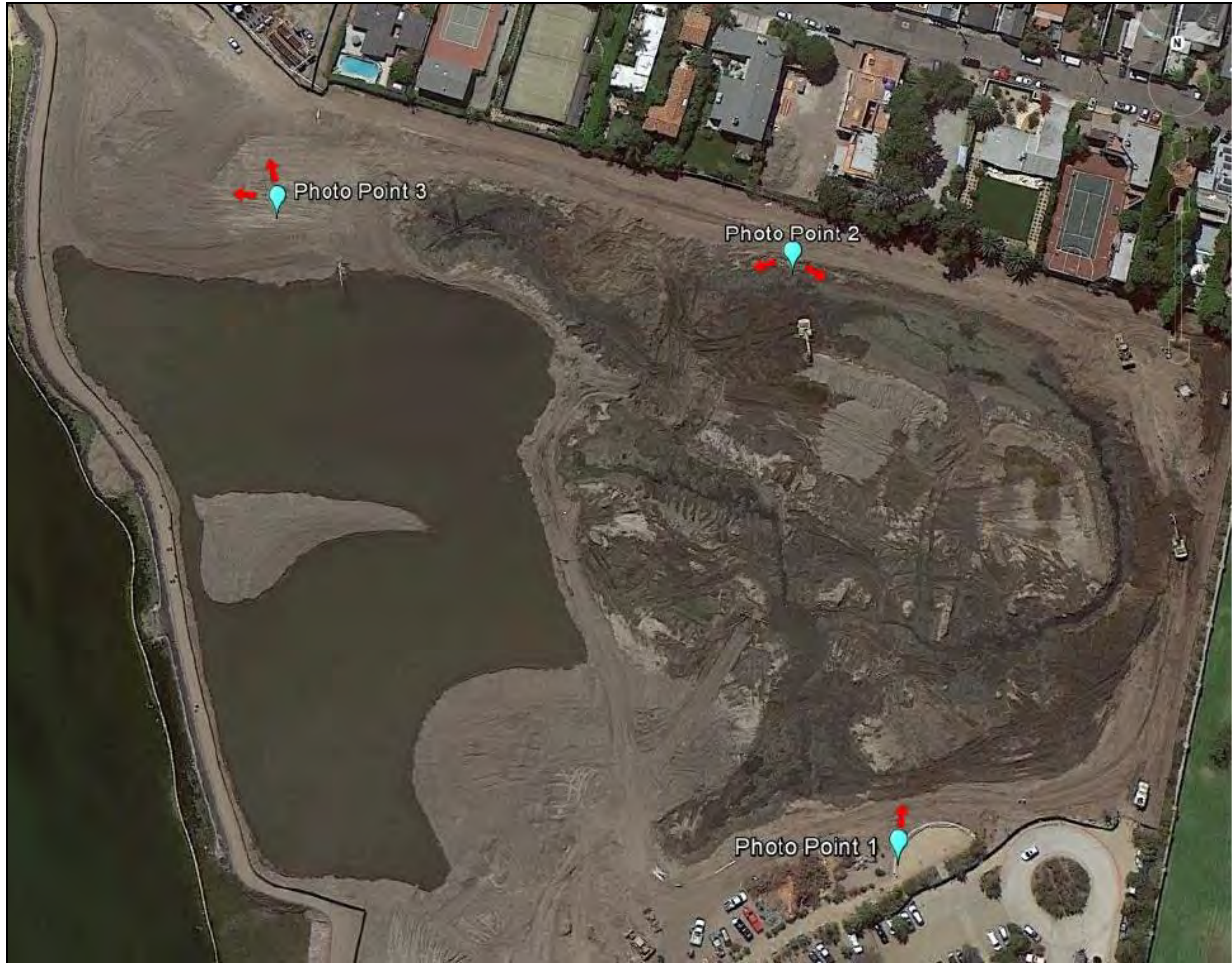
Figure 51. Map of photo point locations and bearing.

| Station | GPS Coordinate (decimal degrees) | Approximate Bearing | Time | Number of Photos |
|---|---|---|---|---|
| Photo Point 2 | 34.03233°, -118.68439° | 300°, 75° | 09:22 AM | 2 |
| Photo Point 3 | 34.03223°, -118.68285° | 220°, 100° | 09:38 AM | 2 |

The primary purpose of this sampling method is to capture broad changes in the landscape and vegetation communities over seasons or years. This method collects georeferenced photos for use in site management (e.g. invasive species tracking) and long-term data collection. Three permanent, photo-monitoring locations (Table 16 and Figure 51) were established to visually document the establishment of vegetation following restoration. Photos were taken at low tide and the stations were located using GPS. The baseline photo point survey was conducted immediately post-restoration on 15 March 2013 at approximately 9am during a low tide. The approximate bearing is relative to the center of the photo. Bearing ranges are included on the datasheets. Photos were taken using a Cannon EOS Rebel T3I on a tripod at a height of 1.5 m.
