PUMPOUT REPORT 2017

California Clean Vessel Act Pumpout Performance Report

San Francisco Estuary Partnership The Bay Foundation

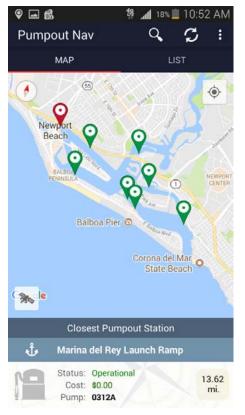
\rightarrow PUMPOUT NAV APP

Pumpout Nav, a free iOS and Android app, is designed for boater use while on-the- go and aboard the vessel. It helps boaters geolocate sewage pumpout stations closest to their present location. The Pumpout Nav app automatically finds the boater's location, and suggests the closest pumpout stations on a map or as a list. The app displays each facility's operational status, cost, hours, and detailed location within the marina for each unit. It also provides instructions on how to use a pumpout station and information about the environmental risks and applicable regulations regarding sewage discharge.

Pumpout Nav is equipped with a crowdsourcing function that allows any user to flag non-functional pumpouts throughout California. If boaters find a non-operational pumpout, they can report the issue directly through the app, and even submit photos. On the marina side, once a boater reports a problem, the marina manager and the local Clean Vessel Act Program are notified via email. The email alert will let marinas know their pumpout could be down and should be inspected. The local Clean Vessel Act Program staff can now follow up with marinas in real time, offer assistance if applicable, and encourage marina managers to apply for Clean Vessel Act funding to address the issue if needed.

Pumpout Nav also has a monitoring feature that allows San Francisco Estuary Partnership and The Bay Foundation to record monitoring data while in the field. Once the data is entered and submitted through the app an automatic email is sent to the facility manager summarizing the results of that monitoring effort.

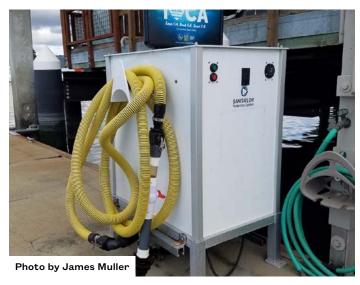
Grand Marina's pumpout is well kept and works like a charm! This marina has a unique feature on their pumpout -- a key fob reader. To turn on this system, boaters must first scan their fob just as you might at a dock gate. This allows the marina to track who is using the pumpout and how many times the unit has being used. This system does require visitors to stop by the office to get a fob to activate the pump, which allows the marina to showcase their other services.

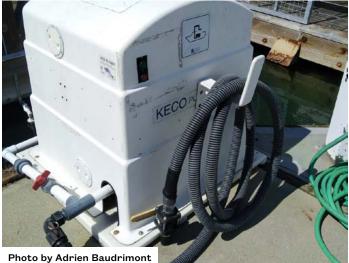
Schoonmaker Point Marina. The Pumpout is about 10 feet away from the terrasse of "Le Garage", a busy restaurant. Michael Rainey, Harbormaster, set up a timer on the Pumpout so it won't run during lunchtime out of respect for the restaurant's clients. A nice example of "vivre ensemble"!

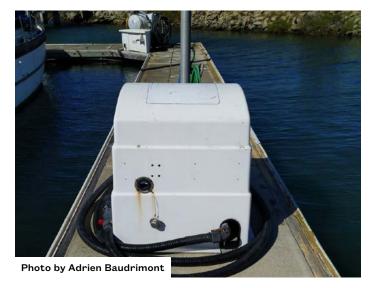
Oyster Cove Marina. Tim Christopher, Harbormaster at Oyster Cove Marina has a monitoring routine that includes a monthly dye tablet test. This pollution prevention tool helps spot leakages in underwater pipes. These types of such tests on a regular basis.
