# Beach Bluffs Restoration Project

## Master Plan

**April 2005**

Beach Bluffs Restoration Project Steering Committee  
Ann Dalkey and Travis Longcore, Co-Chairs

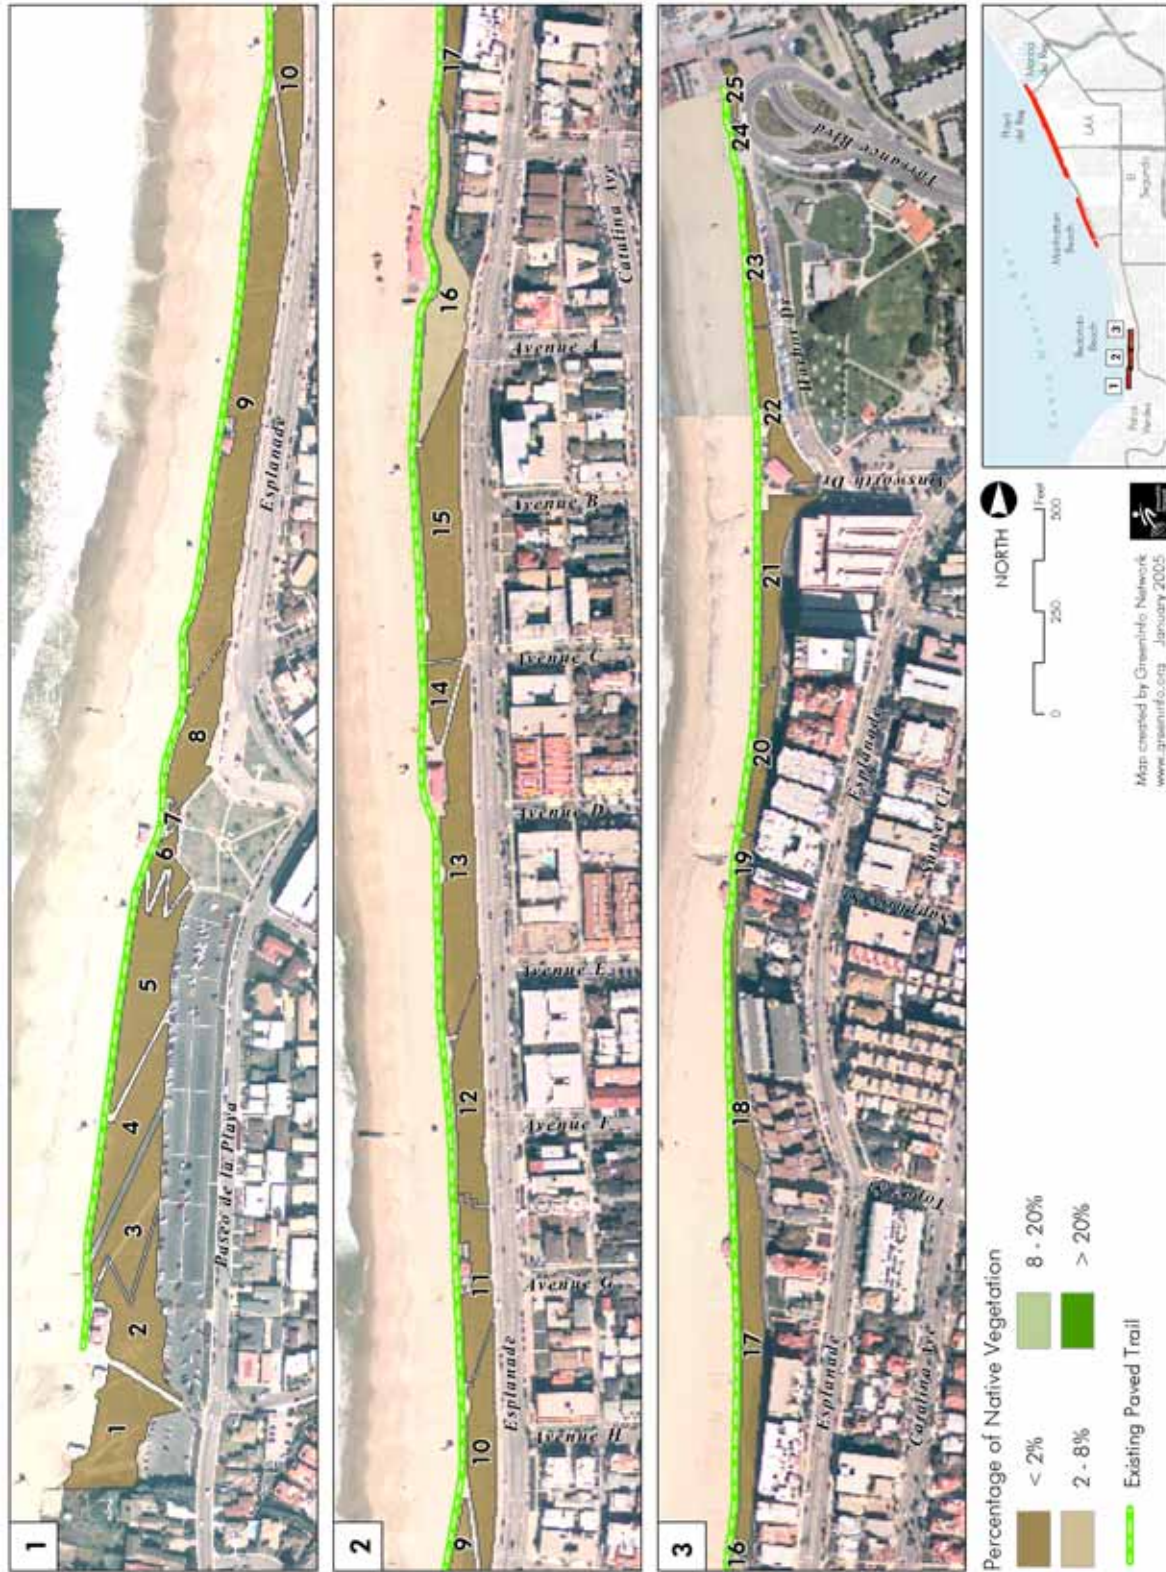
**Figure 6. Undeveloped bluffs along Santa Monica Bay showing percent native vegetation (Southern Focus Area).**

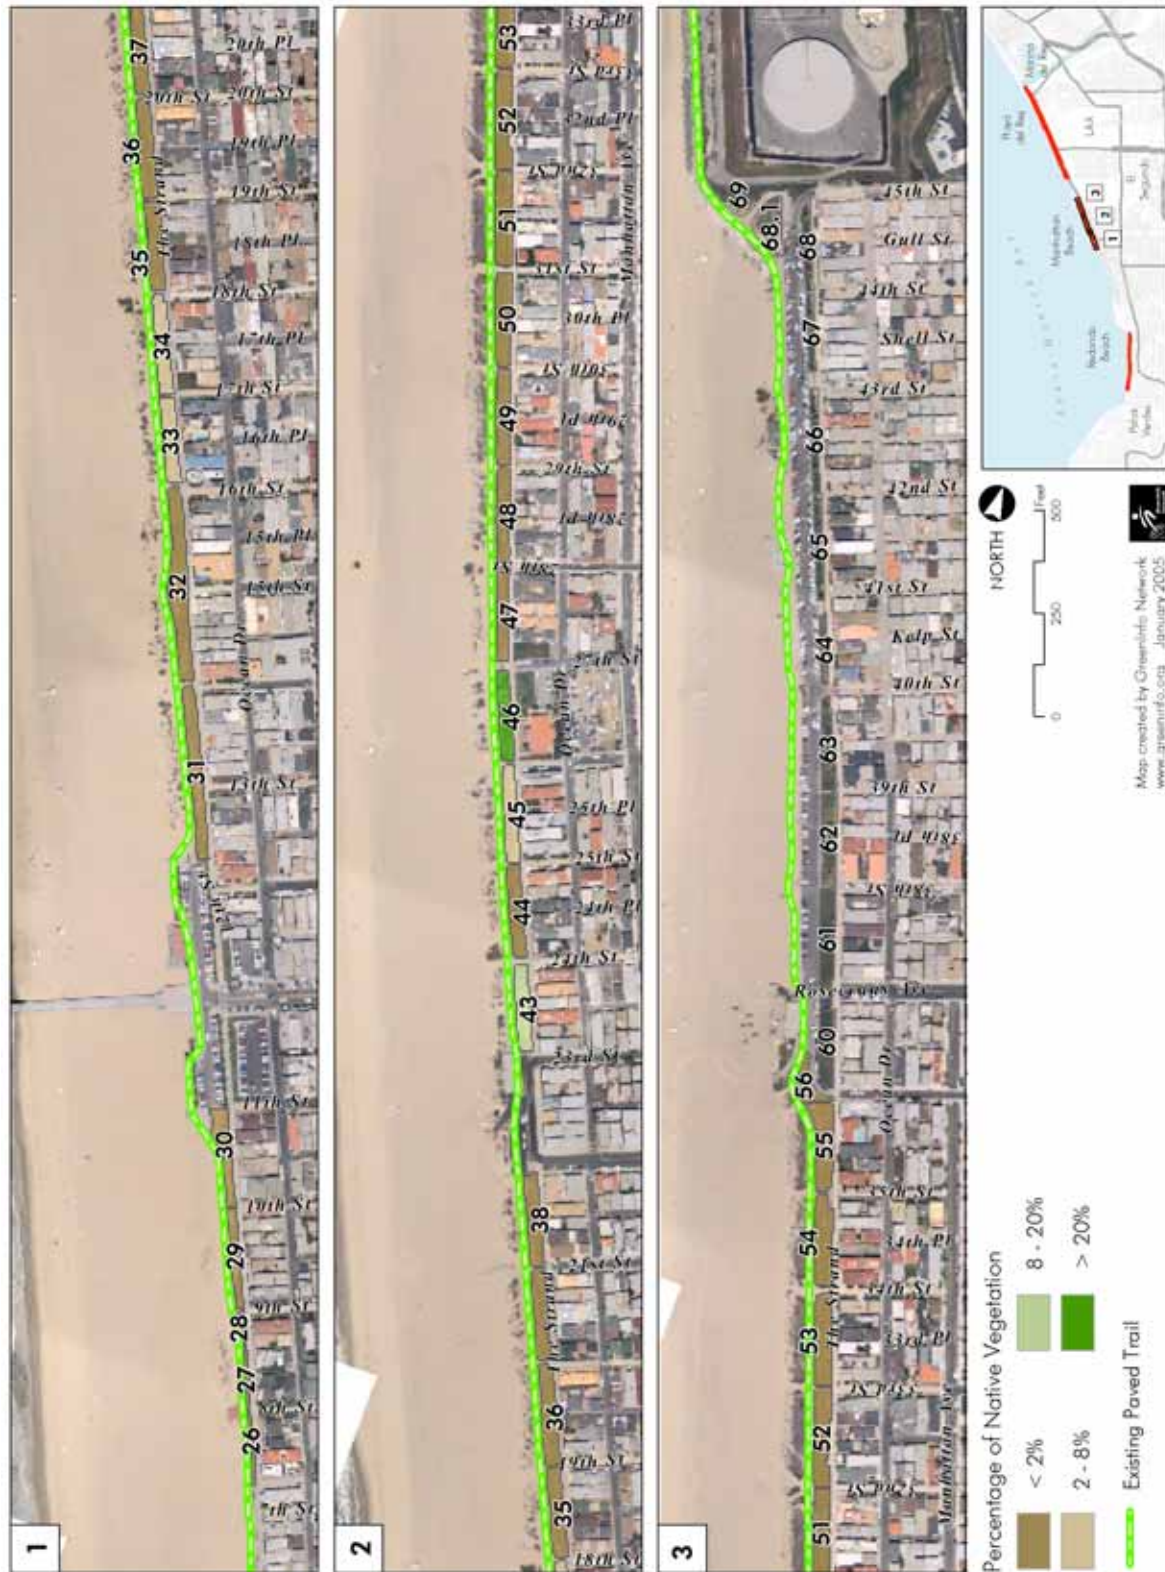
**Figure 7. Undeveloped bluffs along Santa Monica Bay showing percent native vegetation (Central Focus Area).**
